DESIGN EXAMPLES—SECTION 5

## 5.0 CASE STUDY—SAND CREEK

## Sand Creek Channel Improvements at Bluff Lake Park Denver, Colorado

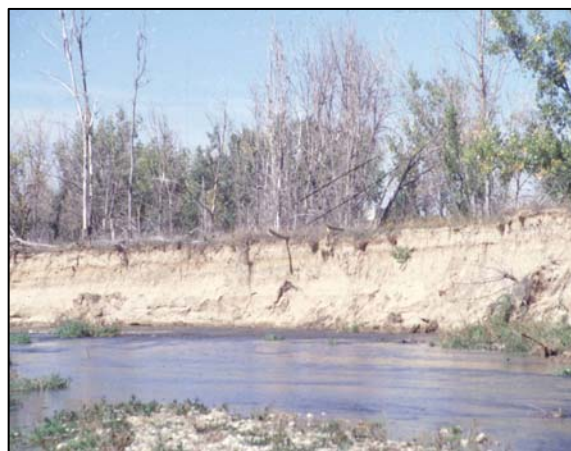
In addition to the integration of bioengineering techniques and traditional methods to provide the necessary stabilization, an important design concept was to create a meandering low-flow channel within the armored outer banks, or flood channel. A 25- to 40-foot-wide low-flow channel designed to convey a base flow of 20 to 50 cfs was left completely unconstrained to meander at will within the 40- to 140-foot-wide channel (conveying the more frequently

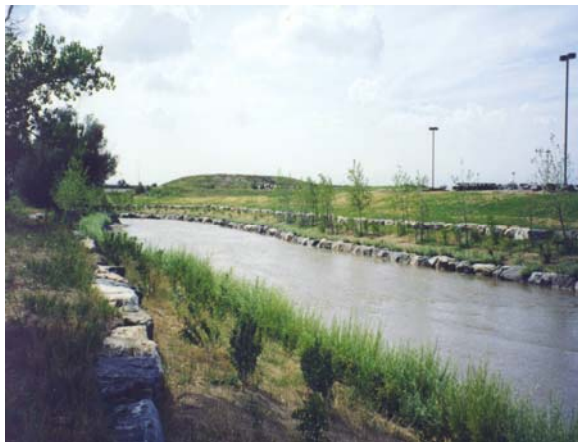
Stabilization of the channel bed was accomplished through the installation of two grouted boulder drop

structures with sheetpile cutoffs. The drop heights (4-foot and 8-foot) were set to achieve an average 0.2 % slope for the reach. The drop structures were designed with a step-pool configuration, with a maximum drop of 1.5 feet between each step and a minimum pool depth of 3 feet. These specifications allow for fish passage and provide resting habitat for migrating fauna. The boulder crests were installed in curving alignments and pools were given uneven shapes and sizes to avoid an overly structured look. The larger drop included a planting terrace along its length to restore streamside vegetation and soften the look of the structure. The structure included the wastewater effluent pipeline crossing in its crest. The cascading step-pool design of the grade control structures makes a nice park amenity with its soothing sound and natural aesthetic quality. Additionally, propane testing has indicated that the structure is an excellent passive re-aerator, with the 8-foot drop exhibiting an overall efficiency of 60% and individual step efficiency of close to 19%.

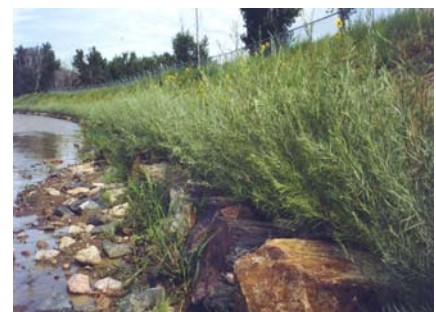
The primary treatment for stabilization of the main channel banks was a double boulder terrace with brush layering. The treatment consisted of two rows of large boulders set on a deep, concrete rubble foundation. The foundation was constructed using recycled runway concrete blocks from the demolition of Stapleton Airport. The minimum cutoff achieved by the boulders and the rubble foundation was 3 feet below the low-flow channel invert. A continuous line of coyote willow (*Salix exigua*) cuttings (brush layering) was then installed behind the lower boulder toe. The provision of vegetation along the immediate channel edge was especially important to restoring biological function because the plants provide leaf litter to the stream system (i.e., base of the food chain), as well as providing overhead cover for fish, and performing shading/cooling functions for the system. A planting terrace with a maximum slope of 3H:1V was created between the rows of boulders. The terraces were planted and seeded with native riparian trees, shrubs, grasses, and forbs. Two unique plant communities were established along

the terraces – cottonwood gallery and riparian scrub-shrub. The bank side slopes created by the combination of boulders and terracing were designed with a maximum effective slope of 2.5H:1V, which provided a substantial reduction from existing slopes. In most areas, the effective side slopes that were achieved were flatter than the design maximum. The slope protection in this treatment comes primarily from the two rows of boulders and secondarily from the root structure, which will be created as the vegetation matures.
