DESIGN EXAMPLES—SECTION 6

6.0 CASE STUDY— GOLDSMITH GULCH

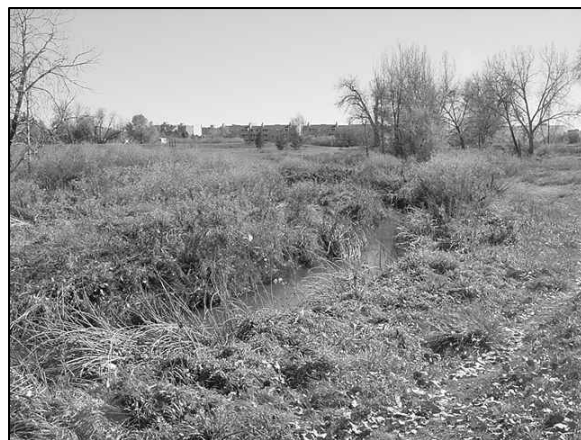
Inherent in all of the alternatives that were considered for channel stabilization was the concept of reducing the channel slope by the construction of drop structures. As a result of the extensive public involvement process that was undertaken during the design phase of the project, it was decided that there would be two drop structures that would divide Bible Park into three distinctly different channel reaches.

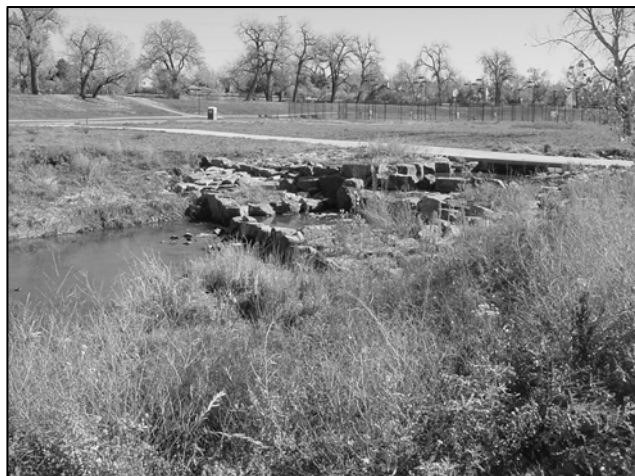
The middle channel reach was the most deeply incised and linear. The middle channel reach is located in the passive area of the park. The width of the park in the middle reach was sufficient to allow for the redevelopment of a new meandering channel. The new meandering channel was designed with sweeping oxbows that would be frequently flooded to sustain wetland vegetation. Sand blankets were installed in the low-lying overbank areas on the inside of bends in an attempt to provide a direct hydraulic connection to the wetland vegetation during low-flow conditions. The low-flow channel banks for the middle reach of the channel were protected with soil riprap that was vegetated with wetland species. Over the course of time, the vegetation in the low-flow channel bank has obscured the soil riprap. A foot path constructed with crusher fines follows close to the constructed meandering channel in the middle portion of the park. The footpath allows for passive enjoyment of the tranquil meandering channel and the enhanced wildlife habitat.

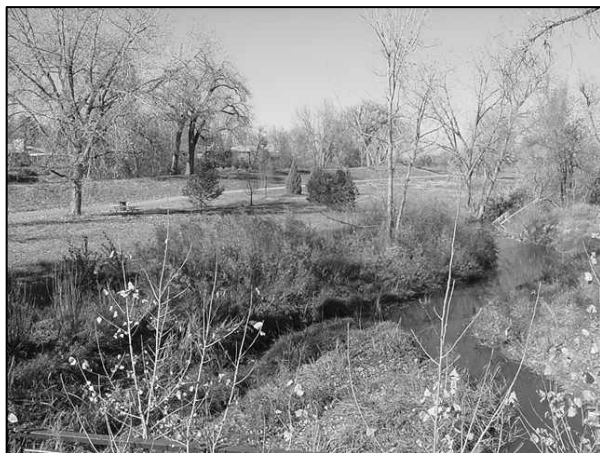
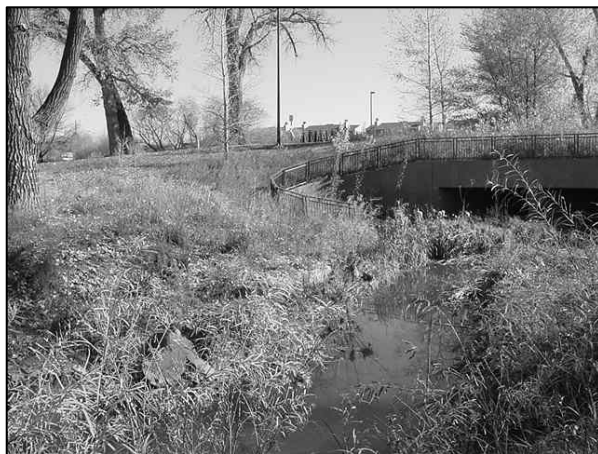
The lower drop structure has significant drop and provides an interesting overlook for park users by combining the drop with a pedestrian crossing. There are significant structural elements to the lower drop

structure. A concrete cutoff wall was integrated with the upstream edge of the trail crossing and the intermediate crests of the rock walls on the downstream face of the drop structure were stabilized with concrete walls that are hidden from view. The upper drop was constructed of boulders and was intended to provide a separation between the meandering channel portion of the park and the existing channel portion of the park. The drop structures have reduced the longitudinal slope of the channel to 0.21 percent.
