DESIGN EXAMPLES—SECTION 7

7.0 CASE STUDY—GREENWOOD GULCH

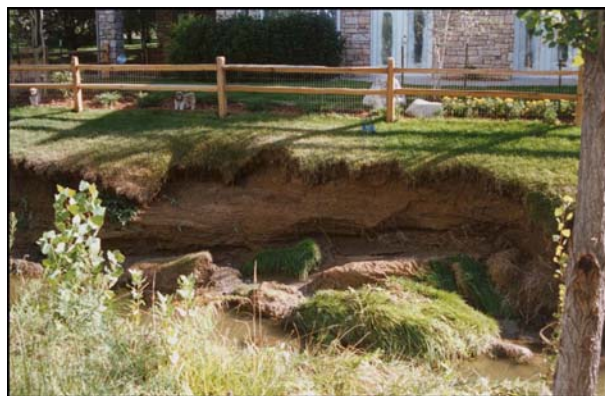
The increased erosion, in combination with some residential encroachment of the natural floodplain, threatened some private properties between Orchard Avenue and Holly Street (Photo 1). Informal attempts at erosion control by the property owners along Greenwood Gulch proved to be ineffective. The eroded materials tended to be deposited downstream in the vicinity of the Holly

Photo 1. Erosion of Residential Properties

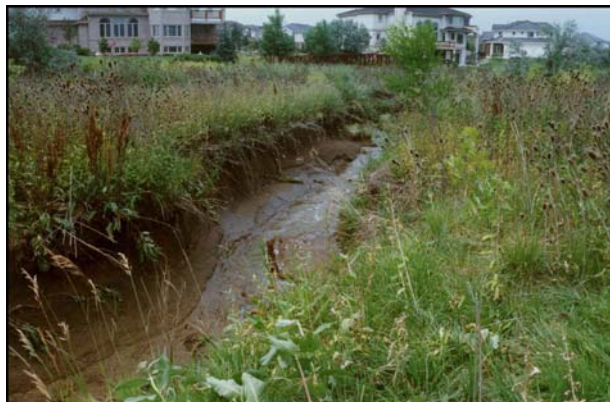
The changing flow and channel erosion regimes, however, were dynamic and eventually the channel became incised in some places to a depth of approximately 10 feet (Photo 2). This further changed the hydrologic regime by lowering the water table in the floodplain, drying up the riparian wetlands and allowing for the encroachment of noxious weeds. The public voiced significant concern with the erosion damage to the trail and the loss of the wetland habitat.

Photo 2. Loss of Wetland Habitat

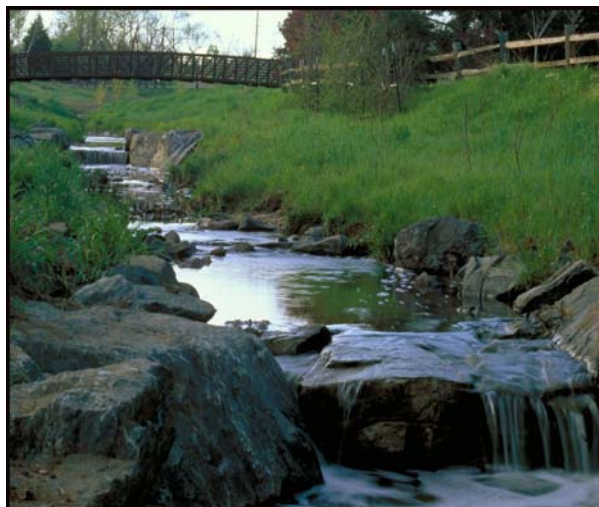
The final design for the reach between Orchard Avenue and the Holly Street bridge included one 4-foot large boulder drop structure immediately downstream of the Orchard Road bridge and six large boulder 1.5-foot drop structures (Photo 3 and Figures 3 and 4). The inclusion of these drop structures flattened the channel bottom slope to an average of 0.30%. The channel side slopes were regraded to slopes ranging from 2:1 to 3.7:1 and were protected with Type M riprap soil.

Photo 3 Large Boulder Drop Structure

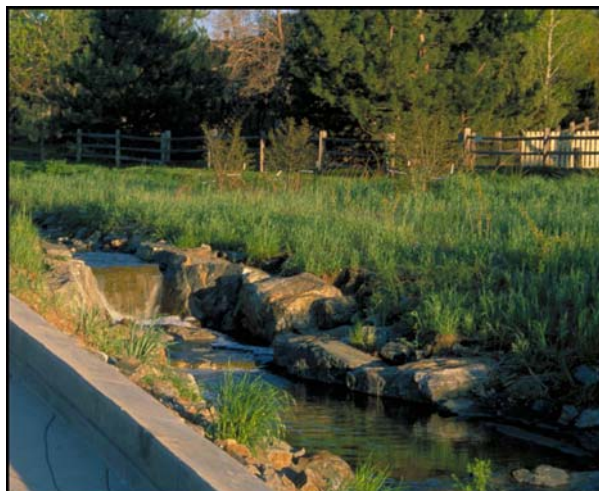
Photo 4 Two-Tier Large Boulder Drop Structure

One two-tier large boulder 4.0-foot drop structure was added upstream of the Holly Street bridge to lower the channel bottom to restore the conveyance capacity of the Holly Street bridge (Photo 4 and Figures 3 and 6).

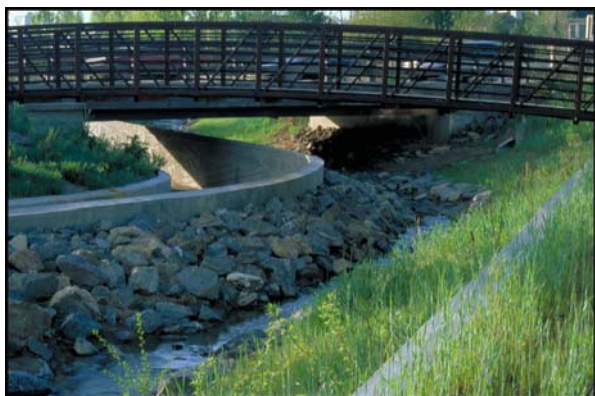
Photo 5 Holly Street Bridge and Riparian Trail

The bridge abutments and an 18-inch gas main crossing the stream channel complicated the relocation of the trail below the Holly Street bridge (Figure 6). The bridge abutments required structural shoring with a 12-inch-thick by 5.2-foot-high concrete wall. The trail was separated from the stream channel by means of a 6-

foot-high curved wall (Photo 5). In one location, the top of the trail was approximately 2 feet below the channel bottom. A sump pump dewateres the foundation for the trail. The trail is protected with a Type H riprap slope against the trail wall with the opposite protected by Type M riprap soil.

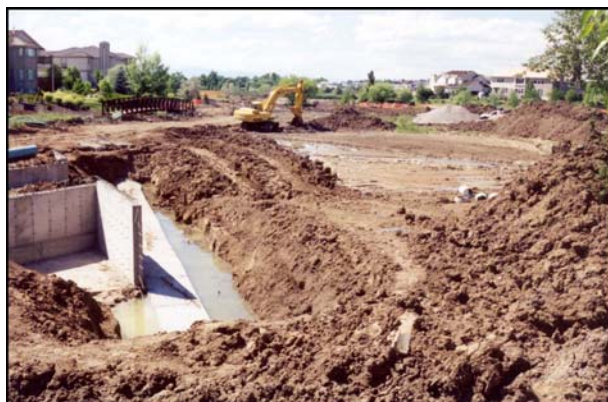
The construction included the excavation of approximately 9,000 cubic yards of sediment deposits (Photo 6). The floodplain was then graded to maintain a “channel” slope of 0.38% to 0.40% between three drop structures constructed with 36-inch minimum dimension boulders (Figure 7). The boulders were carefully placed with strict tolerances (± 2 inches) for top edge elevations to create a wide (80 to 170 feet) flat-bottomed channel (Figure 8).

Photo 6 Excavation of Accumulated Sediment

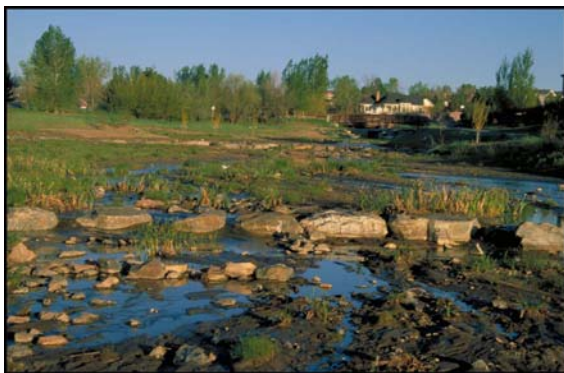
This wide and level configuration for the drop structures encouraged surface flows to spread throughout most of the width of the floodplain shortly following construction (Photos 7 and 8). The flat channel slopes control channel erosion and the wide flow path encourages infiltration of base flows and stormwater. In addition, the cutoff walls at each drop structure impede the longitudinal flow of groundwater, causing it to rise closer to the surface. These higher groundwater elevations, combined with the shallow surface

Photo 7 Upstream View toward Holly Street with Lower Drop No. 1 in Foreground

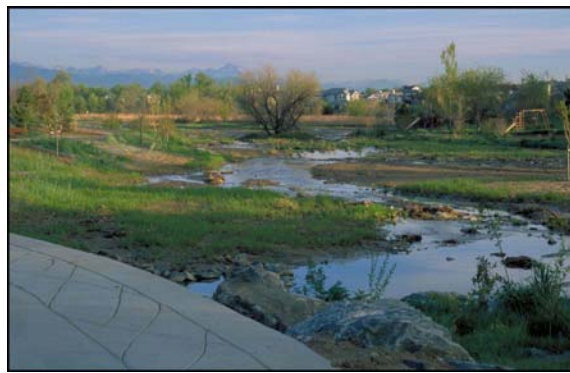
Photo 8 Downstream View from Holly Street toward Lower Drops No. 2 and No. 3

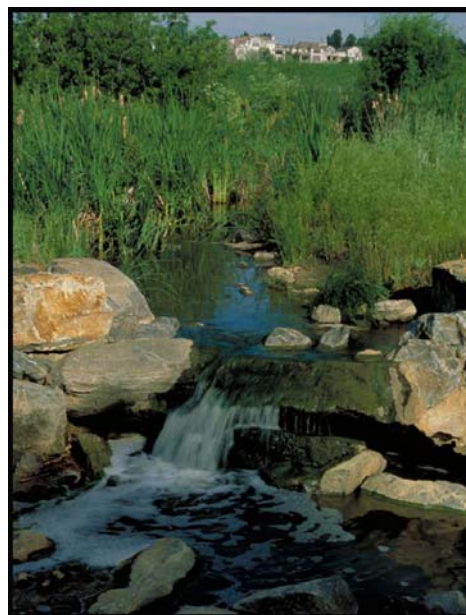
Two large boulder drop structures were constructed approximately 150 feet upstream of the Highline Canal on the two channels (Figure 10 and Photo 11). The same large boulder design concepts used upstream of Holly Street were applied to these lowermost 4-foot-high two-tiered drop structures. Both

Photo 11 Upstream View of Drop Structure No. 2 from Pedestrian Crossing
