# Trash Monitoring and Reporting Plan

*Los Angeles River and Ballona Creek Watersheds*

December 15, 2016

Project No. TOS-SN61

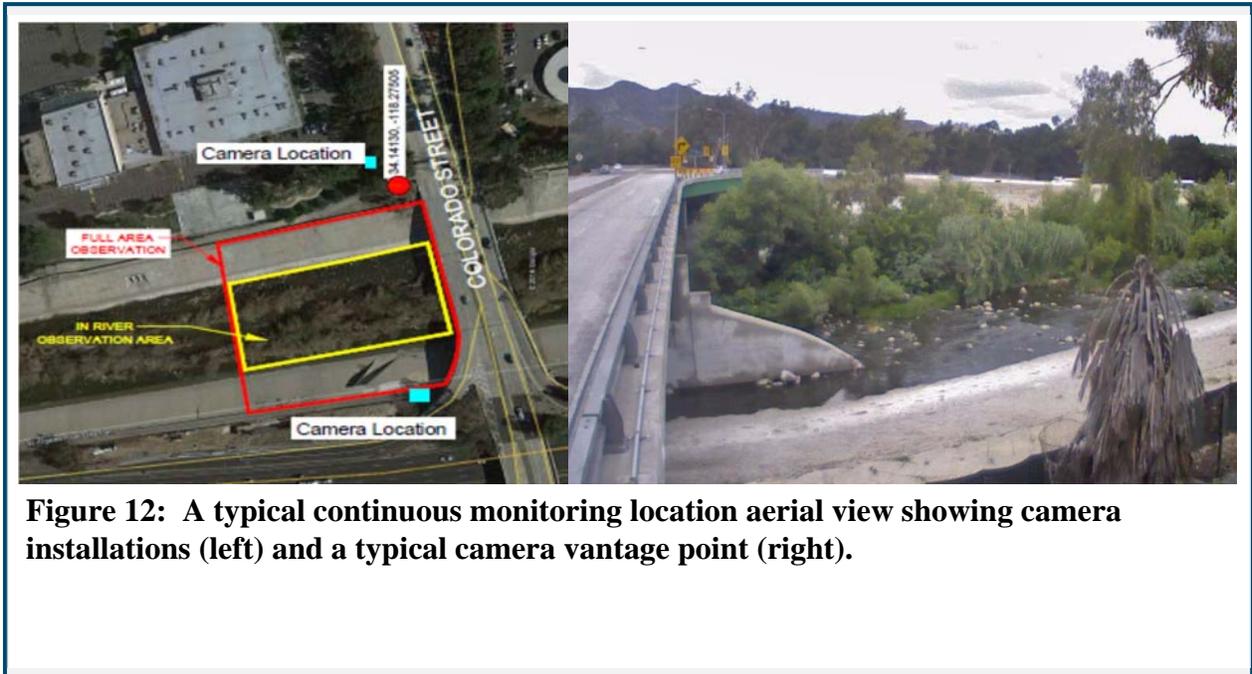
**Figure 12: A typical continuous monitoring location aerial view showing camera installations (left) and a typical camera vantage point (right).**

Pedestrian Bridge looking downstream. Figure 12 shows the camera locations and one of the vantage points for the Colorado Street Bridge location.

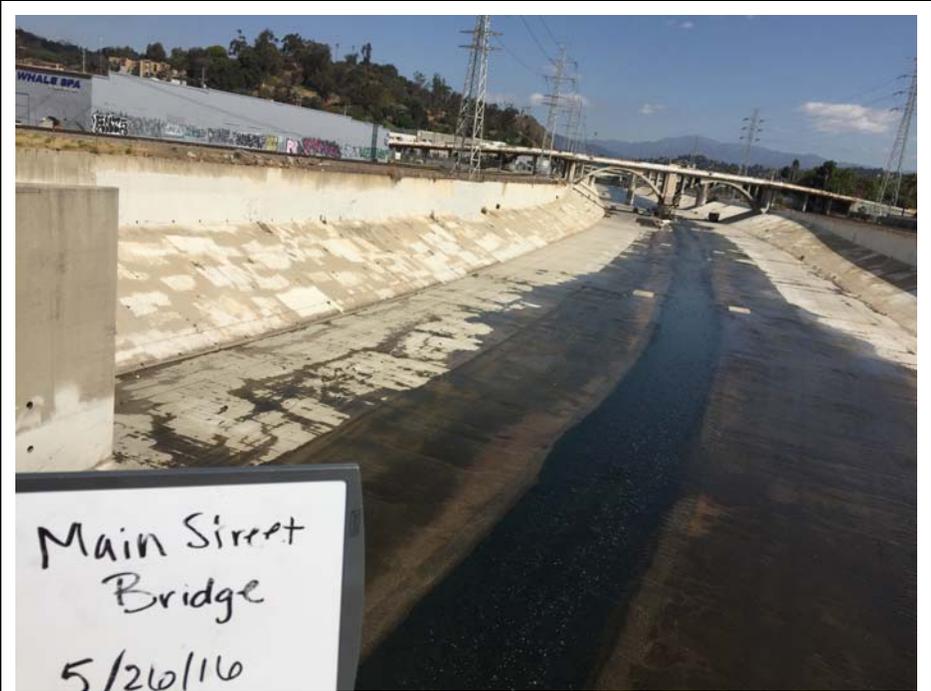
Photograph # 1  
Looking west at the river channel from the Main Street Bridge.

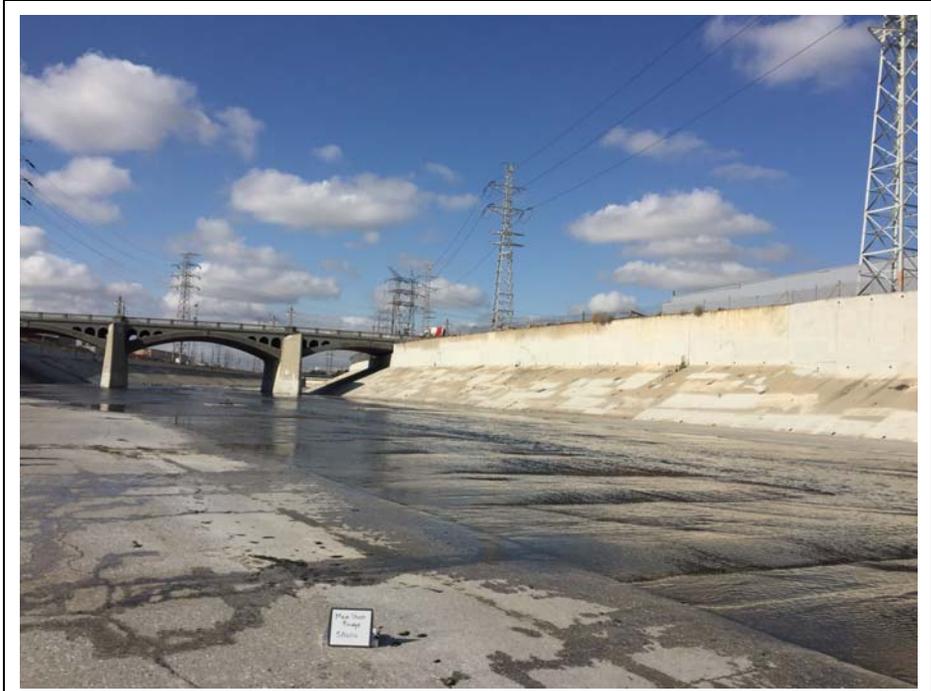
Photograph # 2  
Looking east at Main Street Bridge from within the river channel.

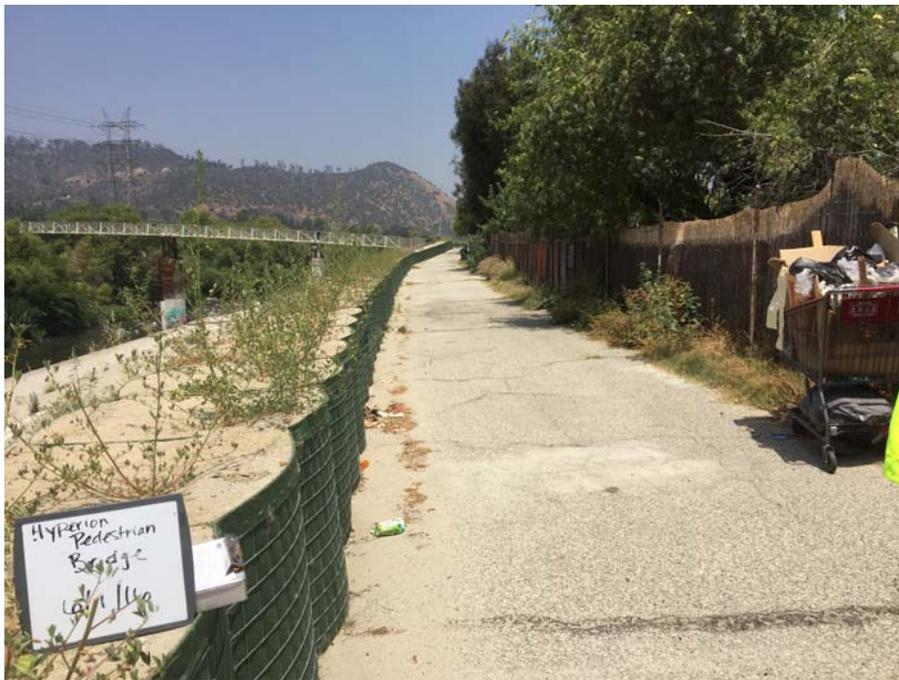
Photograph # 5

Looking north at the Pedestrian Bridge from the east side of the channel. View of the sand bag barrier and walking path. Trash debris observed on the outside of the barrier.

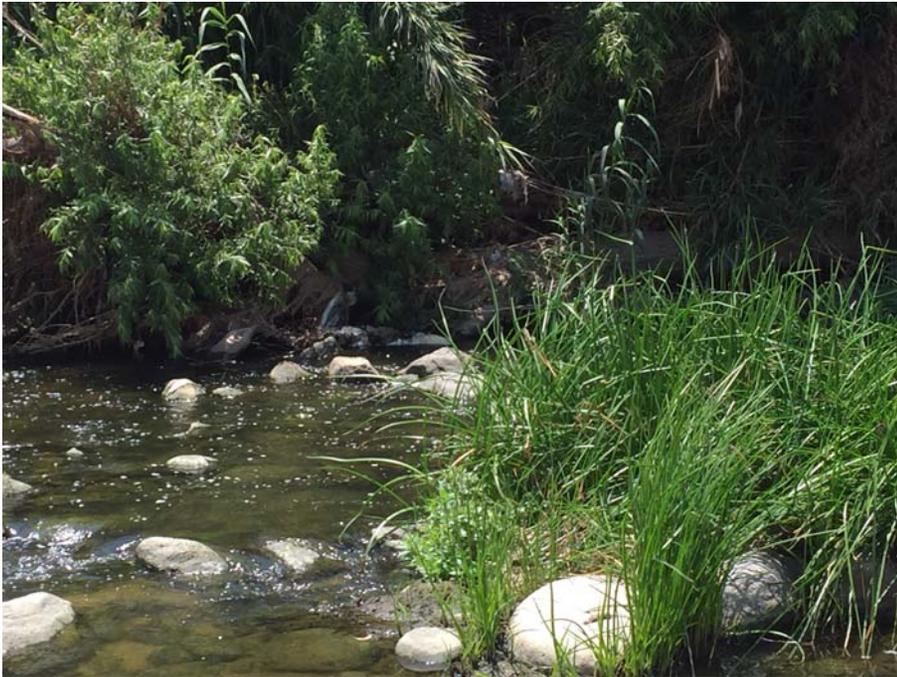
Photograph # 3

View of the trash debris observed within the vegetation.
