Field observations of the condition of inserts, excluders and CDS systems in the Westlake and Park Grove areas of Los Angeles, CA – 4/4/08

Vaikko Allen
CONTECH Stormwater Solutions Inc.
allenv@contech-cpi.com

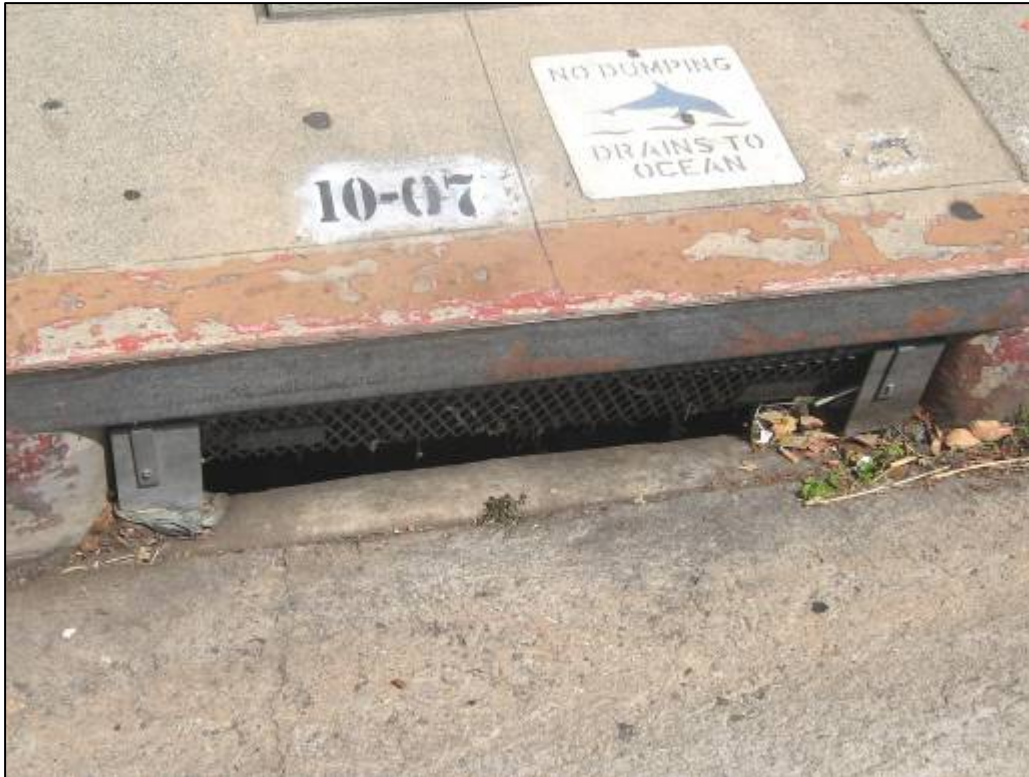
Excluder stuck partially open apparently not due to trash wedged in the opening.

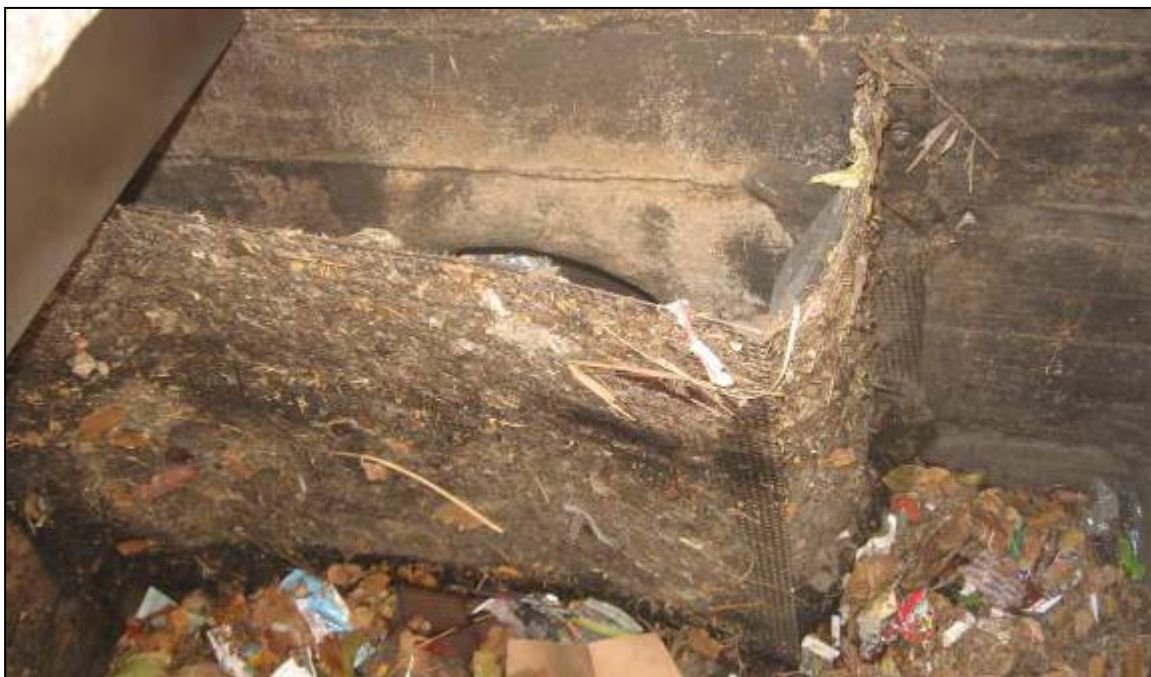
Vertical insert screen totally occluded with evidence of materials passing downstream. About 1"-2" of material on the floor of the catch basin.

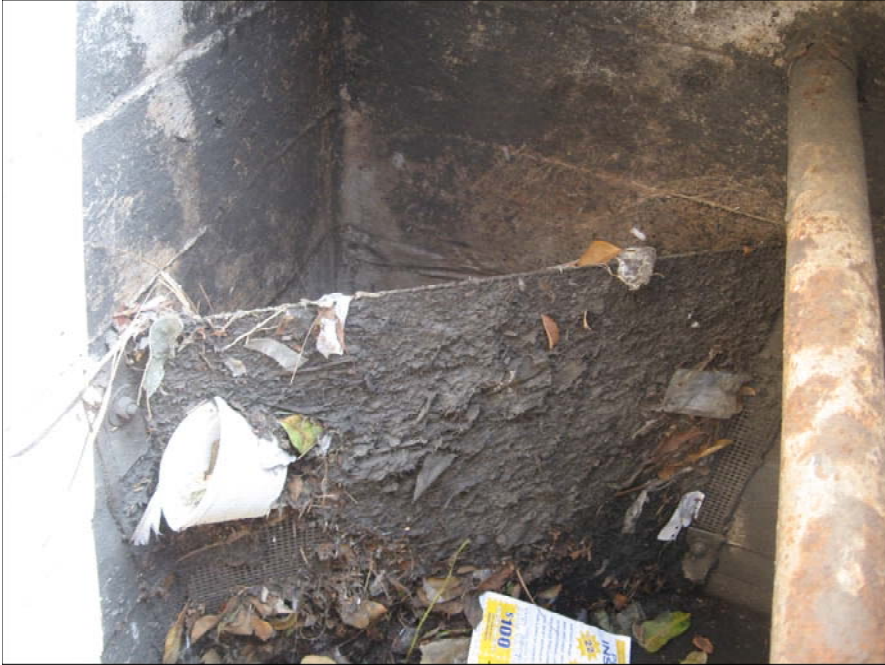
Vertical insert with sediment and debris stapled to the surface. About 10% of the screen area is visible. Materials clearly passing downstream. Less than 1" of material in the catch basin.

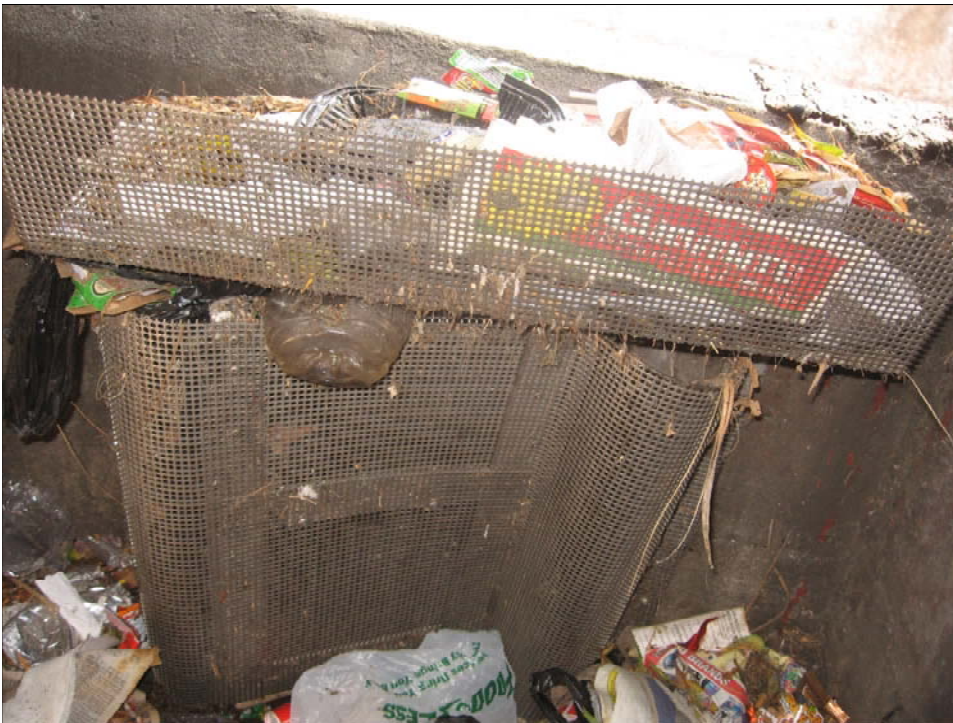
A vertical insert without much material in the screen, but it appears to have buckled under pressure from water pooled in the catch basin. Debris tray is installed under inlet because pipe exits toward street. About 2" of material on the floor of the catch basin.

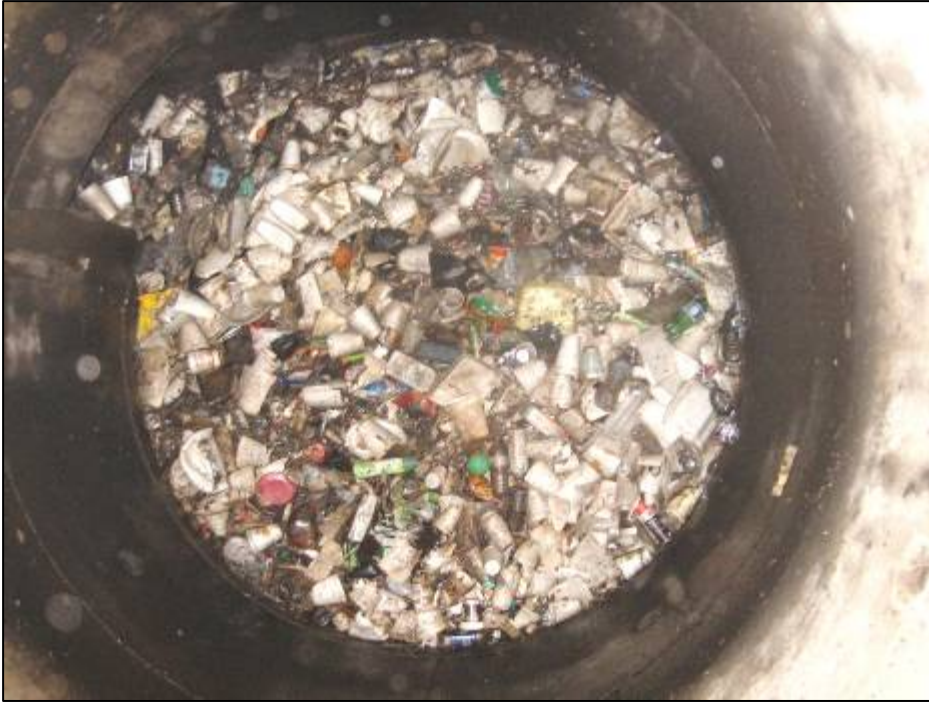
View of 7' diameter CDS separation chamber with a floating Styrofoam mat about 1' thick. Westlake System.

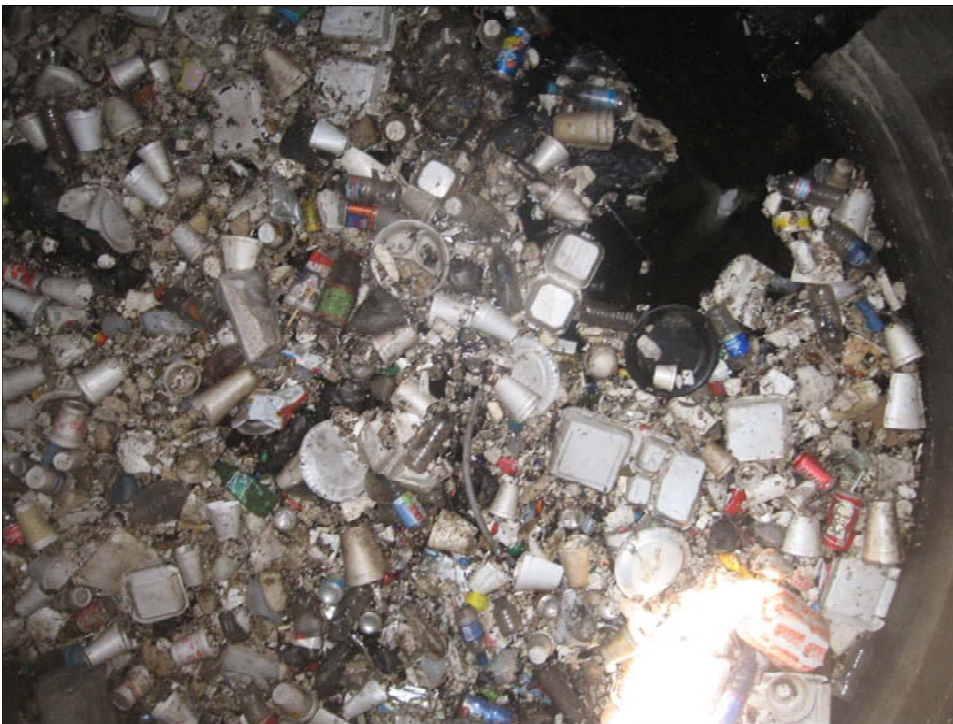
View of 10' diameter CDS separation chamber with a floating Styrofoam mat about 1' thick. Park Grove System.
