Ojai

Waterbody: Fox Canyon Barranca (tributary to San Antonio Creek)

Location: Concrete box channel upstream Ojai Valley Athletic Club and downstream pedestrian walkway (34°26'41.25"N, 119°14'28.43"W)

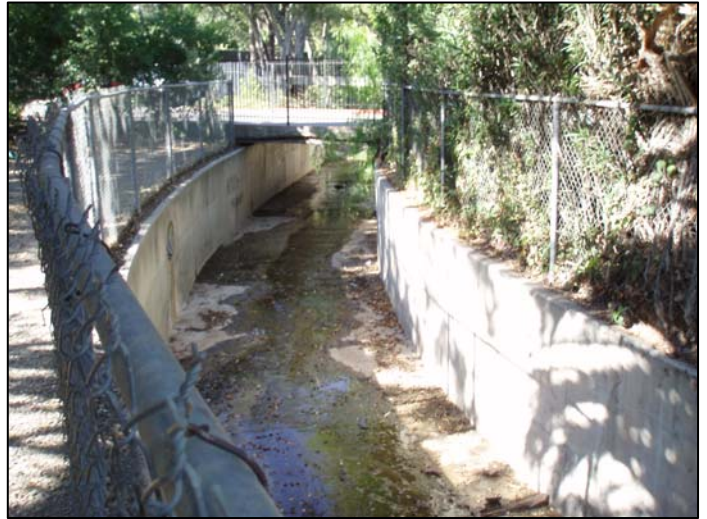
Pros: Numerous bridges to sample from, located behind VCWPD gate, likely well-defined rating table

Dry Season Flow Potential: Likely intermittent year-round flow due to urban runoff

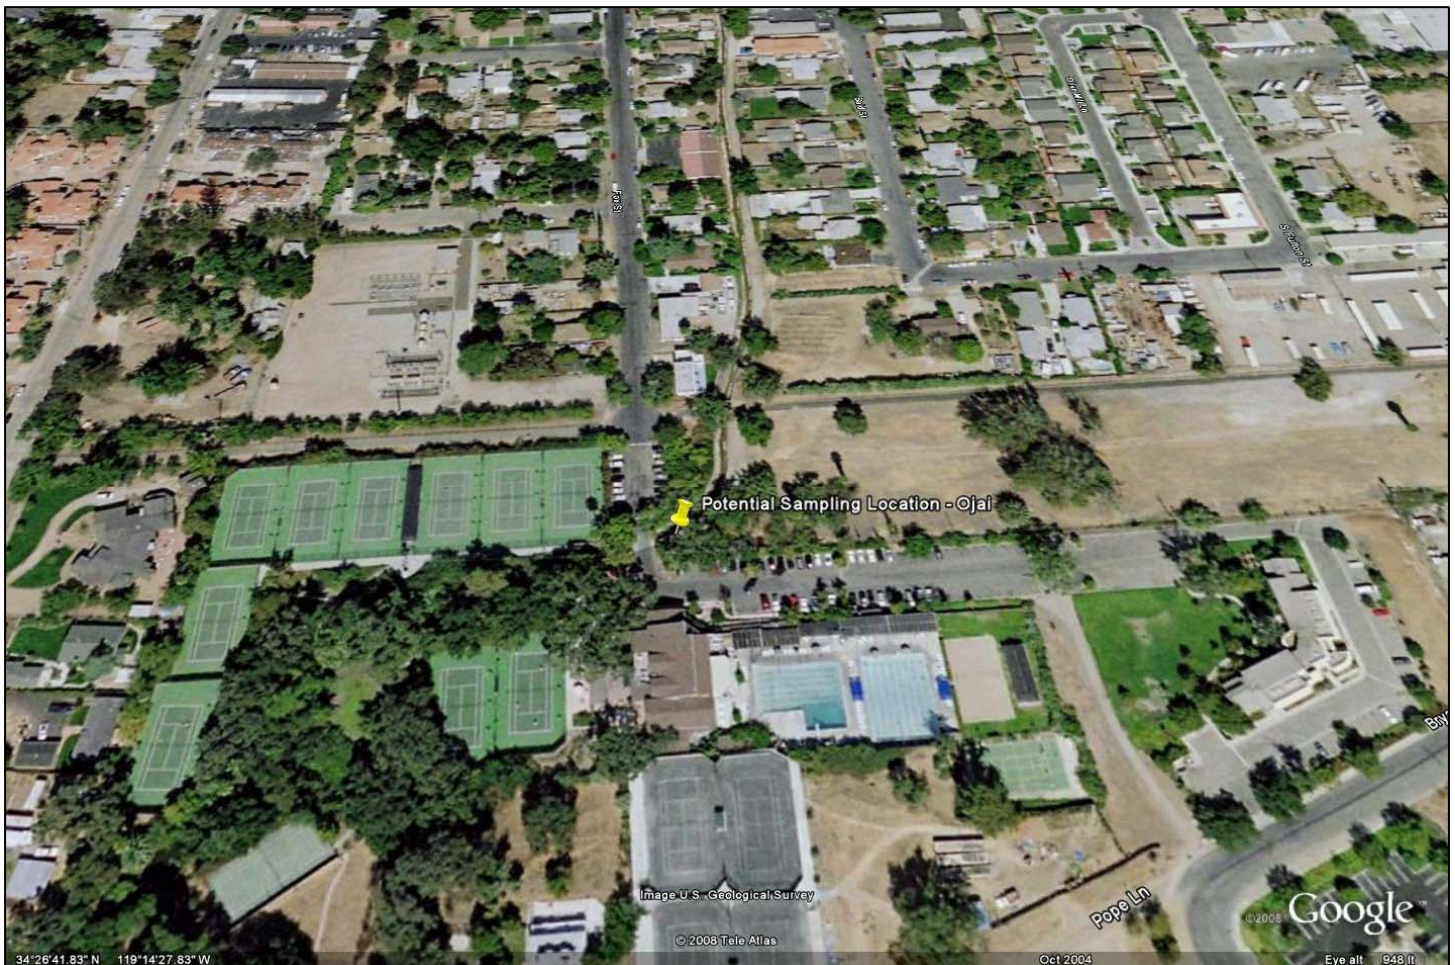
Entire Watershed

Land Use	Acres	% of Total Watershed
Agriculture	83.1	3.0%
Cemeteries	3.8	0.1%
Com_Indus. Mix	7.6	0.3%
Commercial	155.1	5.6%
Facility	43.2	1.5%
Industrial_3	13.2	0.5%
No Info Given	55.6	2.0%
Recreation	312.1	11.2%
Res.1	620.7	22.2%
Res.2	61.3	2.2%
Res.3	534.8	19.1%
Res.4	3.3	0.1%
Schools	100.6	3.6%
Utilities	32.9	1.2%
Vacant Undifferentiated	767.1	27.5%
Totals	2794.7	100.0%

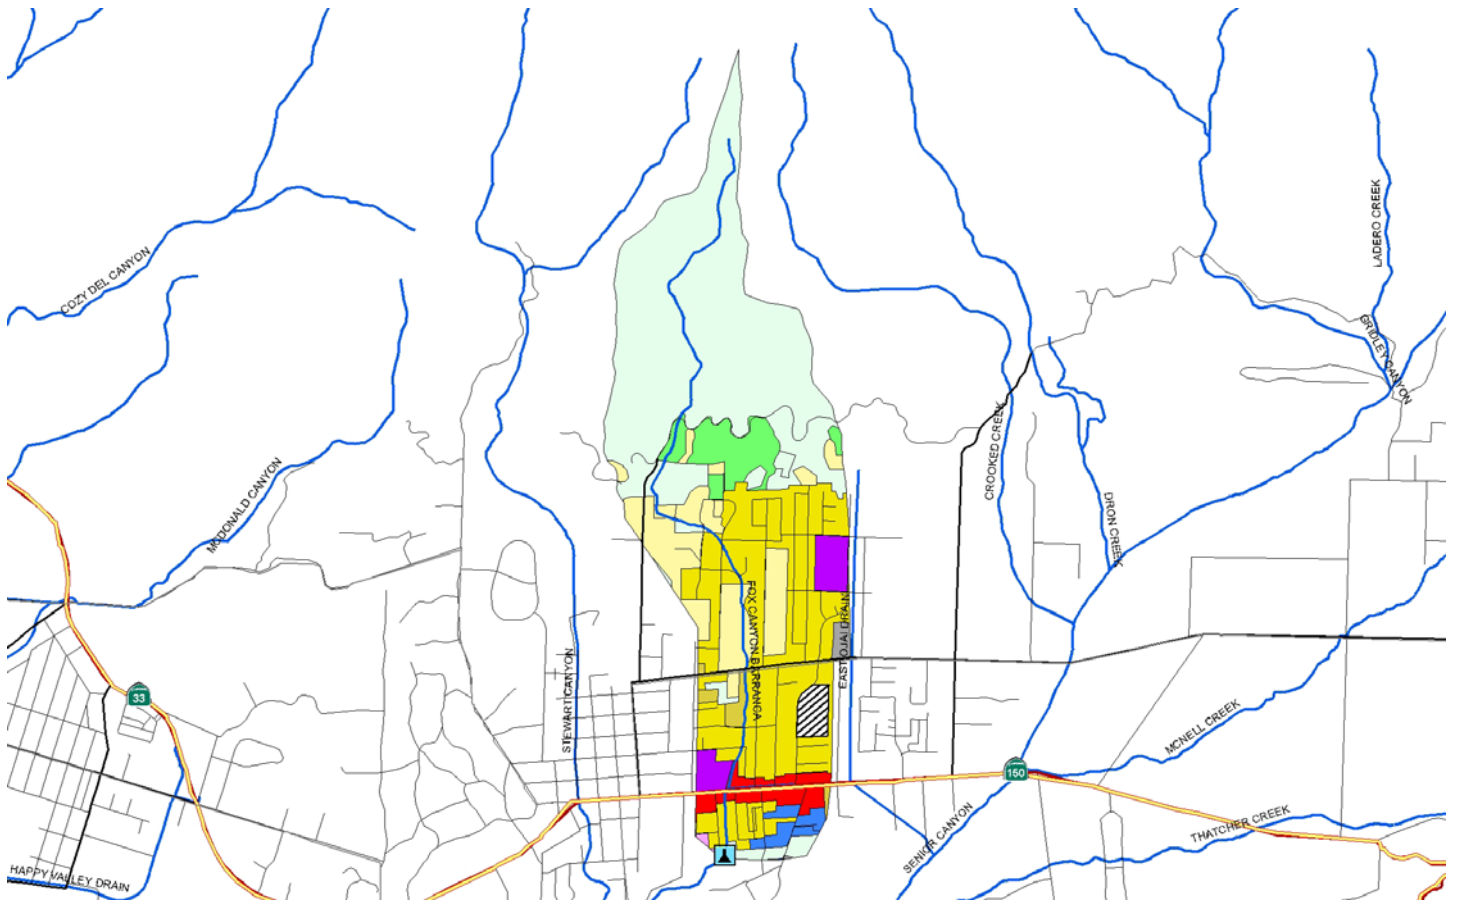
Selected Subwatershed

Land Use	Acres	% of Total Watershed
Agriculture	37.3	5.0%
Commercial	23.8	3.2%
Facility	4.1	0.6%
Industrial_3	11.4	1.5%
No Info Given	10.0	1.3%
Recreation	0.1	0.0%
Res.1	84.3	11.3%
Res.2	8.0	1.1%
Res.3	210.9	28.2%
Res.4	0.1	0.0%
Schools	20.2	2.7%
Utilities	1.0	0.1%
Vacant Undifferentiated	337.5	45.1%
Totals	748.6	100.0%
