REGIONAL WATER QUALITY CONTROL BOARD
CENTRAL VALLEY REGION

LAKE BRITTON HARMFUL ALGAL BLOOM
ASSESSMENT

June 2020

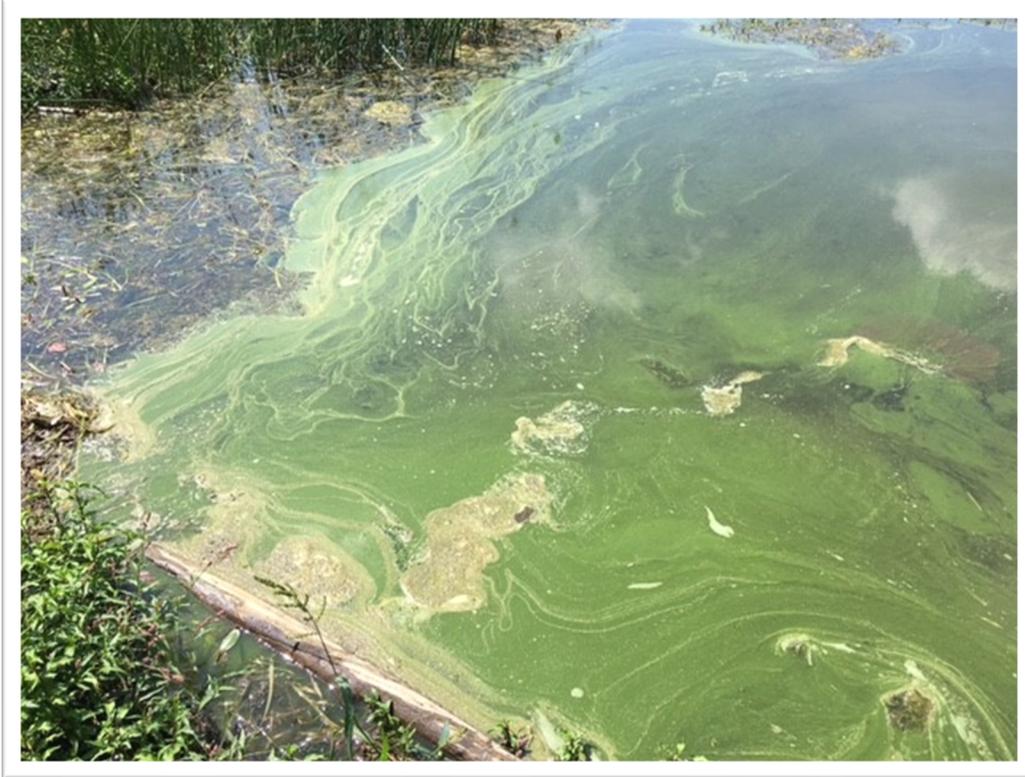
Figure 2: Photo of HABs near Burney Falls State Park beach at Lake Britton, 2017

Generally, cyanobacteria in Lake Britton, seen below in Figures 2-4, is prevalent in the hot summer months. Blooms typically develop in late June/early July and disperse by October. Blooms are most pronounced in the drought years and have an impact to recreational beneficial uses at Lake Britton. HAB species, toxins, and features at the lake are summarized below in Table 2.

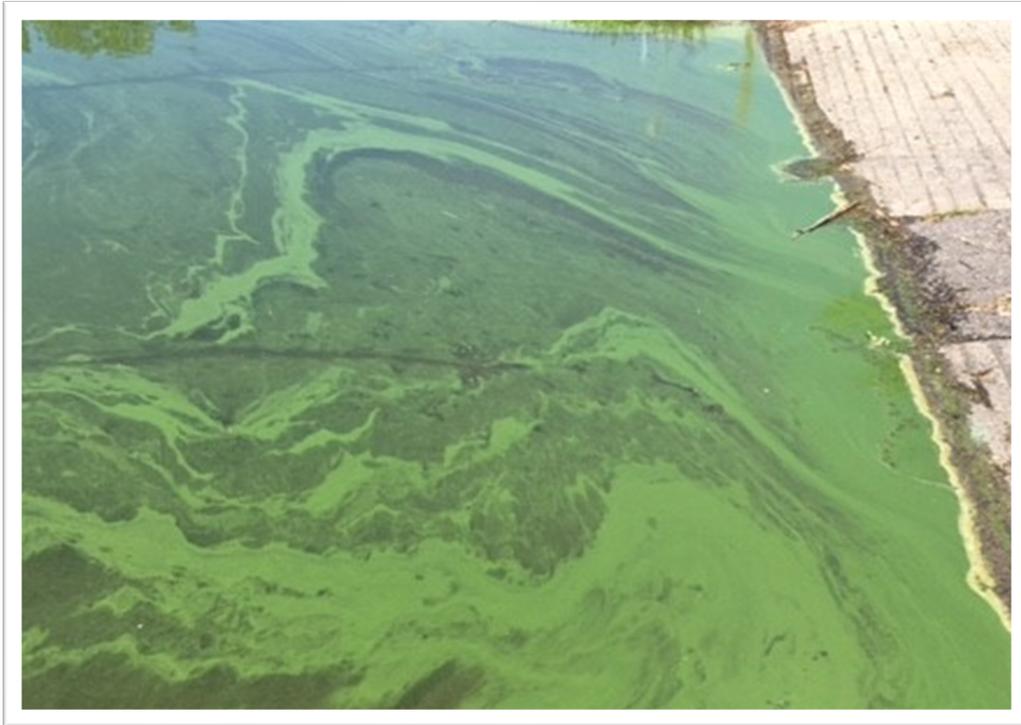
Figure 3: Photo of HAB in Lake Britton at the State Park Boat Ramp, 2016

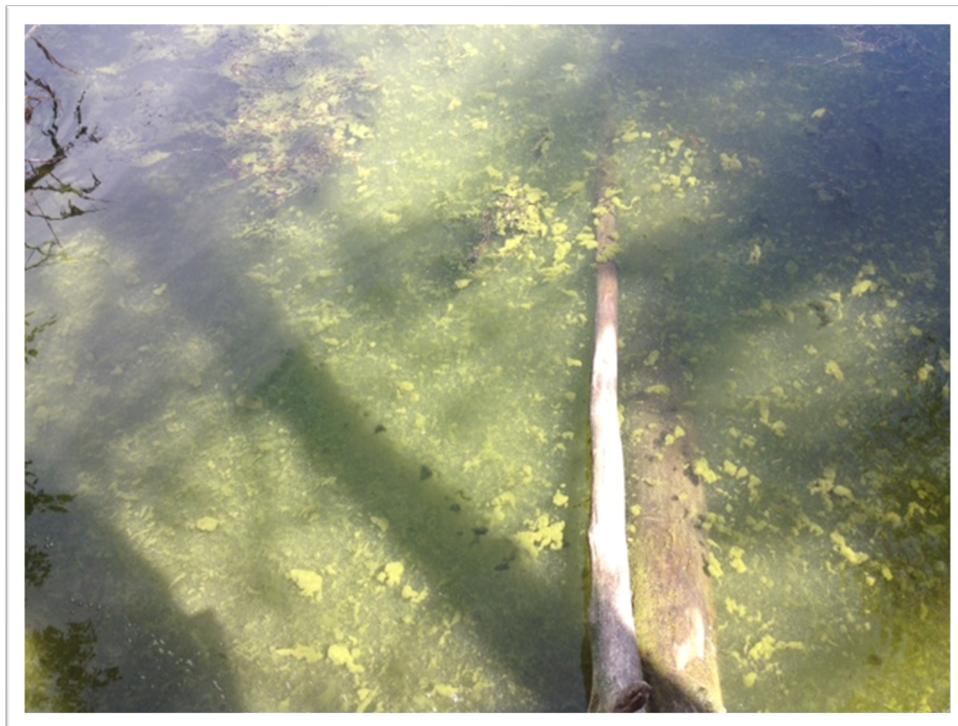
Figure 4: Photo of HABs near Burney Falls State Park beach at Lake Britton, 2015

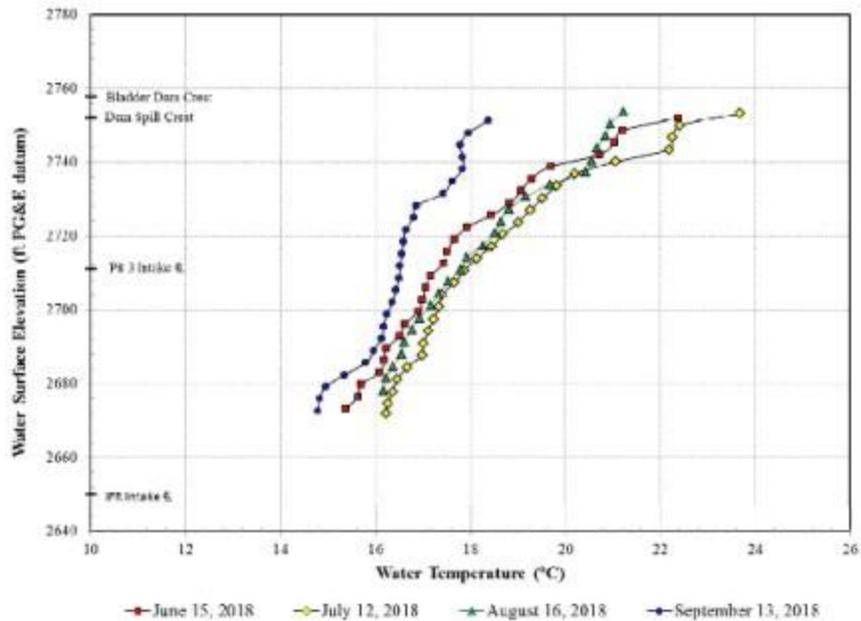
Lake Britton is seasonally stratified by water density with warmer, less dense water near the surface and cool higher density water below in the summer. During the winter, the surface layer cools, wind velocity increases and inflow rises reducing lake stratification. Flow management through the reservoir can influence the lake stratification by drawing water from different levels in the lake. PG&E water column monitoring, lake stratification, and changes produced by water releases all have potential impacts on HABs. Figure 5 compares four water temperature profiles throughout the summer in 2018 (PG&E, 2019). Sampling between June and August all show water temperatures above 20°C .

Figure 6. Comparison of monthly water temperature profiles from Lake Britton near Pit 3 Dam - 2018.

Figure 5: PG&E figure of Lake Britton water temperature at depth, showing warm surface water and cool deep water

The PG&E temperature depth profile, seen above in Figure 5, could also influence HABs in Lake Britton. The lake is stratified in the summer with warm water accumulating in the upper five meters and cool water at depth. This warm layer is produced by warm inflow and air temperatures. The warm layer gets larger during June through September when blooms are most pronounced. This layer provides favorable habitat for cyanobacteria and warm temperatures may also stimulate nutrient cycling in the lake. The low dissolved oxygen layer may also have an impact on phosphorus cycling in the lake. Current flow management is raising water temperatures at middle and lower depths in Lake Britton. Higher water temperatures could stimulate increased nutrient from lake sediment and stimulate activity in benthic life stages of cyanobacteria.

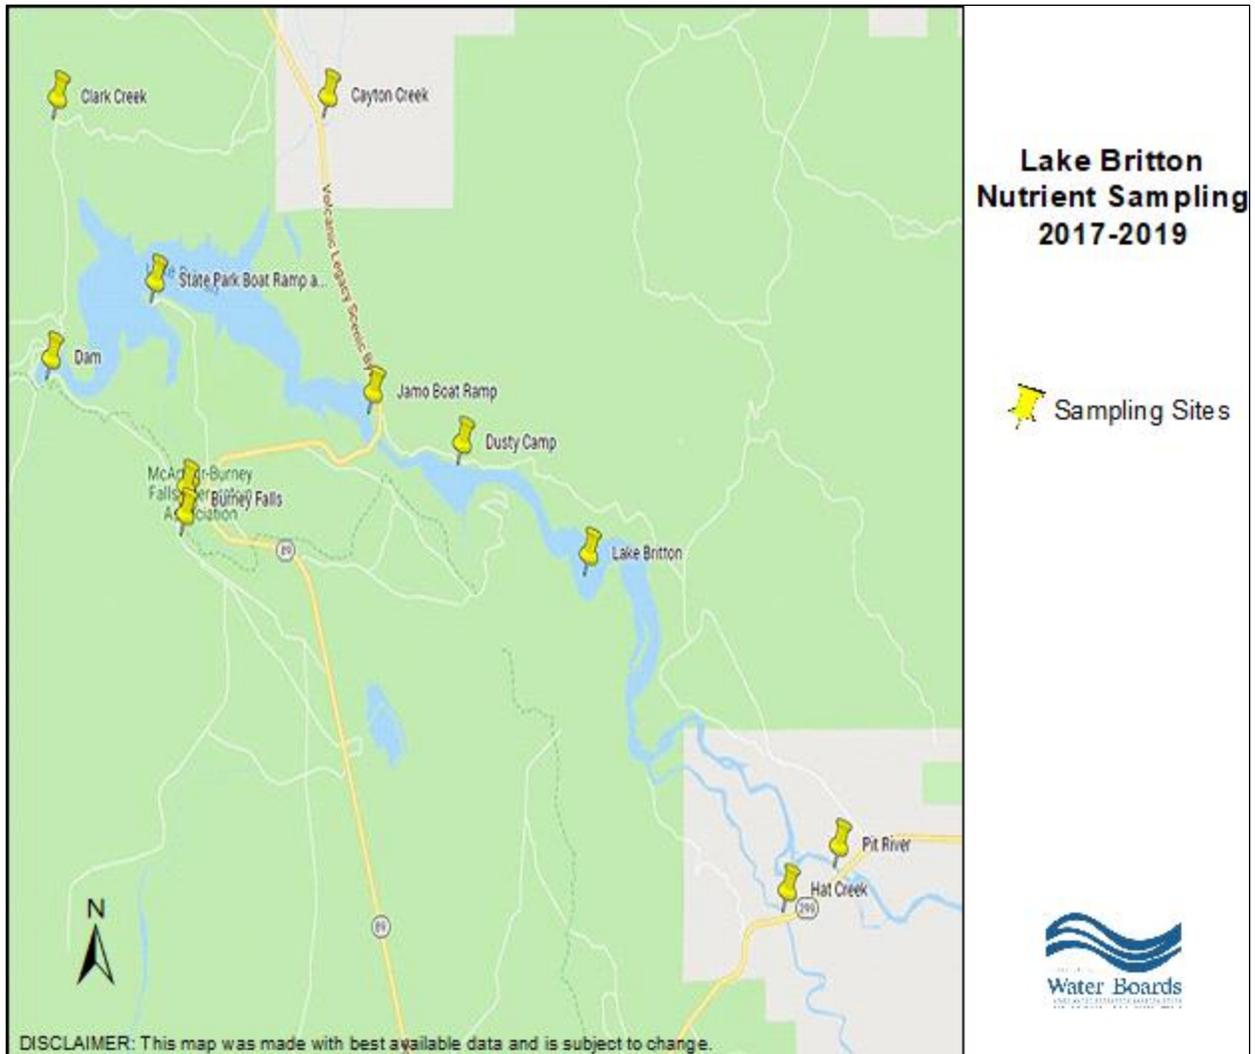
To assess the water quality and potential drivers of HABS in Lake Britton, Waterboard staff conducted water quality sampling over multiple years at the main tributaries entering Lake Britton (Figure 6). Between 2017 and 2019, there were four sampling events that took place both at low water and high water (Table 3). Staff also reviewed temperature data and flow estimates collected by PG&E to compare the temperature stratification.

Figure 6: Map of sampling locations around Lake Britton
