**CALIFORNIA REGIONAL WATER QUALITY CONTROL BOARD
LAHONTAN REGION**

**MEETING OF NOVEMBER 15-16, 2017
SOUTH LAKE TAHOE**

ADDITION TO OCTOBER 2017 EXECUTIVE OFFICER'S REPORT

Incidence of Harmful Algal Blooms Increasing throughout the Lahontan Region

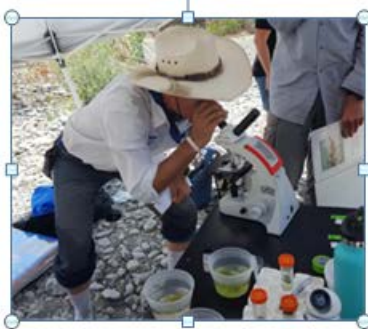
Photo 1: Field Microscope

Photo 1: [VWL](#) staff observing cyanobacteria under a field scope, **Photos 2-4** show photomicrographs of dominant species of cyanobacteria found in samples collected from surface waters in the Lahontan Region.

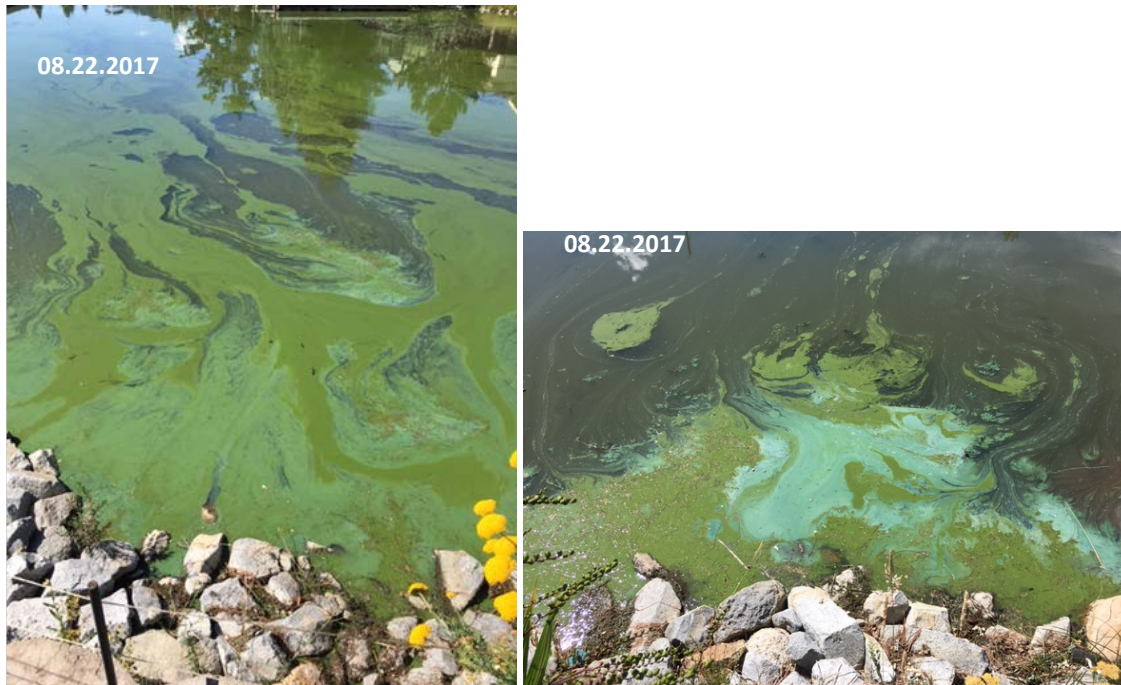
waterways). The following pictures taken on site showed a spilled-paint look, which is a typical appearance of cyanobacteria when it is releasing toxins.

Field visits verified the presence of site indicators of cyanobacteria (blue-green color, floating scum, visible algal mats) throughout the Tahoe Keys West Lagoons. Additionally low levels of cyanotoxins (Anatoxin-a and microcystins) were confirmed by an independent genetics laboratory in samples collected by staff and the Tahoe Keys Property Owners Association (TKPOA). Based on these triggers, Water Board staff recommended the TKPOA advise people, who may be recreating in the impacted water, of the potential health risk. TKPOA posted caution signs throughout the Main Lagoon and also reached homeowners by email, social media, and the [TKPOA Weed Management website](#). The recommendation to post a Caution level advisory was consistent with [health triggers](#) for recreational lakes.

Throughout August and September, staff coordinated with TKPOA, State Board, and USEPA-Region 9 to continue monitoring the HAB event occurring throughout the Tahoe Keys Lagoons. Though toxins were continually detected, levels were never elevated above concentrations that required more than a caution level advisory. The toxin levels detected did not trigger restrictions of recreational activity in the Keys waters. However, the results indicated low levels of Anatoxin-a (a neurotoxin), so staff recommended TKPOA warn the public about the potential risk posed to domestic pets (dogs) because a pet's potential exposure is much greater than it is for a human. When a dog enters water impacted by the cyanobacteria, the dogs can be exposed to the toxins if the dog ingests the water, licks its fur (toxins remain on a saturated coat that then dogs lick), or swallows a glob of algae or scum.

Caution signs throughout the TKPOA community remain in place today. TKPOA staff collected samples on September 18, 2017 and analyzed the samples at a commercial laboratory and sent duplicate samples for analysis at a USEPA laboratory. Both sets of laboratory results indicate cyanotoxin levels continue to decrease throughout the Tahoe Keys Lagoons, as compared to samples collected and analyzed in late August 2017. The EPA laboratory results indicate non-
