This report is part of the Staff Report – Basin Plan Amendments- Revisions to Recreational Standards for Inland Fresh Surface Waters in the Santa Ana Region, January 12, 2012

5.6.5 UAA Analysis: Temescal Creek

The following discussion summarizes and references the August 2010, “Use Attainability Analysis Technical Report for Temescal Creek” CDM, August 2010 (TC Technical Report). Maps, tables, and photographs from the technical report are reproduced here directly or adapted and referenced appropriately. The text also describes Regional Board staff’s observations of Temescal Creek and analysis of data collected.

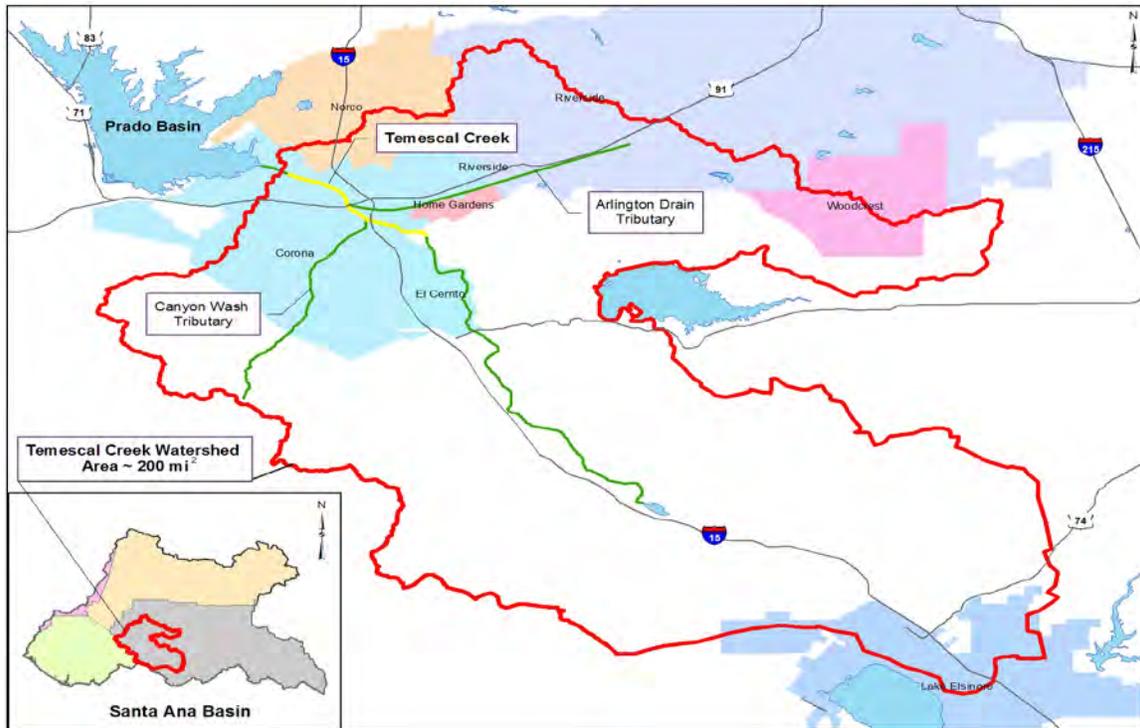
Figure TC-1, Map of Temescal Creek Watershed. Source: Use Attainability Analysis Technical Report for Temescal Creek, CDM, August 2010, Figure 2-1.

The Temescal Creek watershed is located in Riverside County and is approximately 200 mi² in size (Figure TC-1). Temescal Creek extends approximately 28 miles from Lake Elsinore to the Prado Basin. The area of the Creek under study in this UAA is within what is currently identified in the Basin Plan as Temescal Creek, Reach 1, extending from Lincoln Avenue to the Riverside Canal¹ in the City of Corona (Basin Plan, Chapter 3, Table 3-1). Tributaries to Reach 1, which include Arlington Drain, Norco Channel and Main Street Channel, are not included in this UAA.

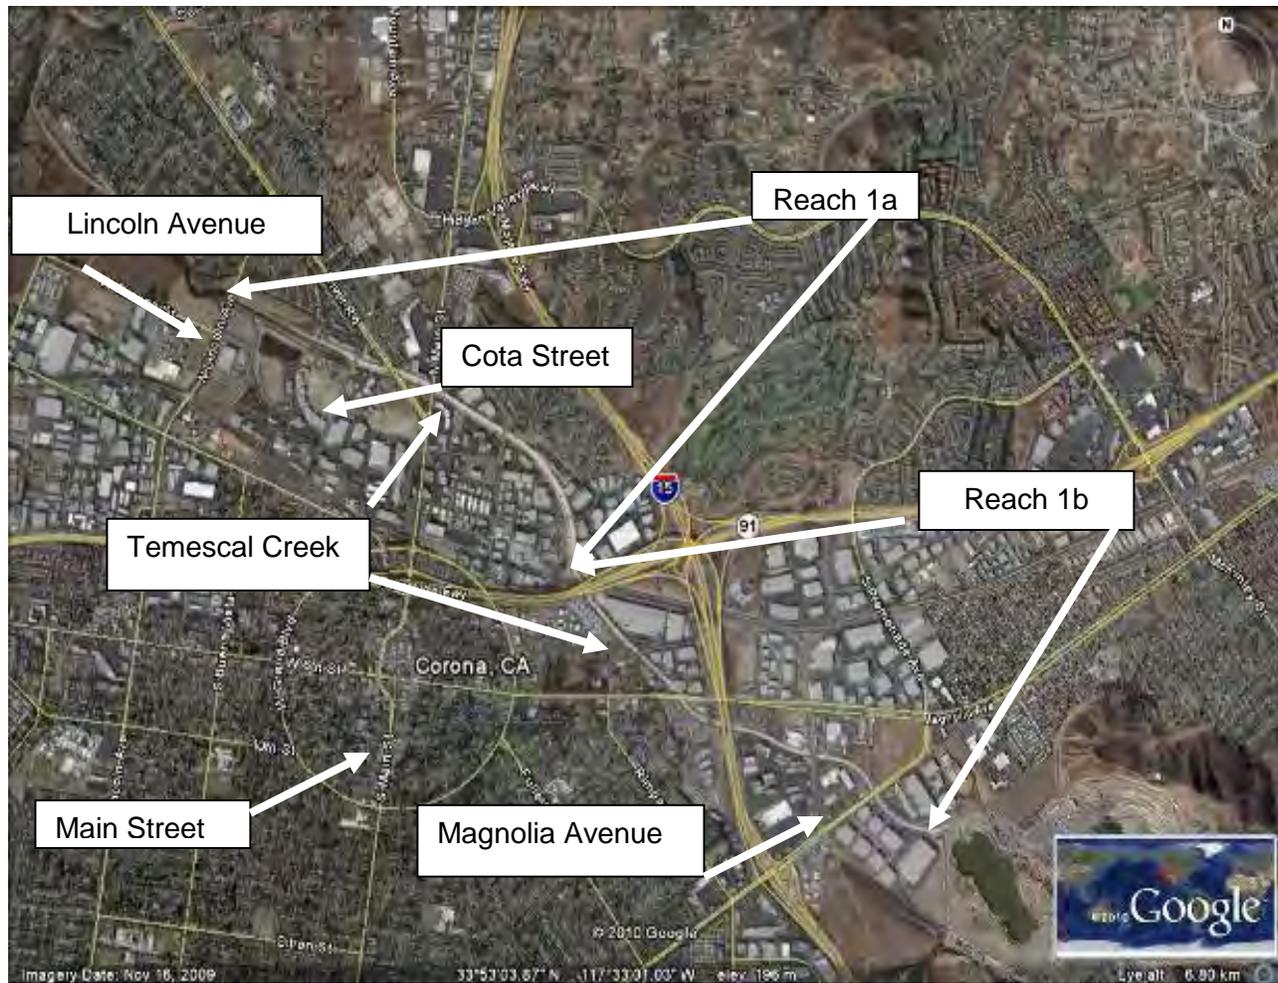
Figure TC-2. Proposed Reach 1a and 1b of Temescal Creek and Surrounding Area.

For the purpose of designating recreation water quality standards, staff proposes that Reach 1 be subdivided into Reach 1a and 1b (see also Section 5.8 of the Staff Report).

Reach 1a: from Lincoln Avenue (33°53'29.904"N, 117°34'12.432"W) to the confluence with the Arlington Channel (identified in the TC Technical Report as the Arlington Drain) (approximately 33°52'51.204"N, 117°33'15.732"W);

Reach 1b: from the confluence with the Arlington Channel to approximately 1,400 feet upstream of Magnolia Avenue (approximately 33°52'1.992"N, 117°31'30.108"W).

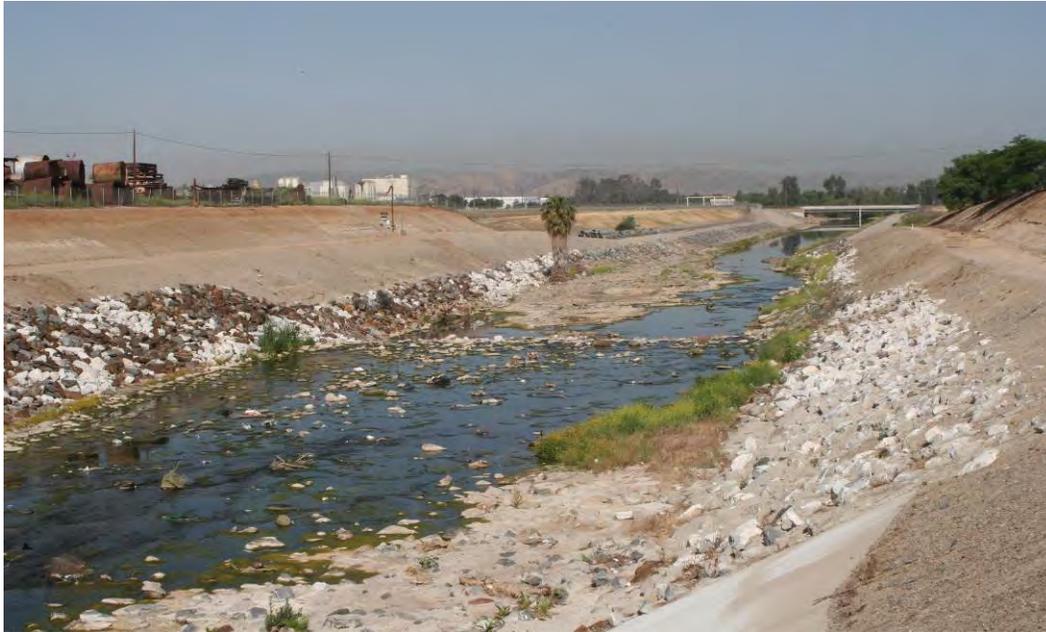
Figure TC-3. Temescal Creek, Reach 1a – facing downstream (downstream of Cota Street, Lincoln Avenue Bridge in distance) Regional Board staff photograph, May 2011.

The downstream section of Reach 1a, from Lincoln Avenue to Cota Street, consists of a channel with a trapezoidal configuration, featuring riprap covered side slopes and an earthen bottom (see Figure TC -3). (See also Figure 2-8 of the TC Technical Report for a photograph of this section of Reach 1a.) This section of the Reach is approximately 0.5 miles in length and has a channel bottom width of approximately 100 ft.

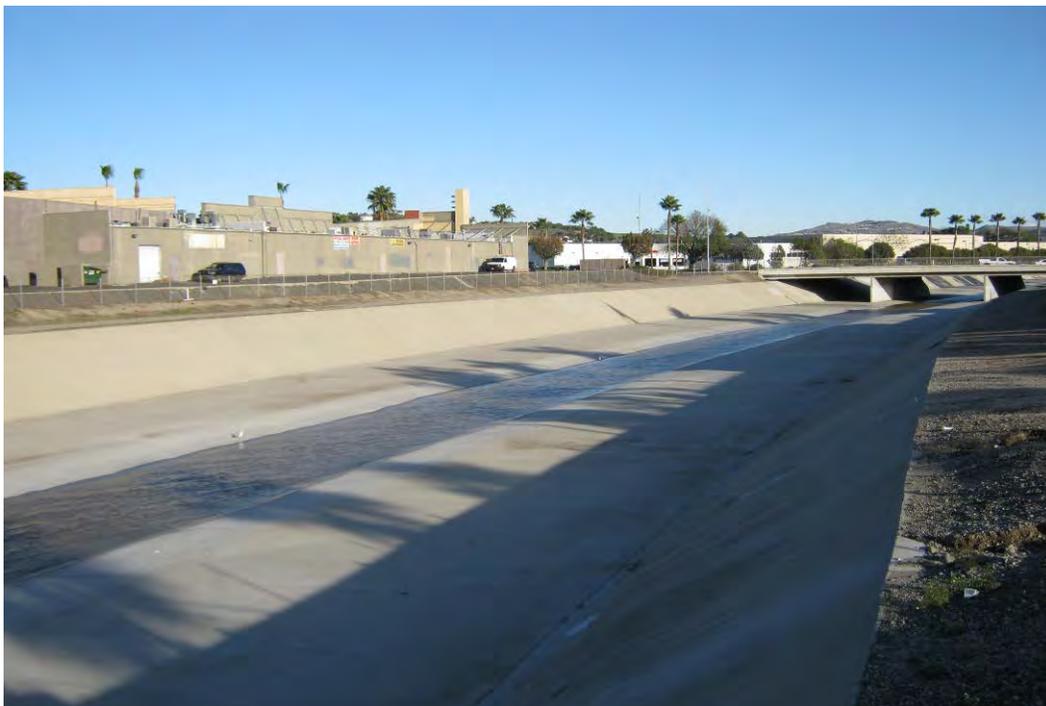
Figure TC-4. Temescal Creek, Reach 1a, at Cota Street looking upstream in the City of Corona. Regional Board staff photograph, December 2010.

The remainder of Reach 1a is a trapezoidal, concrete lined channel. The walls are greater than a 45° slope (Figure TC-4). (See also Figures 2-9, 2-10, 2-11, 3-2, and 3-3 of the TC Technical Report for photographs of this section of Reach 1a.) The channel bottom is approximately 100 feet wide, with a narrow low flow channel in the center of the channel. The proposed Reach 1a terminates upstream at the confluence of the Arlington Channel, which is just downstream of the State Route 91 crossing and culvert. The total length of the proposed Reach 1a is approximately 3 miles.

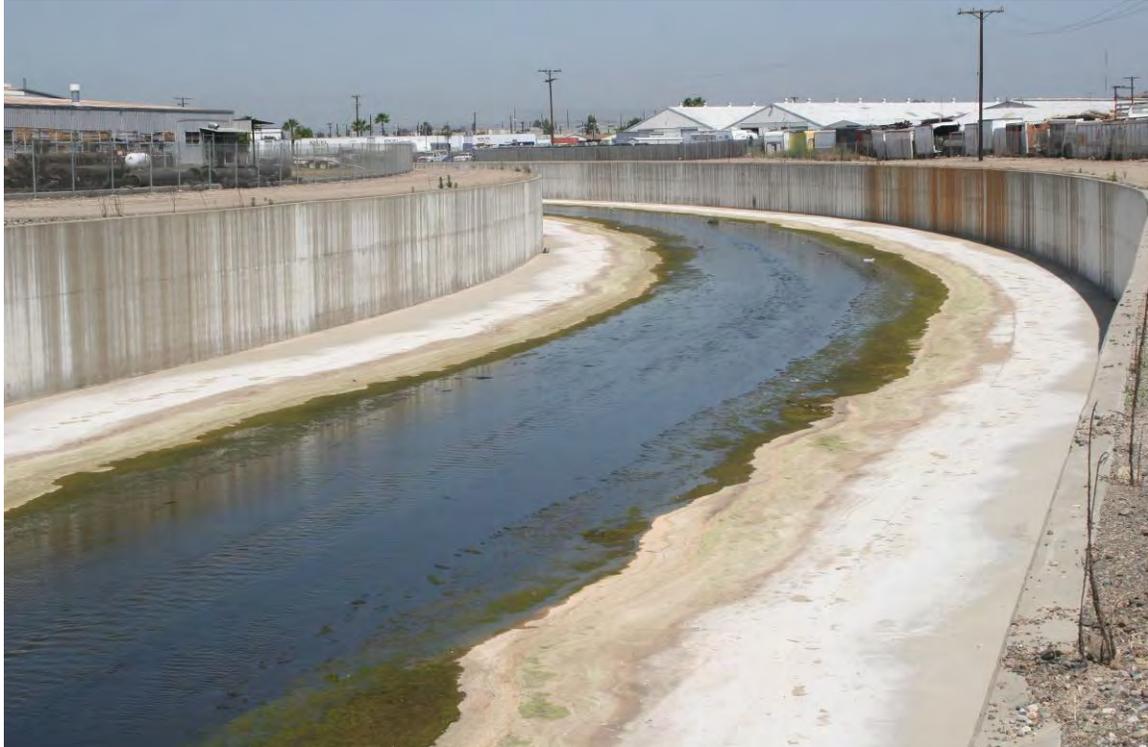
Figure TC-5. Temescal Creek, Reach 1b facing downstream at Magnolia Avenue in the City of Corona. Regional Board staff photograph, May 2011.

From the Arlington Channel confluence to the upstream terminus of the proposed Reach 1b, the channel remains concrete-lined, but transitions from a trapezoidal configuration to vertical walls (~14 ft. high). See Figure TC-5. At approximately 1400 ft. upstream of Magnolia Avenue, the concrete vertical-walled channel transitions to an earthen channel. This point is the upstream terminus of proposed Reach 1b. (See TC Technical Report Figures 2-12 and 2-13.) Reach 1b is approximately 3 miles in length. The Main Street Channel (identified in the TC Technical Report as Canyon Wash), a concrete-lined, vertical-walled channel, is a major tributary to Reach 1b.

Regional Board staff have observed that the dry weather flows typically fill the low flow channel in the concrete-lined section of the proposed Reach 1a to depths less than one foot. Board staff have also observed that in proposed Reach 1a near Lincoln Avenue, where the channel has an earthen bottom and no defined low flow channel, dry weather flows are shallow (less than one foot) and extend across more of the width of the channel (Figure TC-3). Proposed Reach 1b does not have a low flow channel; rather, the channel has a gently sloping V bottom. As a result, dry weather flows generally spread out across the middle of the channel bottom at shallow depth (less than one foot). (See Figure TC-5).

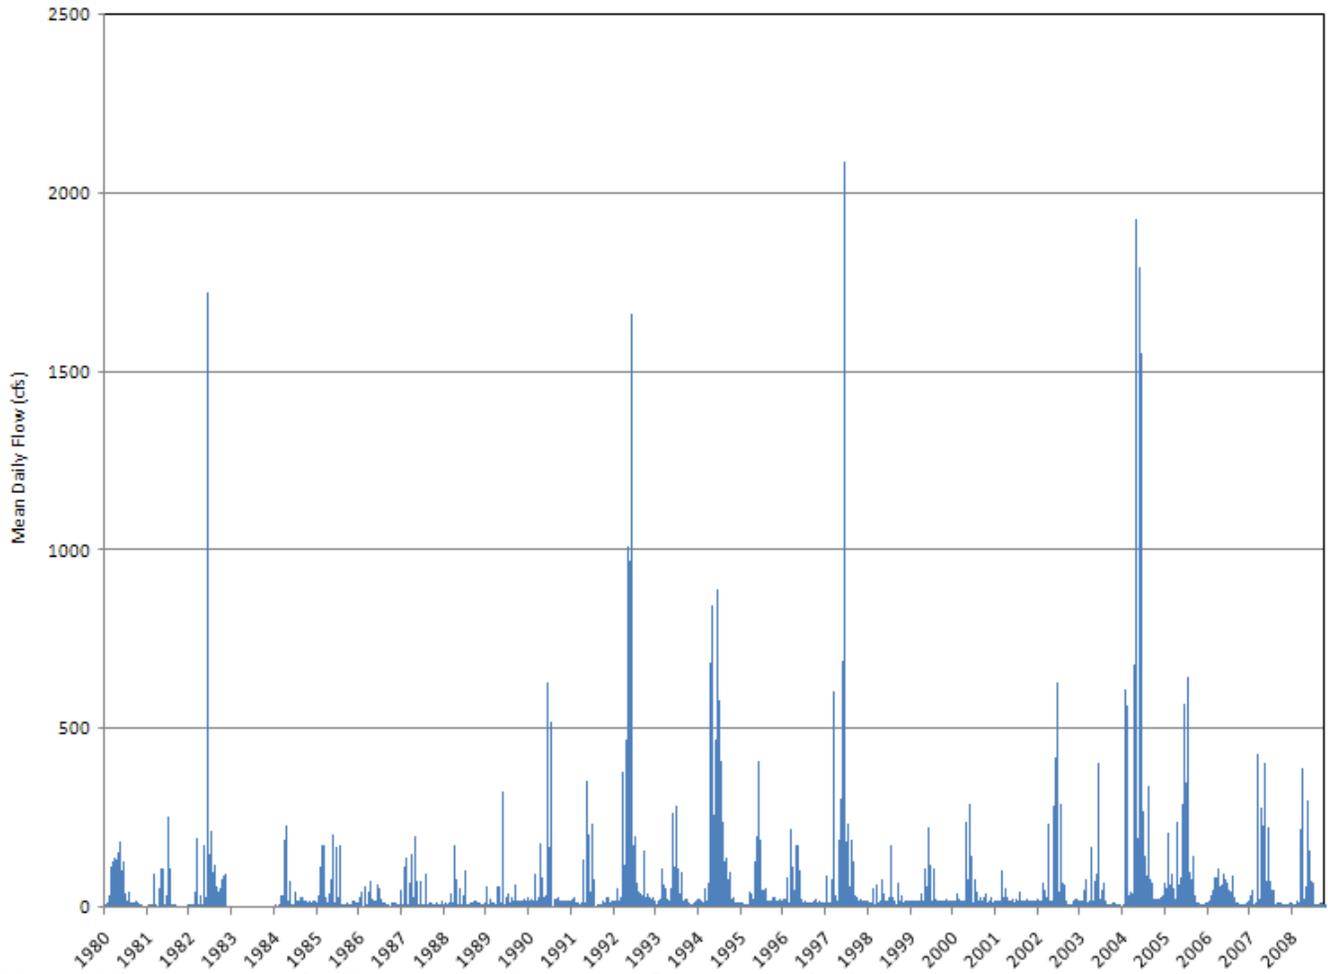
Figure TC-6. Mean Daily Flow in the Temescal Creek at Main Street (Source: Use Attainability Analysis Technical Report for Temescal Creek, CDM, August 2010, Figure 4-2)

Depth of flow has been measured directly in the channel. The relationship between depth of flow and flow rate is defined by a rating curve, which may be used to convert continuous depth records to flow rates. Figure TC-6 presents a hydrograph of the USGS mean daily flow data for 1980 to 2008.

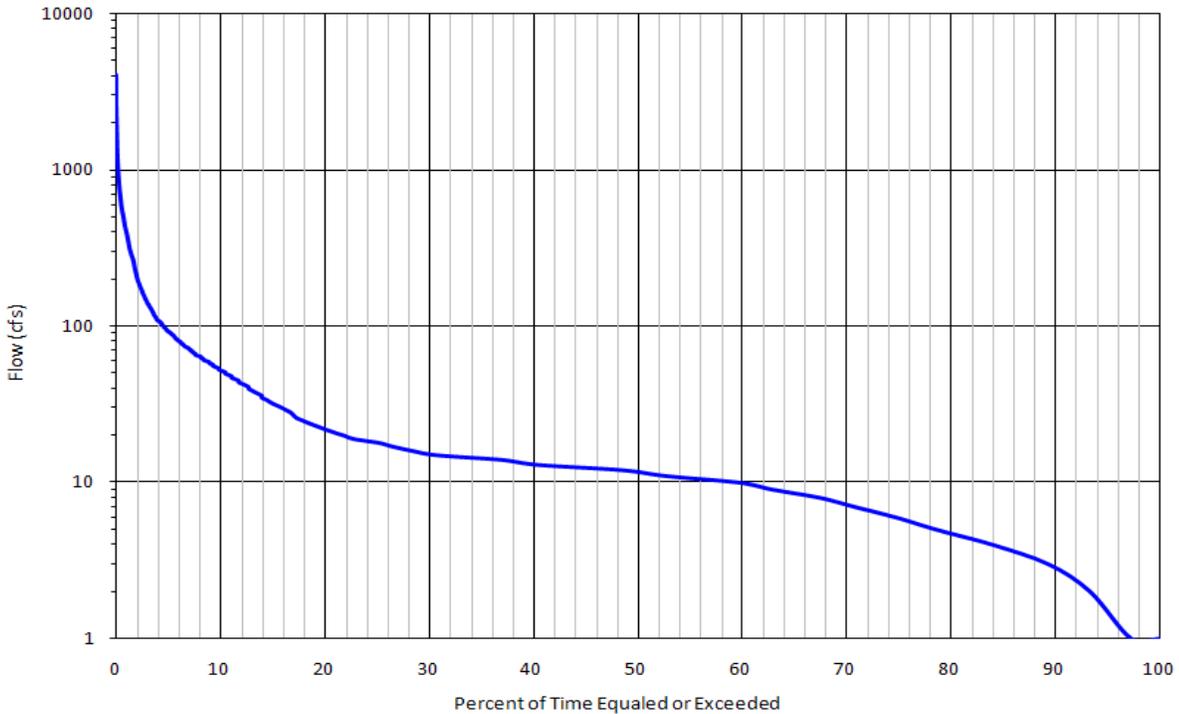
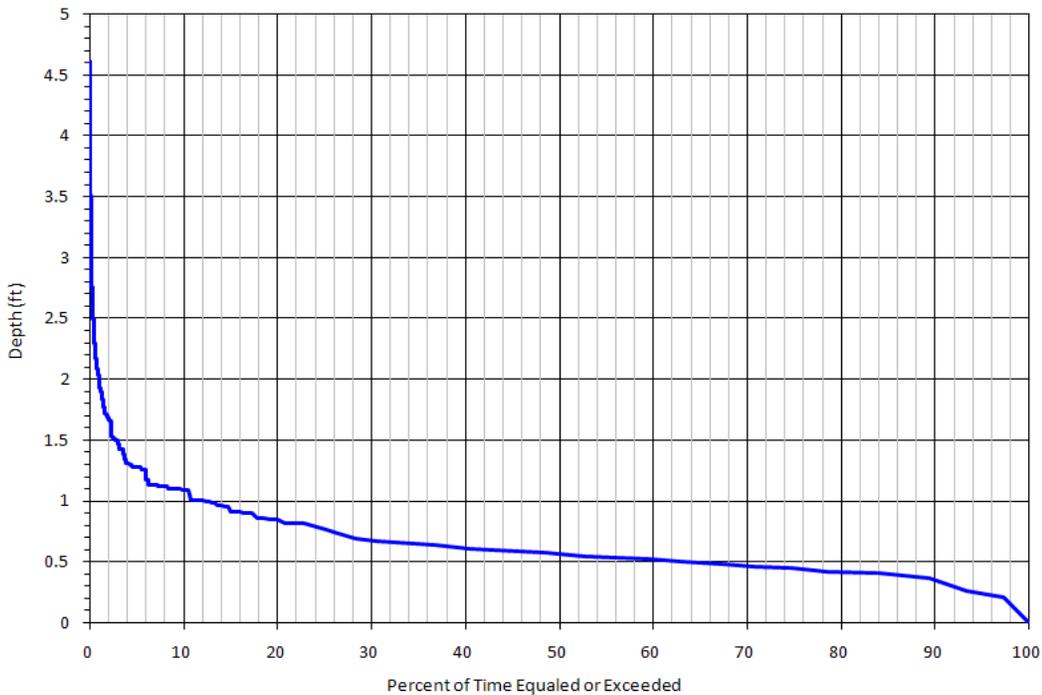
Figure TC-7 (above). Channel Flow Duration Curve for the Temescal Creek at Main Street (1980-2008)
Figure TC-8 (below). Channel Depth Curve for the Temescal Creek at Main Street (1980-2008)
 (Source for both Figures: Use Attainability Analysis Technical Report for Temescal Creek, CDM, August 2010, Figures 4-3 and 4-4, respectively)

Cumulative frequency curves of flow rate and depth from 1980 to 2008 were generated by CDM (Figures TC-7 and 8). Frequency distributions show that more than 90 percent of the time, flow rates and depths are characteristic of dry weather flow conditions. Flow depths during 1980 to 2008 were less than 2 feet approximately 99 percent of the time and less than 1 foot approximately 90 percent of the time (Figure TC-8).

Flow data and analyses are presented above and in the TC Technical Section 4.2.1). The dominant dry weather flows in the proposed Reach 1a and 1b create perennial flows that are less than 1 ft deep 90% of the time (See Figure TC-8). There are no sources of additional effluent discharges that could be used to augment the flows in proposed Reach 1a and 1b to enable the REC1 use be met. As noted, highly treated effluent is already discharged by Lee Lake Water District and the City of Corona to the Creek. However, effluent discharge plans are changing: the District is constructing a recycled water storage pond to promote recycled use of its effluent and the City of Corona will cease operation of and discharge from its WWTP #3, at least on an interim basis. These changes which will result in reduced discharges of treated effluent to Temescal Creek and, thereby, reduced flow levels in the Creek.

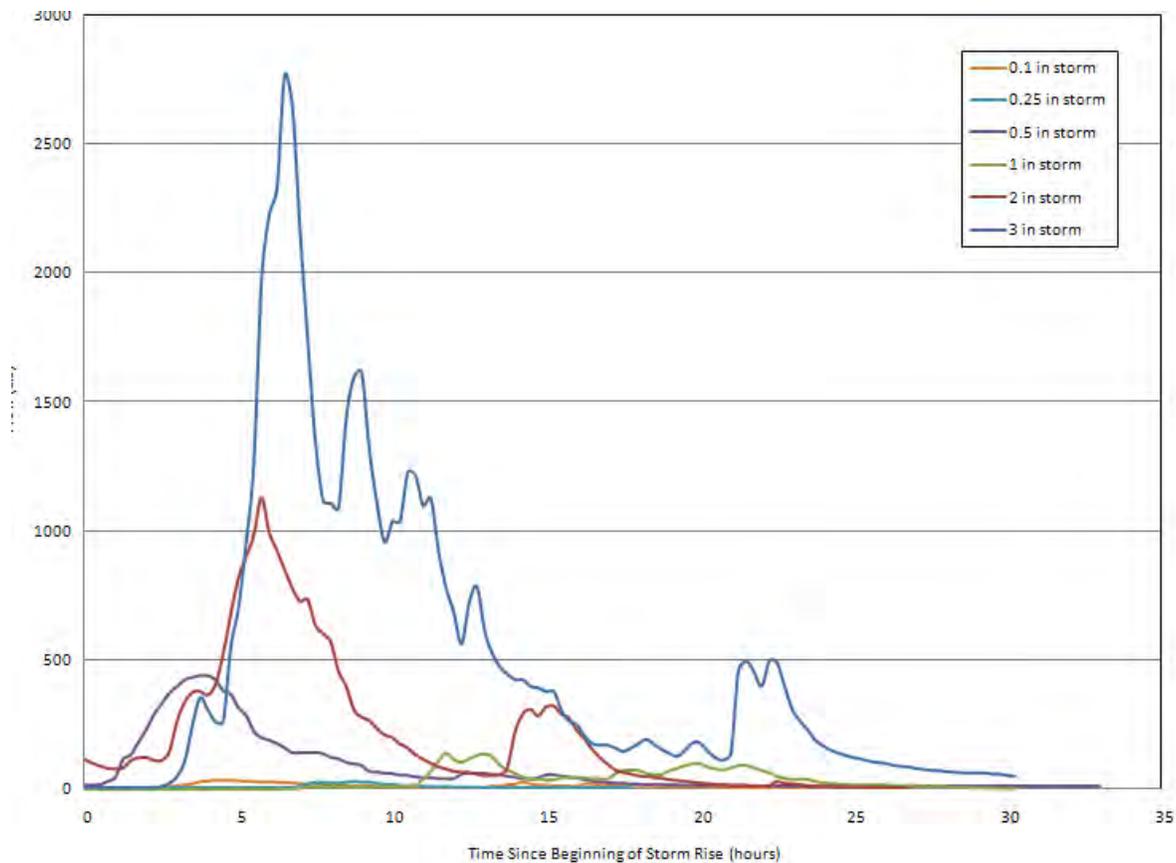
Figure TC-9 Event Hydrographs from the Temescal Creek Flow Record from 1980 to 2008 (Source: Use Attainability Analysis Technical Report for Temescal Creek, CDM, August 2010, Figure 4-5)

Hydrographs showing the typical flow response in the Temescal Creek watershed during rain events of varying depths are shown in Figure TC-9. In this Figure, hydrographs resulting from ¼", ½", ¾", 1", 2" and 3" rainfall events at meteorological stations were overlaid to show similarities or differences in response based on rainfall depth. Analysis of the six storm events of different depths shows that near-dry-weather baseflow channel velocities (and associated depths) returned in as soon as 8 hours following a storm event (ranging from 8 to 30 hours in most cases).

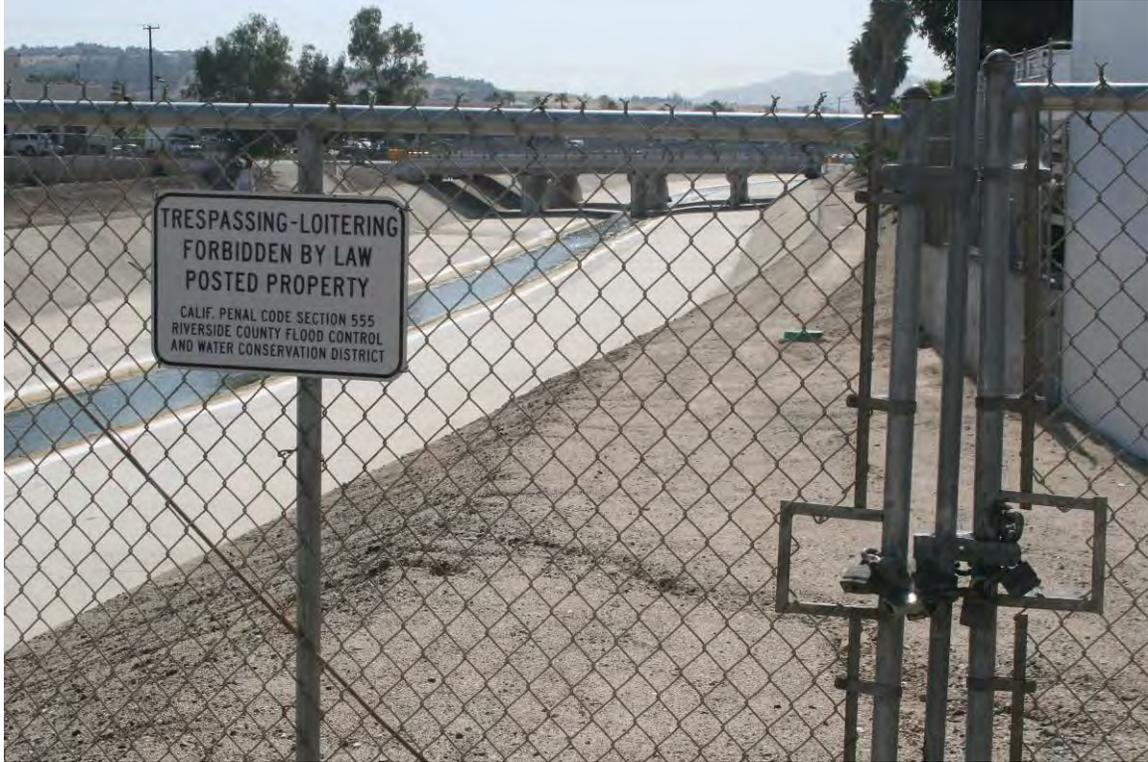
Figure TC-10. Temescal Creek, Reach 1a at Cota Street. Access is prohibited and the channel is fenced with locked gates. Regional Board staff photograph, May 2011.

The Riverside County Flood Control and Water Conservation District (County Flood Control District) prohibits access to their holdings and easements in proposed reaches 1a and 1b of Temescal Creek. The entire channel in proposed Reach 1a and 1b, including adjacent maintenance roads, is fenced and maintenance gates are locked to prevent access. In addition, the channel is posted with no trespassing signs. There are no bicycle, hiking, or other trails adjacent to Temescal Creek in these areas. (See Figure TC-10)

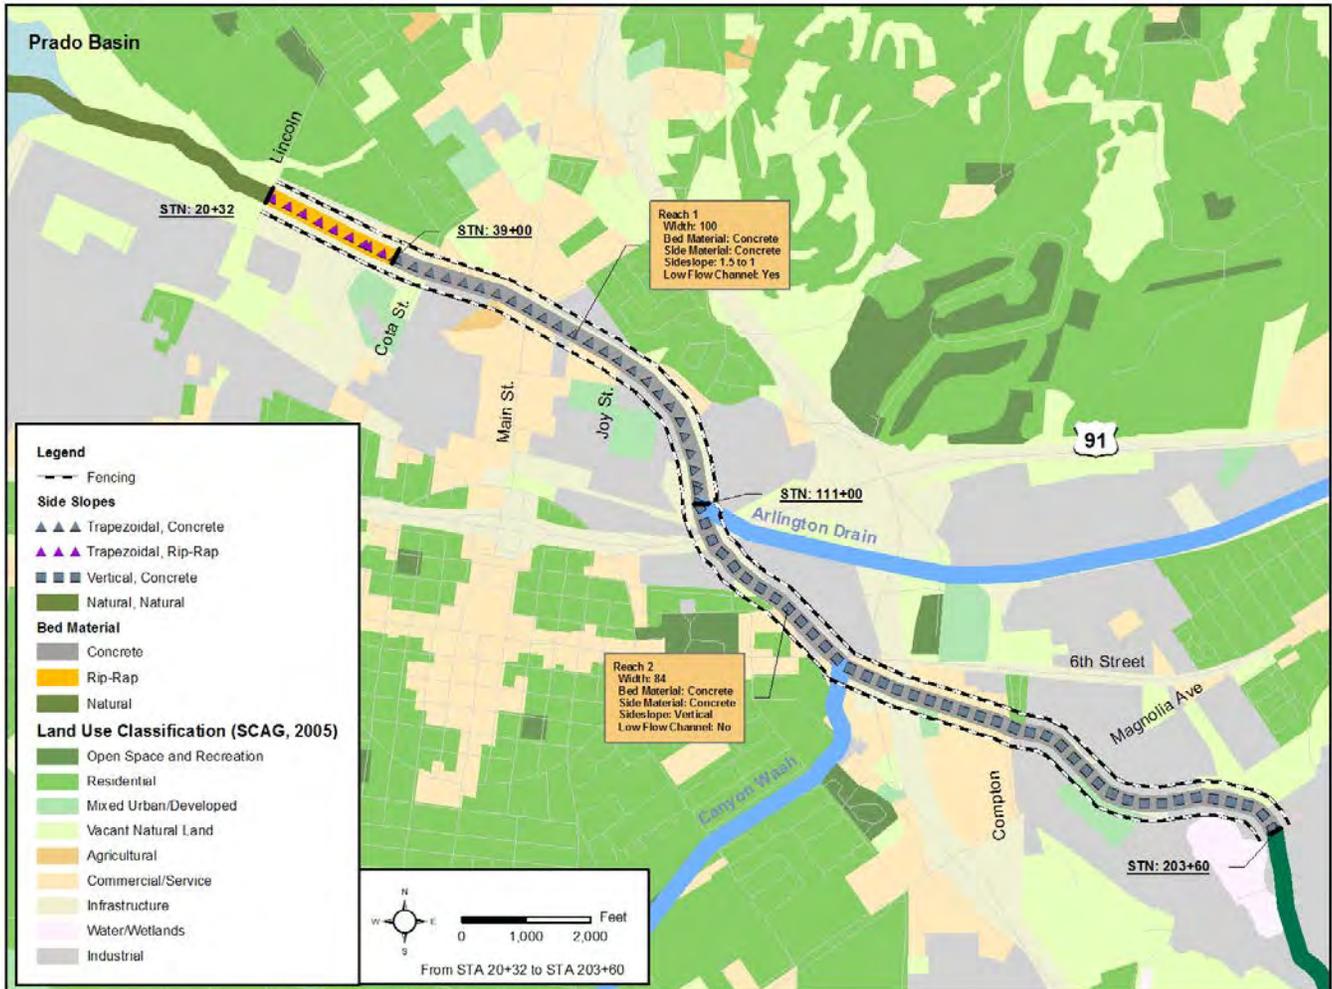
Figure TC-11. Temescal Creek: Channel Characteristics and Land Use. (Source: Use Attainability Analysis Technical Report for Temescal Creek, CDM, August 2010, Figure 2-5)

The watershed adjacent to Temescal Creek, Reach 1a and 1b is largely developed as commercial/industrial, with pockets of residential areas. There are no schools or parks immediately adjacent to the creek in these areas. Limited open space remains adjacent to the Creek. See Figure TC-11.

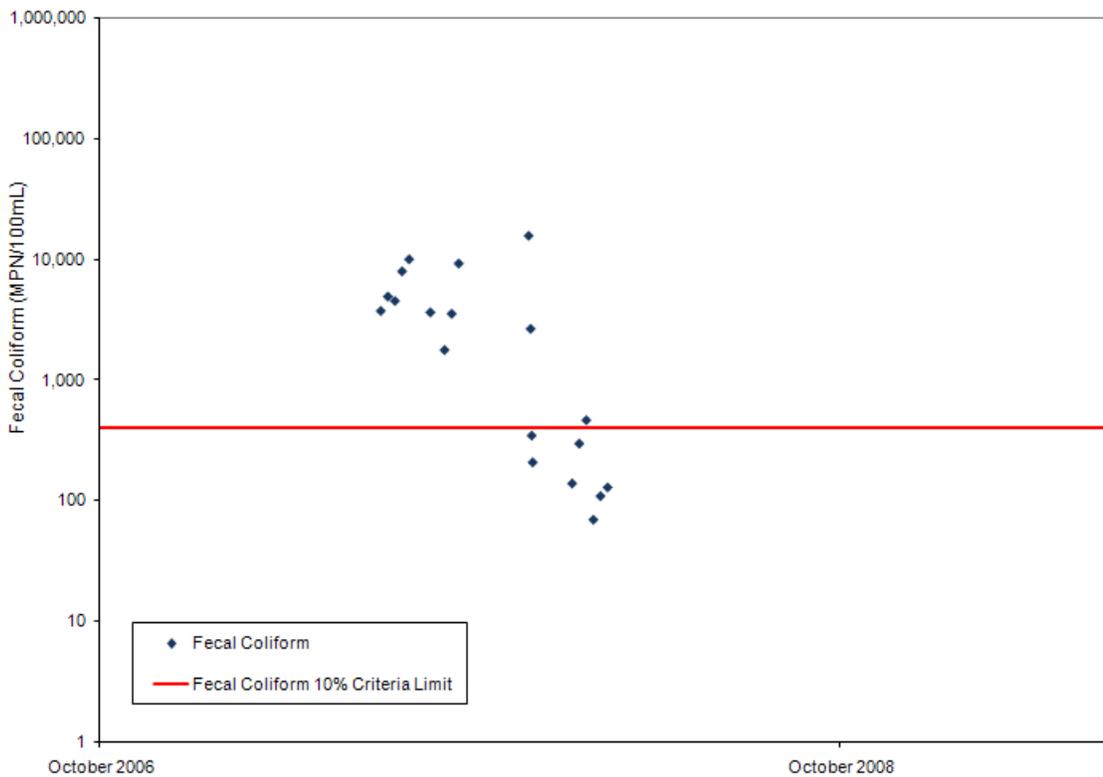
Figure TC-12 Time Series of Fecal Coliform Concentrations in the Temescal Creek from 2007 through 2008 (Source: Use Attainability Analysis Technical Report for Temescal Creek, CDM, August 2010, Figure 3-9)

The analyses show that the existing REC1 fecal coliform objectives and the proposed REC1 *E. coli* objective are not consistently attained. One geomean values was calculated for fecal coliform (13,232 MPN per 100 m/L), which significantly exceeded the current Basin Plan fecal coliform geomean objective (200/100mL). A geomean was also calculated for *E. coli* (3,127 individuals per 100 m/l) that exceeded the proposed geomean objective of 126/100mL. Figure TC-12 presents fecal coliform concentrations from 2007 through 2008. As shown, more than half of the samples exceeded 400/100mL fecal coliform.

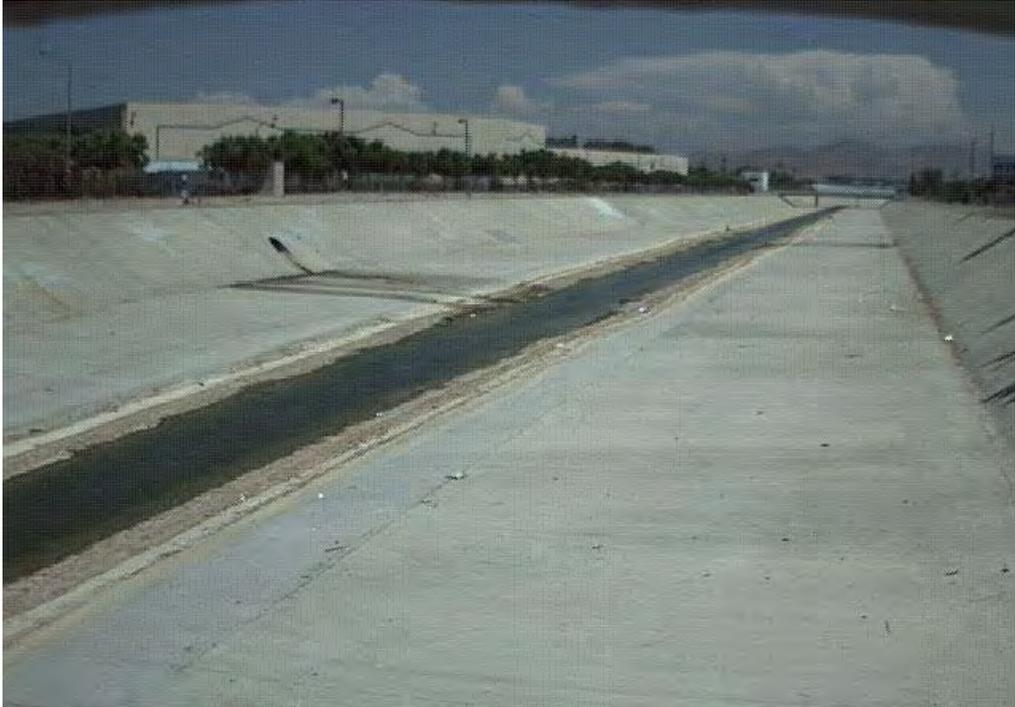
Figure TC-13. Photo of the Camera View at the Recreational Use Survey Location for Temescal Creek at Main Street (Reach 1a) Facing Upstream (Source: Use Attainability Analysis Technical Report for Temescal Creek, CDM, August 2010, Figure 3-2)

Camera views at the survey locations are shown in Figures TC-13 and TC-14.

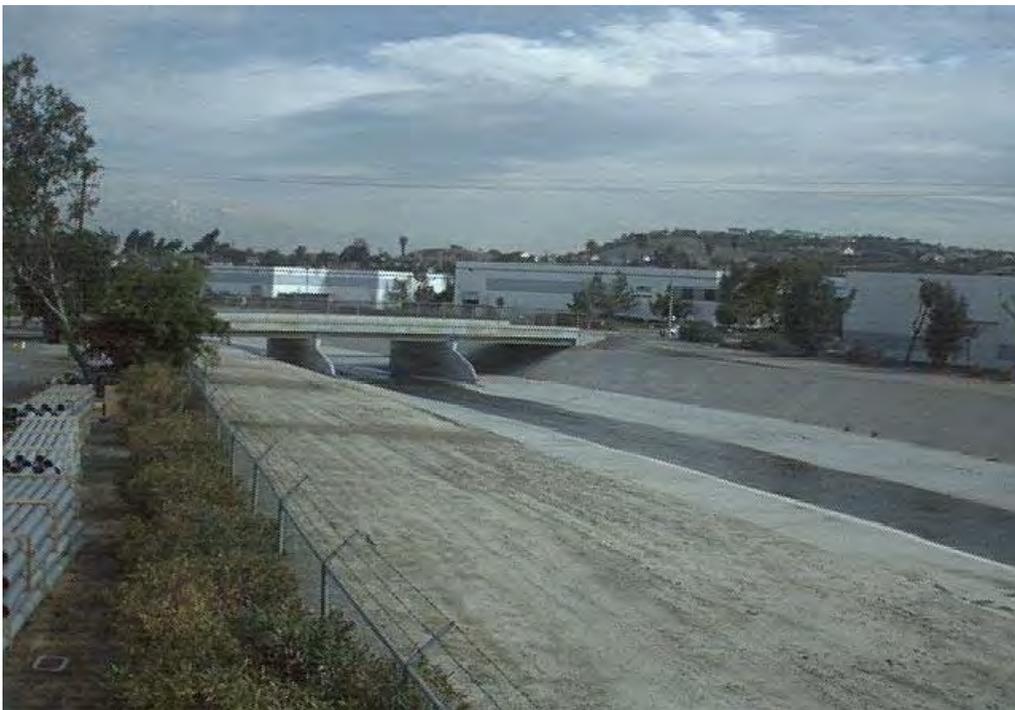
Figure TC-14. Photo of the Camera View at the Recreational Use Survey Location for Temescal Creek at City of Corona WWTP No. 2 (Reach 1a)- Facing Downstream (Source: Use Attainability Analysis Technical Report for Temescal Creek, CDM, August 2010, Figure 3-3)

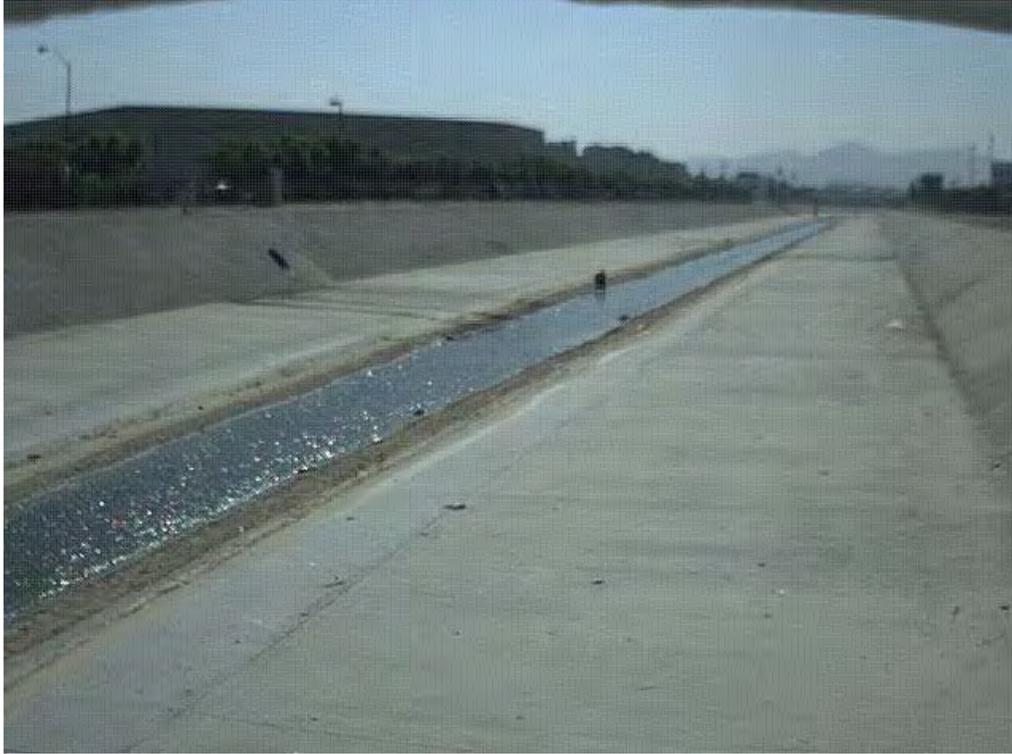
Figure TC-15. Photo of Activity at Temescal Creek at Main Street (proposed Reach 1a), 7/27/2005, 10:00 (Source: Use Attainability Analysis Technical Report for Temescal Creek, CDM, August 2010, Figure 3-4)

As shown in Table TC-5 and Figures TC-15, 16 and 17, there are some limited observations of individuals walking or biking in the proposed Reach 1a. Also as noted, Regional Board staff have on occasion observed individuals walking in the channel of Reach 1a. The evidence of any water contact is extremely limited. While it appears that the individuals observed may be using the channel as a travel route rather than as a recreational opportunity for aesthetic enjoyment, picnicking or other types of REC2 activities, it is possible that such activities are taking place. In view of this, Board staff recommends designating the REC2 beneficial use for the proposed Reach 1a. (This is consistent with the current Basin Plan REC2 designation for Reach 1 (as now defined in the Basin Plan) as a whole.)

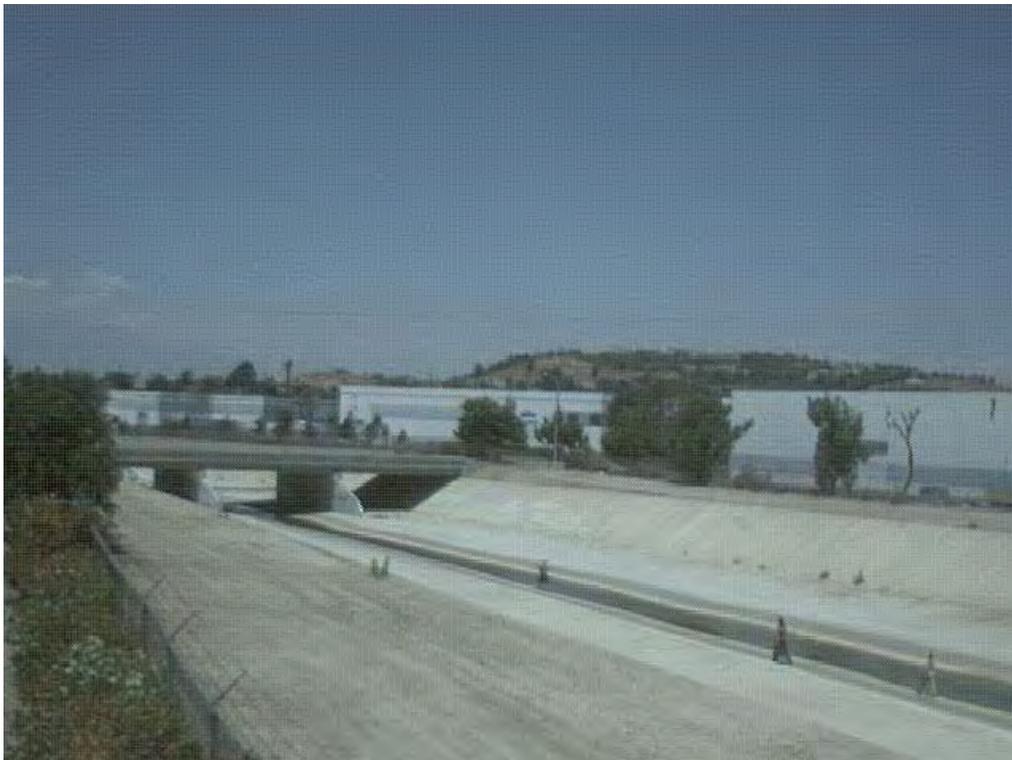
Figure TC-16. Photo of Activity at Temescal Creek at Corona WWTP (proposed Reach 1a), 7/1/2006, 13:30 (Source: Use Attainability Analysis Technical Report for Temescal Creek, CDM, August 2010, Figure 3-6)

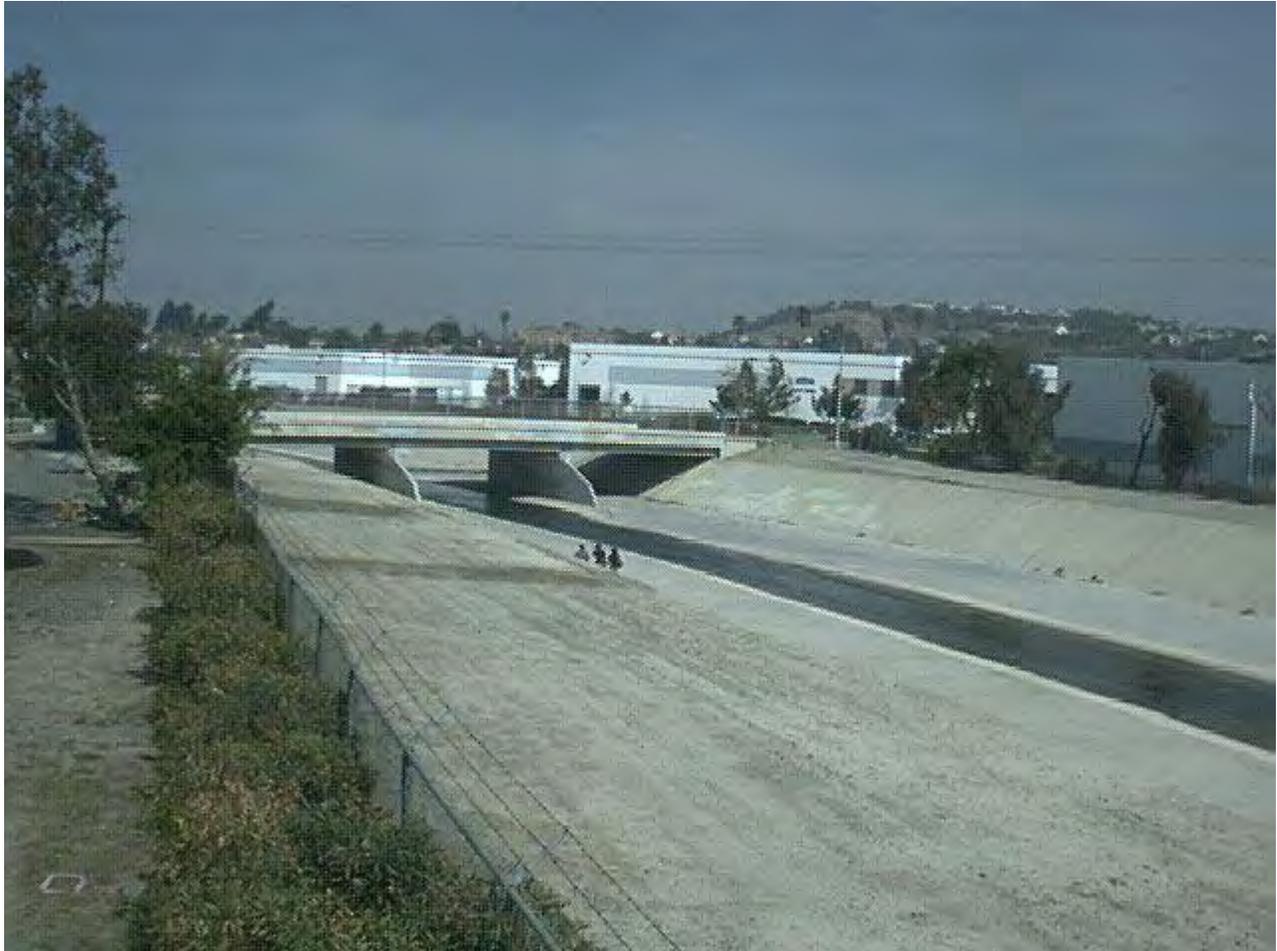
Figure TC-17. Photo of activity at Temescal Creek at Corona WWTP (Proposed Reach 1a), 2/25/2006, 12:15. (Source: Use Attainability Analysis Technical Report for Temescal Creek, CDM, August 2010, Figure 3-7)

As reflected in Table TC-5, the camera survey results indicate a very low frequency of human activity of any kind in Reach 1a of the Creek. While no camera survey was conducted in Reach 1b, it is reasonable to expect similar results (in fact, even less activity), given the channel morphology (vertical concrete walls and bottom; see Figure TC-5) and adjacent land use, which is largely industrial and commercial (see Figure TC-11). Of the 11,166 images collected at the camera survey locations in Reach 1a, only two suggested any type of water contact. In both cases, an individual was observed walking in shallow water in the low flow channel; the contact was limited to below the ankle and of short duration (less than 30 minutes). These images are included here as Figures TC-15 and 16. Thirty-one images showed a few individuals either walking or riding a bicycle in the channel, adjacent to the low flow channel, without body contact. This type of activity is depicted in Figure TC-17.
