**Summary of UAA Greenville-Banning Channel as described in the January 12, 2012 Staff Report (Section 5.6.4. [UAA Analysis Greenville-Banning Channel](#)) and with references from [CDM UAA Technical Report for Greenville-Banning Channel](#)**

**Summary of UAA Greenville-Banning Channel (Continued)**

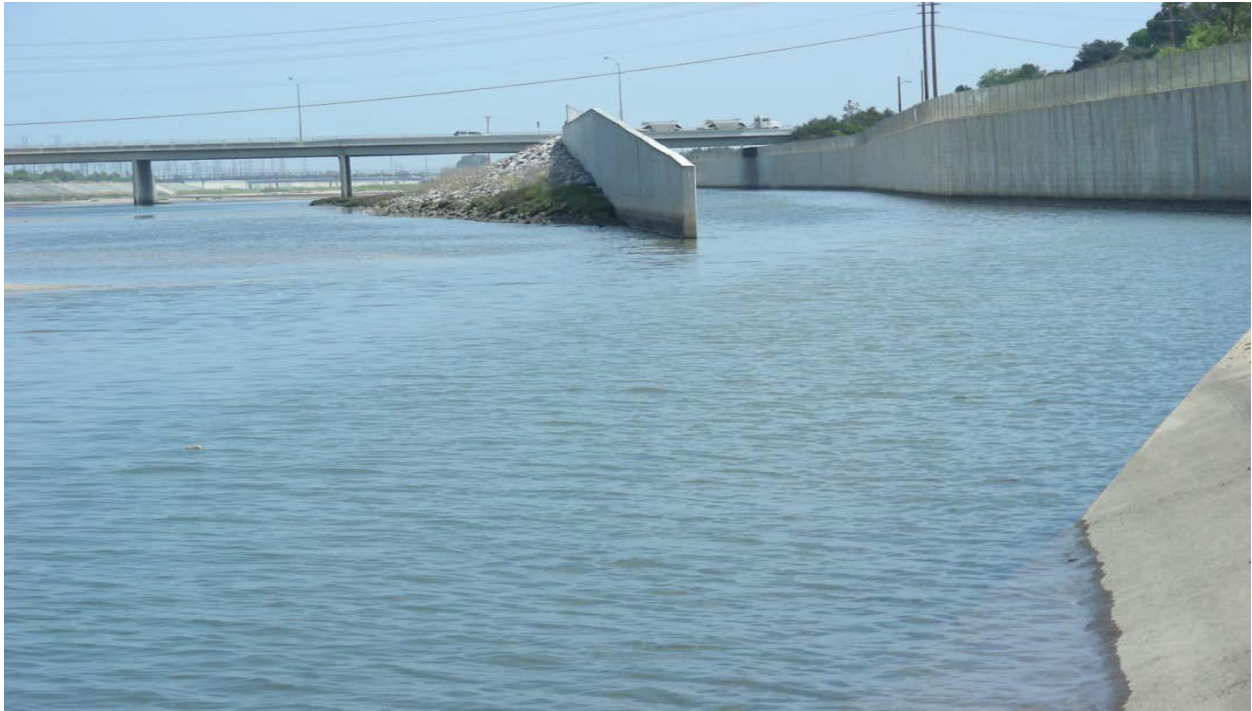
Figure 2-6. Terminus of Greenville Banning Channel tidal prism (right); confluence w/ Santa River (left) (CDM UAA Technical Report GB)

Greenville-Banning Channel	REC1	REC2	40 CFR 131.10(g) Factors	
			131.10(g)(2) Low Flow Hydrologic Modifications	131.10(g)(4)
Tidal Prism	u	X	At high tides several feet deep at confluence with Santa Ana River. At low tides dry at upstream inflatable dam. At high tide on May 24, 2011, 1.5 ft. deep at inflatable dam. RB staff observation.	Concrete vertical wall channel, 60 ft. bottom width, 1.2 miles in length.
Reach 1	u	u	Immediately upstream of inflatable dam when it is in operation, water pools up to about 1.5 ft deep. Most of Reach 1 water levels are < 1 ft. At upstream areas waters sheet flows across bottom. RB staff observation.	Concrete vertical wall channel for 2 miles. The upper 0.20 mile section is concrete with steep (> 45° trapezoidal) walls.
<b>Representative Photographs</b>				
Tidal Prism	See Figures GB-3, GB-4, GB-5 in UAA Analysis GB See Figures 2-6, 2-7 in the CDM UAA Technical Report GB

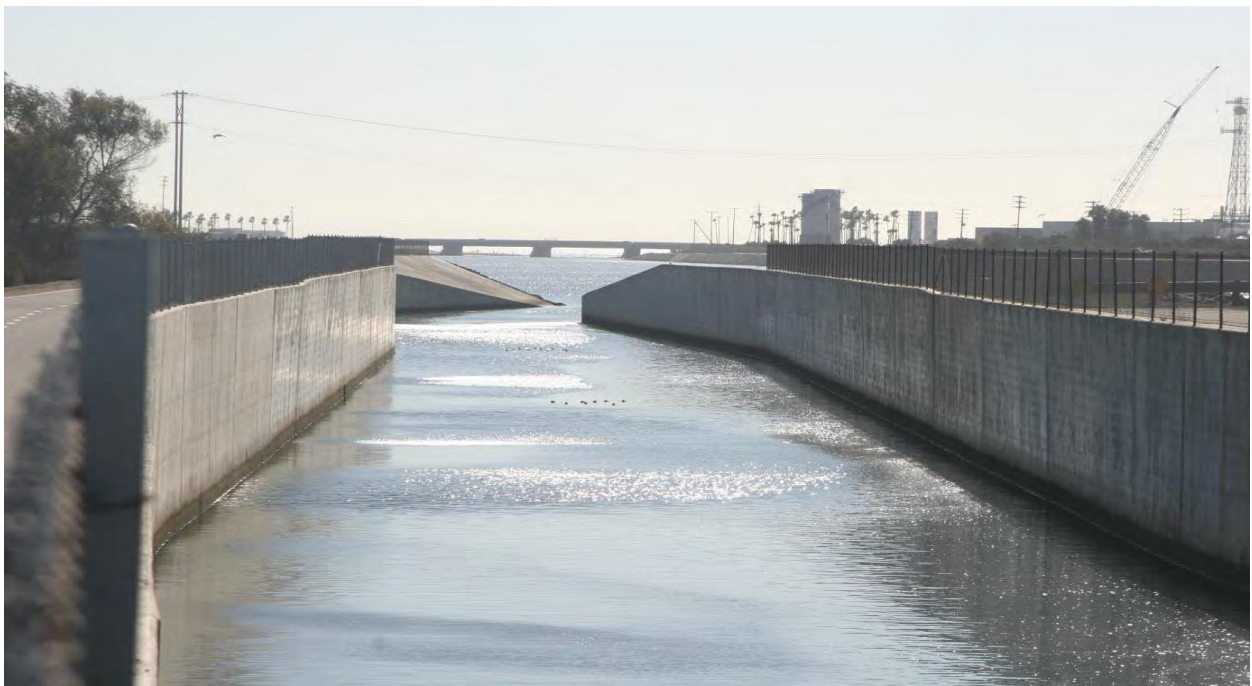
Figure GB-4. Tidal Prism Reach of the Greenville-Banning Channel Facing downstream. (UAA Analysis GB)

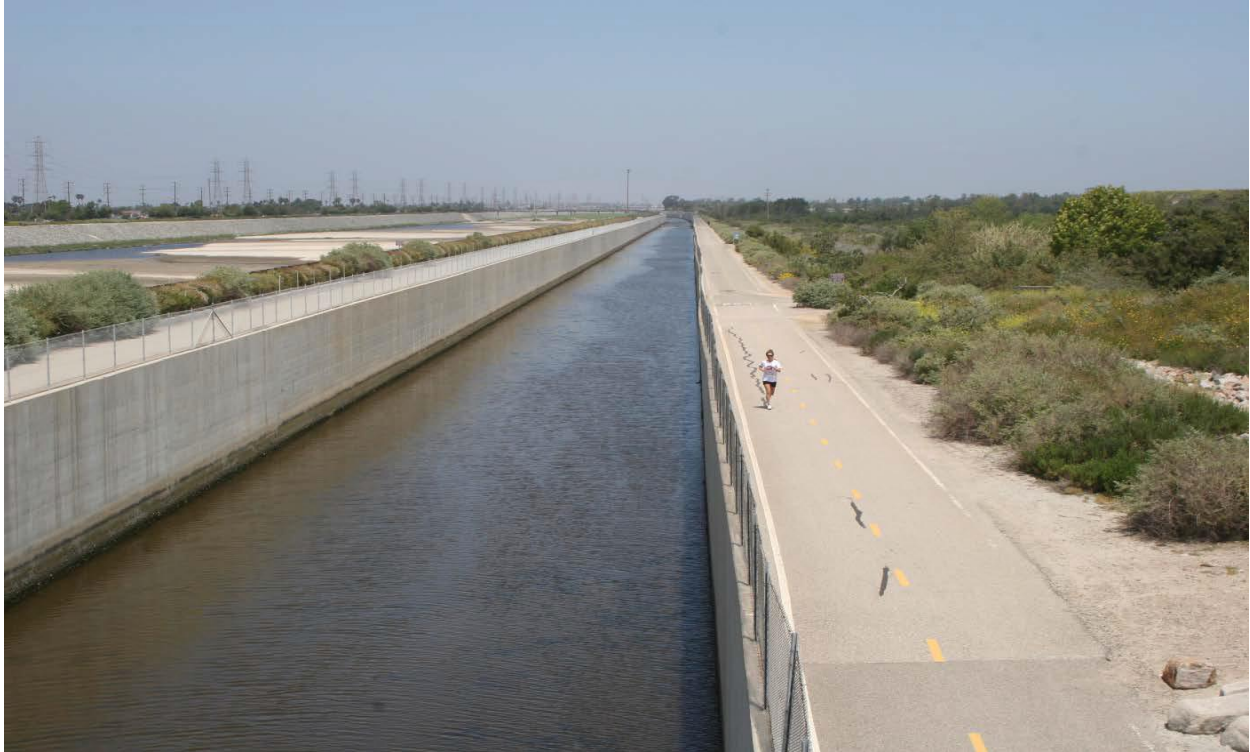
Figure GB-5. Tidal Prism of the Greenville-Banning Channel facing upstream. In Tidal Prism REC 2 use is attained, REC 1 use is not attainable. (UAA Analysis GB)

of such activity. People were observed on the bicycle trail adjacent to the channel (see Figure GB-5).

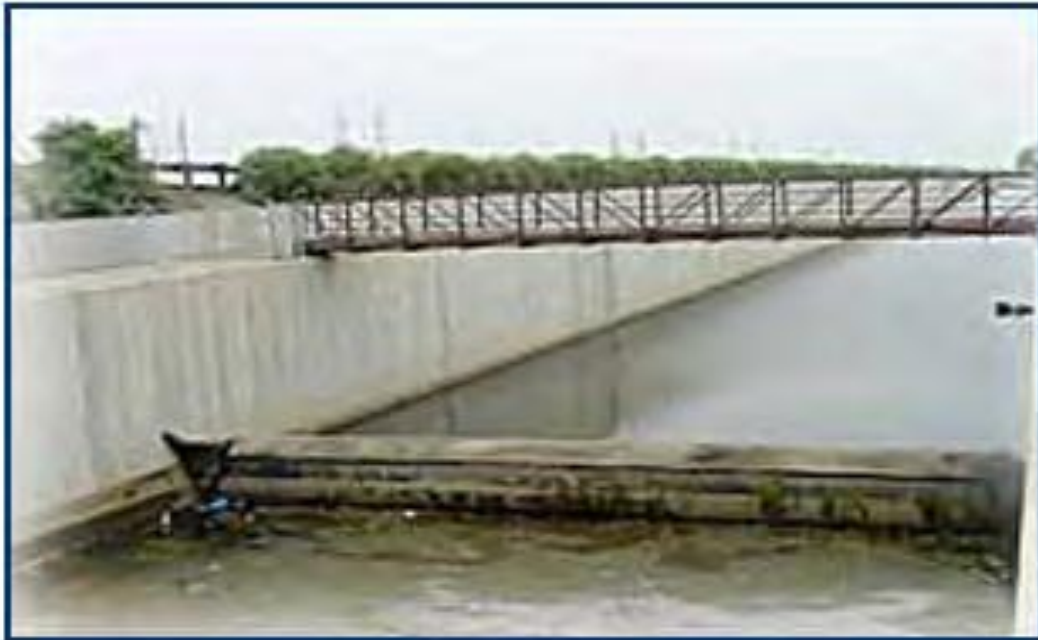
Figure GB-3. Rubber dam diversion at the Greenville-Banning Channel. The dam separates the Tidal Prism Reach from Reach 1. (UAA Analysis GB)

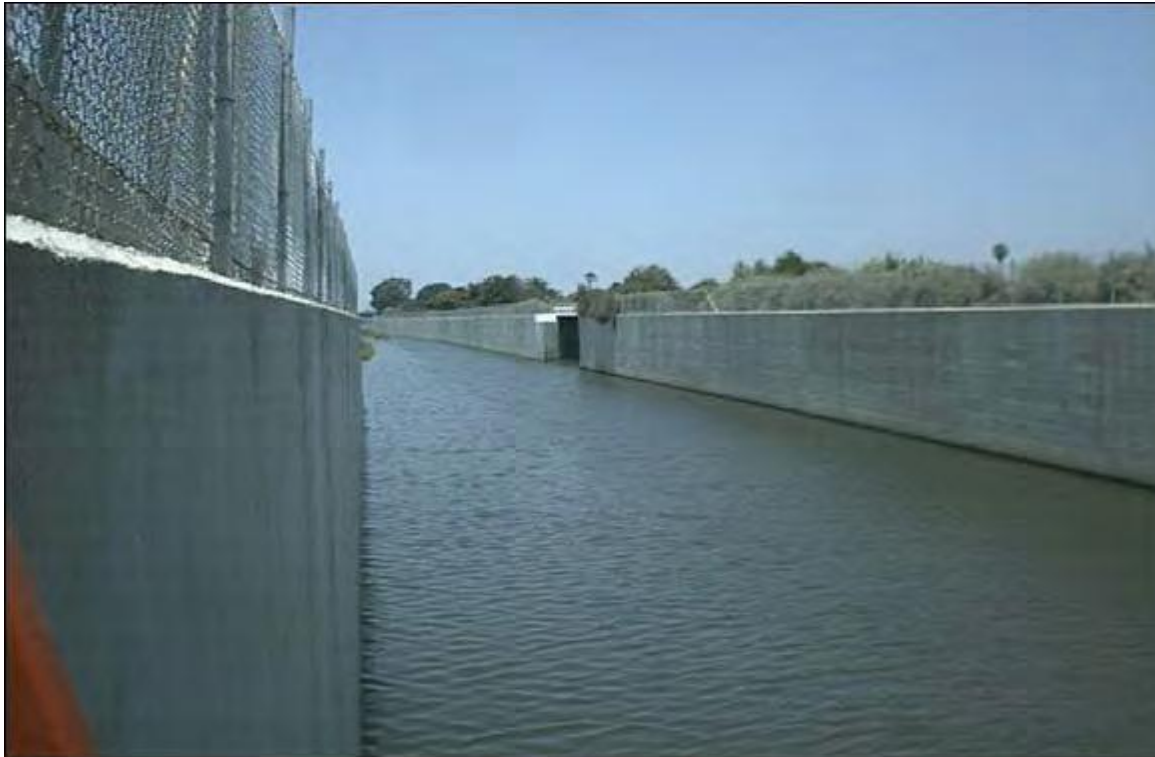
Figure GB-10. Reach 1, Photo REC Survey location, just upstream of inflatable dam. The water behind the dam can be about 1.5 ft. deep. (UAA Analysis GB)

Reach 1	See Figures GB-6, GB-7, GB-10, and GB-11 in UAA Analysis GB See Figure 2-8, of the CDM UAA Technical Report GB

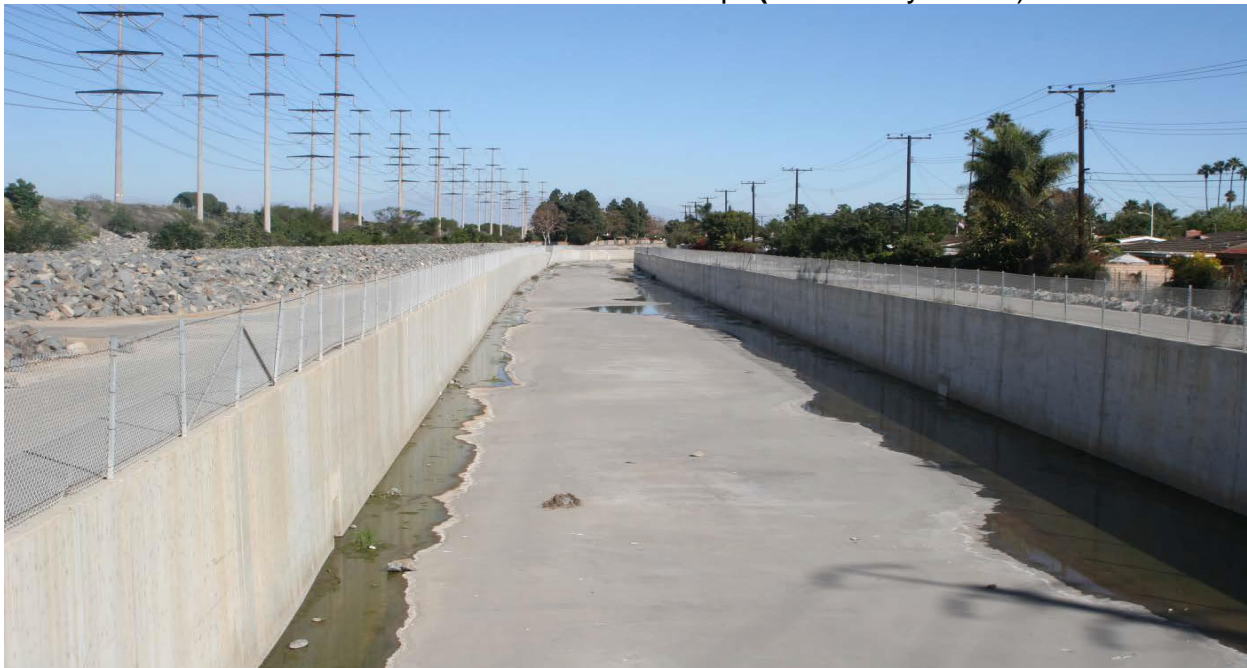
Figure GB-7. Reach 1, facing upstream. REC1 and REC2 uses are not attainable in Reach 1. (UAA Analysis GB)

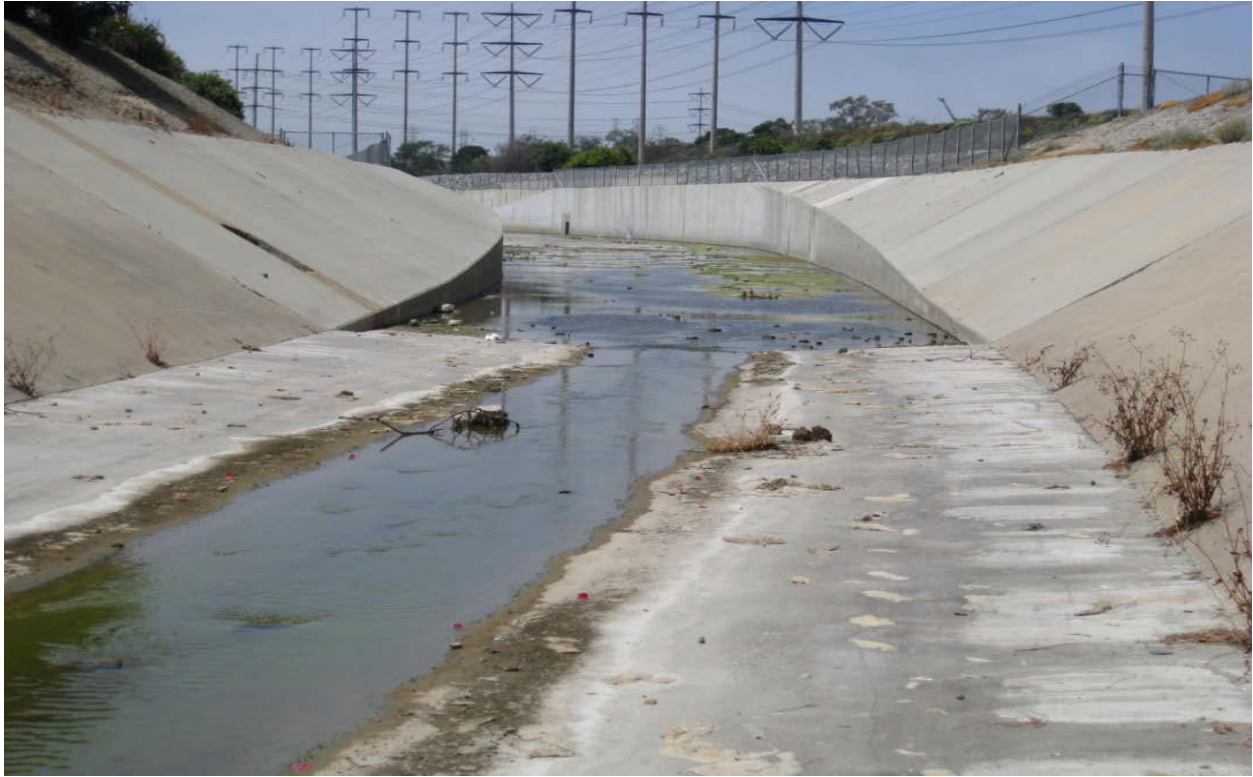
Figures 2-9. Reach .1 Facing downstream, shows transition from vertical to trapezoidal channel. (CDM UAA Technical Report GB)

- b) Reach 1: Vertical walls (except 0.20 mile steep trapezoidal walls, all fenced.
  - i) Channel considered unsafe for public access.

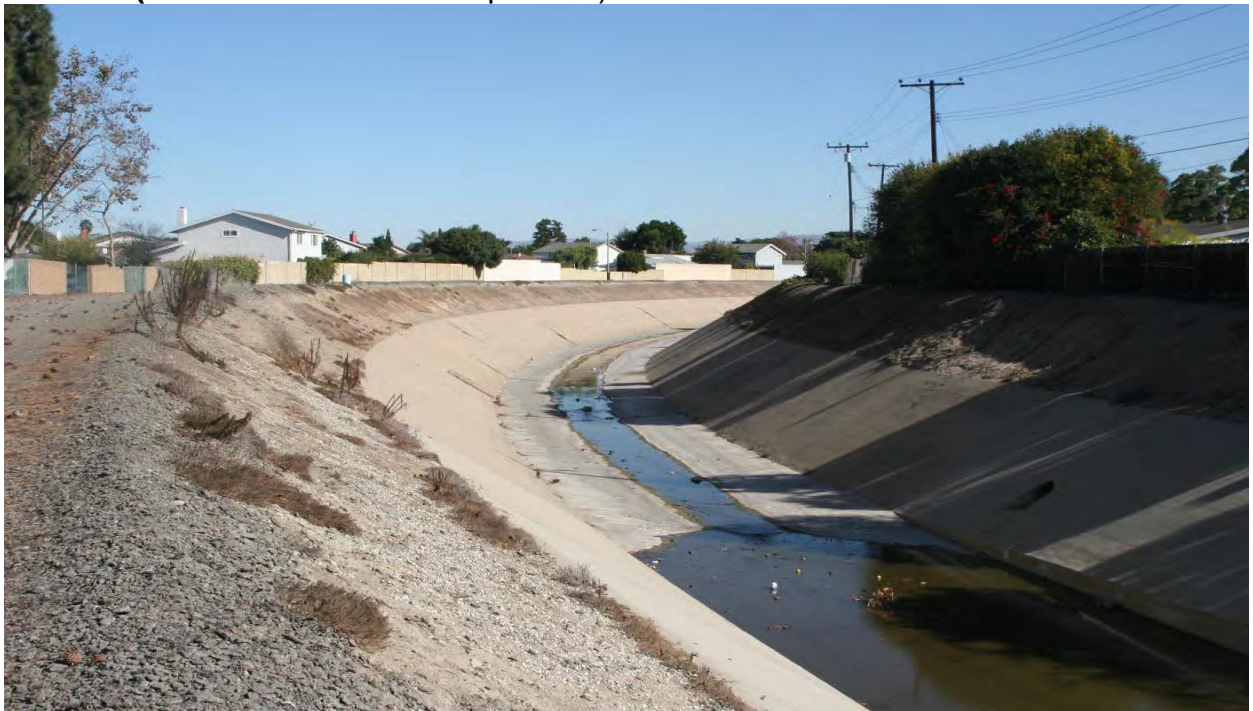
Figure GB-12. Reach 1. Facing upstream, the trapezoidal section is 0.20 mile in length.

- a) Tidal Prism: Santa Ana River (SAR) to the west, Talbert Nature Preserve to the East.
- b) Reach 1: Talbert Nature Preserve, golf course, and residential in most upstream section to the East. Santa Ana River to West. Back of residences to channel and separate by walls/fencing (Figure GB-12).
- c) Bicycle trail along most of both tidal prism and Reach 1, separated from channel by fence.
