CALIFORNIA REGIONAL WATER QUALITY CONTROL BOARD - SAN DIEGO REGION
WATERSHED MANAGEMENT PROGRAM

FACILITY INSPECTION REPORT

FACILITY: Carlsbad Municipal Golf Course

Construction Storm Water Inspection-10/18/05
Carlsbad Municipal Golf Course, WDID# 937C337203
Carlsbad, San Diego County

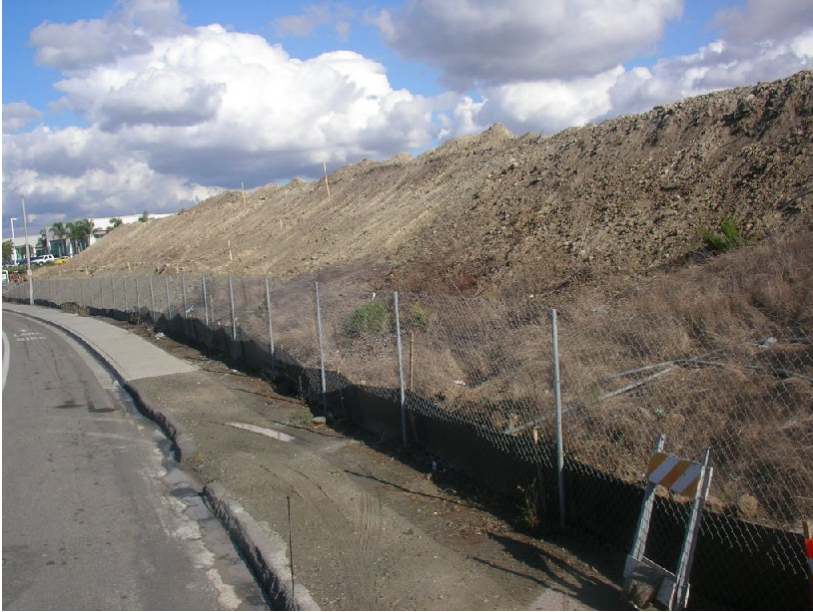
- Site lacks any erosion control BMPs including uncovered, exterior slopes throughout the project (Photos 2-4).
- City or Carlsbad and construction management personnel indicated that sediment basins/traps had been installed at the site. However during the inspection, the location and drainage areas of these sediment basins/traps was not clearly evident. Plastic spillways had been installed at some locations (Photo 5).

Photo 3
Example No Erosion Control on Exterior Slopes (Facing Northeast on College Ave)

- The site needs to implement sediment and erosion control BMPs on the site to prevent the additional discharges of sediment.
- Silt fence installation needs to be corrected.
- Use of sediment basins should meet the sizing requirements of the General Construction Permit and drainage areas to the basins should be clearly defined.
- The SWPPP needs to be amended to address the deficiencies noted and additional BMP requirements.

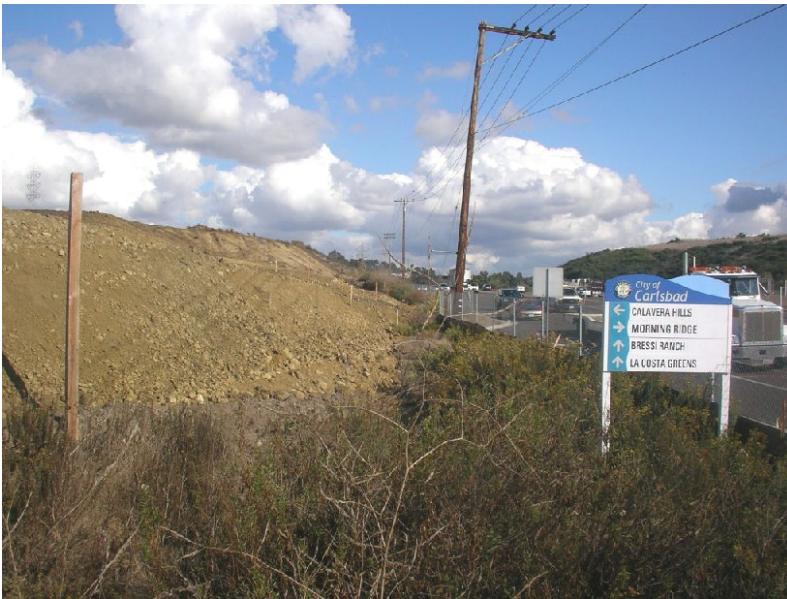
Photo 4
Uncovered Slopes On Palomar Airport Road (Facing East)

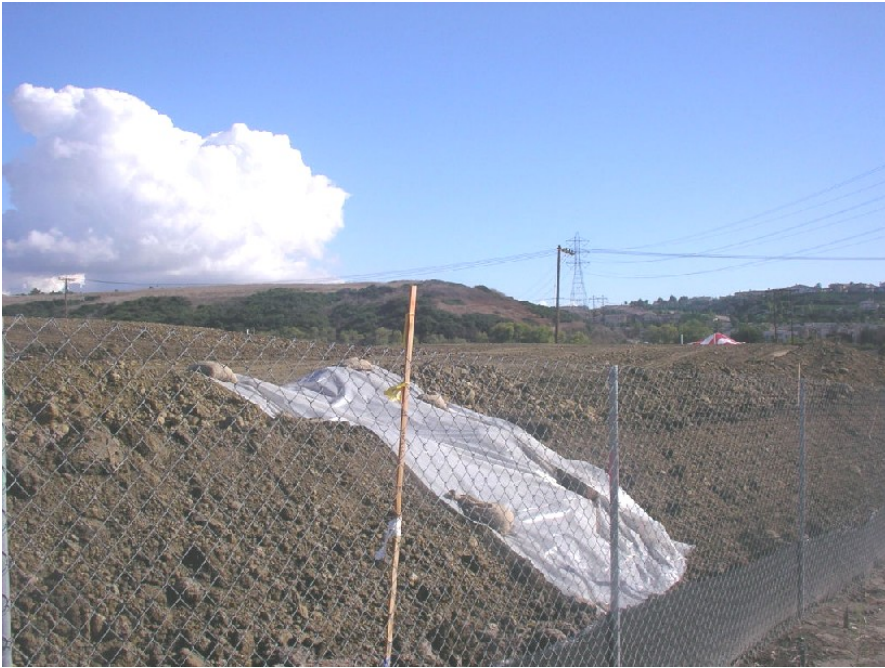
Photo 5
Plastic Spillway For Sediment Trap (Facing Southeast)

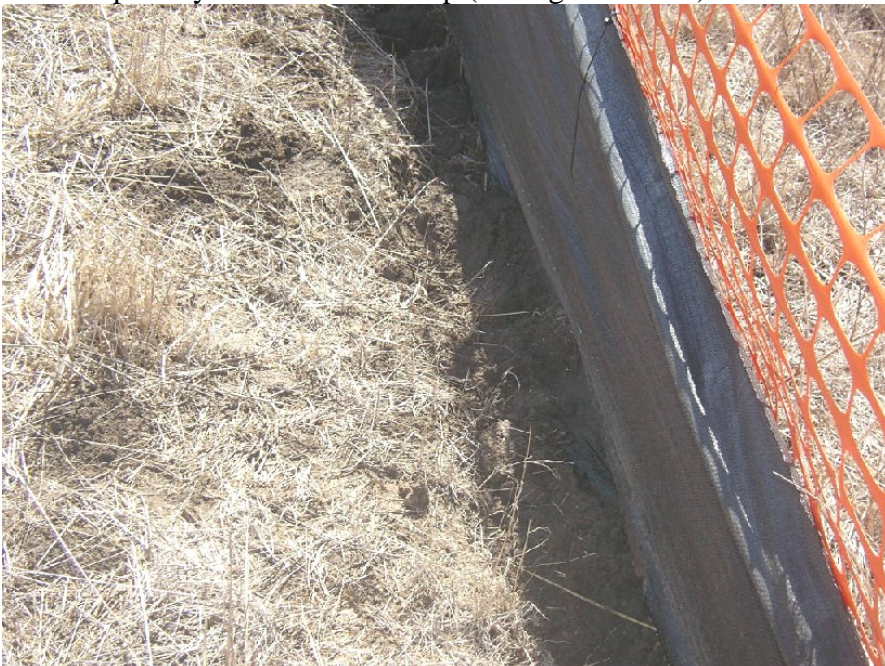
- The site appeared to be relying on silt fence as the main sediment control BMP. The silt fence was installed incorrectly on most of the site perimeter and not trenched into the ground, making it susceptible to undermining (Photo 6).

Photo 6
Example of Incorrect Silt Fence Installation (Not Trenched In)
