Site Characterization Report

**Airport/Former Teledyne Ryan Aeronautical Site
2701 North Harbor Drive
San Diego, California**

**WDID No. 937I004452
(Former TRA Facility)**

GEOSYNTEC CONSULTANTS

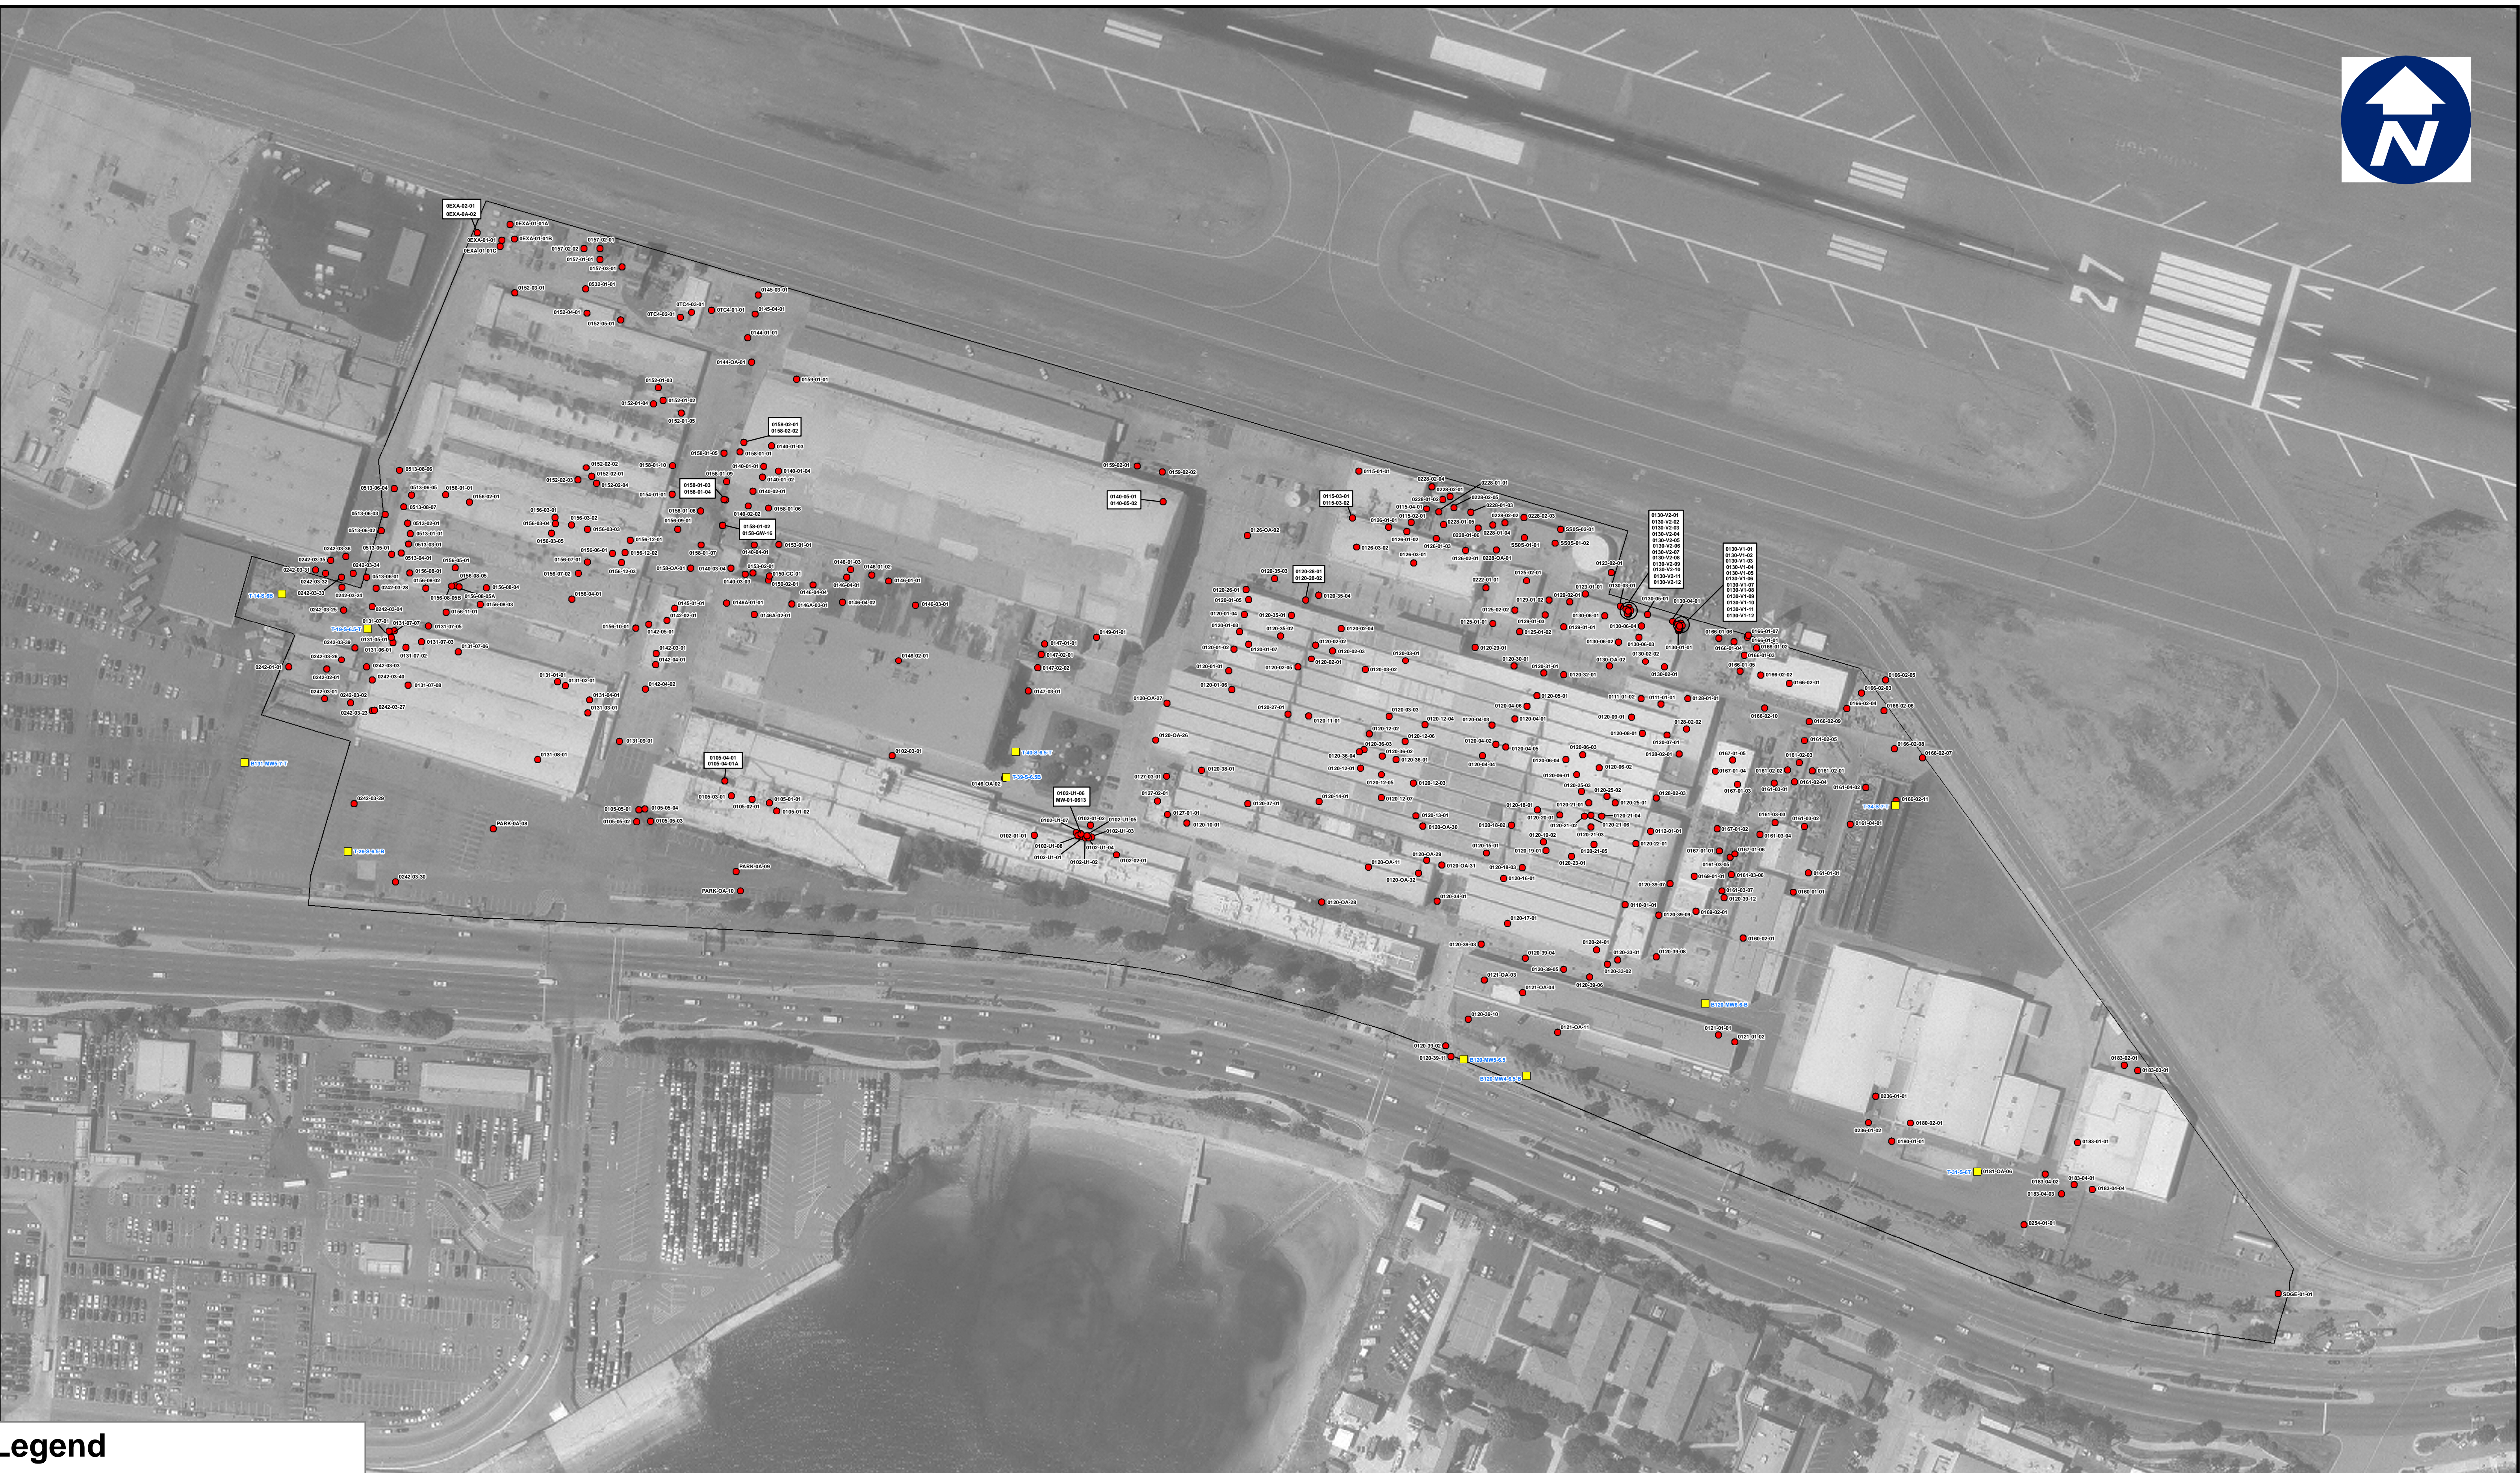
FIGURE NO.	2-5
PROJECT NO.	SC0307
DATE:	DECEMBER 2005

HISTORICAL USE AREAS - ALL CLASSES
 2701 NORTH HARBOR DRIVE
 SAN DIEGO, CALIFORNIA

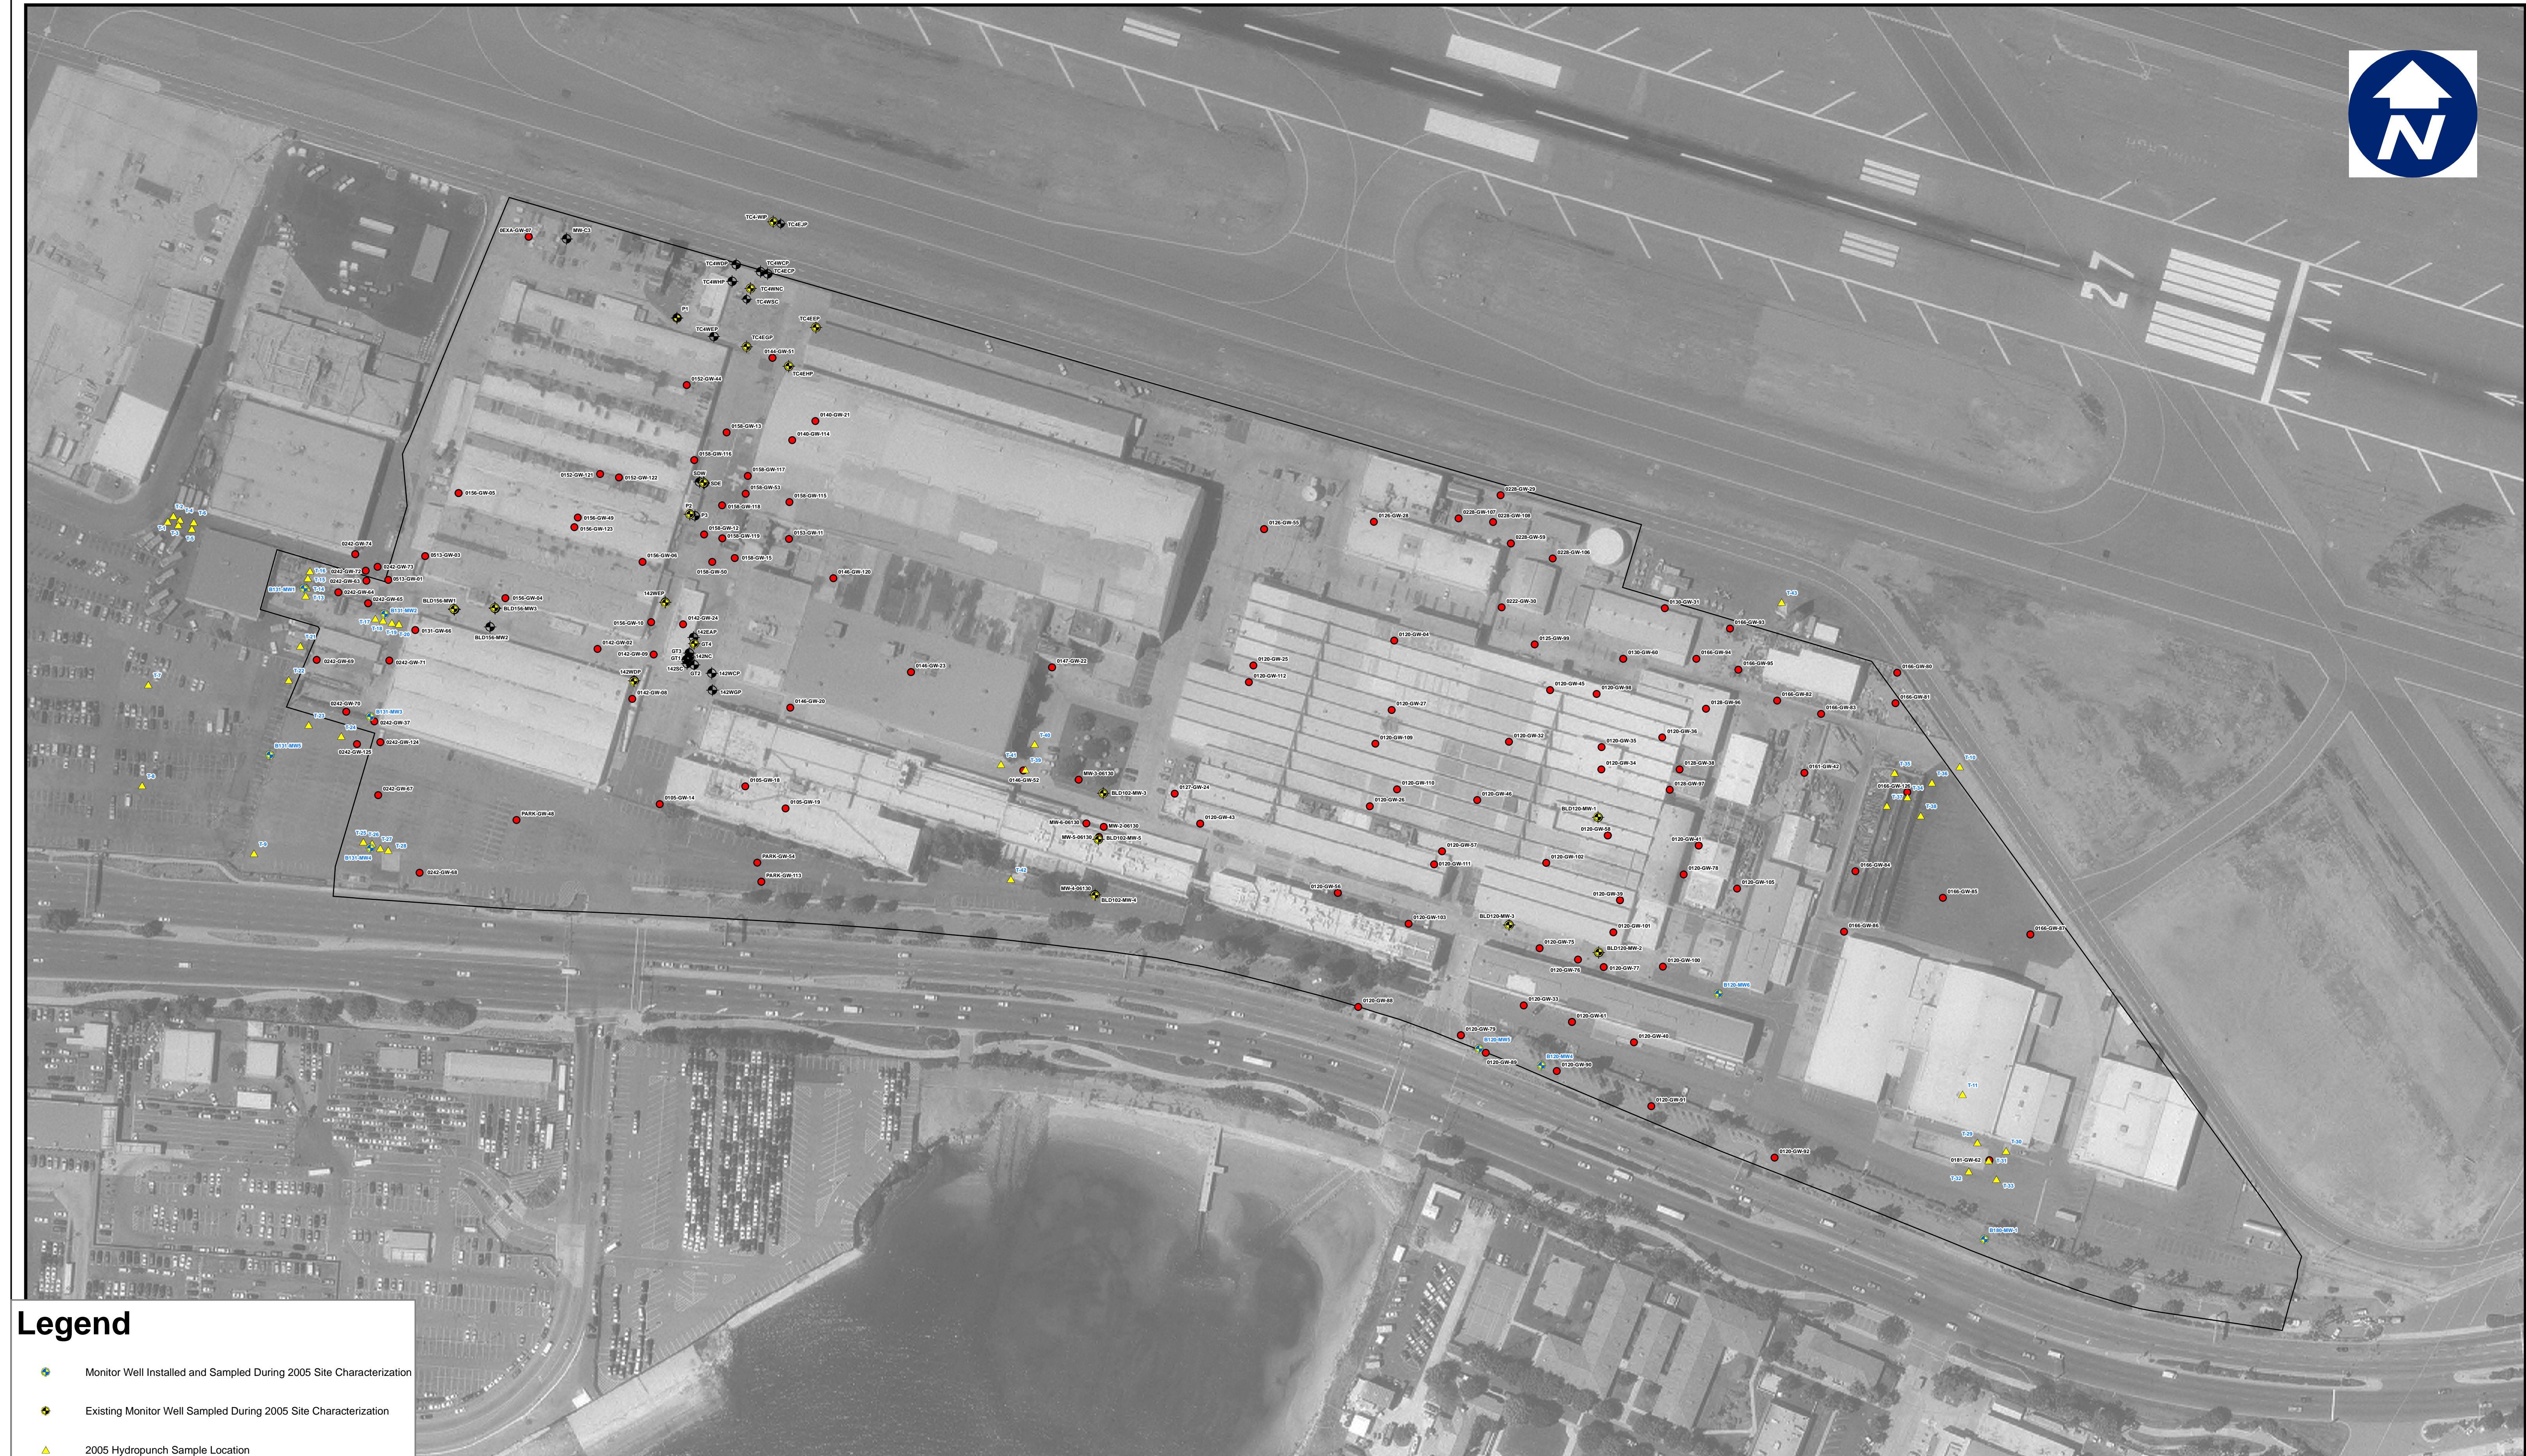
FIGURE NO.	3-1
PROJECT NO.	SC0307
DATE	DECEMBER 2005

GEOSYNTEC CONSULTANTS
SOIL SAMPLE LOCATIONS
2701 HARBOR DRIVE
SAN DIEGO, CALIFORNIA

Groundwater samples were collected from 9 newly installed monitor wells and additional 21 existing monitor wells at the Site (Figure 3-1). Water level was measured in all existing wells prior to sampling using an interface probe to assess the presence of non-aqueous phase liquid (NAPL) (Table 3-6). Groundwater samples were collected using low flow sampling procedure with a bladder pump set in the middle of the water column. The well was then purged at a low rate to minimize draw-down within the well. During purging, the water level, pumping rate, cumulative withdrawal, and field indicator parameters (i.e., DO, turbidity, Eh (ORP), specific conductance, pH, and temperature) were measured and recorded. If excessive draw-

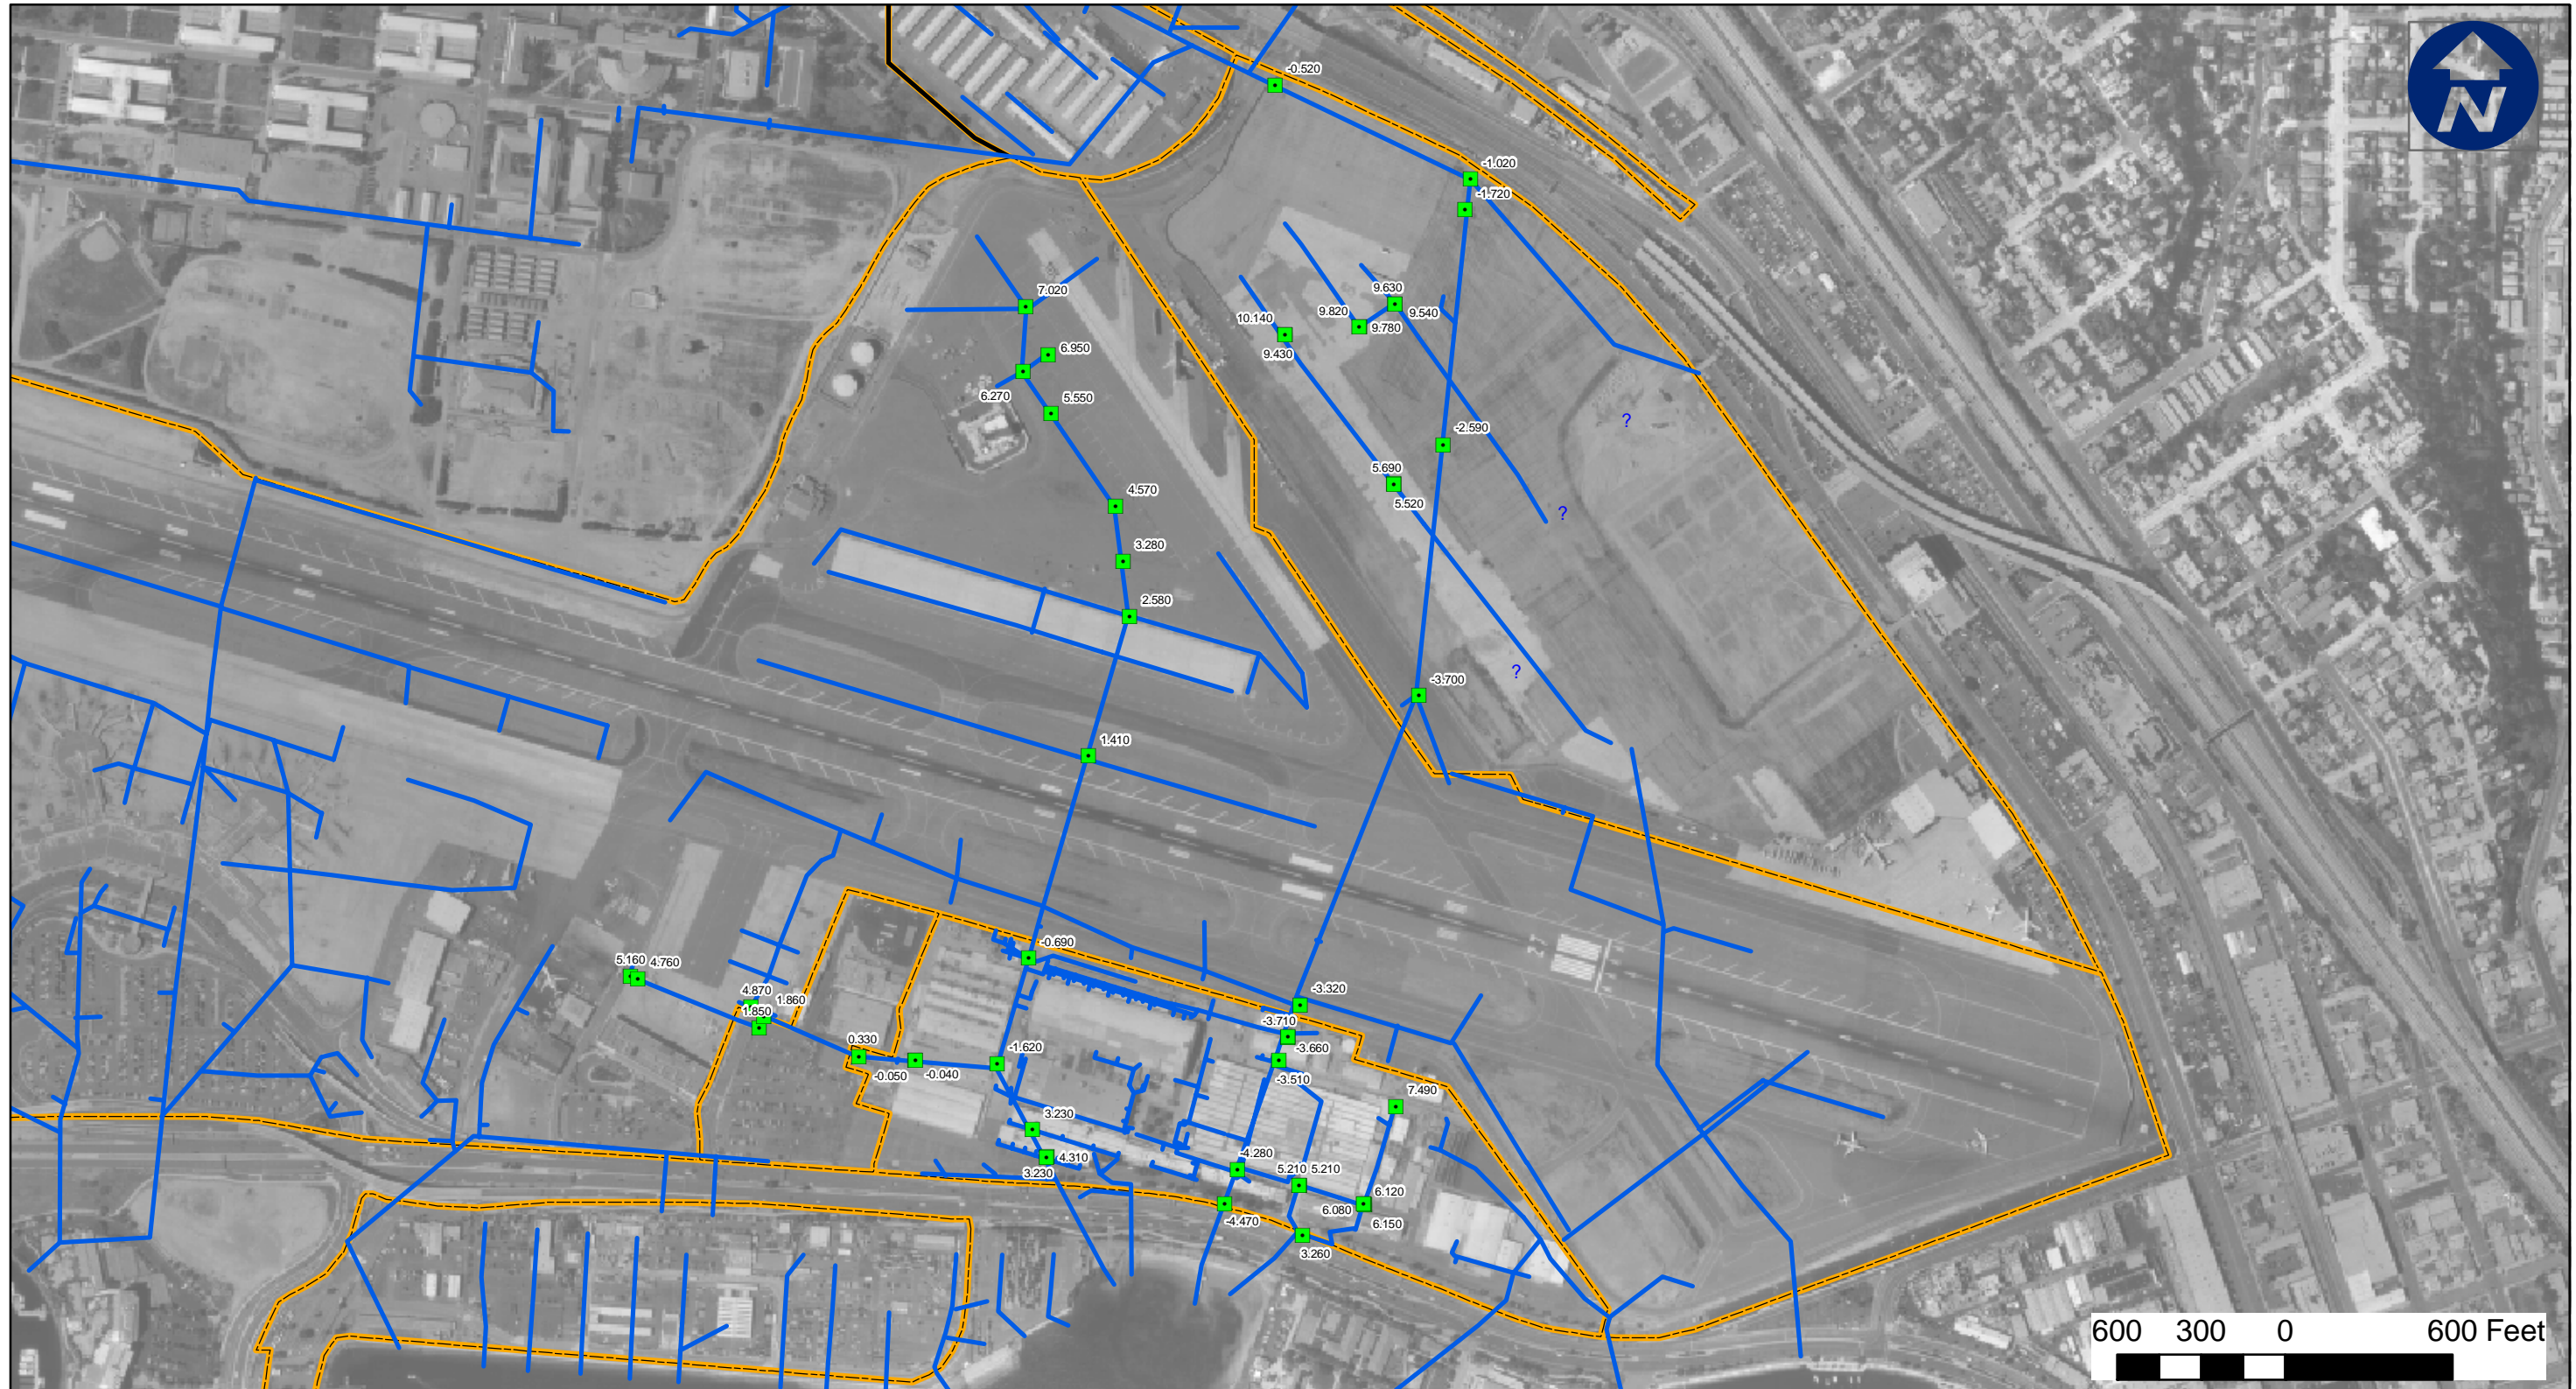
FIGURE NO.	6-1
PROJECT NO.	SC0307
DATE:	NOVEMBER 2005

STORMWATER CONVEYANCE SYSTEM
 2701 NORTH HARBOR DRIVE
 SAN DIEGO, CALIFORNIA

Six storm water outfalls discharge into Convair Lagoon (Figure 6-1). Two of the outfalls are from lines associated with the former GD Harbor Drive facility. The GD Harbor Drive facility reportedly used PCBs in its operations. Of the remaining four outfalls, two are from storm drains that originate from other sites and transect the Site, and two are from storm drains that originate on the Site.

Two additional storm drains in the eastern portion of the Site drain into San Diego Bay and do not contribute to Convair Lagoon (Figure 6-1).

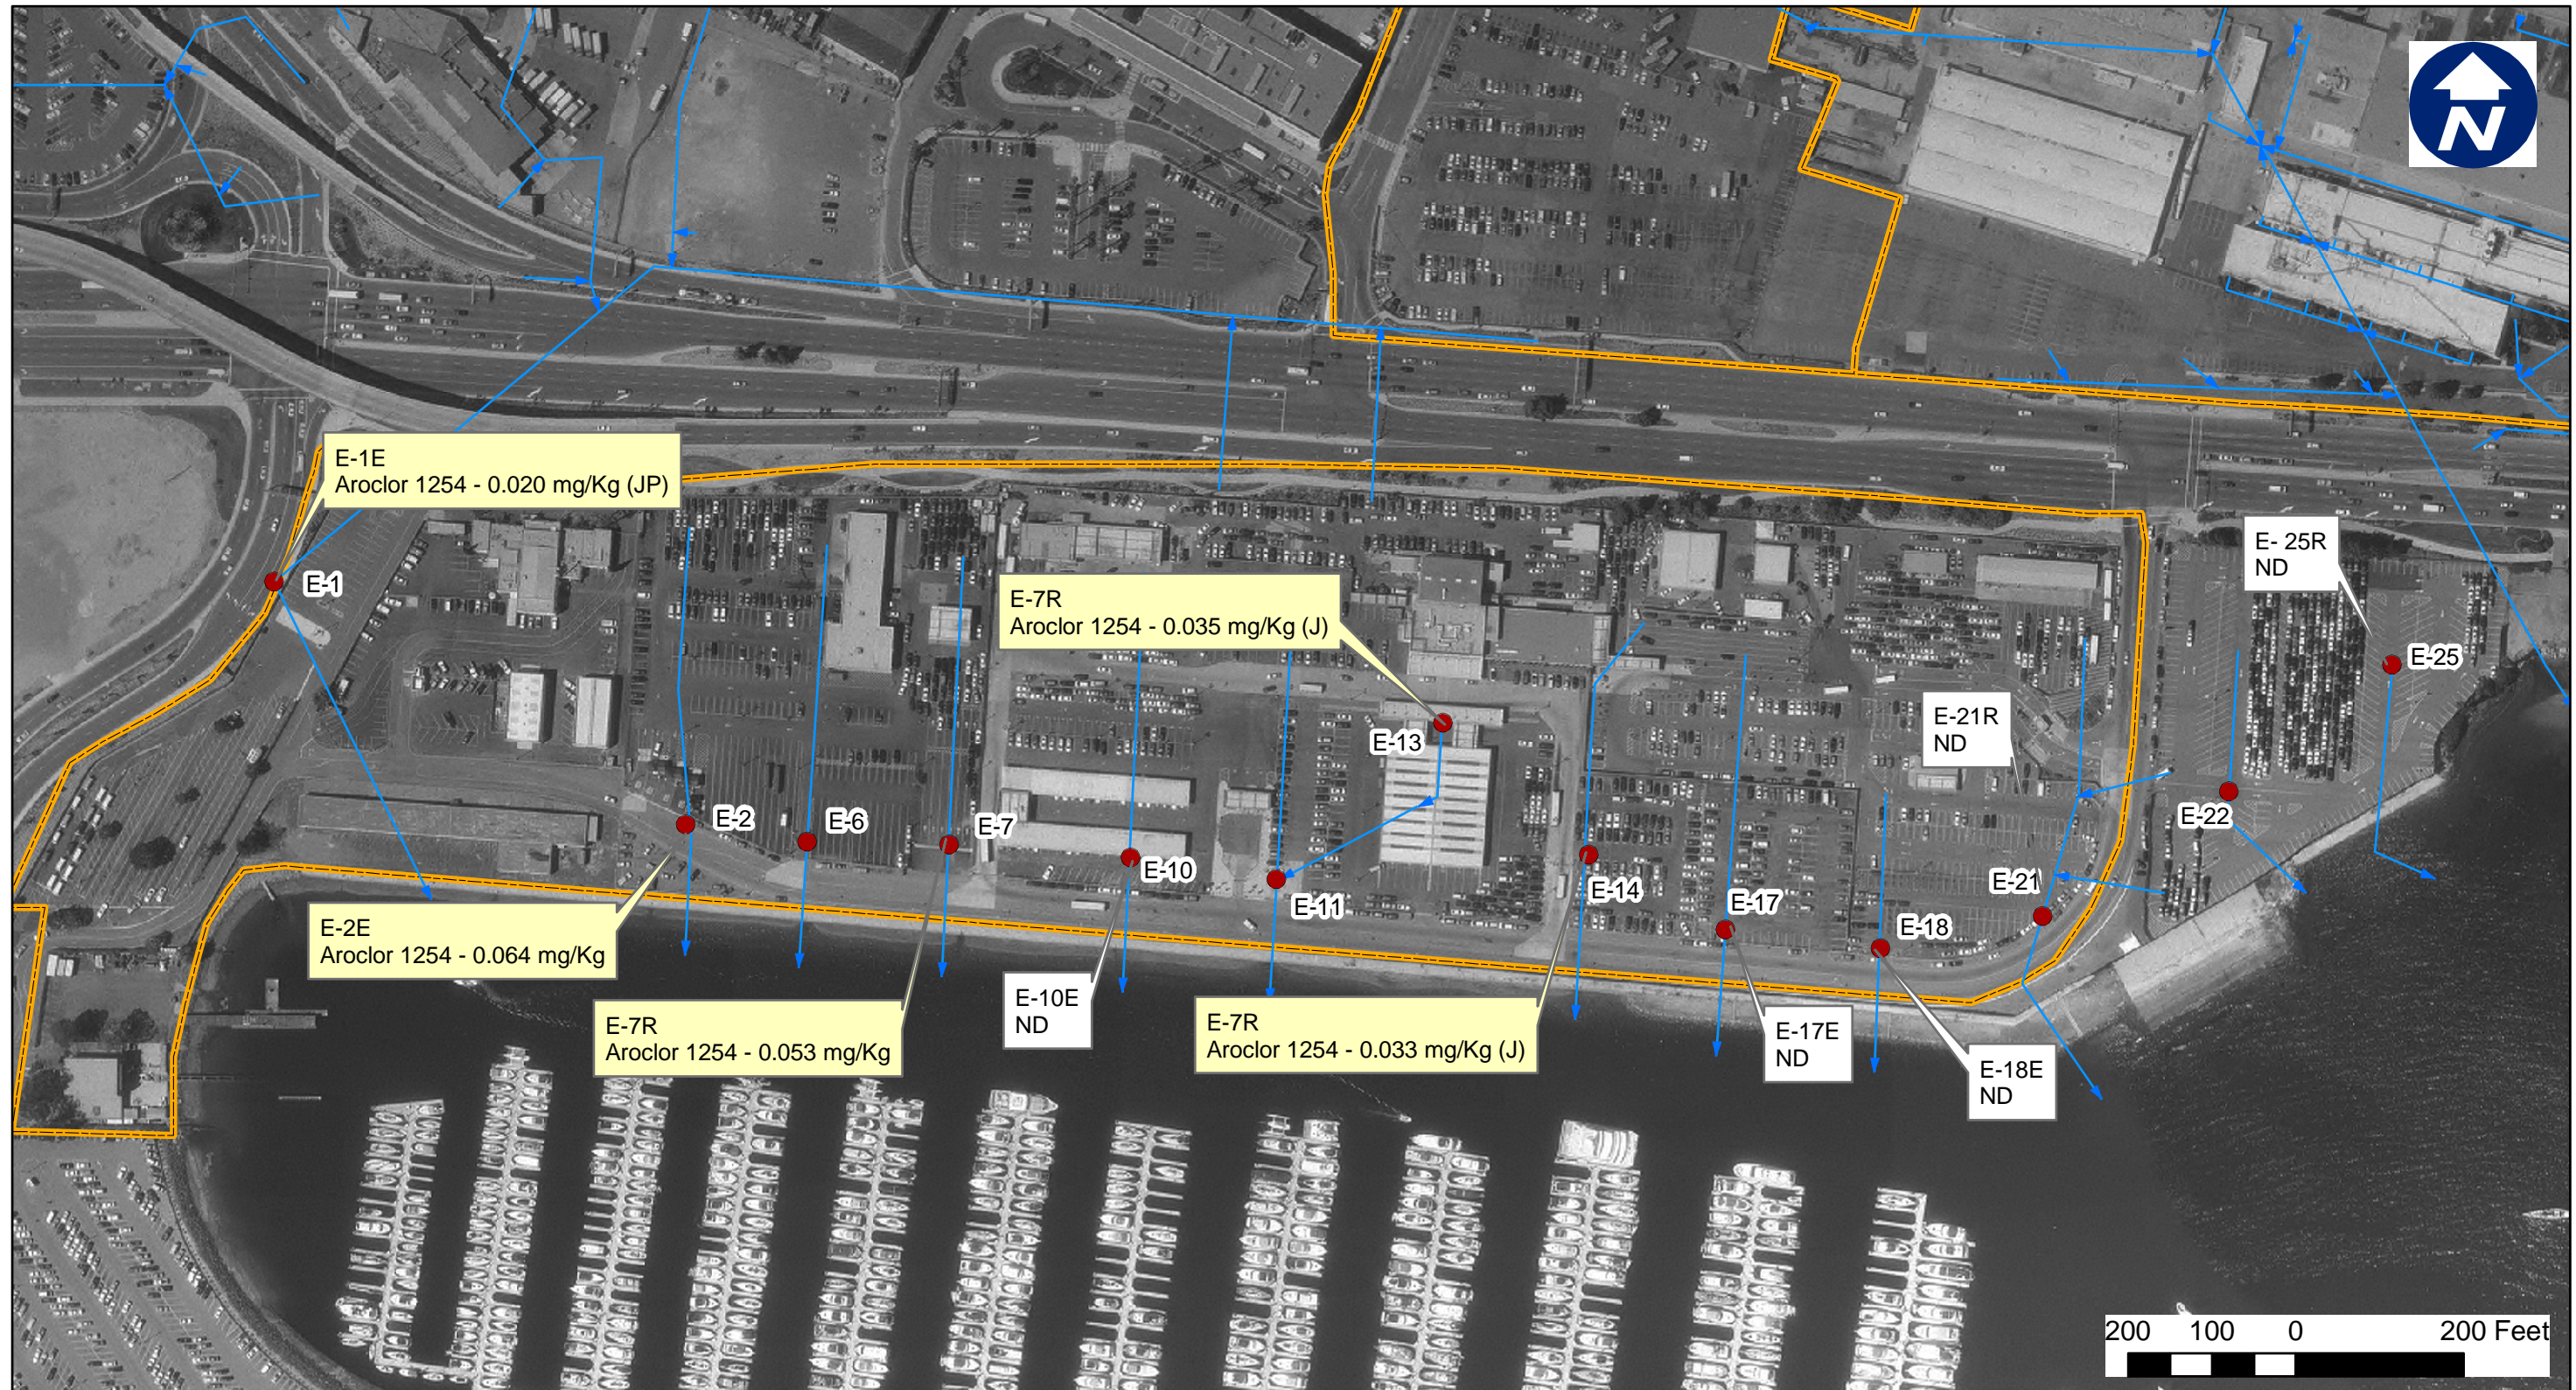
PCB RESULTS IN OFF-SITE SWCS	
FORMER GENERAL DYNAMICS - HARBOR DRIVE SITE	
2701 NORTH HARBOR DRIVE - SAN DIEGO, CALIFORNIA	
FIGURE NO.	7-5
PROJECT NO.	SC0307
DATE:	DECEMBER 2005

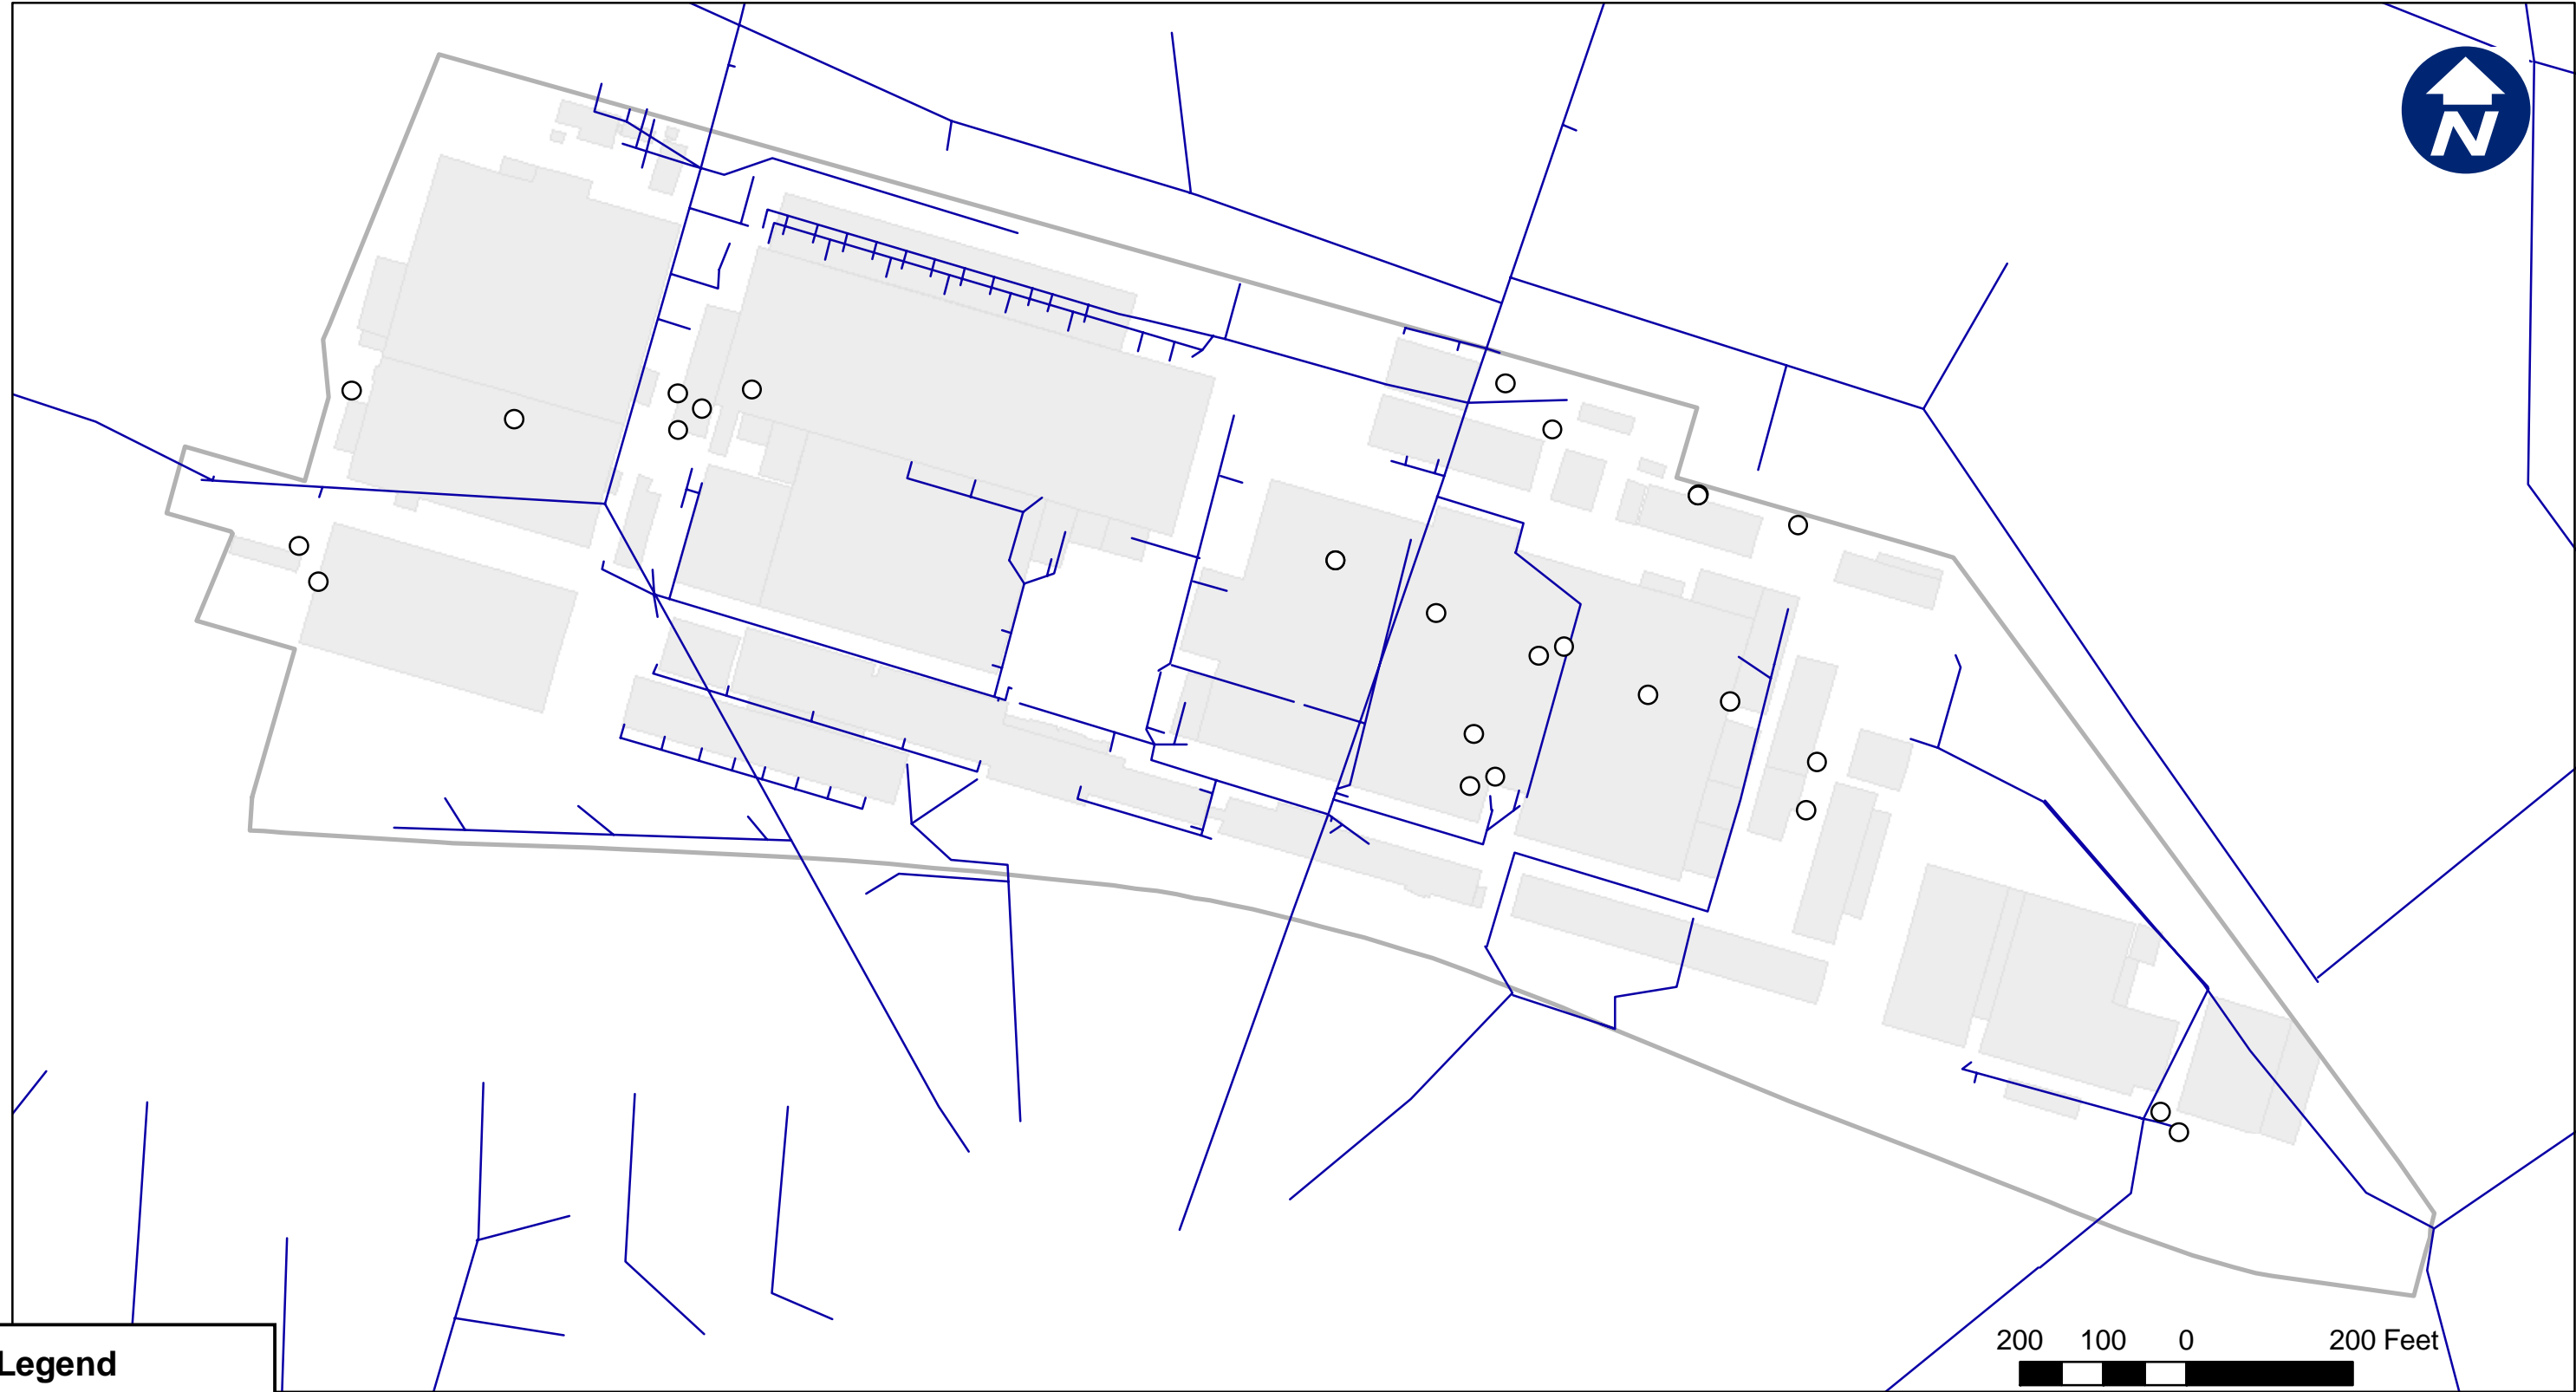
FIGURE NO.	7S-12
PROJECT NO.	SC0307
DATE:	DECEMBER 2005

SELENIUM IN SOIL (0 - 5 FEET)
2701 NORTH HARBOR DRIVE
SAN DIEGO, CALIFORNIA

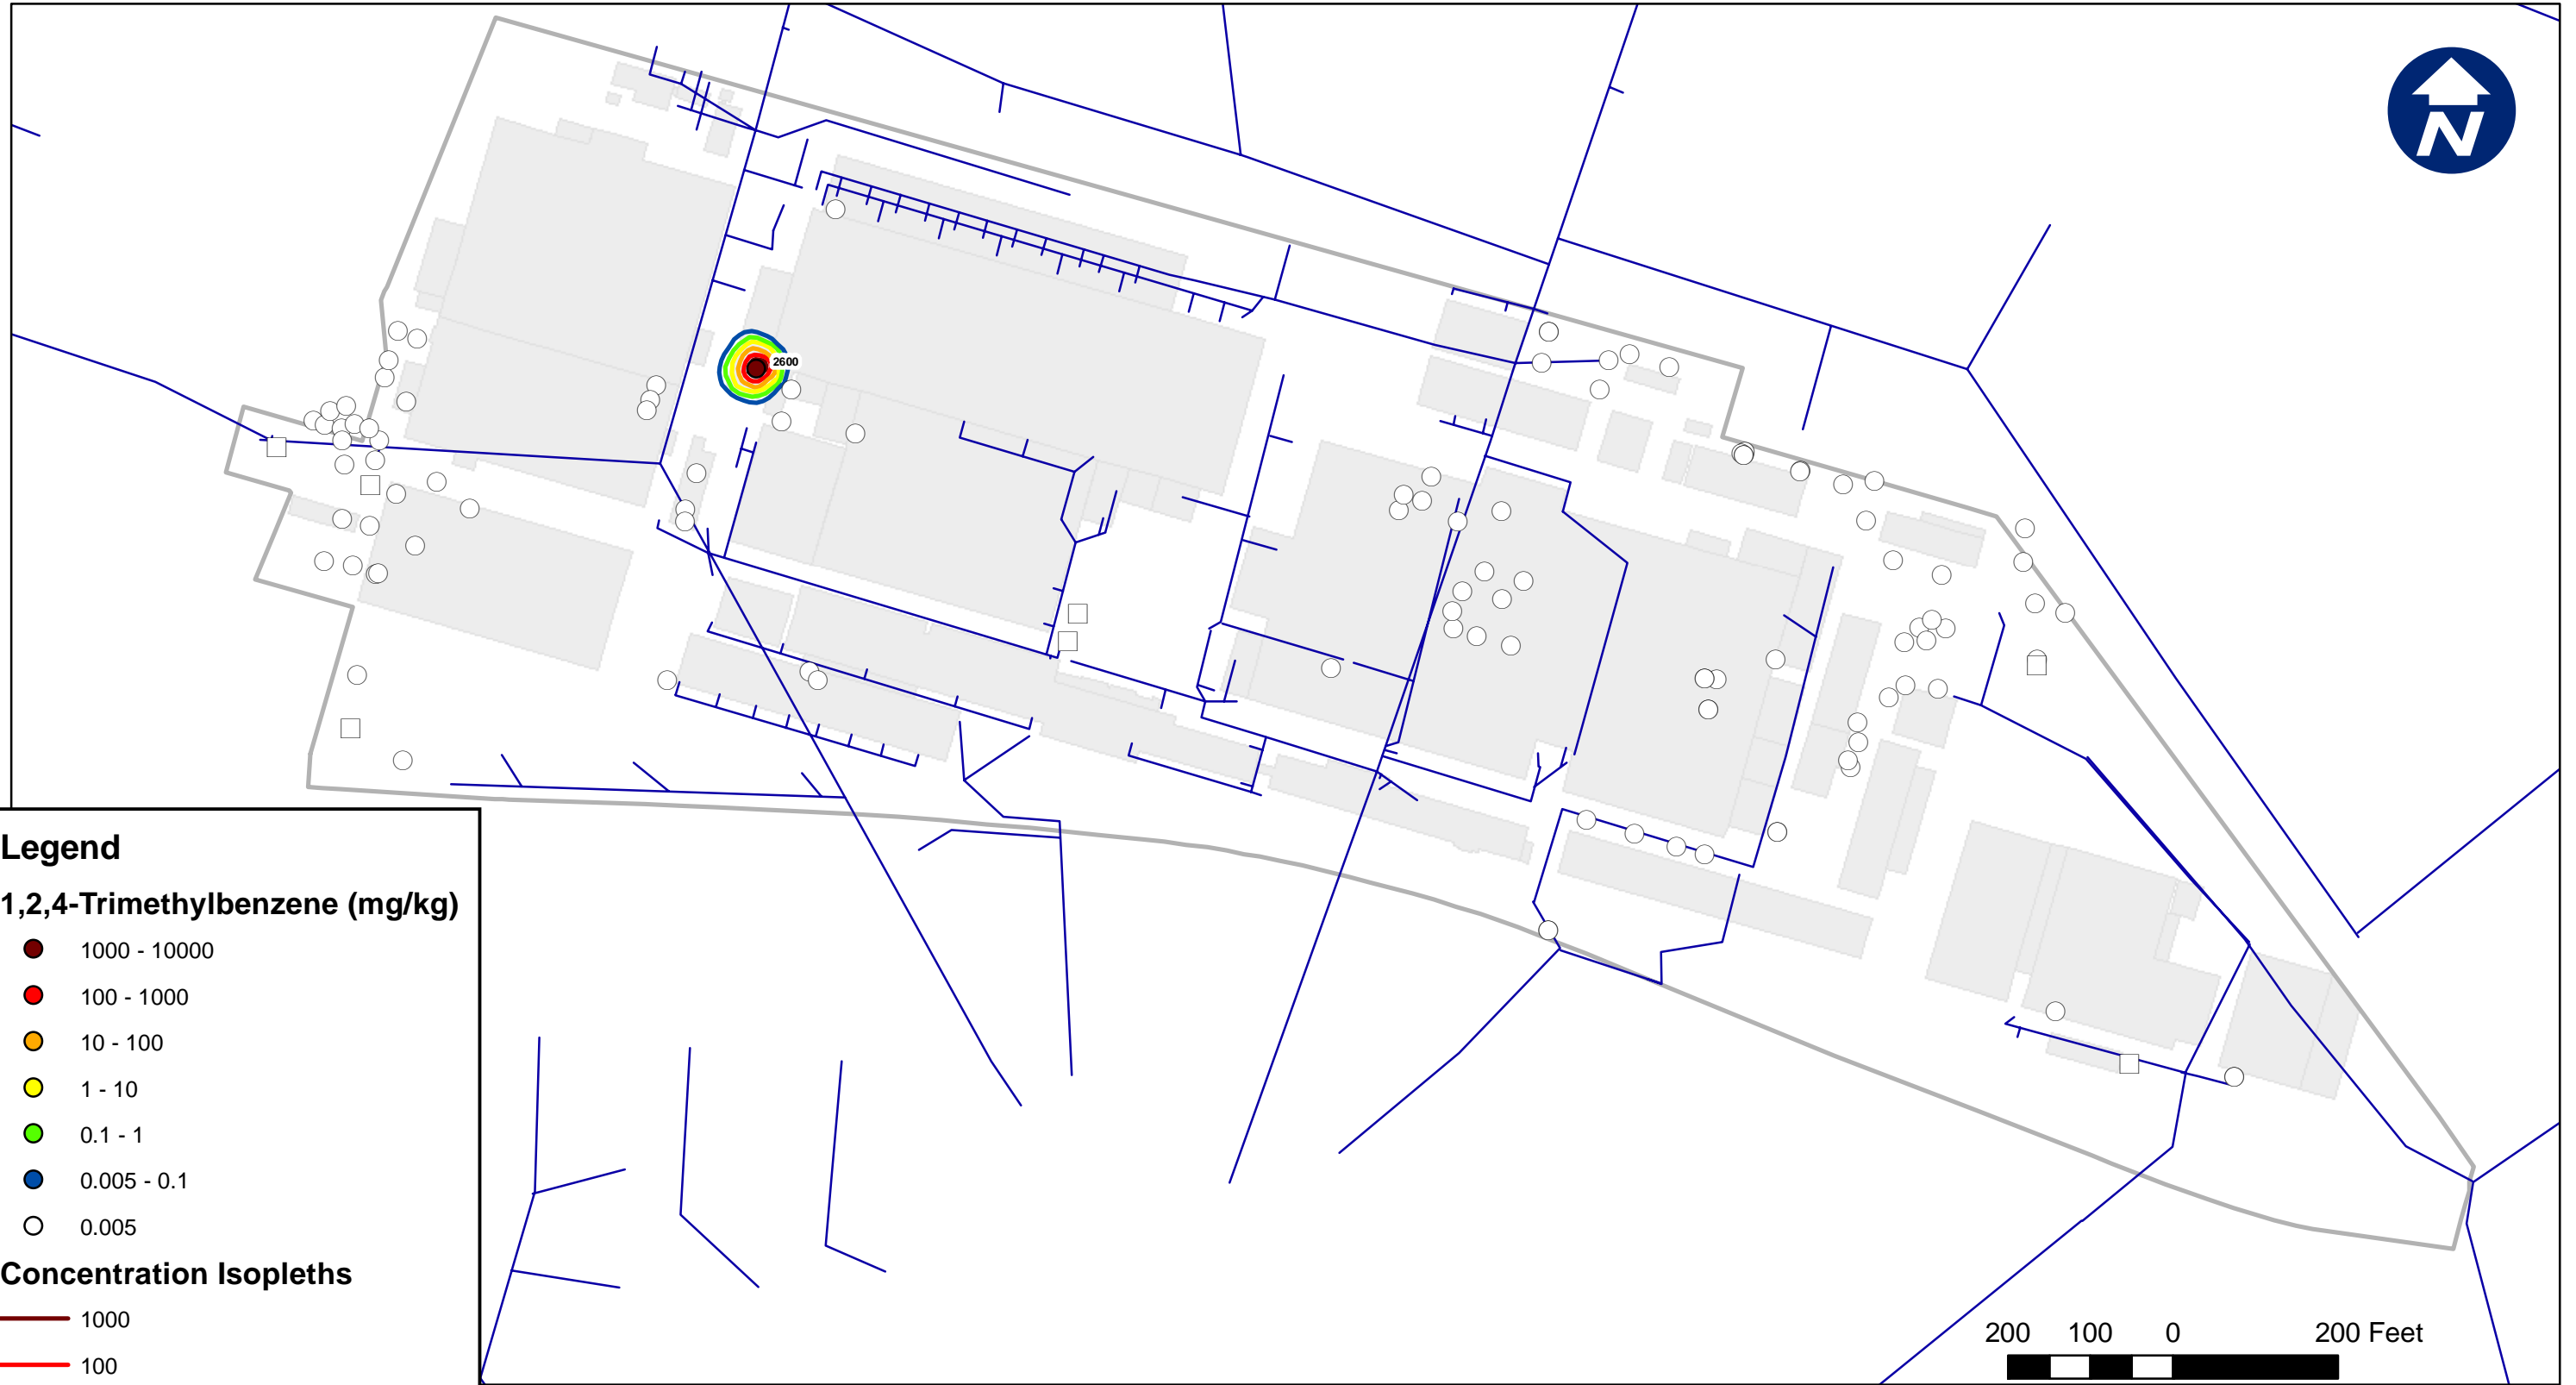
GEOSYNTEC CONSULTANTS	
1,2,4-TRIMETHYLBENZENE IN SOIL (0 - 5 FEET) 2701 NORTH HARBOR DRIVE SAN DIEGO, CALIFORNIA	
FIGURE NO.	7S-18
PROJECT NO.	SC0307
DATE:	DECEMBER 2005
