Site Characterization Report

**Airport/Former Teledyne Ryan Aeronautical Site
2701 North Harbor Drive
San Diego, California**

**WDID No. 937I004452
(Former TRA Facility)**

GEOSYNTEC CONSULTANTS

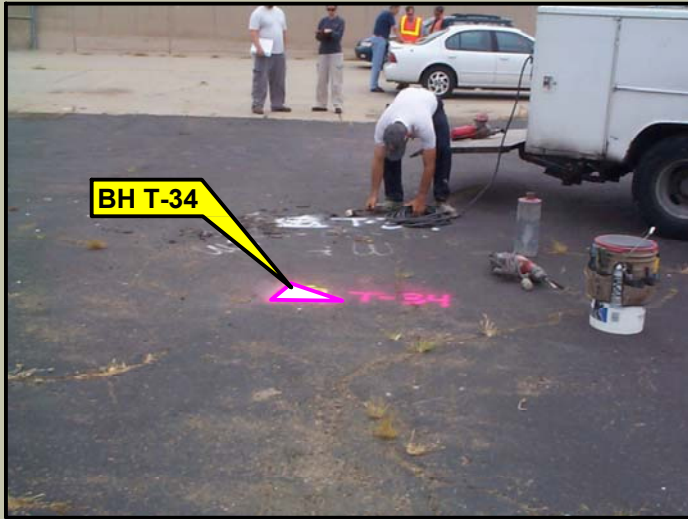
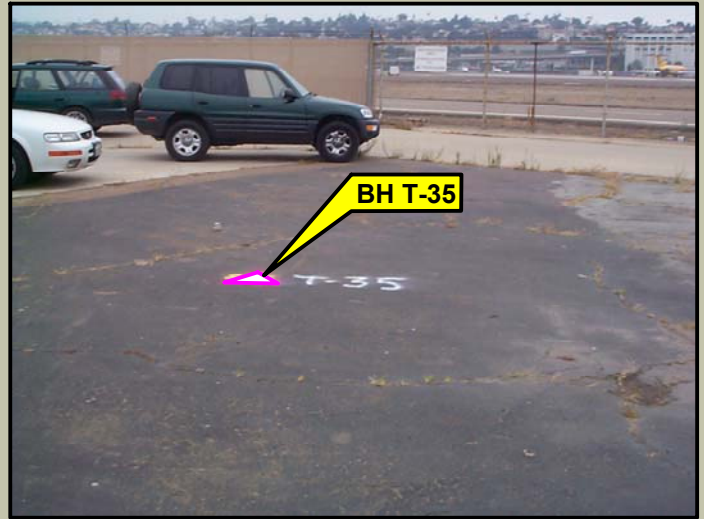
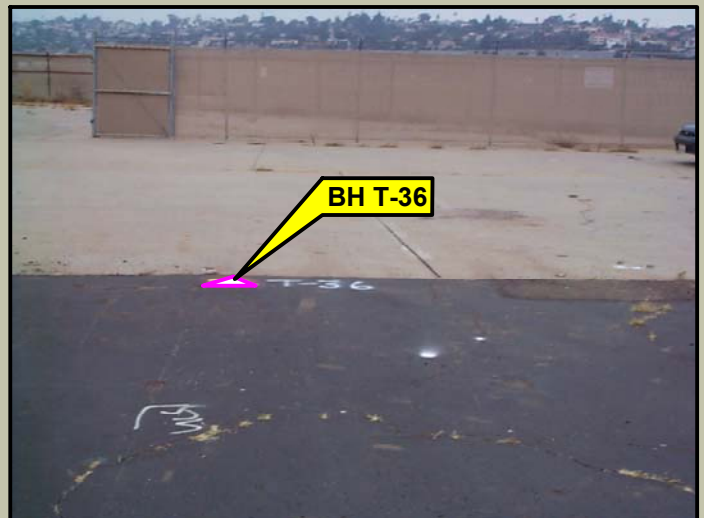
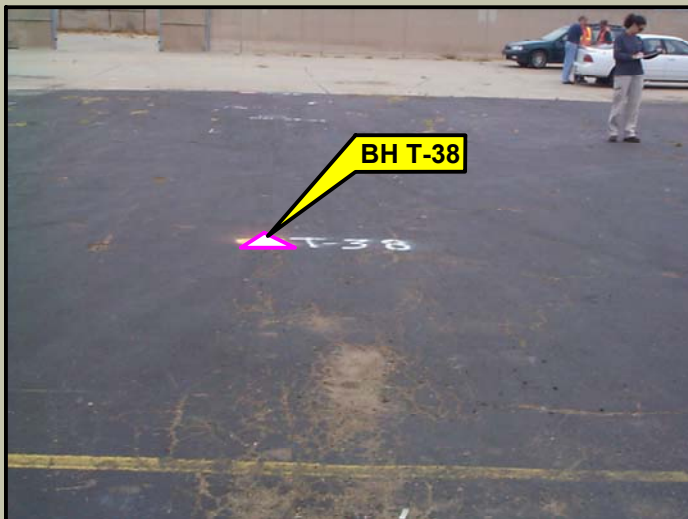
Figure 2

# BOREHOLE PHOTOGRAPHS
