Technical Analysis to Administrative Civil Liability Complaint No. R9-2011-0023

# **TECHNICAL ANALYSIS**

Proposed Administrative Civil Liability Contained in Complaint No. R9-2011-0023 Santa Margarita Water District Plano Force Main Sewer Spill to Tijeras Creek and to the Pacific Ocean, Orange County

March 10, 2011

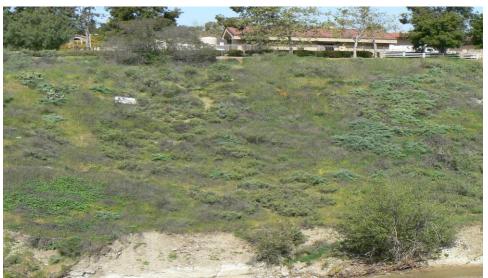
Figure 2. Plano lift station above Tijeras Creek

SMWD reports that on March 23, 2010, at 4:03 p.m., SMWD staff received a "Surge Tank Low" from the Supervisory Control and Data Acquisition (SCADA) system indicating that pressure in the surge tank at the Plano Lift Station was below normal operating range. The surge tank modulates pressure in the Plano 24-inch force main with a combination of air and water to avoid pressure surges which could damage the system or the pumps. The Plano Lift Station facility, located at 21384 Antonio Parkway, Rancho Santa Margarita, is directly west and adjacent to Tijeras Creek. (See Figure 2)

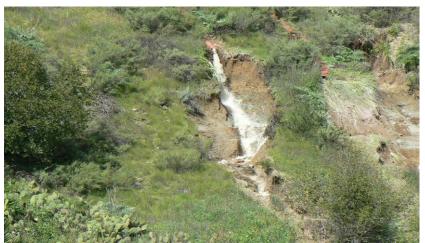
Figure 3. Periodic SMWD discharge of sewage to Tijeras Creek

On Wednesday March 24, in an effort to isolate the ruptured force main for repairs, SMWD started periodically pumping untreated raw sewage from a 6-inch trash pump directly into Tijeras Creek (see Figure 3). This action was used when peak sewage flow rates exceeded the capacity of the vactor trucks to keep up with the spill. This episodic discharge of sewage occurred on the slopes above Tijeras Creek and resulted in erosion of native coastal sage scrub habitat above the creek.

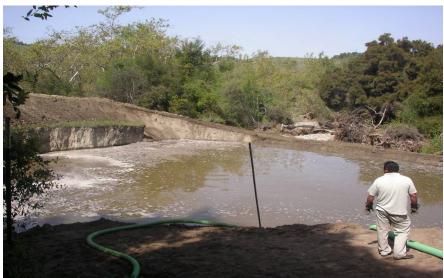
Figure 4. Earthen berm construction on March 25, 2010 to contain raw sewage within Tijeras Creek

Beginning at 9:00 a.m. on Wednesday March 24, 2010, The County of Orange Watershed Department provided assistance to SMWD by constructing an earthen berm within Tijeras Creek. The berm was located within O'Neill Regional Park, approximately one mile downstream from the Plano pump station and 100 yards upstream of the confluence with Arroyo Trabuco Creek (see Figure 4).

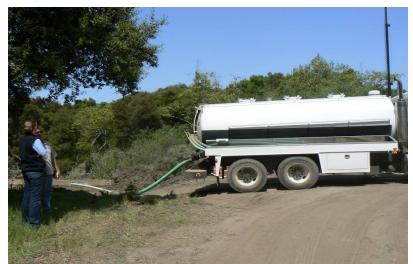
Figure 5. Pumper truck at O'Neill Park earthen berm on March 26, 2010

The berm construction was completed by 3:00 p.m. Construction of the berm prevented the ongoing discharge of untreated sewage from continuing to Arroyo Trabuco Creek, San Juan Creek and ultimately the Pacific Ocean at Doheny Beach. The County of Orange restricted access to O' Neill Park allowing pumper trucks to begin pumping sewage from the berm location and dumping into the Los Flores sewer system (see Figure 5).

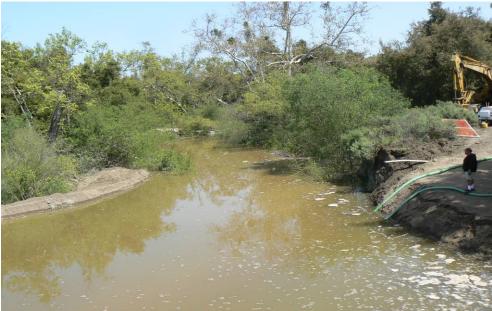
Figure 6. Sewage backed up in Tijeras Creek north of containment berm

While the berm was effective in isolating the impacts of the discharge to an approximately one mile section of Tijeras Creek, it essentially turned the creek into a large "open air" sewage holding pond, with untreated sewage and creek flow backing up behind the berm (see Figure 6)

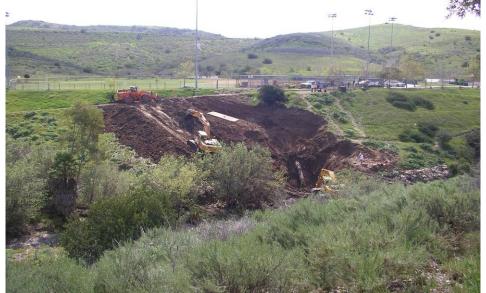
Figure 7. Pipe repair excavation Tijeras Creek on March 25, 2010

By 10:00 a.m. on March 24, 2010 SMWD contractors had excavated and exposed the 24-inch pipeline at the joint below the point in the creek bank where the discharge was first observed (see Figure 7). SMWD believed that it was close to locating the break, and that repairs would be completed by midnight that day. Unfortunately the leak was not at the exposed joint and further excavation was required. The area of the pipe rupture was not uncovered until 1:00 p.m. on March 25, 2010.

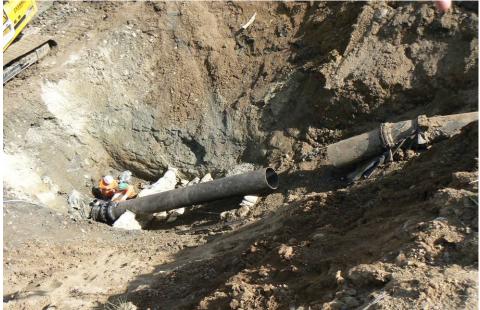
Figure 8. Force main rupture repair work on March 26, 2010

Repairs to the ruptured pipe did not commence until March 26, 2010 (see Figure 8) and were completed at 10:00 p.m. on that day. By midnight the forcemain was loaded and functioning, cleanup of the pump station was commenced, and emergency crews were relieved from their stations.

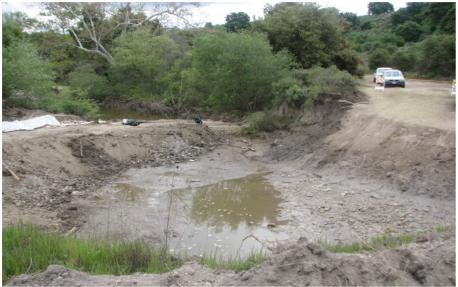
Figure 9. Sewage containment area pumped dry on April 1, 2010

Although repairs to the 24-inch forcemain were complete on March 26, 2010, large amounts of untreated sewage remained impounded behind the berm constructed in Tijeras Creek, and pumping trucks continued to remove sewage from behind the berm for an additional four days until March 30, 2010 (see Figure 9).

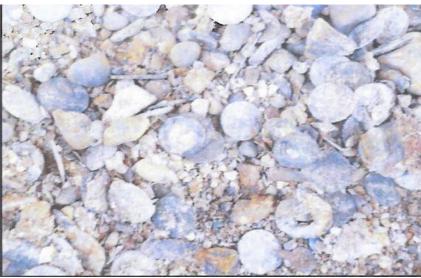
Figure 12. Debris found inside forcemain

Loose debris including nails, screws, rocks and pennies were found in the bottom of the elbow in the forcemain before it rises out of Tijeras Creek (see Figure 12).

The results of the initial investigation into the pipe failure concluded that external corrosion did not appear to be the cause of the failure. The interior lining was either abraded away or was damaged from grit and other debris forced up and down the pipe from the operation of the lift station pipes cycling back and forth. This constant abrasion resulted in the interior coating failure, and exposed the pipe to the wastewater. This led to internal erosion corrosion of the pipe wall and over time to the eventual failure of the forcemain.
