**CALIFORNIA REGIONAL WATER QUALITY CONTROL BOARD  
SAN DIEGO REGION**

**TECHNICAL ANALYSIS**

**ADMINISTRATIVE CIVIL LIABILITY CONTAINED IN  
COMPLAINT NO. R9-2015-0110**

**SAN ALTOS-LEMON GROVE, LLC  
VALENCIA HILLS CONSTRUCTION SITE  
WDID 9 37C369143**

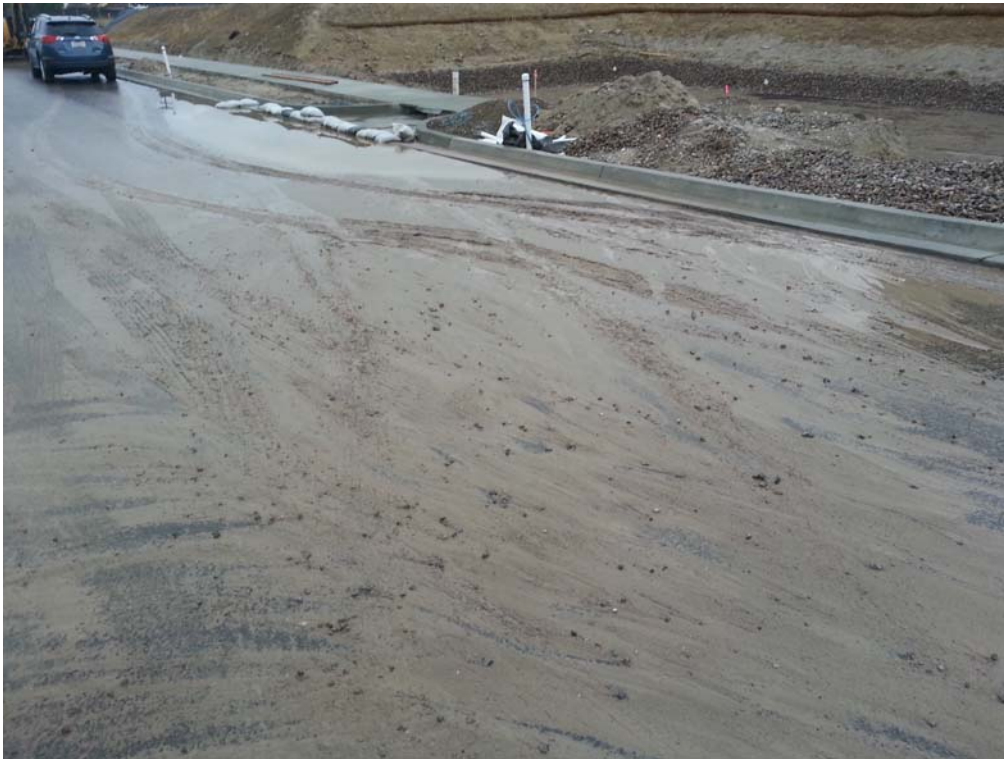
Sediment-laden water was discharged from the Site into Encanto Channel and Chollas Creek on December 4, 12, 17, 31, 2014, May 8, 2015, and September 15, 2015. See Figure 2. May 8, 2015, Sediment Discharge. The violations were noted in the following documents: City Stop Work Notice December 4, 2014 (Exhibit No. 3); City Administrative Citation December 15, 2014 (Exhibit No. 7), and San Diego Water Board Inspection Report December 15, 2014 (Exhibit No. 8); City Contractor Report December 17, 2014 (Exhibit No. 10); City Contractor Report December 31, 2014 (Exhibit No. 12); in photographs and text in San Diego Water Board Inspection Report May 8, 2015 (Exhibit No. 18), and City Administrative Citation September 15, 2015 (Exhibit No. 21). The discharges into Encanto Channel and Chollas Creek were unauthorized and a violation of the Construction Storm Water Permit section III.B. because the Discharger failed to reduce or eliminate the pollutants in the storm water runoff prior to discharge (i.e., to implement BMPs that achieve BAT and BCT).

**Figure 2. May 8, 2015, Sediment Discharge.** View of sediment in street (Orlando Drive) after storm event. Photograph taken by Frank Melbourn, San Diego Water Board. 20150508\_191716.jpg

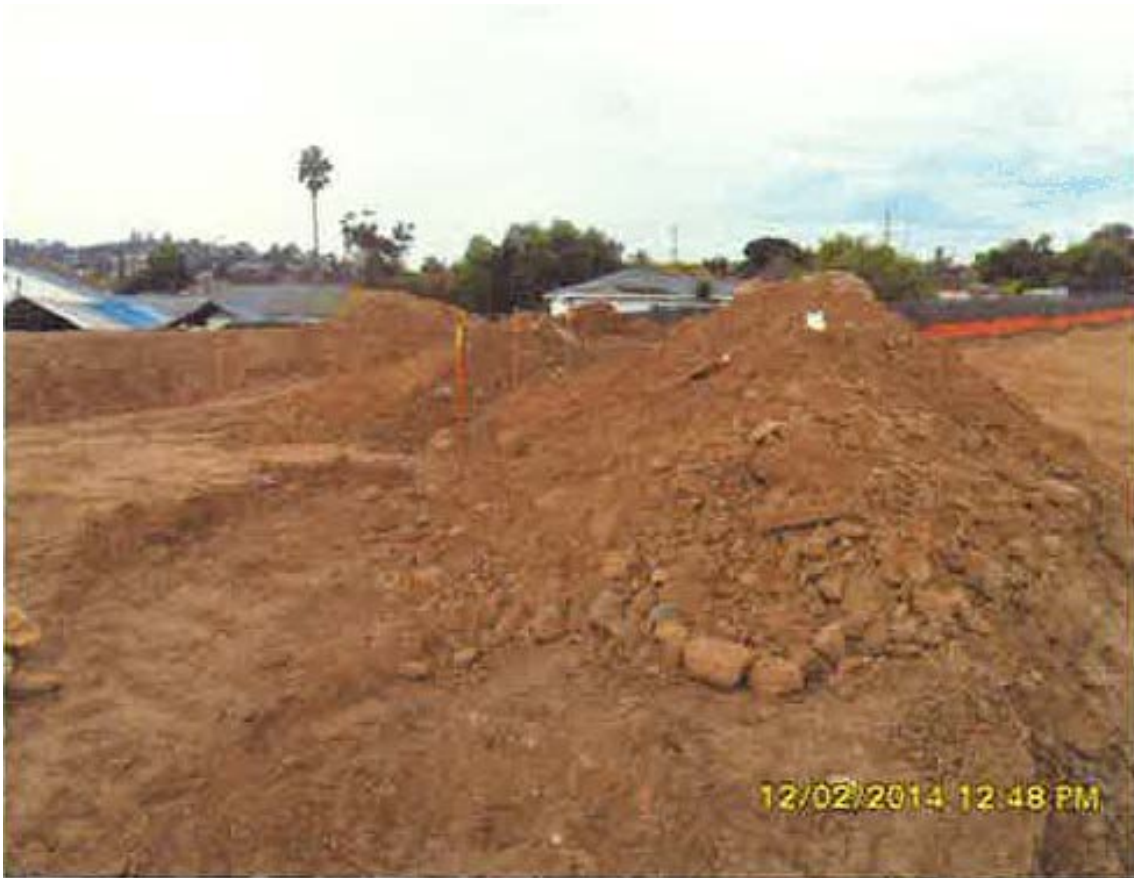
The Discharger was in violation of section B.1.b. for 10 days; from December 2 through 8, 2014, December 15, 2014, May 13, 2015, and September 15, 2015. See Figure 3. Failure to implement material stockpile BMPs. The violations were noted in the following documents: City Stop Work Notice December 2, 2014 (Exhibit No. 2); City Stop Work Notice December 4, 2014 (Exhibit No. 3); City Inspection Report December 8, 2014 (Exhibit No. 4); San Diego Water Board Inspection Report December 15, 2014 (Exhibit No. 8); San Diego Water Board Inspection Report May 13, 2015 (Exhibit No. 19), and City Inspection Report September 15, 2015 (Exhibit No. 22).

**Figure 3. Failure to implement material stockpile BMPs.** Photograph taken by the City of Lemon Grove on December 2, 2014.

- B. Violation No. 2: Failure to Implement Material Stockpile BMPs. (10 days)**  
Pursuant to section B.1.b. in Attachment D to the Construction Storm Water Permit, dischargers are required to “[c]over and berm loose stockpiled construction materials that are not actively being used (i.e. soil, spoils, aggregate, fly-ash, stucco, hydrated lime, etc.)”

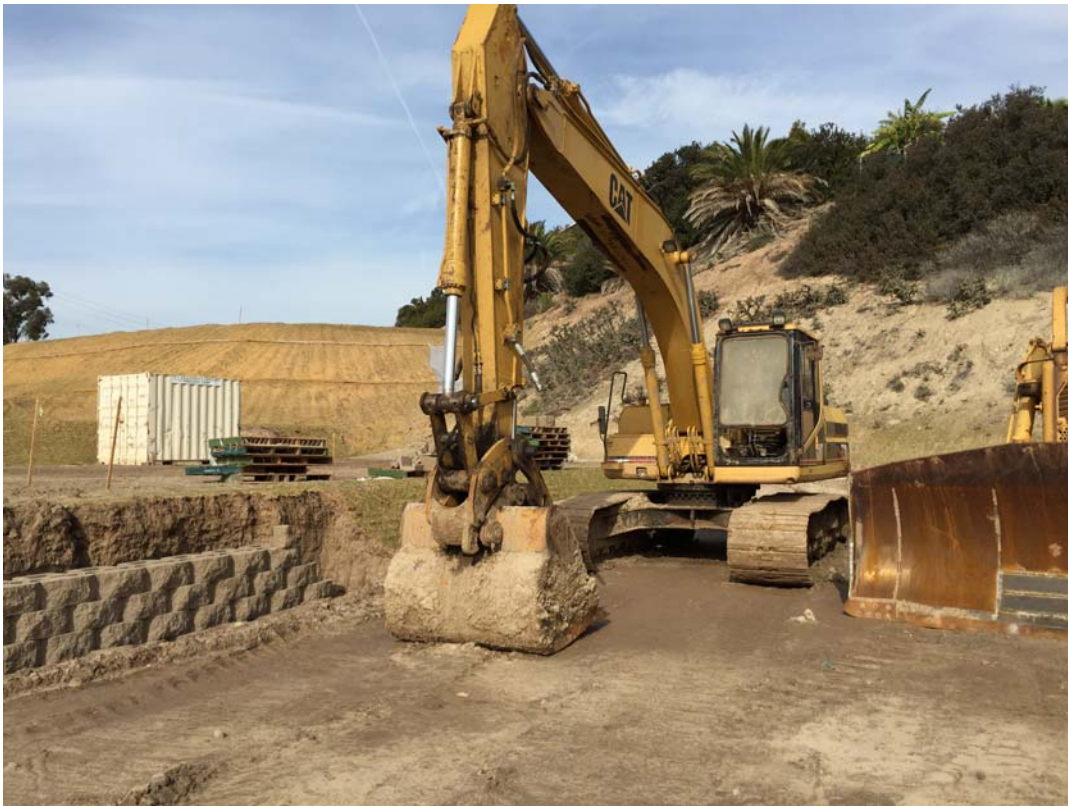
**Figure 4. Failure to have vehicle fluid leak protection.** Photograph taken by Wayne Chiu, San Diego Water Board on December 15, 2014, of heavy equipment without vehicle fluid leak protection. IMG\_5064.jpg

Pursuant to section B.3.a. in Attachment D to the Construction Storm Water Permit, dischargers are required to “[p]revent oil, grease, or fuel to leak in to the ground, storm drains or surface waters.” The Discharger was in violation of section B.3.a. for two days: December 15, 2014; and May 13, 2015. See Figure 4. Failure to have vehicle fluid leak protection. The violations were noted in the following documents: San Diego Water Board Inspection Report December 15, 2014 (Exhibit No. 8); and San Diego Water Board Inspection Report May 13, 2015 (Exhibit No. 19).

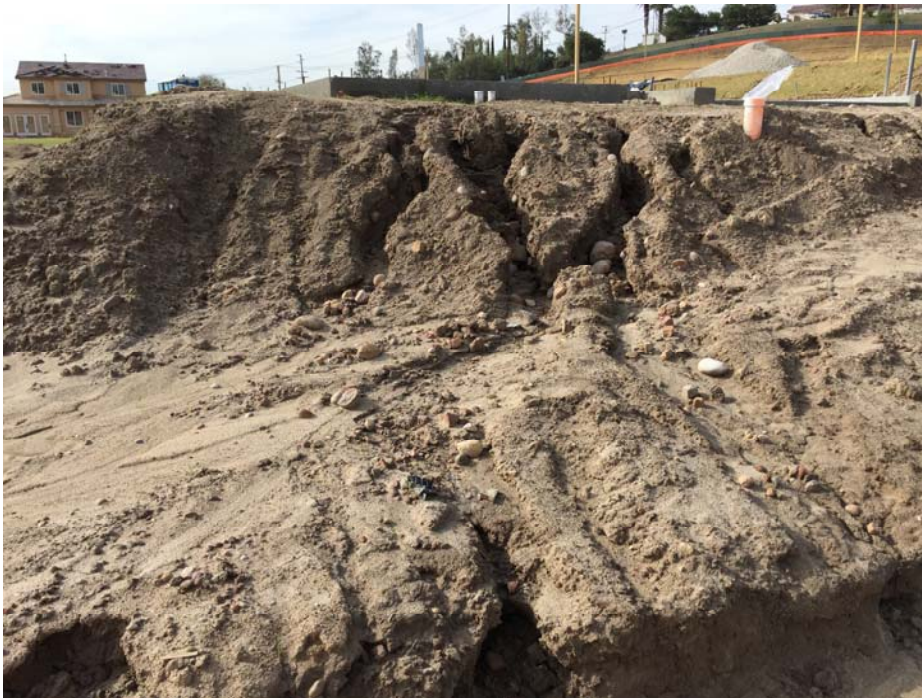
**Figure 5. Failure to implement erosion control BMPs on inactive areas.**

Photograph taken by Wayne Chiu, San Diego Water Board on December 15, 2014, of housing pad without erosion control BMPs. Note the erosion rills. IMG\_5061.jpg

Pursuant to section D.2. in Attachment D to the Construction Storm Water Permit, dischargers are required to “provide effective soil cover for inactive areas and all finished slopes, open space, utility backfill, and completed lots.” The Discharger was in violation of section B.2. for 22 days: 9 days (December 1 through 9, 2014); 2 days (December 15 through 16, 2014); 1 day (January 6, 2015); 1 day (January 14, 2015); 8 days (May 8 through 15, 2015), and 1 day (September 15, 2015). See Figure 5. Failure to implement erosion control BMPs on inactive areas.

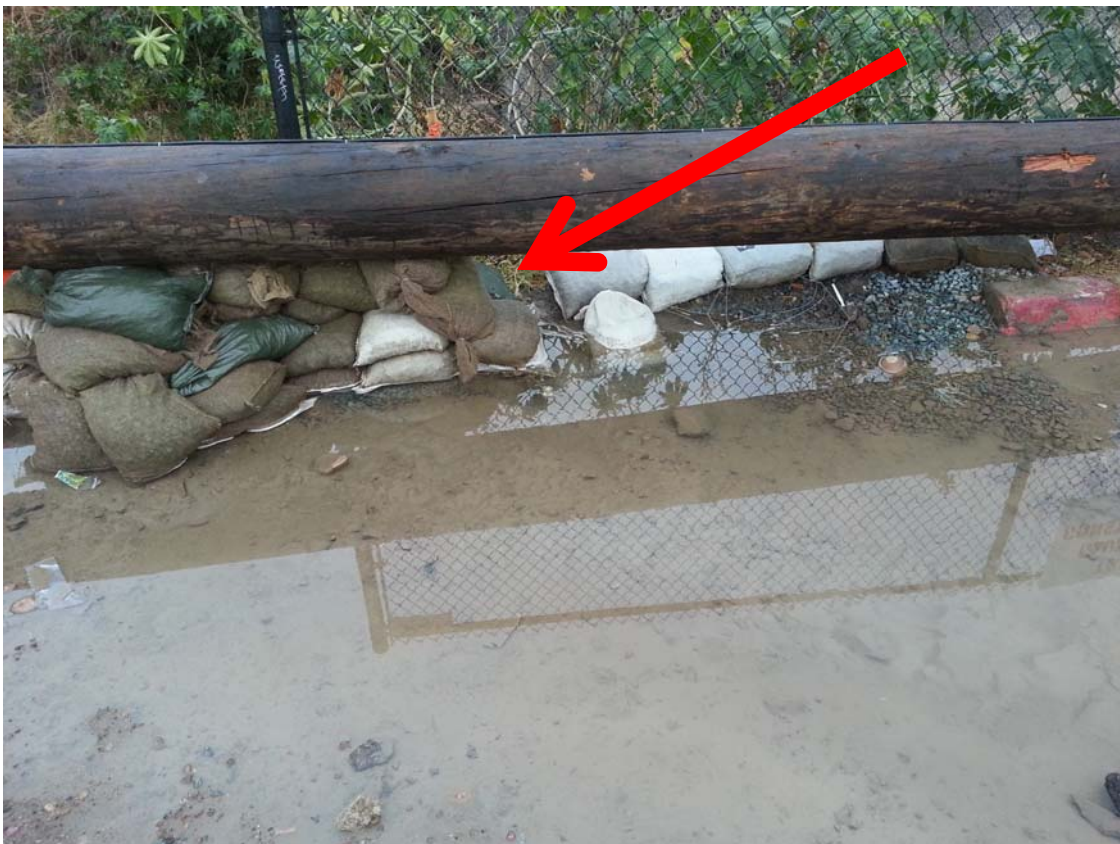
**Figure 6. Failure to implement perimeter sediment control BMPs.** Photograph taken by Frank Melbourn, San Diego Water Board on May 8, 2015, of gap (identified by red arrow) in perimeter sediment control BMPs that resulted in sediment discharge to Encanto Channel. 20150508\_192234.jpg

Pursuant to section E.1. in Attachment D to the Construction Storm Water Permit, dischargers are required to “*establish and maintain effective perimeter controls and stabilize all construction entrances and exits to sufficiently control erosion and sediment discharges from the site.*” The Discharger was in violation of section E.1. for 14 days: 5 days (December 4 through 8, 2014); 2 days (December 15 through 16, 2014); 6 days (May 8 through 13, 2015), and 1 day (September 15, 2015). See Figure 6. Failure to implement perimeter sediment control BMPs. The violations were noted in the following documents: in photographs and text in City Stop Work Notice December 4, 2014 (Exhibit No. 3); City Inspection Report December 8, 2014 (Exhibit No. 4); San Diego Water Board Inspection Report December 15, 2014 (Exhibit No. 8); City Inspection Report December 16, 2014 (Exhibit No. 9); San Diego Water Board Inspection Report May 8, 2015 (Exhibit No. 18); San Diego Water Board Inspection Report May 13, 2015 (Exhibit No. 19), and City Inspection Report September 15, 2015 (Exhibit No. 21).

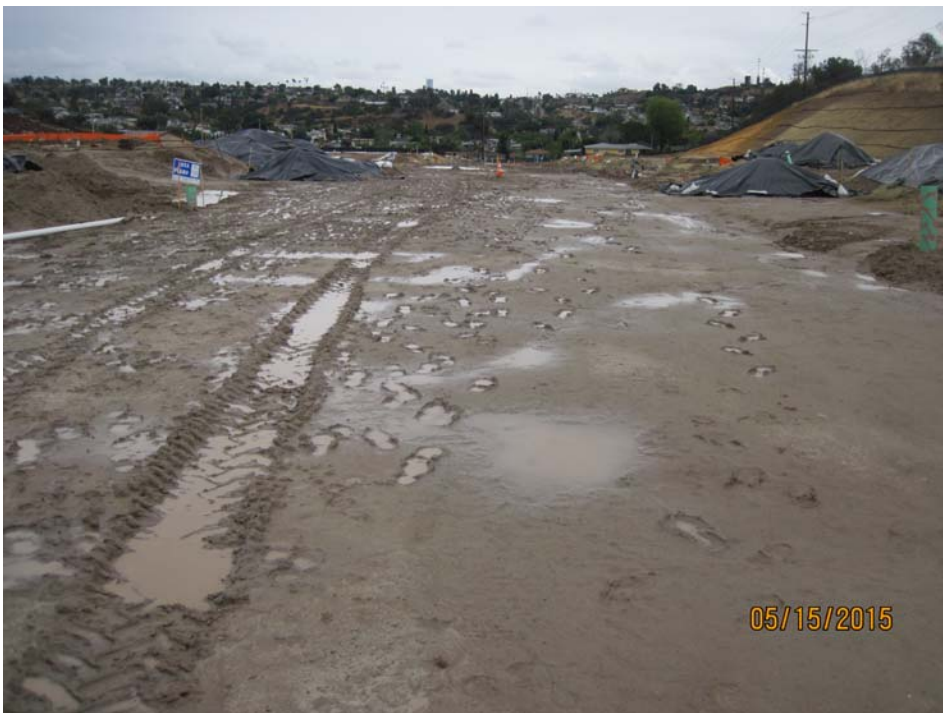
**Figure 7. Lack of erosion control BMPs in active areas.** Photograph on May 15, 2015, of muddy thoroughfare (Tangelos Place) lacking erosion control BMPs after rain event. Photograph taken by Frank Melbourn, San Diego Water Board.  
IMG\_0354.jpg

Pursuant to section E.3. in Attachment D to the Construction Storm Water Permit, dischargers are required to “*implement appropriate erosion control BMPs (runoff control and soil stabilization) in conjunction with sediment control BMPs for areas under active construction.*” The Discharger was in violation of section E.3. for 22 days: 8 days (December 1 through 8, 2014); 2 days (December 15 through 16, 2014); 1 day (January 6, 2015); 2 days (March 23 through 24, 2015); 8 days (May 8 through 15, 2015), and 1 day (September 15, 2015). See Figure 7. Lack of erosion control BMPs in active areas. The violations were noted in the following documents: in photographs and text in City Stop Work Notice December 2, 2014 (Exhibit No. 2); City Stop Work Notice December 4, 2014 (Exhibit No. 3); in photograph in City Inspection Report December 8, 2014 (Exhibit No. 4); San Diego Water Board Inspection Report December 15, 2014 (Exhibit No. 8); City Inspection Report December 16, 2014 (Exhibit No. 9); City Contractor Report January 16, 2015 (Exhibit No. 24); in photograph in City Administrative Citation March 24, 2015 (Exhibit No. 16); in photograph in San Diego Water Board Inspection Report May 8, 2015 (Exhibit No. 18); San Diego Water Board Inspection Report May 13, 2015 (Exhibit No. 19); San Diego Water Board Inspection Report May 15, 2015 (Exhibit No. 20), and City Inspection Report September 15, 2015 (Exhibit No. 22).

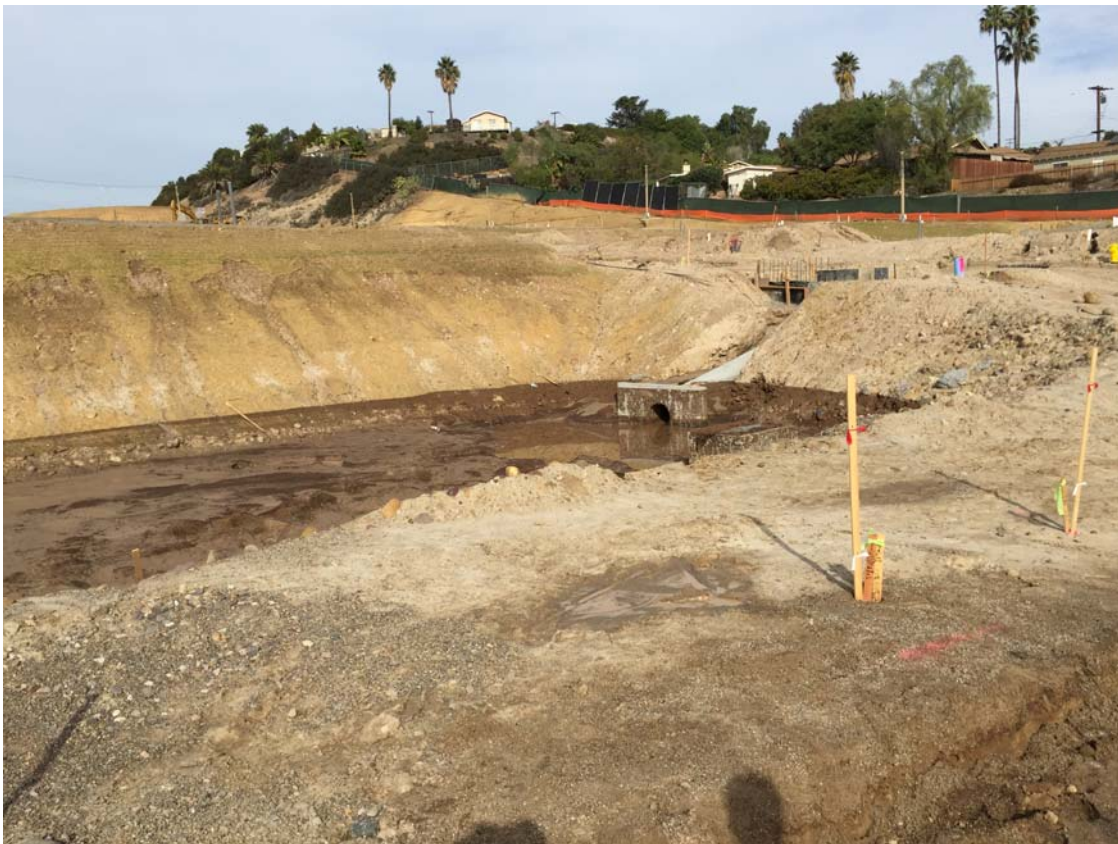
**Figure 8. Failure to apply linear sediment controls.** Photograph taken by Wayne Chiu, San Diego Water Board, on December 15, 2014, depicting the lack of linear sediment controls on a slope. IMG\_5035.jpg

Pursuant to section E.4. in Attachment D to the Construction Storm Water Permit, dischargers are required to “*apply linear sediment controls along toe of slope, face of the slope, and at the grade breaks of exposed slopes to comply with the sheet flow lengths in accordance with Table 1.*” The Discharger was in violation of section E.4. for nine days: 2 days (December 15 through 16, 2014); 6 days (May 8 through 13, 2015), and 1 day (September 15, 2015). See Figure 8. Failure to apply linear sediment controls. The violations were noted in the following documents: San Diego Water Board Inspection Report December 15, 2014 (Exhibit No. 8); City Inspection Report December 16, 2014 (Exhibit No. 9); San Diego Water Board Inspection Report May 8, 2015 (Exhibit No. 18); San Diego Water Board Inspection Report May 13, 2015 (Exhibit No. 19), and City Inspection Report September 15, 2015 (Exhibit No. 22).

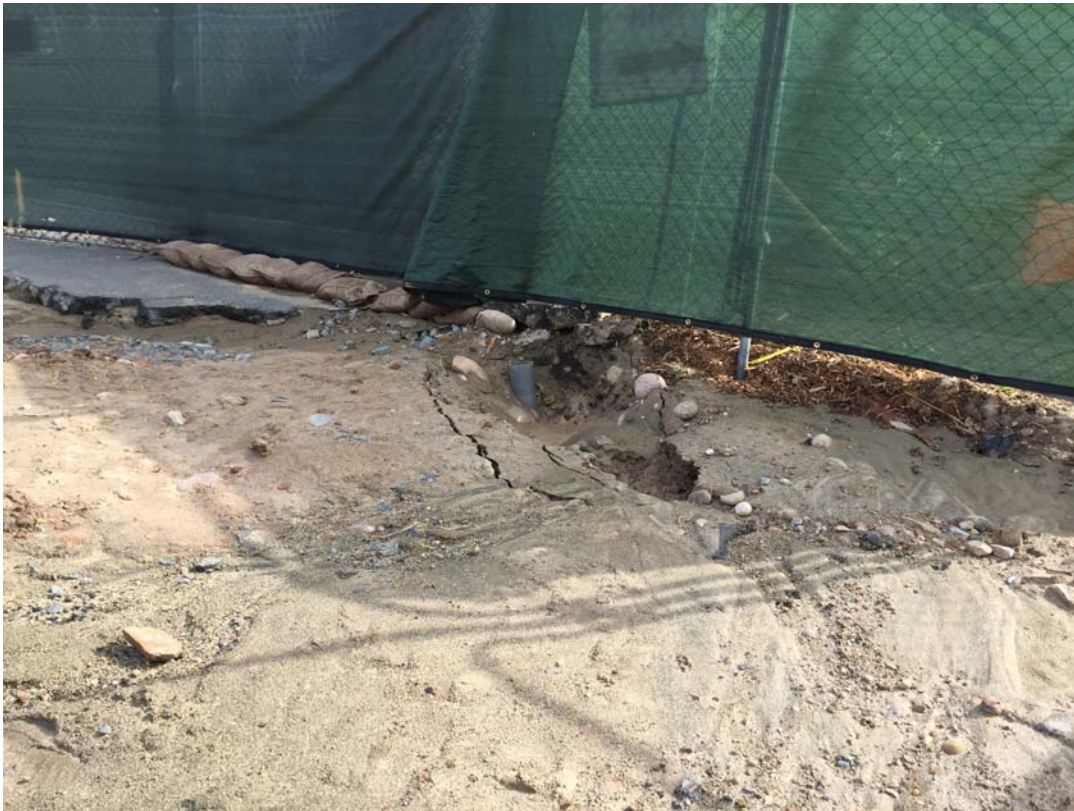
**Figure 9. Failure to manage run-on and runoff.** Photograph taken by Wayne Chiu, San Diego Water Board on December 15, 2014, displaying erosion caused by runoff flowing under fence and offsite. IMG\_5042.jpg.

Pursuant to section F. in Attachment D to the Construction Storm Water Permit, dischargers are required to “effectively manage all run-on, all runoff within the site and all runoff that discharges off the site. Run-on from off site shall be directed away from all disturbed areas or shall be collectively be in compliance with the effluent limitations in this General Permit.” The Discharger was in violation of section F. for seven days: 1 day (December 15, 2014); and 6 days (May 8 through 13, 2015). See Figure 9. Failure to manage run-on and runoff. The violations were noted in the following documents: San Diego Water Board Inspection Report December 15, 2014 (Exhibit No. 8); San Diego Water Board Inspection Report May 8, 2015 (Exhibit No. 18); and San Diego Water Board Inspection Report May 13, 2015 (Exhibit No. 19).

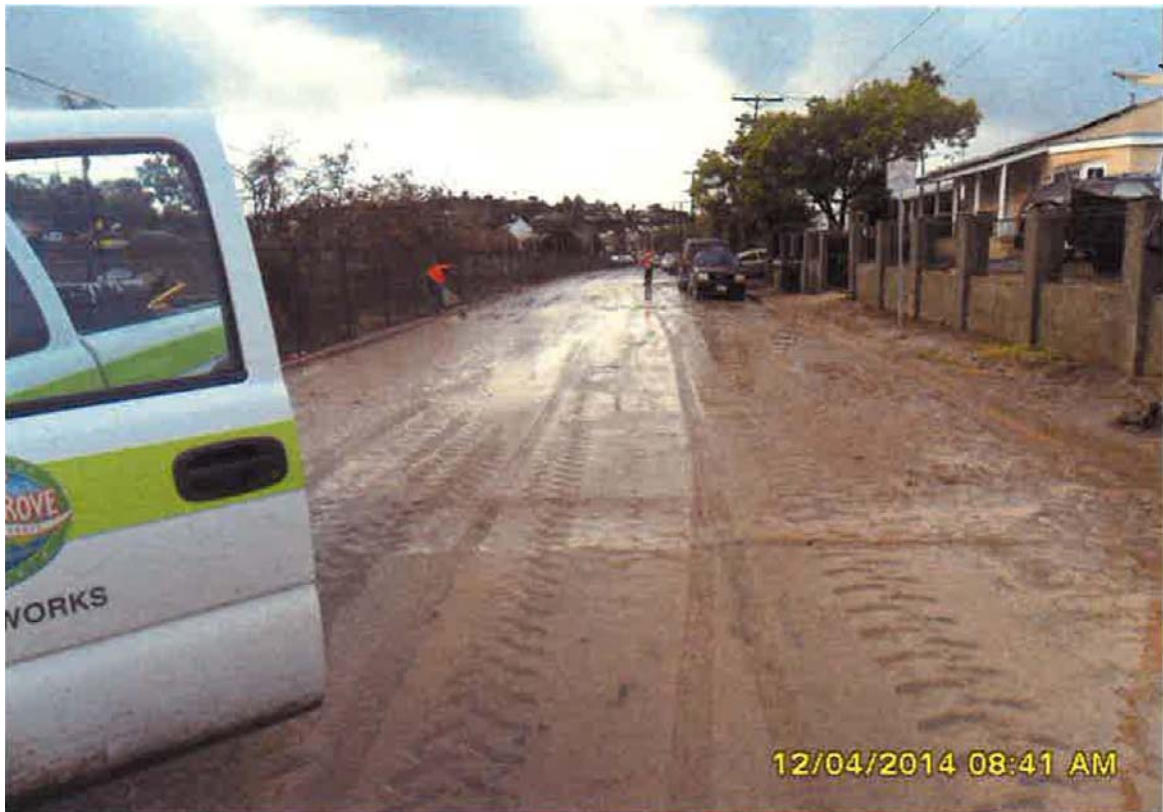
**Figure 10. Failure to remove sediment from roads.** Photograph taken by the City of Lemon Grove on December 4, 2014, depicting sediment on Akins Avenue southwest of the Site.

Pursuant to section E.7. in Attachment D to the Construction Storm Water Permit, dischargers are required “*at a minimum daily (when necessary) and prior to any rain event, the discharger shall remove any sediment or other construction activity-related materials that are deposited on the roads (by vacuuming or sweeping).*” The Discharger was in violation of section E.7. for 10 days: 8 days (December 2 through 9, 2014) December 16, 2014, and September 15, 2015. See Figure 10. Failure to remove sediment from roads. The violations were noted in the City Stop Work Notice December 2, 2014 (Exhibit No. 2); in City photographs from December 4, 2014; City Inspection Report December 8, 2014 (Exhibit No. 4); City Inspection Report December 9, 2014 (Exhibit No. 5); City Inspection Report December 16, 2014 (Exhibit No. 9), and City Inspection Report September 15, 2015 (Exhibit No. 22).

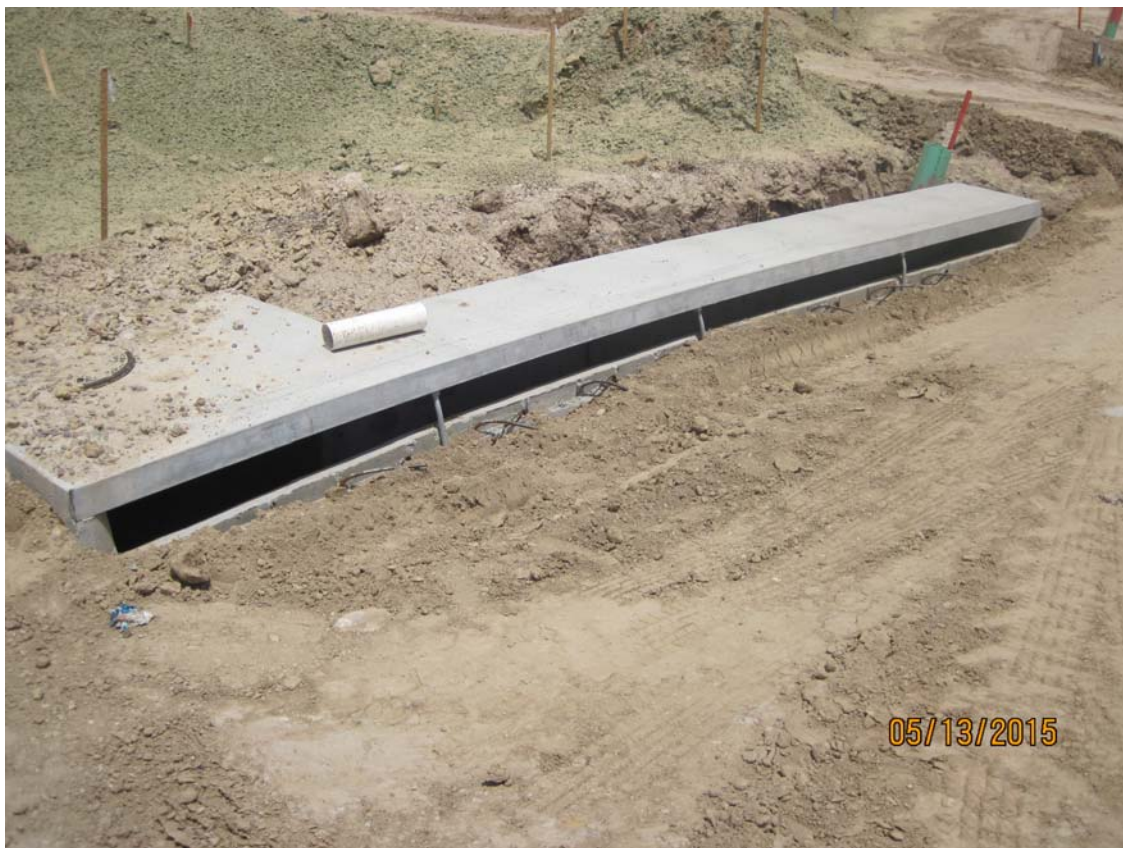
**Figure 11. Failure to protect storm drain inlets.** Photograph taken by Frank Melbourn, San Diego Water Board on May 13, 2015, displaying unprotected storm drain inlet. IMG\_0295.jpg.

Pursuant to section E.6. in Attachment D to the Construction Storm Water Permit, dischargers “*shall ensure that all storm drain inlets and perimeter controls, runoff control BMPs, and pollutant controls at entrances and exits (e.g. tire washoff locations) are maintained and protected from activities that reduce their effectiveness.*” The Discharger was in violation of section E.6. for three days: December 8, 2014; May 13, 2015, and September 15, 2015. See Figure 11. Failure to protect storm drain inlets. The violation was noted in the City Inspection Report December 8, 2014 (Exhibit No. 4); in San Diego Water Board photographs from May 13, 2015 (Exhibit No. 19), and City Inspection Report September 15, 2015 (Exhibit No. 22).

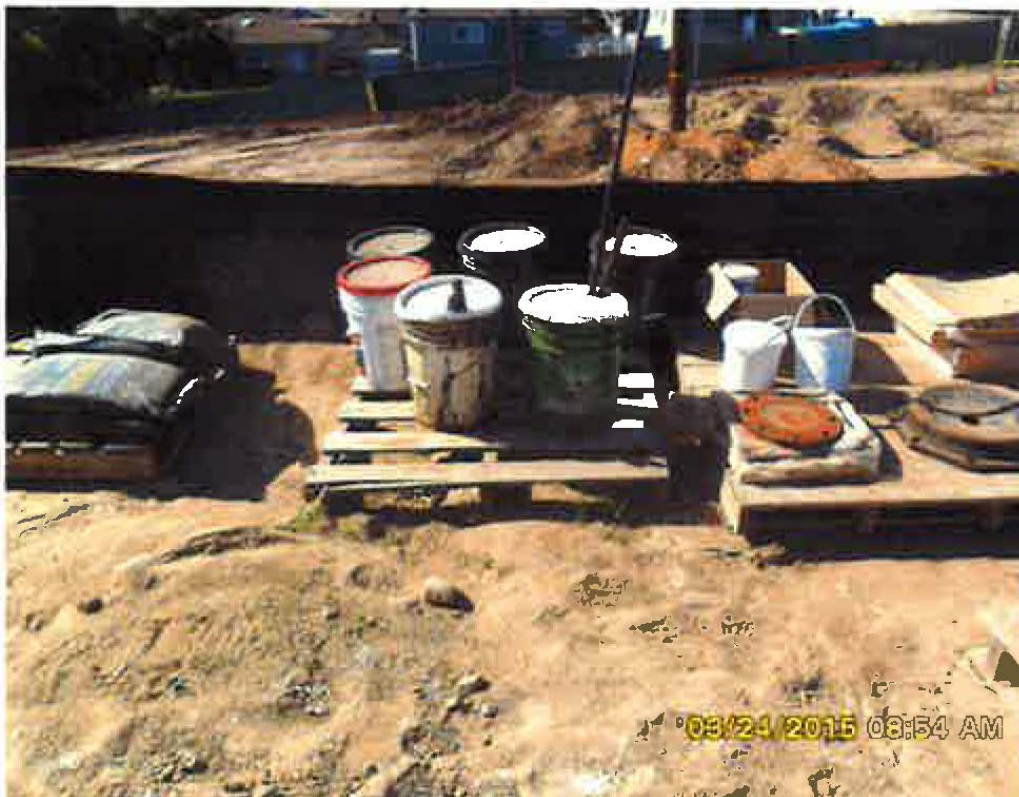
**Figure 12. Failure to properly store chemicals.** Photograph taken by the City of Lemon Grove on March 24, 2015, depicting chemicals and vehicle lubricants stored on pallets without protection from the elements and without secondary containment.

Pursuant to section B.1.c. in Attachment D to the Construction Storm Water Permit, dischargers are required to “[s]tore chemicals in watertight containers (with appropriate secondary containment to prevent any spillage or leakage) or in a storage shed (completely enclosed).” The Discharger was in violation of section B.1.c. for seven days (March 18 through 24, 2015). See Figure 12. Failure to properly store chemicals. The violations were noted in the following documents: City Inspection Report March 18, 2015 (Exhibit No. 13); and City Correct Work Notice March 24, 2015 (Exhibit No. 15).

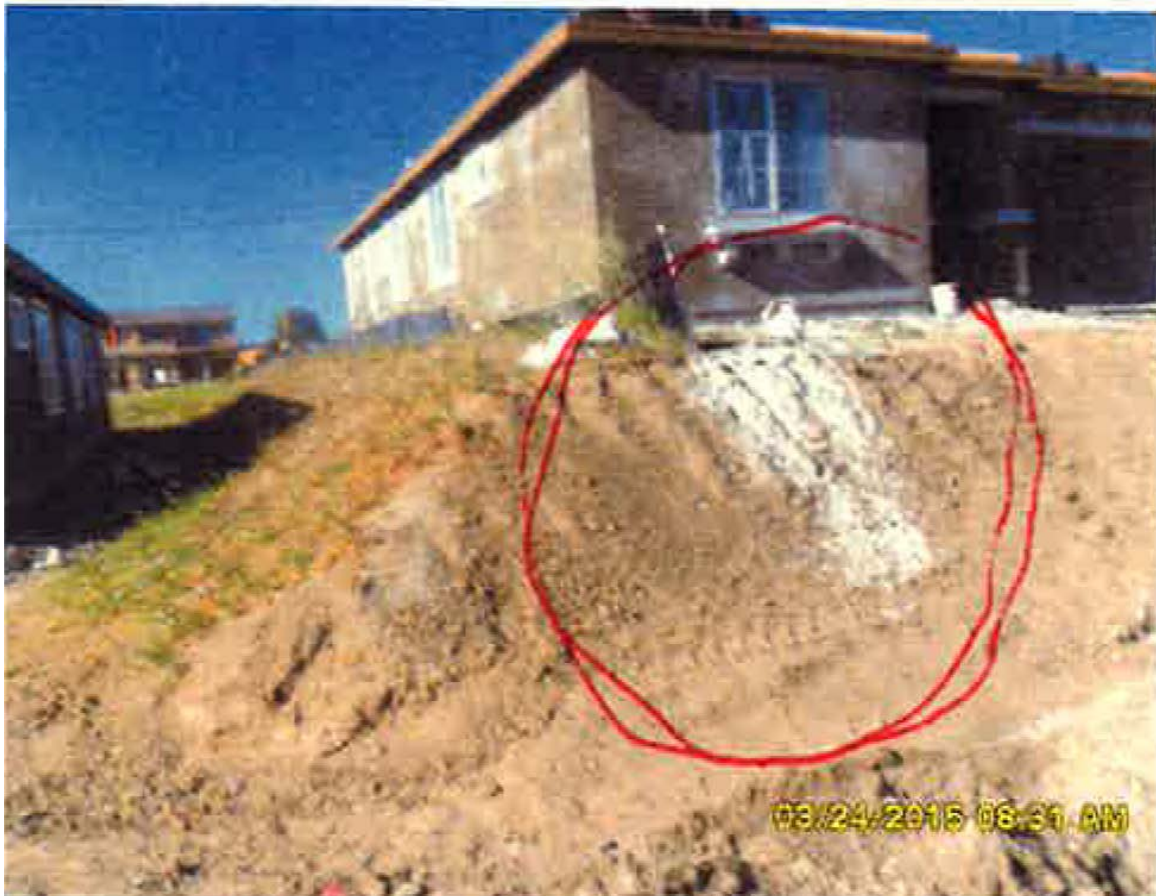
The Discharger was in violation of section B.2.i. for 15 days (March 18 through April 1, 2015). See Figure 13. Failure to prevent discharge of concrete waste to the ground. The violations were noted in the following documents: City Administrative Citation March 19, 2015 (Exhibit No. 14); City Administrative Citation March 24, 2015 (Exhibit No. 16); and City Administrative Citation April 1, 2015 (Exhibit No. 17).

**Figure 13. Failure to prevent the discharge of concrete waste to the ground.** Photograph taken by the City of Lemon Grove on March 24, 2015, depicting discharge of concrete waste on slope (identified by red circle).

Pursuant to section B.2.i. in Attachment D to the Construction Storm Water Permit, dischargers are required to “[e]nsure the containment of concrete washout areas and other washout areas that may contain additional pollutants so there is no discharge into the underlying soil and onto the surrounding areas.”
