Attachment No. 12

SAN DIEGO REGIONAL
WATER QUALITY CONTROL BOARD

From: 15pta@sbceo.org
To: Ben Neill <BNeill@waterboards.ca.gov>
Subject: Re: Dirty Storm Water Flows in Vista #2

attached are some photos that will help you in locating the Vista Village Sprinter Station storm drain inlet that has no BMPs in place - as of today, there are still no BMPs in place at this inlet.

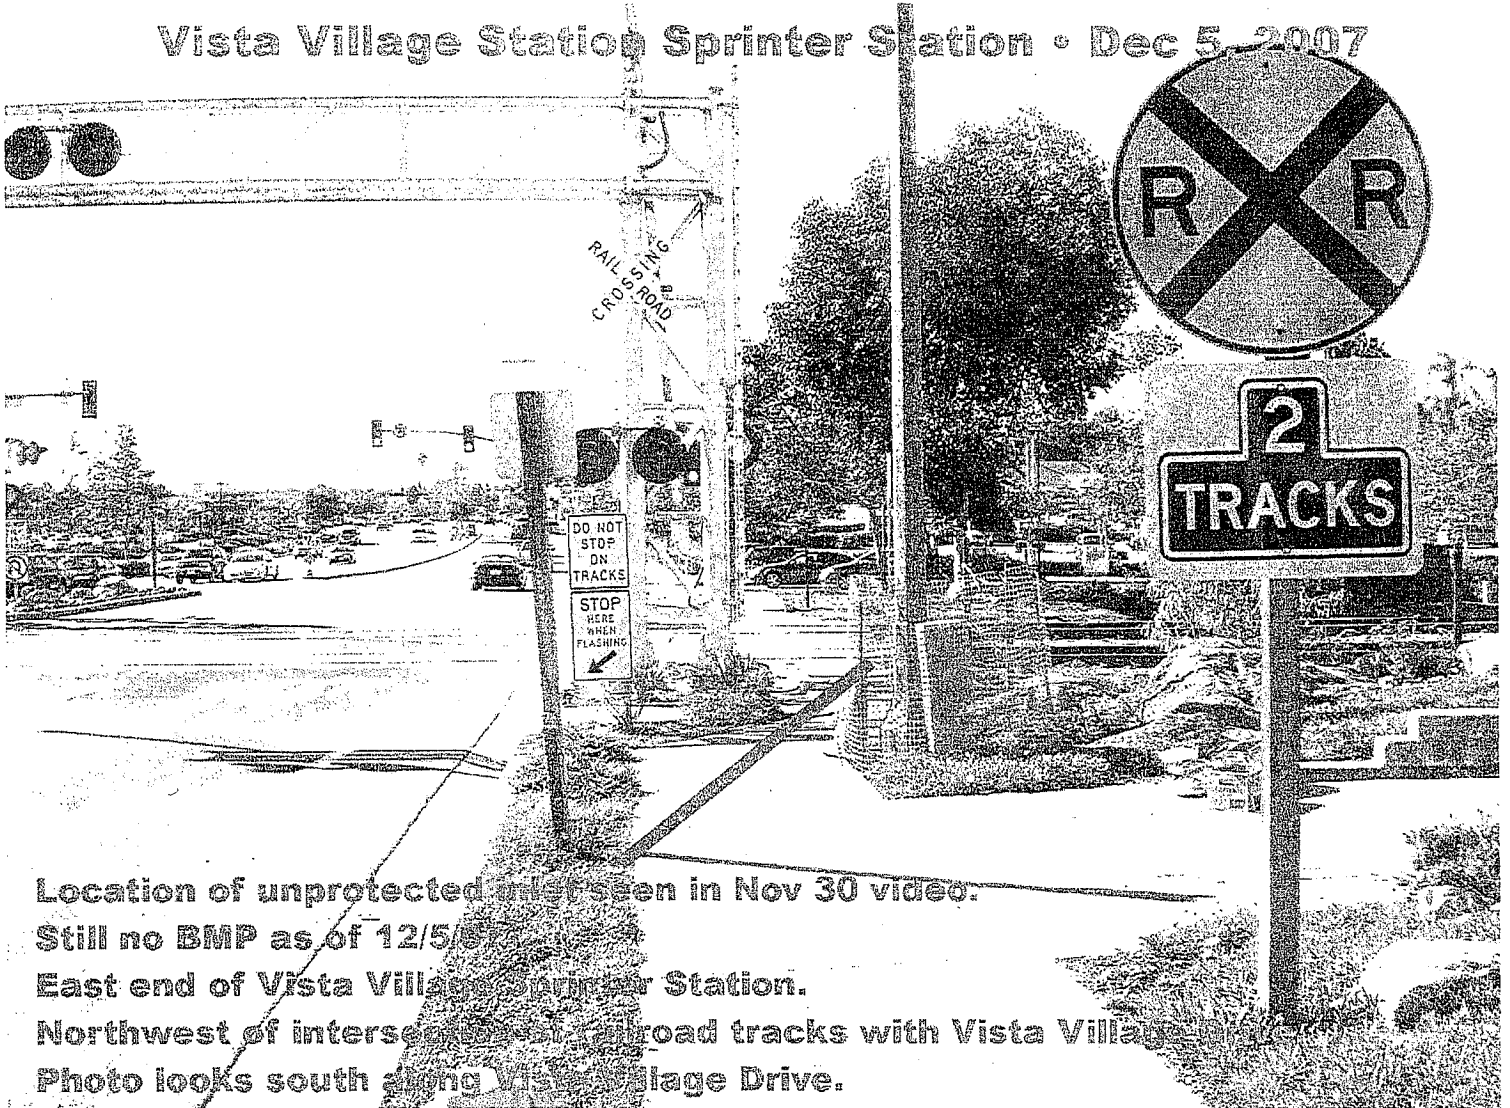
Vista Village East Dec5b.jpg

Location of unprotected inter seen in Nov 30 video.

Still no BMP as of 12/5/07

East end of Vista Village Sprinter Station.

Northwest of intersection of railroad tracks with Vista Village Drive.

Photo looks south along Vista Village Drive.

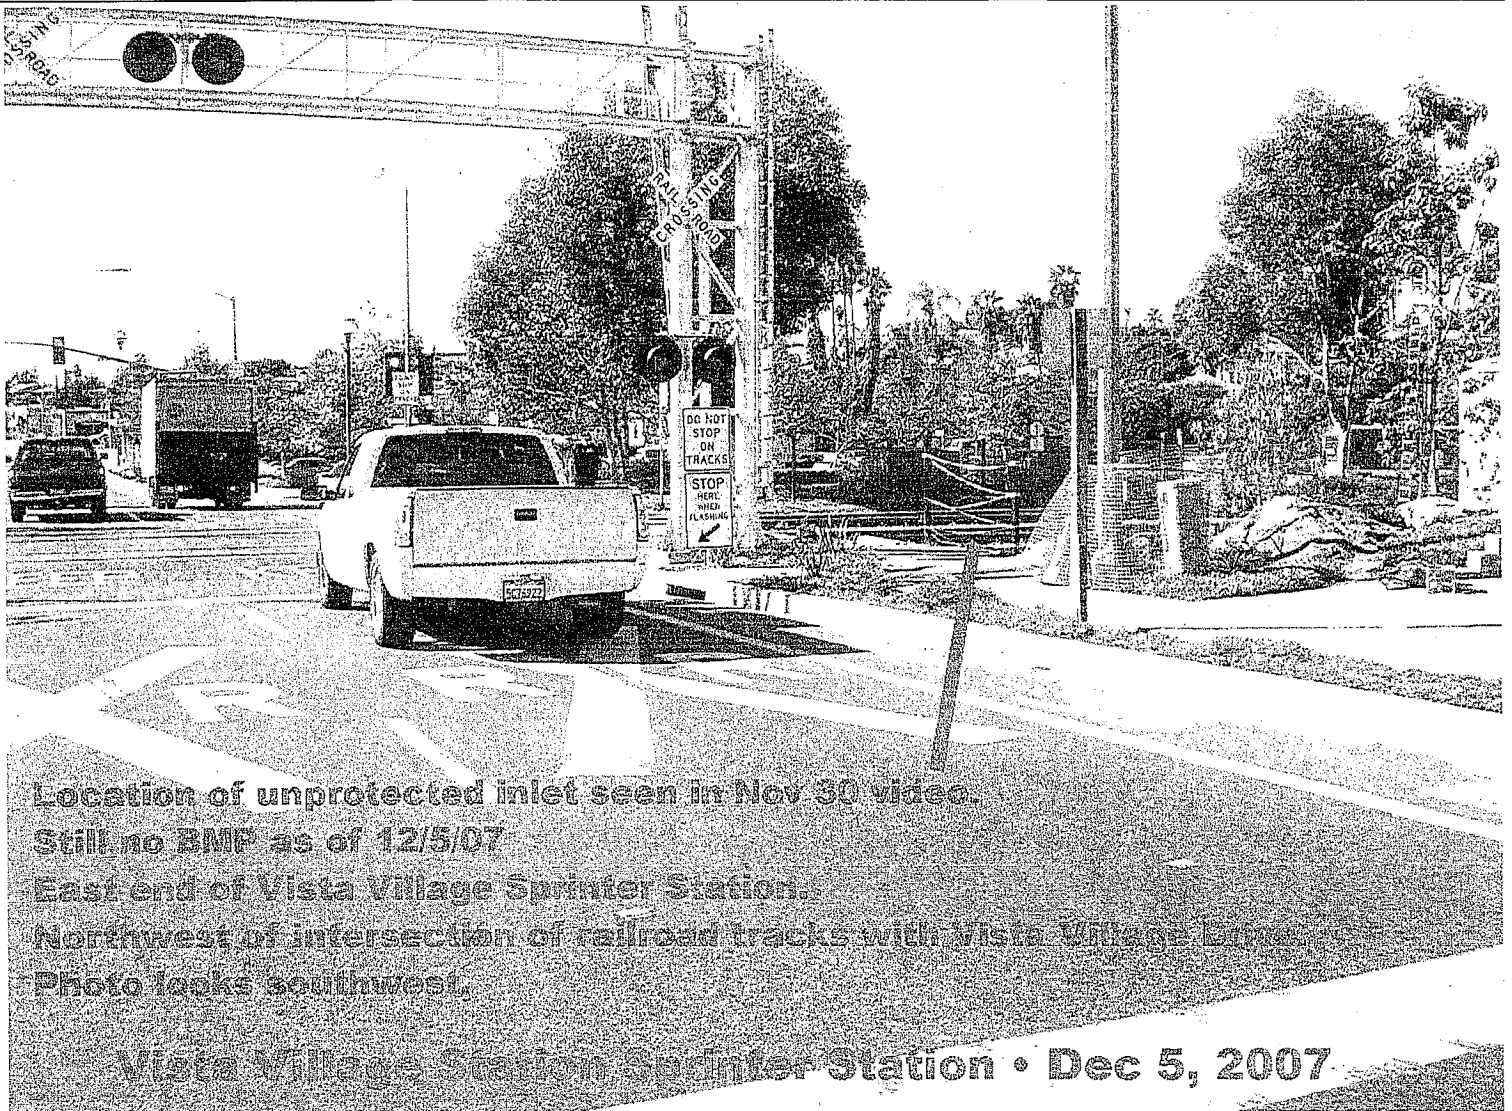
Vista Village East Dec5e.jpg

Location of unprotected inlet seen in Nov 30 video.
Still no BMP as of 12/5/07
East end of Vista Village Sprinter Station.
Northwest of intersection of railroad tracks with Vista Village Lane.
Photo looks southwest.

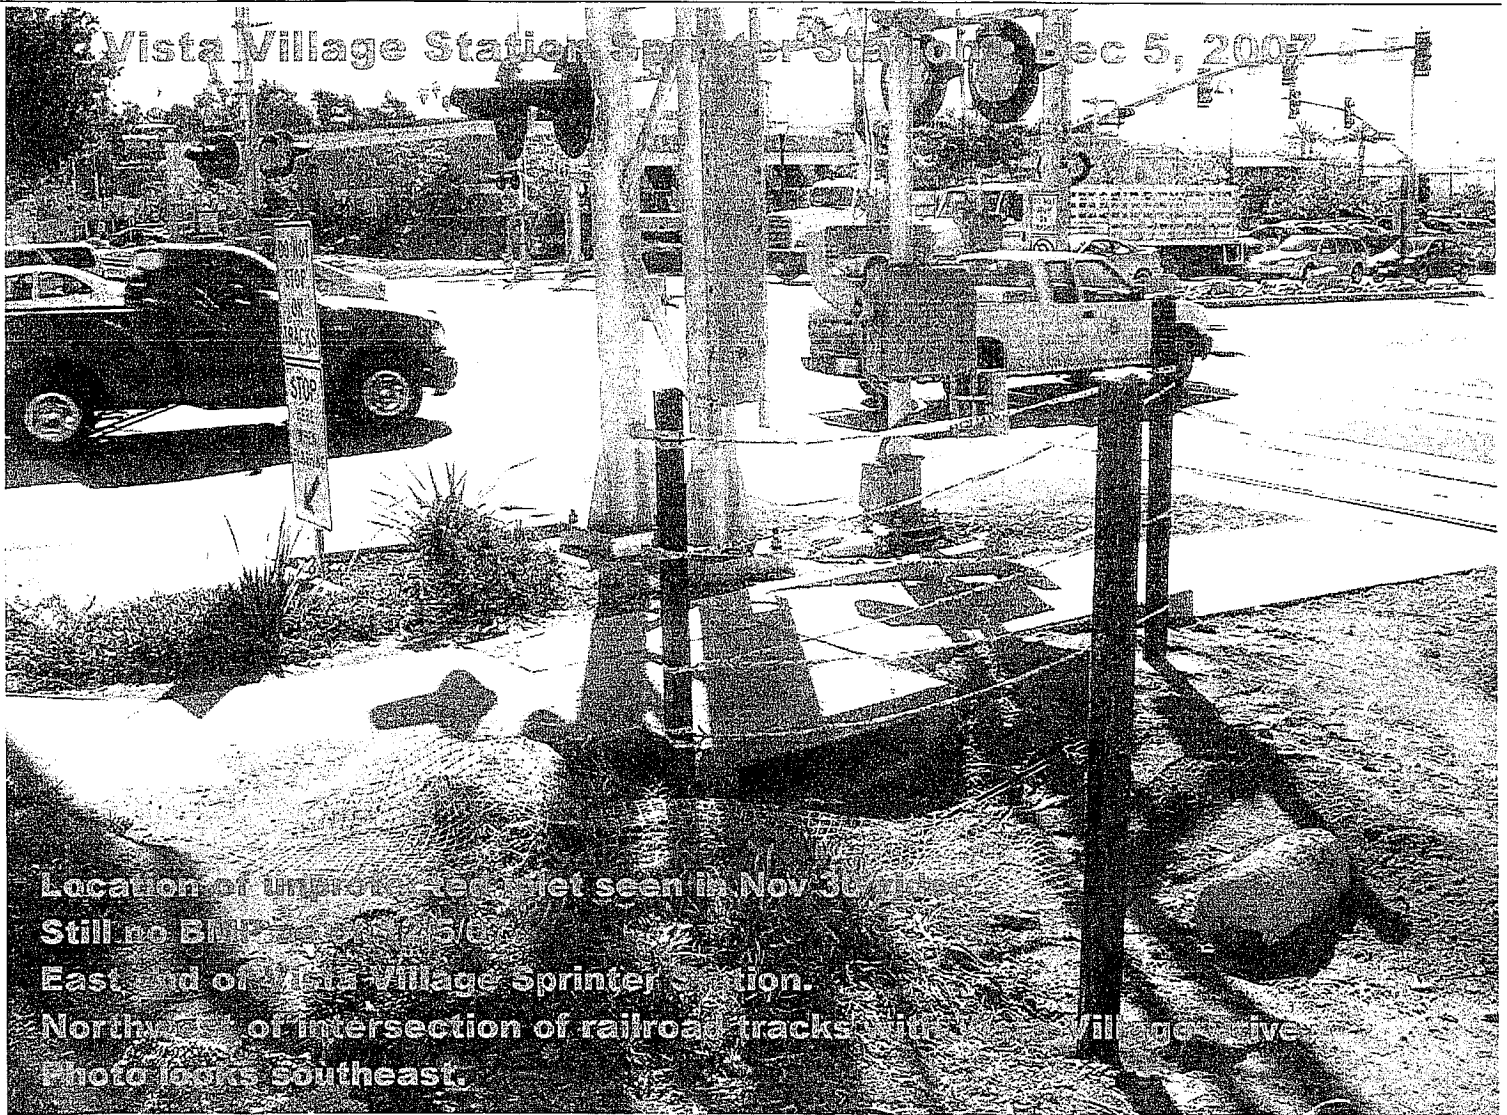
Vista Village Station Sprinter Station • Dec 5, 2007

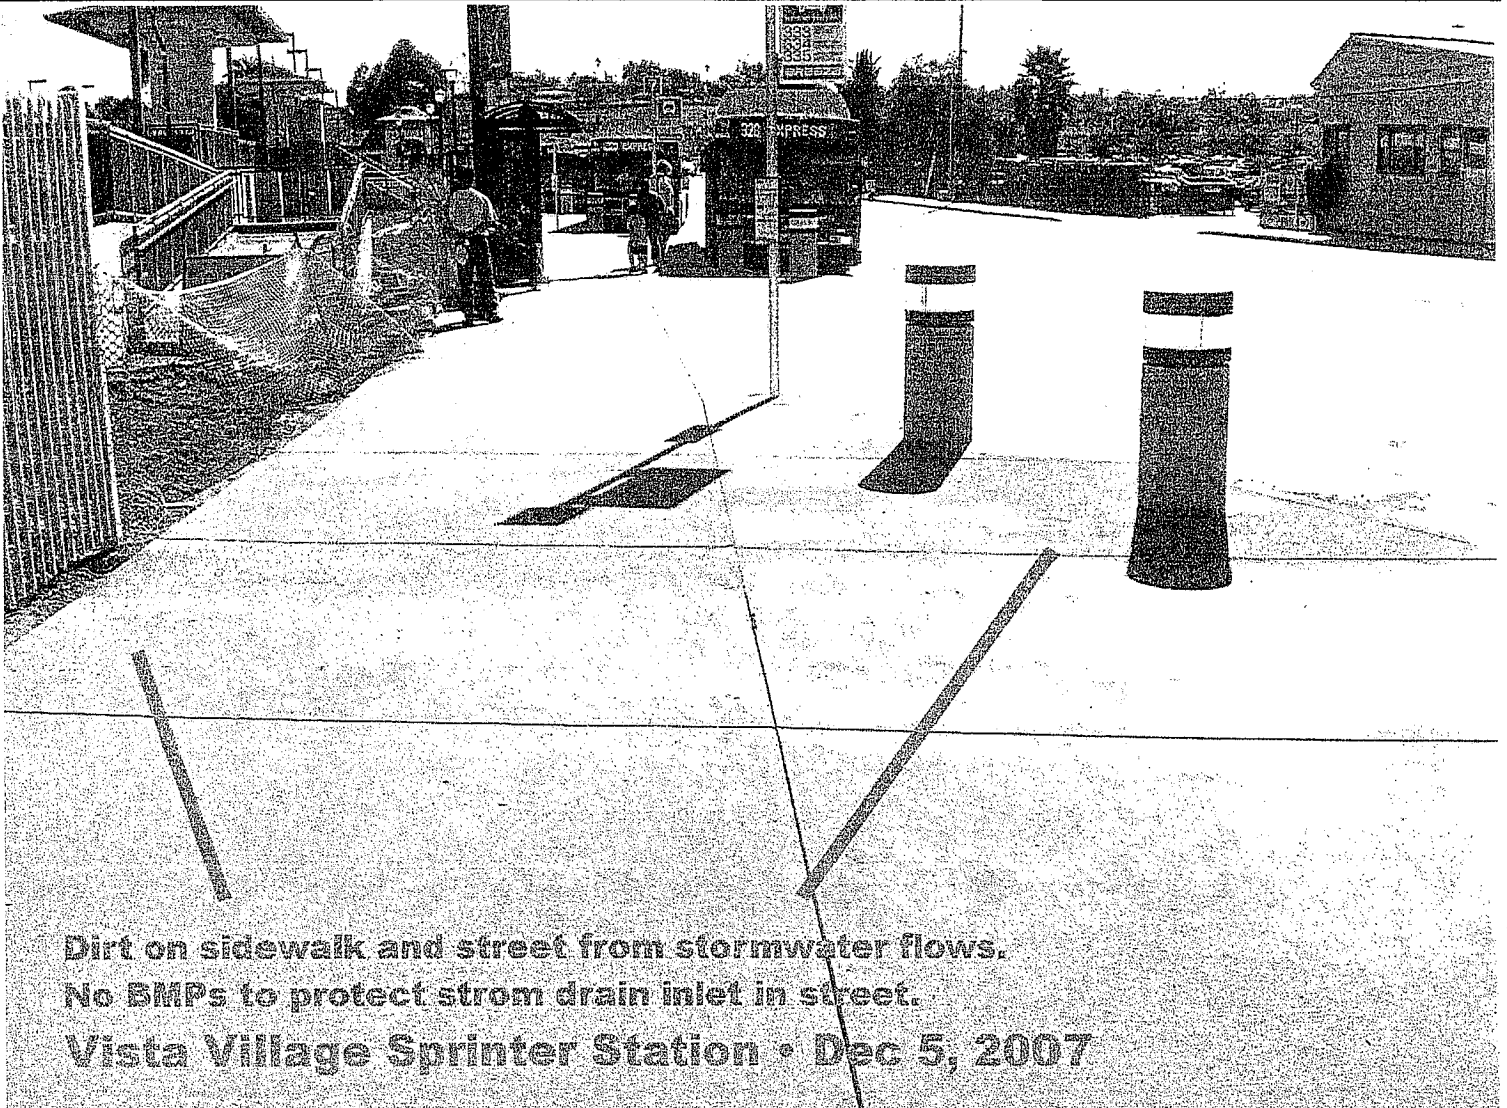
Vista Village Dirt Dec5a.jpg

**Dirt on sidewalk and street from stormwater flows.
No BMPs to protect storm drain inlet in street.**

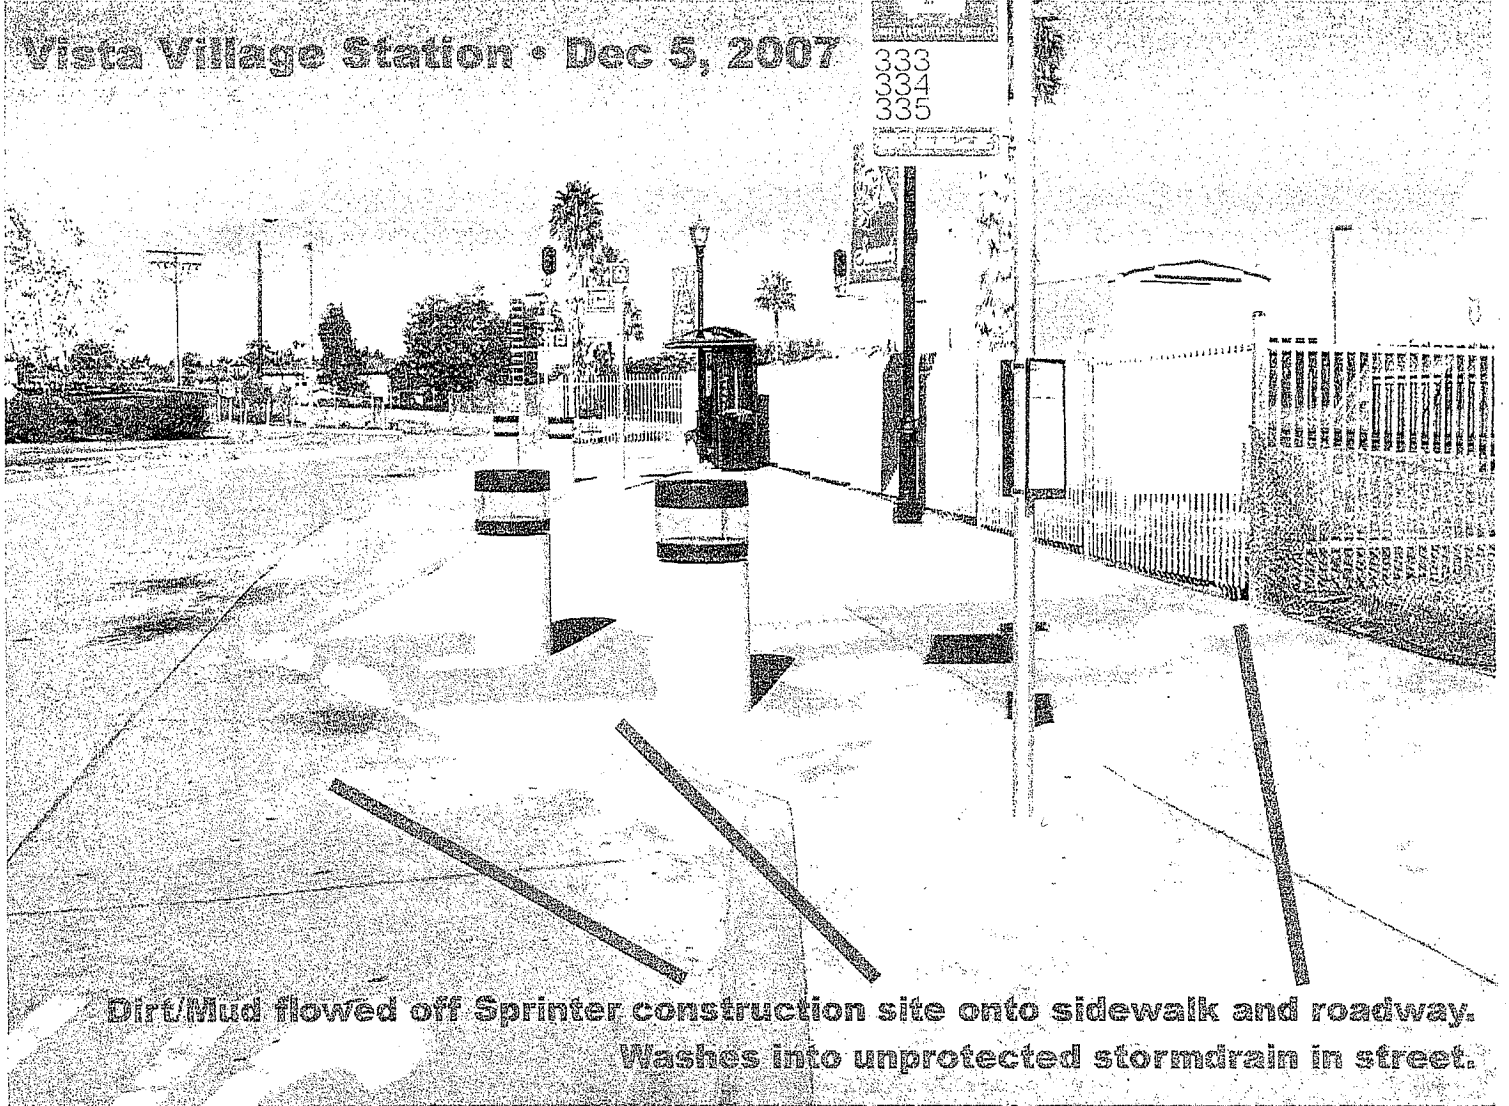
Vista Village Dirt Dec5b.jpg

Dirt/Mud flowed off Sprinter construction site onto sidewalk and roadway. Washes into unprotected stormdrain in street.

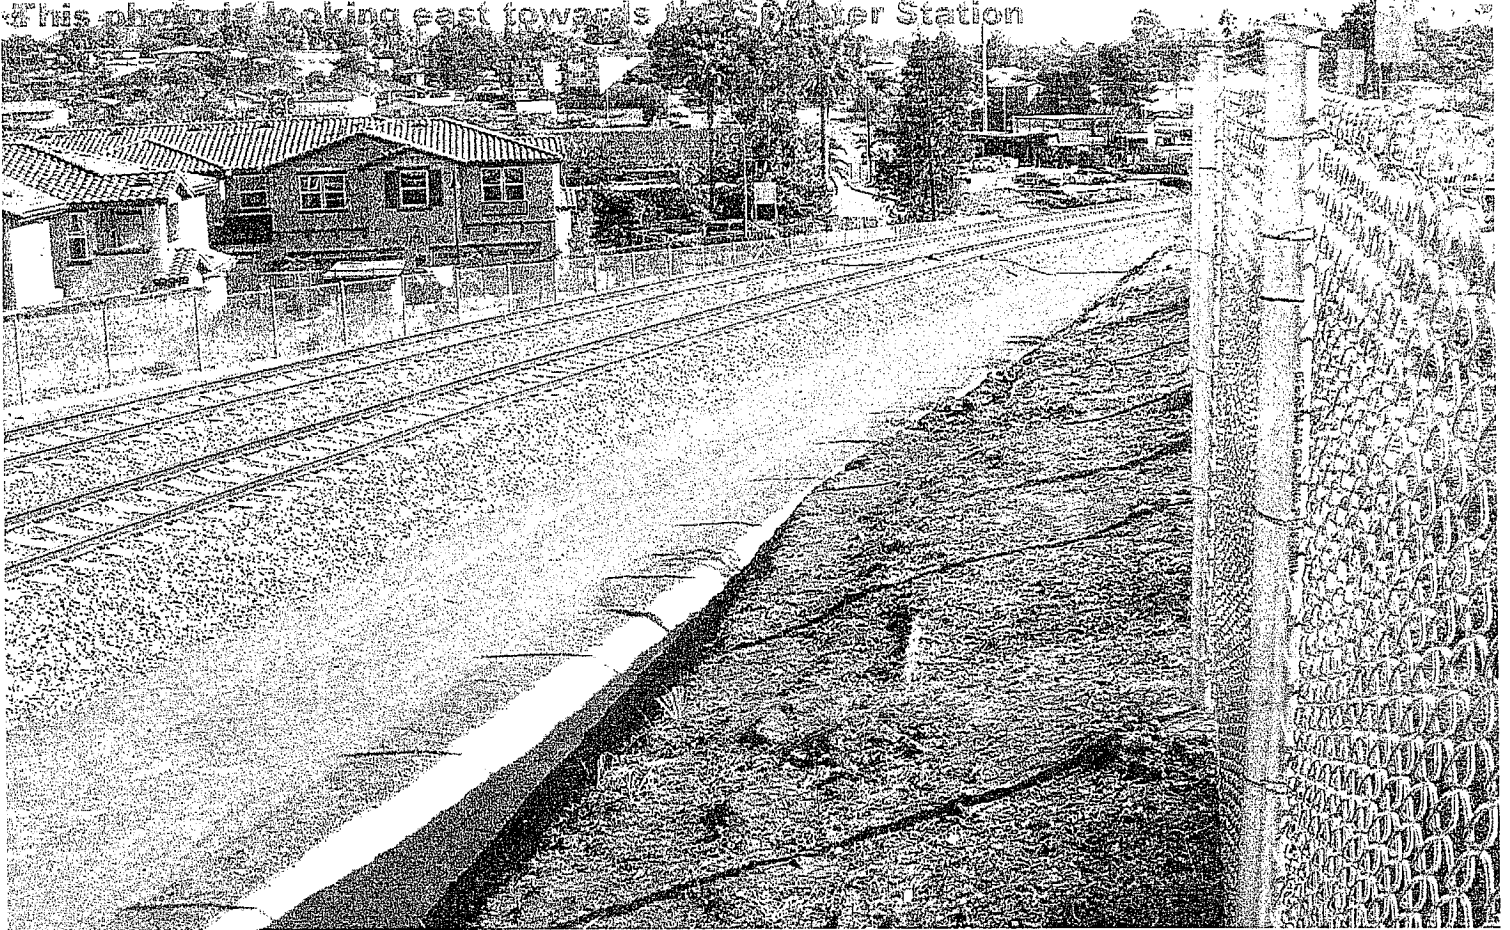
Vista Village Dirt West Dec5a.jpg

Dirt has eroded off slope, over fiber rolls, and into storm drain channel.
This location is about 1/8-1/4 mile west of the Vista Village ticket station.
This photo is looking east towards the Sprinter Station

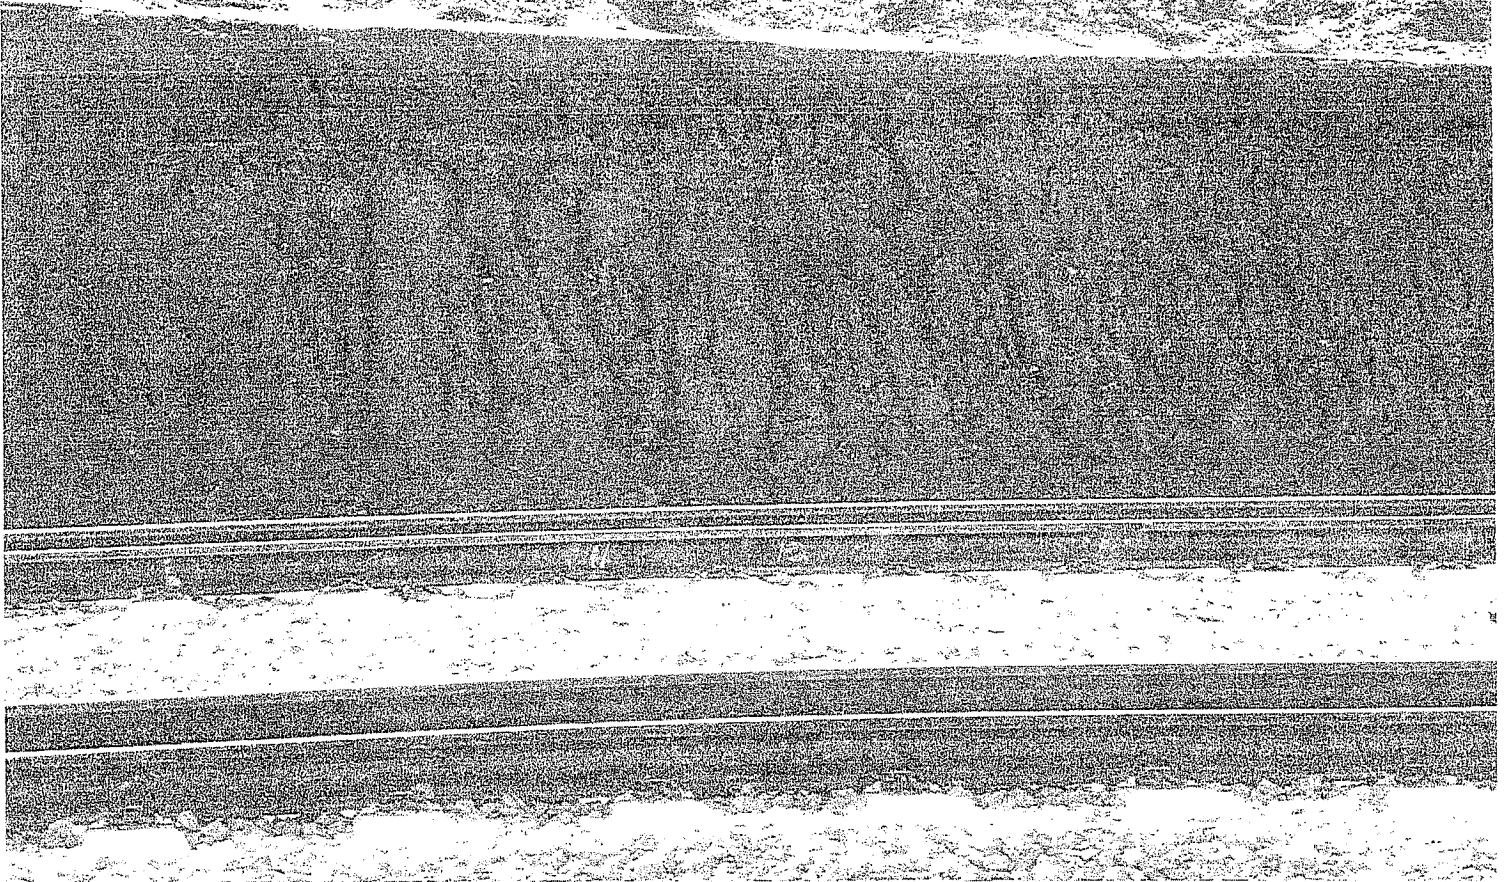
Vista Village Dirt West Dec5b.jpg

Notice gullies in hillside where dirt has washed down into storm drain channel that flows into storm drain inlet. All of this is on NCTD property.

Photo taken about 1/8-1/4 mile west of the Vista Village ticket station.

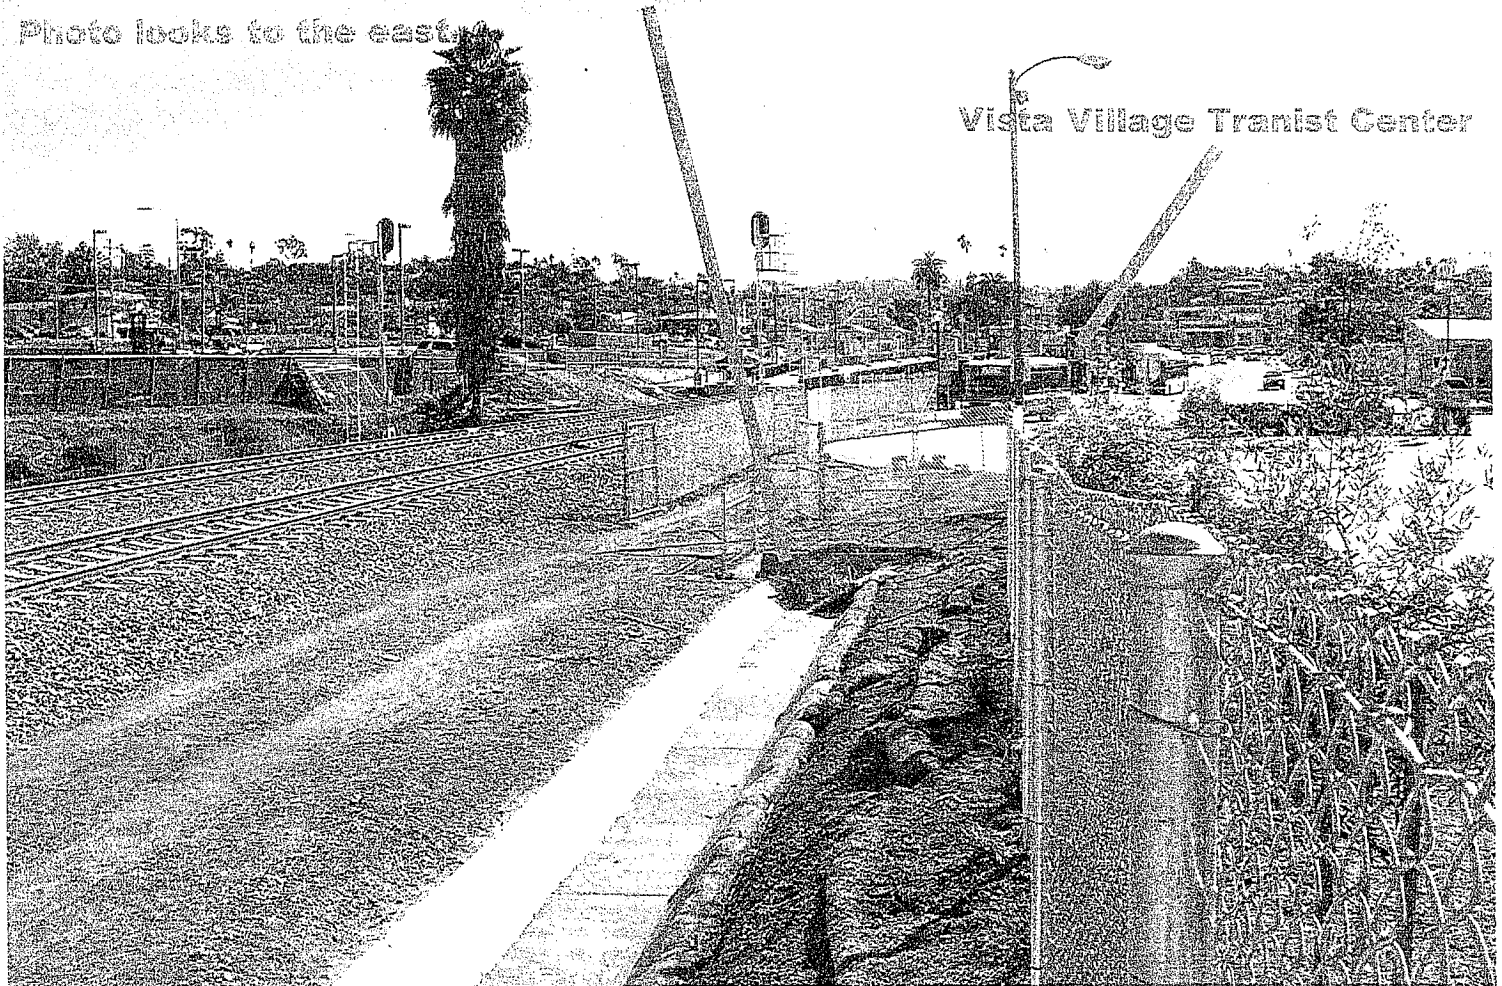
Vista Village Dirt West Dec5c.jpg

This inlet was shown in video taken Dec 1.

Photo looks to the east.

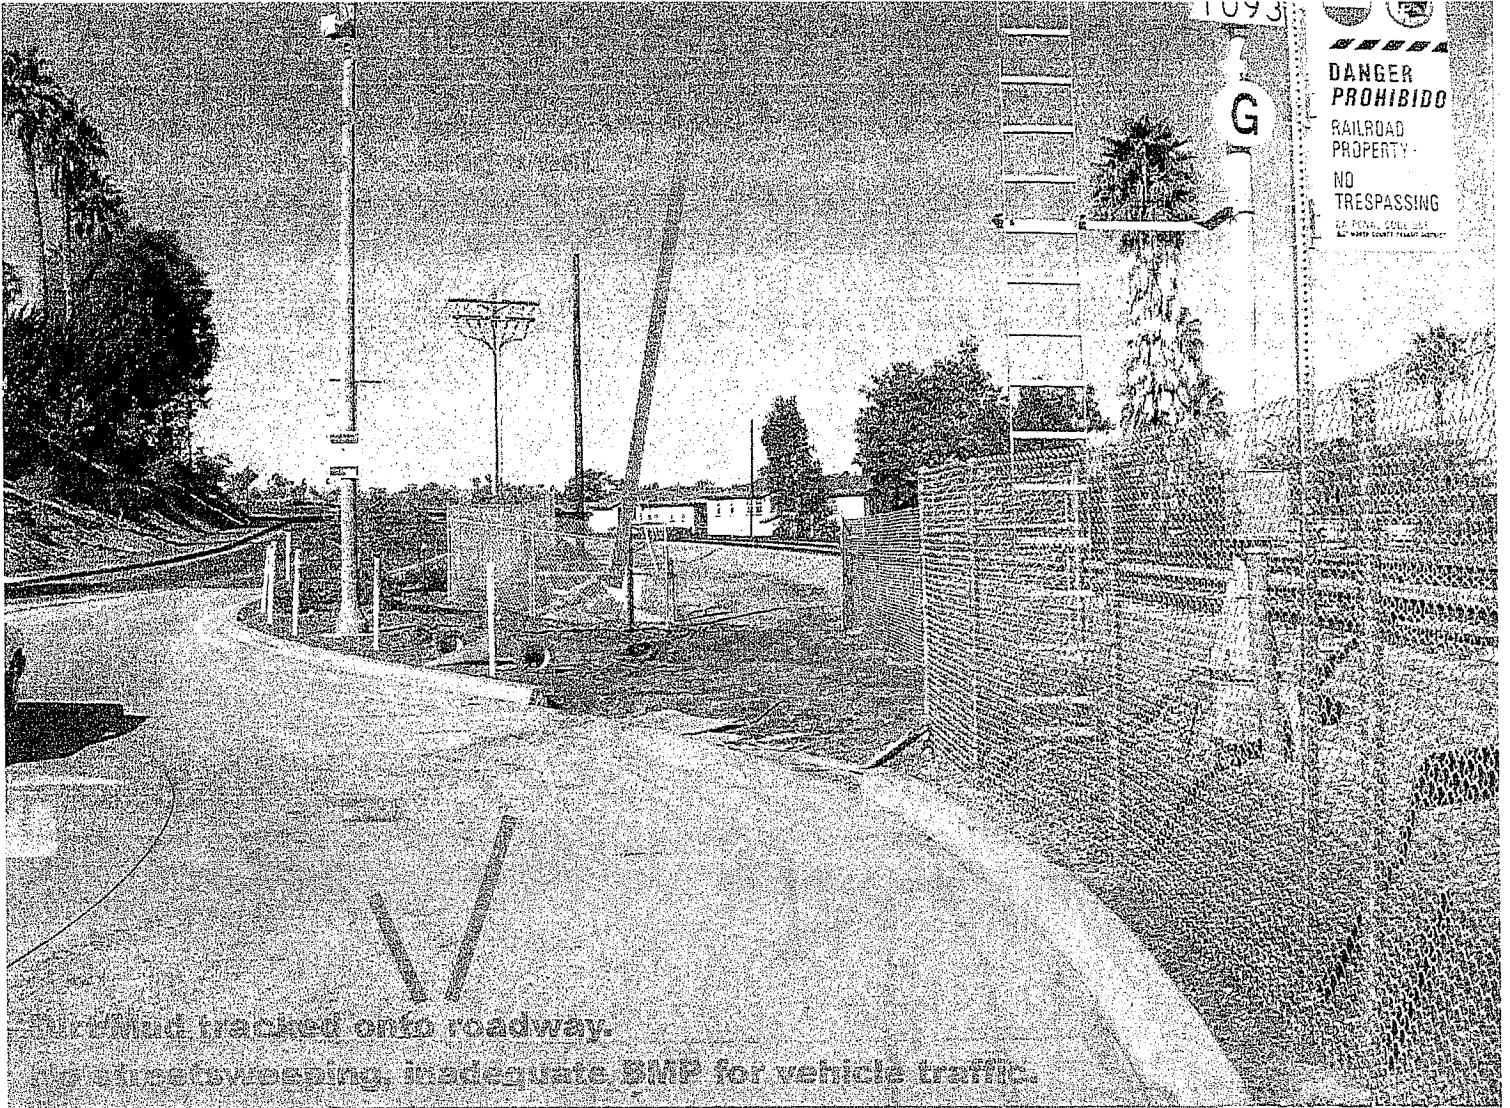
I paid a visit to the site today and some of the photographs taken are attached. I found the source of the dirt in the storm water flow - it was slope erosion that flowed over fiber rolls - there is still significant dirt upstream in the storm channel (the channel that feeds the inlet is on NCTD property for as far as I was able to track it).

Rain is predicted for all day Friday and into Saturday and it does not look like NCTD is going to repair the BMPs at this site, nor does it look like they are going to clean up the dirt that has washed past their BMPs and are now poised to flow into the water of the USA.

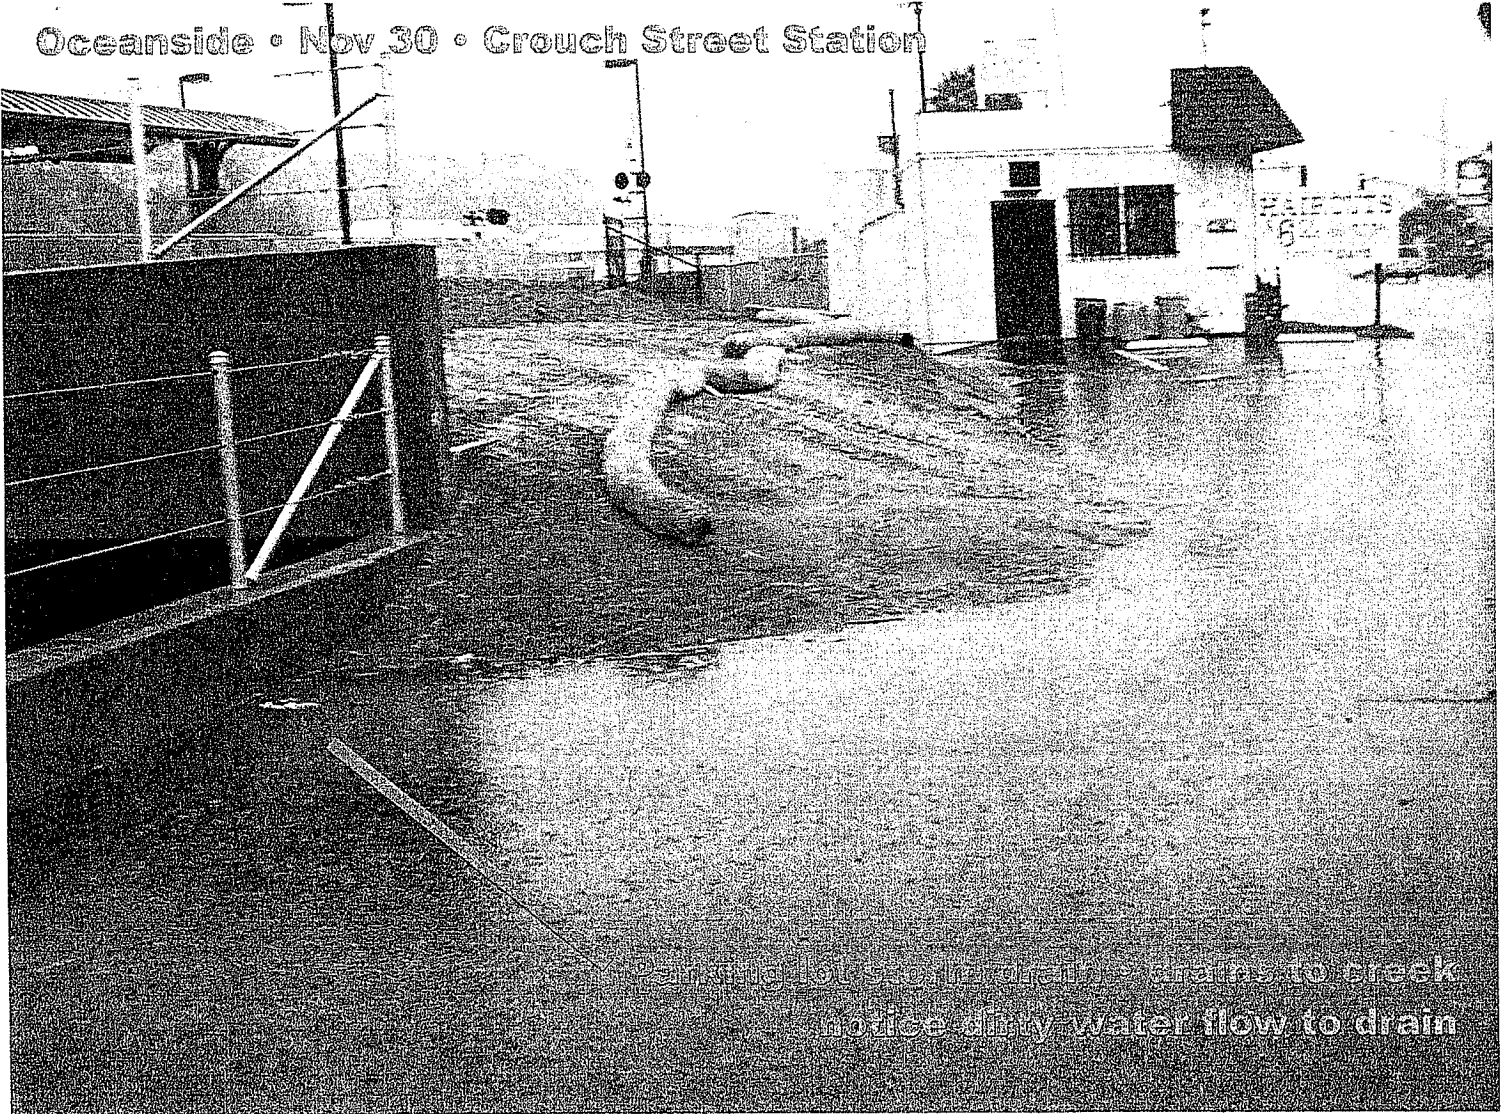
Crouch St Station Nov30.jpg

The attached photo shows dirty water flowing into the parking lot drain that empties directly into the adjacent creek. The location of the photo is at the Crouch Street Sprinter Station in a business's parking lot alongside Oceanside Blvd. Last month, NCTD added a patch of gravel in an attempt to protect this storm drain from the disturbed slope of dirt created by NCTD. The gravel patch has proved itself to be wholly inadequate, which is really no surprise considering that 90% of the slope was unprotected.

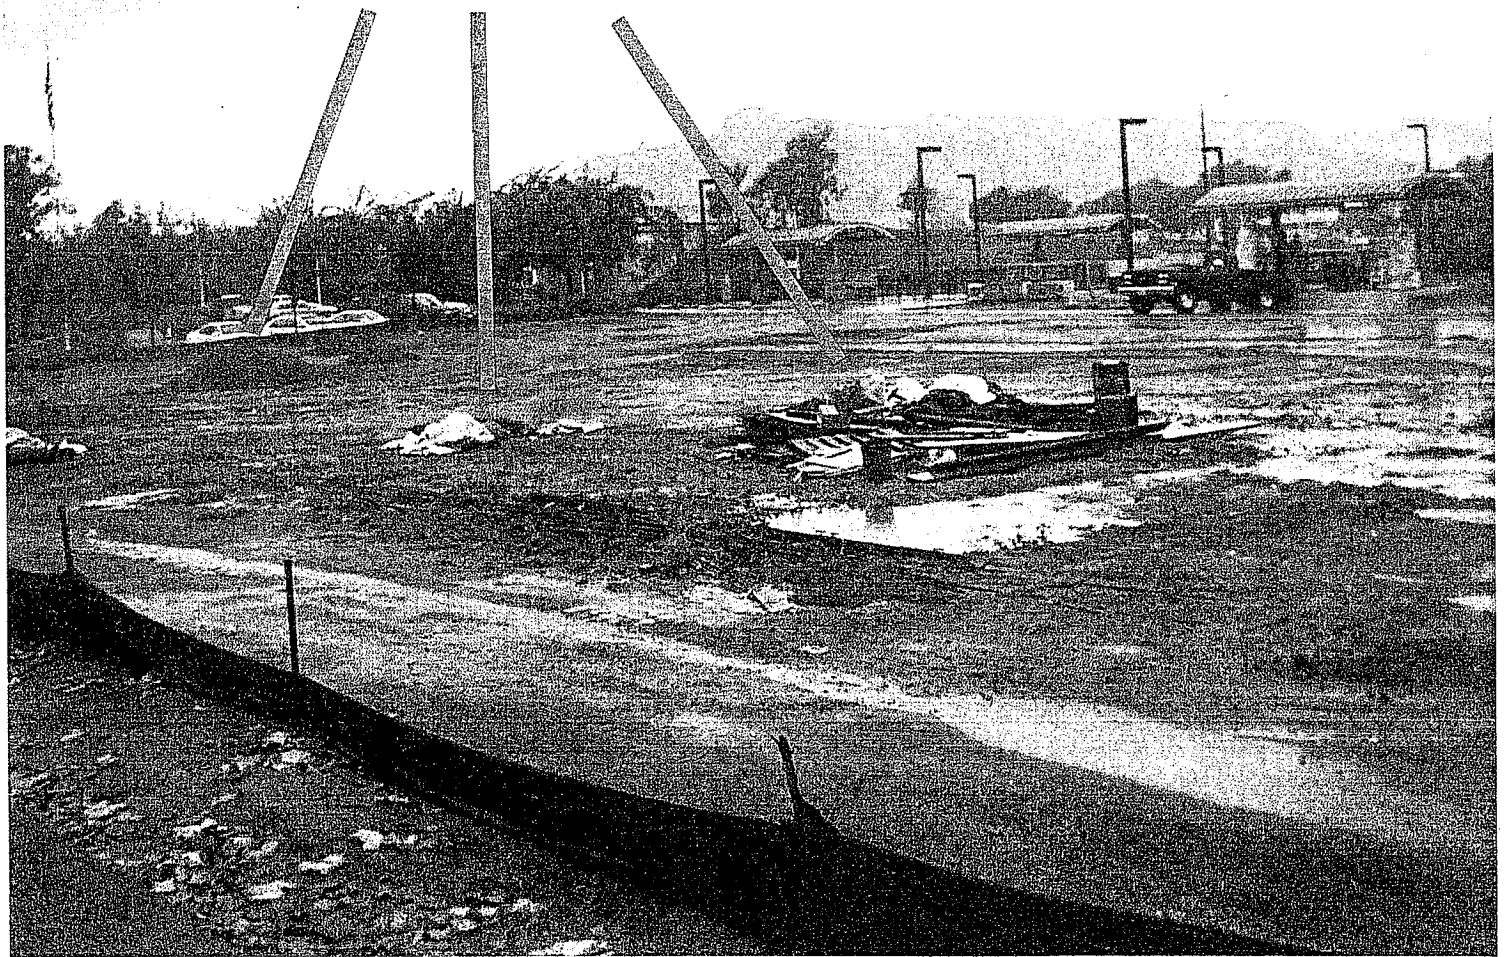
San Marcos Nov30.jpg

In the attached photo, you can see SWPPP violations at the San Marcos Civic Center Sprinter Station. In addition to the visible violations, NCTD has tracked dirt onto the roadways of San Marcos from the vehicle exit point for this work area and NCTD has neglected to sweep up the dirt tracked off-site. This dirt has been washing into storm drains as the rain has been falling all day today.

ps: the truck that is in the back of this photo will likely leave a long trail of mud on San Marcos streets when the driver exits the construction area.

San Marcos • Nov 30 • Civic Center Station Uncovered piles of material and debris

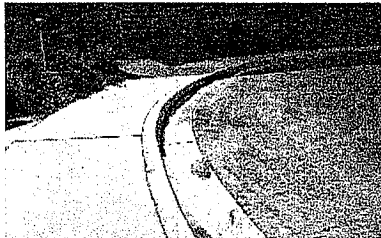
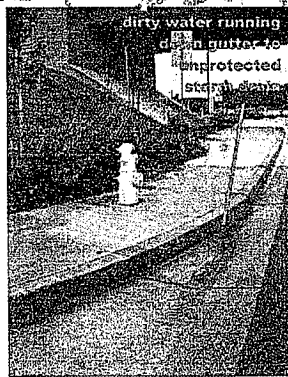
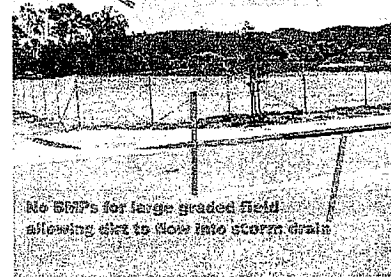
SWPPP SM Loop-2 09-22-07.jpg

Attached is a JPG file of some more of the SWPPP violations that I observed on September 22, 2007 at the Sprinter construction site located along what NCTD refers to as the San Marcos Loop.

Sprinter San Marcos Loop

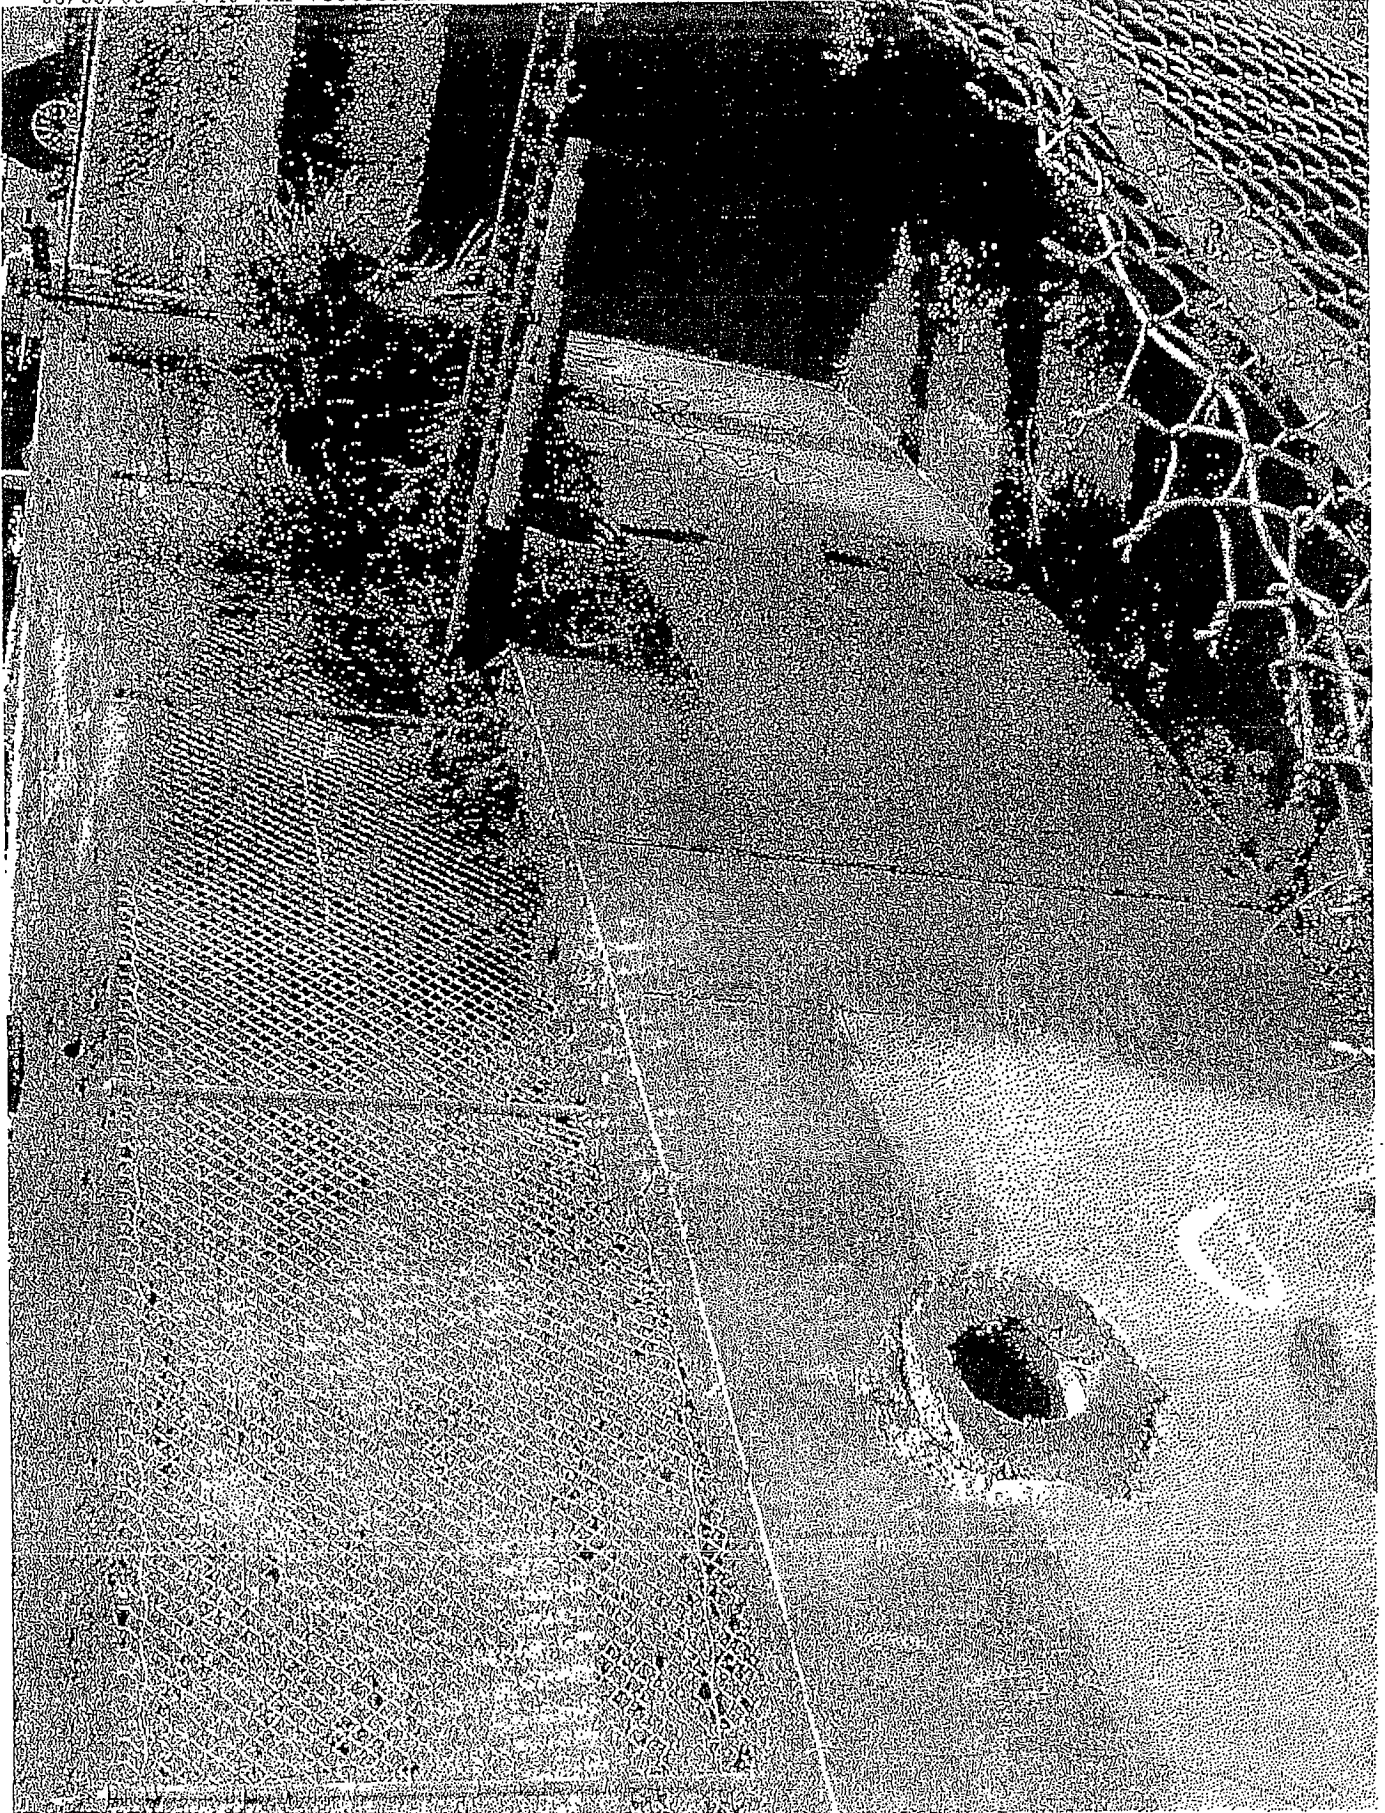
Enclosed is a photograph taken of the drainage channel at west of Santa Fe Avenue between Guajome Street and Main Street. As you can see, the connection between the storm drain pipe and the City's concrete channel, performed by the Sprinter contractor, is deficient. Note also that there is dirt and debris that has been piled against the fence and spilled into the channel. The Sprinter Contractor appears to be in violation of Storm water Pollution Prevention regulations because he has spilled soil into a drainage channel, and there are no measures in place along the graded area next to the channel to prevent erosion of sediment over the wall of the channel and into the Buena Vista creek. As you know, we have recently been experiencing rain storms in Vista.

Please immediately take the necessary steps to correct the connection point and clear the drainage channel and prevent further sedimentation and pollution of the creek, and require the contractor to perform remedial measures to correct the defective work in accordance with the Standard Specifications for Public Works Construction (Greenbook).
