Chronology of Events: Settler's Point/Brightwater Ridge Projects

SECTION 401 WATER QUALITY CERTIFICATION
INSPECTION REPORT

FACILITY: A. Brightwater Ranch, Lakeside CA INSPECTION DATE/TIME: 07/01/2015; 9:00 am
B. Settler's Point/Jackson Ridge, Lakeside CA

**NOTICE OF VIOLATION
No. R9-2015-0120**

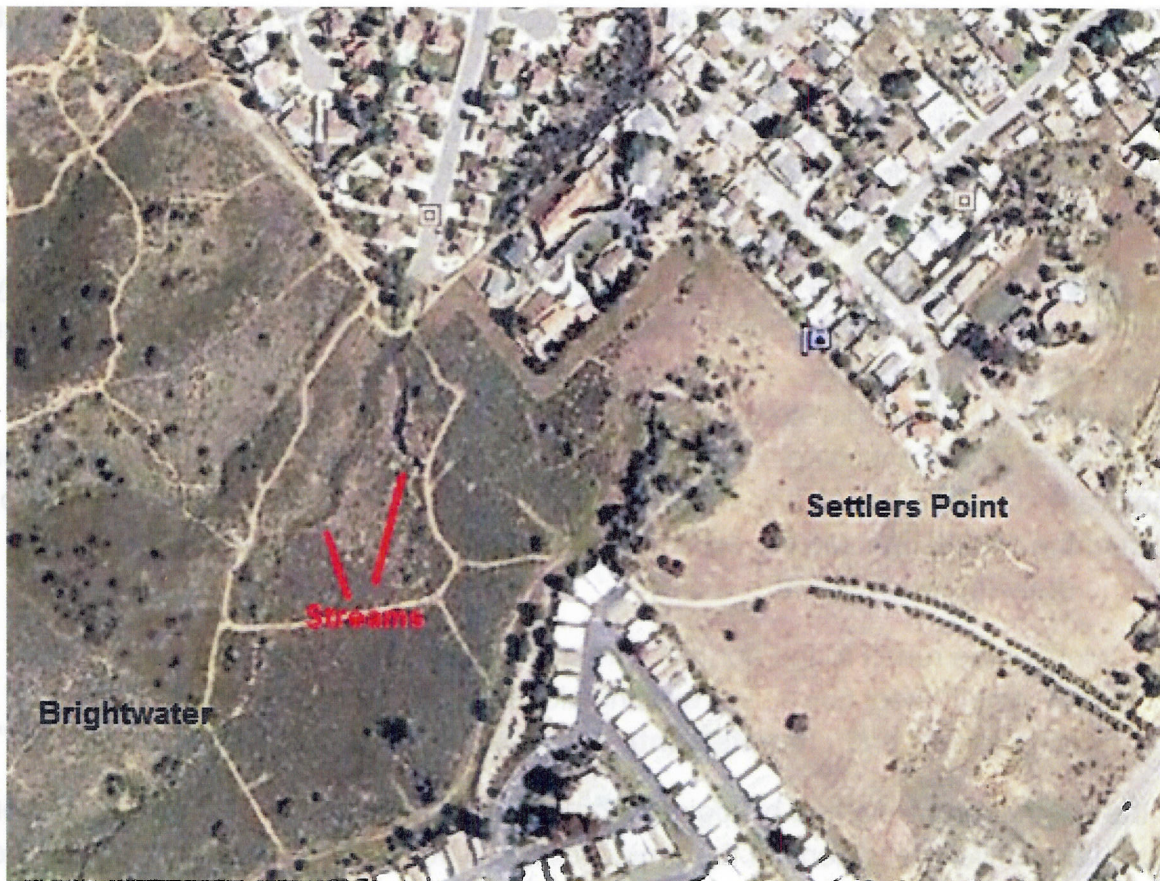
Figure 3. September 2010 Google Earth Aerial photograph

February 12, 2012: The County of San Diego, acting as lead agency under CEQA issues the CEQA Initial Study and Draft Mitigated Negative Declaration for the Settler's Point project. In reviewing the Biological Resources impacts, the County relied on a desktop analysis of the County's Geographical Information System (GIS), the County's Comprehensive Matrix of Sensitive Species, site photos, and the 2006 Biological Technical Report. Had County staff taken more care in this desktop review, aerial photographs could have alerted them to the presence of jurisdictional streams directly off-site in the footprint of the proposed road knuckle (see Figure 3).

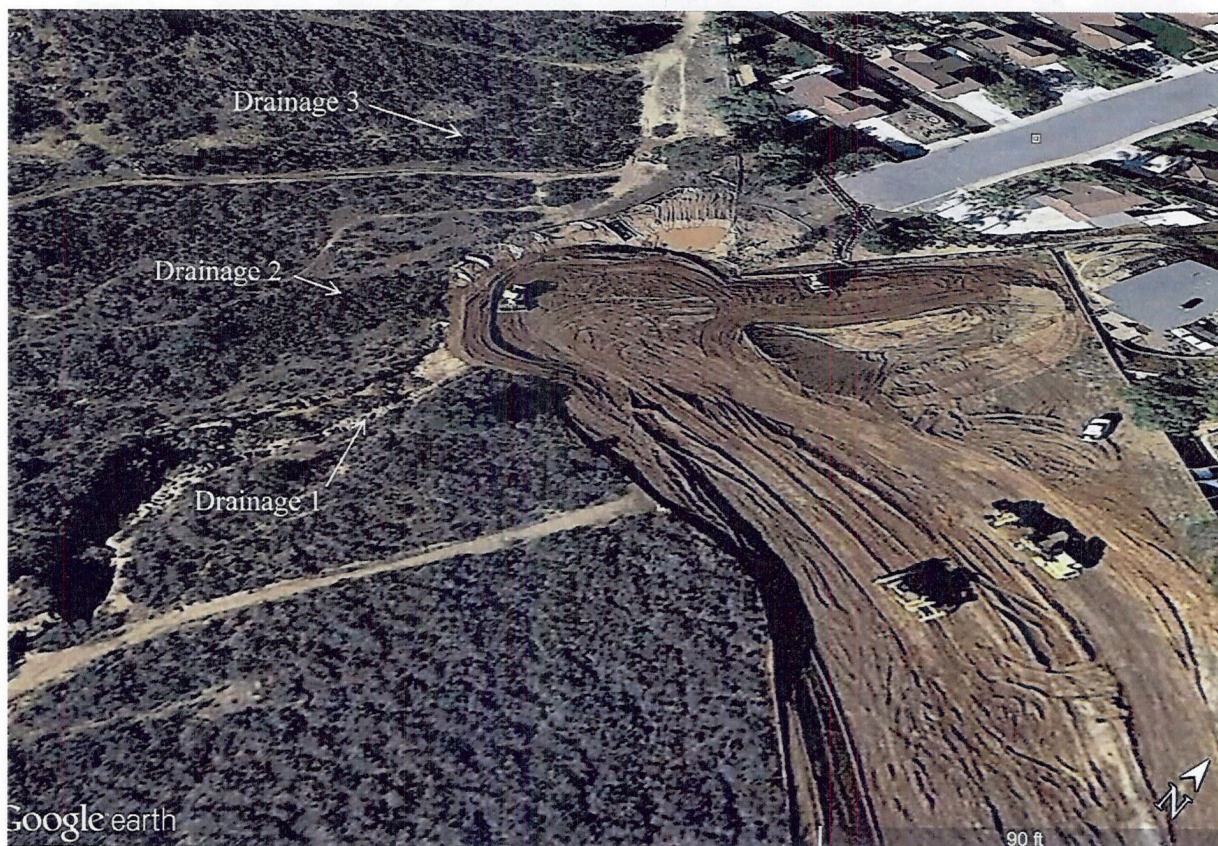
Figure 6. December 2014 Google Earth photo of initiation of grading activity for off-site road knuckle.

April 2015: In early April 2015, Google Earth aerial imagery from December of 2014, reviewed by San Diego Water Board 401 staff during the initial Pulte Homes 401 application completeness review, showed that grading had been conducted on the Brightwater Ranch property in an area with jurisdictional resources (see Figure 6).

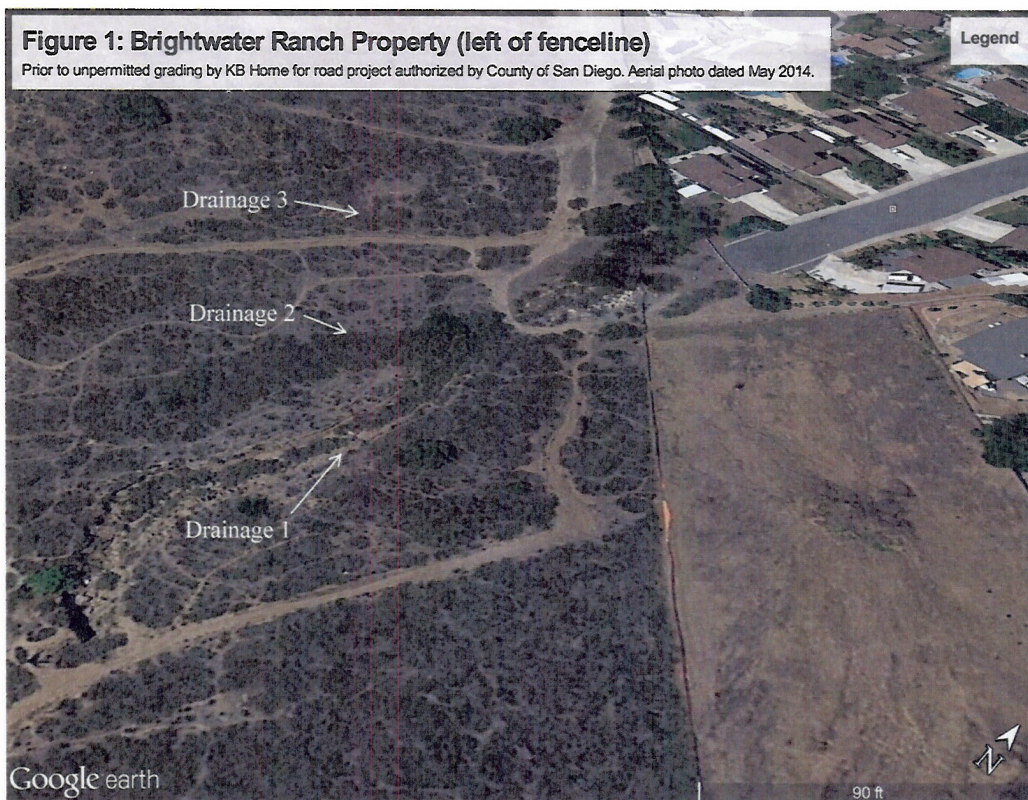
Facility: Brightwater Ranch, Lakeside CA
Inspection Date: 07/01/2015

In early April 2015, Google Earth aerial imagery, reviewed during the initial application completeness review, showed that grading had been conducted on the Brightwater Ranch property in an area with jurisdictional resources some time between May 11, 2014 and December 22, 2014. Figures 1 and 2, below, present the Google Earth aerial images of the property line between Brightwater Ranch and KB Home's adjacent Settler's Point project in May 2014 and December 2014. Figure 3 is a map showing the preliminary jurisdictional delineation of the waters of the U.S. and/or State performed on November 7, 2014 by Joshua Zinn of Helix Environmental Planning and submitted to the San Diego Water Board as part of Brightwater Ranch's 401 certification application on March 10, 2015.

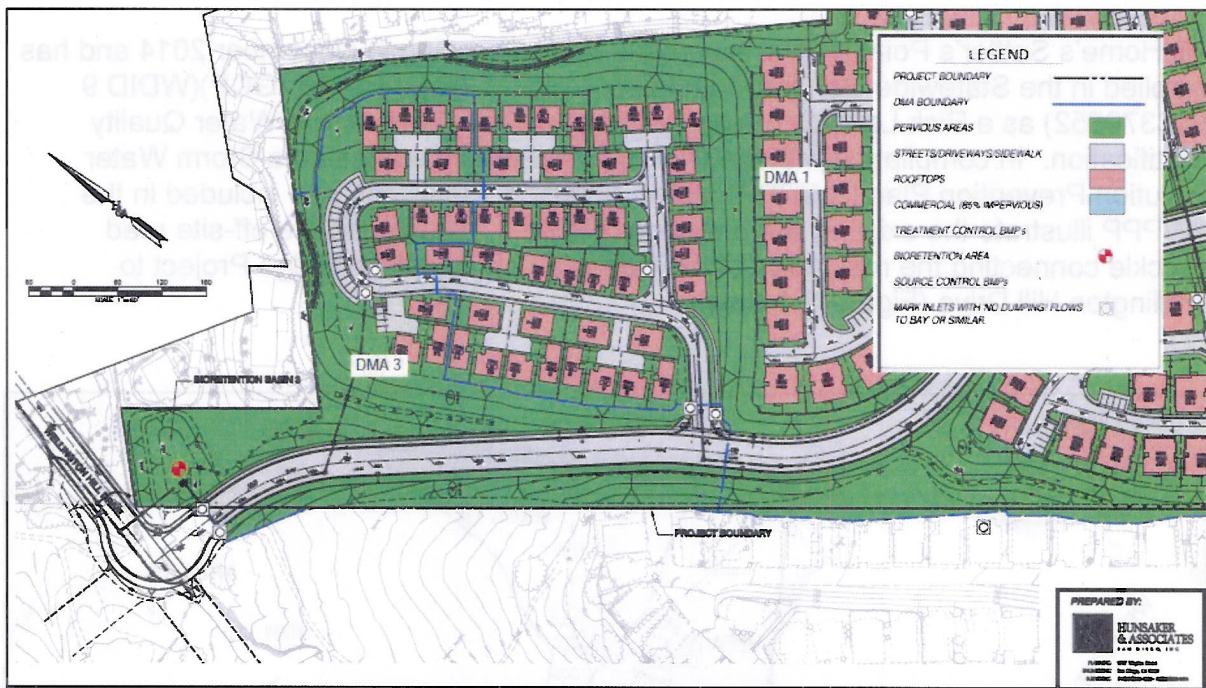
KB Home's Settler's Point project reportedly started grading in December 2014 and has enrolled in the Statewide General Construction Storm Water Permit (GCP)(WDID 9 37C370552) as a Risk Level 2, but did not have a CWA Section 401 Water Quality Certification. In compliance with the GCP, KB Home had submitted a Storm Water Pollution Prevention Plan (SWPPP), dated August 8, 2014. Figures included in the SWPPP illustrate the existing site drainage (Figure 4, below) and the off-site road knuckle connecting the main road of the Settler's Point/Jackson Ridge Project to Wellington Hill Drive (Figure 5, below).

Figure 5: DMA Map for Settler's Point SWPPP showing off-site road knuckle connection to Wellington Hill Drive.

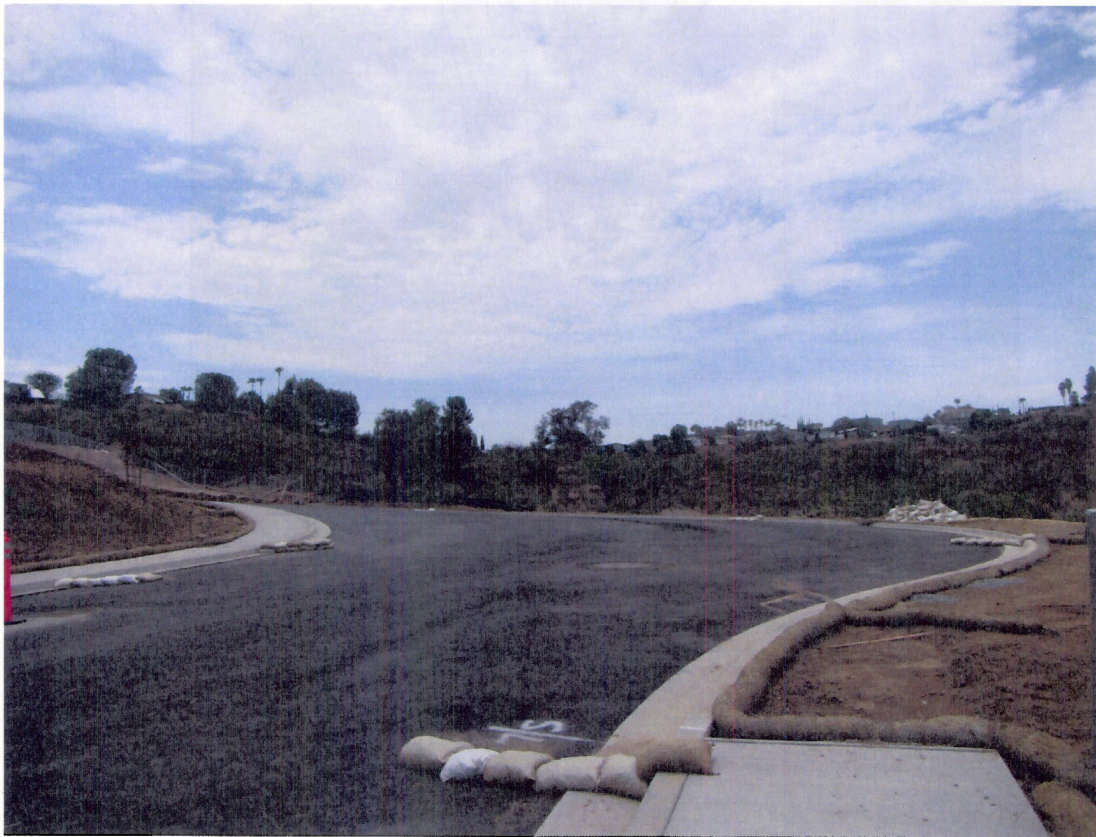
Photo 1: Looking in the direction of the road knuckle from Wellington Hill Drive towards the Brightwater Ranch Property.

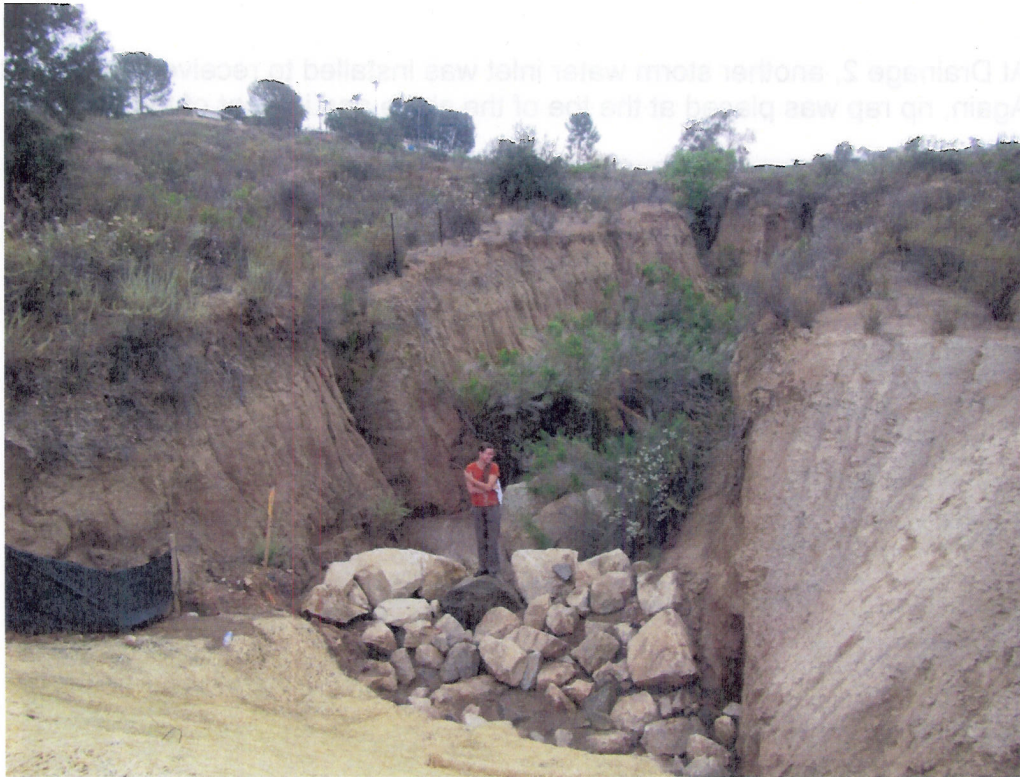
10. Beginning with Drainage 1, Photo 2 shows the unauthorized fill and rip rap that has been placed in the waters of the U.S. and/or State prior to a new storm drain inlet (Photo 3). Sediment is visible in the inlet from the previous day's rain event. Photos 1, 2, and 3 all document that KB Home has discharged unauthorized fill into waters of the U.S. and/or State.

Photo 2: Looking down from the top of the road knuckle into Drainage 1. Melanie Tymes of the Army Corps is approximately 5'4" in height.

1. Pulte Home Corporation and KB Home should cease any additional planned work on the fill area and evaluate removal of the unauthorized fill.
2. Staff will issue a Notice of Violation to responsible parties and will refer further enforcement on this project to the San Diego Water Board's Compliance Assurance Unit.
3. Staff will evaluate the impacts of the unauthorized fill on Pulte Home Corporation's pending 401 Application.

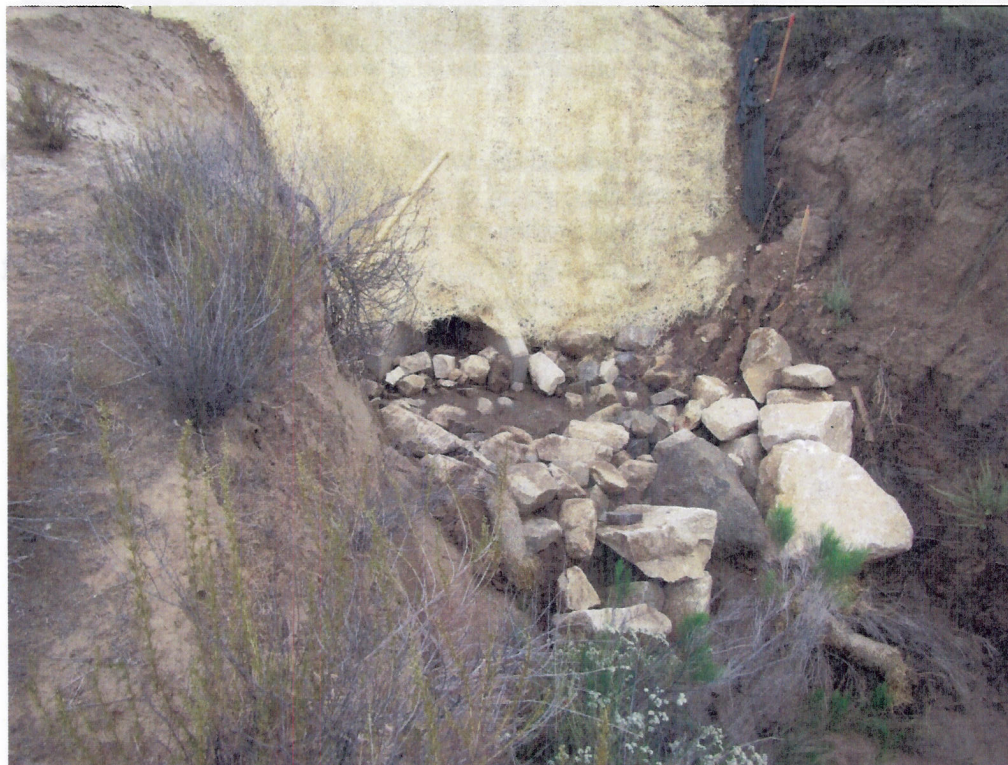
Photo 3: Storm water inlet structure installed at the base of the fill in Drainage 1.

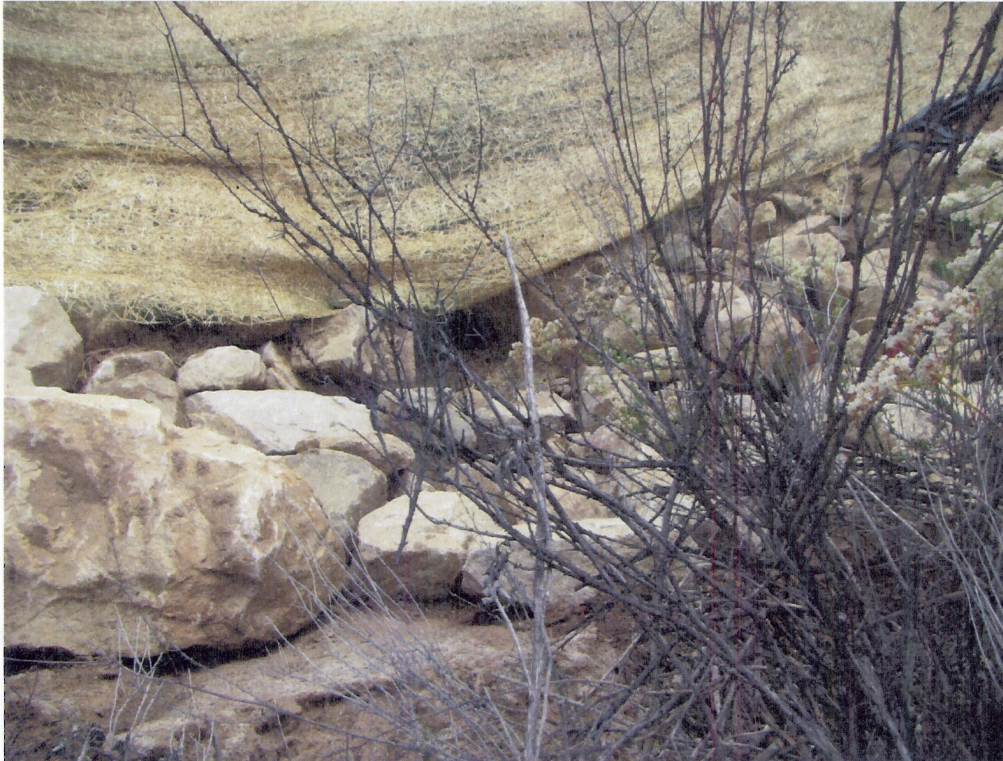
11. At Drainage 2, another storm water inlet was installed to receive flows (Photo 4). Again, rip rap was placed at the toe of the slope and in front of the inlet.

Photo 4: A second storm water inlet structure installed at the base of the fill at Drainage 2.

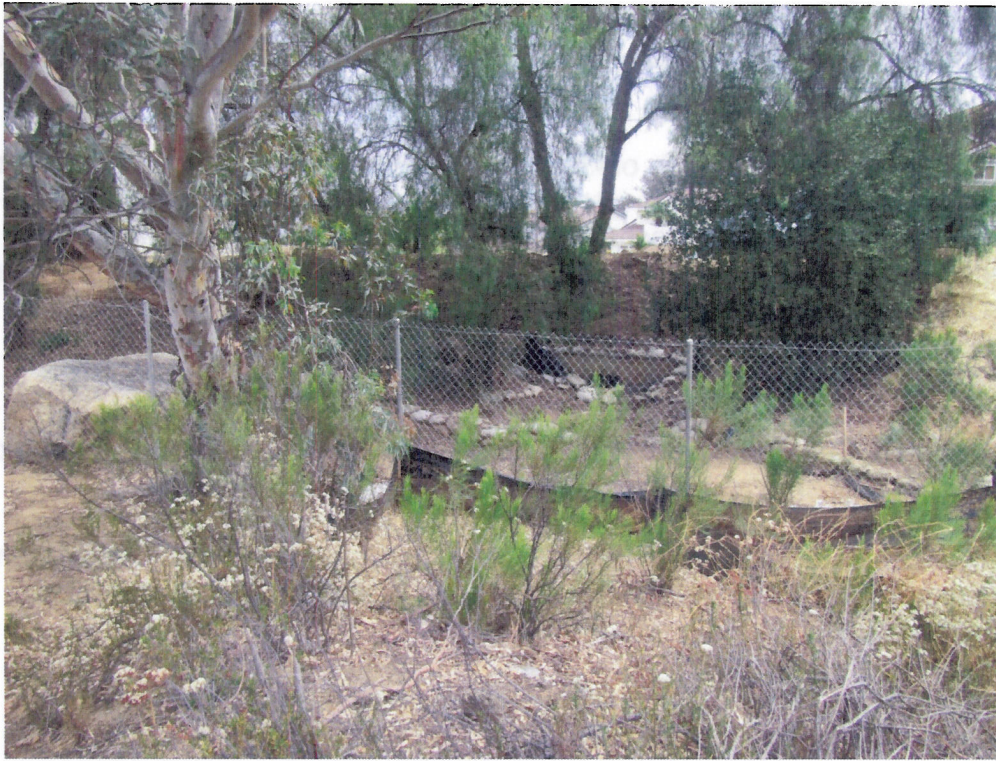
12. A third storm water inlet structure exists, which previously received flows from all three drainages were protected by rows of sand bags and silt fencing (see Photos 5 and 6). The fence line marks the property boundary. In an email correspondence on July 6, 2015, Ms. Ehsan confirmed that the area to right of the fence line in Photo 6 is on the property of the homeowner at 13106 Wellington Hill Drive.

Photo 5: The third storm water inlet structure with construction BMPs in place.

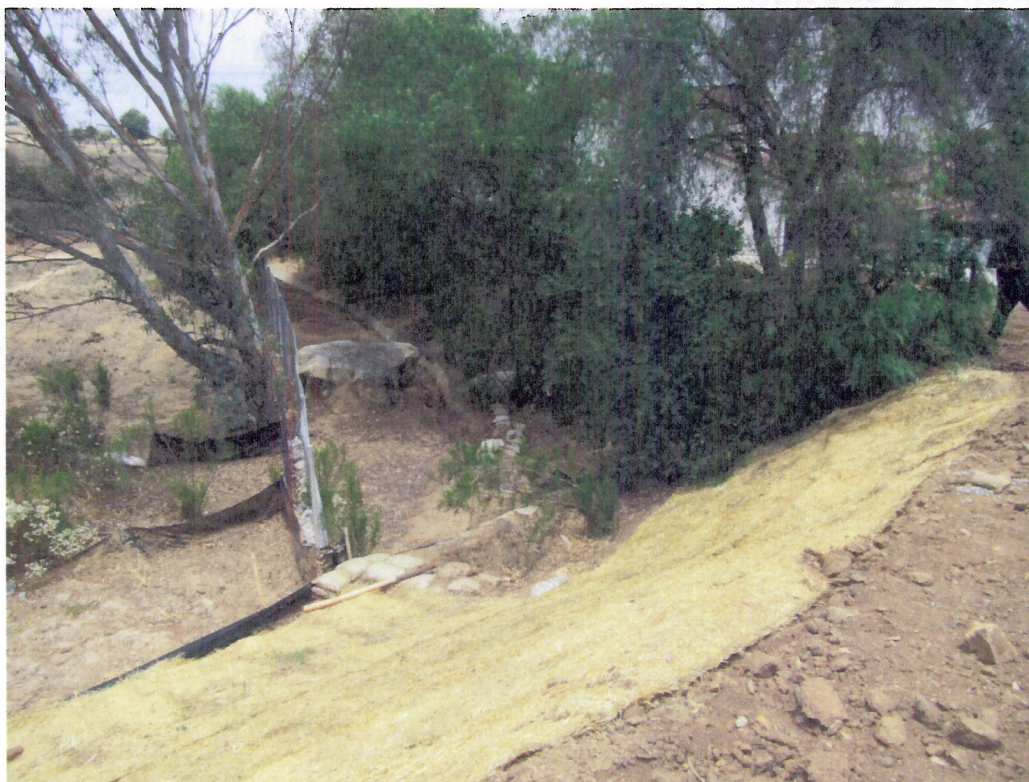
Photo 6: Looking down towards location of storm water inlet 3
