**CALIFORNIA REGIONAL WATER QUALITY CONTROL BOARD - SAN DIEGO REGION
WATERSHED MANAGEMENT PROGRAM**

FACILITY INSPECTION REPORT

FACILITY: Carlsbad Municipal Golf Course

Construction Storm Water Inspection-1/03/06
Carlsbad Municipal Golf Course, WDID# 937C337203
Carlsbad, San Diego County

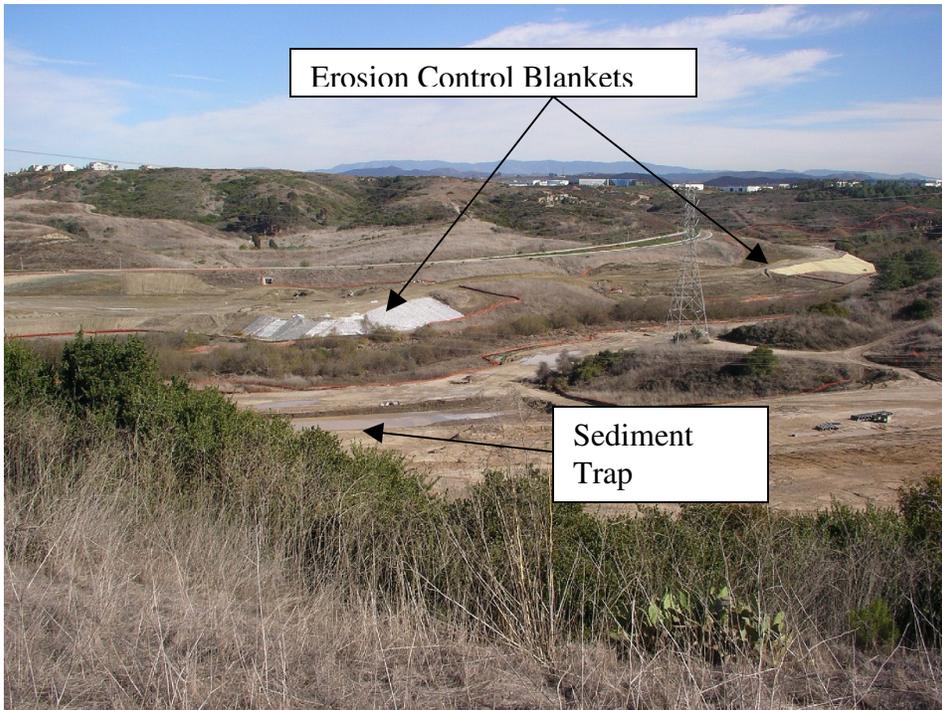
- The site has implemented additional erosion and sediment control BMPs for the recent storm event.
- Straw erosion control blankets and plastic sheeting were installed on the exterior and some interior slopes (Photo 1).
- Sediment basins/traps were constructed at various locations per the City's weather triggered action plan (Photo 1). Gravel bag check dams have been installed on most rough graded roads. New silt fence has been installed along the entire perimeter and along interior drainages. (Photo 2)
- At the time of the inspection, no evidence of sediment discharges was observed.
- Additional BMPs have been stockpiled at the site.

Photo 1
Example of BMPs at Site (Facing North)

- The City appears to be implementing adequate erosion and sediment control BMPs per its weather triggered action plan and revised SWPPP.
- The City's new erosion control contractor appears to be more effective in implementing and maintaining the construction BMPs.
- The site should be reinspected during larger rain events.

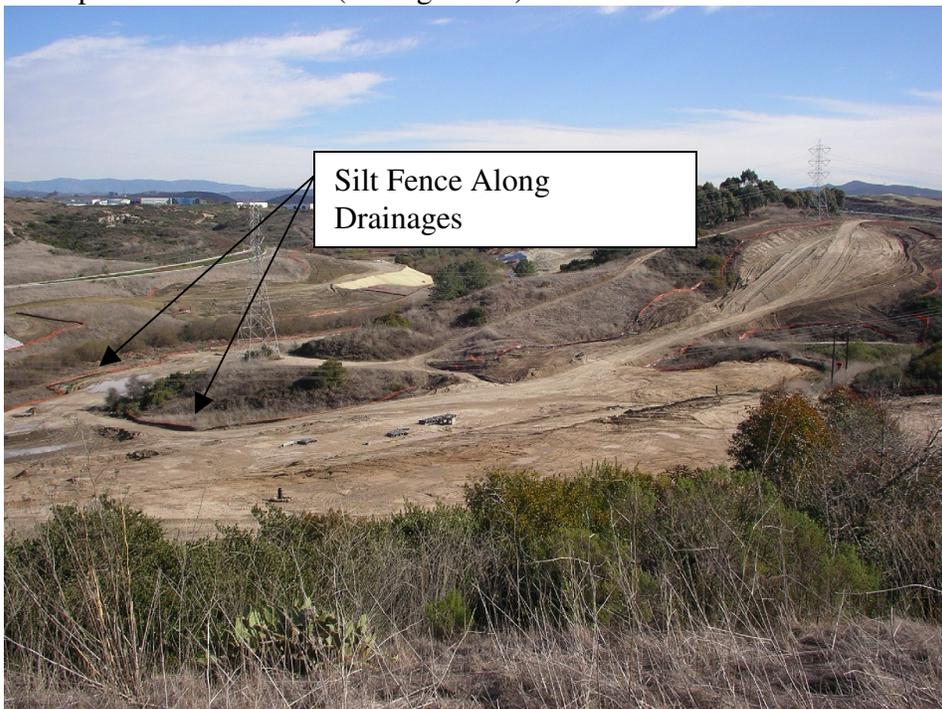
Photo 2
Example of Silt Fence Along Interior Drainages (Facing Northeast)
