**CALIFORNIA REGIONAL WATER QUALITY CONTROL BOARD - SAN DIEGO REGION
WATERSHED MANAGEMENT PROGRAM**

FACILITY INSPECTION REPORT

FACILITY: 501 & 505 1st Street, Coronado, CA 92118

401 File #: 05C-041

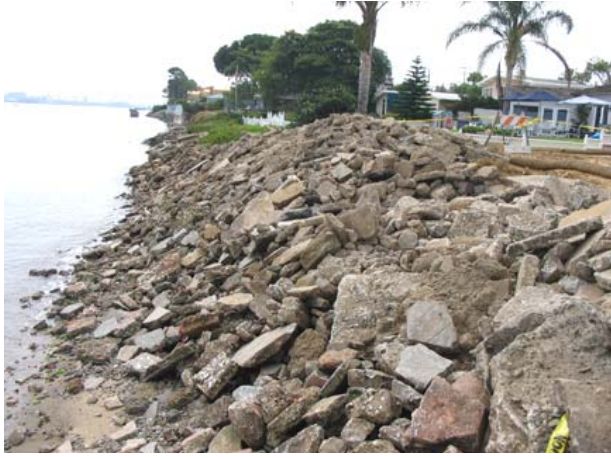
- 401 certification (File No. 05C-041) issued to Bill & Heidi Dickerson was for riprap replacement along 80 linear feet of shoreline in front of the property. The project as proposed would have removed 450 cy of existing riprap (see Figure 1) and replaced it with filter fabric and quarry riprap. The project as put forth in the 401 application would have been similar to the adjacent City of Coronado shoreline stabilization project. (See Figure No. 5). The 401 cert. Did not authorize the construction of a seawall or the deposition of sand into the Bay to form a beach.

Figure 1. Pre-Construction condition of shoreline (photo provided by the SD Port District)

- A Cleanup and Abatement Order is recommended requiring the removal of the seawall and artificial Beach, and direct the responsible parties to construct the project as permitted. A study needs to be done to determine if eelgrass has been impacted, and if this is the case, mitigation should be provided consistent with the Southern California Eelgrass Mitigation policy.
- Coordination should be sought with the Port District and Army Corps for any enforcement action to assure regulatory consistency.
-

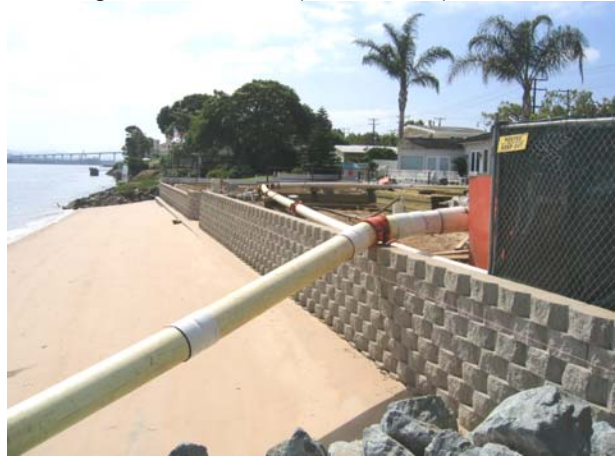
Figure 2. Post construction shoreline condition, with un-permitted seawall construction, and discharge of fill material (beach sand)

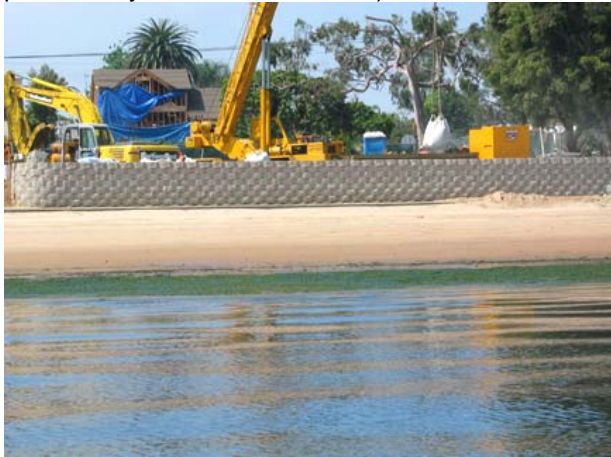
- There is no record of the residents of 505 1st Street applying for authorization to do any work on the shoreline bordering their property.
- Sensitive Eelgrass habitat is present all along the shallow water adjacent to both properties (see figures 3 & 4). Uprooted clumps of eelgrass were noted on the shore during the inspection. It is unknown at this time if construction of the artificial beach has impacted eelgrass. Erosion of the beach sand in the future has the potential to further degrade eelgrass habitat.

Figure 3. Eelgrass bed, 501 1st Street (photo provided by the SD Port District)

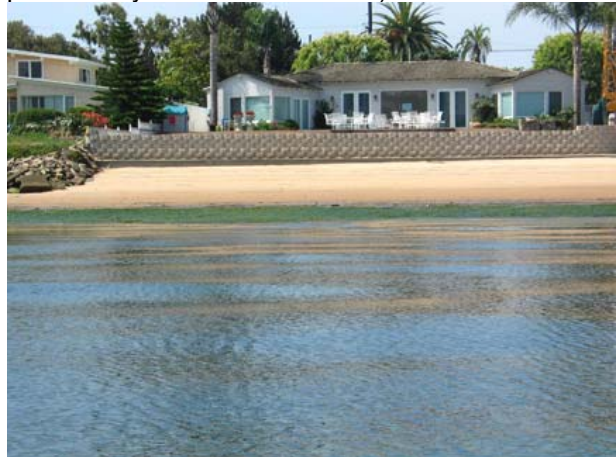
Figure 4. Eelgrass bed 505 1st Street (photo provided by the SD Port District)

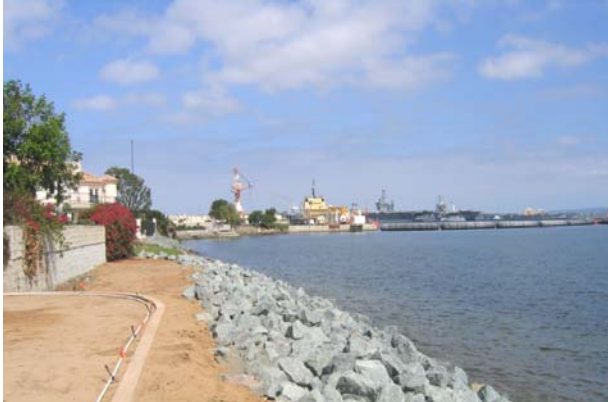
Figure 5. Photo looking north at the City of Coronado shoreline protection project (05C-067) which is how the project at 501 1st Street was permitted to be constructed.

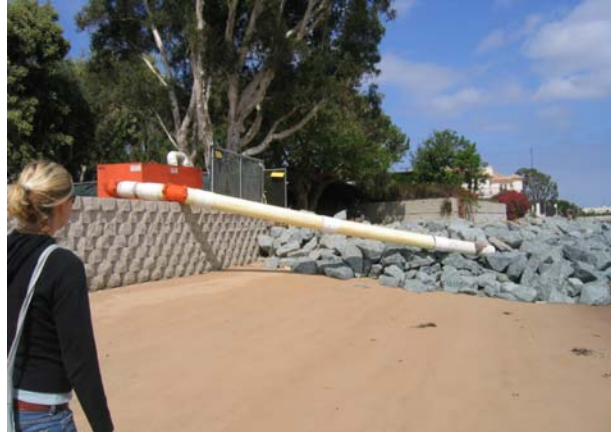
Figure 6. It is unknown what the pipe shown here is discharging offsite into City of Coronado Project footprint (possibly used to spread sand on constructed beach?)

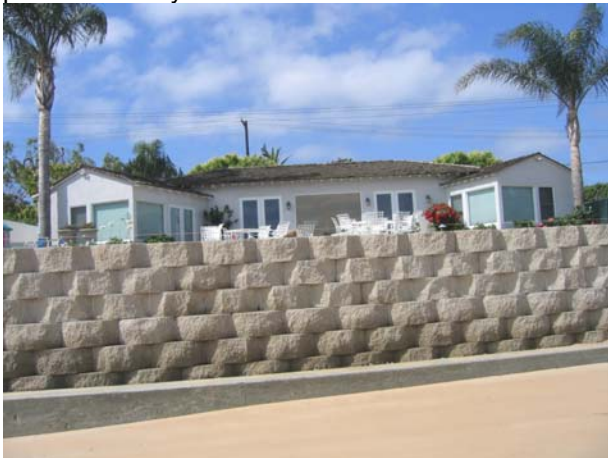
- According to the Port District staff the seawall encroaches into Port District jurisdictional shoreline by approx. 1- foot.

Figure 7. Concrete footing encroaches over MHTL by approx. 1-foot for the entire length of the wall, per Port survey.

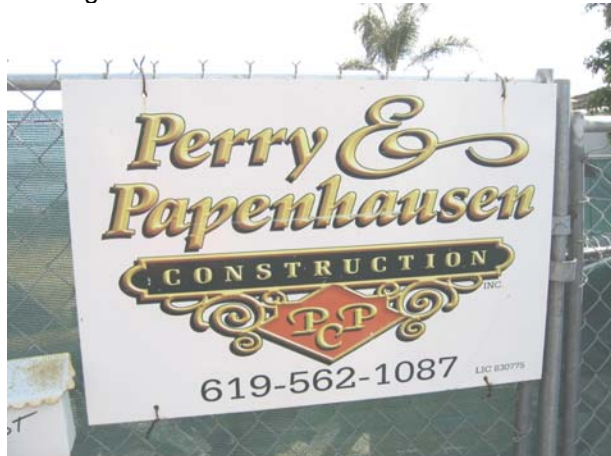
Figure 8. Construction company responsible for building the new home at 501 1st Street
