Exhibit No. 1

State Water Resources Control Board

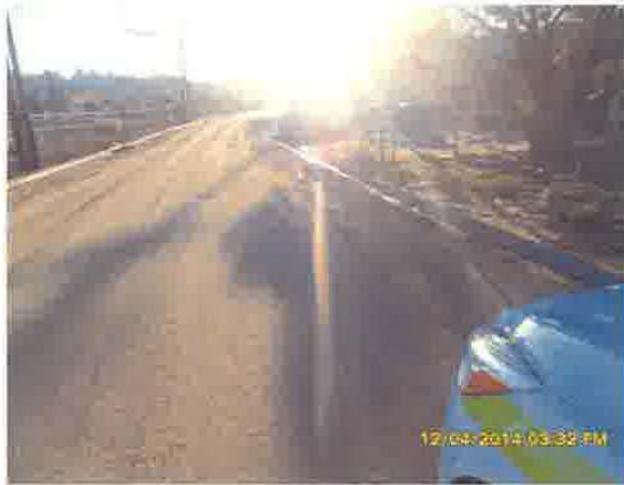
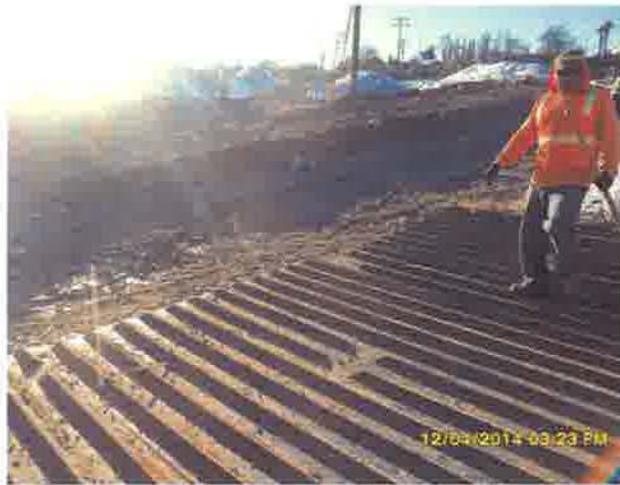
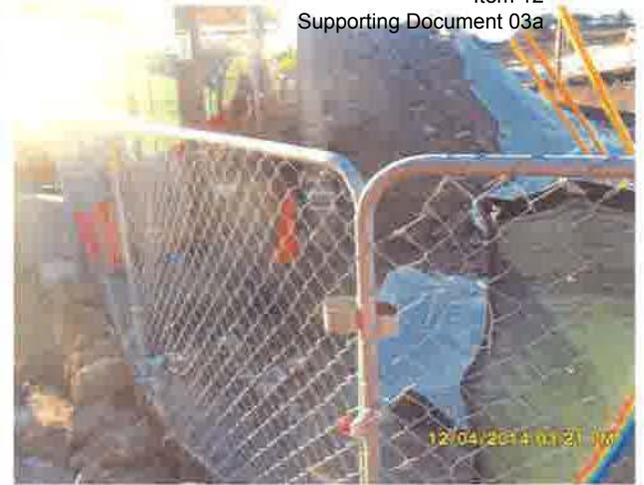
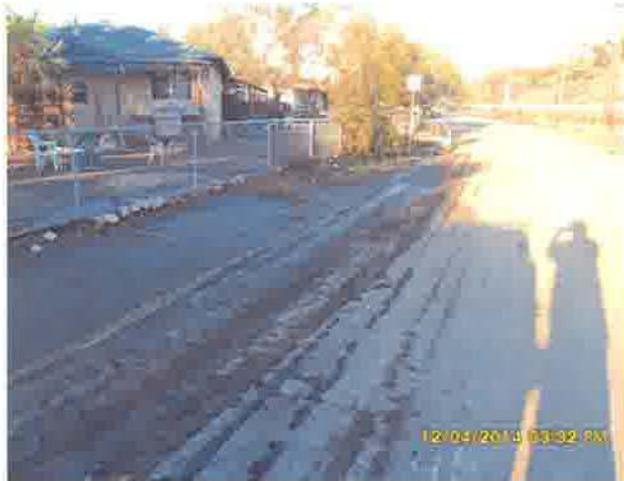
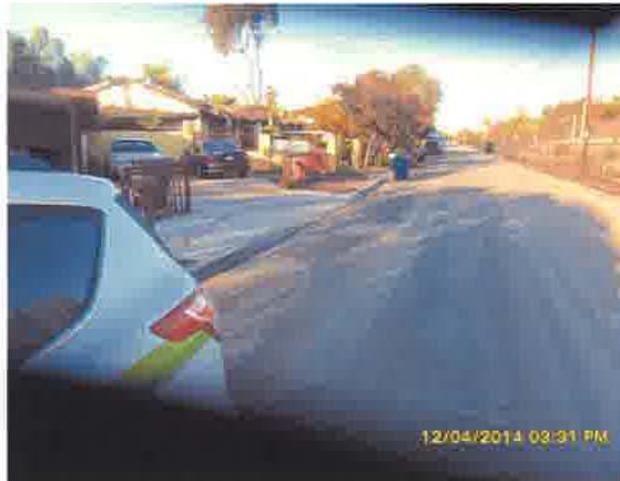
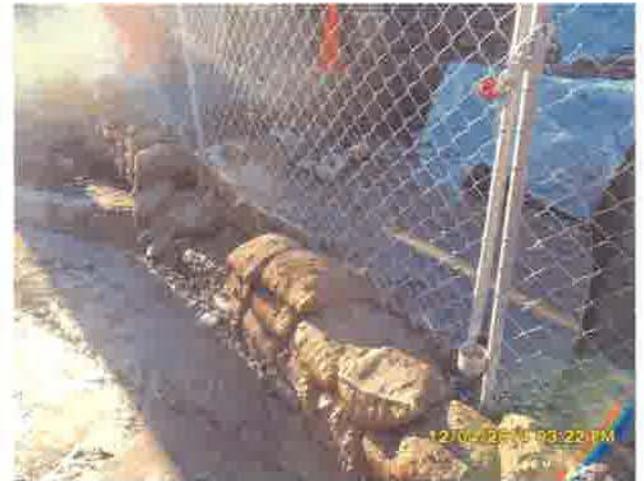
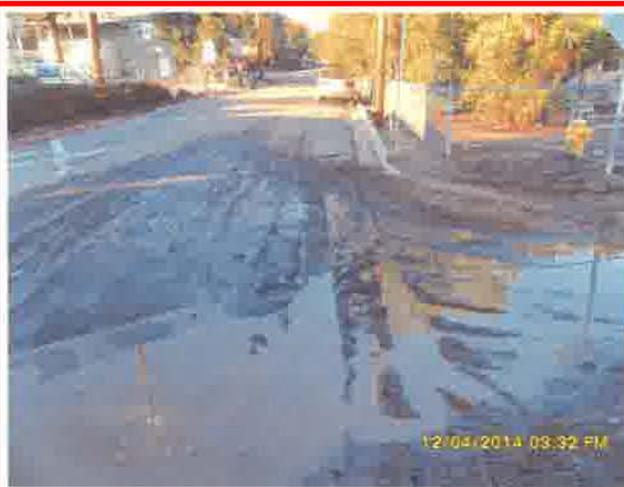
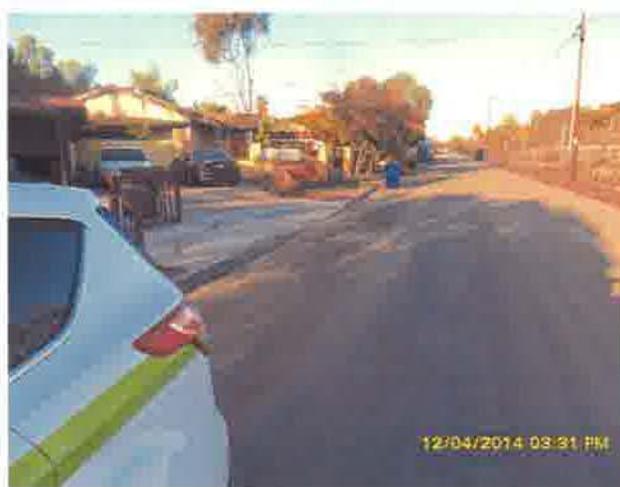
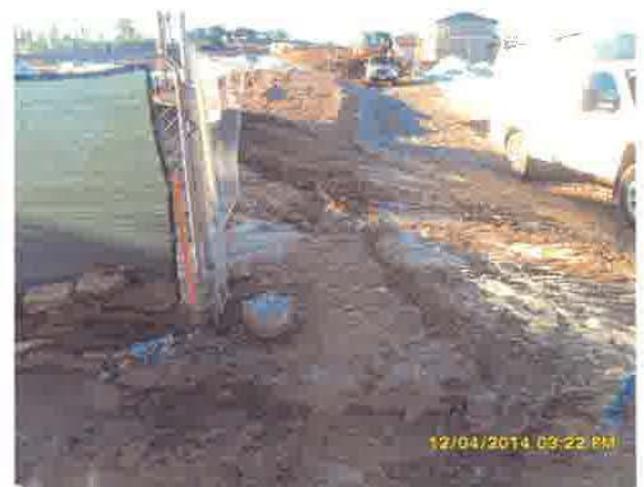
* Having deficiencies in your erosion control is a violation of the City of Lemon Grove's Grading Ordinance. A violation of the City's Grading Ordinance is a misdemeanor. Each separate day or portion thereof on which a violation exists or is allowed to exist shall constitute a separate offense punishable by the provisions of the Ordinance.

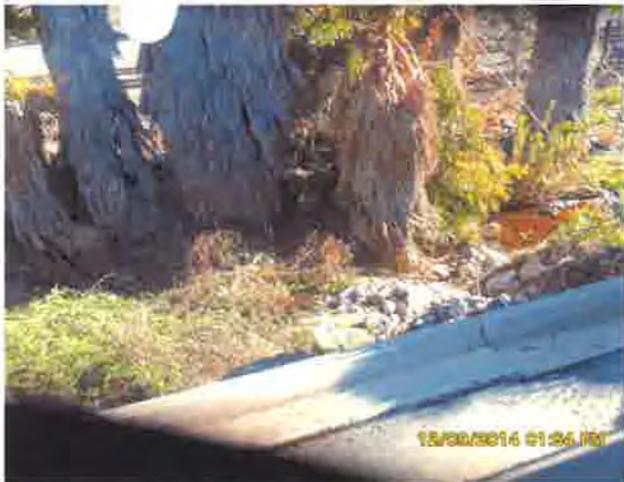
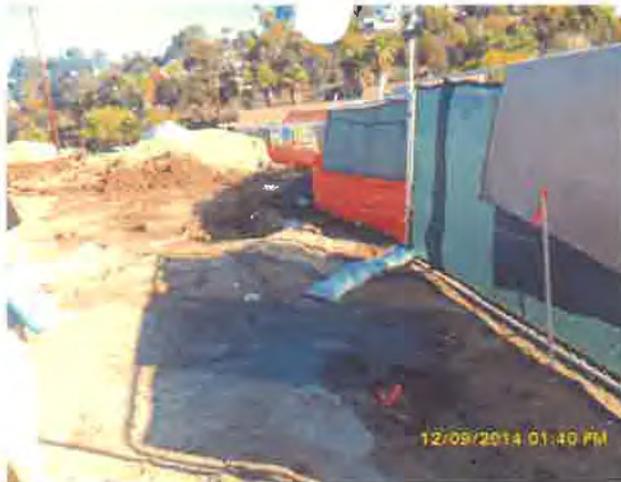
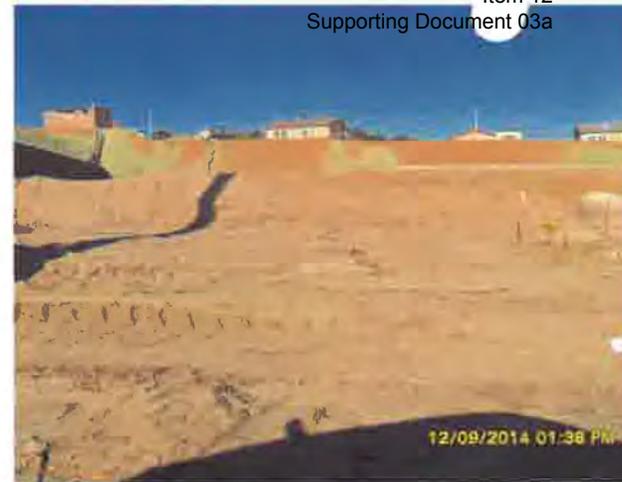
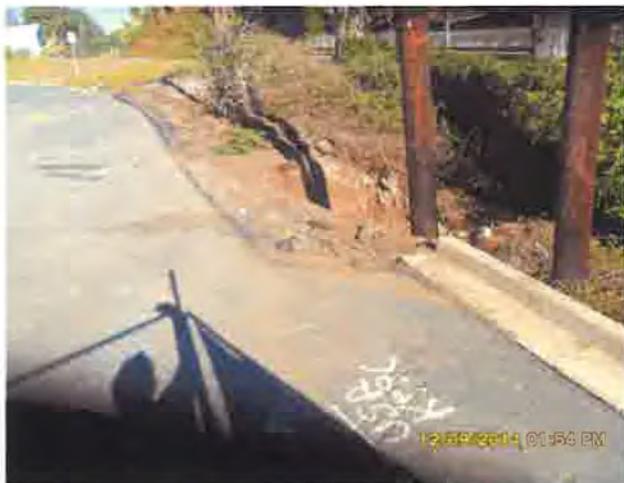
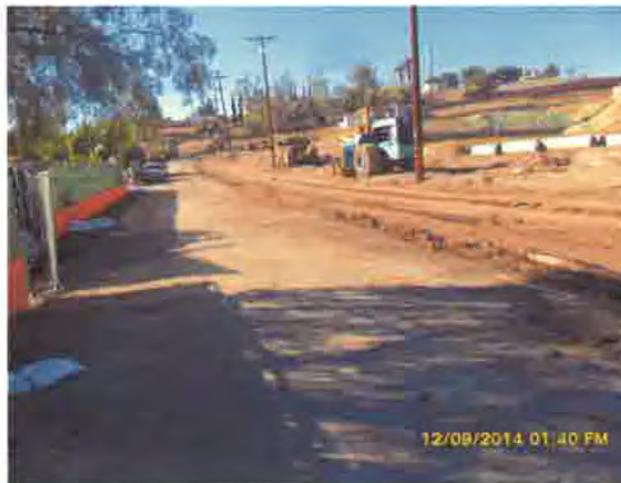
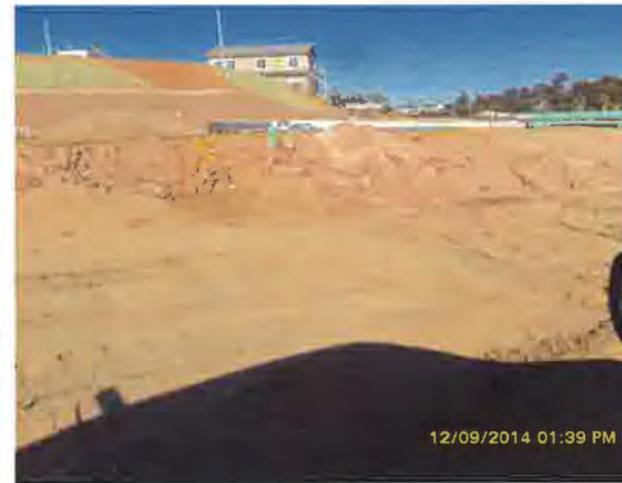
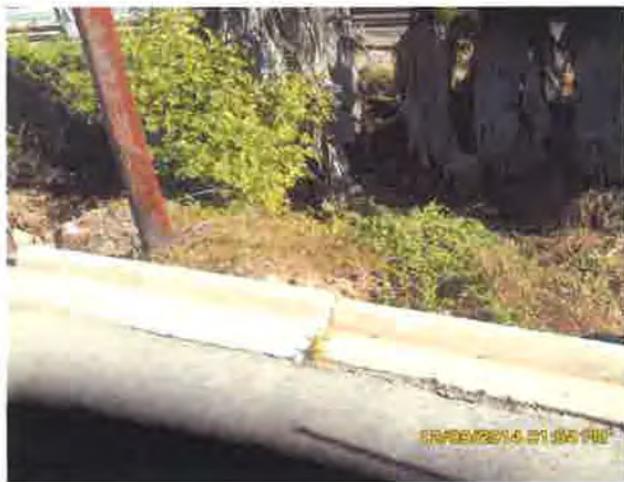
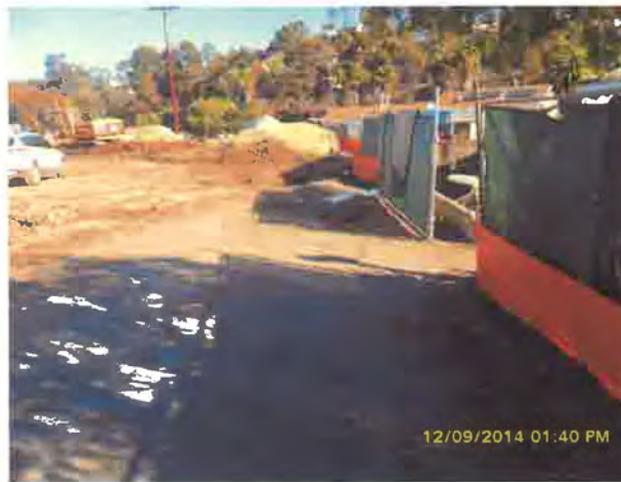
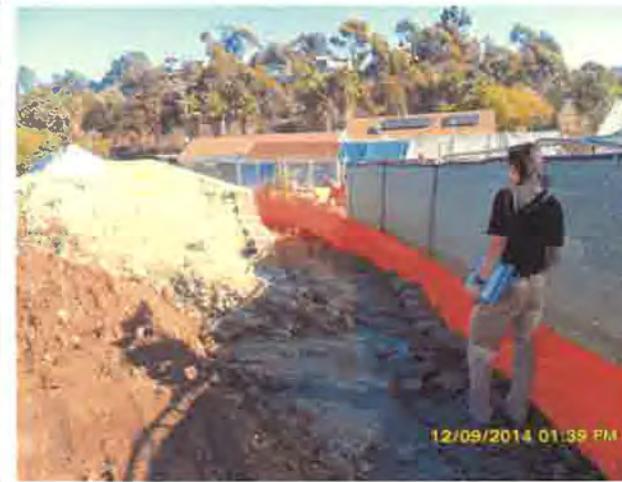
* Having deficiencies in your erosion control is a violation of the City of Lemon Grove's Grading Ordinance. A violation of the City's Grading Ordinance is a misdemeanor. Each separate day or portion thereof on which a violation exists or is allowed to exist shall constitute a separate offense punishable by the provisions of the Ordinance.

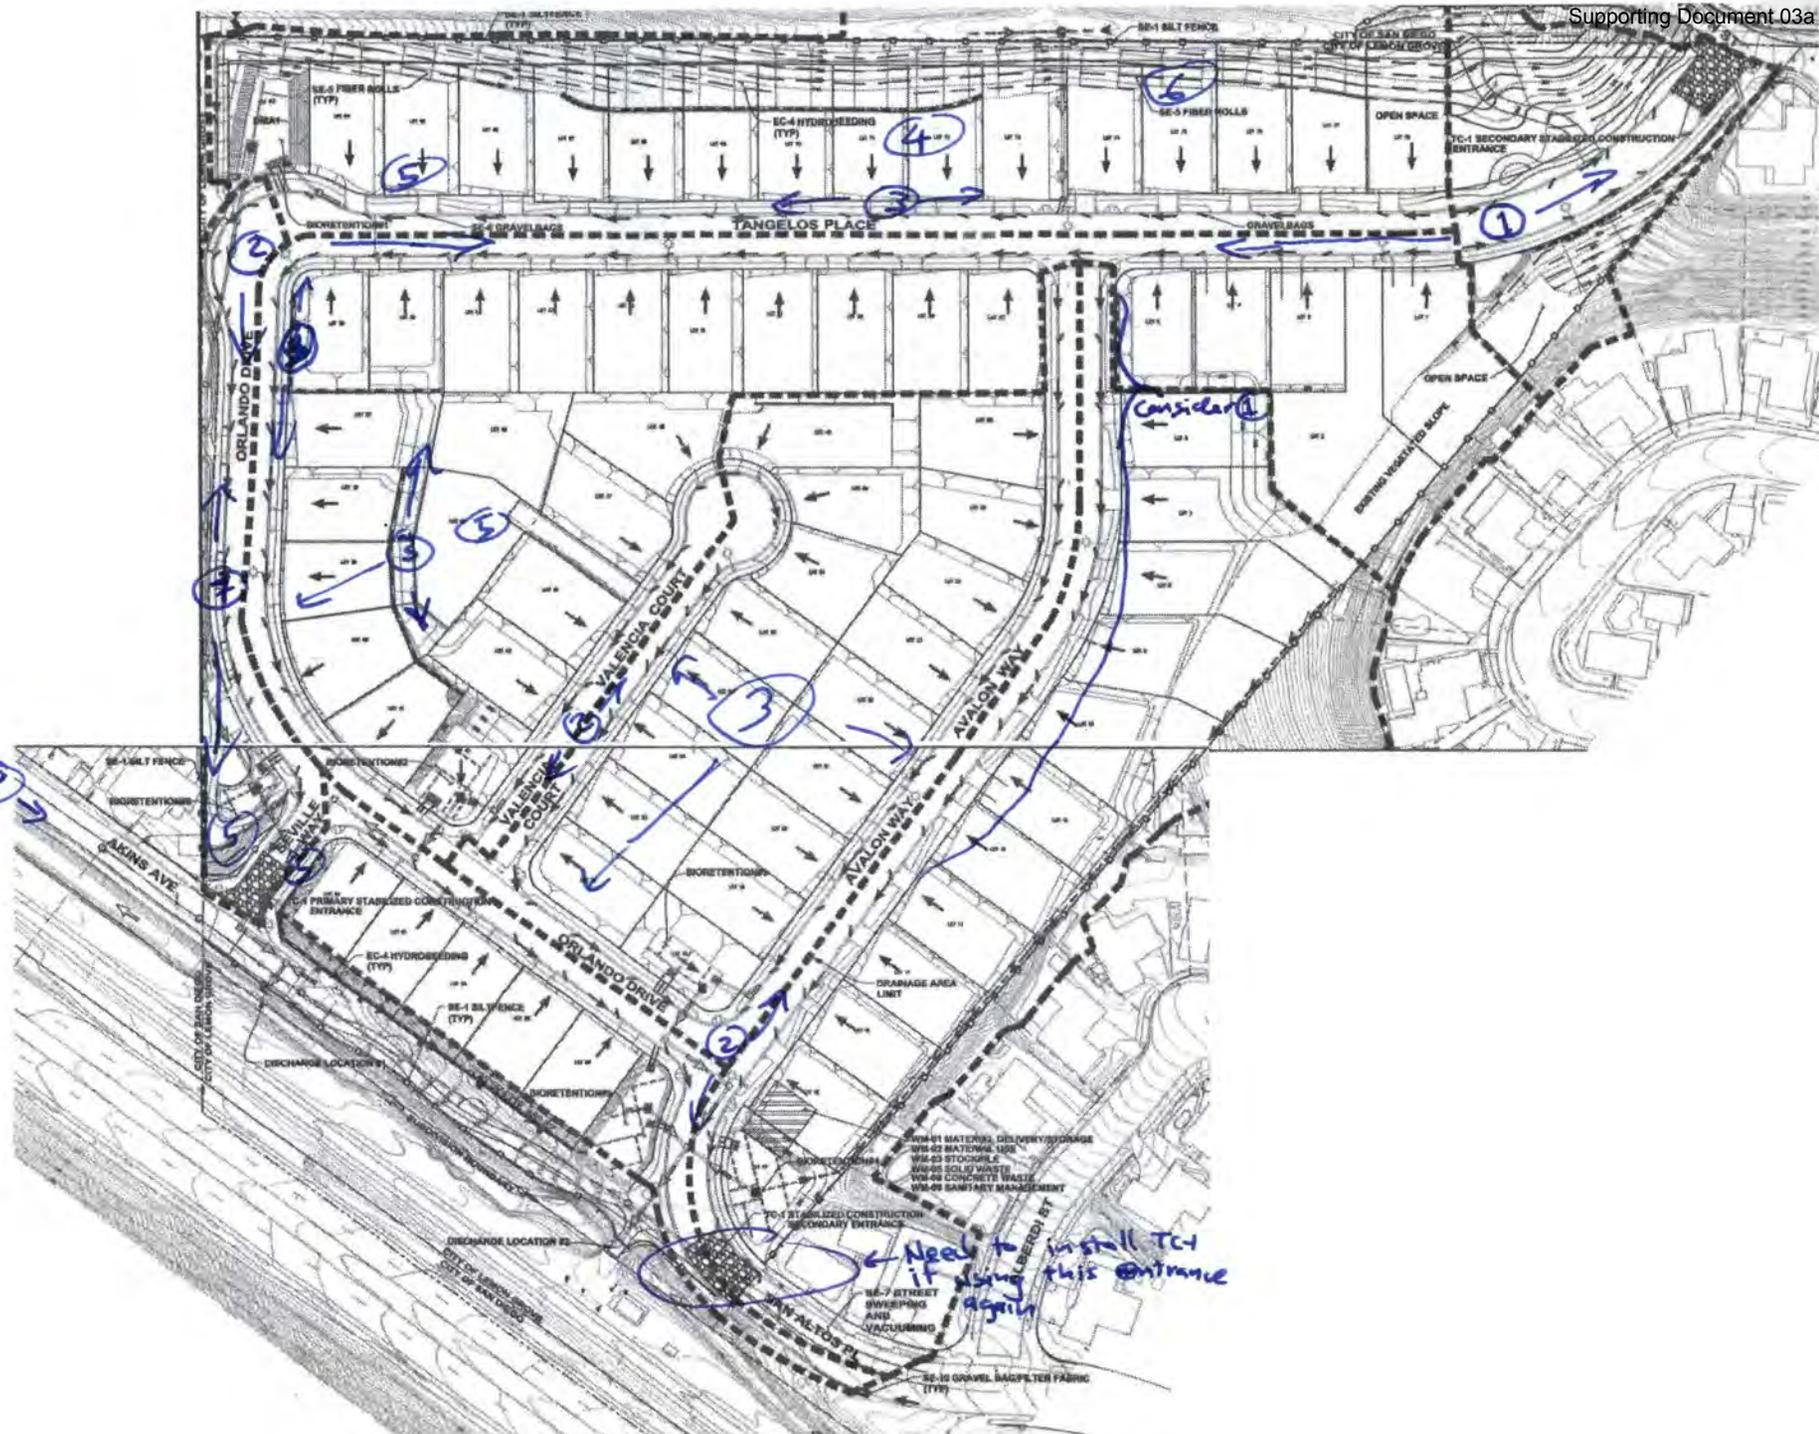
Lemon Grove Municipal Code							
Up	Previous	Next	Main		Search	Print	No Frames
Title 8 HEALTH AND SAFETY							
Chapter 8.48 STORMWATER MANAGEMENT AND DISCHARGE CONTROL

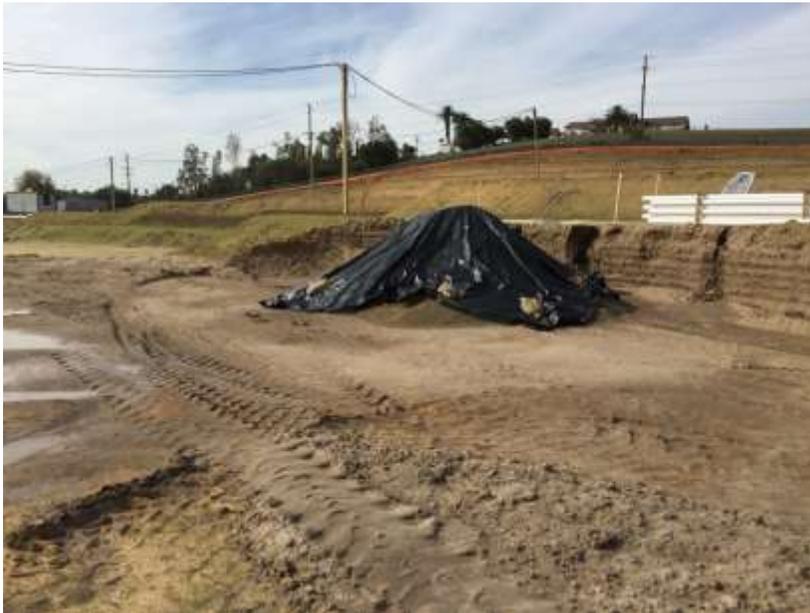
Facility: Valencia
Inspection Date: 12/15/2014

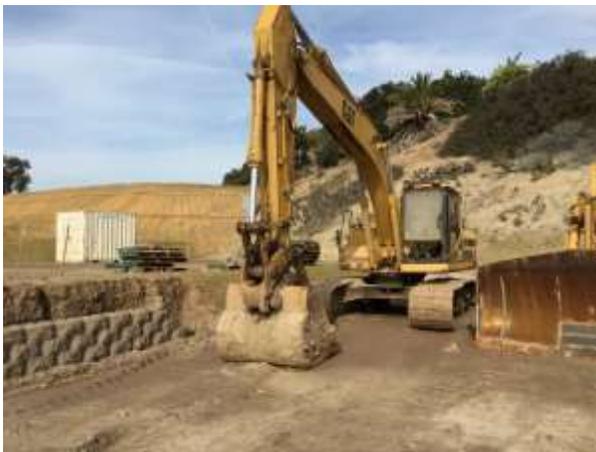
Photo 1 shows soil **stockpile without adequate containment**. Evidence of erosion and sediment transport along that base of the stockpile. Most stockpiles observed during inspection lacked adequate containment.

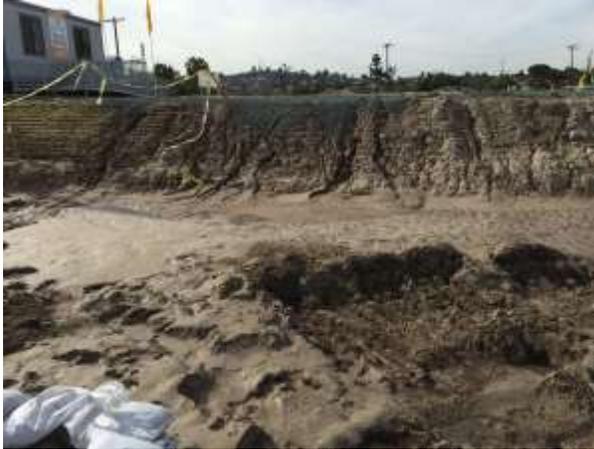
Facility: Valencia
Inspection Date: 12/15/2014

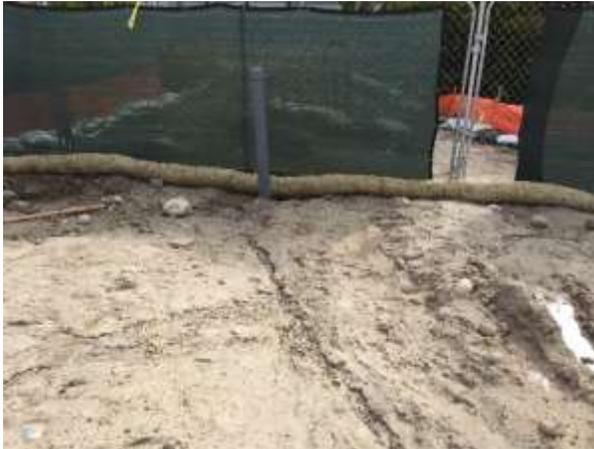
Facility: Valencia
Inspection Date: 12/15/2014

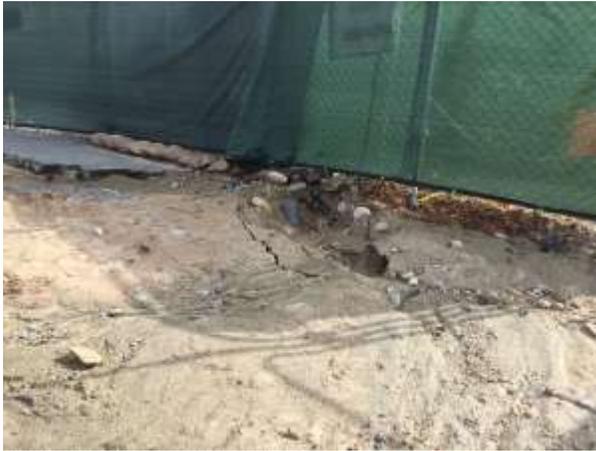
Facility: Valencia
Inspection Date: 12/15/2014

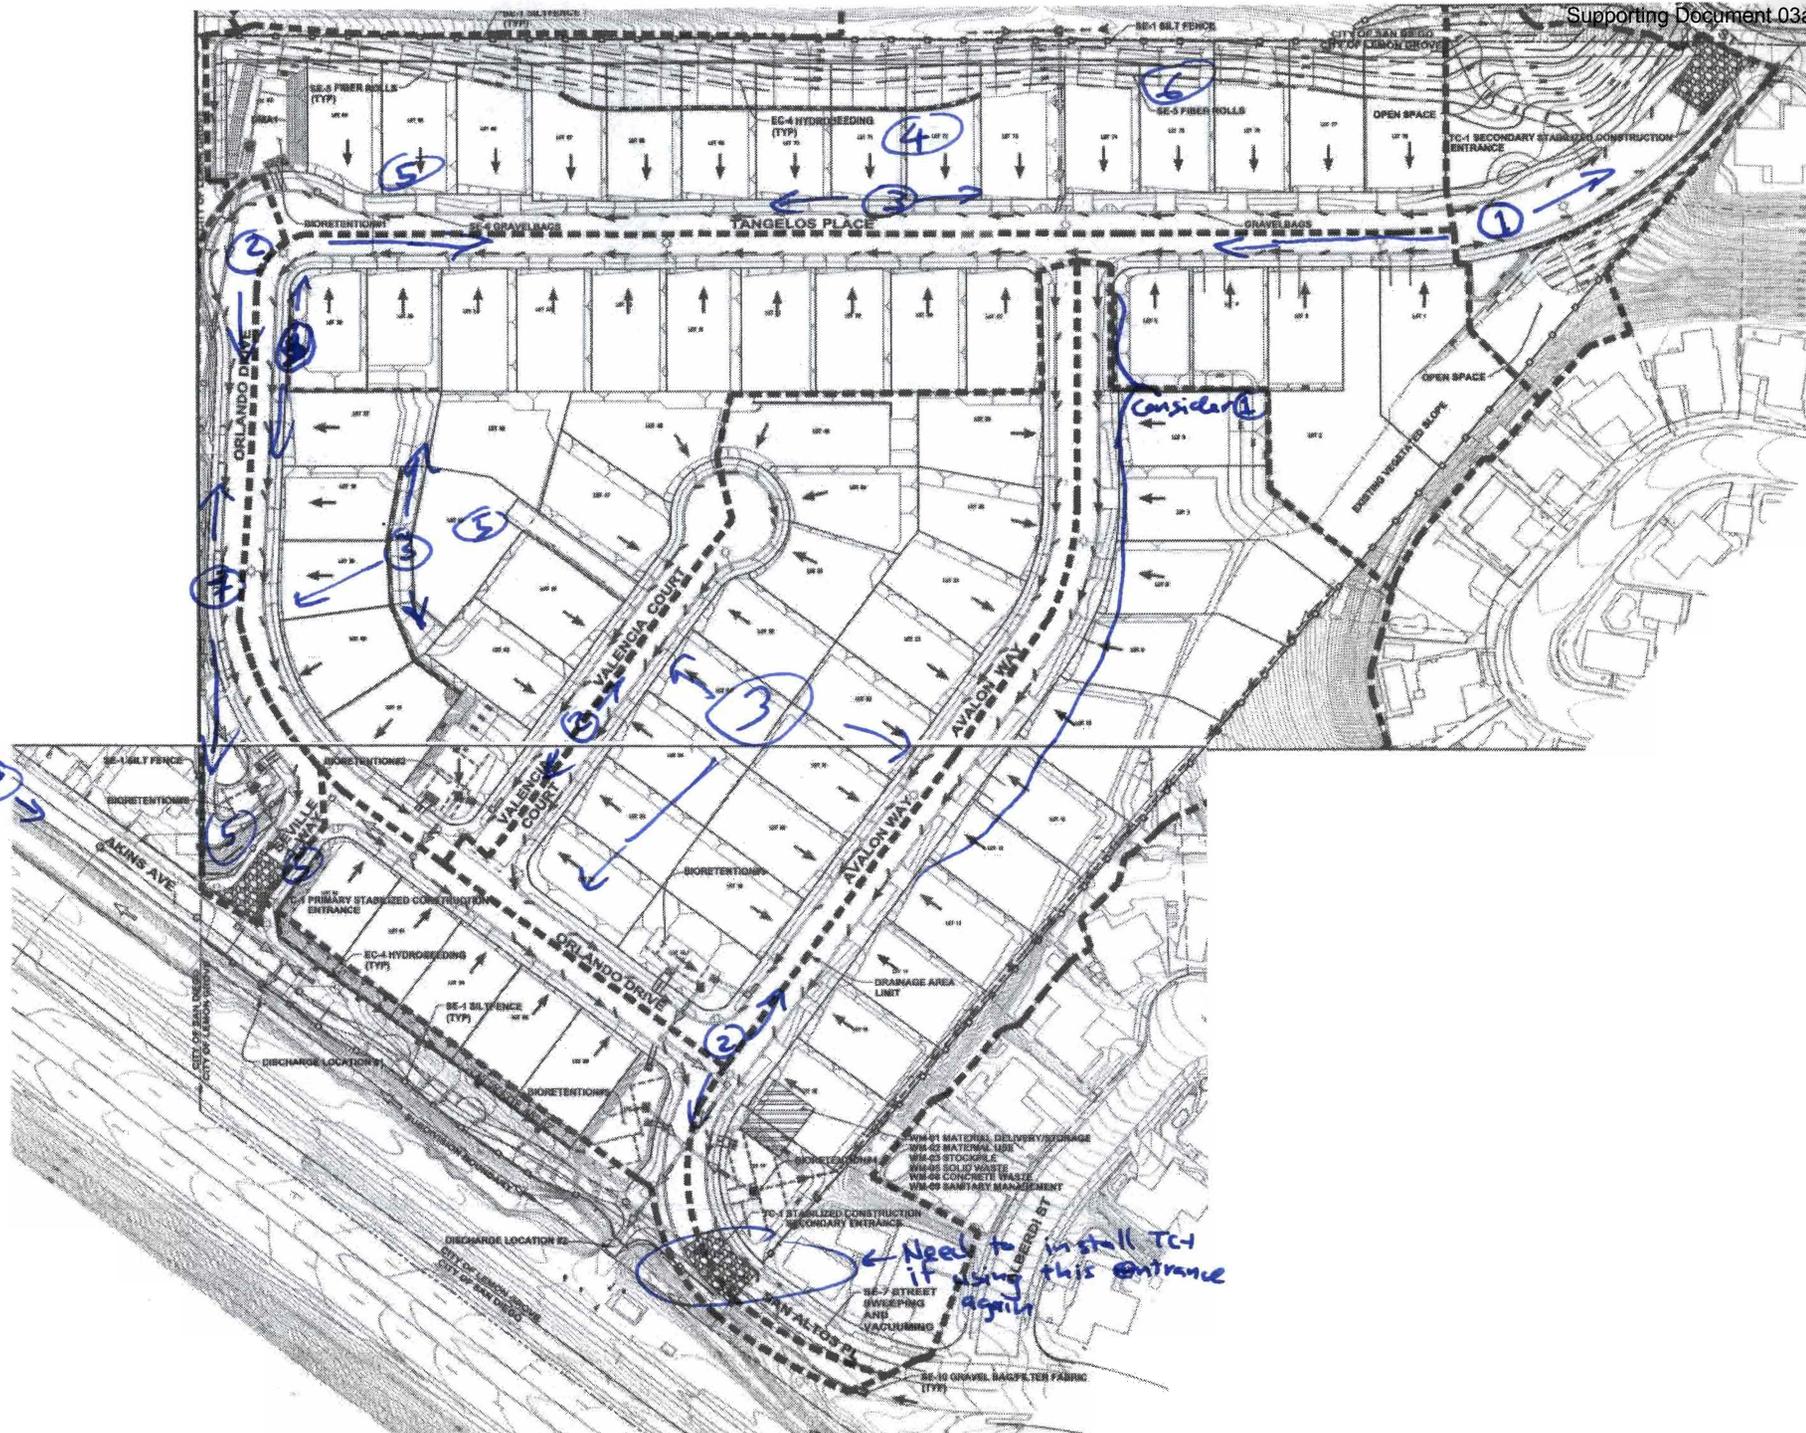
- ⑧ • Sweep road to remove sediment

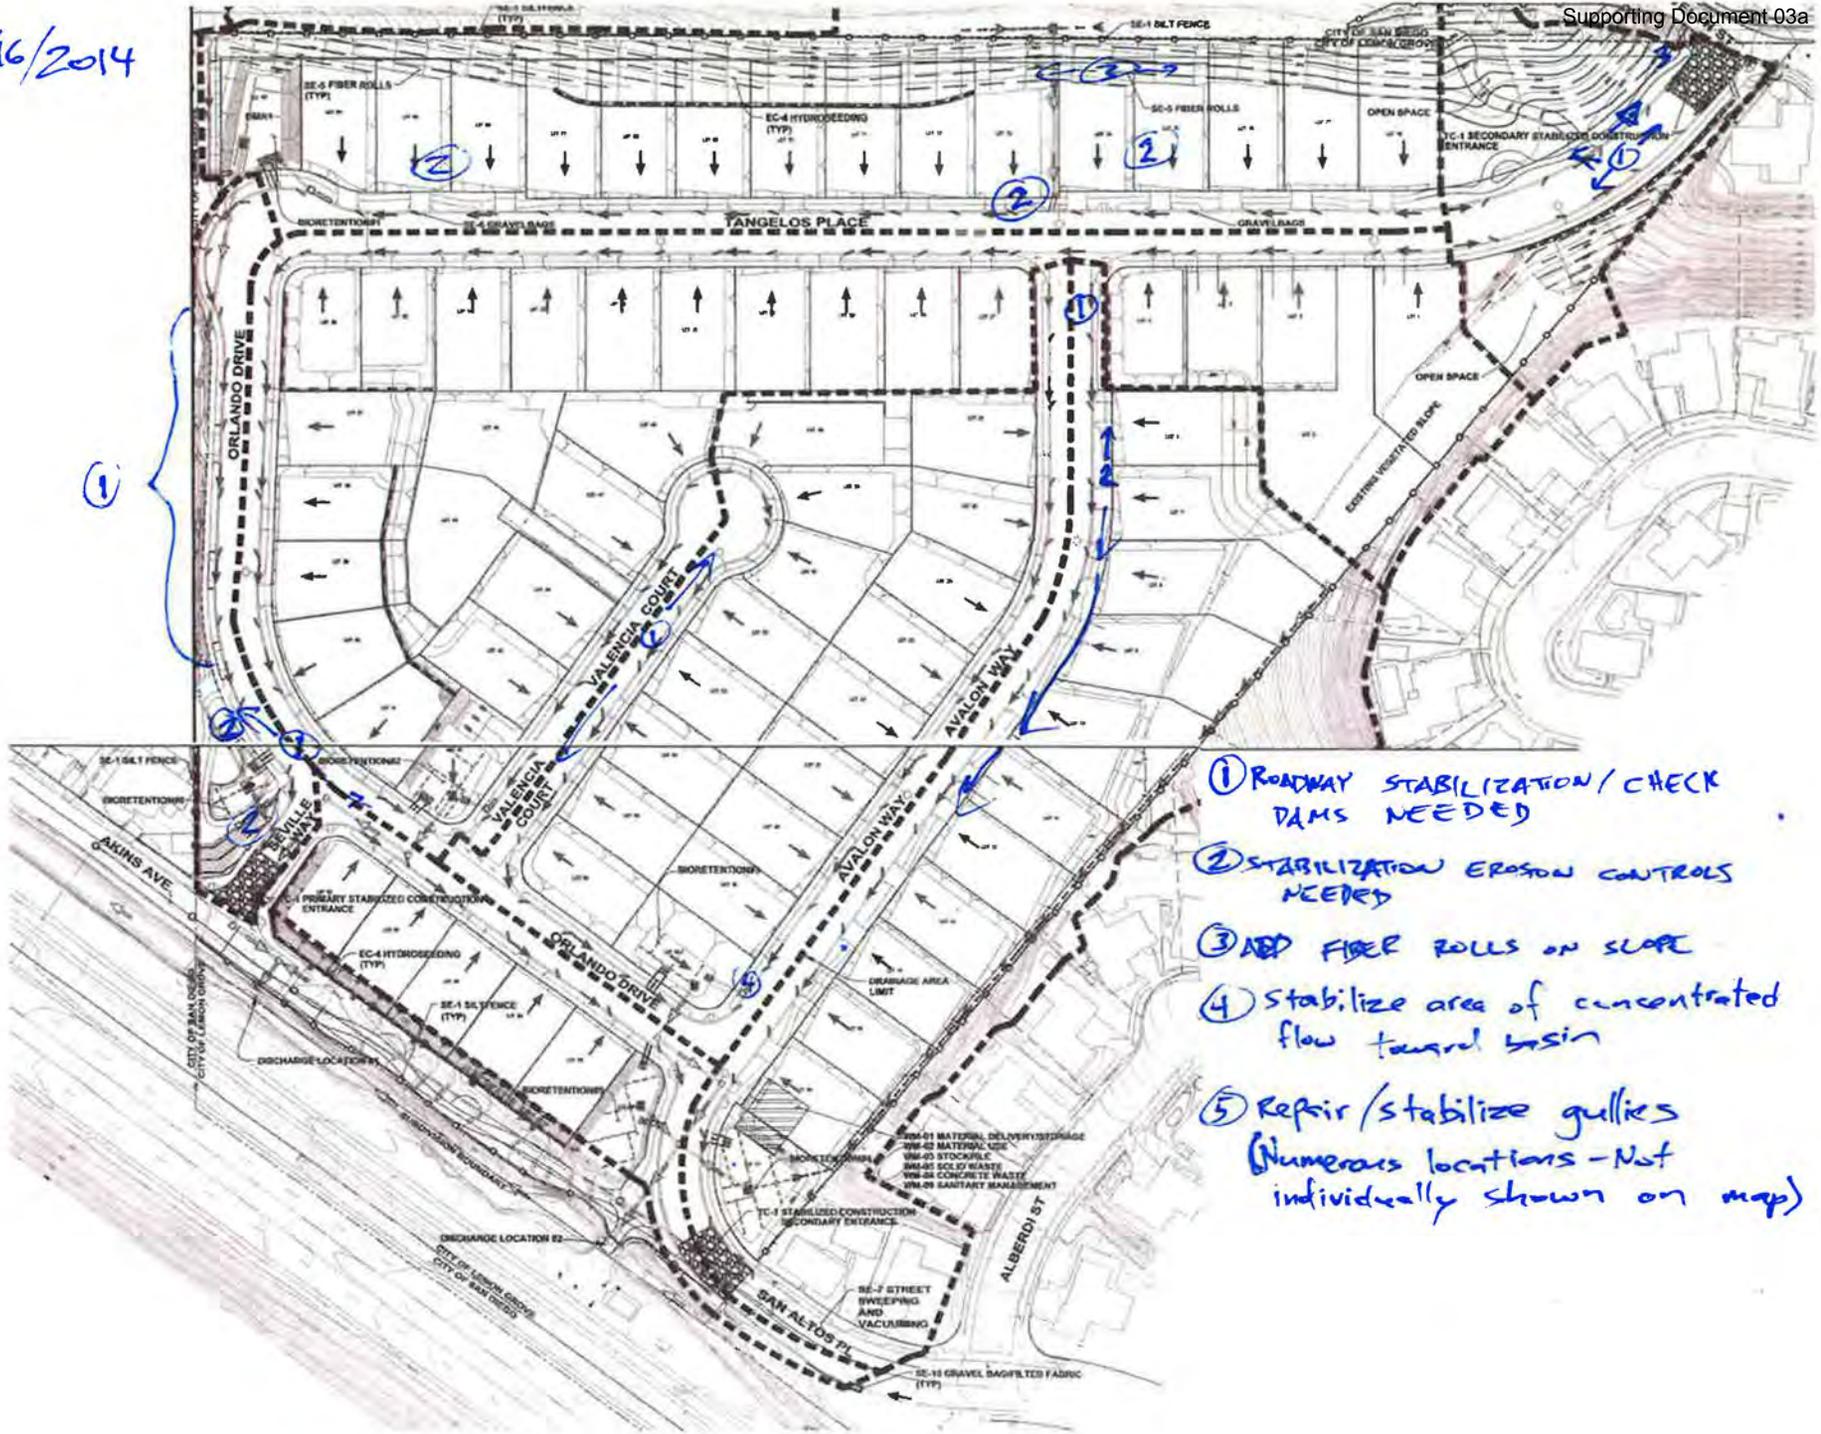
- ① ROADWAY STABILIZATION/CHECK DAMS NEEDED
- ② STABILIZATION EROSION CONTROLS NEEDED
- ③ ADD FIBER ROLLS ON SLOPE
- ④ Stabilize area of concentrated flow toward basin
- ⑤ Repair/stabilize gullies
(Numerous locations - Not individually shown on map)

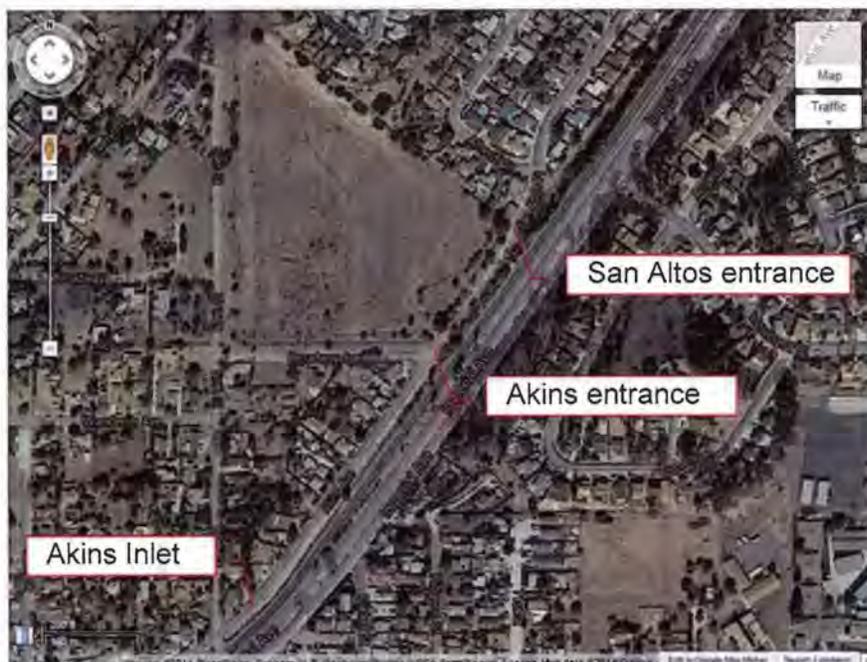
Figure 1. Observation Locations

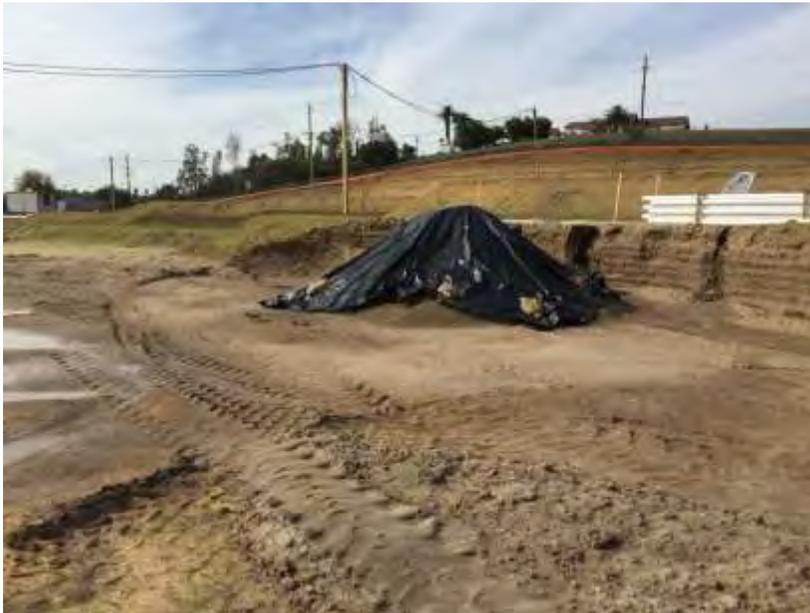
Facility: Valencia
Inspection Date: 12/15/2014

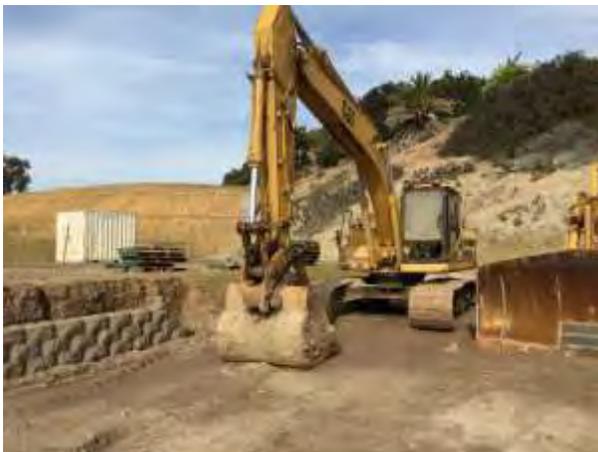
Photo 1 shows soil stockpile without adequate containment. Evidence of erosion and sediment transport along that base of the stockpile. Most stockpiles observed during inspection lacked adequate containment.

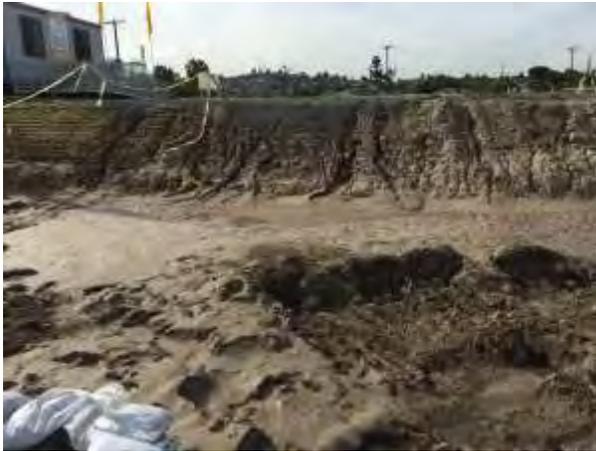
Facility: Valencia
Inspection Date: 12/15/2014

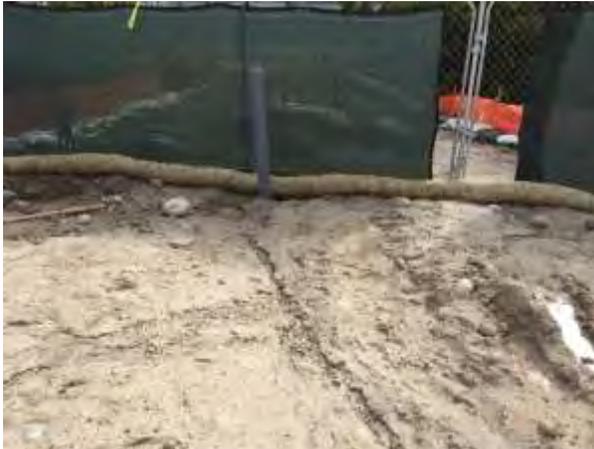
Facility: Valencia
Inspection Date: 12/15/2014

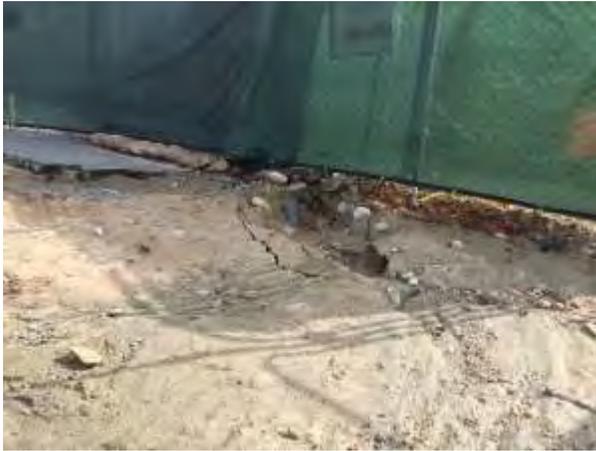
Facility: Valencia
Inspection Date: 12/15/2014

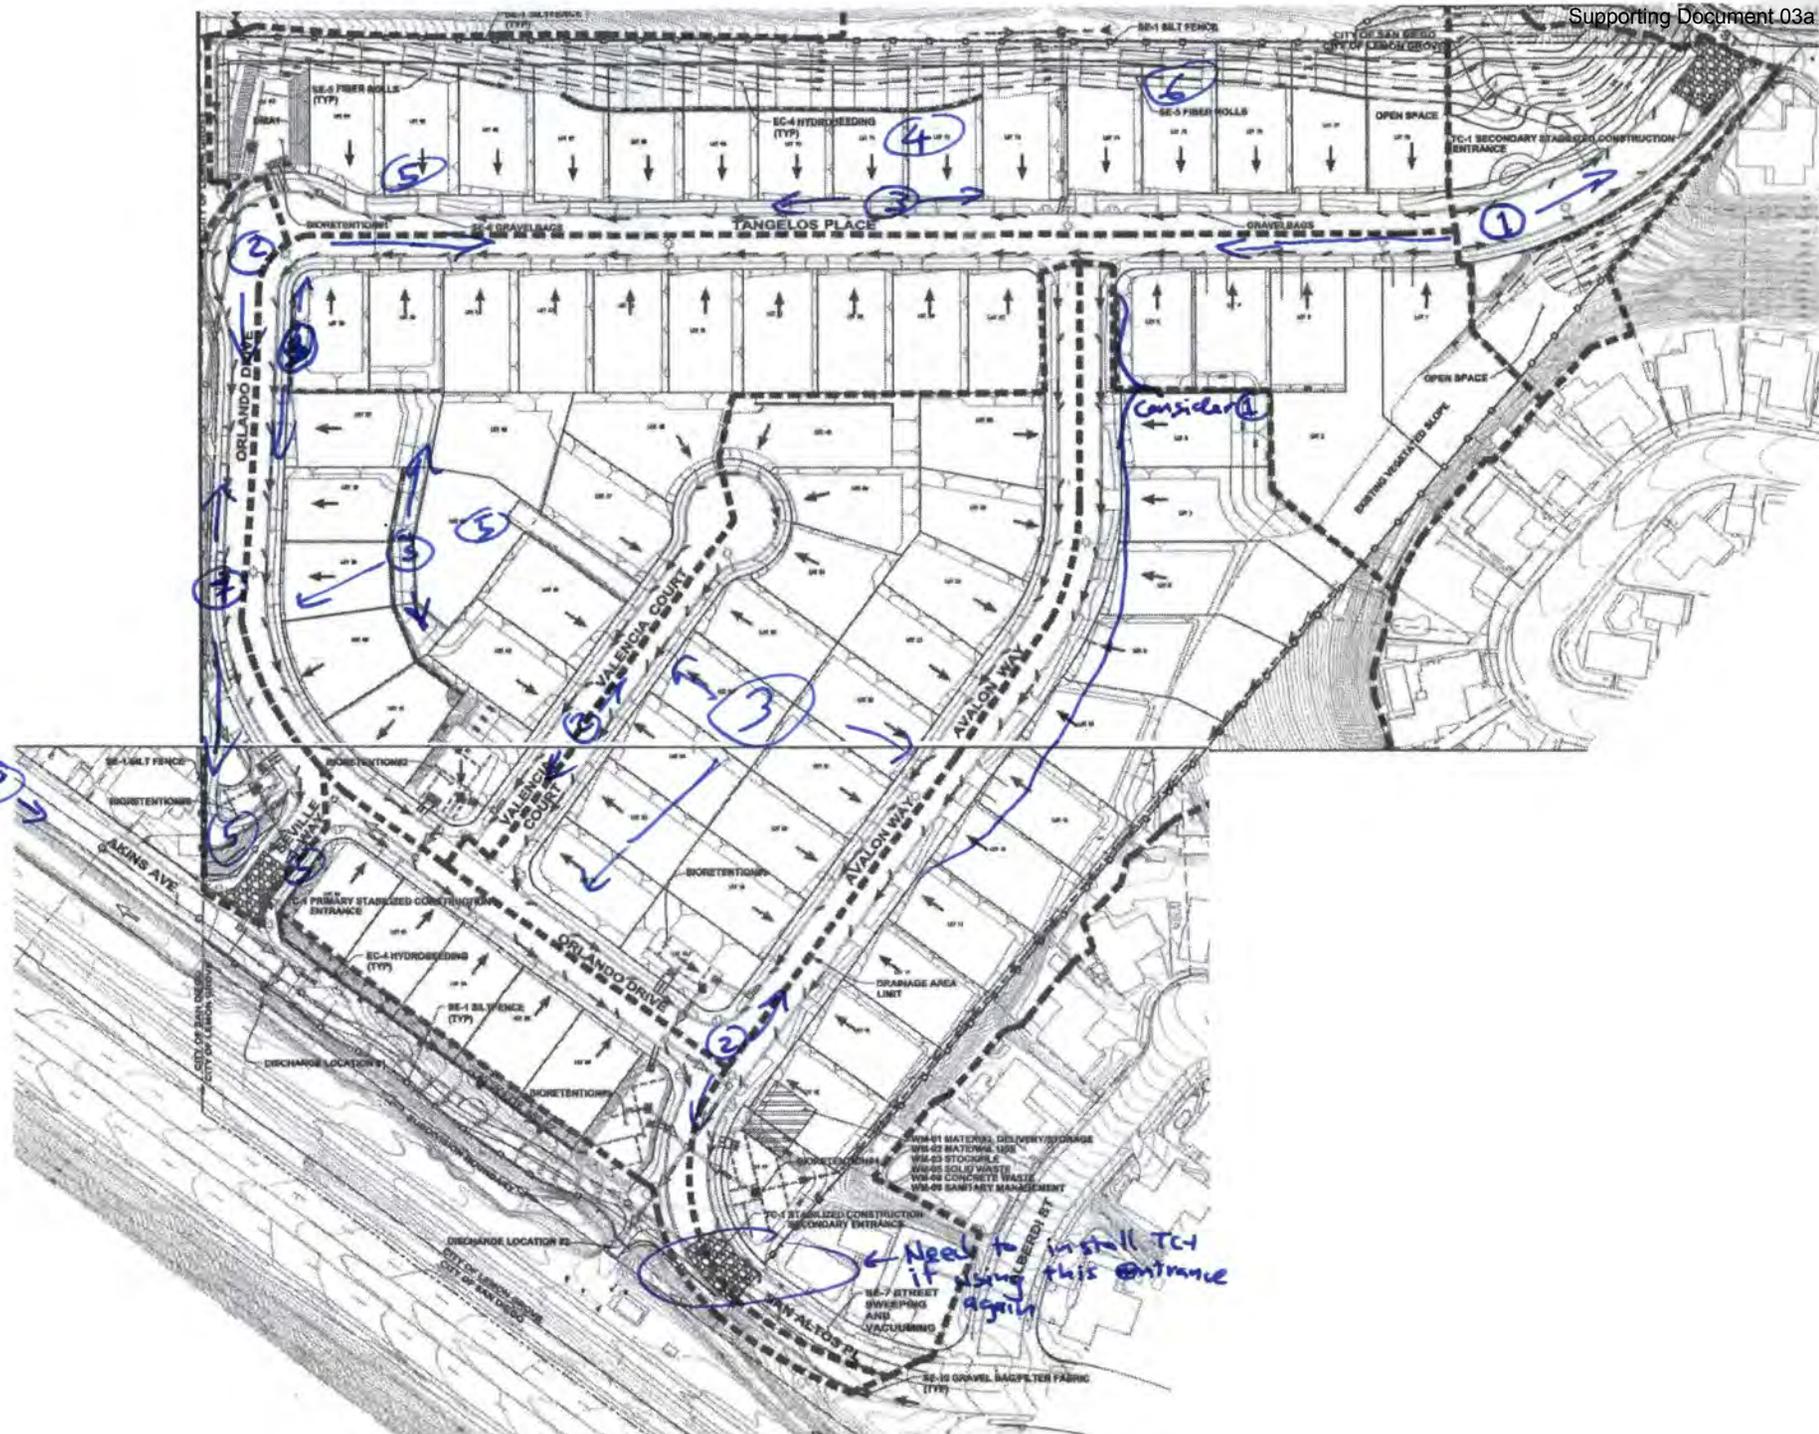
- ⑧ • Sweep road to remove sediment

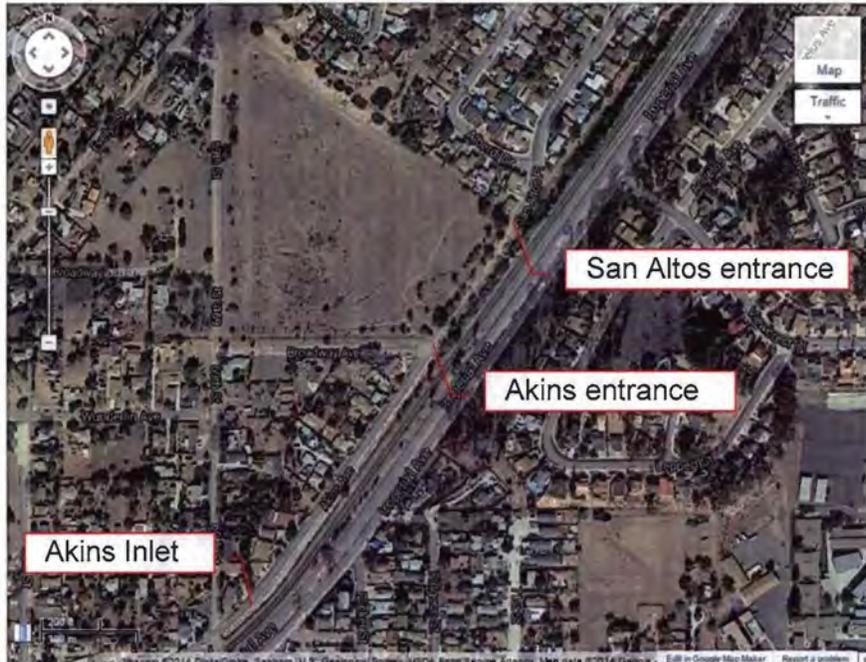
Figure 1. Map of Site and Immediate Vicinity
