Exhibit No. 1

State Water Resources Control Board

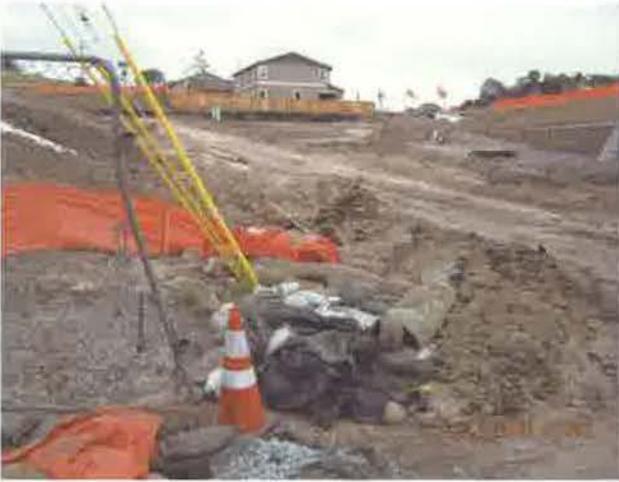
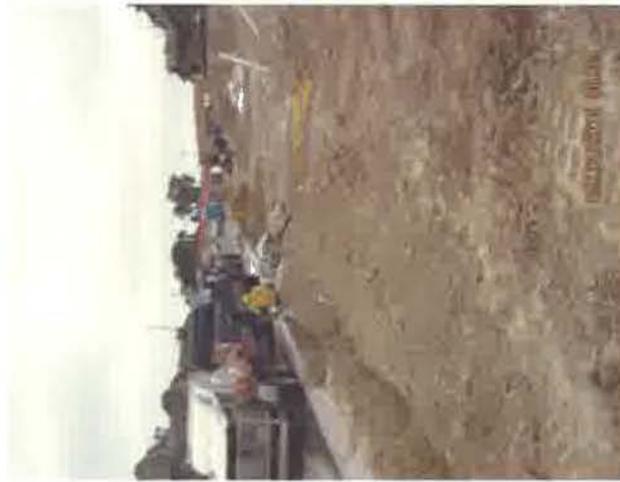
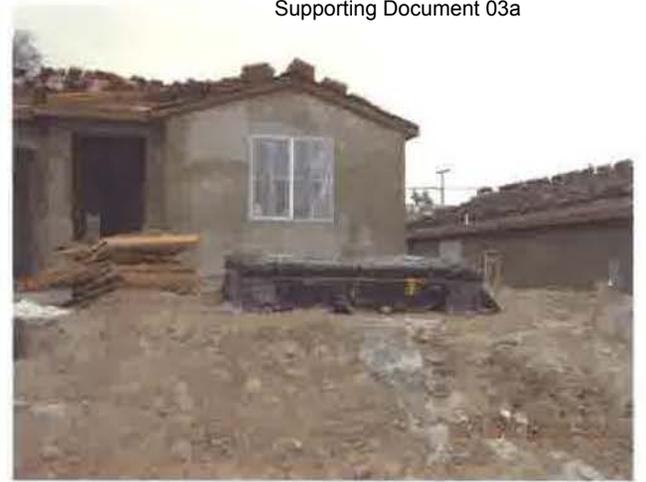
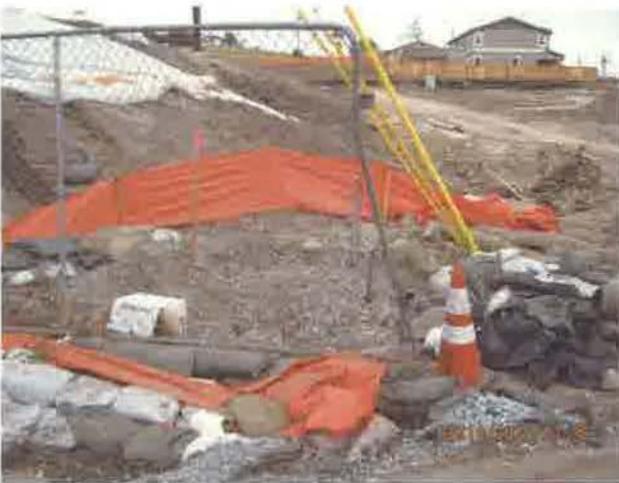
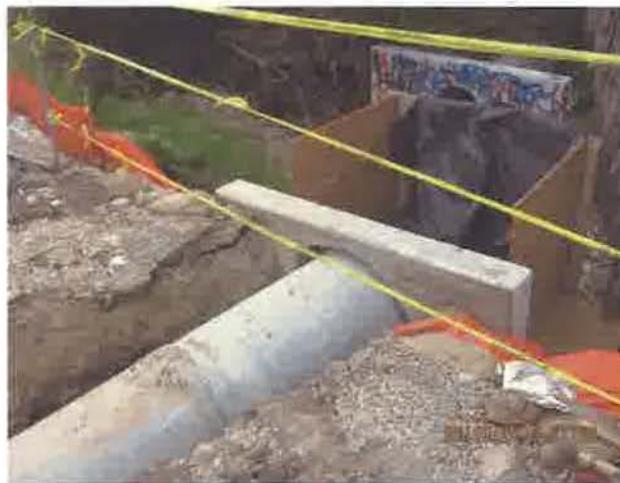
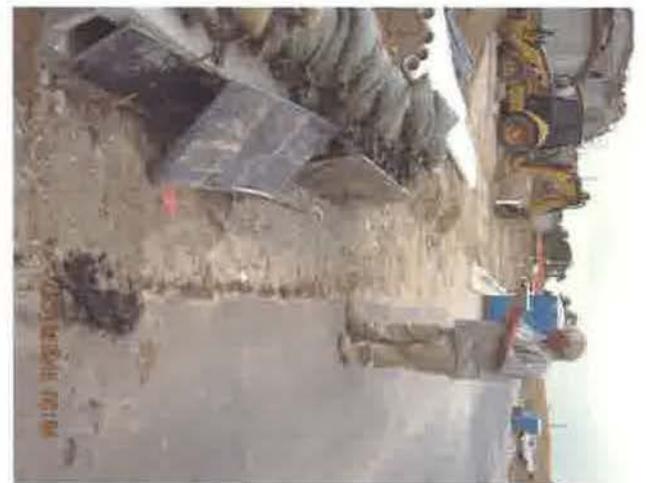
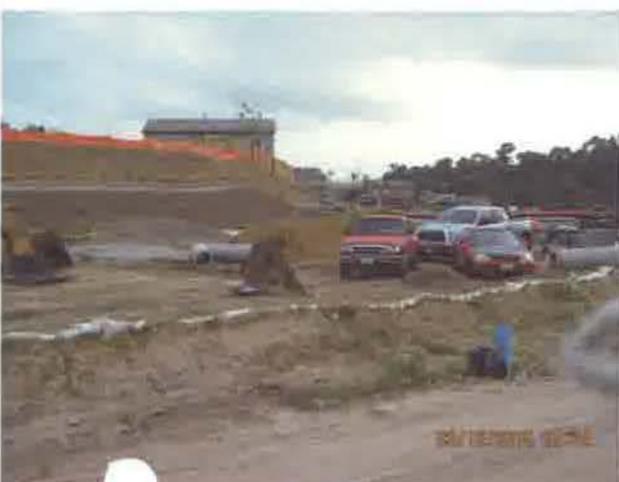
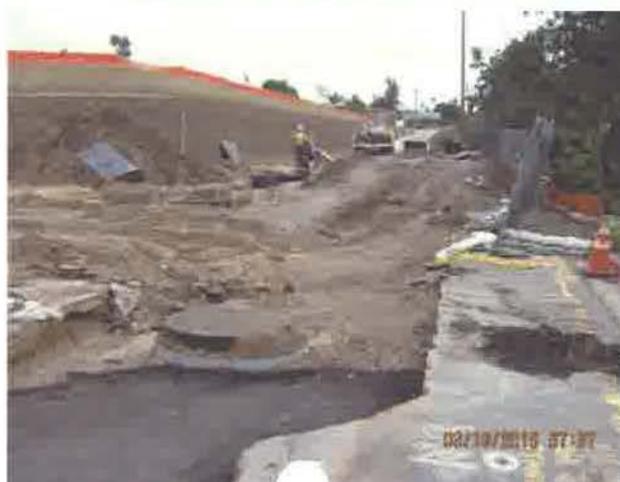
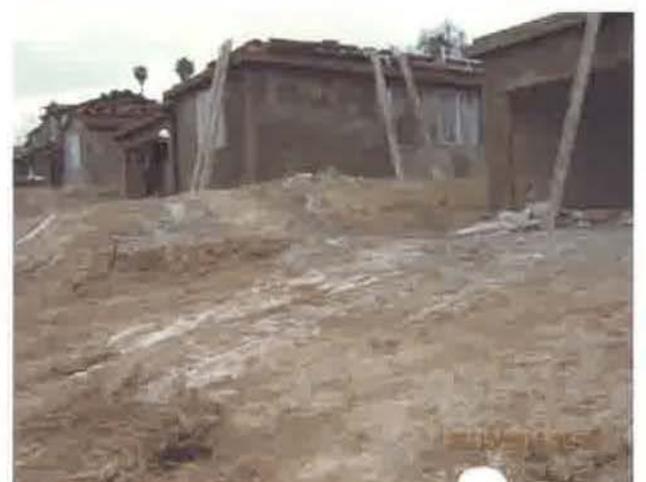
- ① IMPLEMENT ADEQUATE EROSION CONTROLS ON SLOPES & SIDEWALLS
- ② CLEAN UP CONCRETE WASTE OBSERVED AT MULTIPLE LOCATIONS AND ENSURE THAT ALL EMPLOYEES USE WASHOUTS PROPERLY
- ③ IMPLEMENT ADEQUATE TRACKING CONTROLS IN DRIVEWAY TRANSITIONS FROM PAVEMENT TO EXPOSED LOTS
- ④ PROTECT INLET AND SURROUNDING AREA OF EXPOSED SOIL
- ⑤ SWEEP/CLEAN SEDIMENT FROM ROADWAY
- ⑥ IMPLEMENT ADEQUATE EROSION CONTROLS ON EXPOSED INACTIVE AREAS
- ⑦ PROVIDE STABILIZATION AT INLETS TO BASINS
- ⑧ REPLACE/REFRESH STABILIZED CONSTRUCTION ENTRANCE
- ⑨ IMPLEMENT ADEQUATE PERIMETER CONTROL BMPs
- ⑩ ENSURE THAT DRIP PANS ARE PLACED UNDER VEHICLES WHEN NOT IN USE
- ⑪ PROVIDE SECONDARY CONTAINMENT FOR LIQUID STORAGE

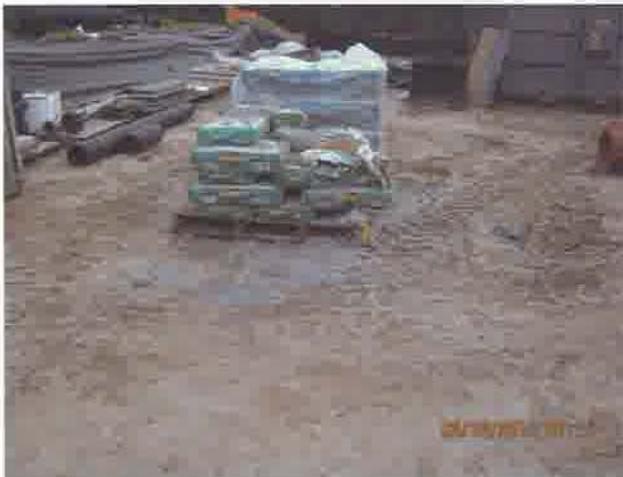
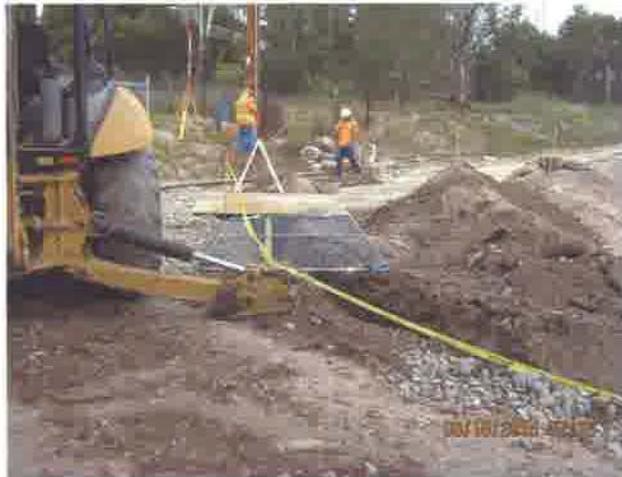
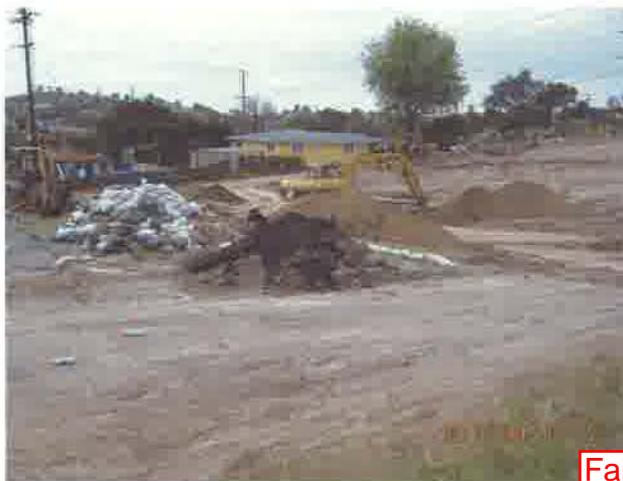
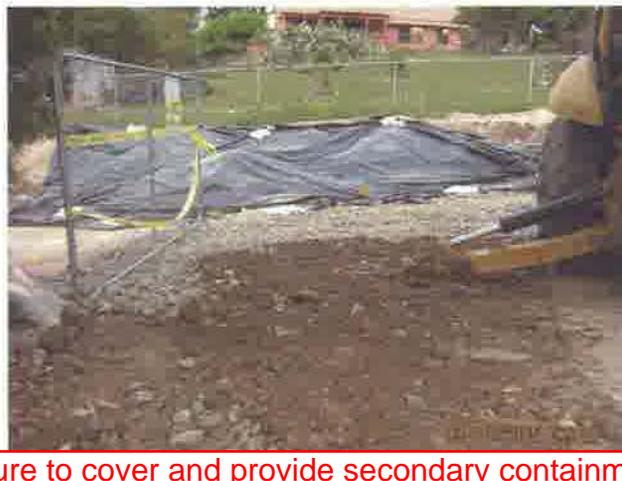
Failure to cover and provide secondary containment.

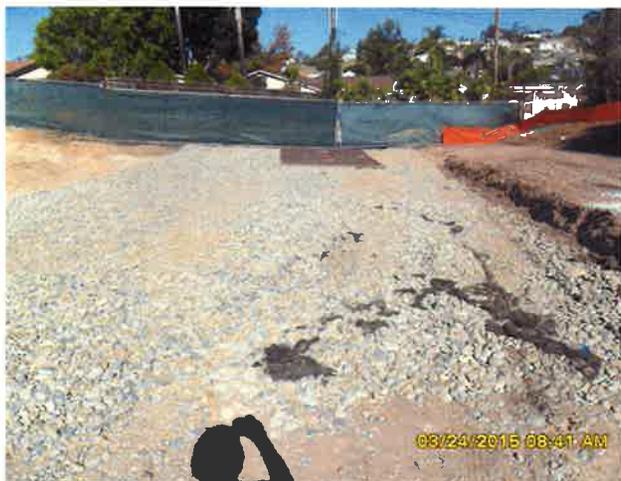
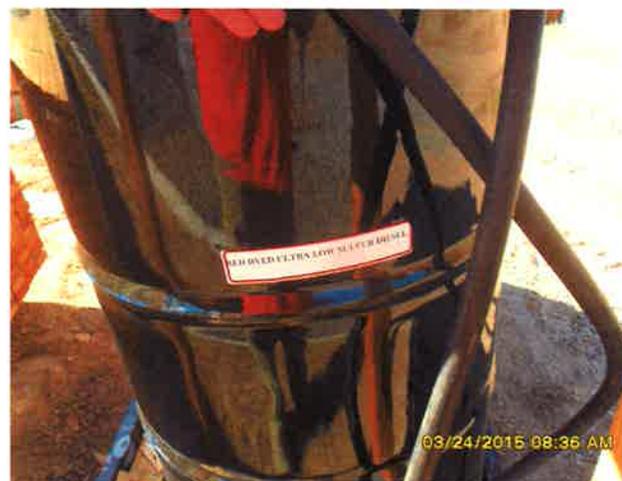
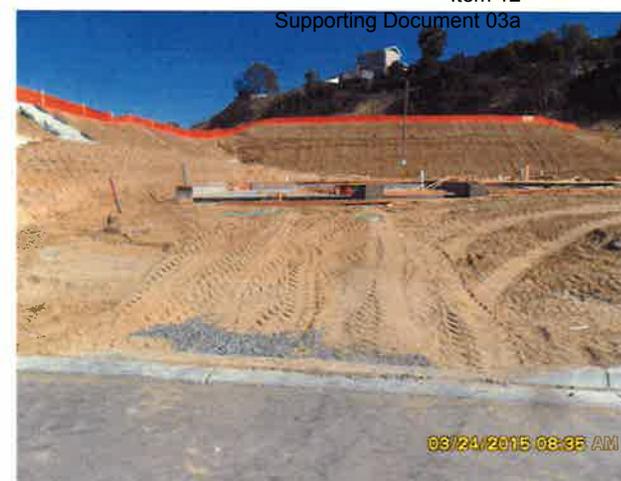
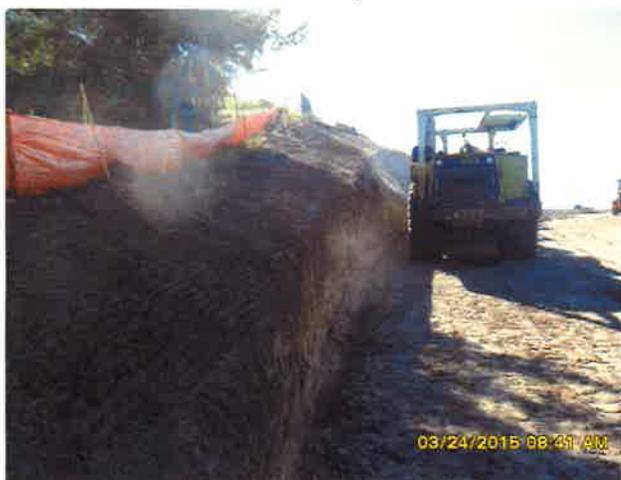
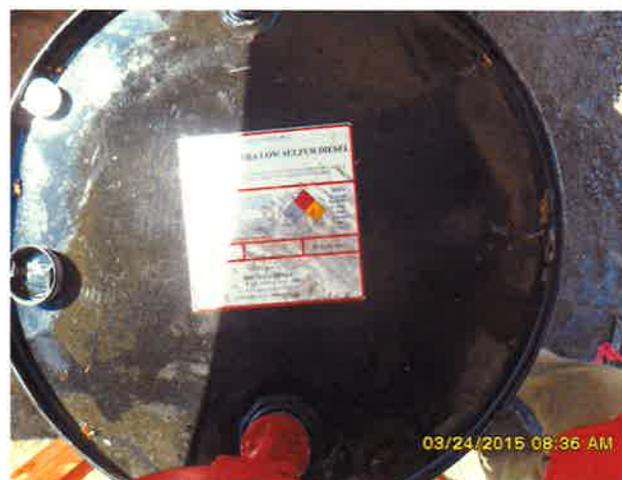
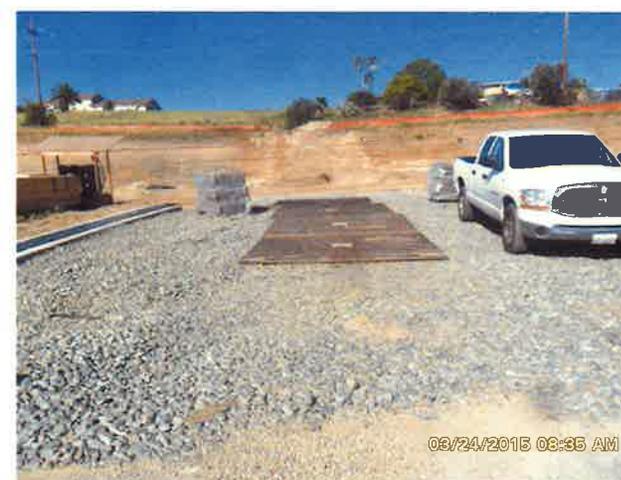
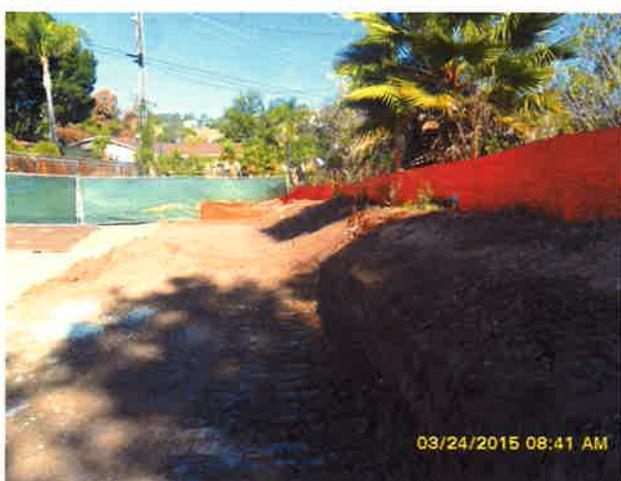
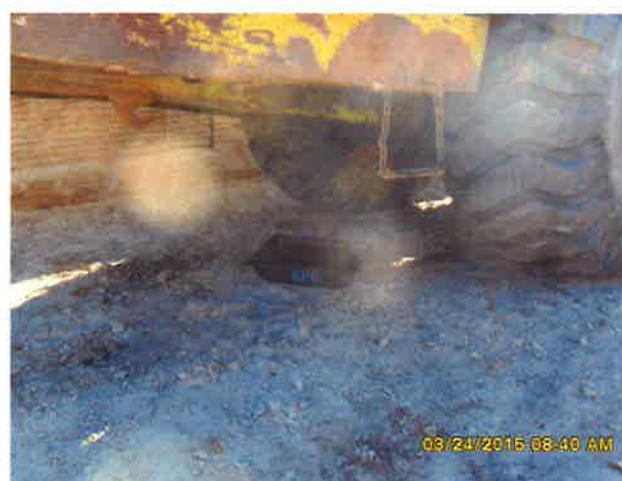
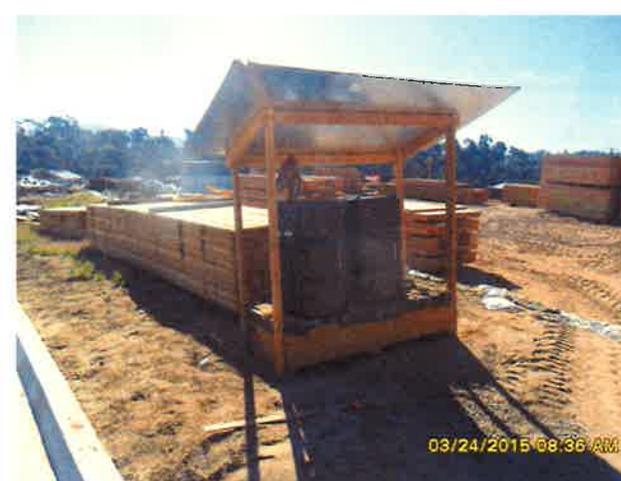
* Having deficiencies in your erosion control is a violation of the City of Lemon Grove's Grading Ordinance. A violation of the City's Grading Ordinance is a misdemeanor. Each separate day or portion thereof on which a violation exists or is allowed to exist shall constitute a separate offense punishable by the provisions of the Ordinance.

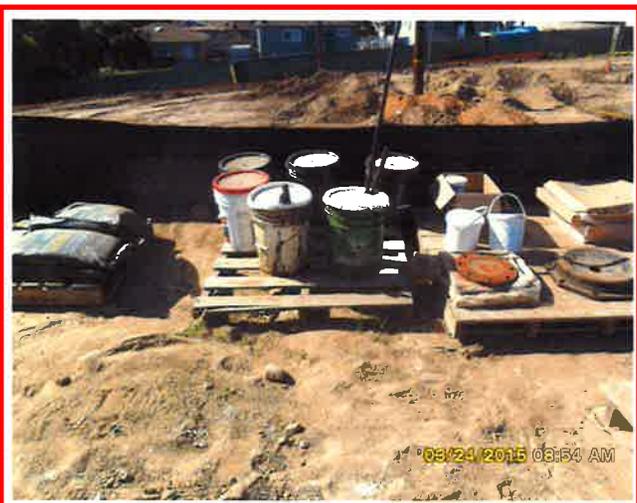
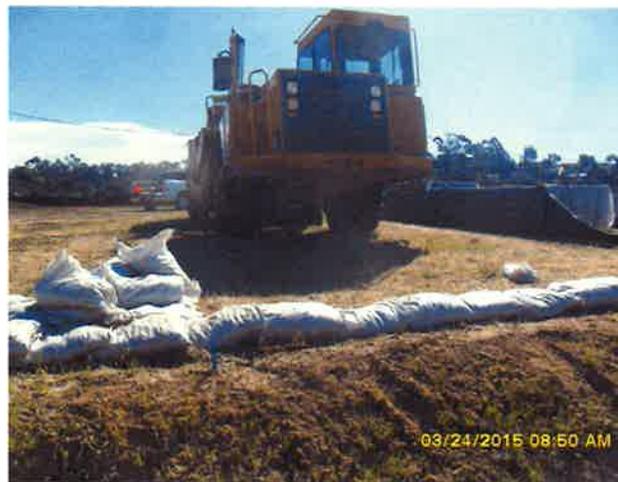
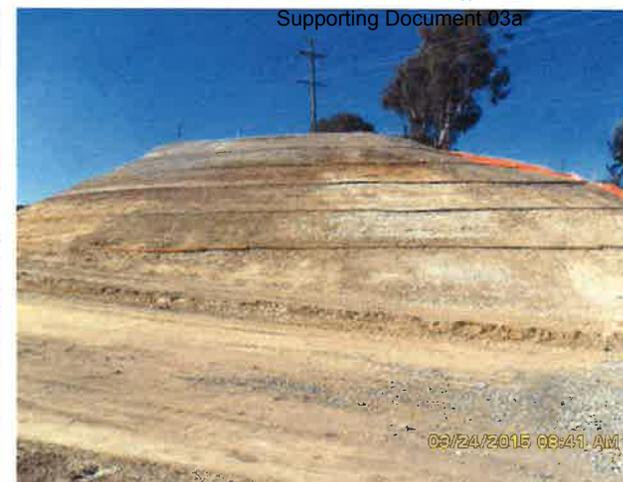
Failure to cover and provide secondary containment.

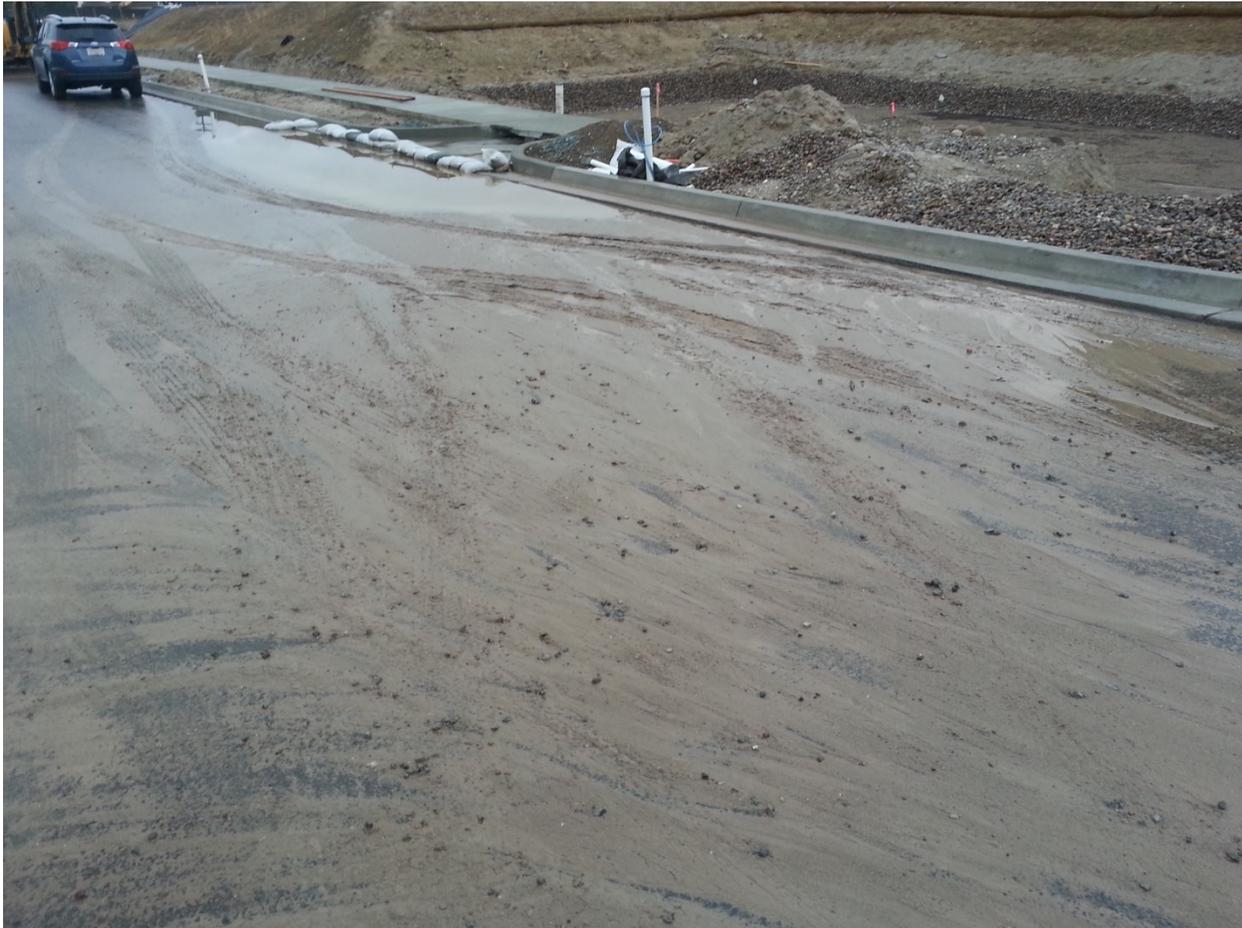
Photograph No. 1: 20150508_191716.jpg, taken by Frank Melbourn, San Diego Water Board

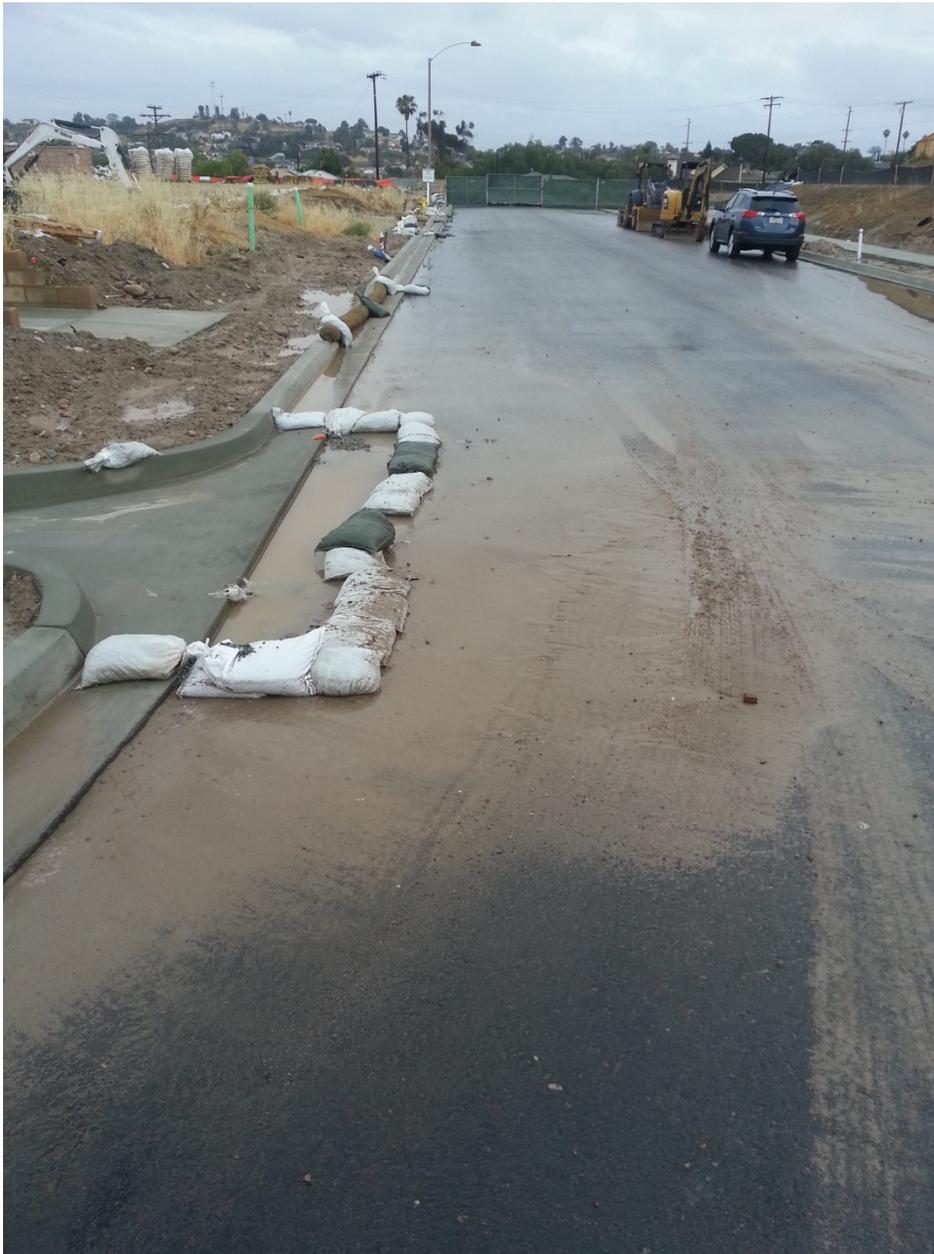
Photograph No. 2: 20150508_191734.jpg, taken by Frank Melbourn, San Diego Water Board
