## ERRATA SHEET

2 Notice of Hearing and Issuance of  
Complaint No. R9-2015-0110 for  
Administrative Civil Liability against  
San Altos Lemon Grove, LLC for violations  
of Order No. 2009-0009-DWQ

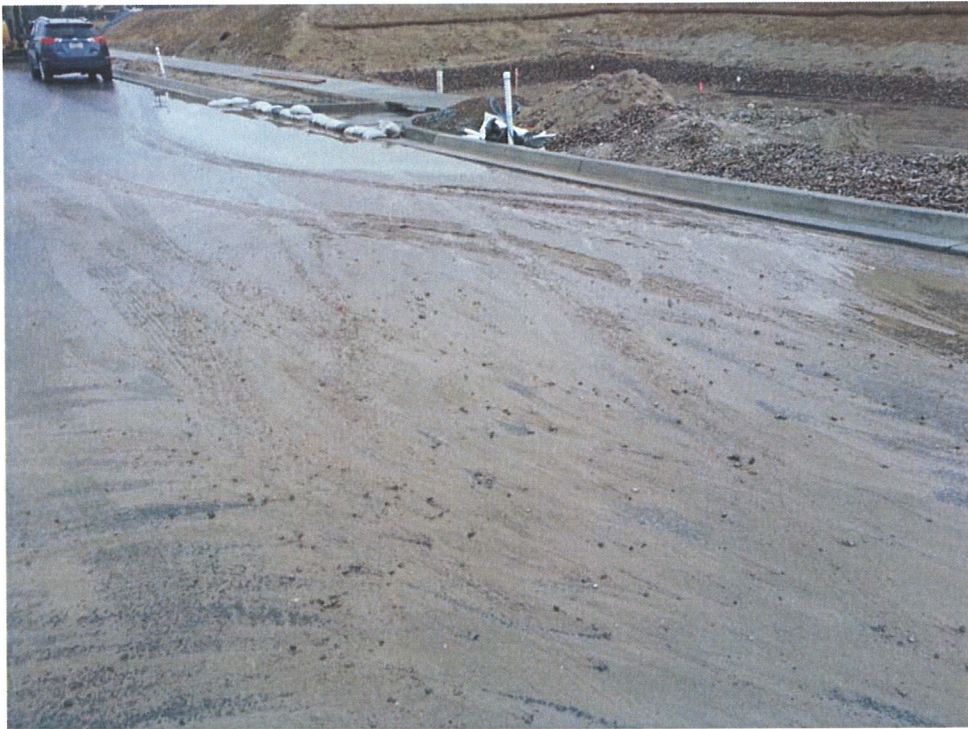
Sediment-laden water was discharged from the Site into Encanto Channel and Chollas Creek on December 4, 12, 17, 31, 2014, May 8, 2015, and September 15, 2015. See Figure 2. May 8, 2015, Sediment Discharge. The violations were noted in the following documents: City Stop Work Notice December 4, 2014 (Exhibit No. 3); City Administrative Citation December 15, 2014 (Exhibit No. 7), and San Diego Water Board Inspection Report December 15, 2014 (Exhibit No. 8); City Contractor Report December 17, 2014 (Exhibit No. 10); City Contractor Report December 31, 2014 (Exhibit No. 12); in photographs and text in San Diego Water Board Inspection Report May 8, 2015 (Exhibit No. 18), and City Administrative Citation September 15, 2015 (Exhibit No. 21). The discharges into Encanto Channel and Chollas Creek were unauthorized and a violation of the Construction Storm Water Permit section III.B. because the Discharger failed to reduce or eliminate the pollutants in the storm water runoff prior to discharge (i.e., to implement BMPs that achieve BAT and BCT).

**Figure 2. May 8, 2015, Sediment Discharge.** View of sediment in street (Orlando Drive) after storm event. Photograph taken by Frank Melbourne, San Diego Water Board. 20150508\_191716.jpg

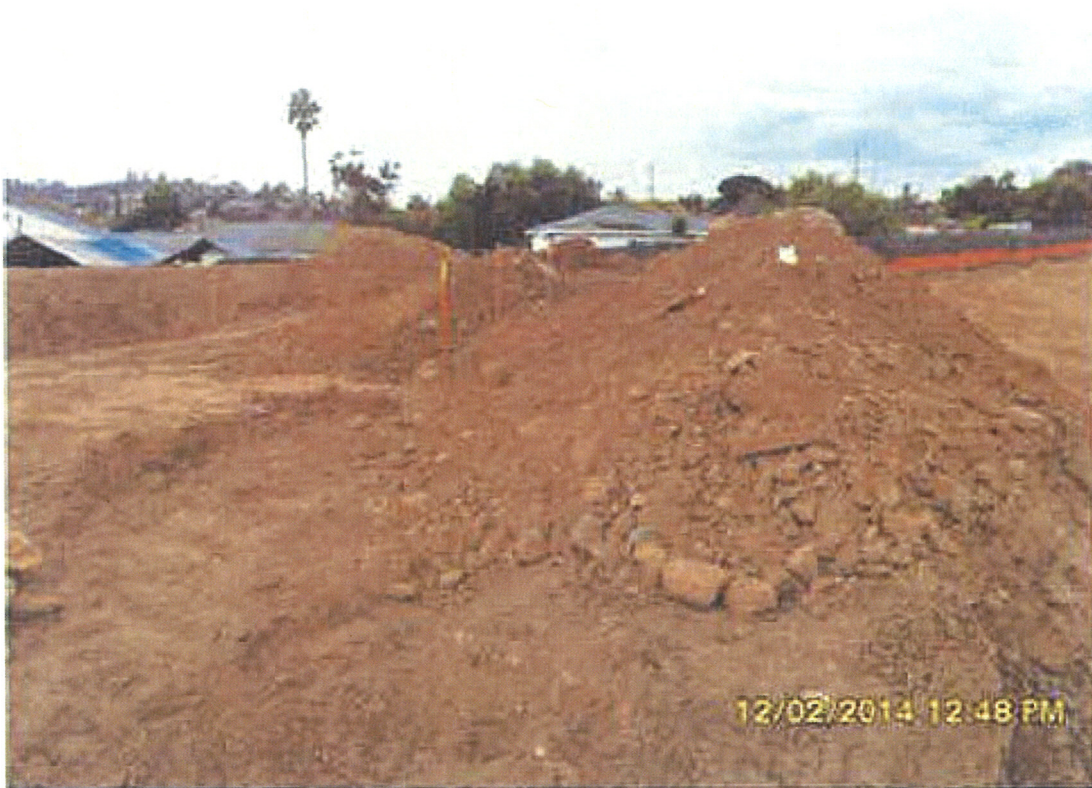
The Discharger was in violation of section B.1.b. for 10 days; from December 2 through 8, 2014, December 15, 2014, May 13, 2015, and September 15, 2015. See Figure 3. Failure to implement material stockpile BMPs. The violations were noted in the following documents: City Stop Work Notice December 2, 2014 (Exhibit No. 2); City Stop Work Notice December 4, 2014 (Exhibit No. 3); City Inspection Report December 8, 2014 (Exhibit No. 4); San Diego Water Board Inspection Report December 15, 2014 (Exhibit No. 8); San Diego Water Board Inspection Report May 13, 2015 (Exhibit No. 19), and City Inspection Report September 15, 2015 (Exhibit No. 22).

**Figure 3. Failure to implement material stockpile BMPs.** Photograph taken by the City of Lemon Grove on December 2, 2014.

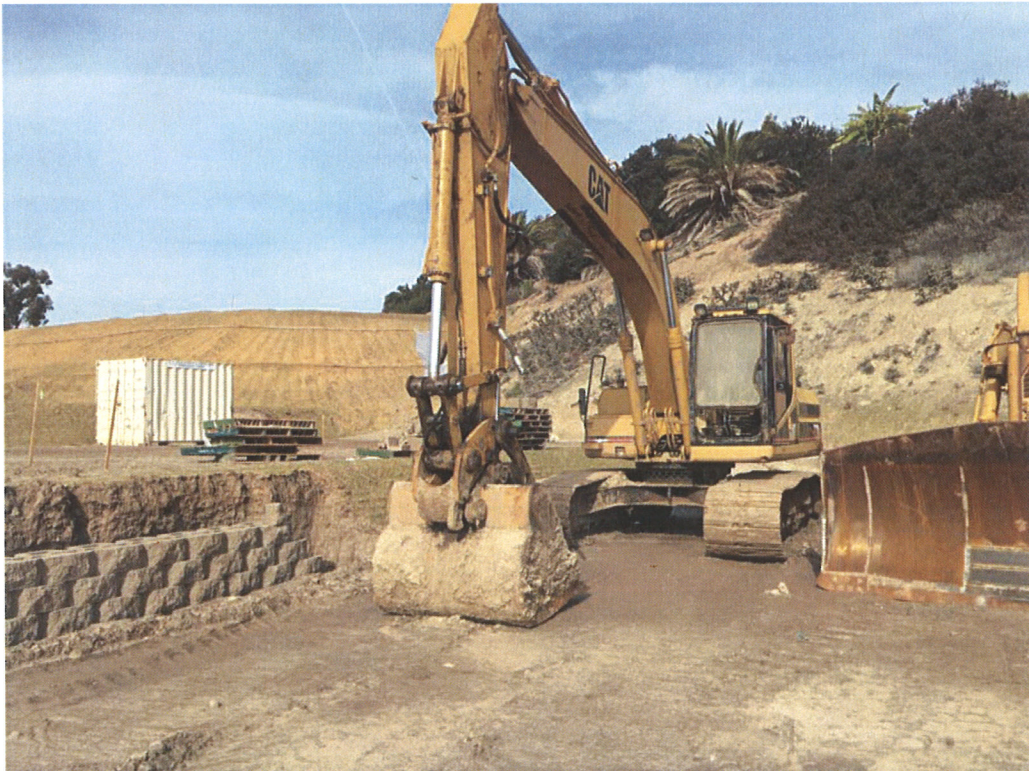
Pursuant to section B.3.a. in Attachment D to the Construction Storm Water Permit, dischargers are required to “[p]revent oil, grease, or fuel to leak in to the ground, storm drains or surface waters.” The Discharger was in violation of section B.3.a. for two days: December 15, 2014; and May 13, 2015. See Figure 4. Failure to have vehicle fluid leak protection. The violations were noted in the following documents: San Diego Water Board Inspection Report December 15, 2014 (Exhibit No. 8); and San Diego Water Board Inspection Report May 13, 2015 (Exhibit No. 19).

**Figure 4. Failure to have vehicle fluid leak protection.** Photograph taken by Wayne Chiu, San Diego Water Board on December 15, 2014, of heavy equipment without vehicle fluid leak protection. IMG\_5064.jpg

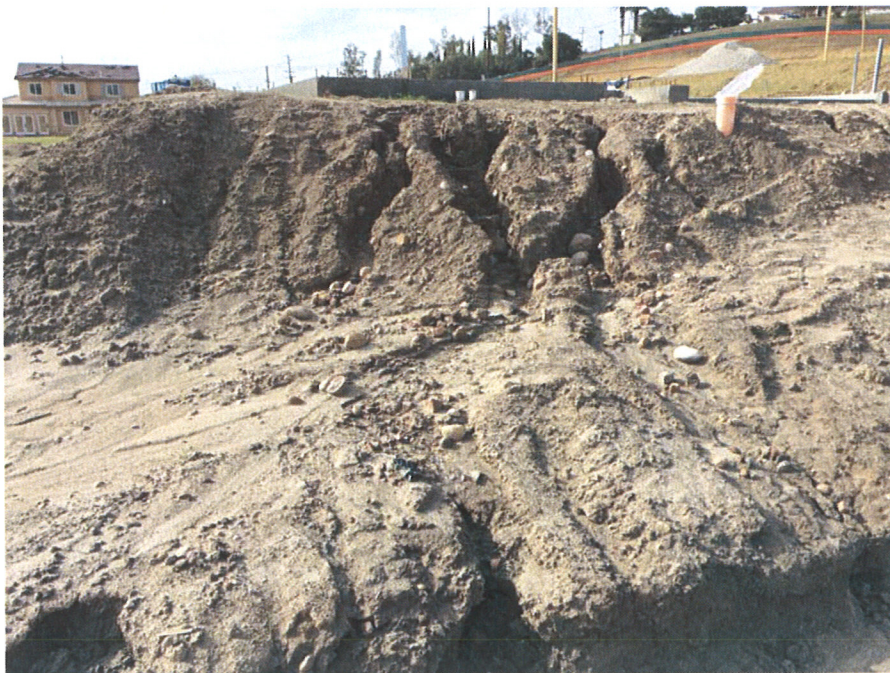
**Figure 5. Failure to implement erosion control BMPs on inactive areas.**

Photograph taken by Wayne Chiu, San Diego Water Board on December 15, 2014, of housing pad without erosion control BMPs. Note the erosion rills. IMG\_5061.jpg

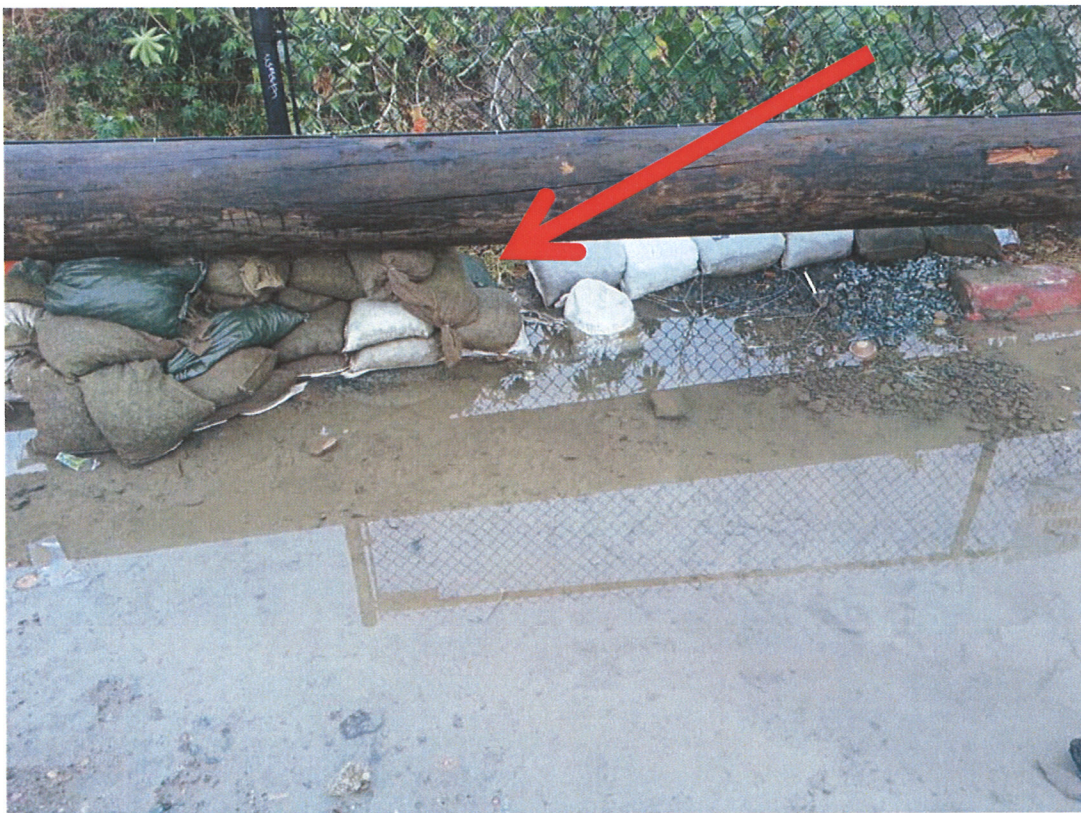
Pursuant to section E.1. in Attachment D to the Construction Storm Water Permit, dischargers are required to “*establish and maintain effective perimeter controls and stabilize all construction entrances and exits to sufficiently control erosion and sediment discharges from the site.*” The Discharger was in violation of section E.1. for 14 days: 5 days (December 4 through 8, 2014); 2 days (December 15 through 16, 2014); 6 days (May 8 through 13, 2015), and 1 day (September 15, 2015). See Figure 6. Failure to implement perimeter sediment control BMPs. The violations were noted in the following documents: in photographs and text in City Stop Work Notice December 4, 2014 (Exhibit No. 3); City Inspection Report December 8, 2014 (Exhibit No. 4); San Diego Water Board Inspection Report December 15, 2014 (Exhibit No. 8); City Inspection Report December 16, 2014 (Exhibit No. 9); San Diego Water Board Inspection Report May 8, 2015 (Exhibit No. 18); San Diego Water Board Inspection Report May 13, 2015 (Exhibit No. 19), and City Inspection Report September 15, 2015 (Exhibit No. 21).

**Figure 6. Failure to implement perimeter sediment control BMPs.** Photograph taken by Frank Melbourn, San Diego Water Board on May 8, 2015, of gap (identified by red arrow) in perimeter sediment control BMPs that resulted in sediment discharge to Encanto Channel. 20150508\_192234.jpg

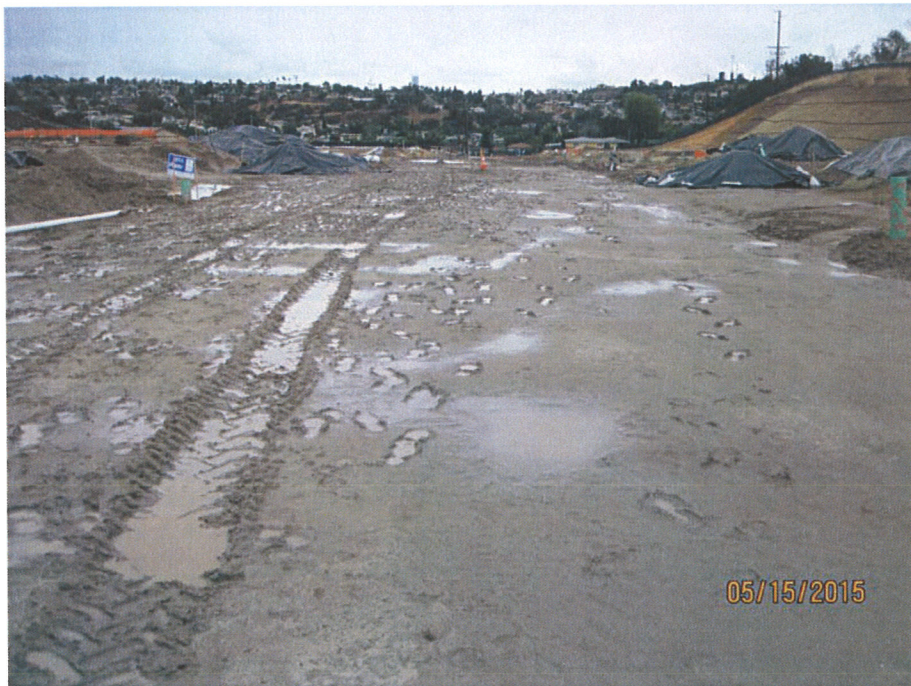
Pursuant to section E.3. in Attachment D to the Construction Storm Water Permit, dischargers are required to *"implement appropriate erosion control BMPs (runoff control and soil stabilization) in conjunction with sediment control BMPs for areas under active construction."* The Discharger was in violation of section E.3. for 22 days: 8 days (December 1 through 8, 2014); 2 days (December 15 through 16, 2014); 1 day (January 6, 2015); 2 days (March 23 through 24, 2015); 8 days (May 8 through 15, 2015), and 1 day (September 15, 2015). See Figure 7. Lack of erosion control BMPs in active areas. The violations were noted in the following documents: in photographs and text in City Stop Work Notice December 2, 2014 (Exhibit No. 2); City Stop Work Notice December 4, 2014 (Exhibit No. 3); in photograph in City Inspection Report December 8, 2014 (Exhibit No. 4); San Diego Water Board Inspection Report December 15, 2014 (Exhibit No. 8); City Inspection Report December 16, 2014 (Exhibit No. 9); City Contractor Report January 16, 2015 (Exhibit No. 24); in photograph in City Administrative Citation March 24, 2015 (Exhibit No. 16); in photograph in San Diego Water Board Inspection Report May 8, 2015 (Exhibit No. 18); San Diego Water Board Inspection Report May 13, 2015 (Exhibit No. 19); San Diego Water Board Inspection Report May 15, 2015 (Exhibit No. 20), and City Inspection Report September 15, 2015 (Exhibit No. 22).

**Figure 7. Lack of erosion control BMPs in active areas.** Photograph on May 15, 2015, of muddy thoroughfare (Tangelos Place) lacking erosion control BMPs after rain event. Photograph taken by Frank Melbourn, San Diego Water Board.  
IMG\_0354.jpg

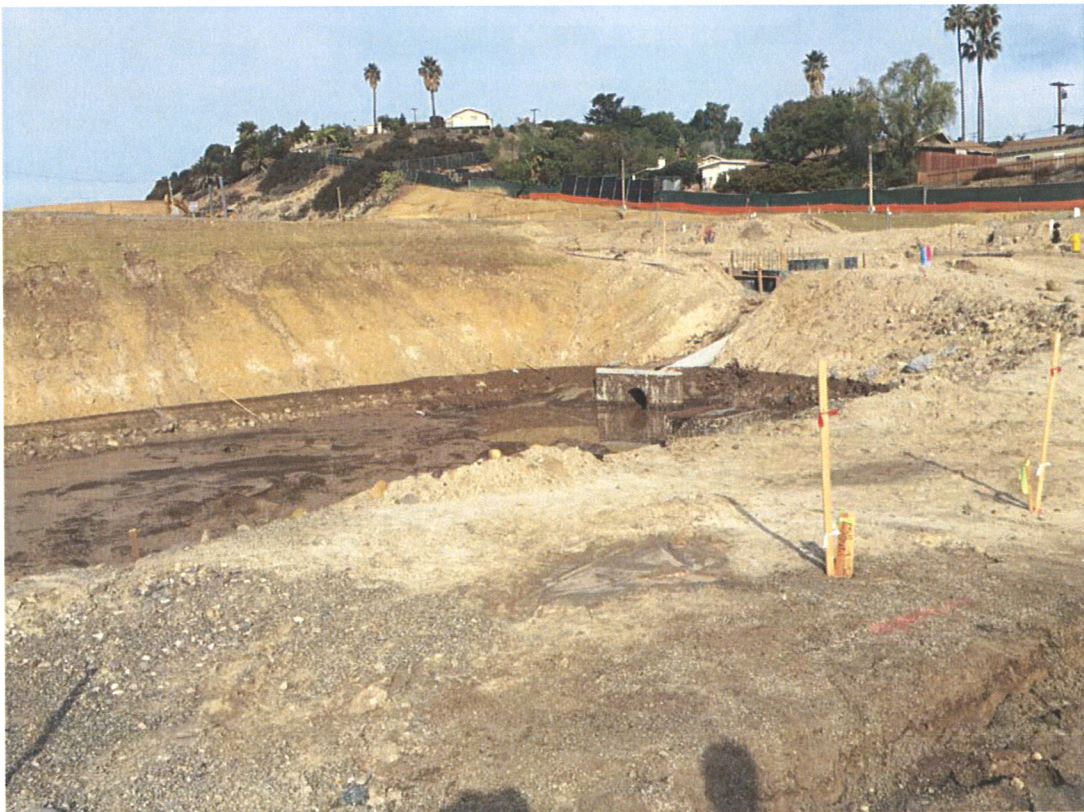
Pursuant to section E.4. in Attachment D to the Construction Storm Water Permit, dischargers are required to “*apply linear sediment controls along toe of slope, face of the slope, and at the grade breaks of exposed slopes to comply with the sheet flow lengths in accordance with Table 1.*” The Discharger was in violation of section E.4. for nine days: 2 days (December 15 through 16, 2014); 6 days (May 8 through 13, 2015), and 1 day (September 15, 2015). See Figure 8. Failure to apply linear sediment controls. The violations were noted in the following documents: San Diego Water Board Inspection Report December 15, 2014 (Exhibit No. 8); City Inspection Report December 16, 2014 (Exhibit No. 9); San Diego Water Board Inspection Report May 8, 2015 (Exhibit No. 18); San Diego Water Board Inspection Report May 13, 2015 (Exhibit No. 19), and City Inspection Report September 15, 2015 (Exhibit No. 22).

**Figure 8. Failure to apply linear sediment controls.** Photograph taken by Wayne Chiu, San Diego Water Board, on December 15, 2014, depicting the lack of linear sediment controls on a slope. IMG\_5035.jpg

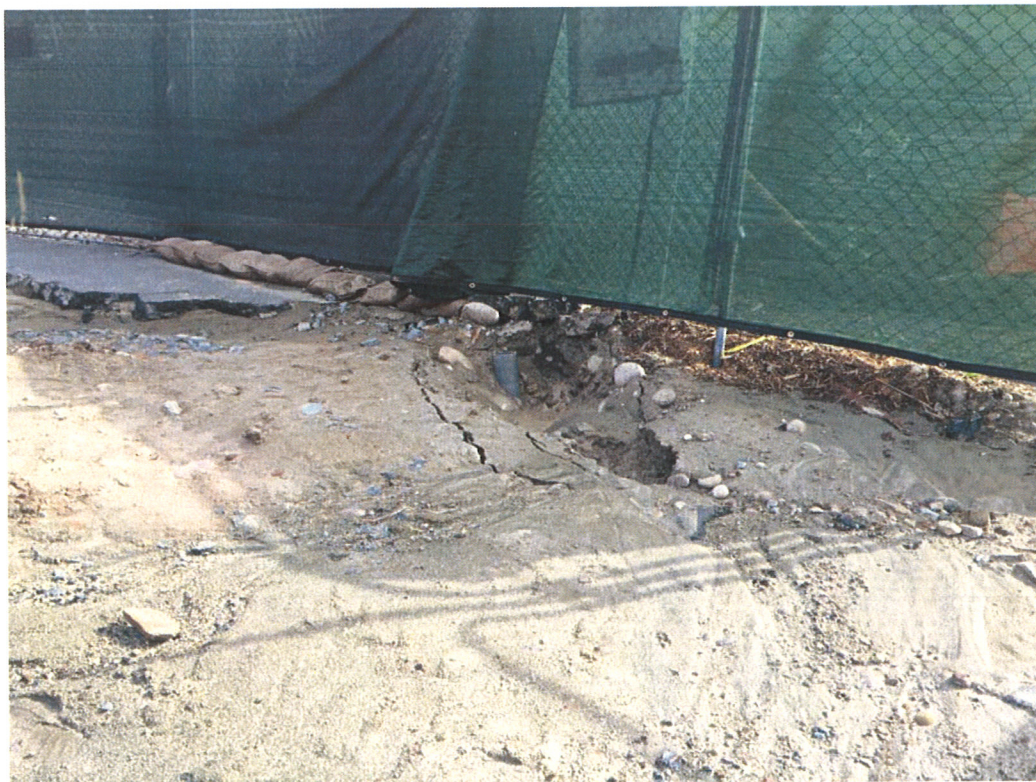
Pursuant to section F. in Attachment D to the Construction Storm Water Permit, dischargers are required to “effectively manage all run-on, all runoff within the site and all runoff that discharges off the site. Run-on from off site shall be directed away from all disturbed areas or shall be collectively be in compliance with the effluent limitations in this General Permit.” The Discharger was in violation of section F. for seven days: 1 day (December 15, 2014); and 6 days (May 8 through 13, 2015). See Figure 9. Failure to manage run-on and runoff. The violations were noted in the following documents: San Diego Water Board Inspection Report December 15, 2014 (Exhibit No. 8); San Diego Water Board Inspection Report May 8, 2015 (Exhibit No. 18); and San Diego Water Board Inspection Report May 13, 2015 (Exhibit No. 19).

**Figure 9. Failure to manage run-on and runoff.** Photograph taken by Wayne Chiu, San Diego Water Board on December 15, 2014, displaying erosion caused by runoff flowing under fence and offsite. IMG\_5042.jpg.

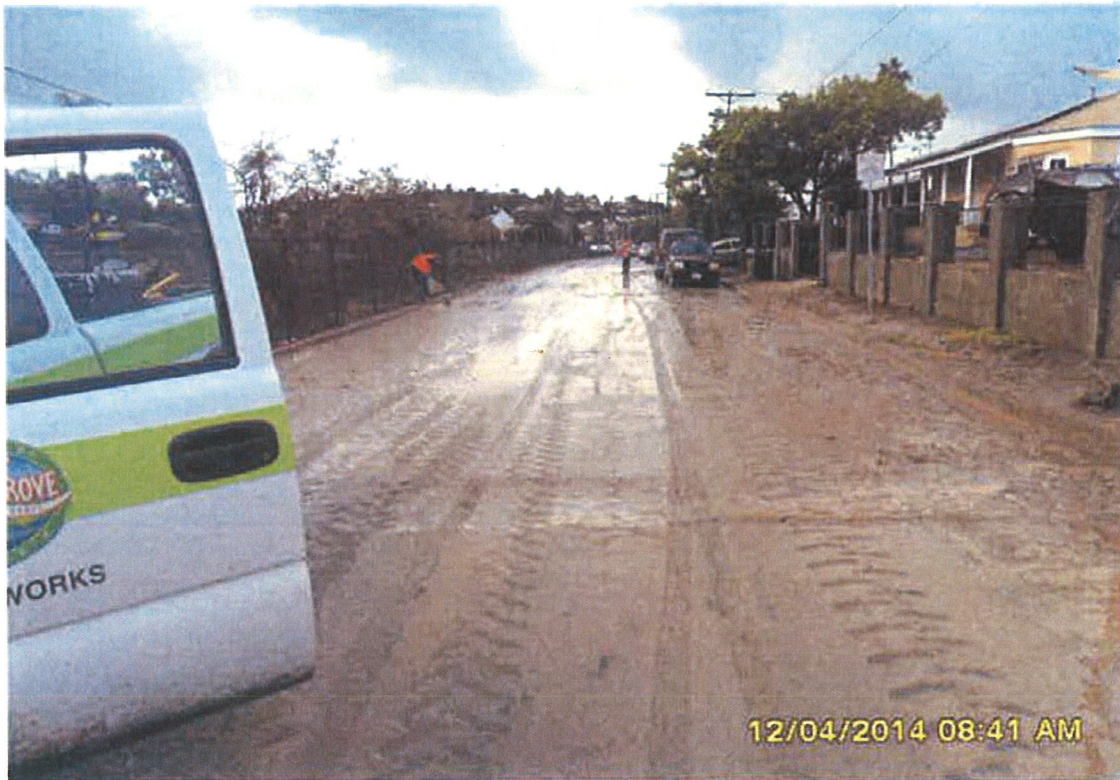
See Figure 10. Failure to remove sediment from roads. The violations were noted in the City Stop Work Notice December 2, 2014 (Exhibit No. 2); in City photographs from December 4, 2014; City Inspection Report December 8, 2014 (Exhibit No. 4); City Inspection Report December 9, 2014 (Exhibit No. 5); City Inspection Report December 16, 2014 (Exhibit No. 9), and City Inspection Report September 15, 2015 (Exhibit No. 22).

**Figure 10. Failure to remove sediment from roads.** Photograph taken by the City of Lemon Grove on December 4, 2014, depicting sediment on Akins Avenue southwest of the Site.

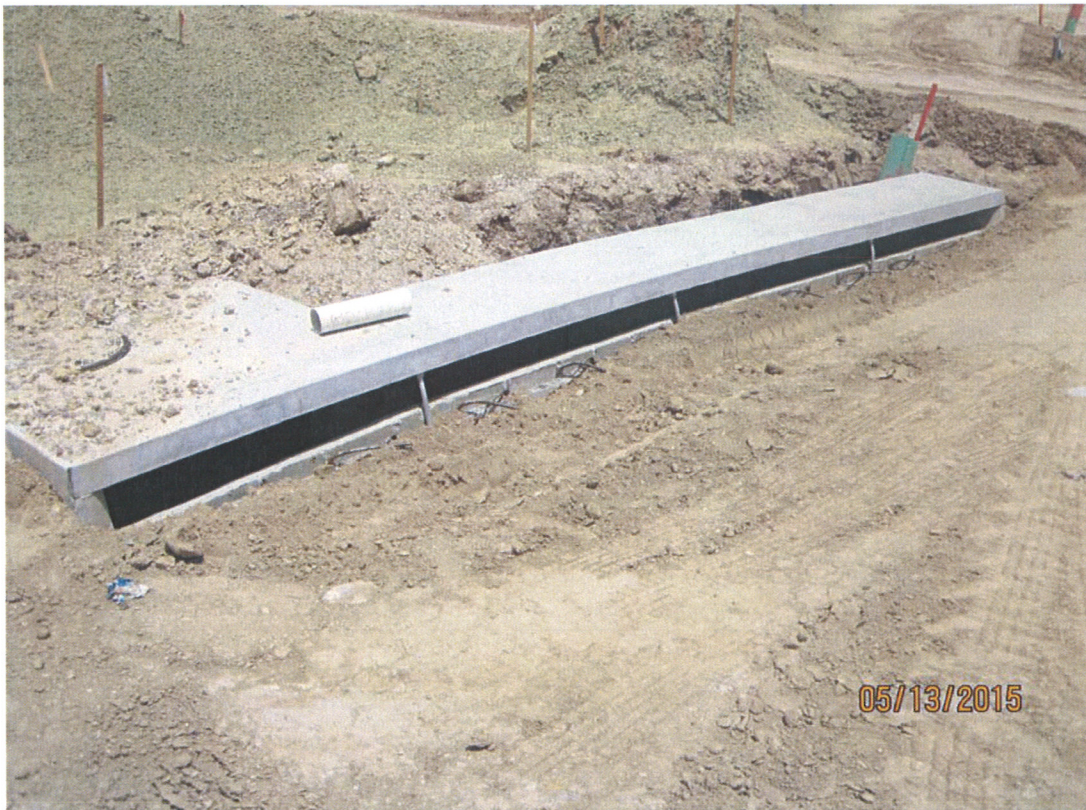
Pursuant to section E.6. in Attachment D to the Construction Storm Water Permit, dischargers “shall ensure that all storm drain inlets and perimeter controls, runoff control BMPs, and pollutant controls at entrances and exits (e.g. tire washoff locations) are maintained and protected from activities that reduce their effectiveness.” The Discharger was in violation of section E.6. for three days: December 8, 2014; May 13, 2015, and September 15, 2015. See Figure 11. Failure to protect storm drain inlets. The violation was noted in the City Inspection Report December 8, 2014 (Exhibit No. 4); in San Diego Water Board photographs from May 13, 2015 (Exhibit No. 19), and City Inspection Report September 15, 2015 (Exhibit No. 22).

**Figure 11. Failure to protect storm drain inlets.** Photograph taken by Frank Melbourn, San Diego Water Board on May 13, 2015, displaying unprotected storm drain inlet. IMG\_0295.jpg.

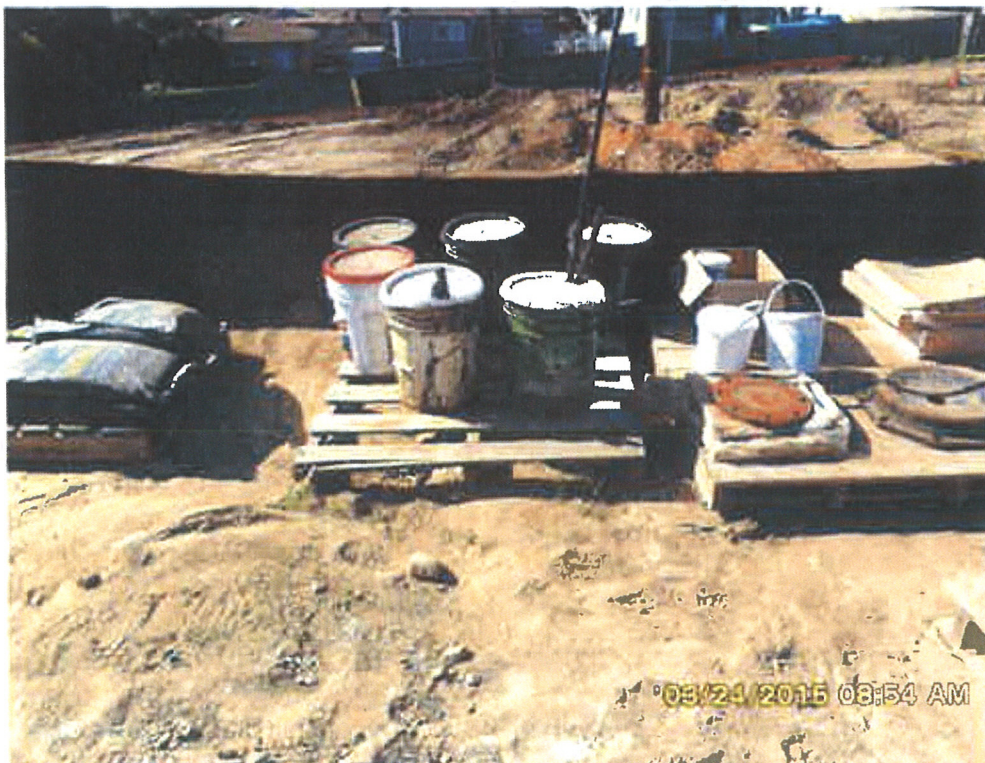
Pursuant to section B.1.c. in Attachment D to the Construction Storm Water Permit, dischargers are required to “[s]tore chemicals in watertight containers (with appropriate secondary containment to prevent any spillage or leakage) or in a storage shed (completely enclosed).” The Discharger was in violation of section B.1.c. for seven days (March 18 through 24, 2015). See Figure 12. Failure to properly store chemicals. The violations were noted in the following documents: City Inspection Report March 18, 2015 (Exhibit No. 13); and City Correct Work Notice March 24, 2015 (Exhibit No. 15).

**Figure 12. Failure to properly store chemicals.** Photograph taken by the City of Lemon Grove on March 24, 2015, depicting chemicals and vehicle lubricants stored on pallets without protection from the elements and without secondary containment.

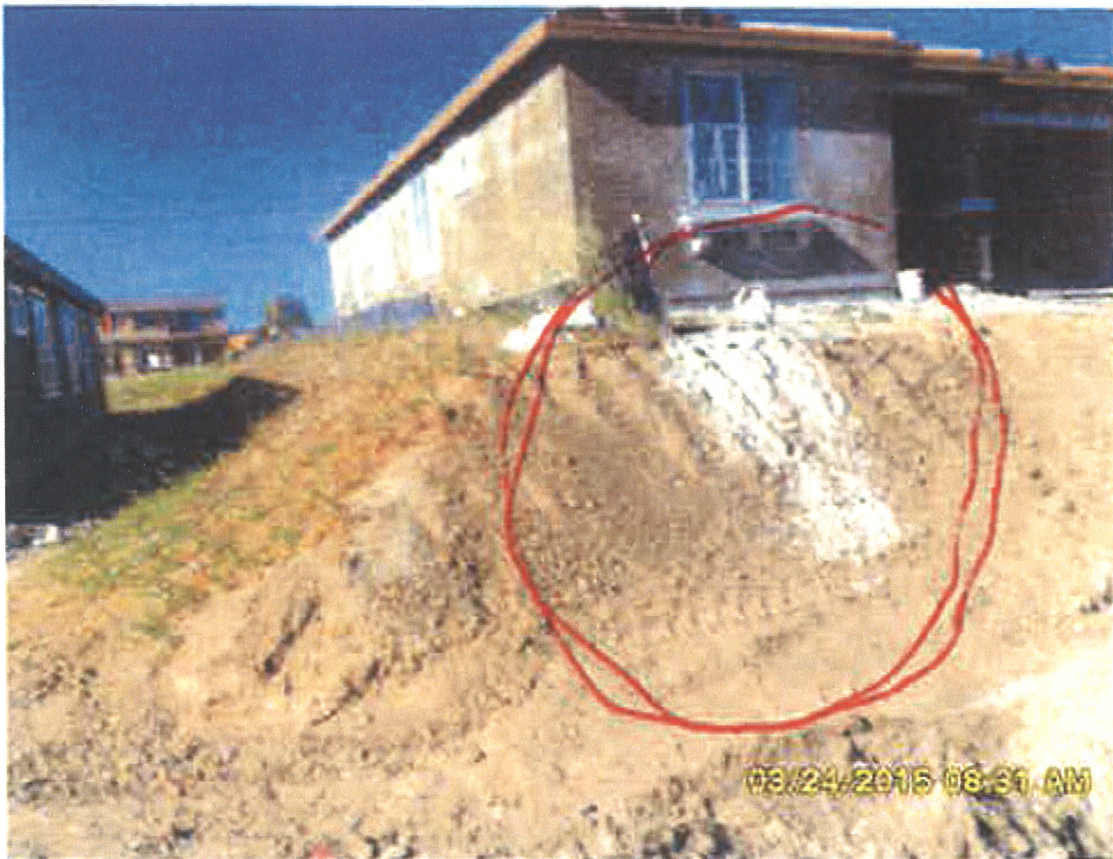
The Discharger was in violation of section B.2.i. for 15 days (March 18 through April 1, 2015). See Figure 13. Failure to prevent discharge of concrete waste to the ground. The violations were noted in the following documents: City Administrative Citation March 19, 2015 (Exhibit No. 14); City Administrative Citation March 24, 2015 (Exhibit No. 16); and City Administrative Citation April 1, 2015 (Exhibit No. 17).

**Figure 13. Failure to prevent the discharge of concrete waste to the ground.** Photograph taken by the City of Lemon Grove on March 24, 2015, depicting discharge of concrete waste on slope (identified by red circle).

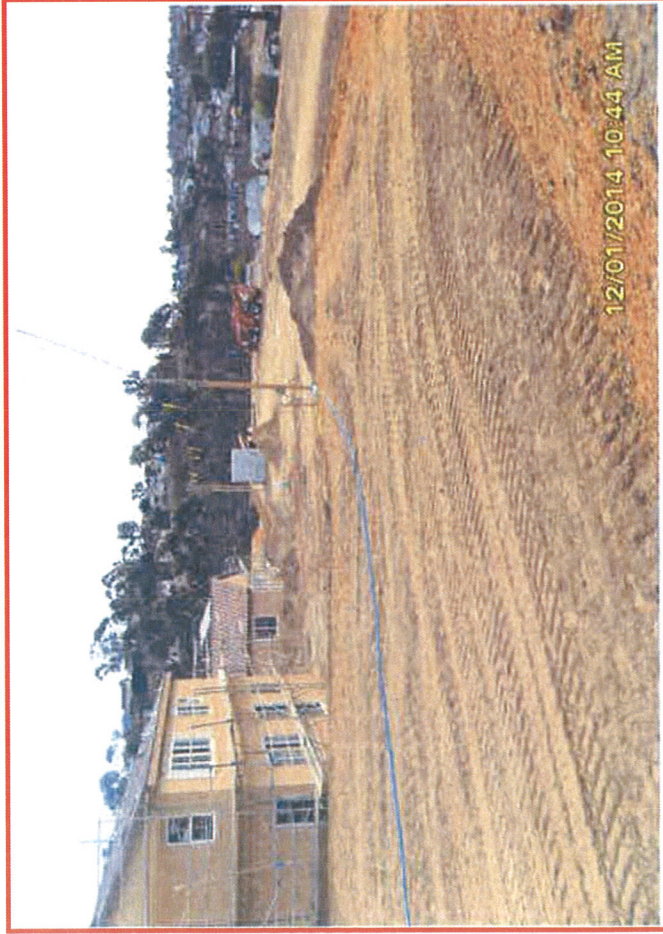
Lack of eroision control BMPs on inactive areas.

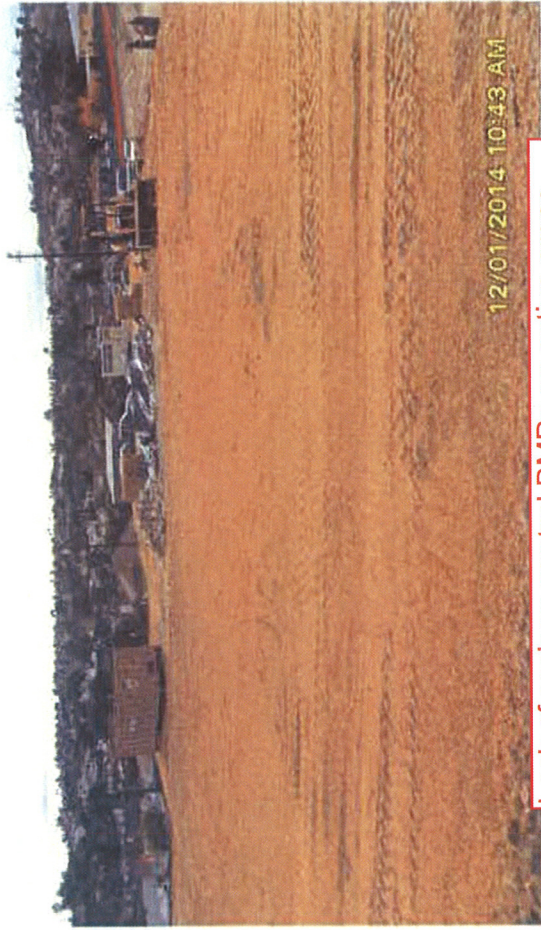
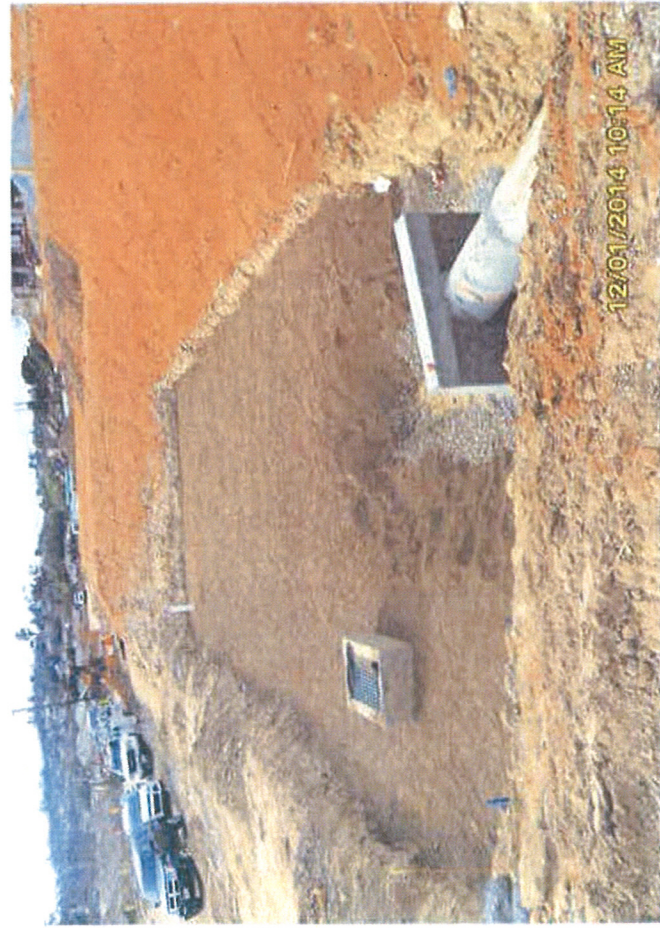
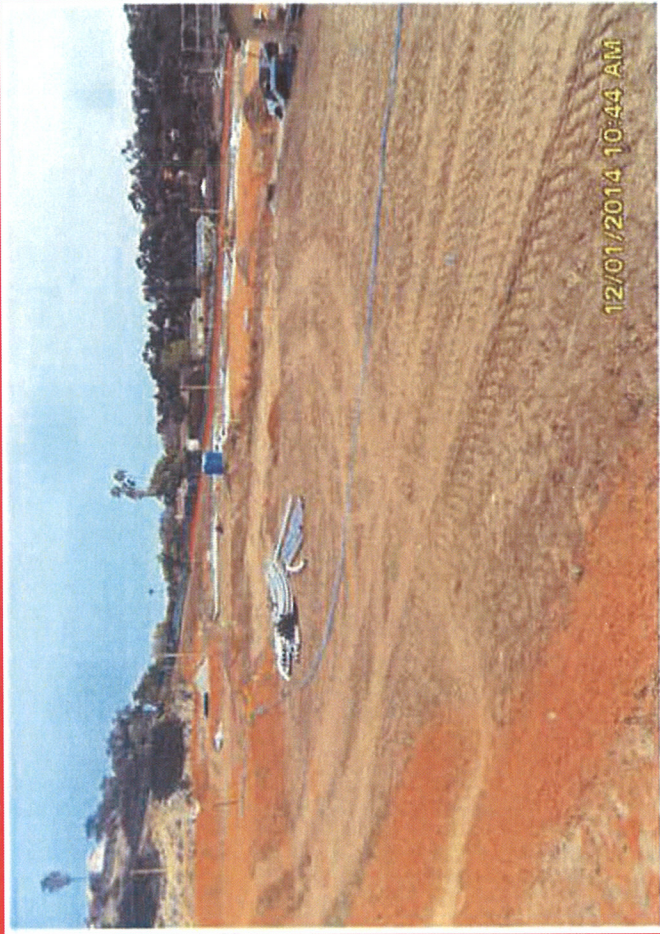
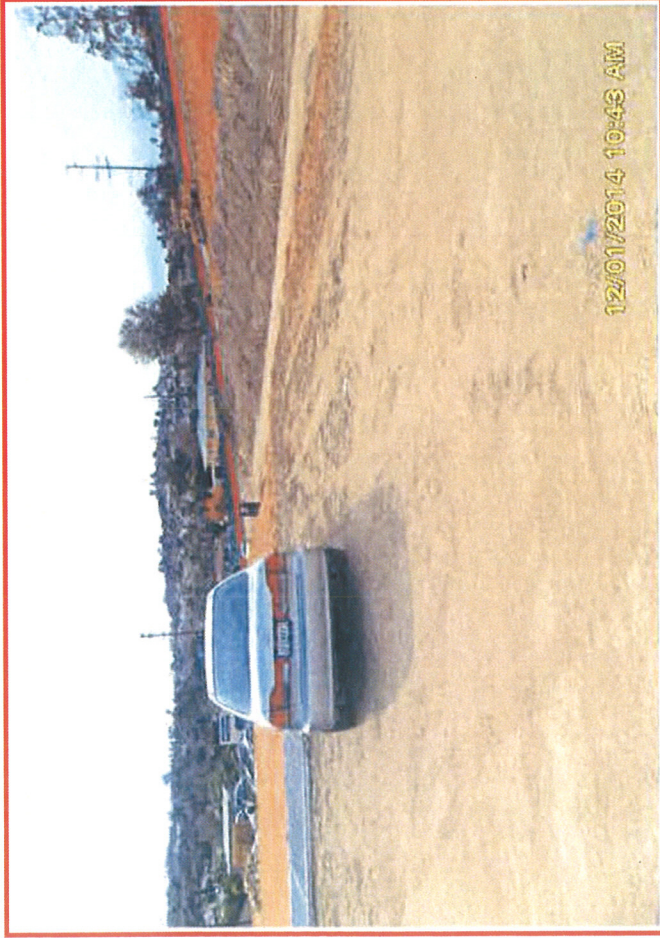
Lack of eroision control BMPs on active areas.

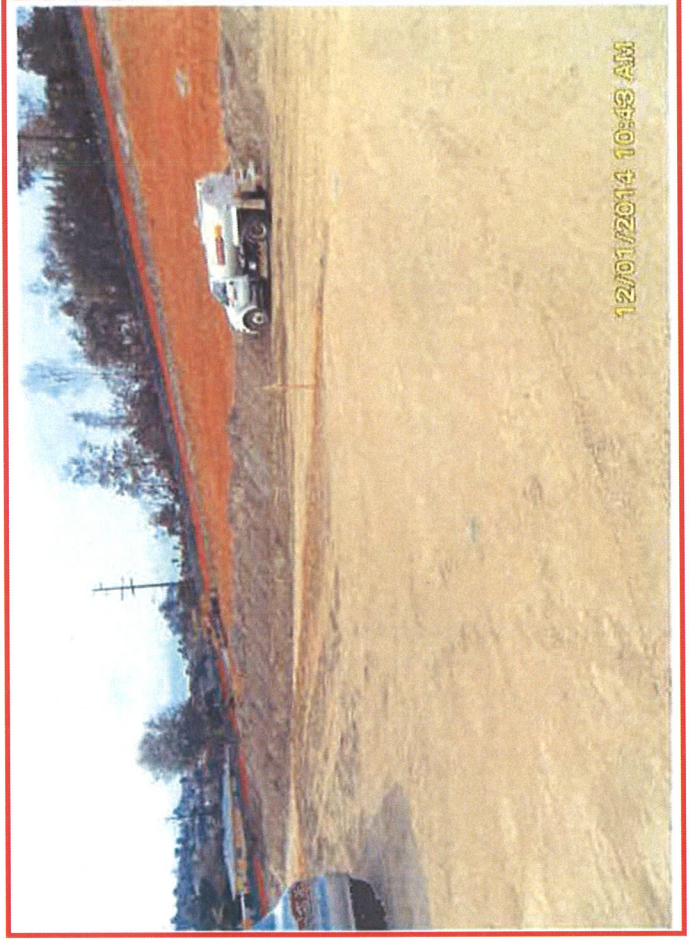
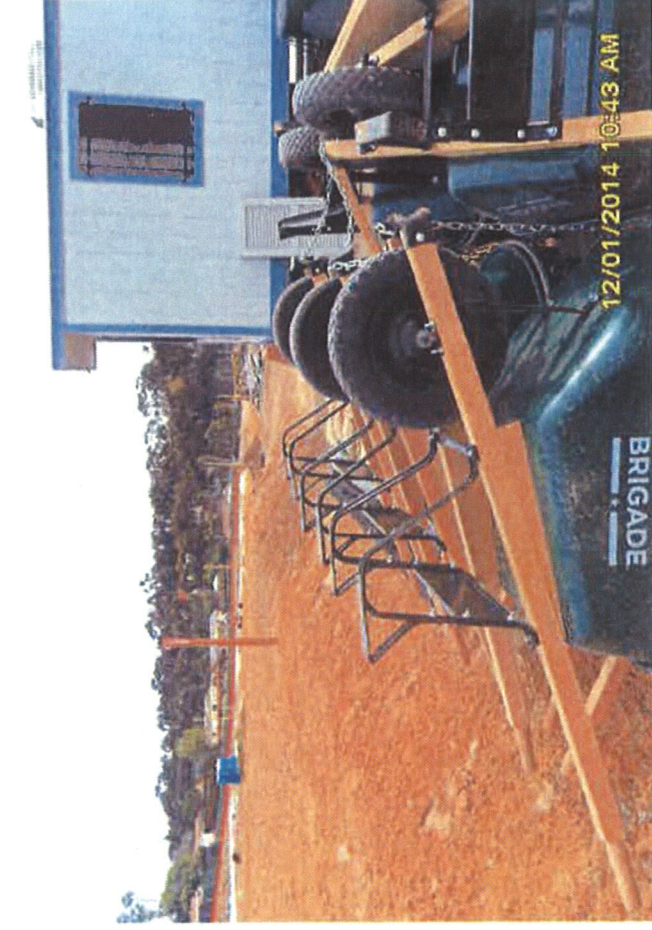
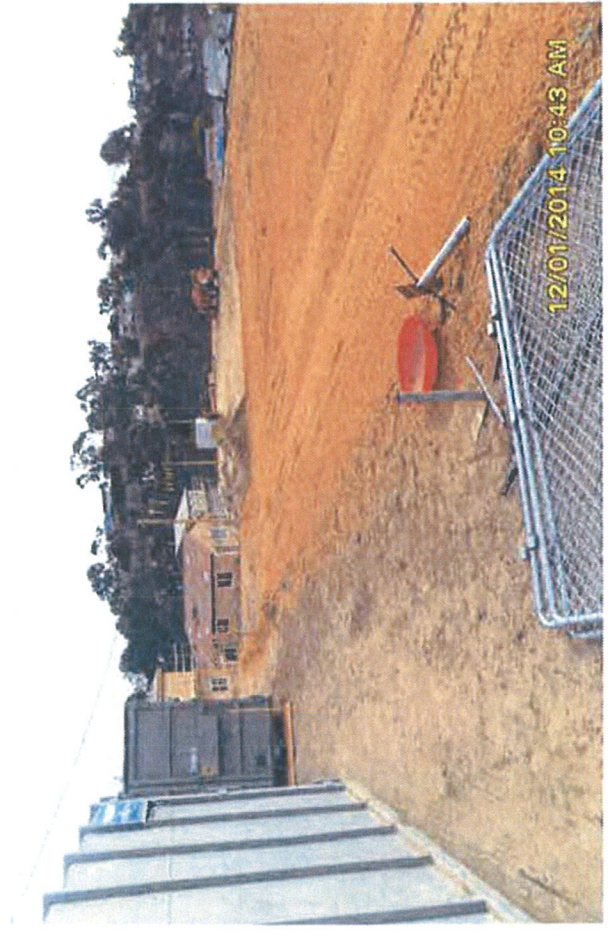
Lack of eroision control BMPs on inactive areas.

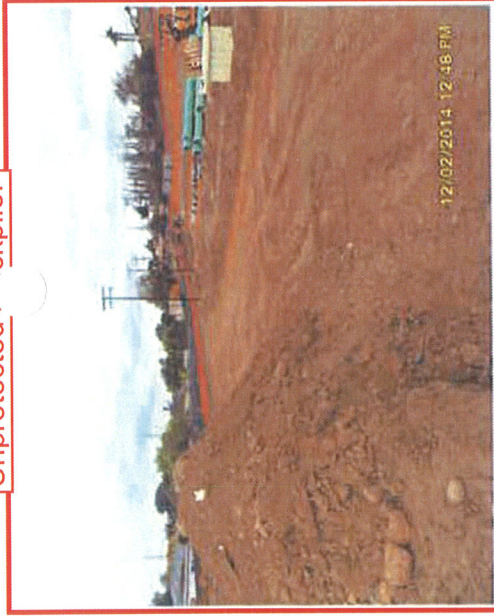
12/02/2014 12:48 PM

Unprotected stockpile.

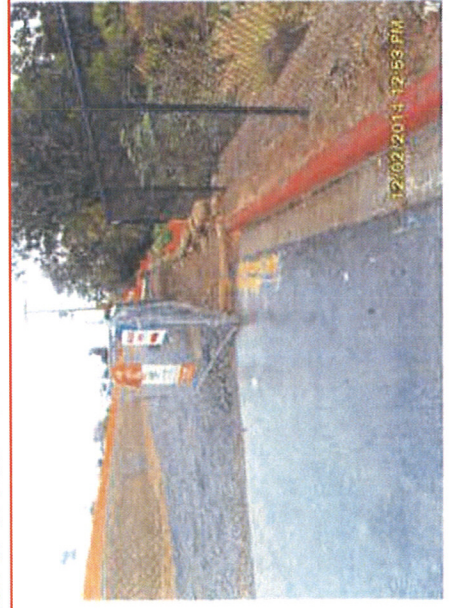
12/02/2014 12:53 PM

Lack of erosion control BMPs on inactive areas.

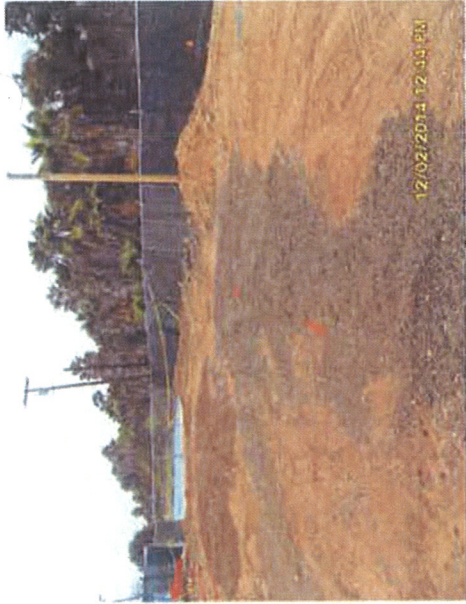
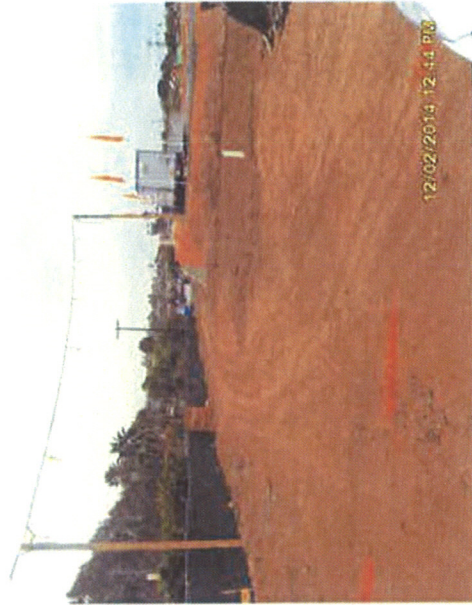
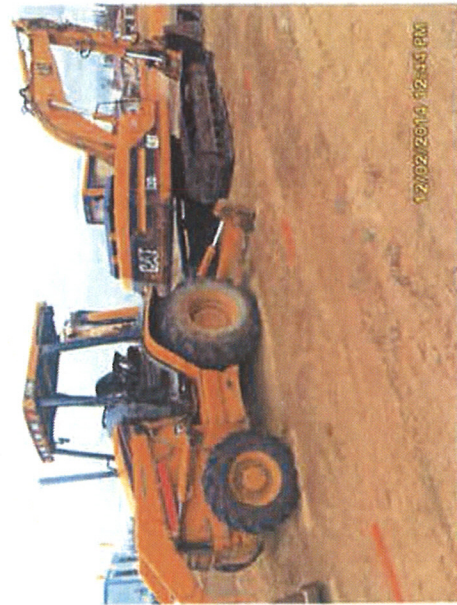
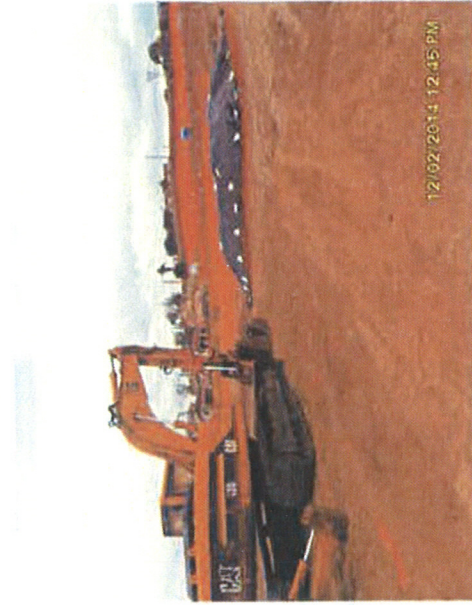
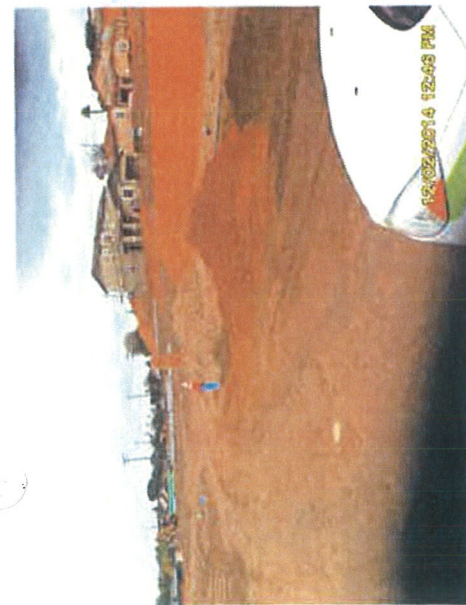
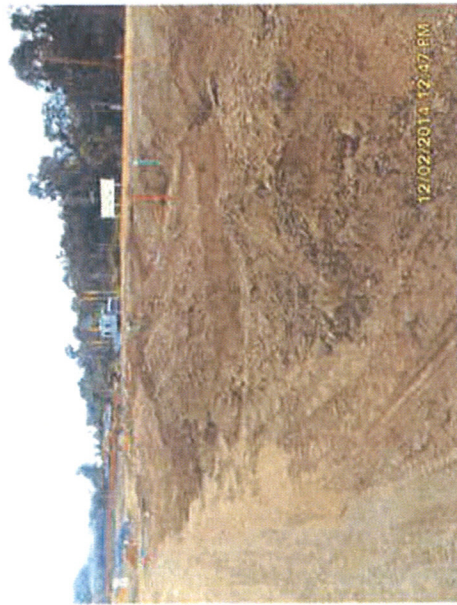
Stockpiles lack coverage and perimeter containment.

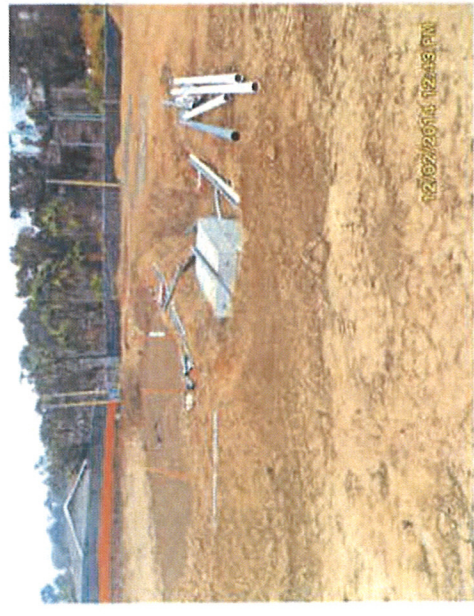
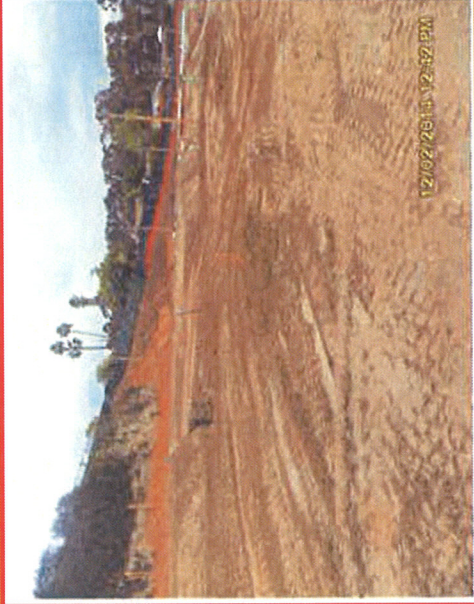
Lack of eroision control BMPs on active areas.

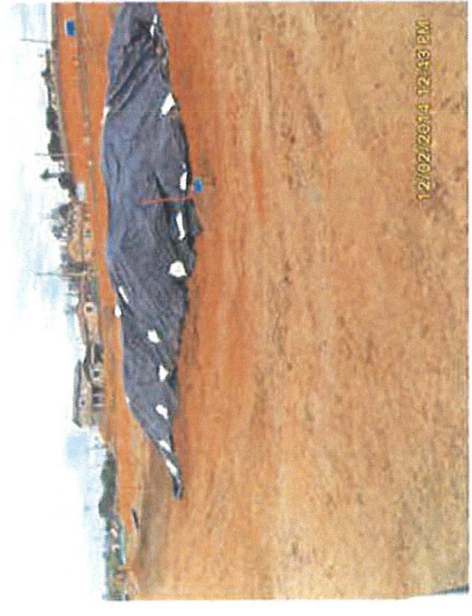
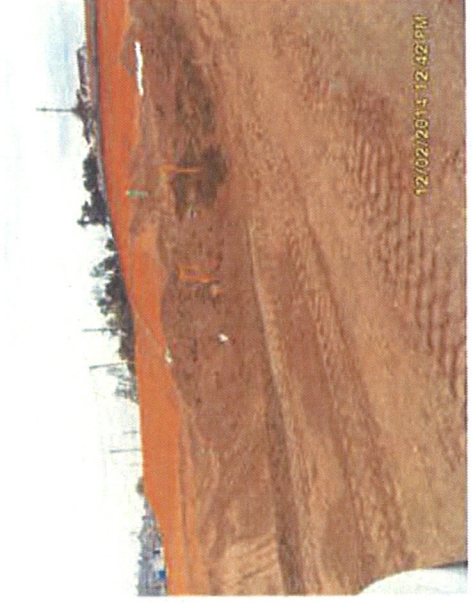
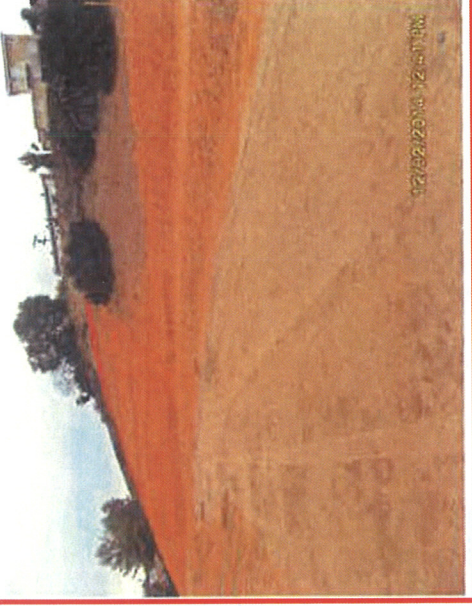
Lack of eroision control BMPs on inactive areas.
