## ERRATA SHEET

2 Notice of Hearing and Issuance of  
Complaint No. R9-2015-0110 for  
Administrative Civil Liability against  
San Altos Lemon Grove, LLC for violations  
of Order No. 2009-0009-DWQ

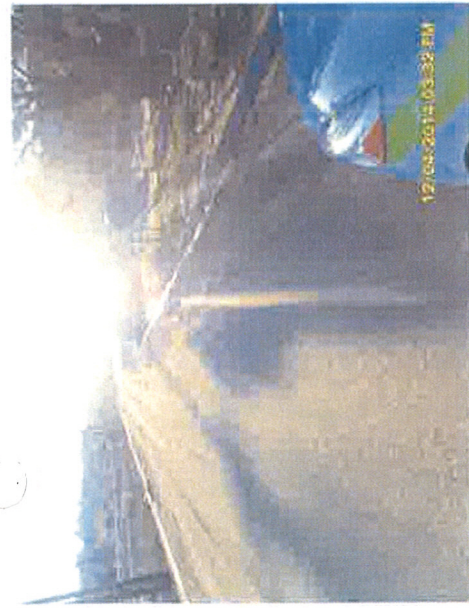
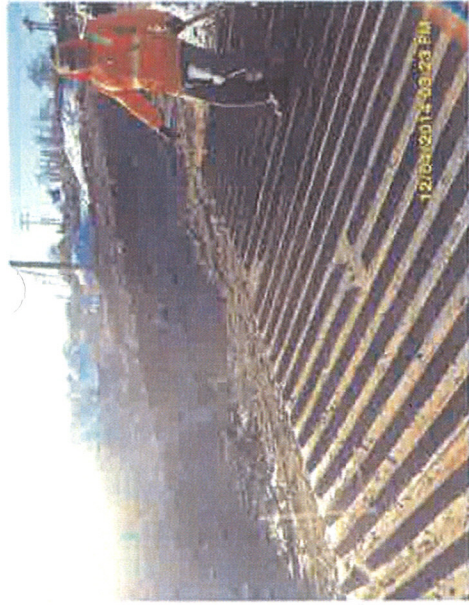
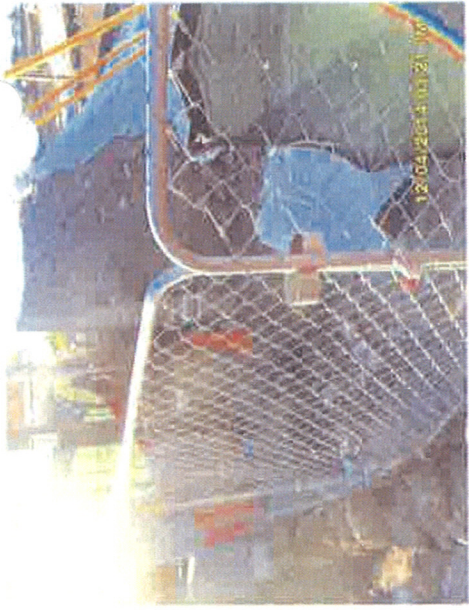
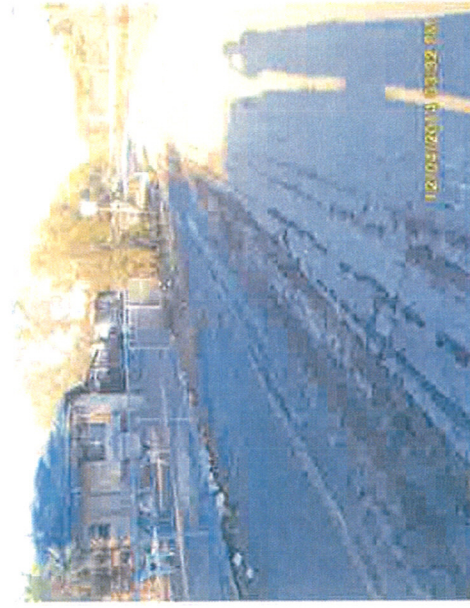
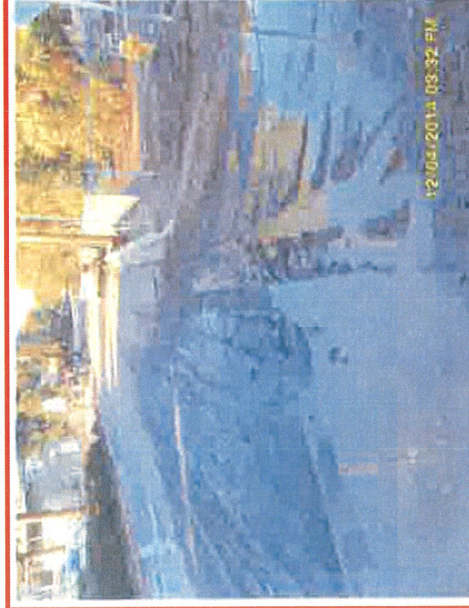
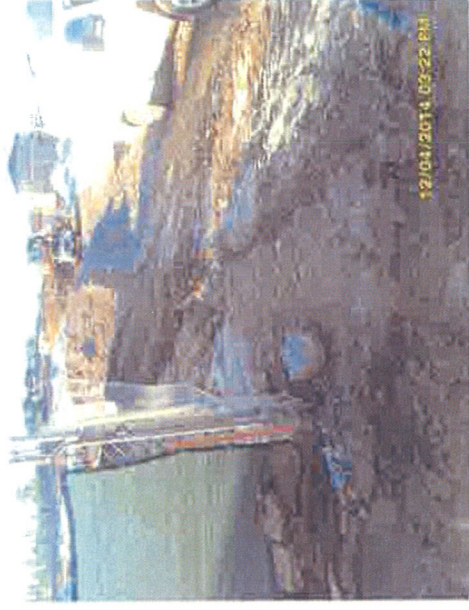
Sediment in street.

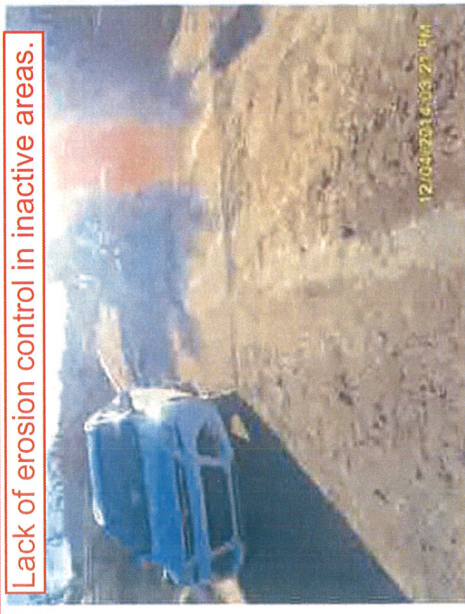
Lack of erosion control in inactive areas.

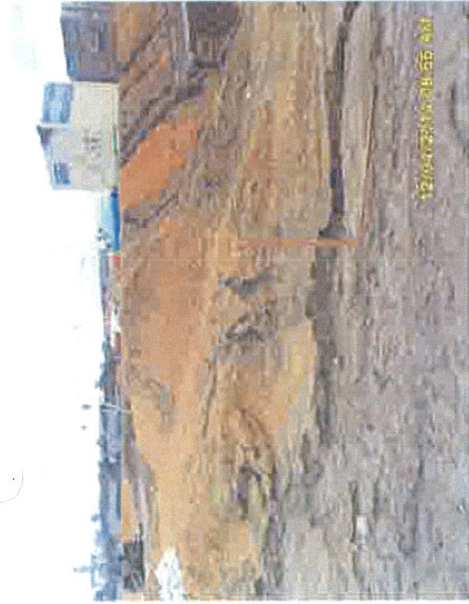
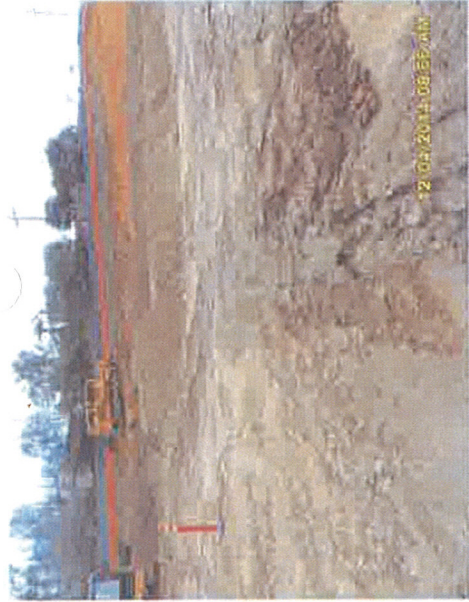
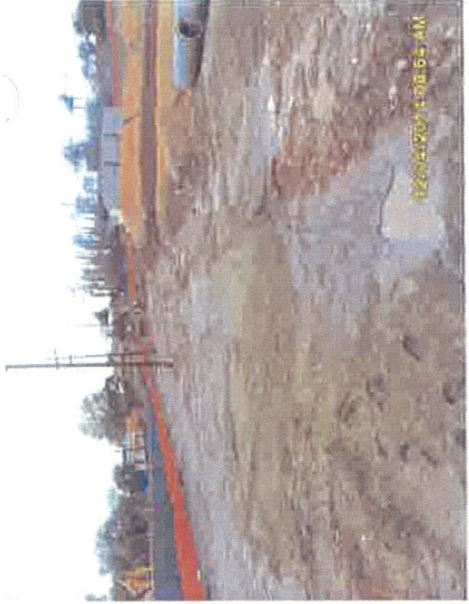
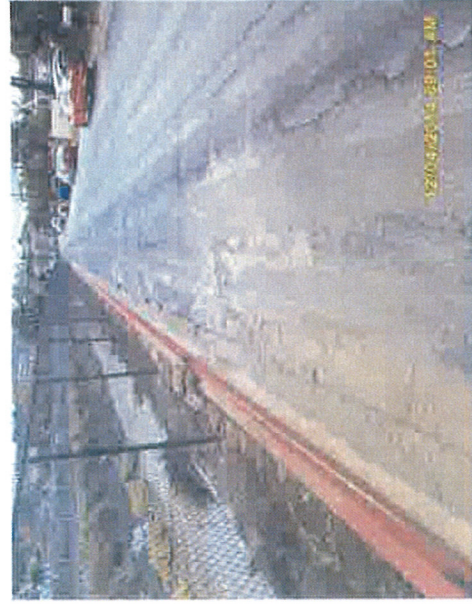
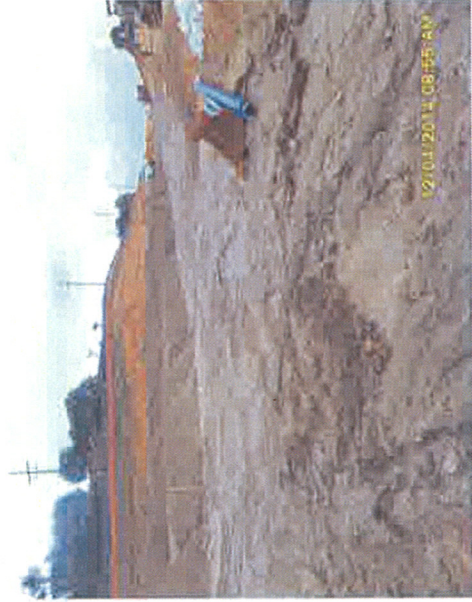
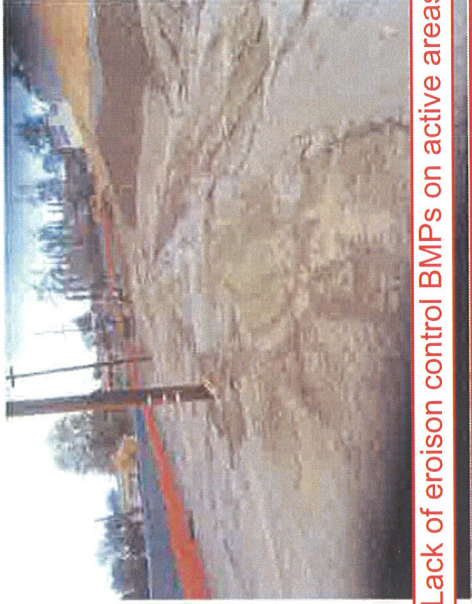
Lack of erosion control BMPs on active areas.

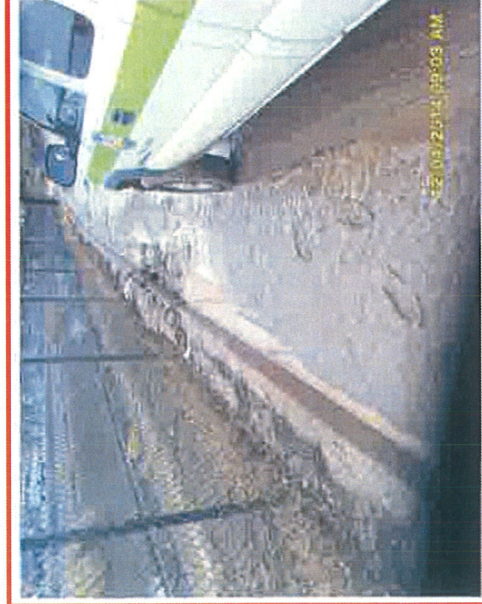
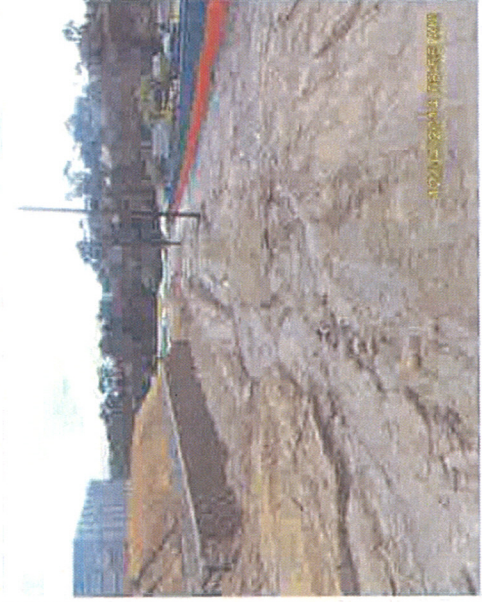
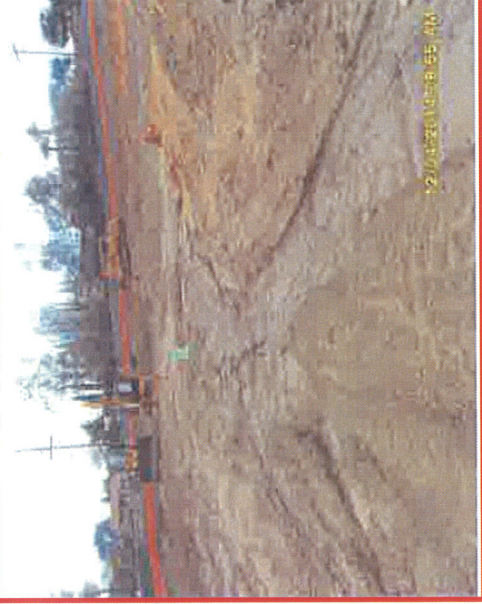
Sediment in street.

Although stockpile is partially covered it lacks perimeter containment.

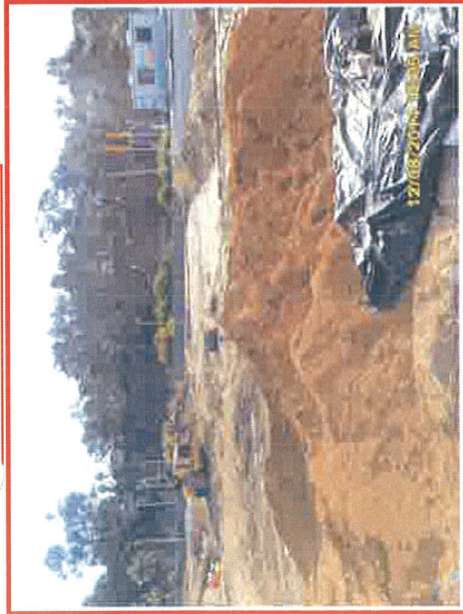
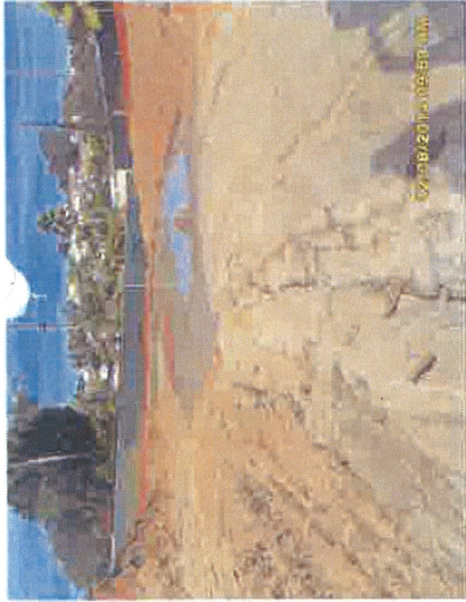
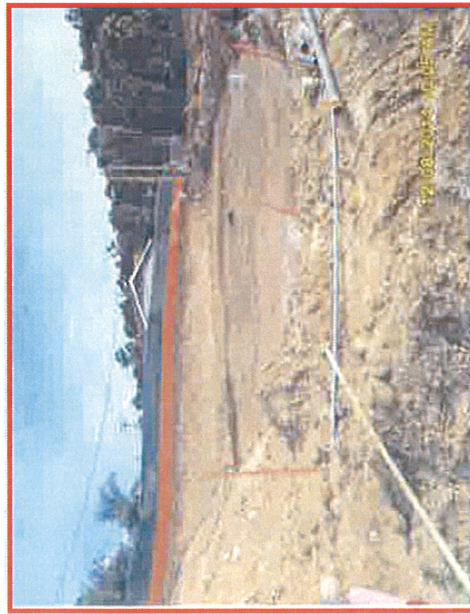
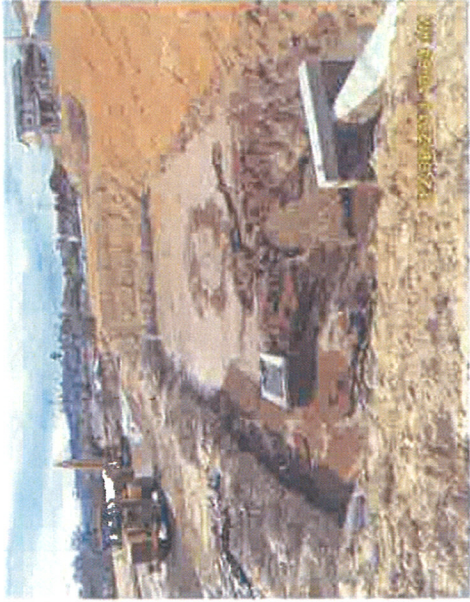
Incovered stockpile.

NOT WRITTEN LAST WEEK, CONTRACTOR WORKING ON  
ITEMS

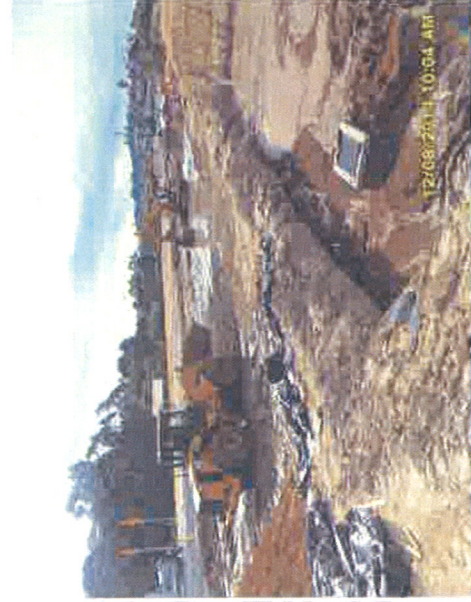
Lack of erosion controls in inactive areas.

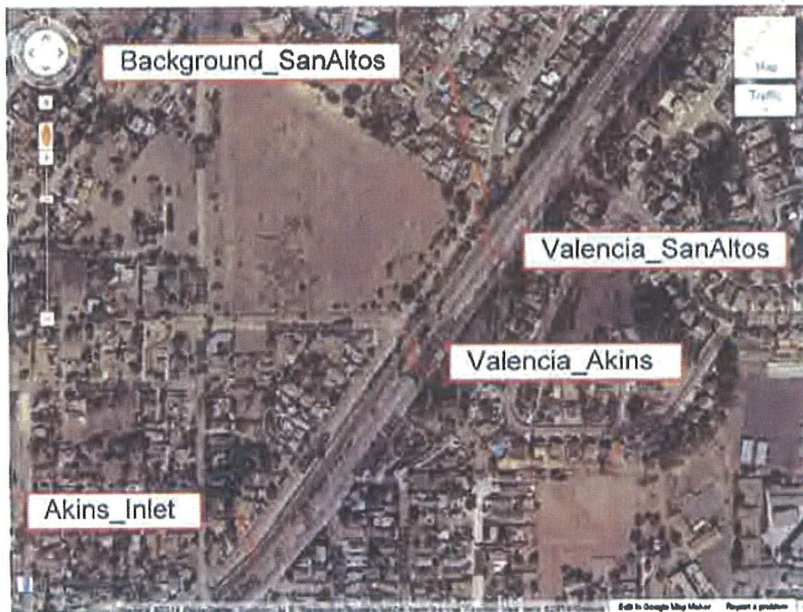
Figure 1. Sampling Locations

**Table 1. Sampling Results**

Site	Sample Date	Sample Time	Turbidity (NTU)
Valencia_Akins	12/12/2014	11:05	505
Background_SanAltos	12/12/2014	11:26	18.73
Valencia_SanAltos	12/12/2014	11:27	427
Valencia_Akins	12/12/2014	11:55	513
Akins_Inlet	12/12/2014	11:58	477

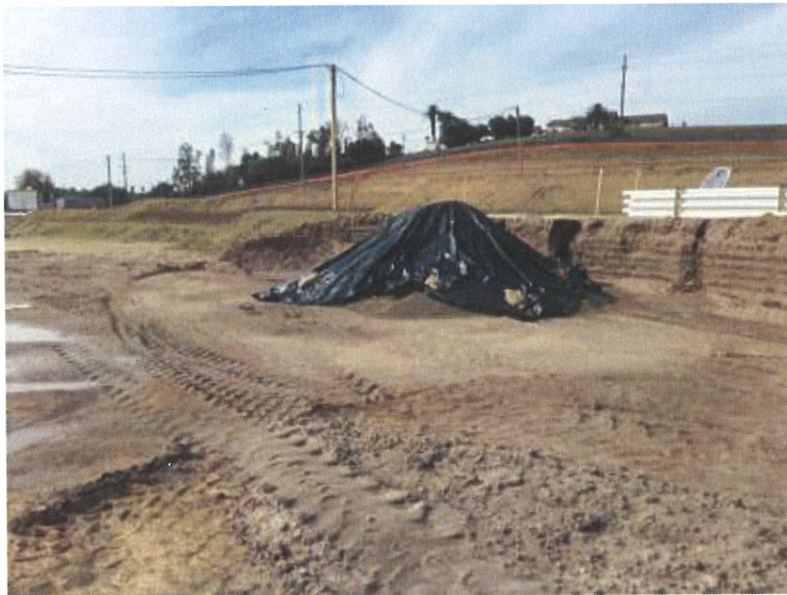
Photo 1 shows soil stockpile without adequate containment. Evidence of erosion and sediment transport along that base of the stockpile. Most stockpiles observed during inspection lacked adequate containment.

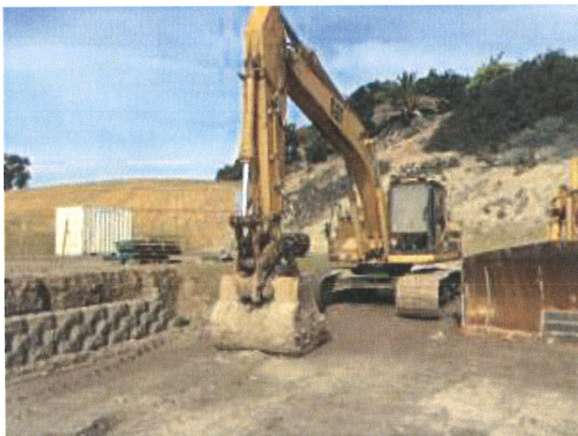
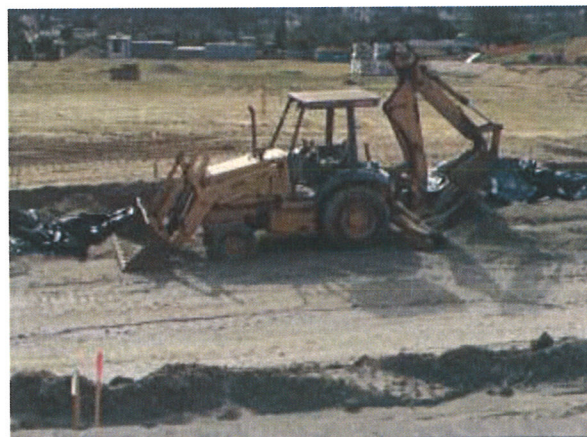
Photos 2 and 3 show construction equipment and vehicles without appropriate BMPs (e.g. drip pans) to prevent oil, grease, or fuel to leak in to the ground, storm drains, or surface waters. Most vehicles observed during inspection lacked appropriate BMPs.

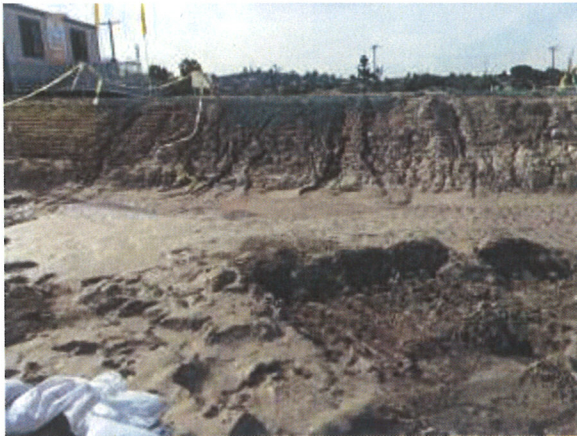
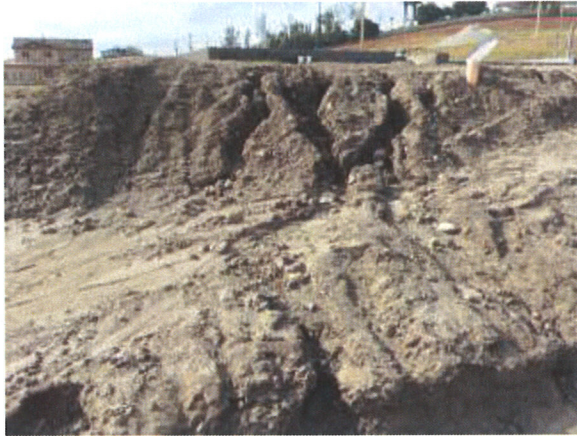
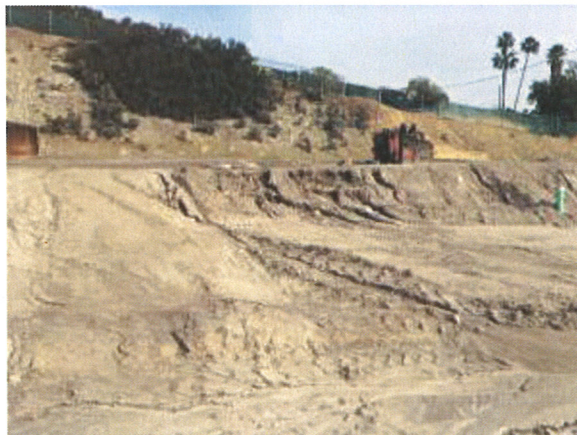
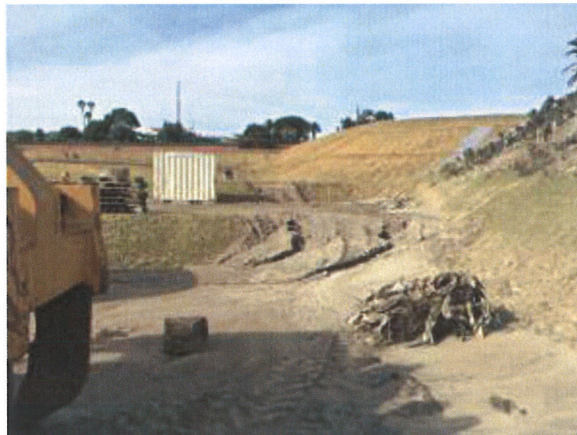
Photos 4 through 7 show completed building pads and adjacent slopes without any erosion controls and evidence of significant erosion and sediment transport. Photo 8 shows evidence of erosion and sediment transport in unpaved road sloping to locations shown in Photos 9 through 11. Sediment from completed lots and slopes in Photos 4 through 7 transported to road in Photo 8 lacking any erosion control measures during storm events, and inadequate runoff controls to reduce and prevent transport of sediment through site.

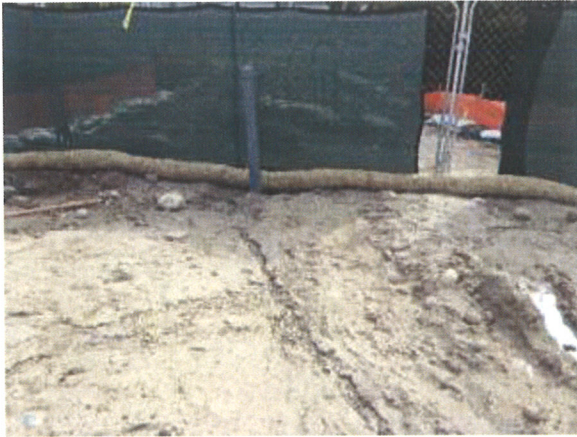
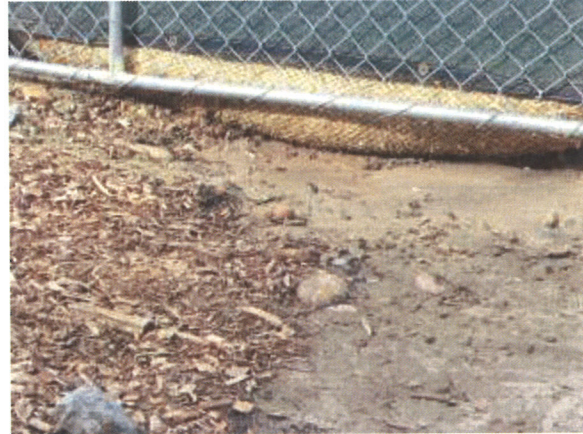
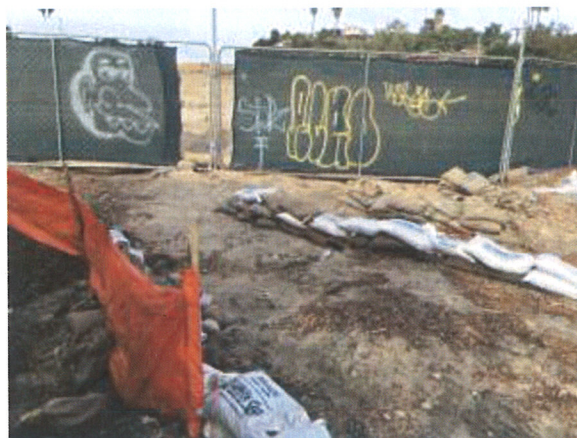
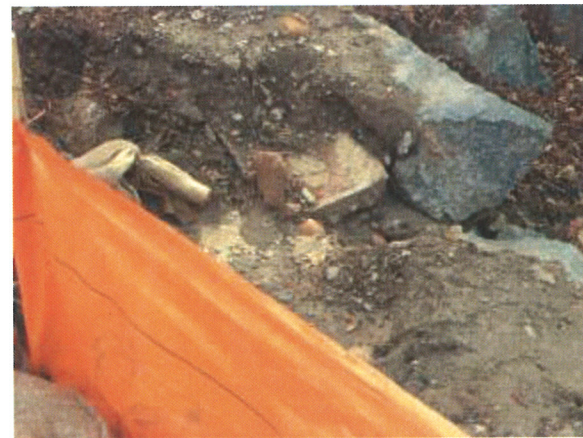
**Photos 9 through 12** show inadequate implementation of perimeter sediment controls and run-on/runoff controls to prevent discharges of sediment from the site. Photo 9 shows evidence of erosion and sediment transport from road shown in Photo 8 to perimeter with inadequately installed perimeter sediment and runoff controls (i.e. fiber roll not properly trenched and staked). Photos 10 shows evidence of sediment transport from the site beneath the inadequately installed perimeter sediment and runoff controls. Photo 11 shows evidence of sediment transport from the site to MS4 channel protected by silt fence and gravel bags. Photo 12 shows **sediment that has been discharged into the MS4 channel** due to inadequate implementation of erosion, sediment, and runoff controls by the site.

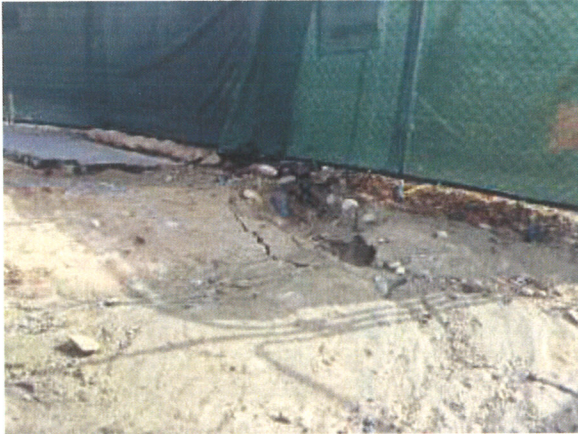
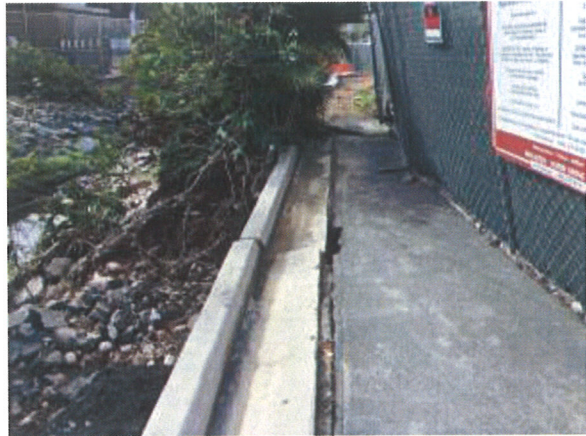
**Photos 13 and 14** show lack of effective perimeter sediment controls and run-on/runoff controls. Photo 13 shows evidence of erosion and sediment transport due to lack of perimeter run-on controls. Photo 14 shows evidence of sediment discharged from the site to the MS4 drainage system due to **erosion caused by run-on** that then ran off the site due to inadequate perimeter sediment controls and runoff controls.

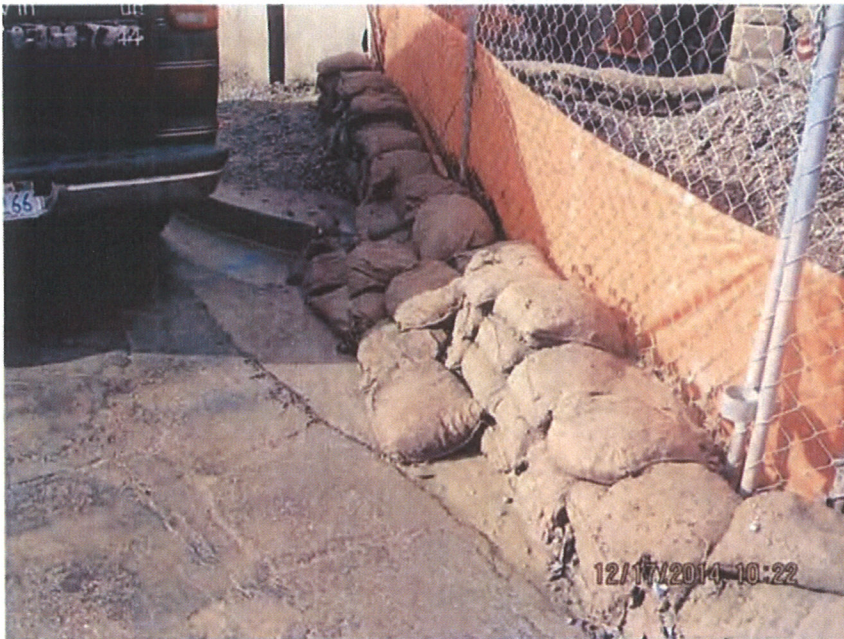
Photo 1. Evidence of sediment discharge at Akins entrance/exit

**Evidence of sediment discharge** was observed at the Akins entrance/exit location (Photos 1 and 2) and along the curb farther downstream (Photo 3). A crew from Downstream Services was power washing the curb along Akins to remove accumulated sediment (Photos 4, 5, and 6). This indicates that there likely had been a noticeable sediment discharge earlier in the day. Based on talking with the crew, our understanding is that they were working on behalf of the Valencia project, and they also planned to use a vector truck to remove accumulated sediment from the downstream storm drain on Akins. The crew was taking measures to prevent discharge of water from power washing, including using a vector truck to reclaim the water, but a small amount of water was observed discharging to the inlet along Akins. The water was seeping through gravel bags around the inlet and discharge to the storm drain. A sample of the power washing discharge water was collected, and turbidity was measured at 52 NTU.

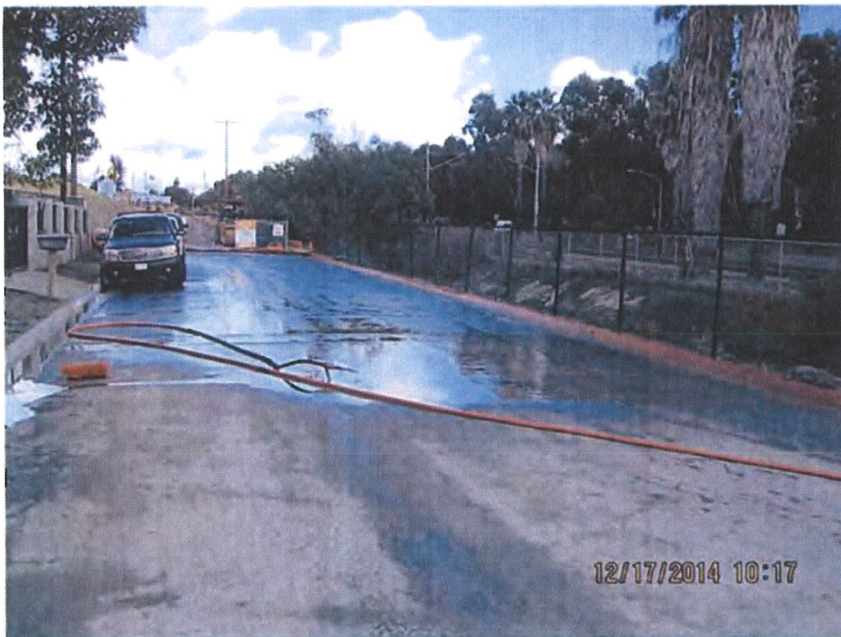
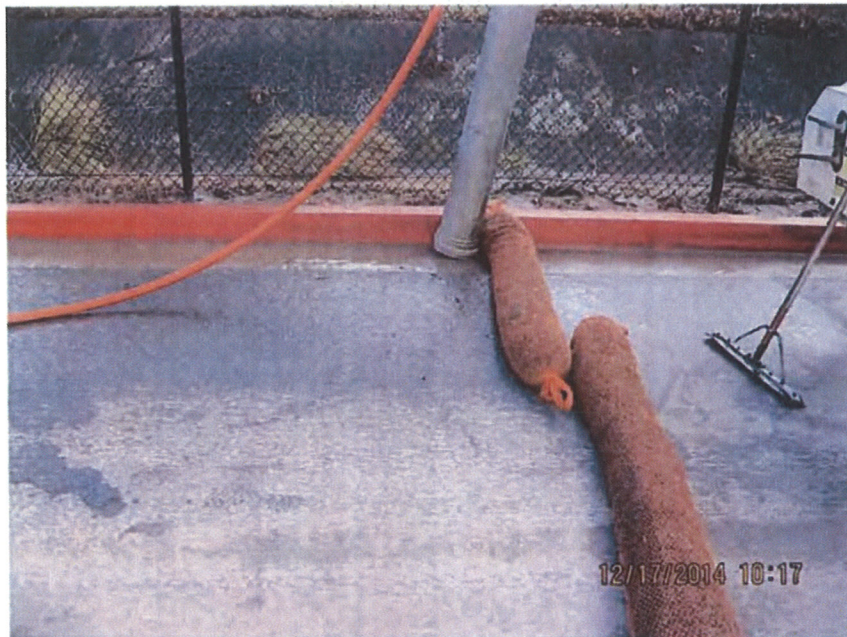
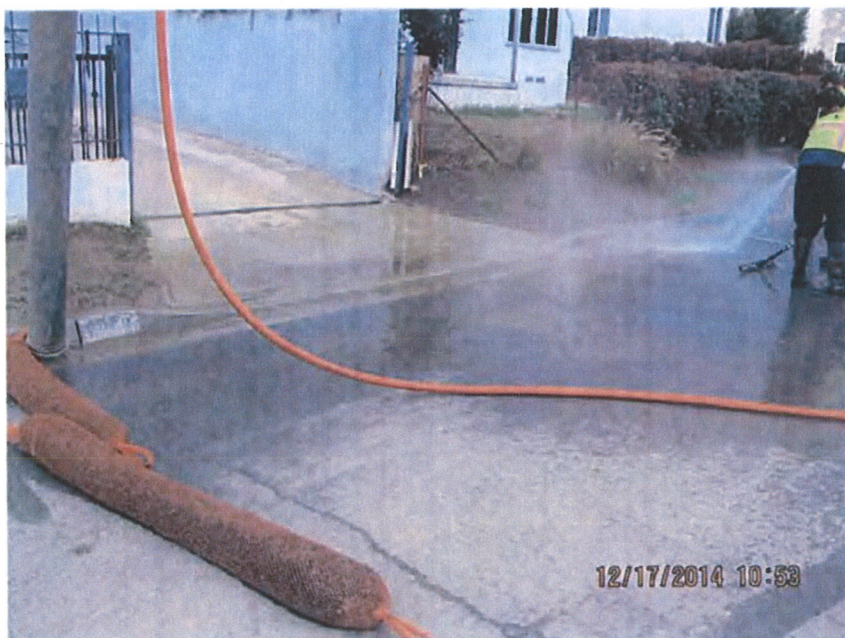
Photo 4. Power washing activity performed by Downstream Services

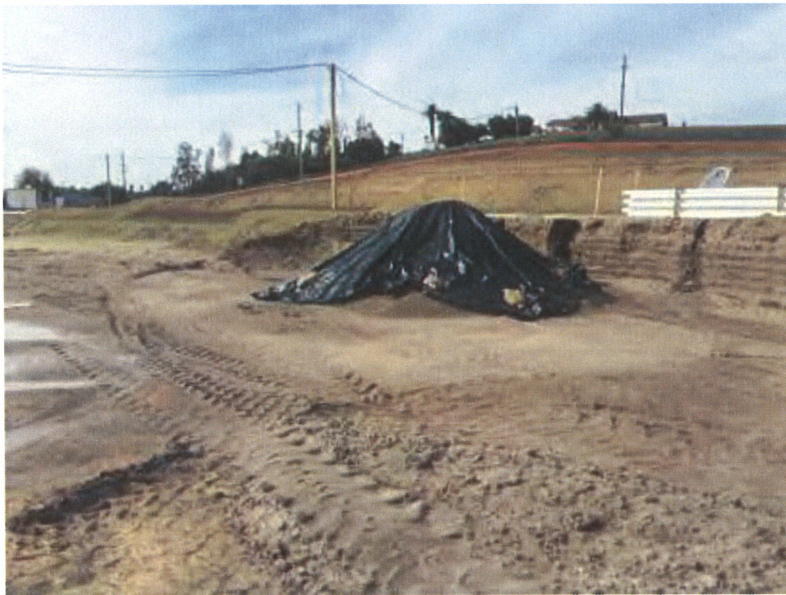
**Photo 1** shows soil stockpile without adequate containment. Evidence of erosion and sediment transport along that base of the stockpile. Most stockpiles observed during inspection lacked adequate containment.

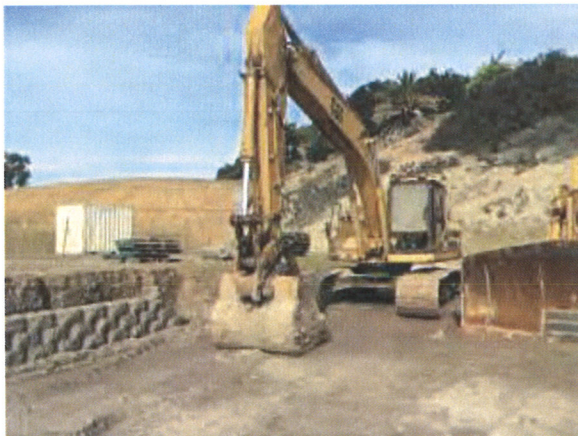
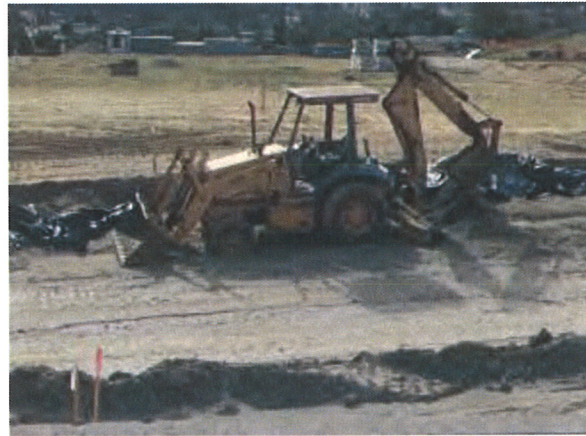
**Photos 2 and 3** show construction equipment and vehicles without appropriate BMPs (e.g. drip pans) to prevent oil, grease, or fuel to leak in to the ground, storm drains, or surface waters. Most vehicles observed during inspection lacked appropriate BMPs.

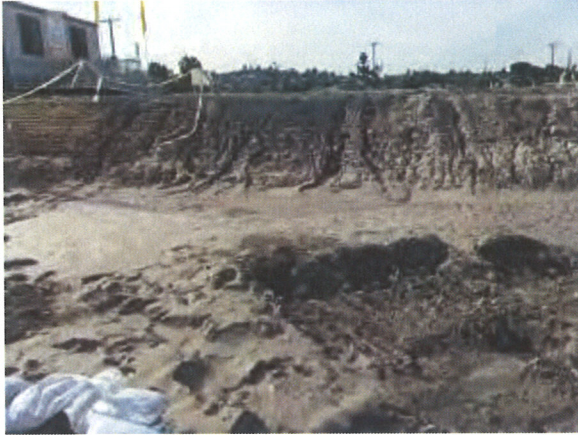
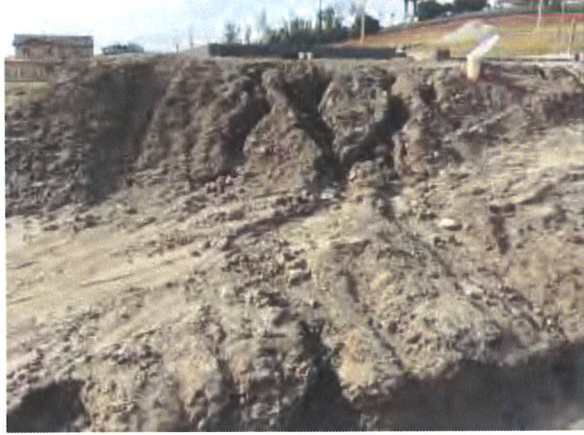
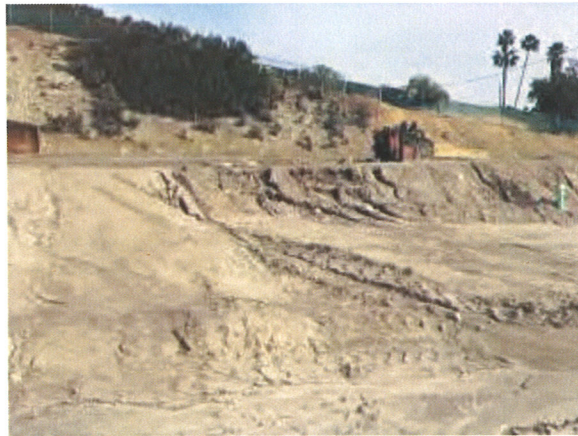
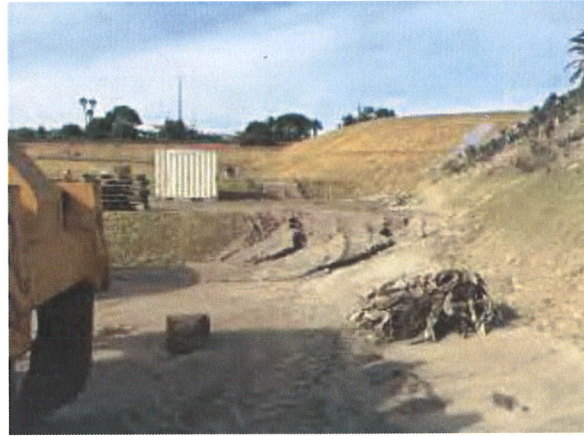
**Photos 4 through 7** show completed building pads and adjacent slopes without any erosion controls and evidence of significant erosion and sediment transport. **Photo 8** shows evidence of erosion and sediment transport in unpaved road sloping to locations shown in Photos 9 through 11. Sediment from completed lots and slopes in Photos 4 through 7 transported to road in Photo 8 lacking any erosion control measures during storm events, and inadequate runoff controls to reduce and prevent transport of sediment through site.

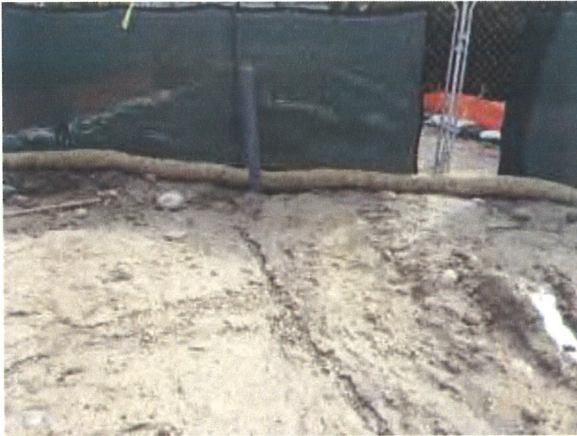
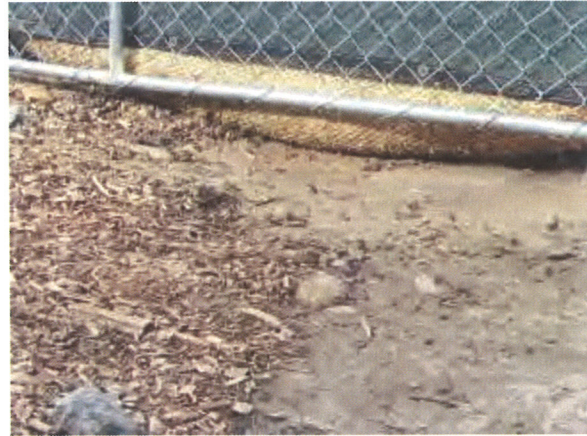
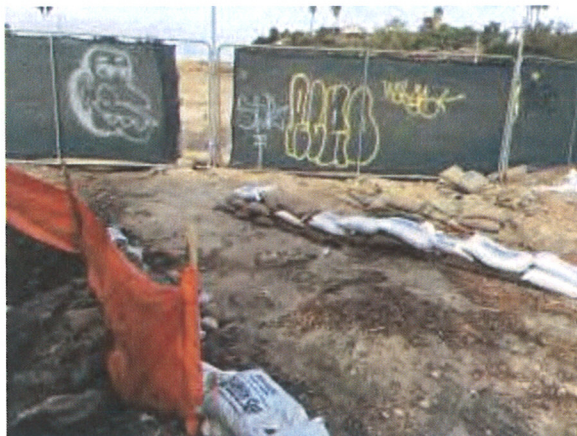
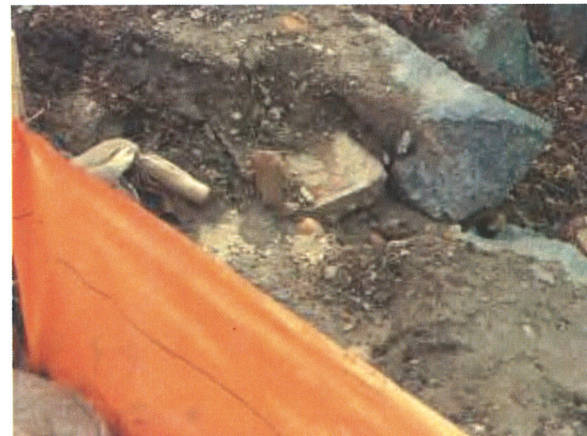
**Photos 9 through 12** show inadequate implementation of perimeter sediment controls and run-on/runoff controls to prevent discharges of sediment from the site. Photo 9 shows evidence of erosion and sediment transport from road shown in Photo 8 to perimeter with inadequately installed perimeter sediment and runoff controls (i.e. fiber roll not properly trenched and staked). Photos 10 shows evidence of sediment transport from the site beneath the inadequately installed perimeter sediment and runoff controls. Photo 11 shows evidence of sediment transport from the site to MS4 channel protected by silt fence and gravel bags. Photo 12 shows sediment that has been discharged into the MS4 channel due to inadequate implementation of erosion, sediment, and runoff controls by the site.

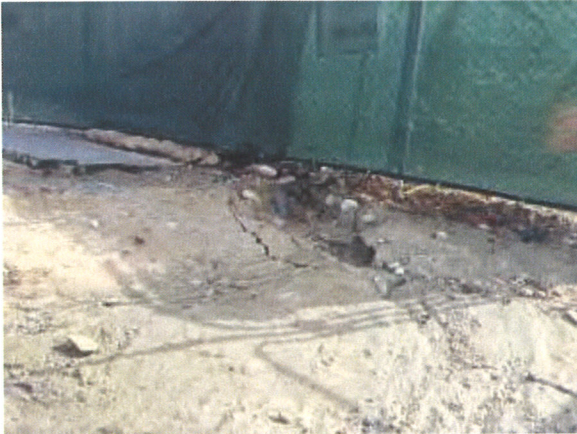
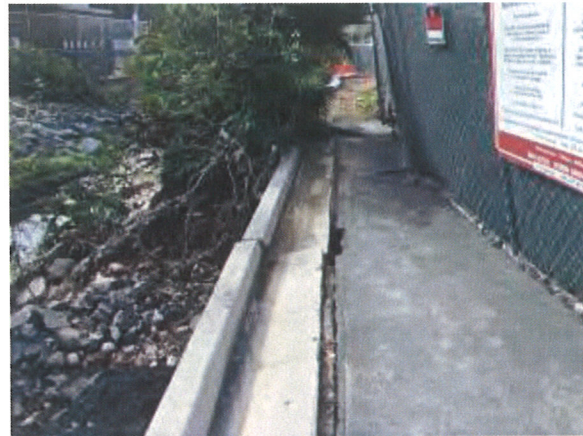
**Photos 13 and 14** show lack of effective perimeter sediment controls and run-on/runoff controls. Photo 13 shows evidence of erosion and sediment transport due to lack of perimeter run-on controls. Photo 14 shows evidence of sediment discharged from the site to the MS4 drainage system due to erosion caused by run-on that then ran off the site due to inadequate perimeter sediment controls and runoff controls.

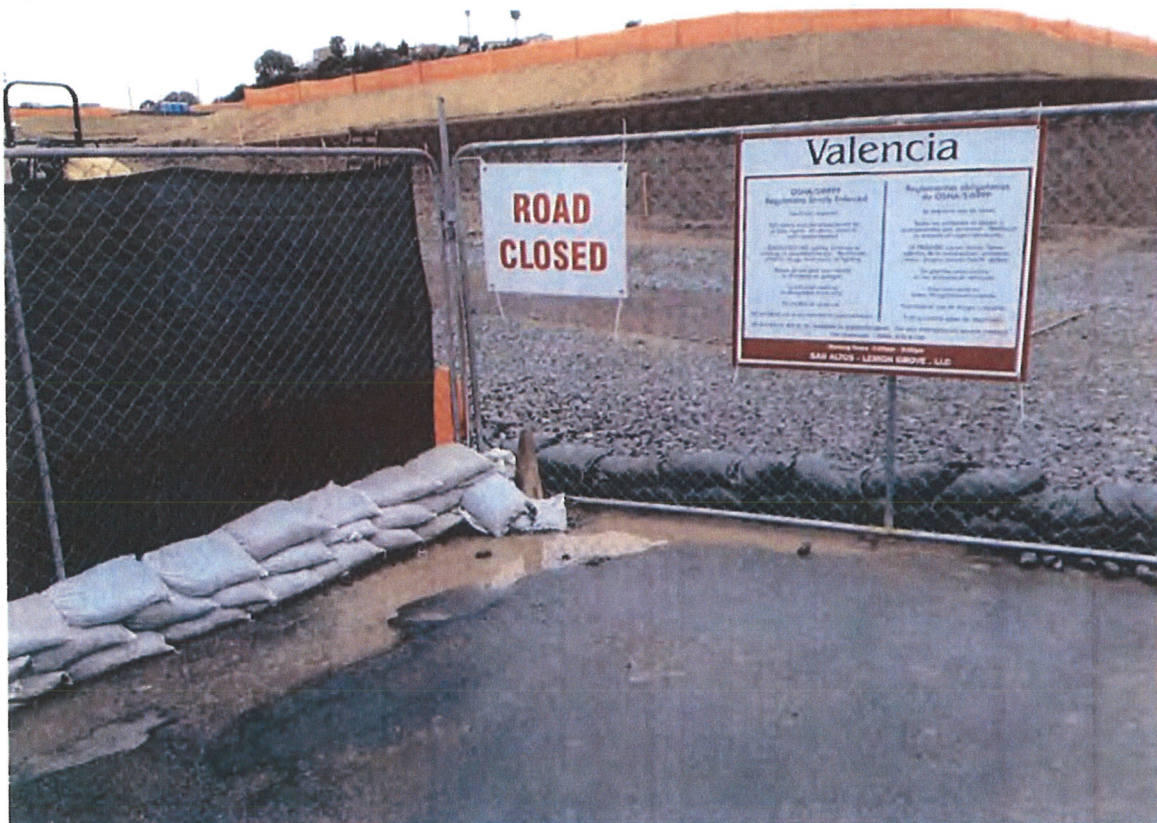
Photo 1. Ponded Water at Akims Avenue Entrance/Exit

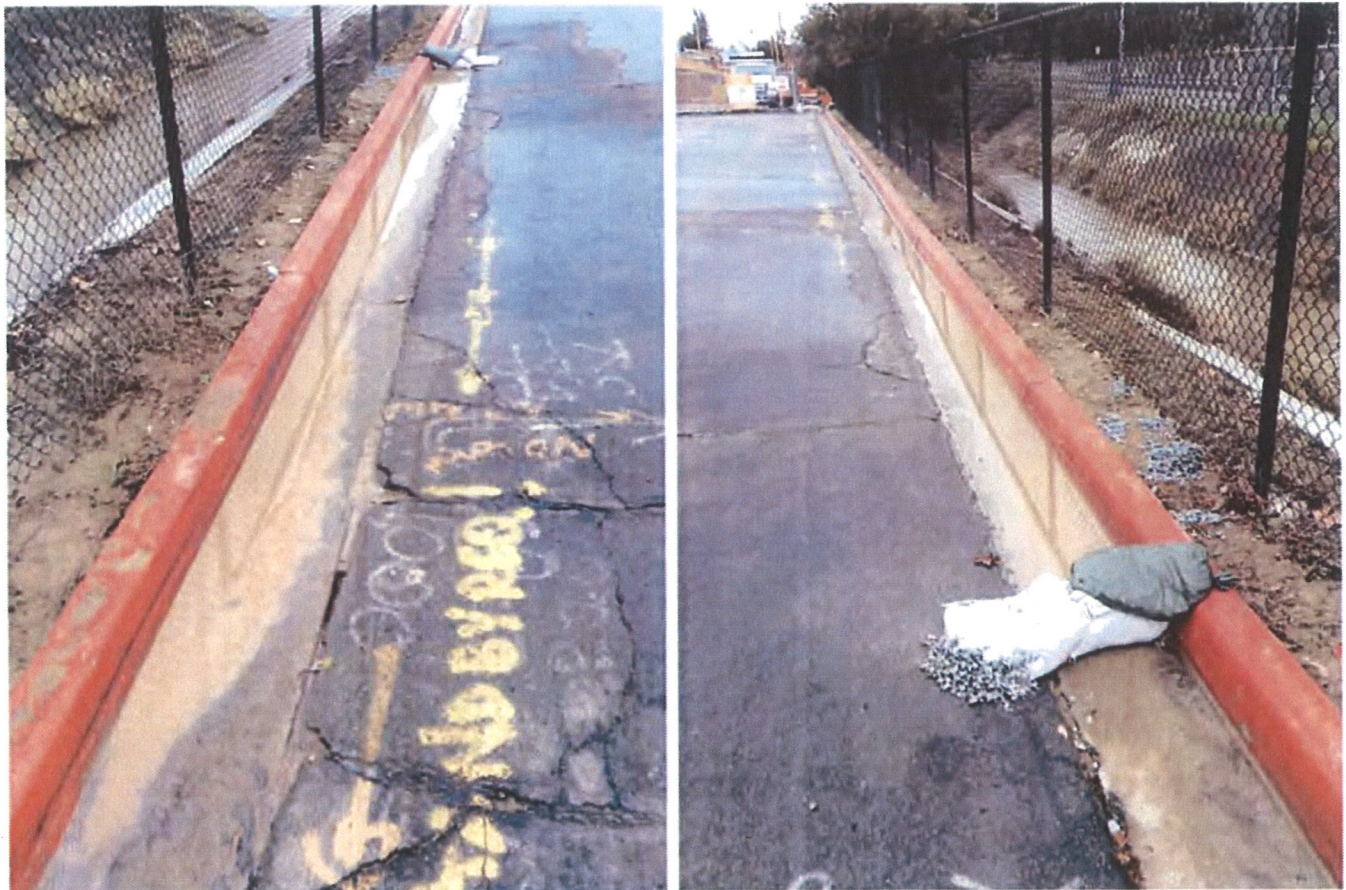
Ponded water was observed at the Akins Avenue entrance/exit location and behind several sets of gravel bags installed along Akins Avenue. Samples were collected from the ponded water at the Akins Avenue entrance/exit (Photo 1) and from ponded water behind the first set of gravel bags downstream of the Akins Avenue exit/entrance (Photos 2 and 3). Turbidity was measured at 250 NTU in the first sample (Akins entrance/exit), and 235 NTU in the second sample (first set of gravel bags along Akins).

Photos 2 & 3. Ponded Water at First Set of Gravel Bags Downstream of Akins Avenue Entrance/Exit (Looking downstream and upstream, respectively)

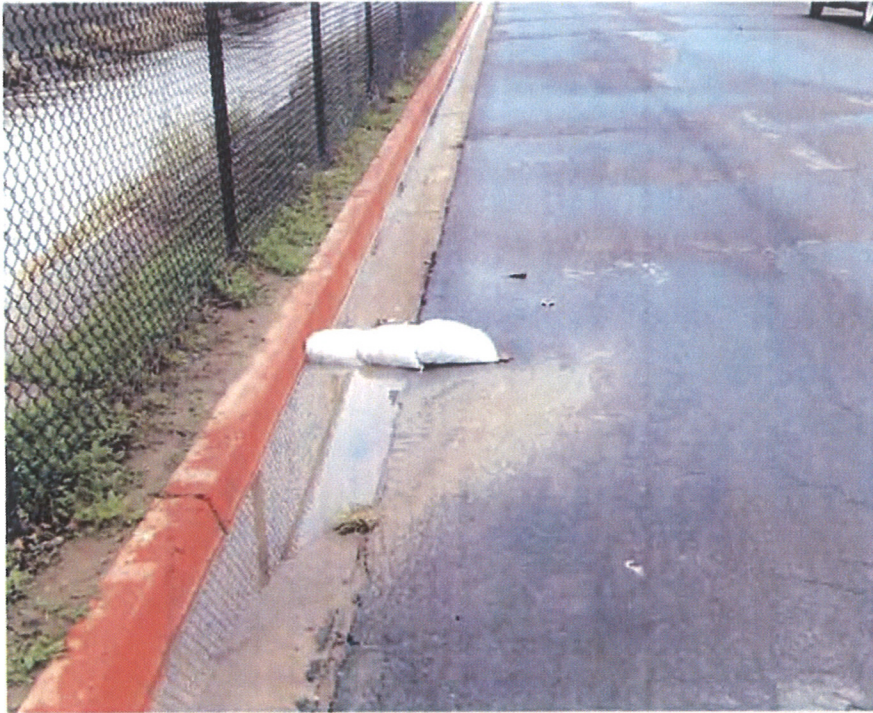
Observations farther downstream along the curb indicated that in some places sediment had been conveyed around gravel bag installations. Photo 4 gives an example of this. Sediment accumulation was also noted along Akins Avenue, close to the storm drain inlet.

Photo 4. Evidence of Discharge Carrying Sediment around Gravel Bags along Akins Avenue

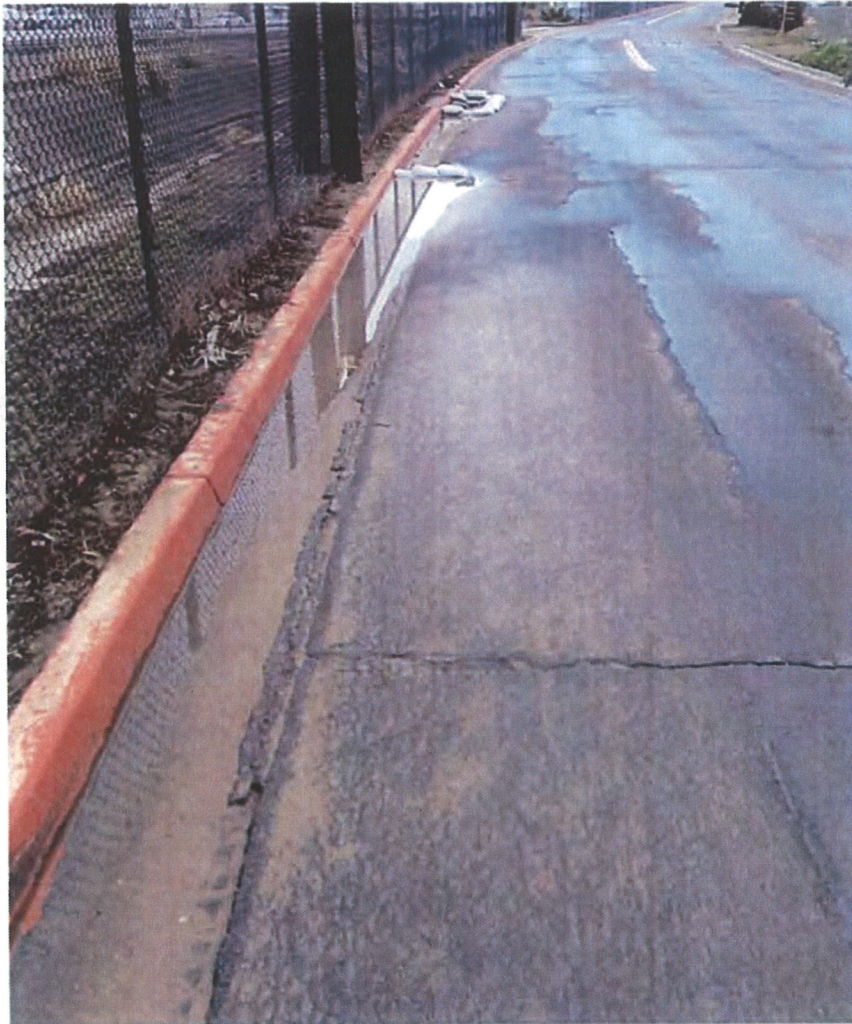
Photo 5. Sediment Accumulation along Akins Avenue, Close to Inlet

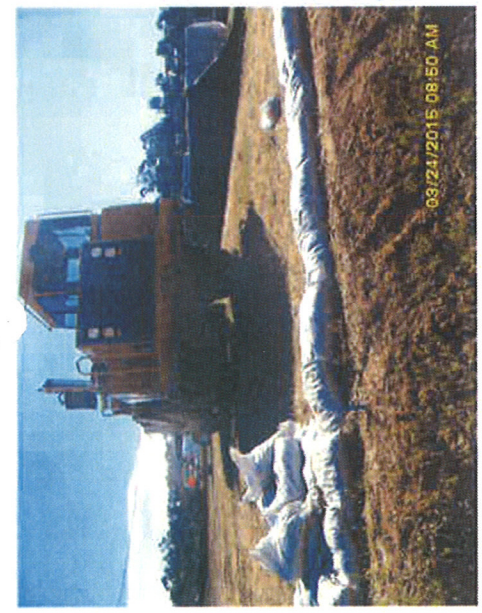
Failure to cover and provide secondary containment.

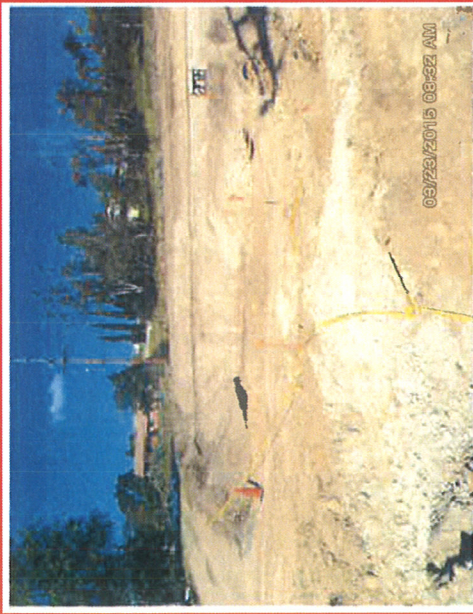
Lack of erosion controls in active areas.
