## ERRATA SHEET

2 Notice of Hearing and Issuance of  
Complaint No. R9-2015-0110 for  
Administrative Civil Liability against  
San Altos Lemon Grove, LLC for violations  
of Order No. 2009-0009-DWQ

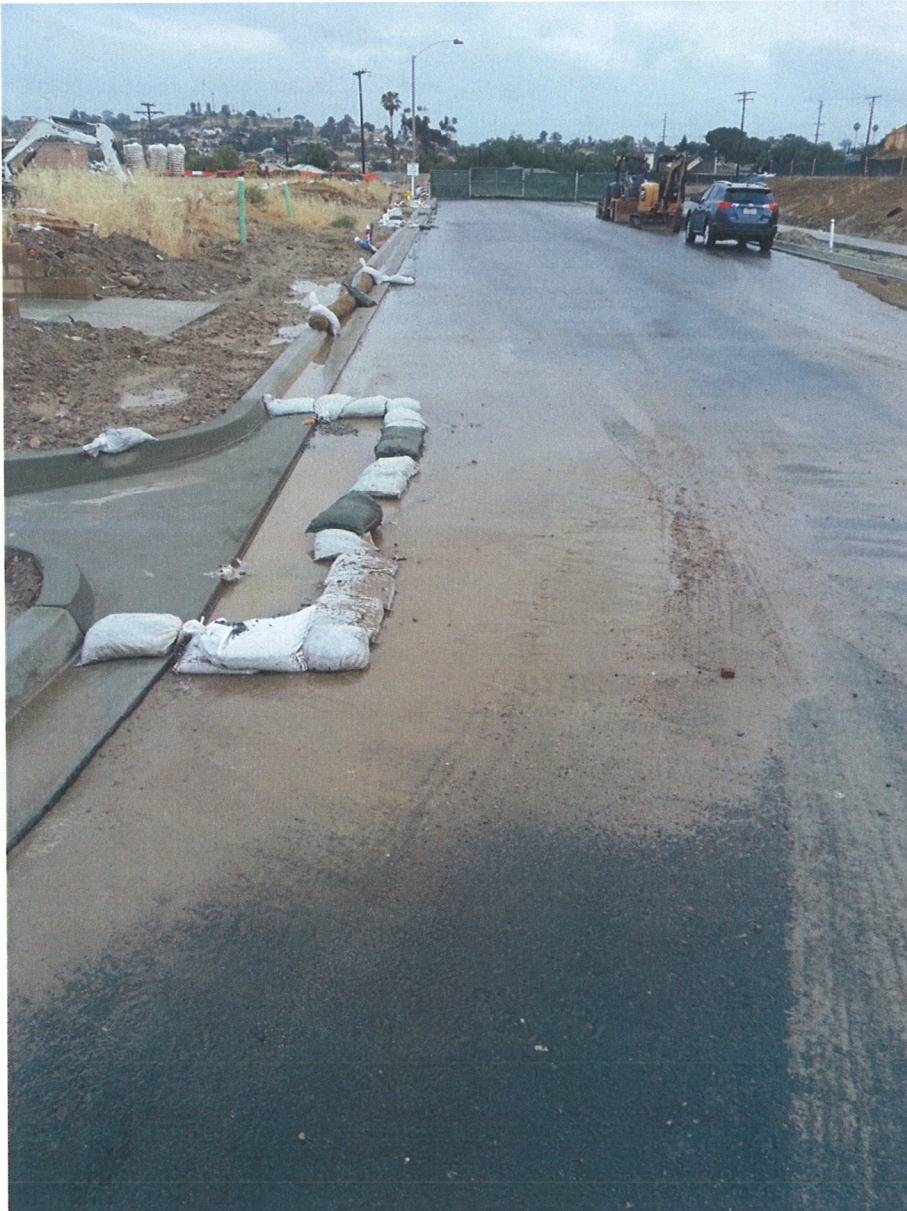
**Photograph No. 2:** 20150508\_191734.jpg, taken by Frank Melbourn, San Diego Water Board

**Photograph No. 2** looks southwest at Orlando Drive from San Altos Place. The photograph displays a **sediment discharge** from disturbed construction areas into the street. The photograph also displays unprotected (absent erosion control BMPs) disturbed soil and a lack of sediment controls above street gutters. The gravel bags deployed to protect the storm drain inlet were ineffective as evidenced by the turbid sediment laden storm water on the inside edges of the gravel bags. Again the use of gravel bag chevrons could have been implemented in the street.

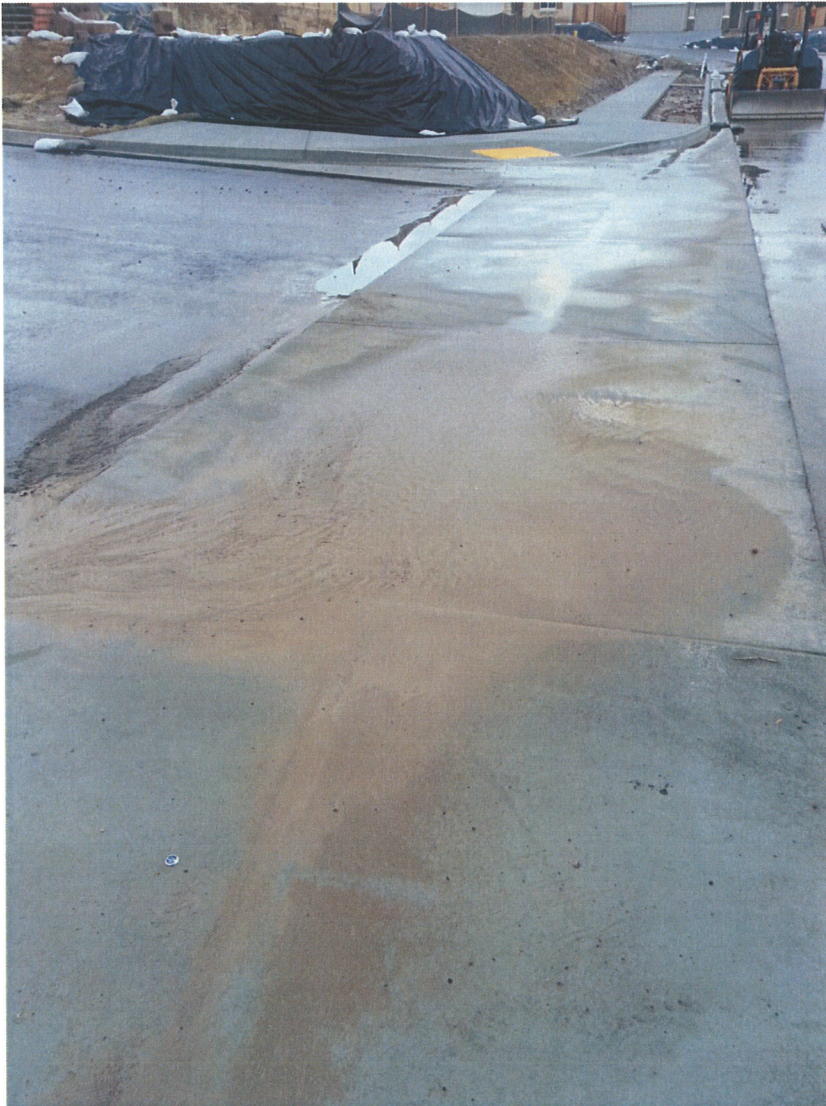
**Photograph No. 3:** 20150508\_191955.jpg, taken by Frank Melbourn, San Diego Water Board

**Photograph No. 3** looks northeast at the corner of Valencia Court and Orlando Drive from Orlando Drive. The photograph displays a **sediment discharge** from disturbed construction areas into the street. Except the area with plastic sheeting, displayed slopes in the photograph show signs of erosion, and were lacking erosion and sediment control BMPs at their base.

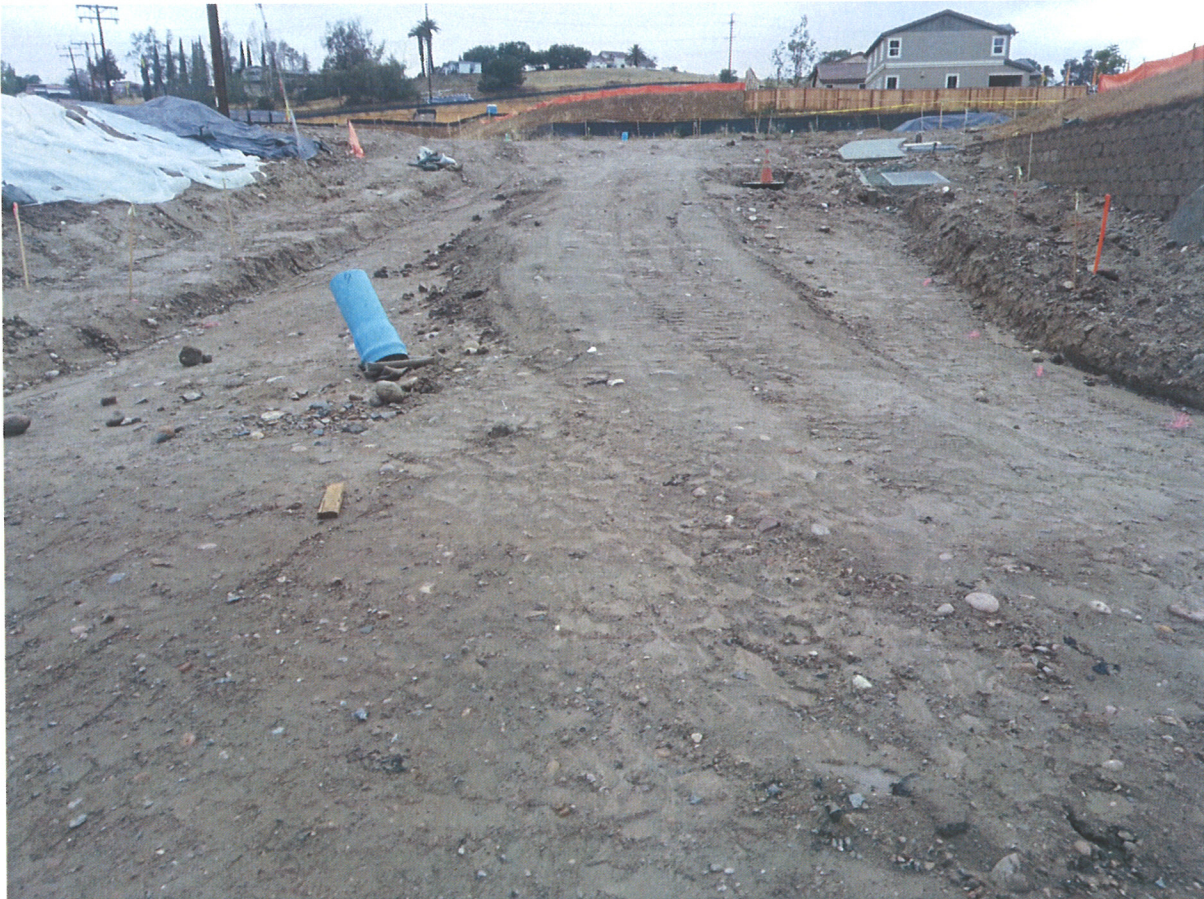
**Photograph No. 4:** 20150508\_192214.jpg, taken by Frank Melbourn, San Diego Water Board

**Photograph No. 4** looks northwest up Seville Way from Akins Avenue. The photograph displays disturbed soil without erosion control BMPs and sediment control BMPs.

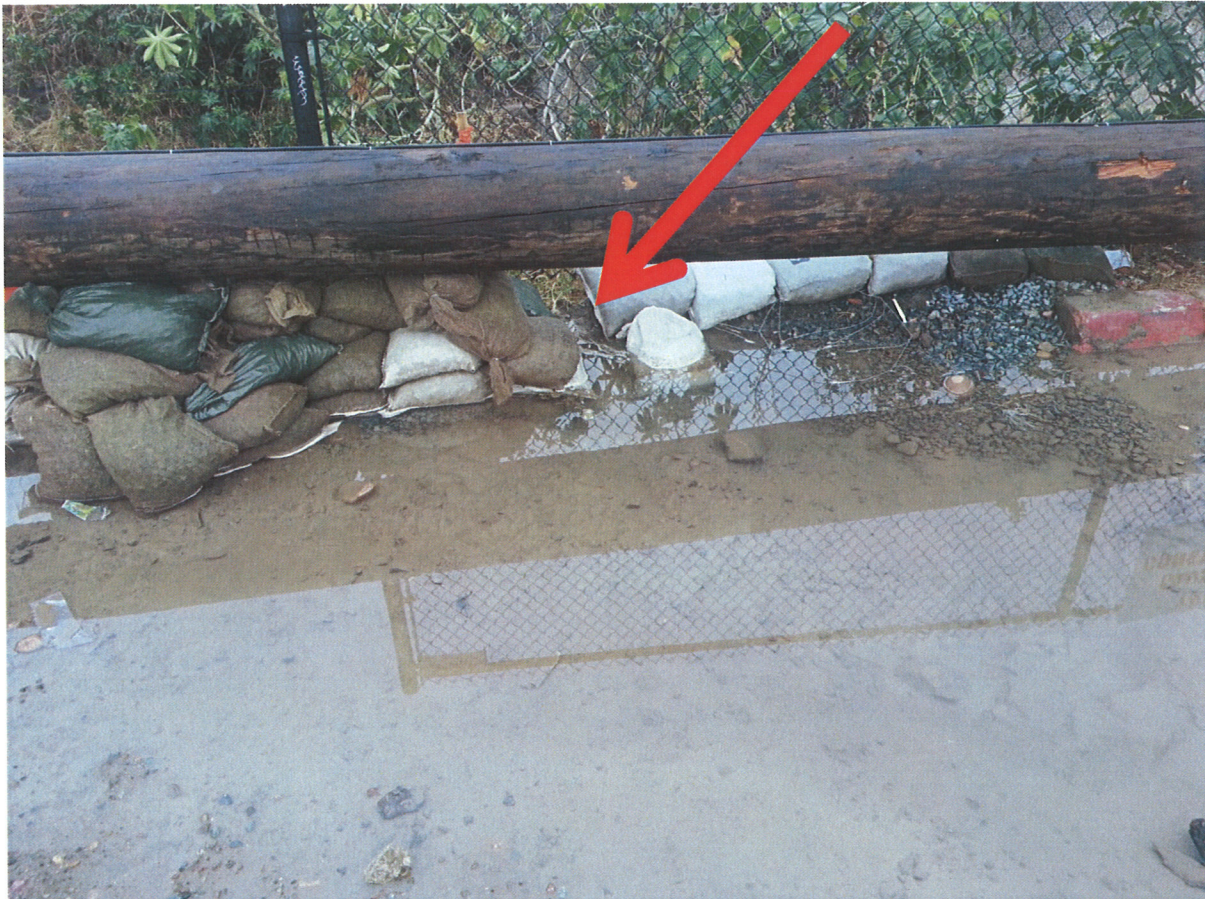
**Photograph No. 5:** 20150508\_192234.jpg, taken by Frank Melbourn, San Diego Water Board

**Photograph No. 5** looks southeast onto the unnamed tributary to Chollas Creek from the intersection of Seville Way and Akins Avenue. The photograph displays the **sediment discharge point** between the gap (identified by red arrow) in the site perimeter control BMPs into the unnamed tributary. A buildup of eroded sediment from the site can be seen at the base of the gravel bags.

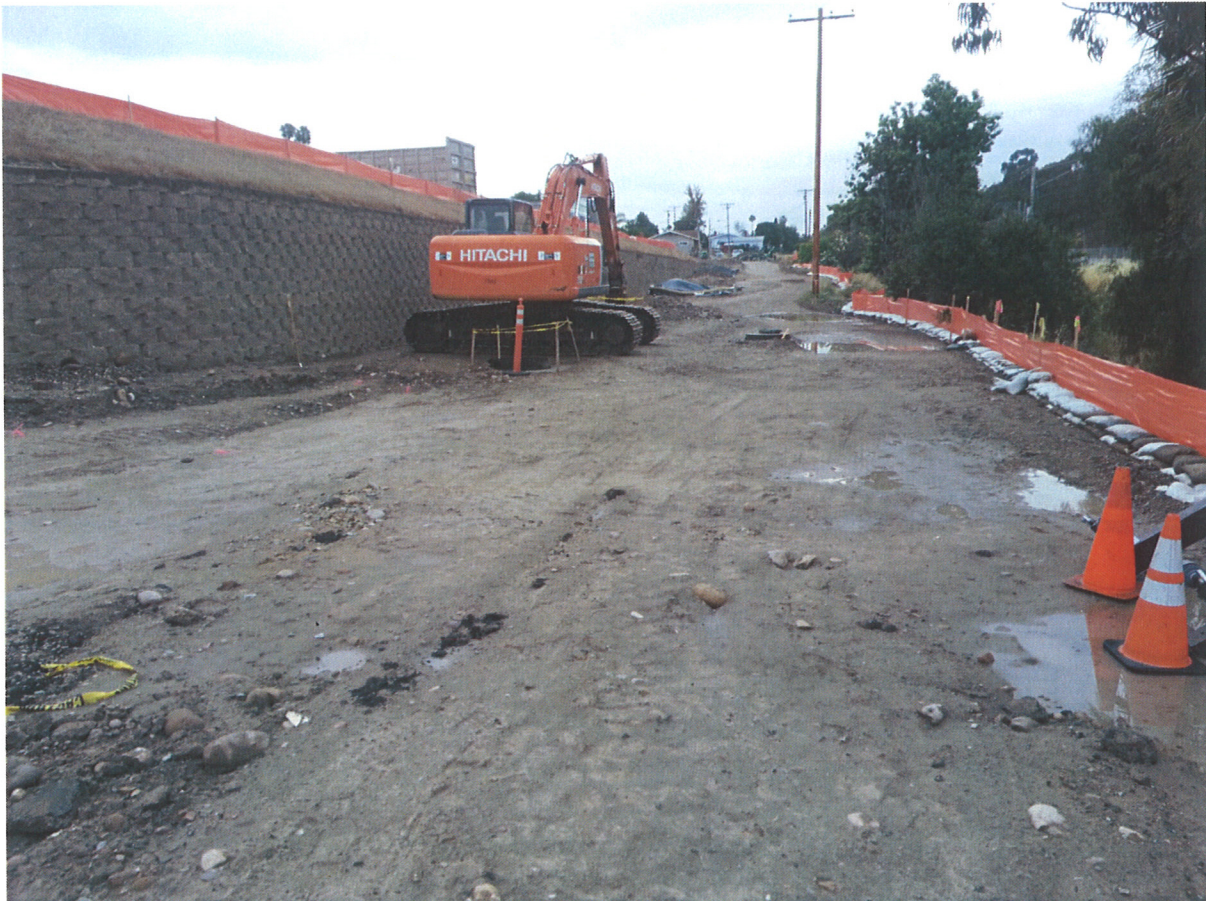
**Photograph No. 6:** 20150508\_192253.jpg, taken by Frank Melbourn, San Diego Water Board

**Photograph No. 6** looks northeast onto Akins Avenue from the intersection of Akins Avenue and Seville Way. The photograph displays disturbed soil **without erosion control BMPs** and **sediment control BMPs**. The photograph also displays perimeter control BMPs on the right hand side.

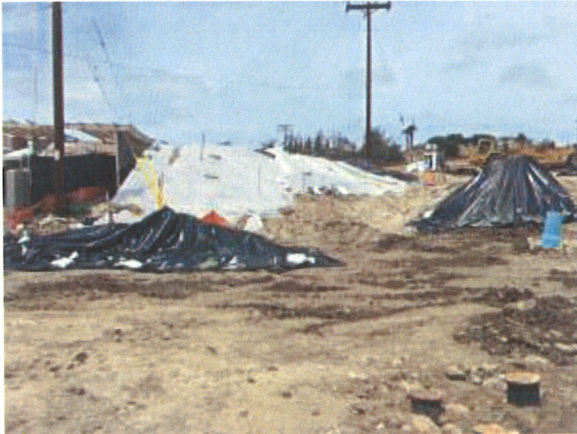
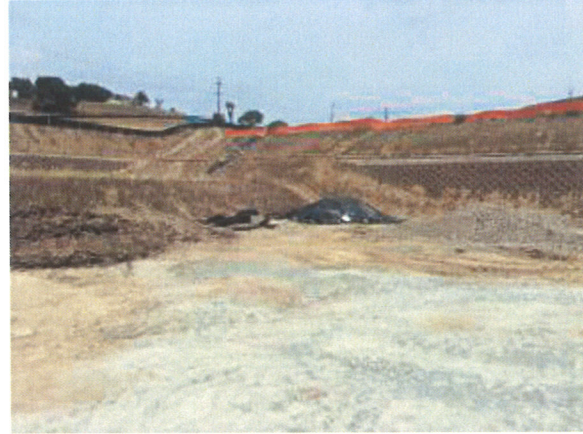
Photos 1 and 2 shows soil stockpiles covered with black plastic without adequate containment. Slope in Photo 1 covered with white plastic lacks linear sediment controls at the based and at grade break along top of slope.

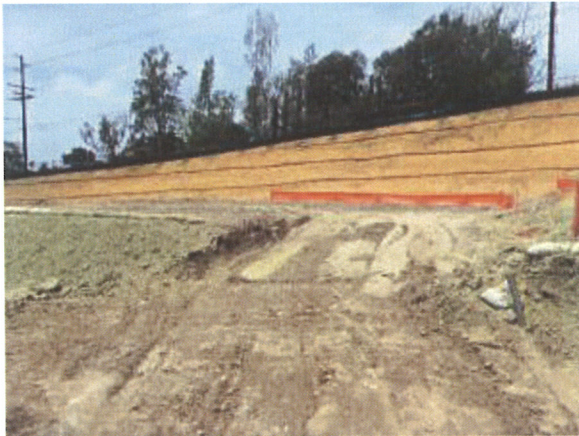
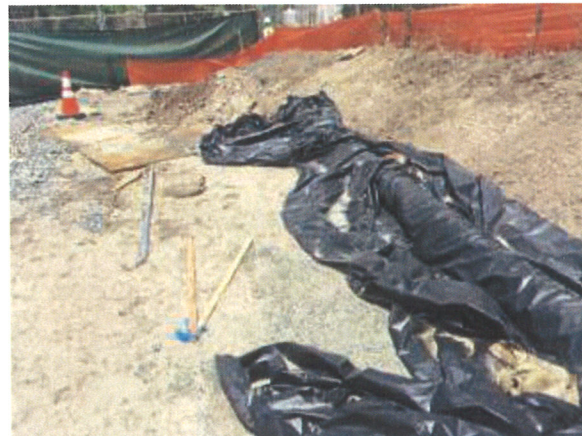
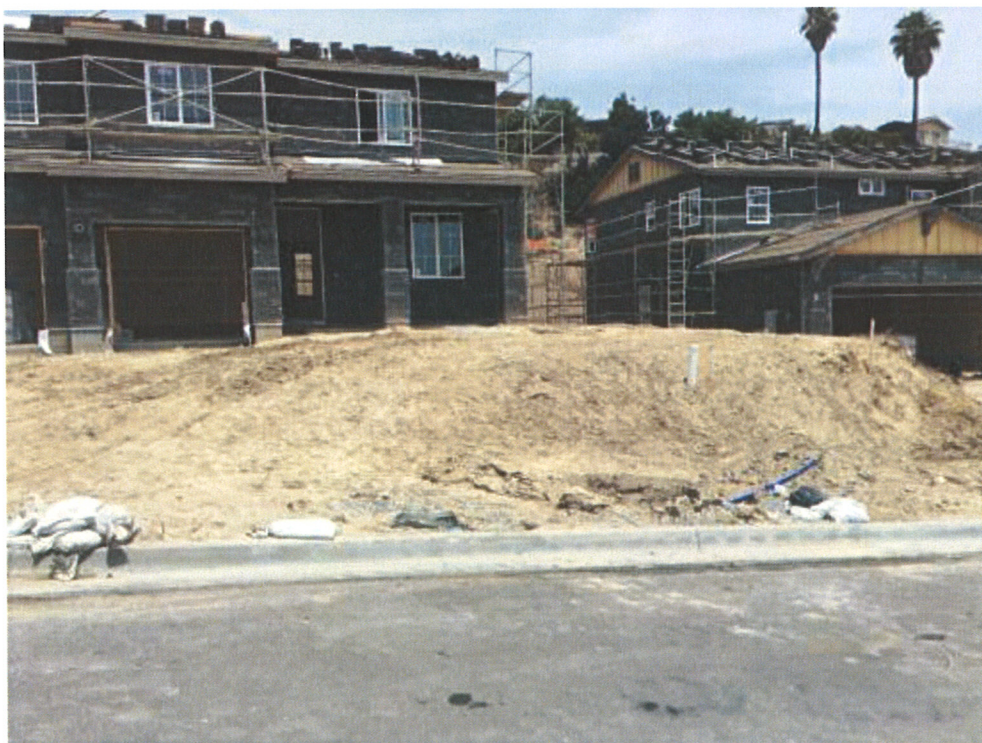
Photos 4 through 6 show several **inactive areas**, or areas that can be made to be inactive, **lacking any effective soil cover**. Photo 4 shows a completed lot that could have been stabilized with an effective soil cover and protected from activity. Photo 5 shows a slope that appeared to be inactive and potentially finished without effective soil cover. Photo 6 shows a slope in front of a building being constructed that could have been stabilized with an effective soil cover and made to be inactive.

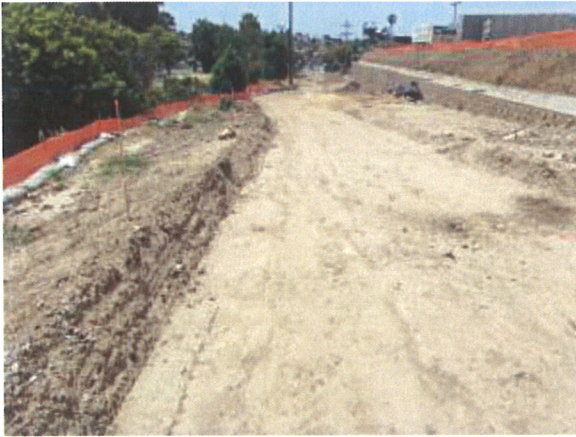
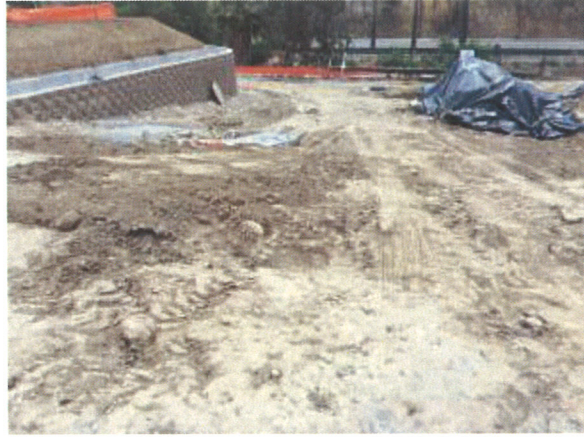
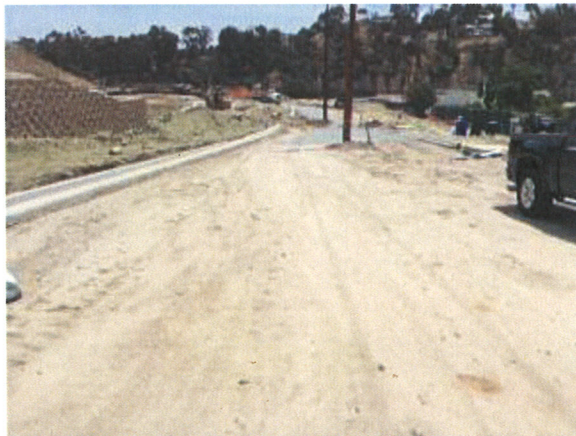
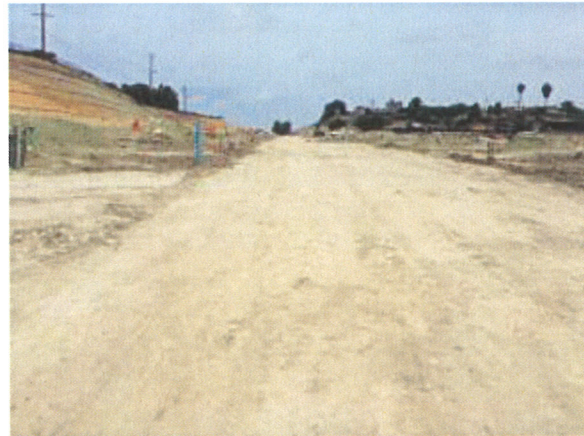
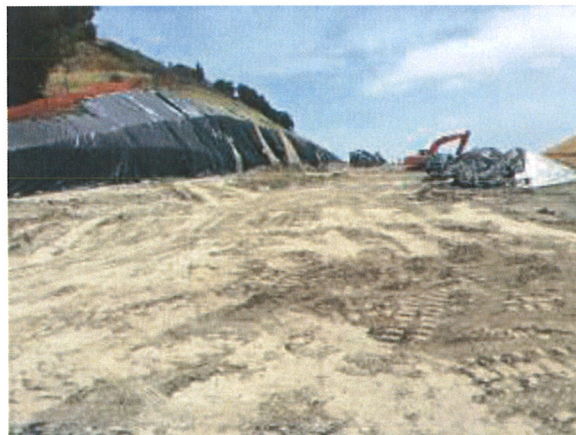
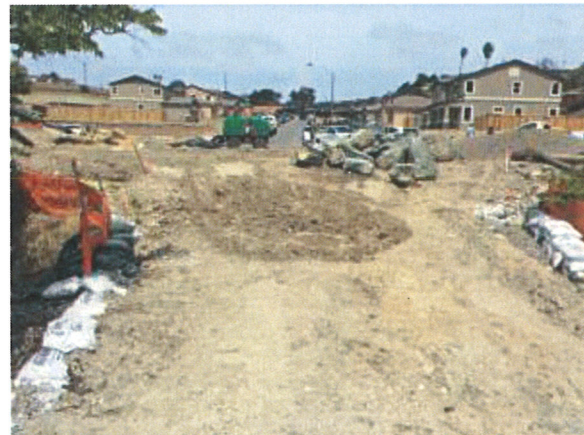
4. **Active areas** were observed to **lack appropriate erosion control BMPs** (runoff control and soil stabilization) to prevent erosion during storm events (See Photos 7 through 12). Risk Level 2 construction sites are required to implement appropriate erosion control BMPs (runoff control and soil stabilization) in conjunction with sediment control BMPs for areas under active construction.

Photos 9 through 12 showed several **active areas** of the site that **lacked** any evidence of **soil stabilization** measures ready to be implemented to reduce erosion potential or other measures to reduce sheet flow lengths. Photos 8, 9, 11, and 12 are slopes toward where runoff would flow toward a low point and perimeter of the site.

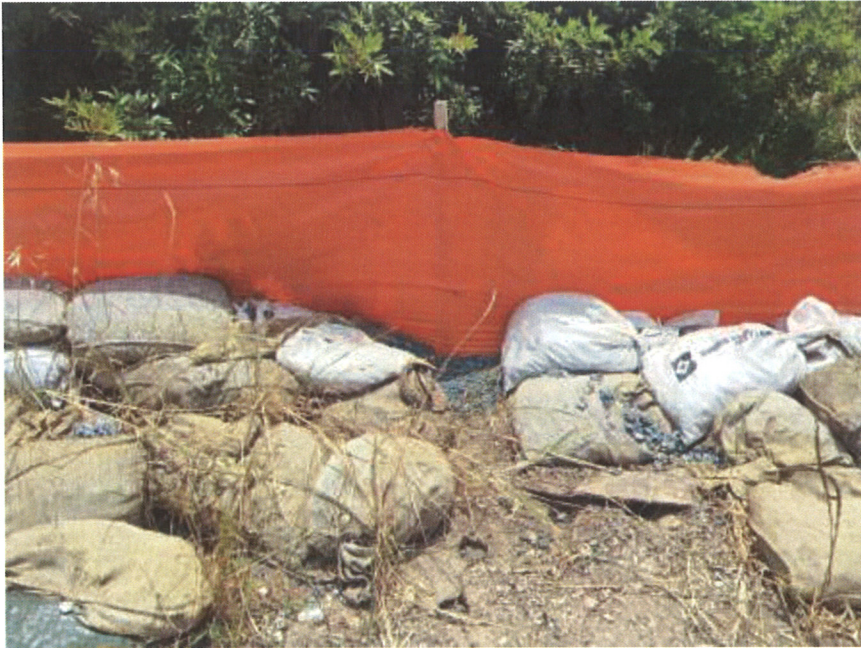
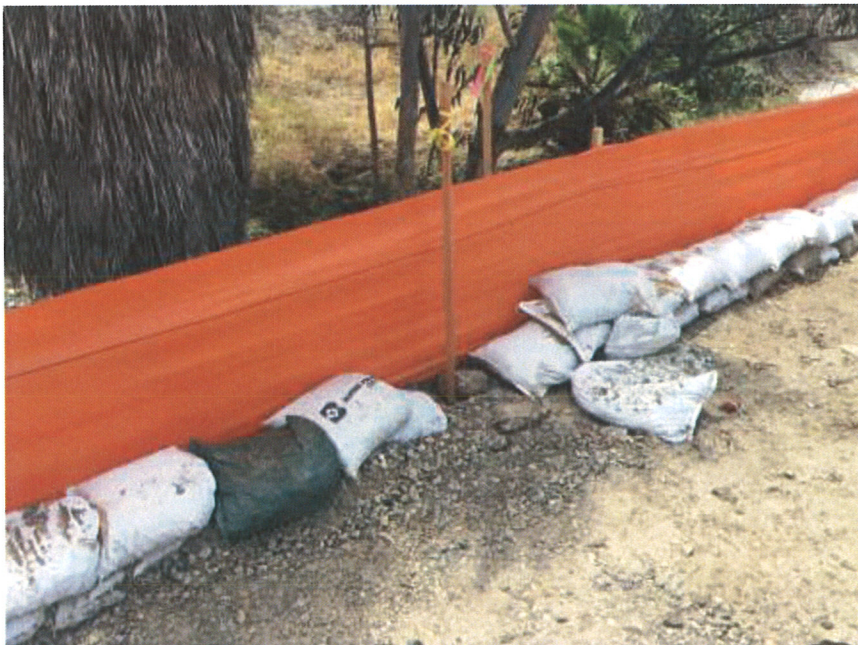
6. Lack of effective perimeter sediment controls observed (See Photos 13 and 14). All construction sites are required to establish and maintain effective perimeter controls and stabilize all construction entrances and exits to sufficiently control erosion and sediment discharges from the site.

**Photos 13 and 14** show areas of the perimeter where additional attention, repair, or maintenance is necessary to ensure the site has effective perimeter sediment controls to prevent erosion and sediment discharges from the site.

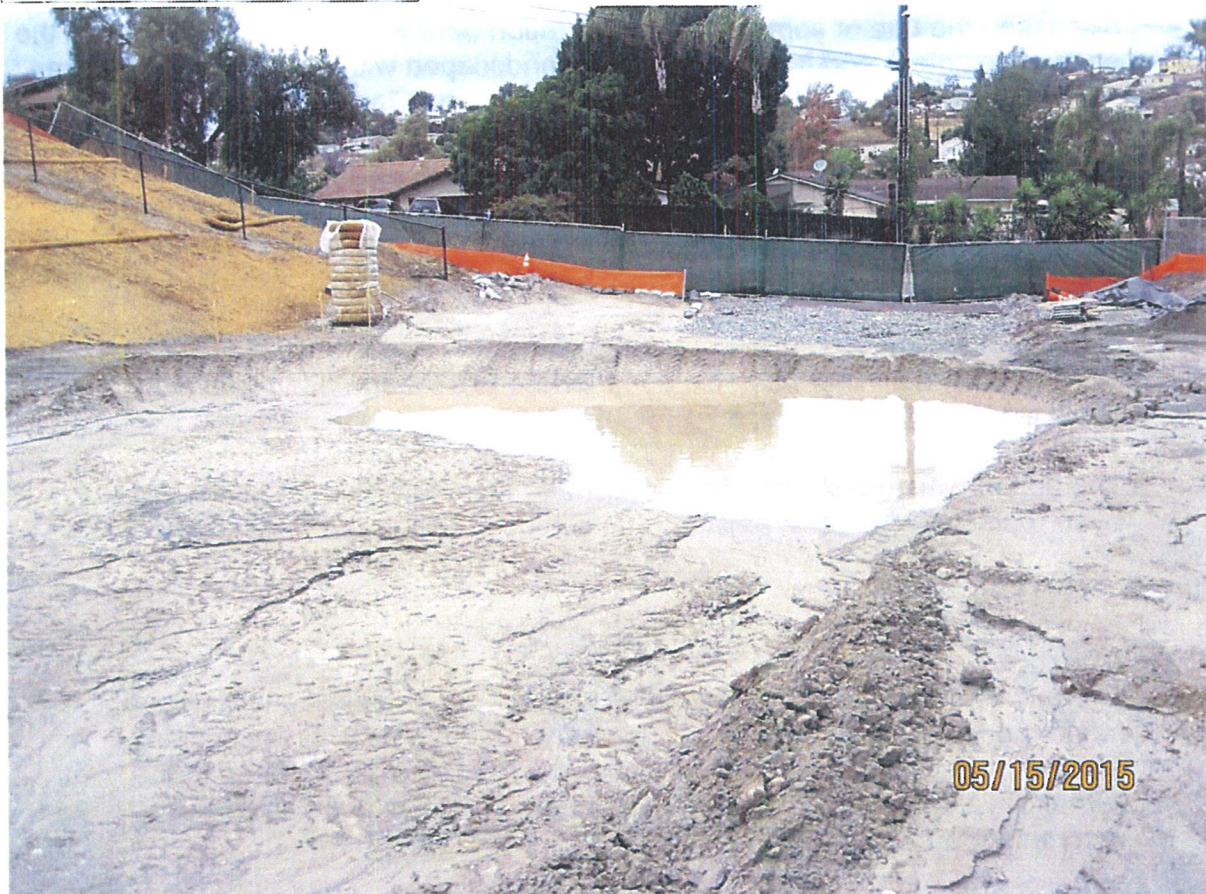
**Photograph No. 1:** IMG\_0350.jpg, taken by Frank Melbourn, San Diego Water Board

**Photograph No. 1** looks north from Tangelos Place onto Evelyn Street (behind green fence). The photograph displays an earthen berm holding back storm water runoff and eroded sediment. The soil on this side of the construction site is highly erosive. Sprayed erosion control can be seen on the slopes, as well as fiber rolls for sediment control. Large gravel and a rocker plate are installed at the site entrance as sediment controls. There was an **absence of erosion controls** on the graded street. There were **no sediment controls** but for the earthen berm.

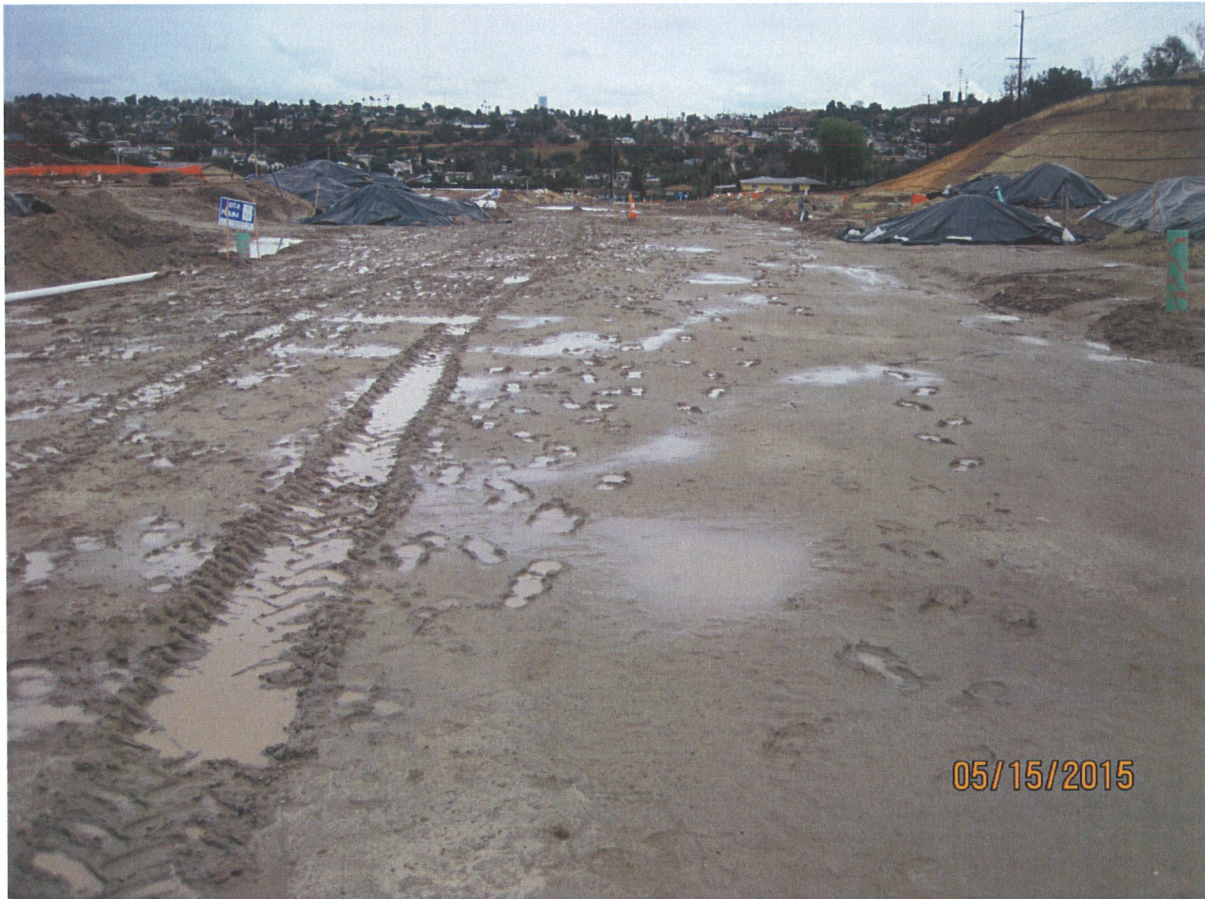
**Photograph No. 2:** IMG\_0354.jpg, taken by Frank Melbourn, San Diego Water Board

**Photograph No. 2** looks south down Tangelos Place. The photograph displays a muddy thoroughfare without erosion and sediment control measures. Some, but not all of the stockpiles are covered with black plastic.

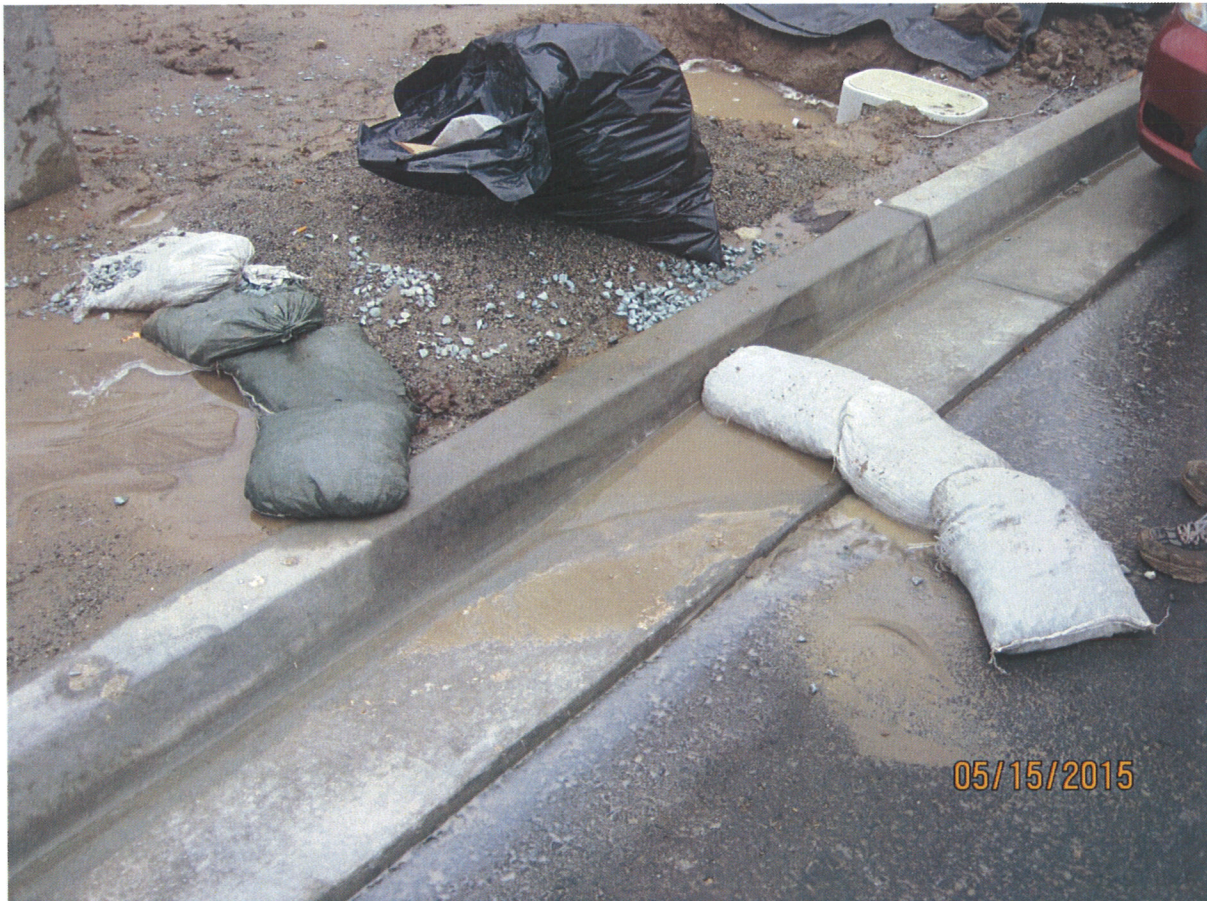
**Photograph No. 3:** IMG\_0356.jpg, taken by Frank Melbourn, San Diego Water Board

**Photograph No. 3** looks southeast down Avalon Way. The photograph displays sediment buildup behind a gravel back chevron or check dam in the gutter. Gravel bags were also used as sediment controls on this house lot to decrease the sediment discharge to the curb. The downhill storm drain inlet is connected to an on-site sediment basin. Spraying a soil stabilizer on the graded housing pads would reduce the erosive threat and sediment load to the street and basin.

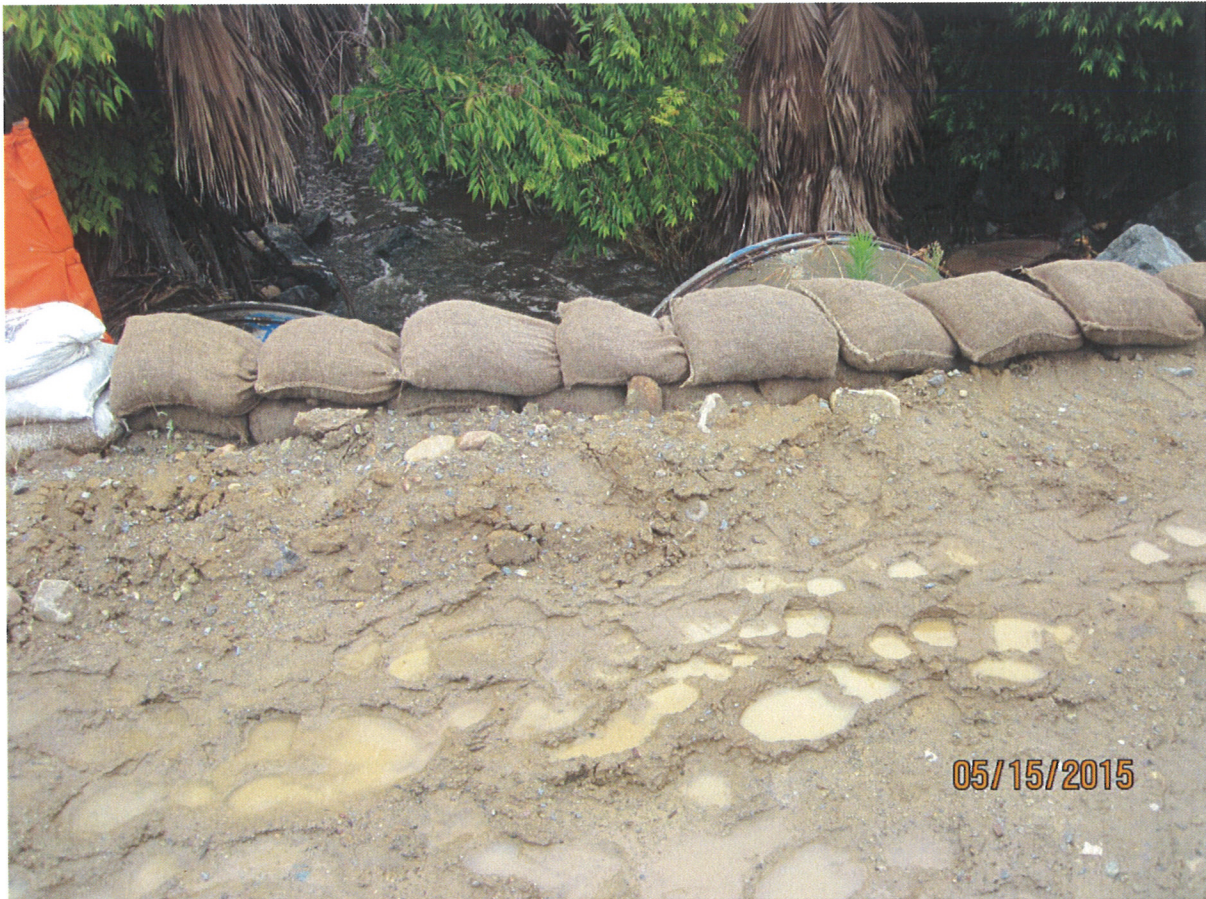
**Photograph No. 4:** IMG\_0359.jpg, taken by Frank Melbourn, San Diego Water Board

**Photograph No. 4** looks northeast and upstream of the creek from the creek crossing near the San Altos Place entrance. The photograph displays the addition of a row of gravel bags to reduce the likelihood of a sediment discharge to the creek. Spraying the area with a soil stabilizer would greatly reduce the threat of a sediment discharge to the creek.

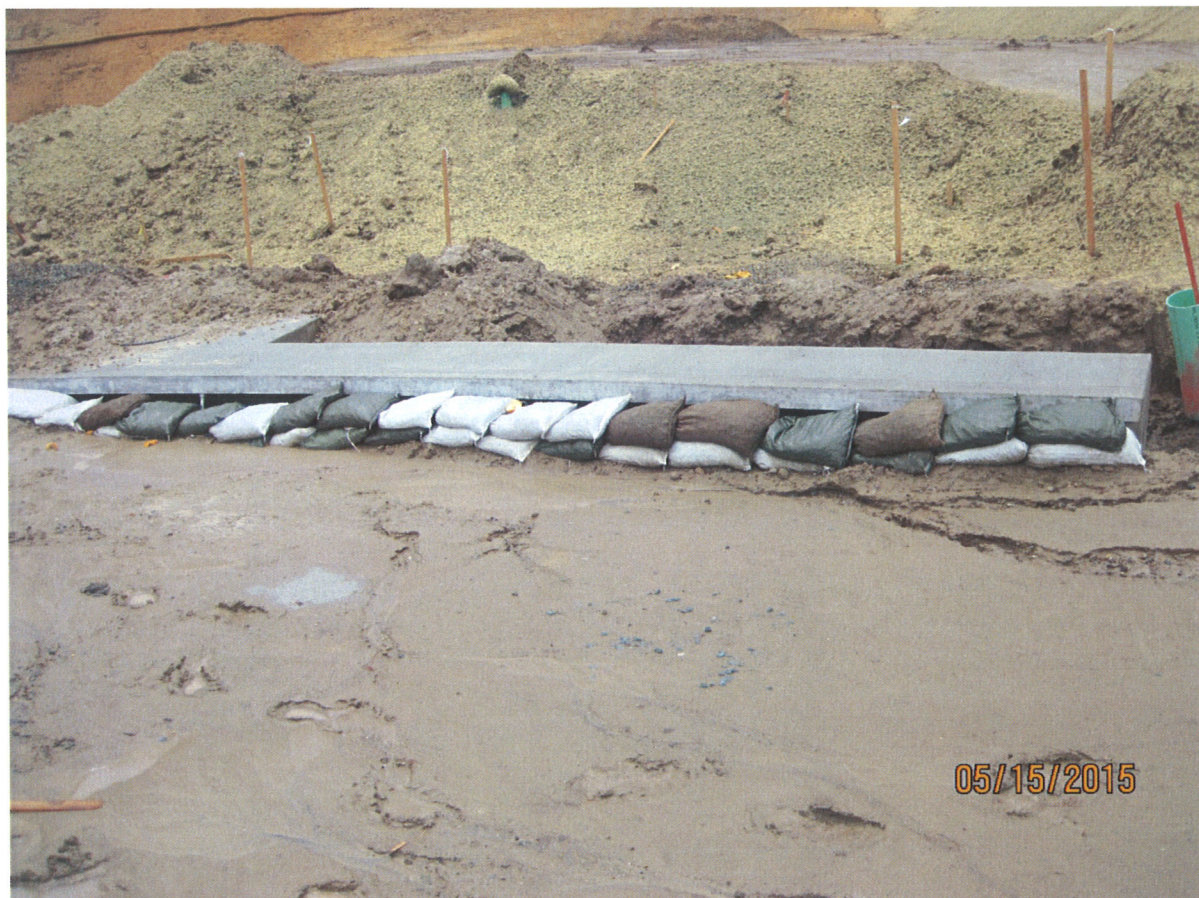
**Photograph No. 5:** IMG\_0366.jpg, taken by Frank Melbourn, San Diego Water Board

**Photograph No. 5** looks west from the south end of Tangelos Place at a storm drain inlet protected with gravel bags. There are no erosion or sediment control measures on Tangelos Place. Erosion rills and sediment buildup are displayed.

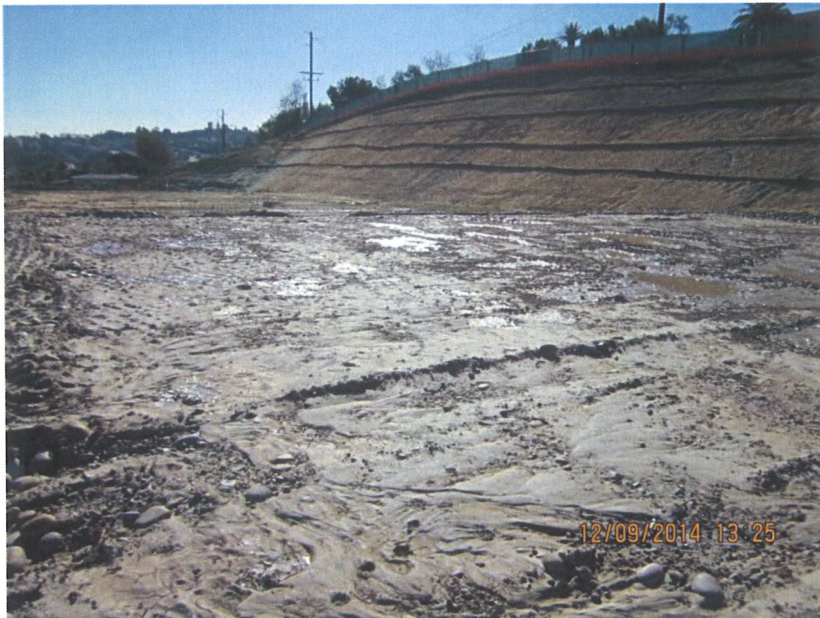
Gravel bag inlet protection BMPs were not always in place	Gravel bags were put in place to protect on-site and downstream off-site inlets.
Filter fabric used as part of inlet protection became potentially clogged by hydroseeding materials	Filter fabric was replaced.
Stockpiles were placed close to a drain inlet. The inlet is elevated above the ground height in that area, decreasing the risk of discharge, but stockpiles still need to be relocated away from the drain.	This deficiency was first observed on January 6. On January 14, the stockpiles had been covered, but they had not been moved sufficiently far enough away from the drain inlet. The developer is still required to address this item.
Sediment control BMPs were lacking or damaged in places.	A significant amount of additional silt fences and gravel bags were added to the site perimeter and the perimeters of lots.

Photo 1. Lot lacking erosion control BMPs

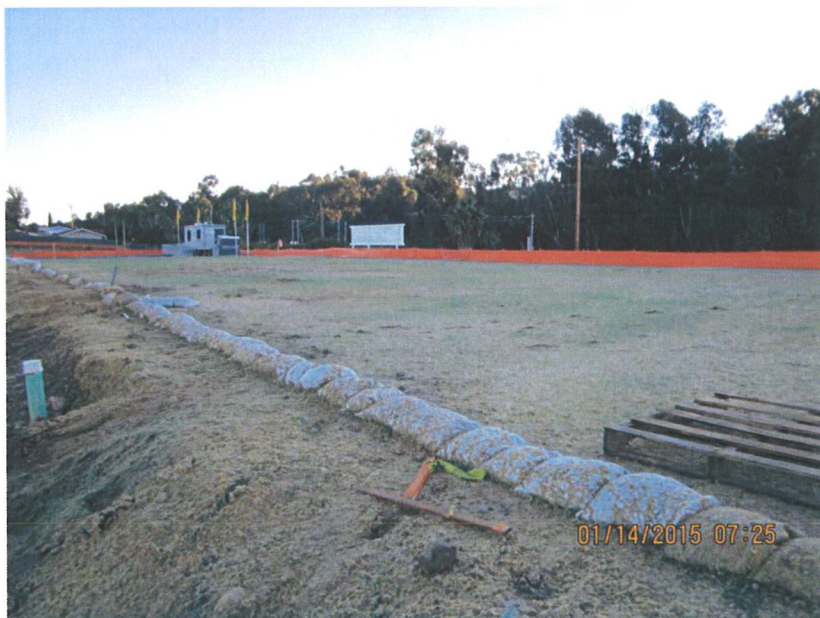
Photo 2. Hydroseed added to a lot

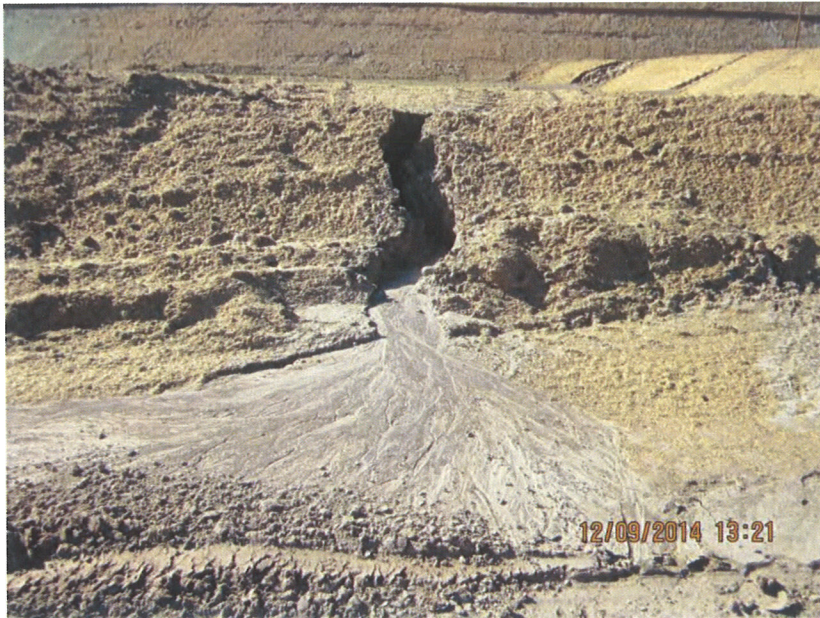
Photo 3. Evidence of erosion at edge of a lot

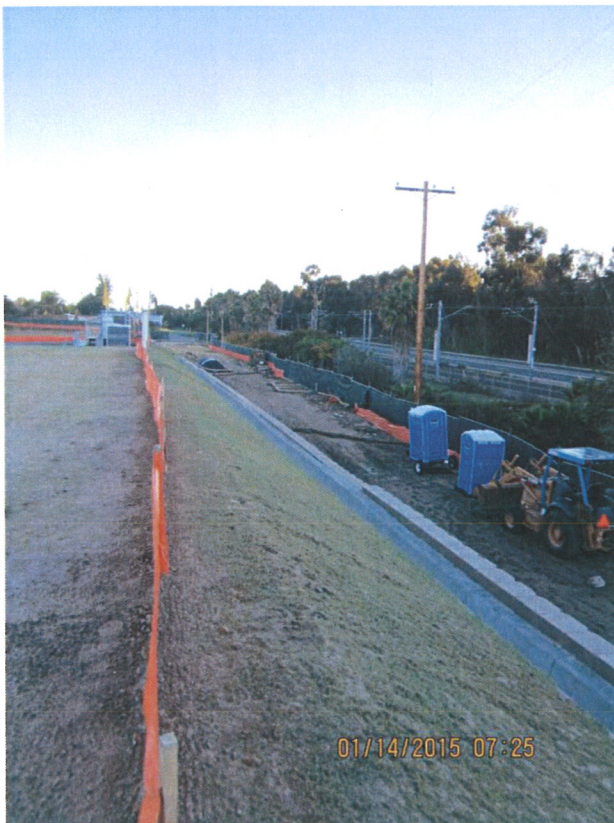
Photo 4. Rills filled in, area re-hydroseeded, silt fence added to perimeter of lot.

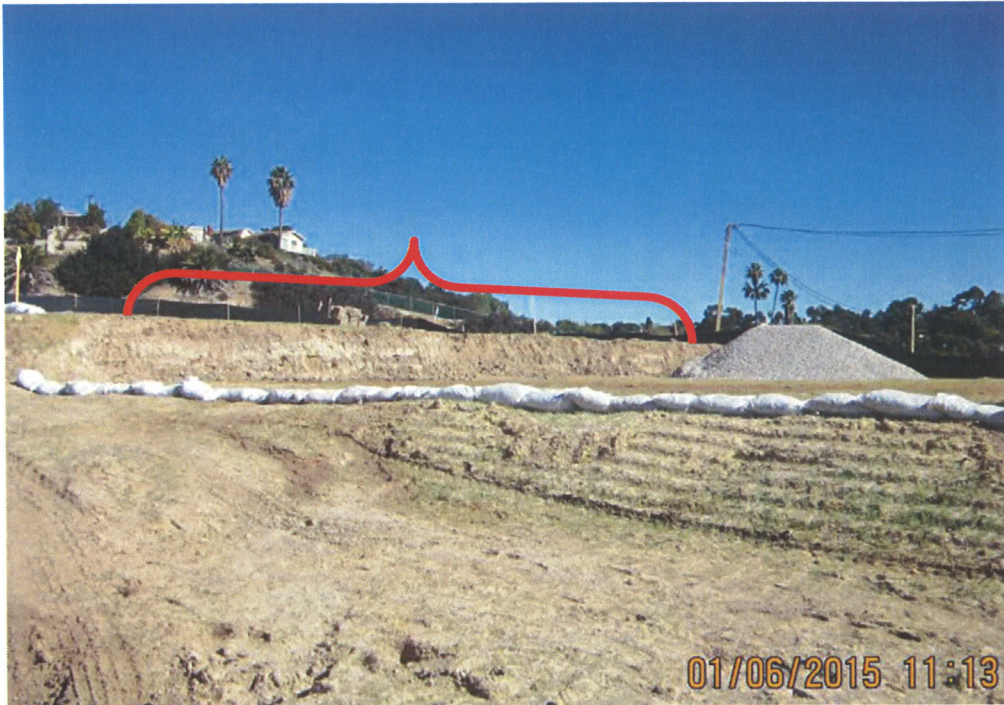
Photo 5. Sidewall without adequate erosion control

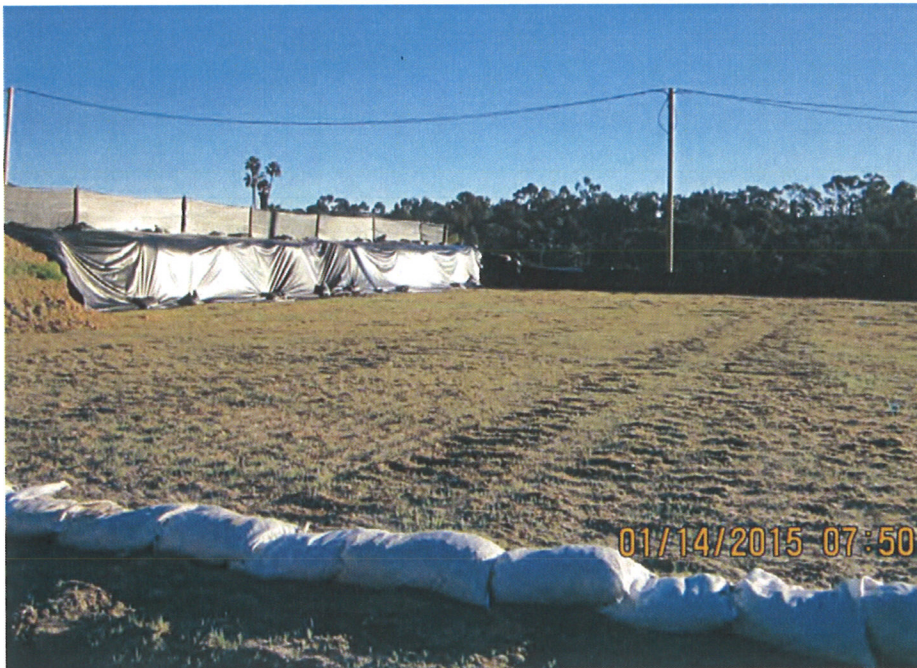
Photo 6 Sidewall protected with plastic sheeting.

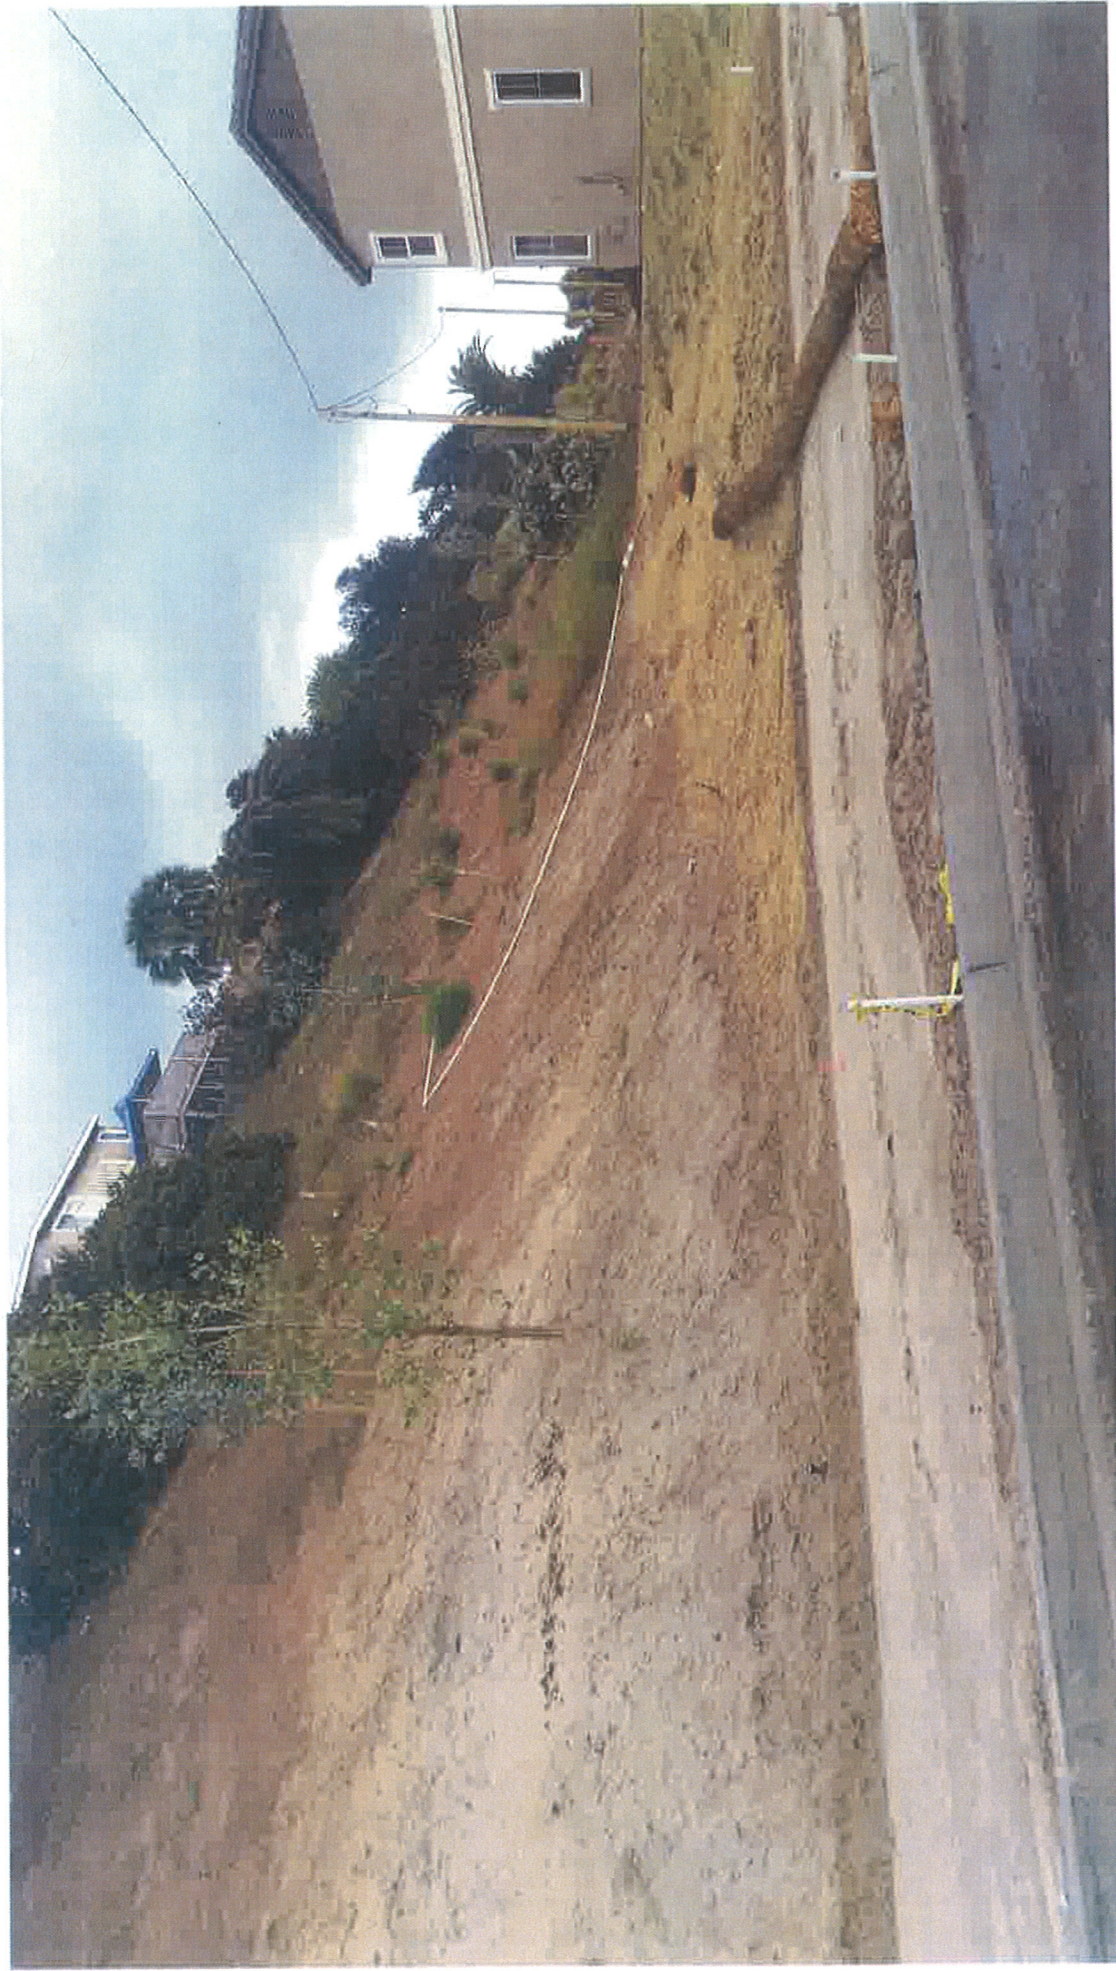
Erosion / sediment control Valencia Dec 5, 2015
