## ERRATA SHEET

2 Notice of Hearing and Issuance of  
Complaint No. R9-2015-0110 for  
Administrative Civil Liability against  
San Altos Lemon Grove, LLC for violations  
of Order No. 2009-0009-DWQ

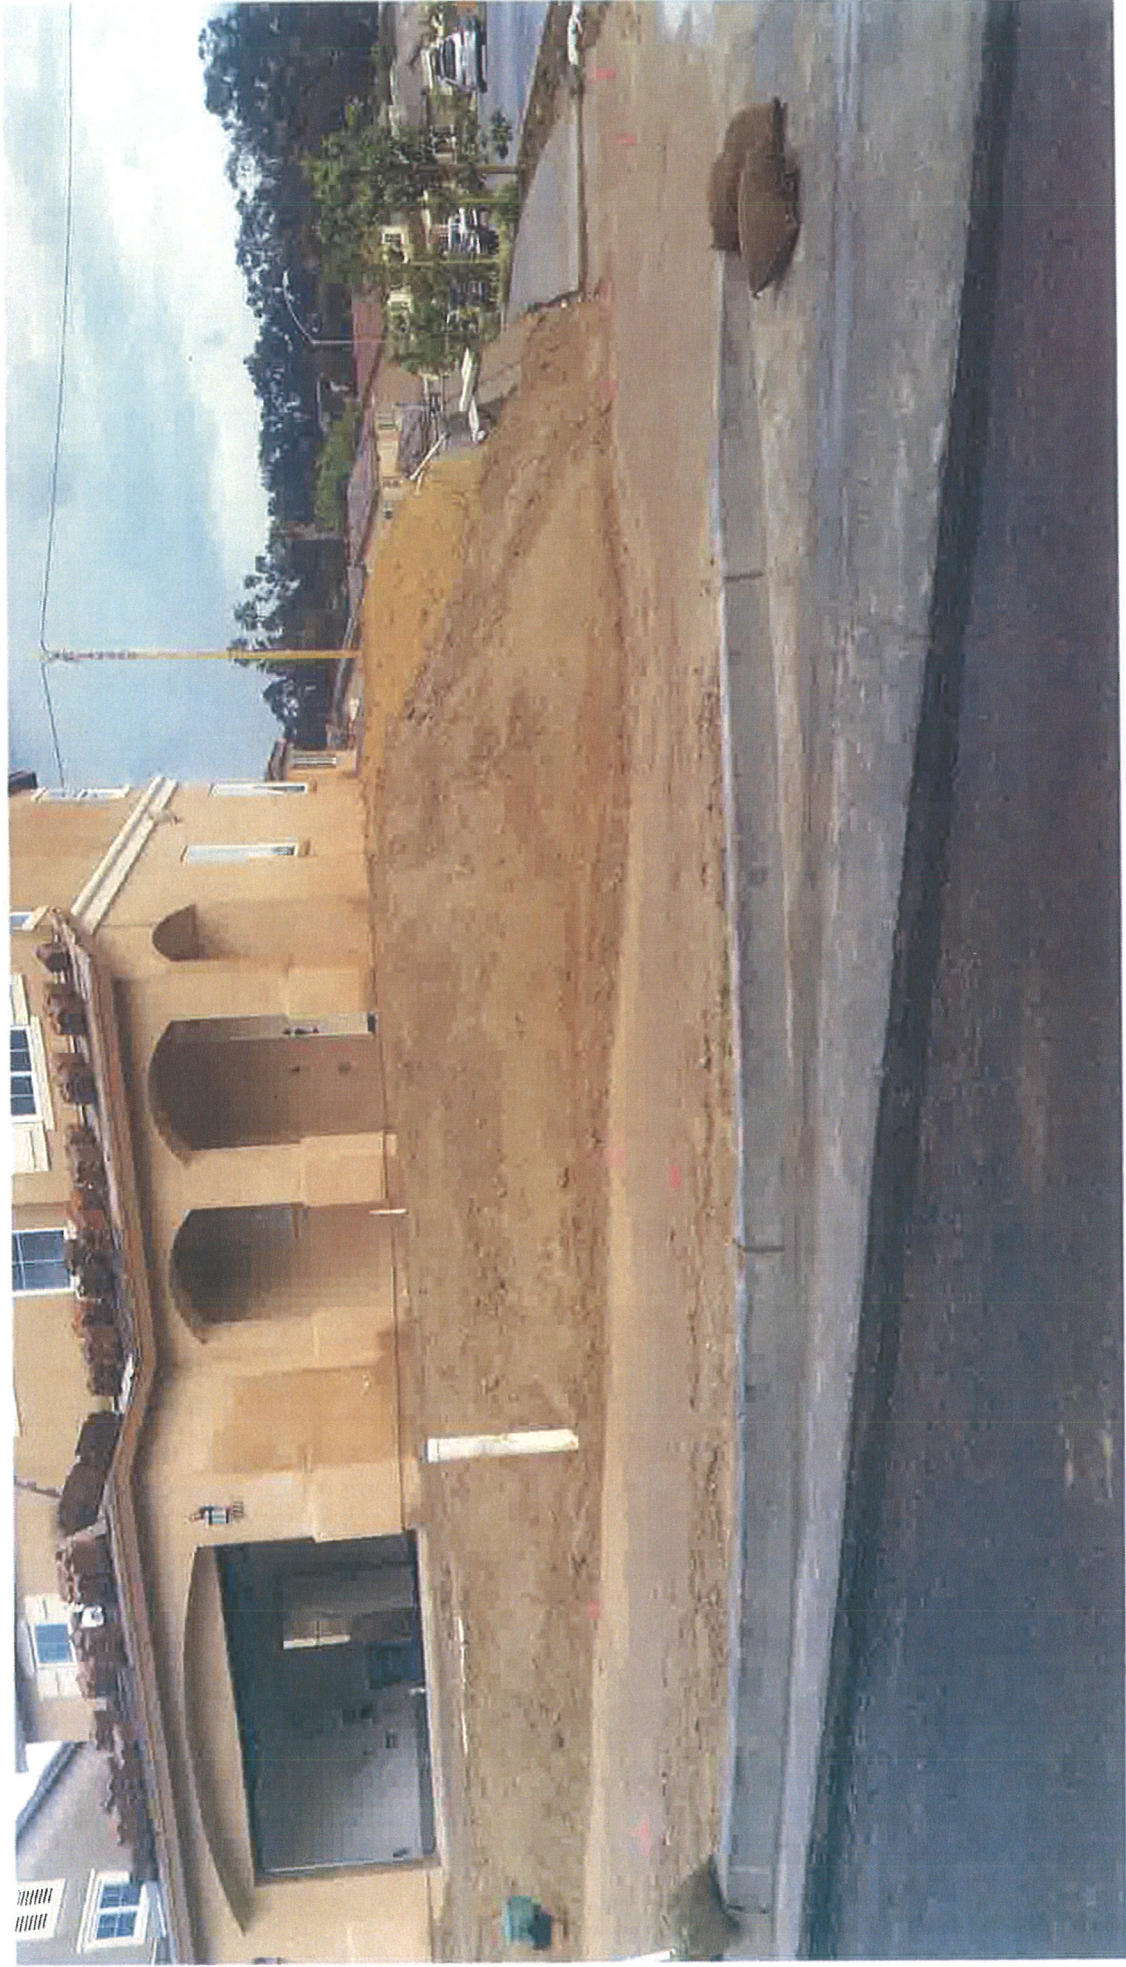
Erosion Control / Stockpile Valencia Oct 5, 2015

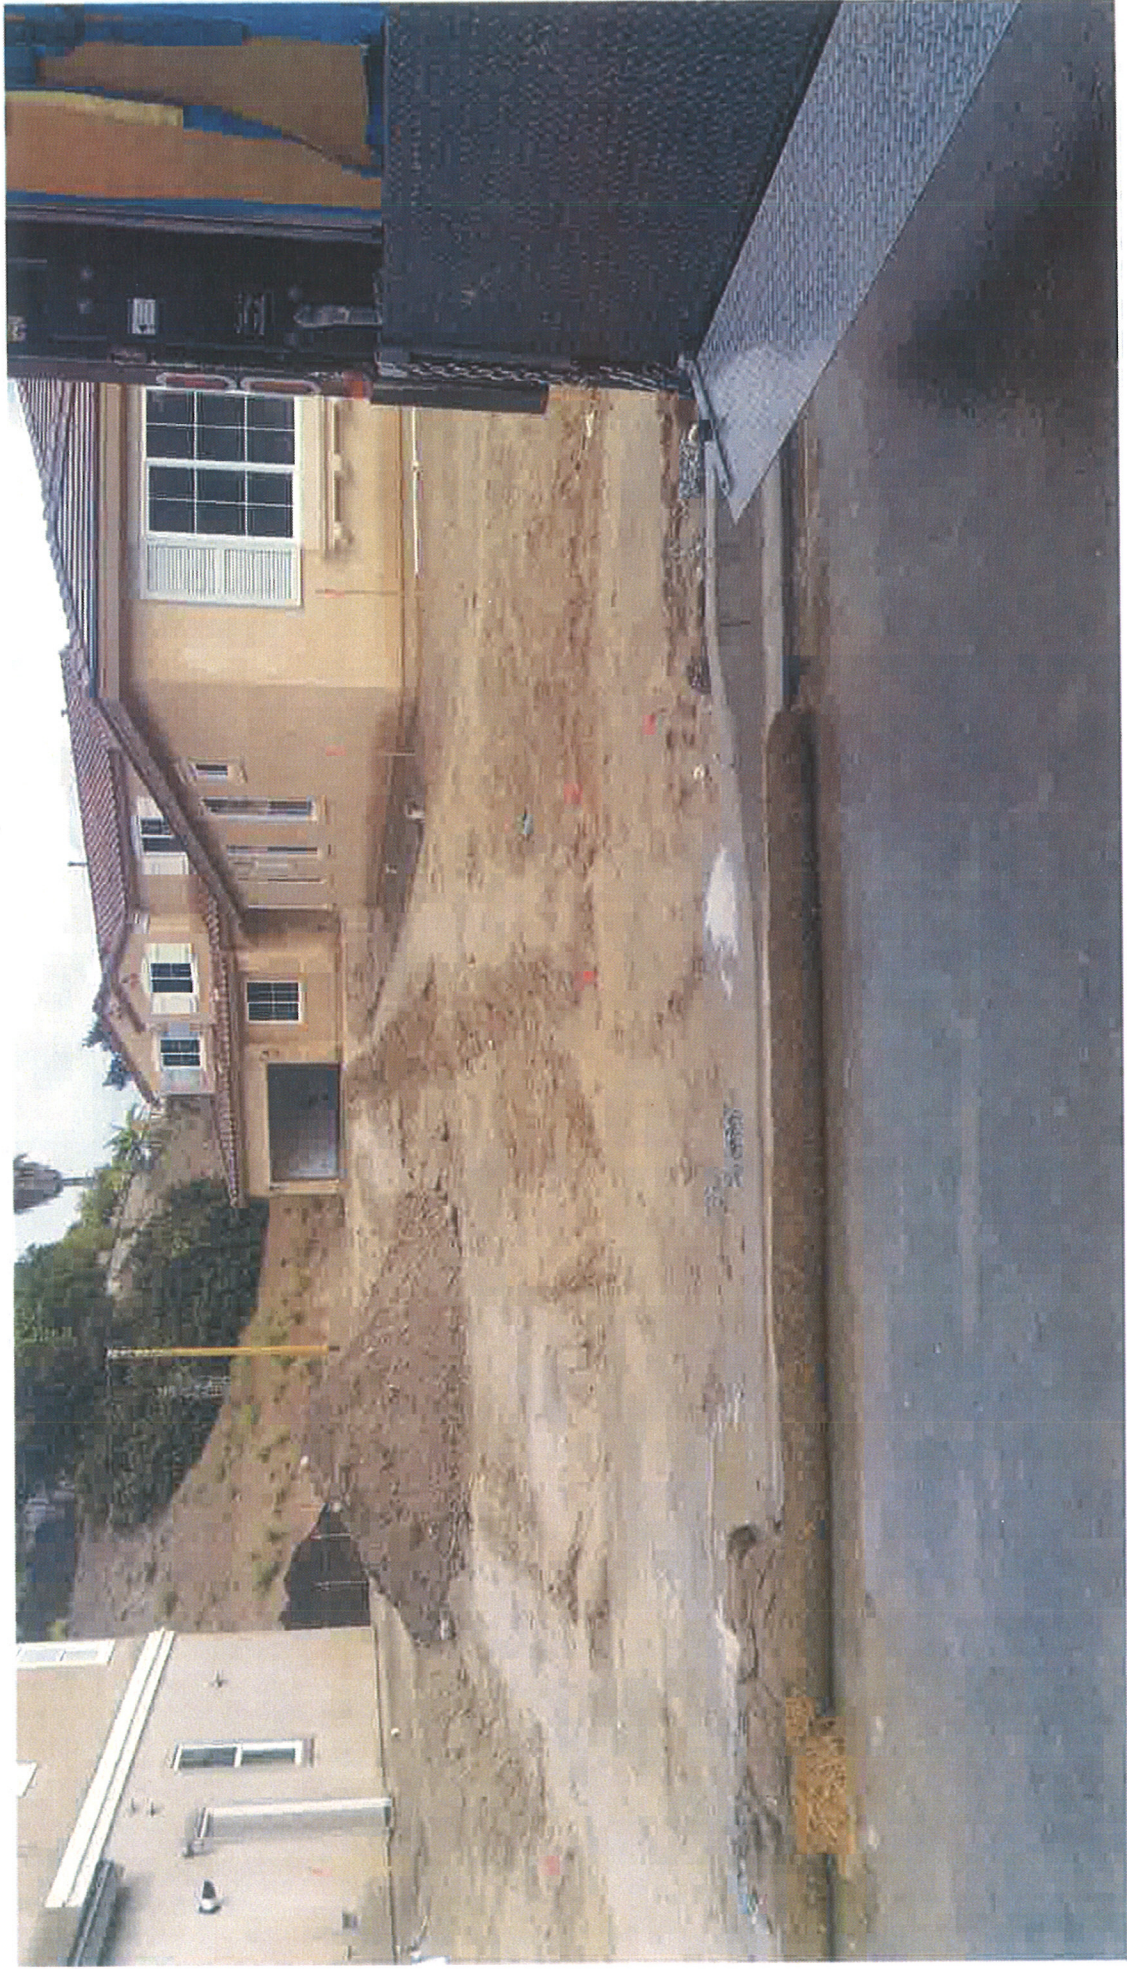
Valencia Oct 5, 2015 Failure to maintain Banks, Erosion Control

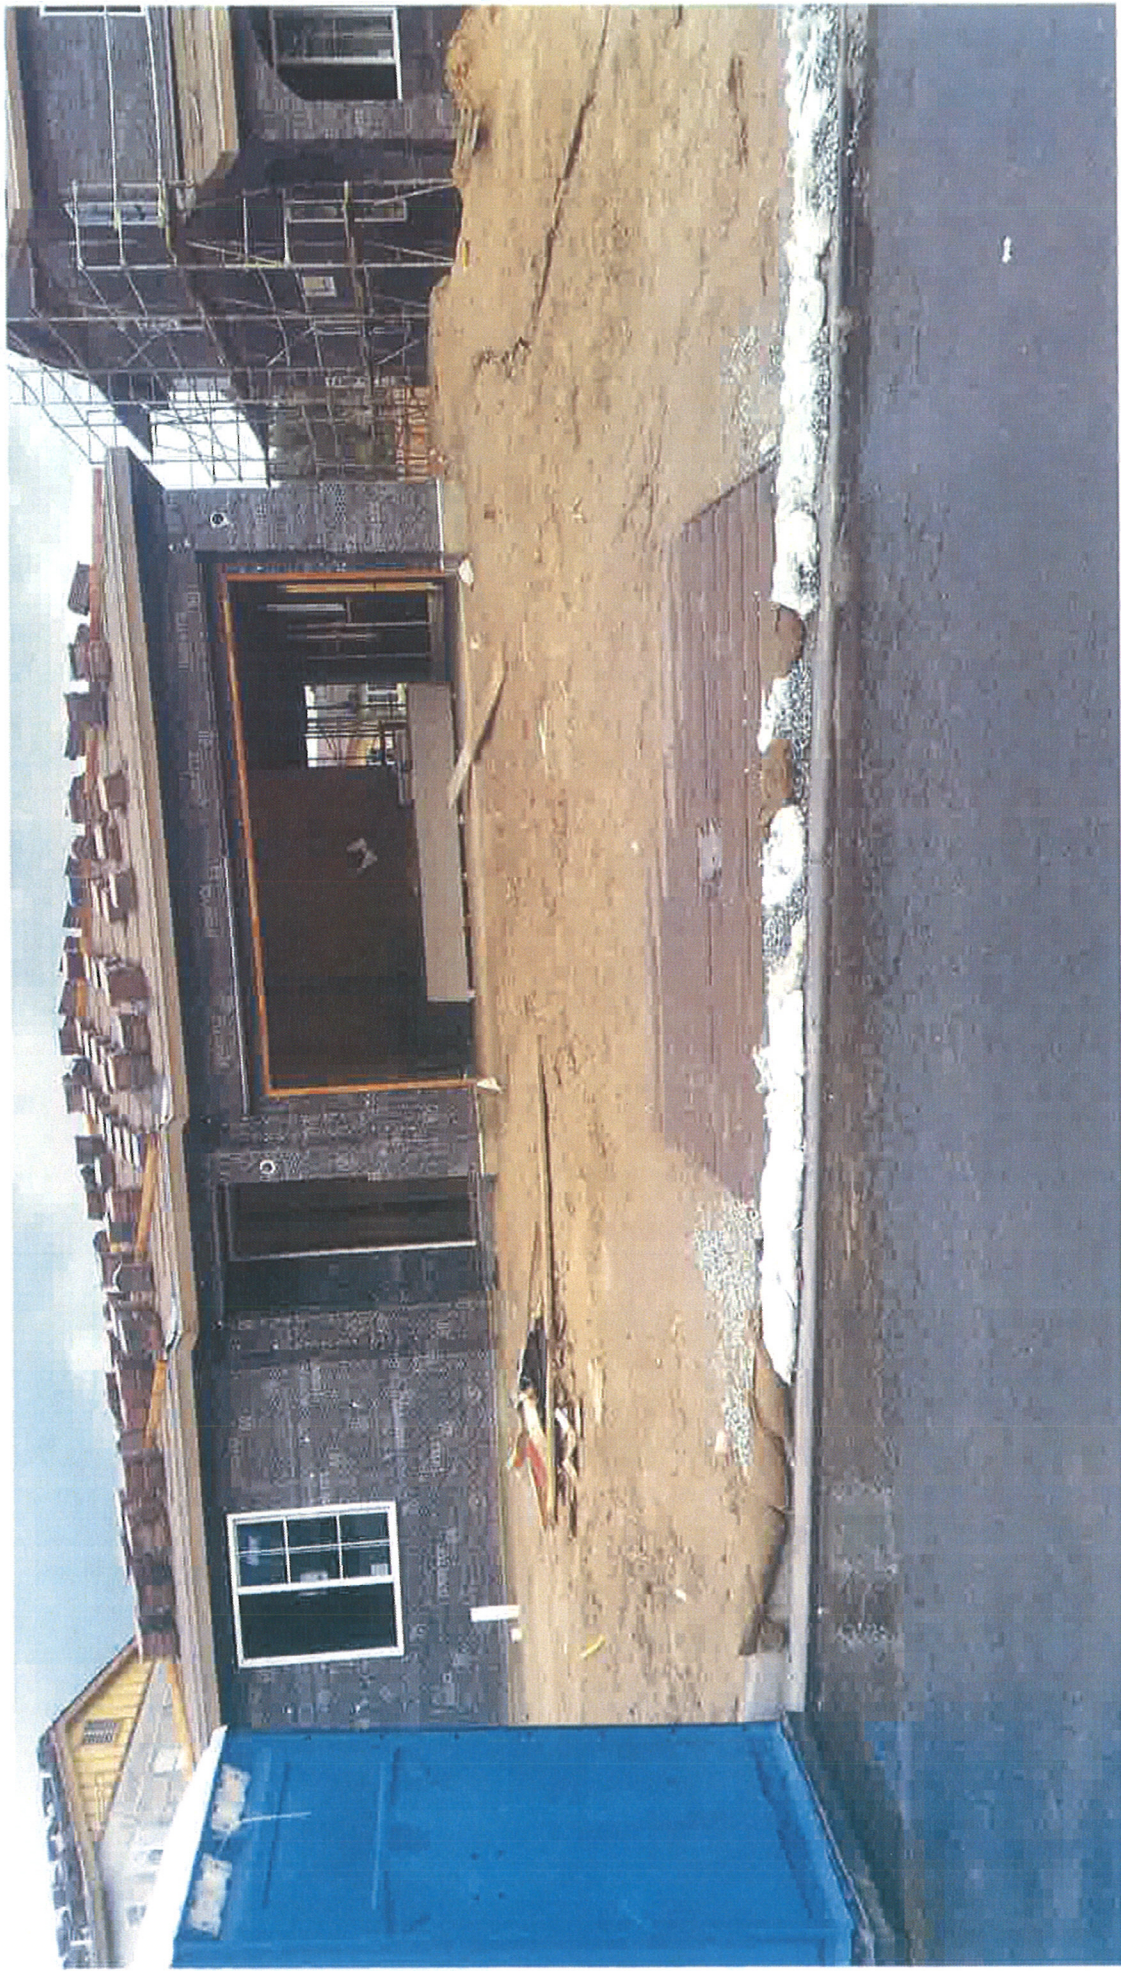
Bmp Failure Lakewood Oct 5, 2015
