RE: NOTICE OF VIOLATION NO. R9-2008-0099

- 1. Faraday Avenue Extension and Carlsbad Oaks North Business Park
- 2. Agua Hedionda Channel Dredging Project

Notice of Violation R9-2008-0099; July 2, 2008 Inspection Report

City of Carlsbad 401 Certification Inspections

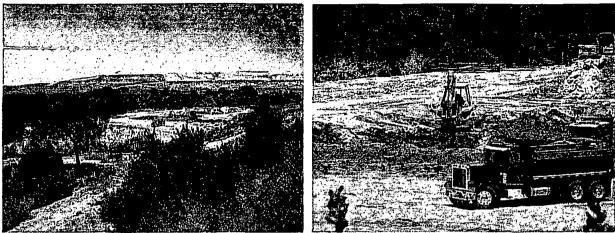
Picture on left (IMG_0485.JPG): Taken from the parking lot of the building at Apsen Way and S. Melrose Dr., overlooking mitigation area. Notice work being conducted in the mitigation area.

Picture on right (IMG 0486.JPG): Closer view of work being done in the mitigation area.

quarterly water quality monitoring samples, which are required during construction, were being taken in January 2005. Heavy machinery and earth moving work being conducted in the mitigation area was observed during the site inspection on July 2, 2008, indicating that the site is not functioning as a mitigation site.

On 7/2/08 the Regional Board inspected the creation area of the mitigation site, located west of South Melrose Drive, south of Faraday Avenue extension. Visual observations indicate that the completed mitigation site, inside the orange fencing, is not the required 3.5 acres. This is further supported by the only the mitigation related report received, the *Mitigation Compliance Report for the Carlsbad Oaks North On-site Mitigation Area* (No. 200200641-JMP), which states 3.06 acres of wetlands were created. Some work has been conducted, as plantings were observed in the southern portion of the site.

Also, heavy machinery and work was observed being conducted in the mitigation area.

Due to a lack of reporting, it is unknown if this work is related to the sewage spills in April 2007. Also as a result of the lack of reporting, it is unknown if the required enhancement component of mitigation has been completed. It appears that the required mitigation is not complete, and was not completed in the time required. (See the photographs on the next page.)

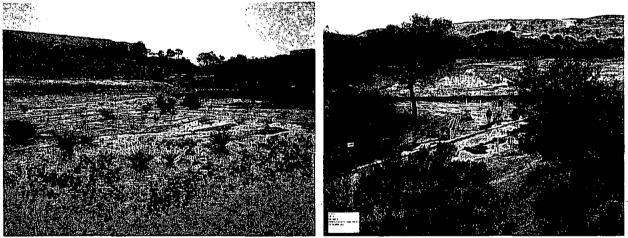
Picture on left (**Photo 159**: 4/3/07, Frank Durazo): Reference the lone tall tree in the background of this picture, is the same tree in the foreground of the above picture, and the picture to the right.²

Picture on right (**Photo 42.** 04/07/2007 16:45, Cirilo Mariscal, Overview of the spilled sewage into the containment area): Taken from relatively the same vantage point as the above left picture.³
