Subject: Notice of Violation No. R9-2013-0077, All Toyo Lex Auto Recycling, General NPDES Permit No. CAS000001, Order No. 97-03-DWQ, for Discharges of Storm Water Associated With Industrial Activities

NOTICE OF VIOLATION No. R9-2013-0077

Storm Water Industrial General Permit Inspection Report

Insp. Date & Time:	March 18, 2013	Inspected By:	Whitney Ghoram
WDID#	9 371018543	SMARTS Inspection #2018328	
Operator Name:	Mr. Pejman Ghannadian,	Owner	
Facility Name:	All Toyo Lex Auto Recycling		
Facility Address:	805-B Energy Way, Chula Vista, CA 91911		
Facility Contact:	Pejman Ghannadian

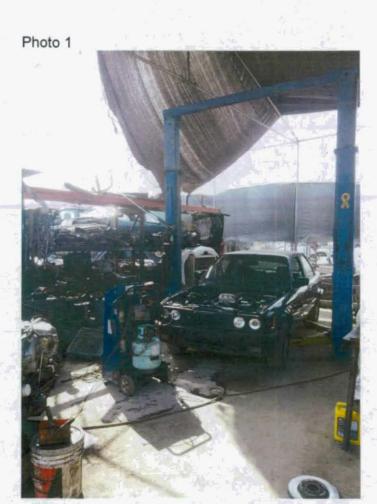
During the inspection the site was found in extremely poor condition, lacking adequate Structural BMP's and Non Structural BMPs, including poor housekeeping. The auto repair shop area is not adequately protected (covered) and has exposure to storm water (photo 1). Car engines are on the ground and leaking fluids (photo 2). Multiple areas of the site have soil and gravel soaked with oil, grease, and petroleum based liquids (photos 3, 4, 5). Car batteries are exposed, stored on top of car (photo 6). The inspector requested immediate cleanup and proper disposal of all contaminated soil, replacement of old absorbant socks (photo 7), and proper storage of leaking engines, and car batteries in a protected secondary containment area. The inspector also requested implementation of BMPs, housekeeping, and employee training necessary to prevent discharges of pollutants to the ground and or to surface waters. All corrective actions were required to be completed by March 22, 2013. To date, the corrective actions have not been completed. Discharges of process waste and pollutants commingled with storm water from All Toyo Lex Auto Recycling are prohibited.

Issue a Notice of Violation to All Toyo Lex Auto Recycling for lack of structural BMP's to prevent run-off of process waste water. Request Additional BMPs. Due to discharger failure to clean up site since the last request, and failure to pay annual fees, I recommend referral to the COG for Enforcement.

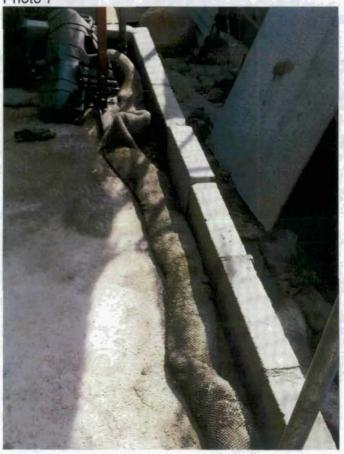
Photo 7

During the inspection, the site lacked adequate Structural BMP's and Non Structural BMPs, including poor housekeeping. The auto repair shop area is not adequately protected (covered) and has exposure to storm water (photo 1). Car engines are on the ground and leaking fluids (photo 2). Multiple areas of the site have soil and gravel soaked with oil, grease, and petroleum based liquids (photos 3, 4, 5). Car batteries are exposed, stored on top of car (photo 6). The inspector requested immediate cleanup and proper disposal of all contaminated soil, replacement of old absorbant socks (photo 7), and proper storage of leaking engines, and car batteries in a protected secondary containment area. The inspector also requested implementation of BMPs, housekeeping, and employee training necessary to prevent discharges of pollutants to the ground and or to surface waters. All corrective actions were required to be completed by March 22, 2013. To date, the corrective actions have not been completed. Discharges of process waste and pollutants commingled with storm water from All Toyo Lex Auto Recycling are prohibited.
