Subject: Notice of Violation No. R9-2015-0039 for Illegal Fill of Unnamed Creek, Gunnarsson Grove, Fallbrook, CA.

## NOTICE OF VIOLATION No. R9-2015-0039

# CITIZEN COMPLAINT INSPECTION REPORT

Facility: Gunnarson Grove, Fallbrook CA

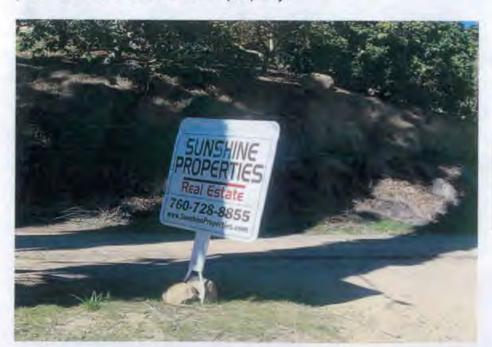
#### Photo 1

At approximately 1:30 pm on January 23, 2015, San Diego Water Board inspectors Christopher Means and Nicole Gergans arrived at the entrance to the property off Via Cordoniz Road. A for sale sign was posted at the entrance to the property (see Photo 1), and inspectors observed a car parked in proximity to a workshed on the property. Inspectors did not note any No Trespassing signs posted at the entrance to the property.

For Sale sign at entrance to the property. Facility: Gunnarson Grove, Fallbrook CA

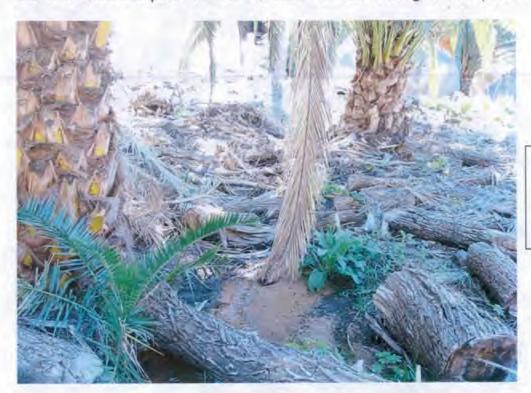
Photo 2

Inspectors entered the property in an attempt to contact someone in charge, to discuss the alleged violations. As the inspectors were walking down the driveway there appeared to be a large amount of cut up wood and other organic material that had been dumped within the stream bed constricting its flow (see Photo 2).

Cut wood and organic debris in stream.

- 1. Draft a Notice of Violation
- Request a site visit with owner to discuss potential voluntary compliance and removal of dam structure and cleanup of cut up wood out of creek.
- The San Diego Water Board should coordinate any potential enforcement action with State Board Division of Water Rights Enforcement Unit.

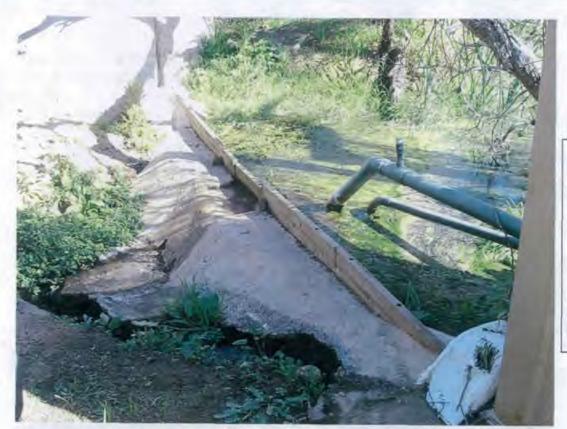
#### Photo 3

The dam restricts the velocity and volume of flow in the stream, which leads to higher temperatures and promotes the growth of algae behind and downstream of the structure. This degrades the water quality of the stream, and impacts the Warm Freshwater Habitat (WARM) beneficial use of the stream. Algal blooms were noted during the inspection behind the dam and throughout the downstream segment of the stream on the adjacent property. The unauthorized diversion of water from the pump house structure also has the potential to negatively impact the downstream agricultural and riparian beneficial uses of the stream. If the dam is found to be an unauthorized discharge of waste it is in violation of CWC Section 13260(a)(1) and CWC Section 13376.

3. While looking for an onsite responsible party to discuss the alleged violations, inspectors observed a dam structure constructed of cement and wood in the stream (see Photo 3), and pump house and associated piping adjacent to the stream and dam (see Photo 4). Inspectors were unable to contact anyone on site and left the property at approximately 1:45 pm.

Concrete and wood dam structure. This constitutes an unauthorized discharge fill to waters of the US and State. Note algal growth behind structure.

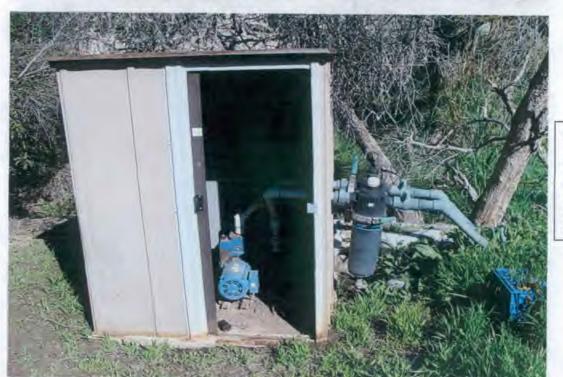
#### Photo 4

Pump house enclosure directly adjacent to stream. Facility: Gunnarson Grove, Fallbrook CA

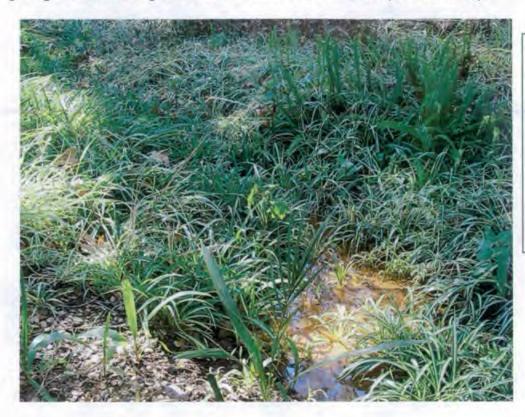
#### Photo 5

4. The structure reduces flow and velocity of the stream downstream, leading to warmer slower water and promoting algal blooms. This was apparent on the adjacent property's stream where a long portion of the stream had a bright orange algal bloom along the entire bottom of the stream (see Photo 5).

Orange algae was 3" thick and prevalent all along the lower reach of the stream on the adjacent property.
