Subject: Compliance Evaluation Inspection for the Marine Group Boat Works – National City, Order No. R9-2013-0026 (NPDES Permit No. CAG719001)

NPDES Compliance Evaluation Inspection (CEI) Checklist

Facility Narrative

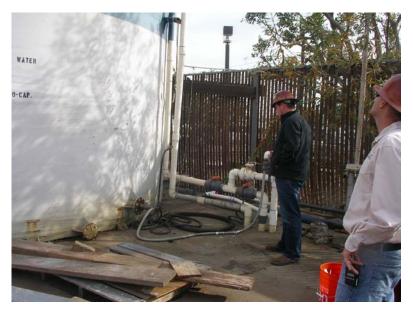
Photo 1. Piping to 50,000 gallon storage tank on-site.

- The Facility has a system to collect storm water in a 50,000 gallon tank and discharge to the sanitary sewer. The same system is used to collect wash water on-site. The system appeared operational. A boat was being washed near the travel lift. Water was going into an inlet. A pump could be heard at a different inlet pumping water to the storage tank. No discharge was visible to the receiving water. See photos 1, 2, 3, and 13.

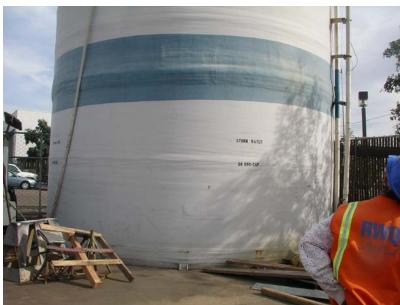
Photo 2. 50,000 gallon storage tank onsite.

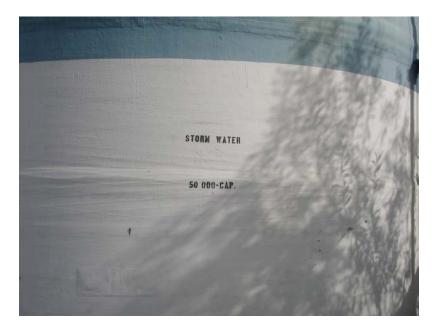
Photo 3. 50,000 gallon storage tank is labeled STORM WATER even though wash water also goes to this tank.

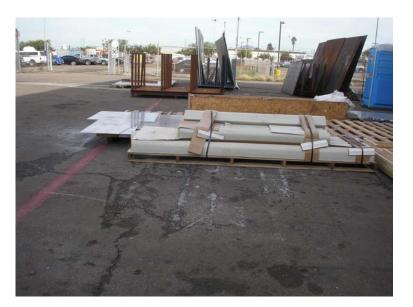
- 3. The inspectors observed metal shavings on the ground during the inspection. (Photos 4 and 5) If not swept up at the end of the day, this would be a violation of the Facility's Storm Water Pollution Plan (SWPPP), submitted in accordance with section X.D of the General Boatyard Permit. The Discharger is required to maintain compliance with the SWPPP.

Photo 4. Metal shavings were visible outside of building where construction of ships occurs.

- Metal shavings were noted on the ground. The Discharger stated that they move equipment inside and sweep at the end of the day. See photos 4 and 5.
- A drum labeled hazardous waste was stored outside the hazardous waste area across from the blasting building with no secondary containment or cover. Other empty drums and cubes were stored in this area. The Discharger stated that this was not hazardous waste and needs a new label. Barrels of waste must be properly stored and labeled. See photos 6 and 7.
- Standing water was visible in hazardous waste secondary containment. The Dischargers stated that they pump the containment at the end of the day and there was rain over the weekend. See photos 8, 9, 10, 11, and 12.
- The Discharger stated that they sweep daily and maintain other BMPs to prevent the discharge of waste.

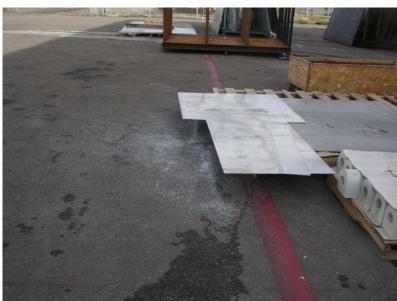
Photo 5. Close up of the metal shavings in photo 4.

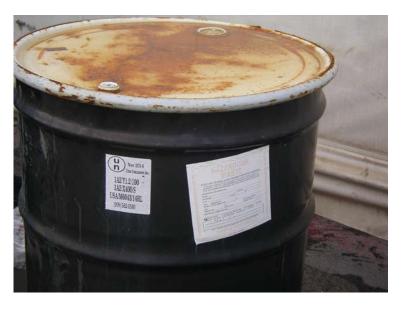
- 4. The inspectors observed a drum labeled hazardous waste stored outside the hazardous waste area across from the blasting building with no secondary containment or cover. (Photos 6 and 7) Hazardous waste must be labeled and stored in accordance with all applicable federal, State, and local laws. Improper labeling of waste is a violation of section VIII.2.a of the General Boatyard Permit. The inspectors observed standing water visible in hazardous waste secondary containment. (Photos 8, 9, 10, 11, and 12) Allowing water and other waste to accumulate in hazardous waste secondary containment areas is a violation of section X.B of the General Boatyard Permit. By February 2, 2016, the Discharger is required to submit documentation showing that 1) the barrel shown in photos 6 and 7 has been properly labeled and properly stored and 2) the secondary containment shown in photos 8, 9, 10, 11, and 12 is free of liquid. (CIWQS Viol ID 1002135 & 1002136)

Photo 6. This drum was labeled hazardous waste and had no secondary containment.

Photo 7. Close up of label on drum in photo 6.

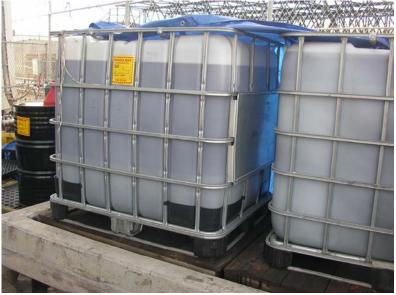
Photo 8. Cubes of oily bilge water have secondary containment. There was some water in the secondary containment.

Photo 9. Close up of label showing hazardous waste, bilge water.

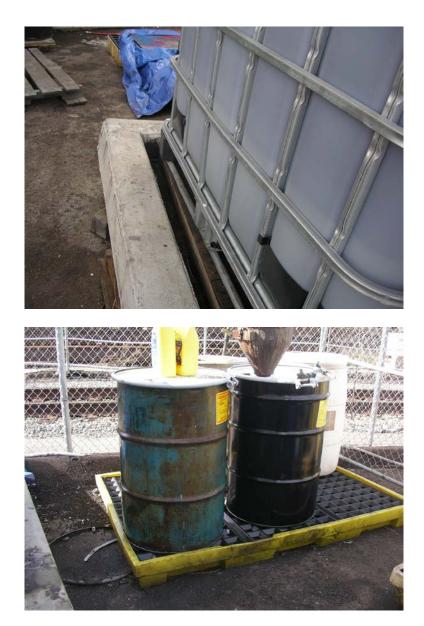
Photo 10. Secondary containment of bilge water cubes with water.

Photo 11. Hazardous waste drums on secondary containment. There was water in the secondary containment. A worker was adding material to the drum on the right with the funnel.

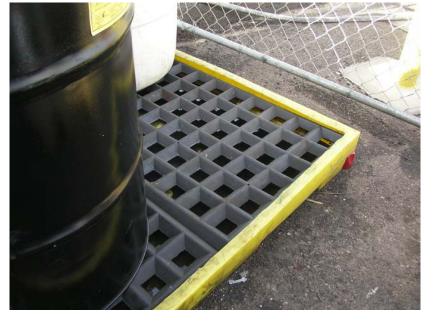
Photo 12. Water in secondary containment for drums in photo 11.

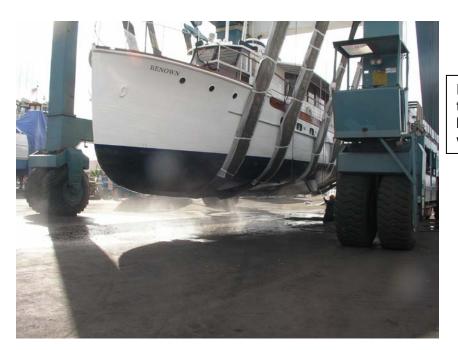
Photo 13. Boat being washed near travel lift pier. Water flowed into a catch basin. A pump could be heard pumping water to the 50,000 gallon tank.
