**Waste Discharge Requirements
and
Water Quality Certification
Oak to Ninth Project
City of Oakland, Alameda County**

**An Assessment of the Habitat Value of Pier Pilings at the Ninth Avenue Wharf and
Vicinity and Recommendations for the Oak to Ninth Project**

May 15, 2011

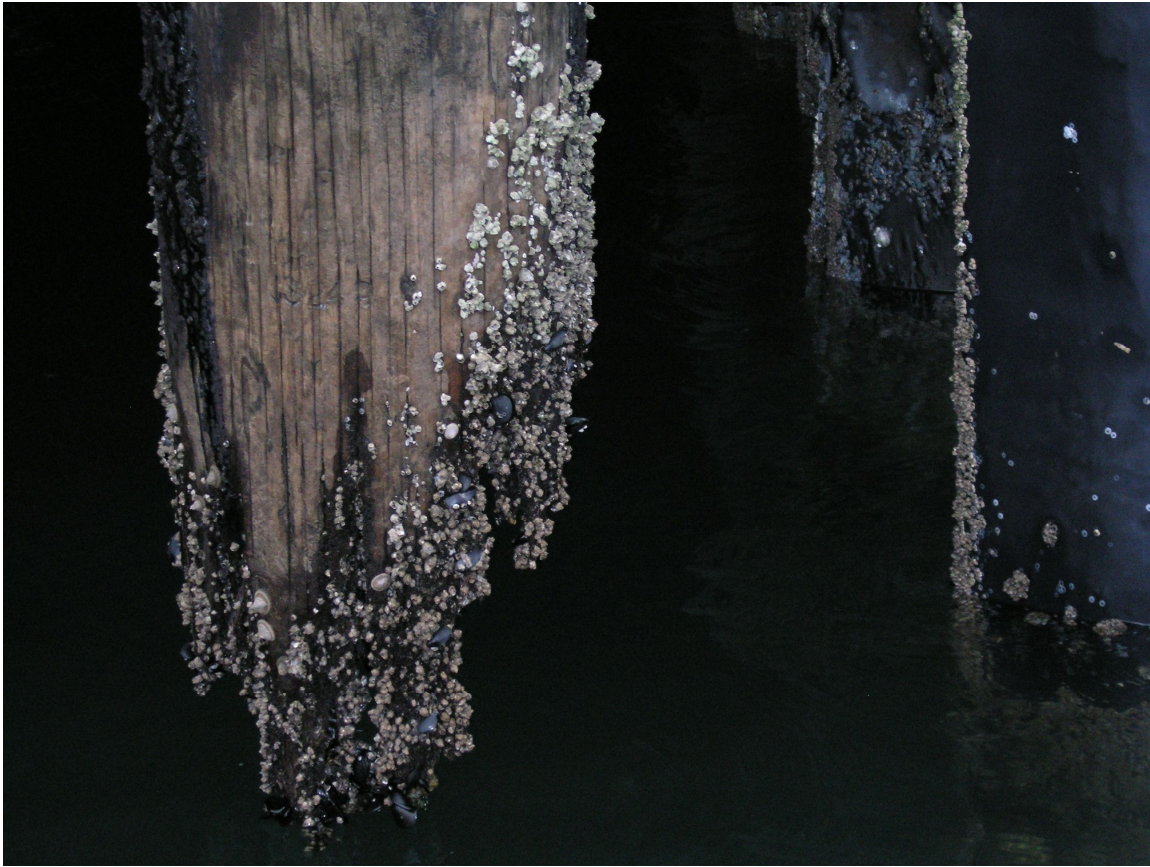
On the whole, the pilings near Shoreline Park West were in a state of disrepair. Many were broken and hanging loose from the pier; in other cases only submerged stumps remained (Fig 1). Some of the pilings had been wrapped with PVC. It was difficult to tell whether all of the pilings had a creosote coating, but many of the ones we saw clearly had some creosote (Fig 2).

Figure 1. Broken pilings, hanging from the pier, were typical at the Ninth Avenue Wharf.

3. Removal of creosote pilings may resuspend toxins. Recommendations for removal methods that minimize release of toxins are discussed in two recently released reports: Removal of Creosote-Treated Pilings and Structures from San Francisco Bay (Werme et al. 2010) and San Francisco Bay Subtidal Habitat Goals Report (California State Coastal Conservancy and Ocean Protection Council et al. 2010).

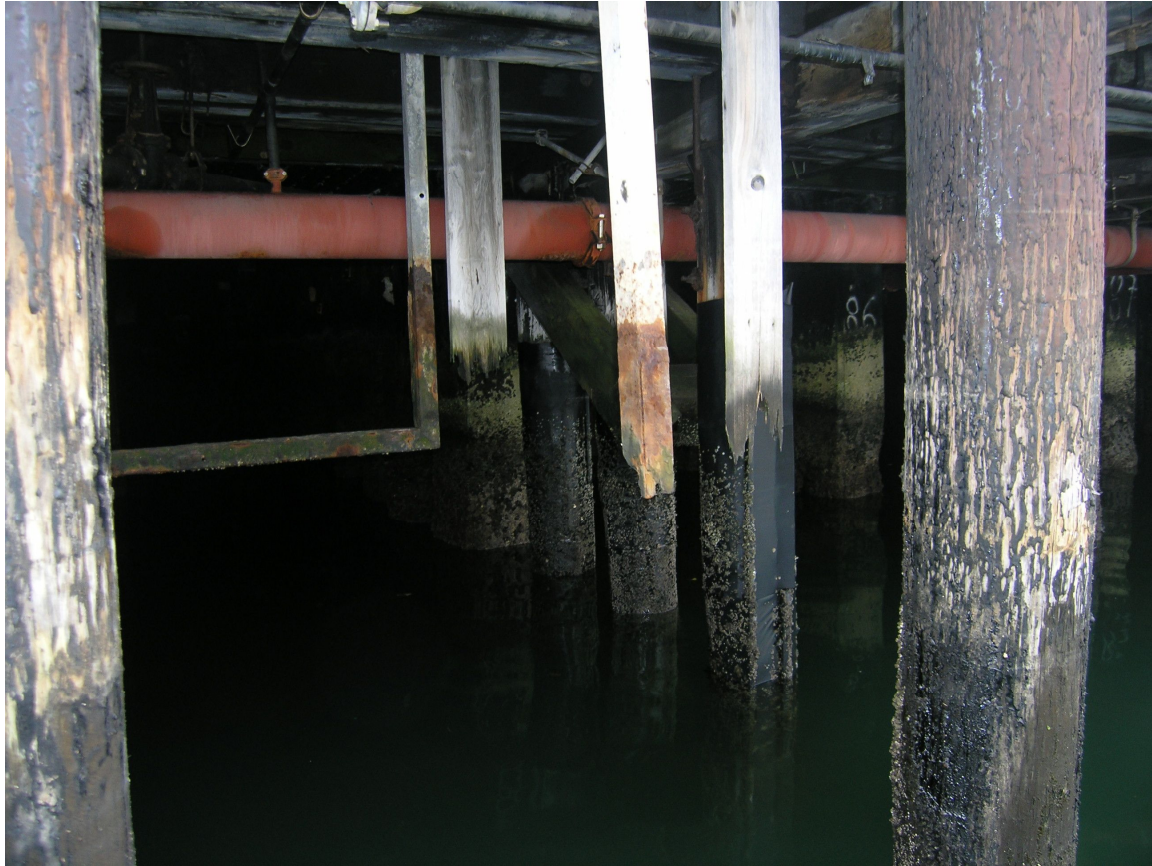
The Ninth Avenue Wharf reportedly has both concrete and green timber (non-creosoted) pilings (Moffatt and Nichol 2006). The timber pilings on the bayside edge support a timber apron, which will be removed as part of the retrofit. The pilings we were able to inspect were the outermost 2-3 rows of timber pilings. Some of these appeared to be covered in creosote.

Figure 2. Many of the pilings at the Ninth Avenue Wharf are coated in creosote.

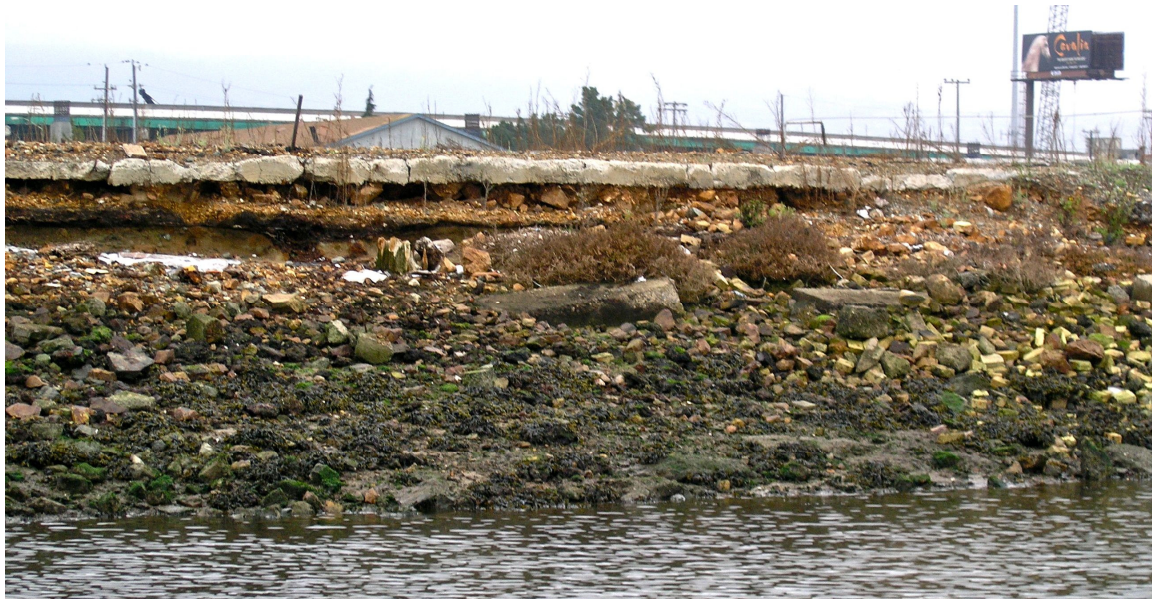
Macroalgal cover appeared to be limited to small patches of *Ulva* spp. and small amounts of a tufty red alga tentatively identified as the non-native *Caulacanthus okamurae*. A native red alga *Gratelopia lanceolata* and a non-native *Lomentaria hakodatensis* were found on the buoy we inspected, but not on the pilings. These species are common on floating docks throughout the Bay (pers. obs.). The native brown rockweed *Fucus distichus* was abundant on the shoreline rip-rap in the areas surrounding the pilings (Fig. 3), but was not found on the pilings themselves.

Figure 3. The native brown rockweed *Fucus gardneri* is plentiful in the intertidal zone rip-rap at the site.

2. Where replacement of existing rip-rap and other hard intertidal structures is planned, take actions to preserve the *Fucus* currently growing along the shoreline edges. Such actions could include incorporating pieces of the existing rip-rap with *Fucus* attached to them into the new seawall, or transplanting adults following methods such as those being developed by Peter Raimondi's laboratory (University of California, Santa Cruz). Fleshy macroalgae like *Fucus* provide habitat for native fish, invertebrates and other algae, and may facilitate other organisms such as native oysters in the intertidal zone by mitigating heat stress (see Whittaker et al. 2010 and references therein). Populations of *Fucus* may be difficult to regain once lost, as their propagules have a limited dispersal distance (Sousa 1984, Stekoll and Deysher 1996).

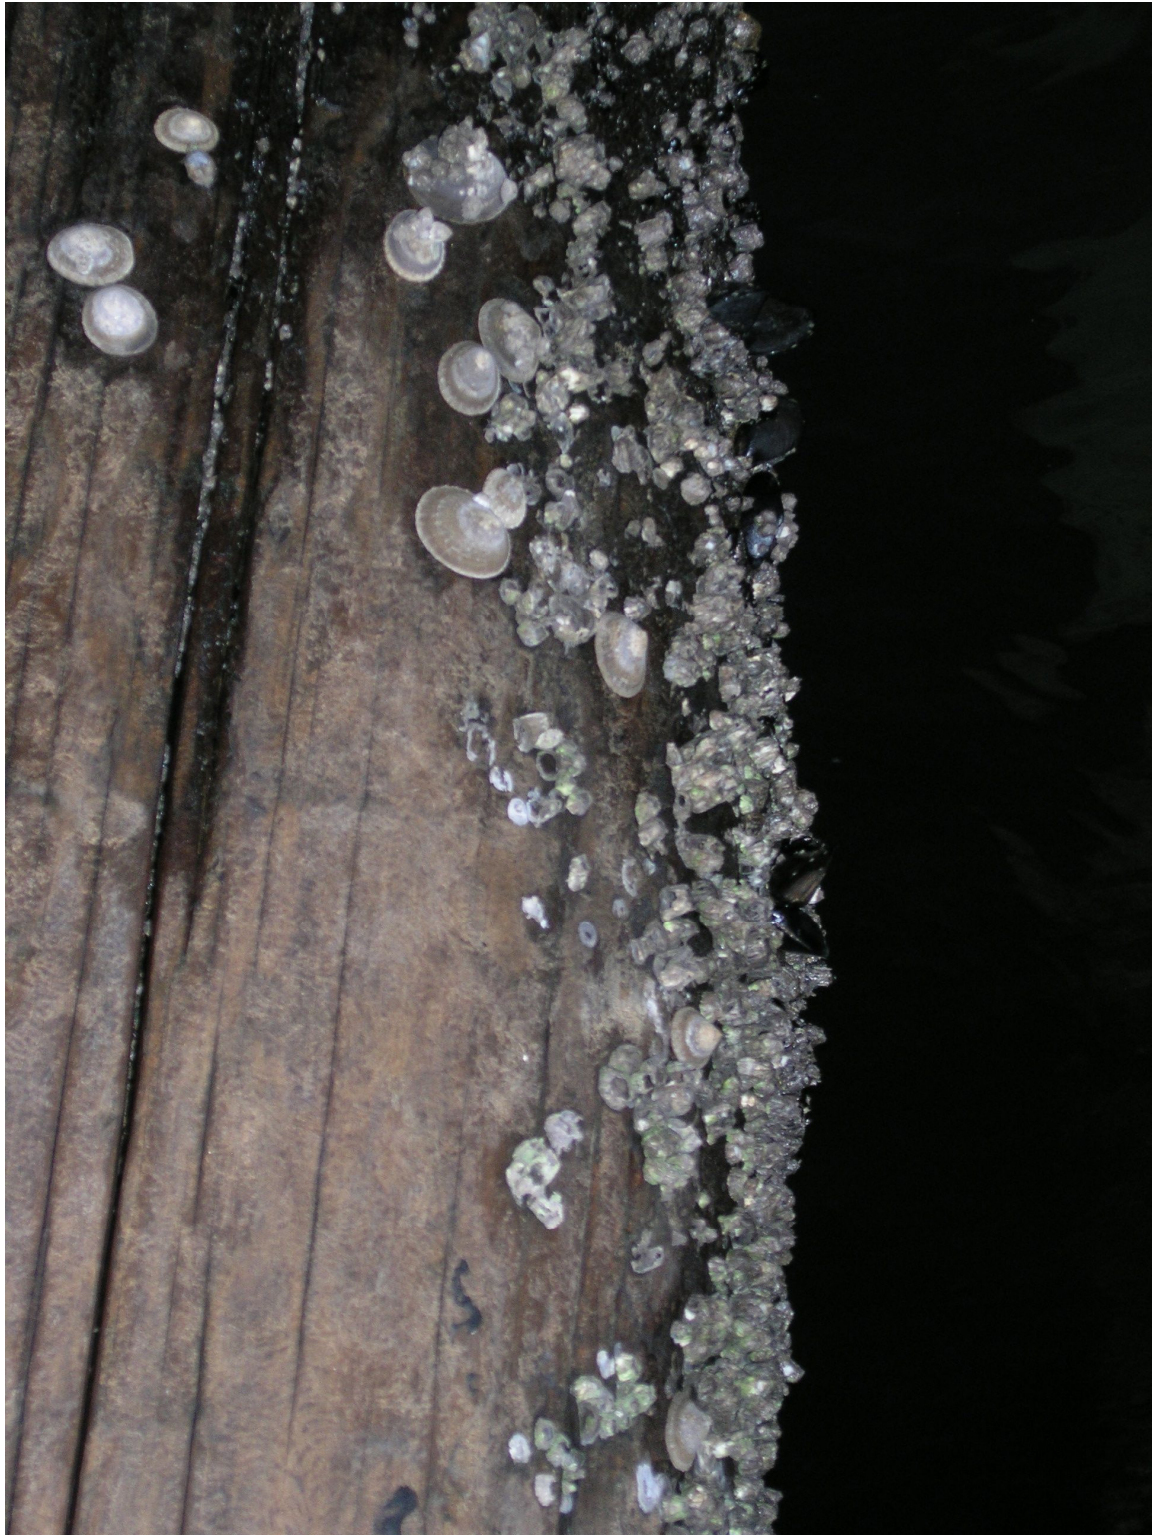
Invertebrate animals were the numerically dominant organisms on the pilings. Barnacles (*Balanus crenatus* and *Amphibalanus amphitrite*) were by far the most abundant organisms (in

the 100s-1000s of individuals/piling) above and just below the waterline. Mussels (*Mytilus* spp.), native oysters (*Ostrea lurida*) and limpets were also common (10s of individuals/piling) (Fig. 4). Large numbers (100s of individuals) of the large non-native solitary tunicate *Styela clava* were found on some of the pilings; there were also a few pilings that had significant cover of the non-native colonial tunicate *Didemnum* sp.

Figure 4. Barnacles dominate the pilings in the high intertidal zone at the site; native oysters, mussels and limpets are also present.

1. Where feasible, extend the placement of suitable heterogeneous hard substrate (such as stone rip rap, preferably native source, or Reef Balls¹) from the shoreline into the shallow subtidal (2-3 m below MLLW). This will provide habitat for native shoreline species dependent on hard substrate. Such substrate could be incorporated into the shoreline erosion protection design and could be integrated in a living shoreline approach that includes shoreline softening and restoration of native upland and marsh vegetation.
