Sonoma Valley Fires

Monitoring Plan

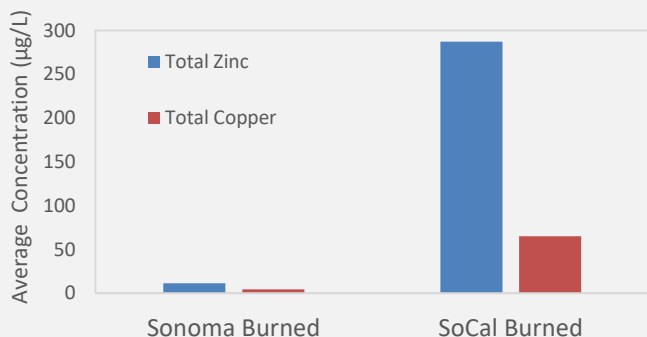
Figure 5. Comparison of metal concentrations in post-fire storm samples for Sonoma Creek and Southern California (Stein et al., 2012).

- All samples were below acute toxicity thresholds.
- Nine of 576 samples exceeded chronic objectives for selenium, mercury, dissolved oxygen, or pH. Two of these exceedances occurred at the unburned reference site.
- Increased pH at Kenwood during first storm could have been a fire signal. However, no other pH exceedances were observed in this study.
- Observed increases in metals and nutrients are likely a natural increase that occurs during storms and not related to the fire.
- The small increase in metals and nutrients between baseline and storm flows was similar for burned watersheds and the reference, unburned watershed.
- In contrast, metal concentrations from burned areas in Southern California were often hundreds of times higher than burned areas in this study (Figure 5).
