Sonoma Valley Fires

Monitoring Plan

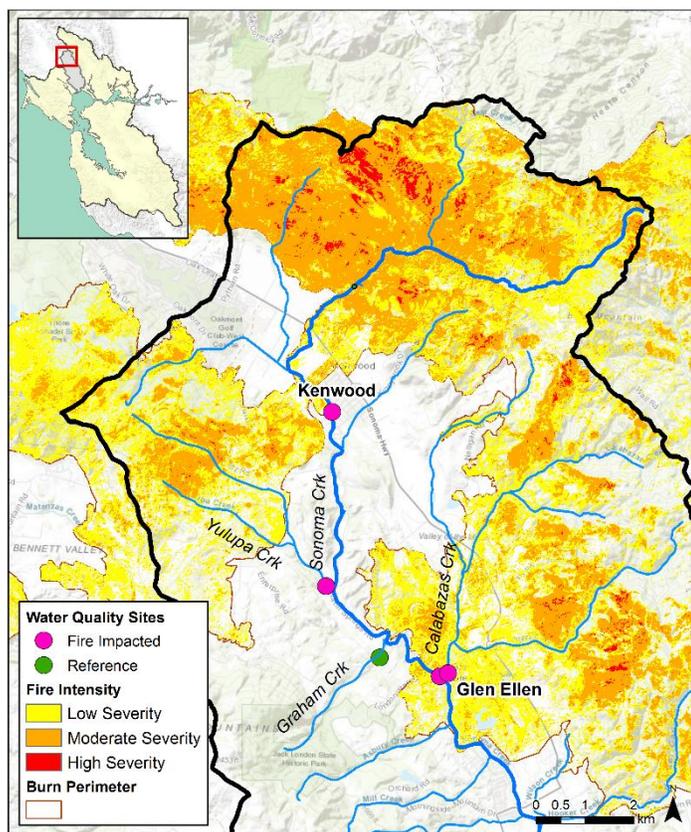
Figure 2. Post-fire water quality monitoring sites in the Sonoma Creek Watershed

The Water Board collected samples from the locations in Fig. 2 on five occasions; pre-storm (baseline), during the beginning of the first storm of the season, and again during three subsequent "qualifying" storms. A qualifying storm was defined as predicted rainfall ≥ 1 inch in a 24-hour period. Precipitation and flow rates for each of the four storms are depicted in Fig. 4. More information on the San Francisco Bay Water Board's post-fire monitoring plan is available [here](#).

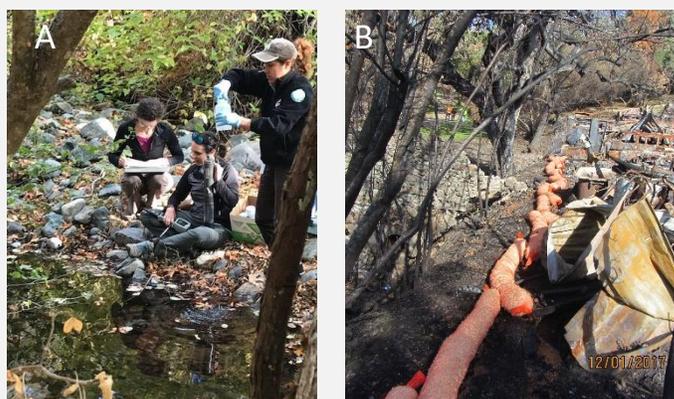
Figure 3. A) Water Board and Sonoma Ecology Center Staff collecting baseline samples at Sonoma Creek. Photo by Melissa Roberts, Sonoma Ecology Center. B) Erosion and drainage controls installed next to burned structure near creek.

- The 2017-2018 winter was relatively dry. Storm magnitude and intensity may not have been high enough to mobilize all burned material.
- Slope stabilization, erosion and drainage controls, and other similar practices may have prevented burned material from entering the creeks.
 - Efforts were focused at properties in close proximity to creeks and other locations where pollutants would be readily carried to creeks via stormwater.
- 82% of burned structures within 100 ft from the stream were assessed and stabilized by Cal Fire and Sonoma Ecology Center staff, with some funding provided by the Water Boards.

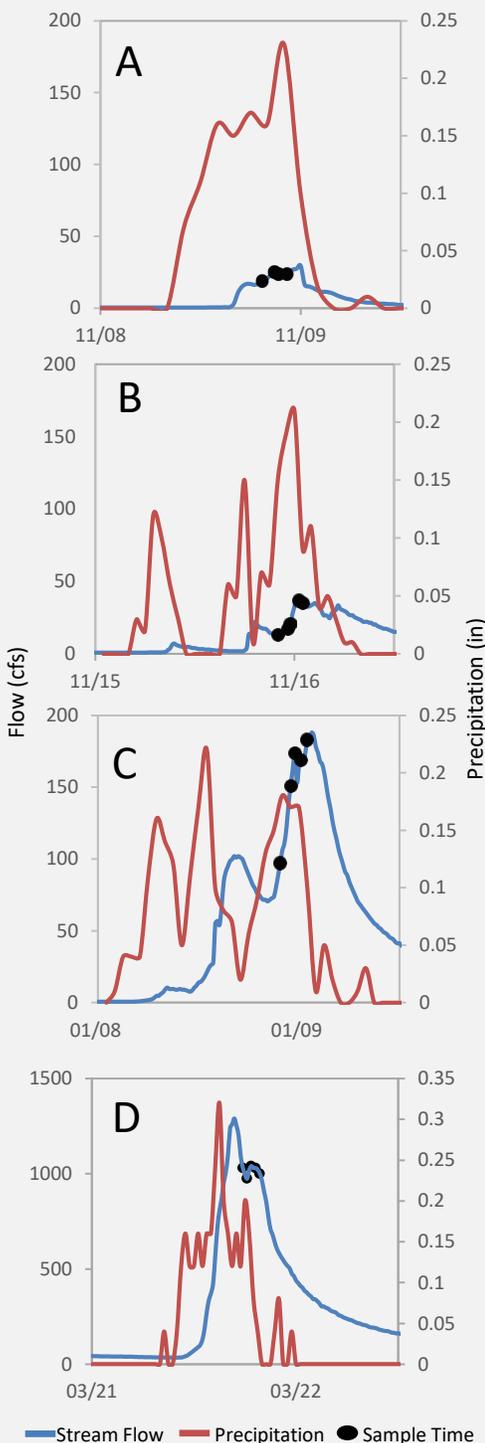
Figure 4. Precipitation, flow, and collection time for samples collected on A) Nov. 8-9, 2017 for a 1.25" storm; B) Nov. 15-16, 2017 for a 1.75" storm; C) Jan. 8-9, 2018 for a 2.65" storm; D) March 21-22 for a 2.22" storm. Flow data from Sonoma Creek at Kenwood, USGS Gage #11458433. Hourly precipitation data from California Irrigation Management System (CIMIS) Bennet Valley Station #158.

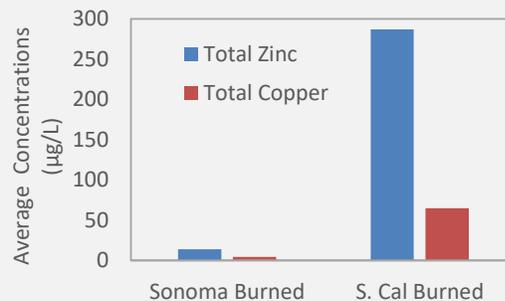
Figure 5. Comparison of metal concentrations in post-fire storm samples for Sonoma Creek and Southern California (Stein et al., 2012).

- Twenty of 969 samples exceeded chronic objectives for metals, oxygen, or pH. Four of these exceedances occurred at the unburned reference site.
- Increased pH at Kenwood during first storm could have been a fire signal. However, no other pH exceedances were observed in this study.
- Observed increases in metals and nutrients are likely a natural increase that occurs during storms and not related to the fire.
- The small increase in metals and nutrients between baseline and storm flows was similar for burned watersheds and the reference, unburned watershed.
- In contrast, metal concentrations from burned areas in Southern California were often hundreds of times higher than burned areas in this study (Figure 5).
