HORSESHOE POND

ESTUARY FACT SHEET

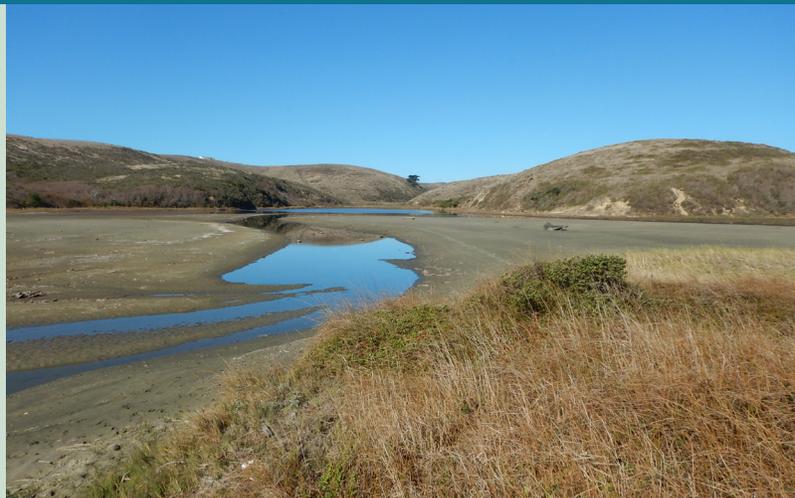
CRAM Attribute and Index Scores

ATTRIBUTE	SITE SCORE	AVERAGE COUNTY SCORE
Buffer and Landscape	88	84
Hydrology	100	87
Physical Structure	44	52
Biotic Structure	67	78
Index Score	75	75

CRAM index scores for the estuary compared to the Marin County average.

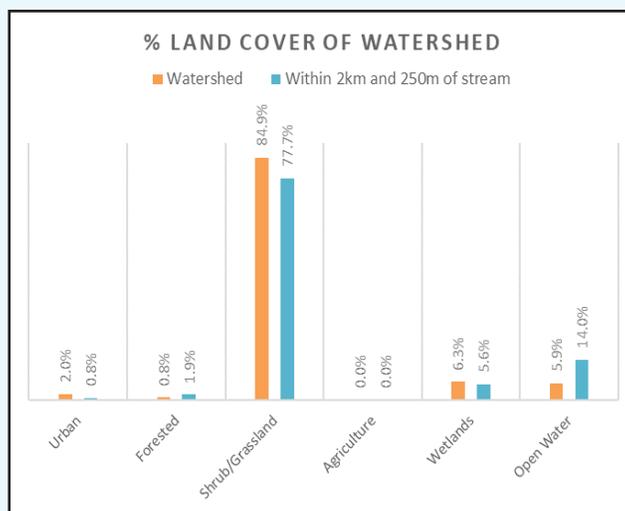
Percent land cover within entire watershed compared to within a buffer of 2km upstream of outlet and 250 meters from stream.

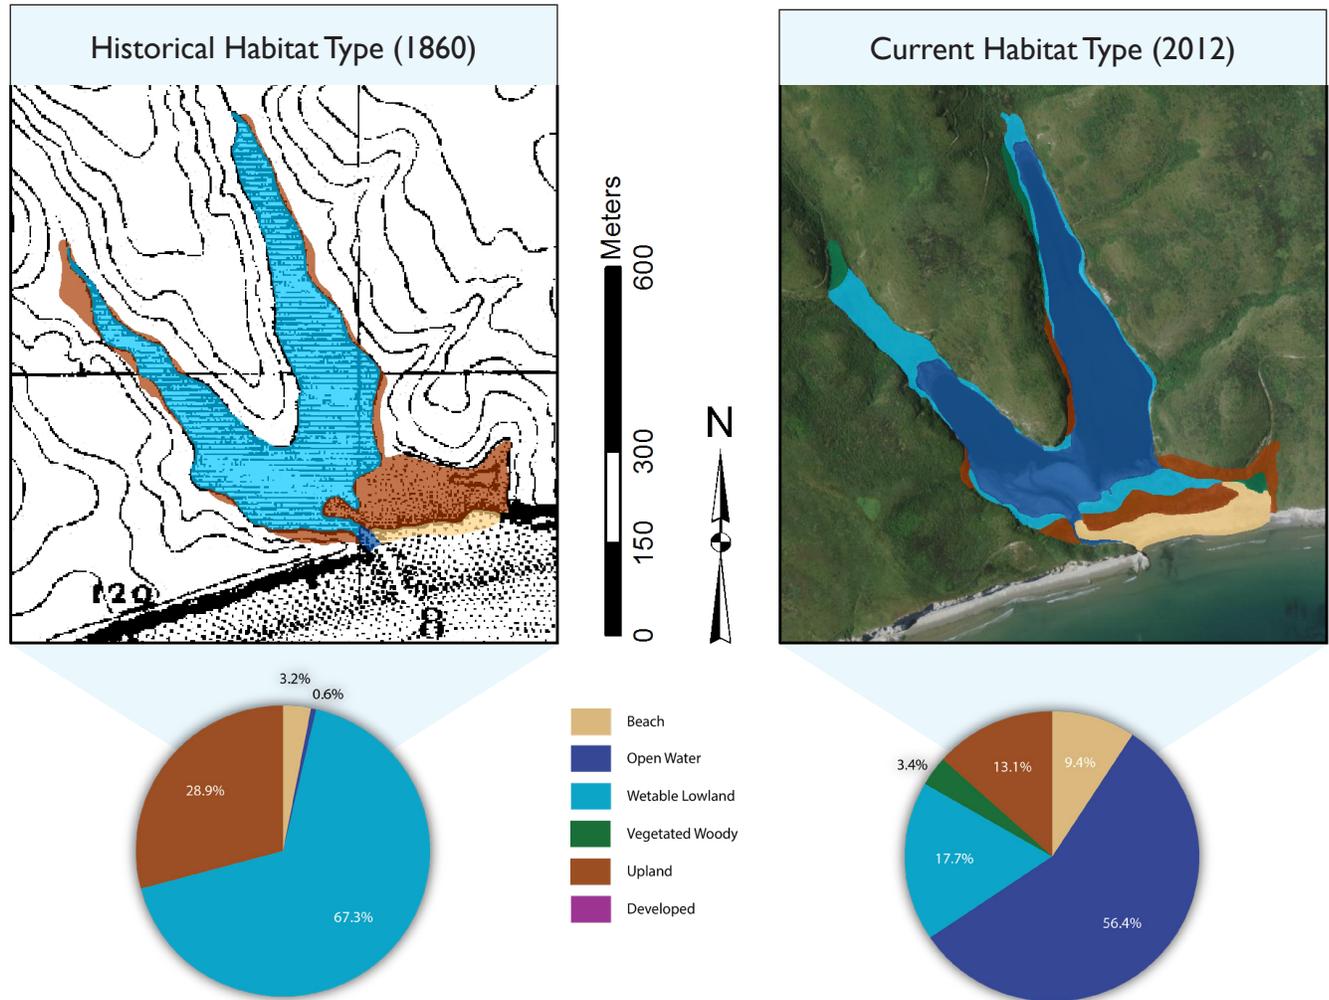
Habitat type maps and charts for 1860 and 2012. Habitat maps uses a NOAA nautical chart (1860) for the historical map and National Agriculture Imagery Program (NAIP) imagery (2012) for the current map.

Summary: The site's CRAM Index score (75) fell into the *good* condition category. The red-legged frog is the only special status species of concern known to be present within the estuary. Land cover within the watershed is dominated by shrub/grassland. A restoration project in the early 2000's returned previously altered areas of the estuary to its pre-colonization condition.

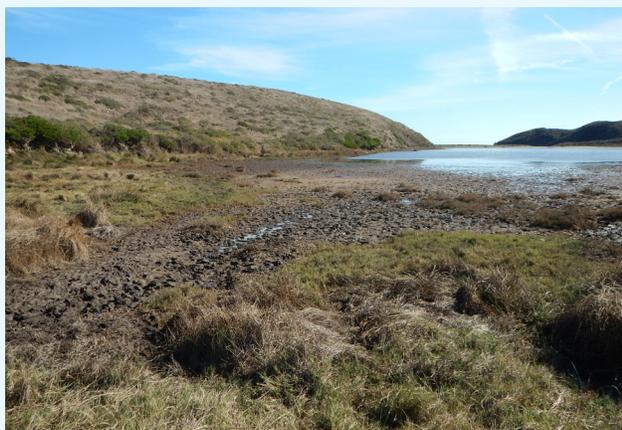
Wettable lowland habitat at Horseshoe Pond Lagoon

- Continued monitoring to assess evolution of restored habitats.
- Conduct periodic surveys for special-status species.
- Ensure cows do not have access to the wettable lowland which impacts physical and biotic structure.
