Water Quality Improvement Plan to Address the Sediment Impairment on San Gregorio Creek

Final Staff Report

**California Regional Water Quality Control Board
San Francisco Bay Region**

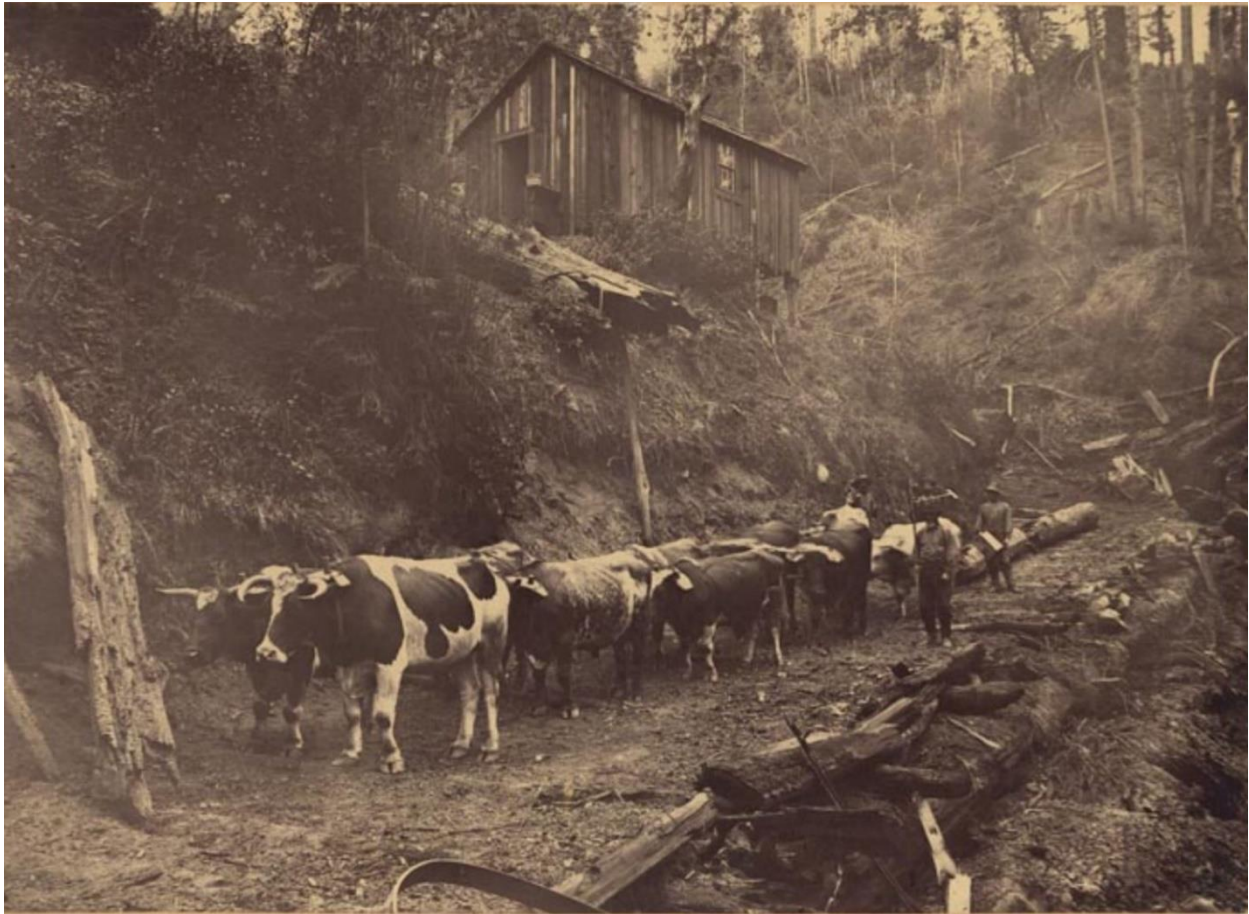
Figure 5.2 Oxen train hauling logs on corduroy road near La Honda (photo taken in 1881; Stanger 1967)

Logging and milling activities caused many adverse impacts to water quality. Construction of skid trails, or temporary roads, and roads for timber harvest increased sediment erosion and delivery to streams, and tree removal increased land surface runoff and consequent erosion. Oxen were used to haul logs, and stream beds were commonly used as 'corduroy roads' where logs were laid perpendicular to the direction of travel to more easily skid logs to their destination, effectively destroying part or all of the channel morphology and substrate (Figure 5.2).

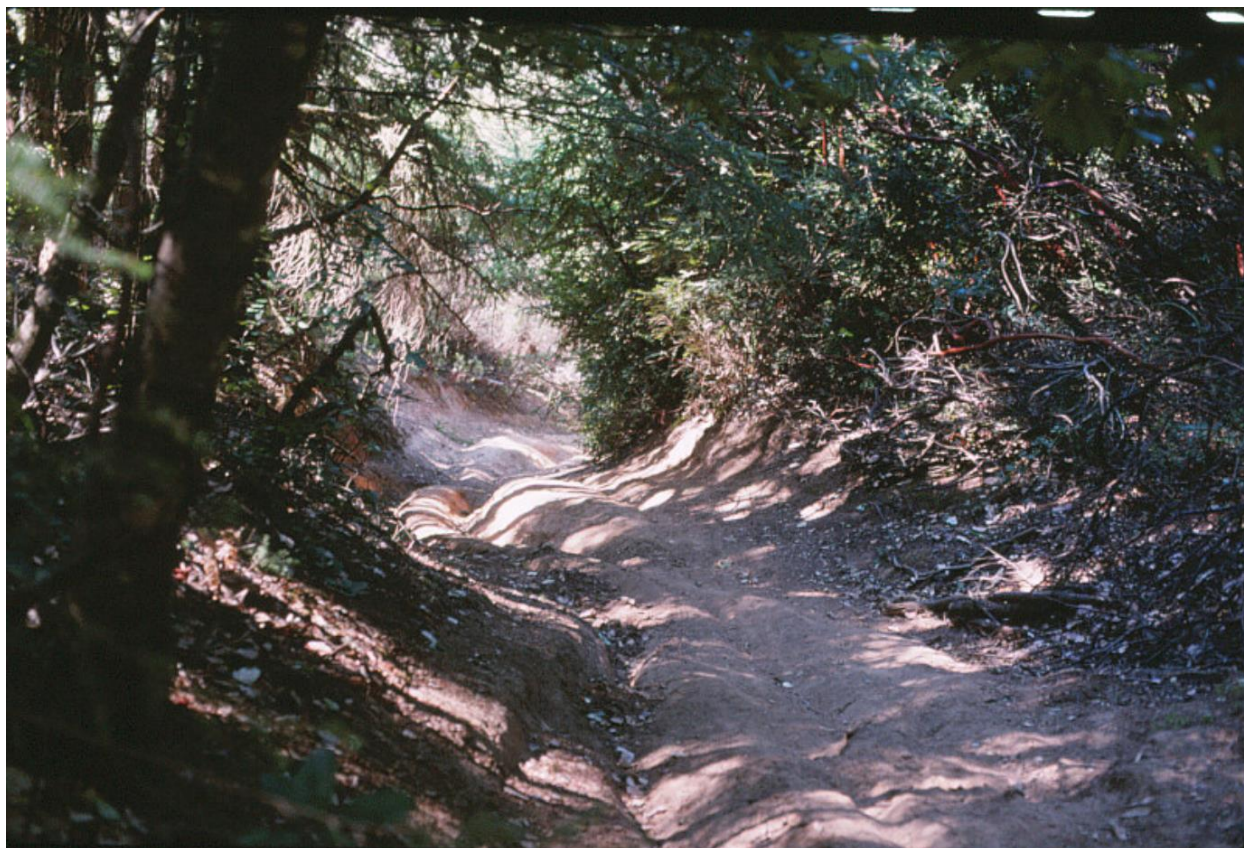
Figure 5.4 Abandoned throughcut logging road with deep rilling in the El Corte de Madera Creek Preserve (photo taken in 1994)

The extent of logging through the 1970s and 1980s is partly known. Midpen reported that the upper watershed of El Corte de Madera Creek was logged intermittently until about 1988, when the land was purchased to form an open space preserve, and that logging in the La Honda Creek subwatershed occurred throughout the 1970s and 1980s until 1988 (Hébert 2020). Although logging had largely ceased by the 1990s, legacy impacts of old logging roads and skid trails remained (Figure 5.4).
