*Final Technical Report*

## **A Rapid Trash Assessment Method Applied to Waters of the San Francisco Bay Region: Trash Measurement in Streams**

**August 2005**

**SAN FRANCISCO BAY REGIONAL WATER QUALITY CONTROL BOARD**

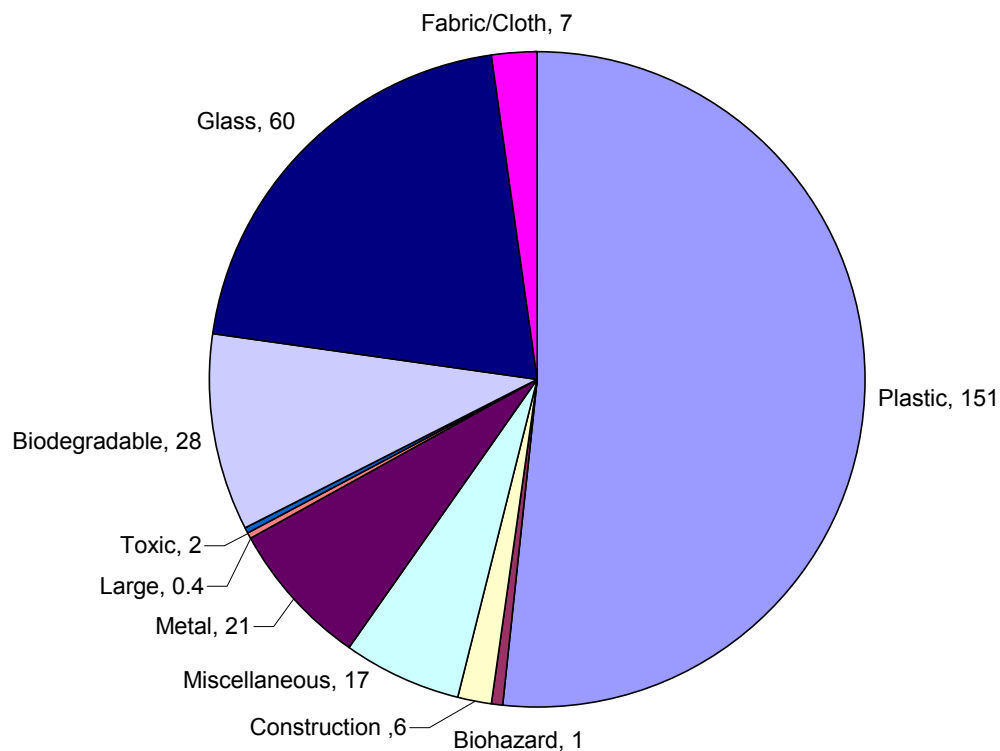
**Figure 2: Average number of pieces of trash, by category, per 100 foot reach for all sites and all seasons.**

The 85 site visits conducted by Water Board staff and students over three years and multiple seasons confirmed that high levels of trash are present throughout urban streams in the San Francisco Bay Region. On average, across all sites and seasons, 293 pieces of trash were collected per 100 foot reach of stream, equaling 2.93 pieces per linear foot of stream (Figure 2). Over 50% of this total, or 1.51 pieces per linear foot of stream, was composed of plastic items. Glass (21%) and biodegradable items (10%) were also commonly found. Most sites contained less than 500 pieces of trash, while several sites contained many more pieces, up to a maximum of 1133 pieces, or 11.33 pieces per linear foot of stream (Figure 3). Overall, 72% of all trash items were found below the high-water line, while 28% of items were found above the high-water line. Certain types of items were found almost exclusively below the high-water line, including toxic items (88%), construction debris (87%), and glass (82%). Forty-one percent of biodegradable items were found above the high water line, indicative of the frequency with which paper is transported by wind into stream channels. The average total Rapid Trash Assessment (RTA) score was 47, with a range from 8 to 112 (out of a possible 120) (Figure 4). Lower RTA scores reflect higher levels of trash. A high RTA score, overall or in a specific category, represents more desirable, less trashed conditions. Total RTA scores were strongly related to the number of plastic pieces found at sites (Figure 5).

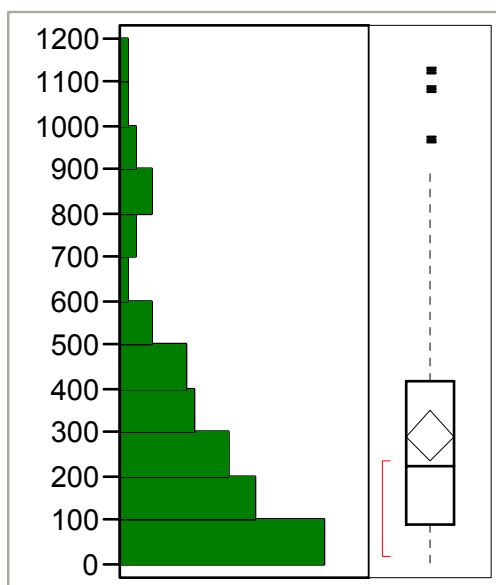
**Figure 3: Frequency histogram of the number of pieces of trash found per 100 foot reach (site). The diamond indicates the mean and the standard error about the mean. The box indicates the median and the 25<sup>th</sup> and 75<sup>th</sup> percentiles, while the whiskers indicate the 5<sup>th</sup> and 95<sup>th</sup> percentiles.**

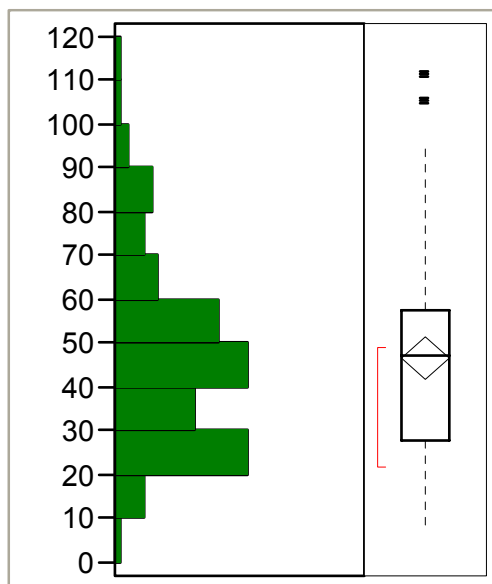
**Figure 4: Frequency histogram of total RTA trash scores for each site visit. Symbols are the same as in Figure 3.**

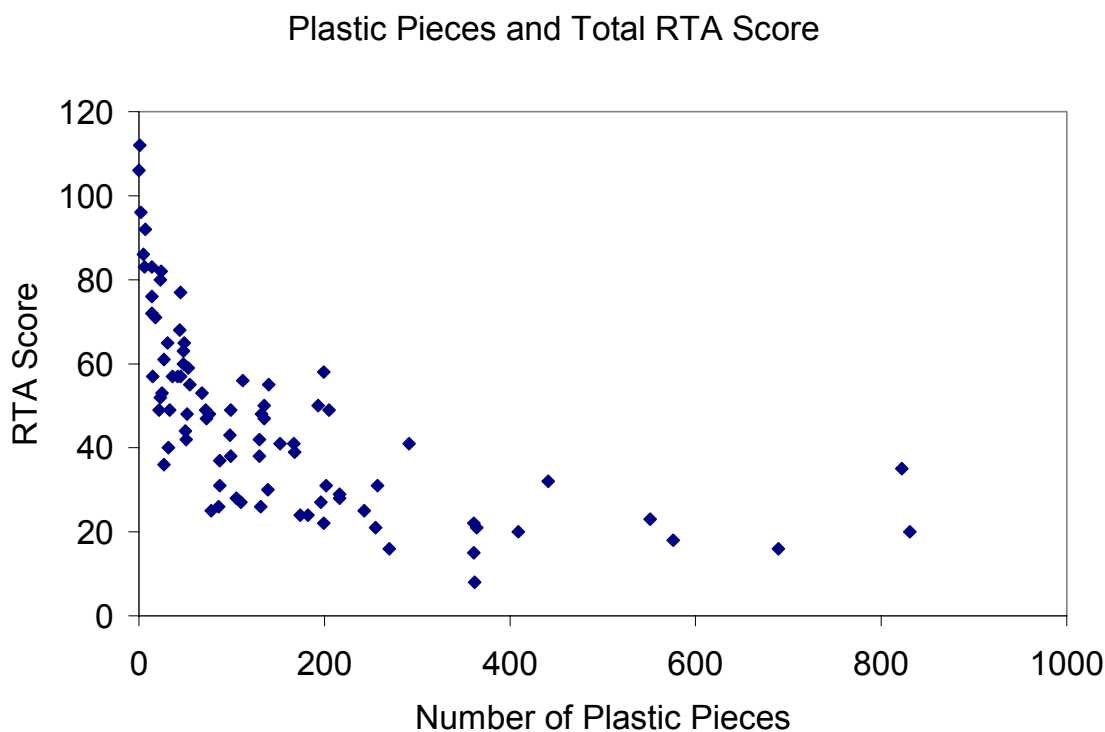
**Figure 5: Total RTA score relative to the total number of plastic pieces found at sites.**

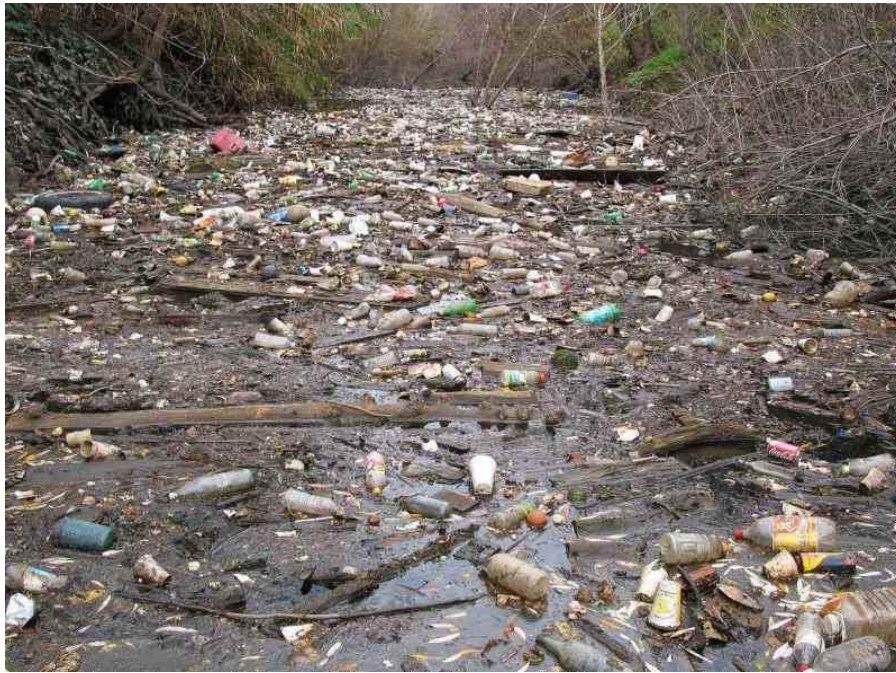
**Figure 6: Photo of the trash buildup behind a fallen tree immediately downstream of the Julian Street bridge, Coyote Creek, San Jose, CA, January 27, 2004. Photo by Friends of Coyote Creek.**

The 26 sites surveyed did not include the worst-case conditions of trash in the region (Figure 6, below, for example), where obstructions can cause buildup of floating trash in

wet weather conditions. Other problem sites not surveyed include homeless encampments, although some of the sites were downstream of such major sources of trash. The most trash pieces per 100 feet of stream documented in this report was 1,133 pieces at Baxter Creek at Booker Park in Richmond. Figure 6, in comparison, shows a level of trash that may exceed 10,000 pieces per 100 feet.

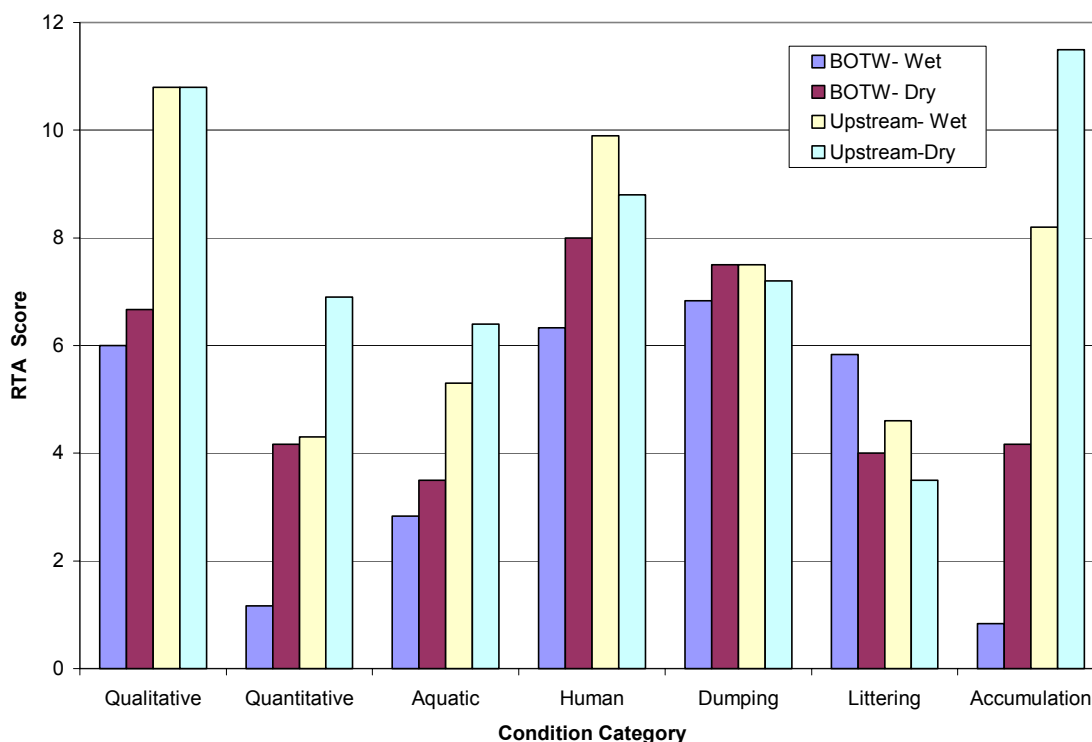
**Figure 7: Average condition category scores from a subset of sites that were sampled during revisits that bracketed both wet and dry seasons. Data is presented for both wet and dry season surveys from 6 BOTW sites and 10 upstream sites. Maximum RTA scores for all condition categories is 20, except littering and dumping which is 10.**

Condition category scores within the total RTA score reflected differences in trash deposition between both (1) wet and dry seasons and (2) BOTW and sites further upstream. Figure 7 presents a comparison of average RTA scores at a subset of sites where site revisits well-bracketed both the wet and dry seasons. Bottom of the watershed (BOTW) sites tended to score lower than sites further upstream in the watershed in nearly all trash condition category scores, with the exception of dumping and littering (Figure

7). Qualitative scores were much lower at BOTW sites than upstream sites, indicating the “first impression” of BOTW sites is consistently more negative with respect to trash.

Accumulation scores were also much lower at BOTW sites than upstream sites, but wet season scores are much lower for both site locations than dry season scores, reflecting the seasonality of trash accumulation. At BOTW sites, the dry season scores for accumulation were markedly lower than the wet season accumulation scores for upstream sites, shown at the far right of Figure 7. As noted above, at BOTW sites the trash is dominated by plastics. The graph at the far right of Figure 7 therefore shows that plastics continue to be delivered to the bottom of watersheds and into the San Francisco Bay during the dry season. Trash can be delivered to streams, the topographic low points in watersheds, by wind and dry season urban runoff (e.g., over-irrigation), and these data suggest it is a significant source. Trash control efforts in the Los Angeles region associated with TMDL implementation tend to focus on runoff events to capture the largest volume of trash, but the observations documented in this report show that dry season delivery of trash is likely significant.

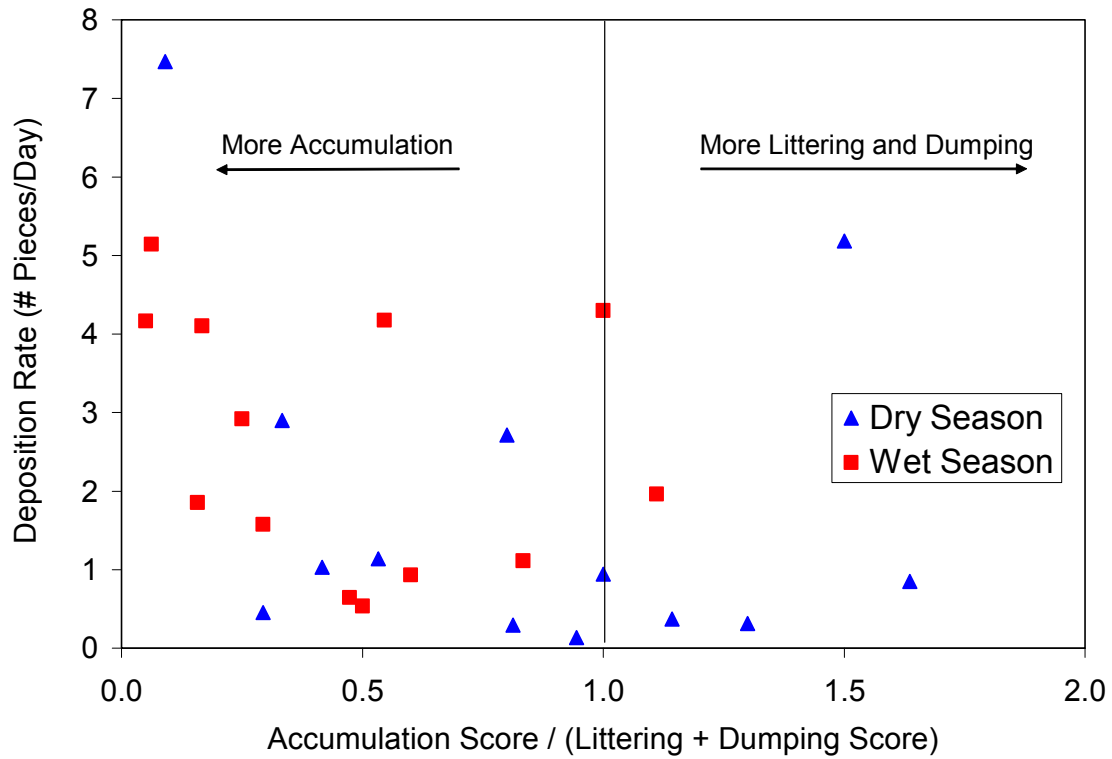
**Figure 8: Deposition rates at sites versus the relative importance of accumulation from upstream and localized littering and dumping.**

Deposition rates were much lower in the dry season than the wet season, generally below 1 piece of trash per day (Table 1, Figure 8). Several sites had high deposition rates during the dry season, associated with localized littering (Figure 9). Many of these high dry season deposition rates occur at public parks. Management priorities at these sites should focus on encouraging the proper disposal of trash in and around the stream.

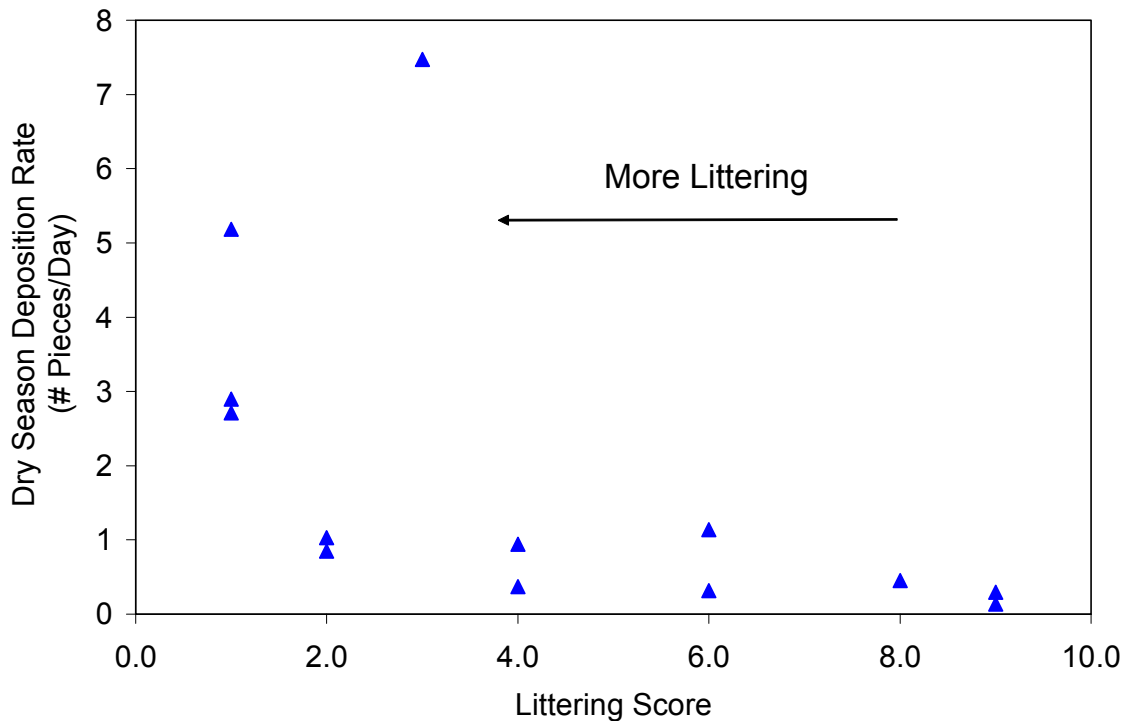
Figure 9: Dry season trash deposition rates relative to the RTA littering score.

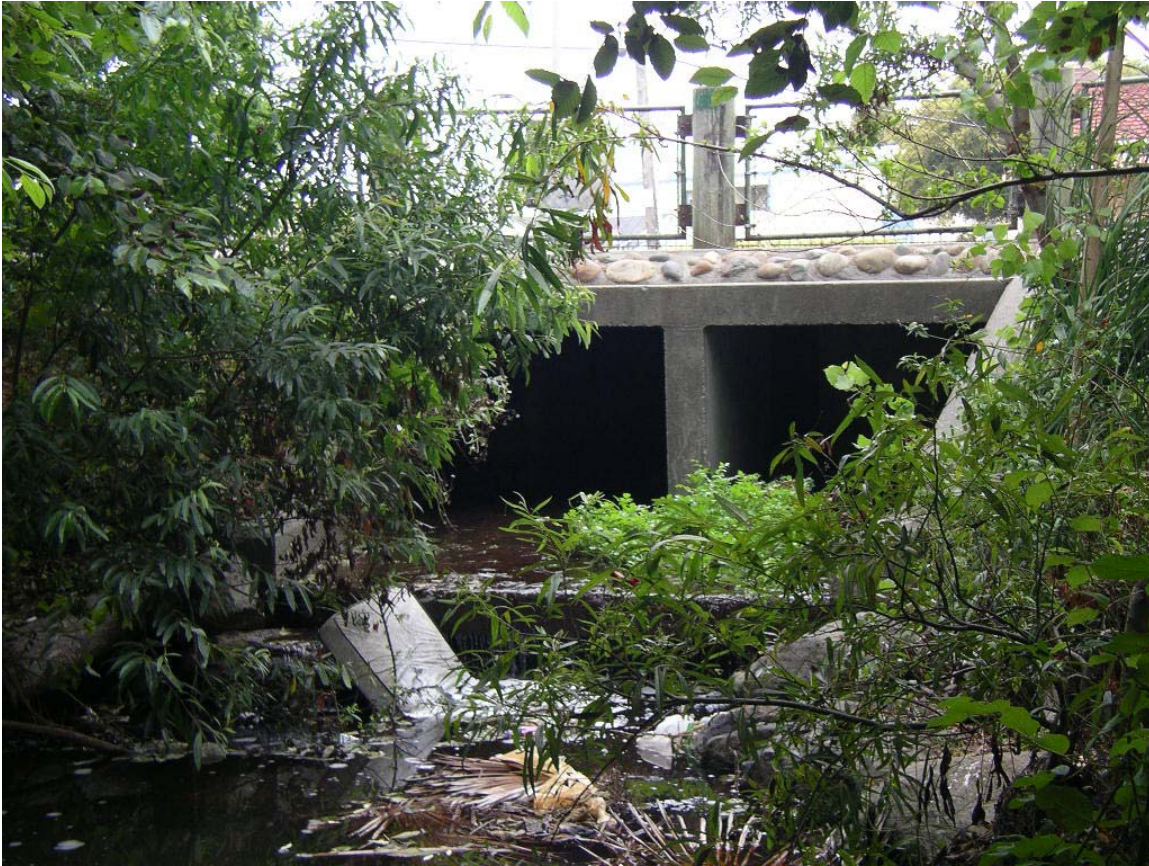
**Figure 10: View looking upstream from Booker T. Anderson Park trash survey site (BAX030), showing dumped mattress and low gate above culvert at street crossing, upstream of park. Photo by Steve Moore, August 23, 2005.**

The site is surrounded by residential areas. A stream restoration project occurred here a few years ago, with the concrete channel removed and a riparian corridor established, which has developed well (though at most 20' in width). There was evidence of park use at each survey, particularly on the east bank where there is grass, a playground, and a ball field. The trash site is about ¼ of the way into the park from the upstream culvert. At the culvert is a large pool. Many dumped items were observed in this pool, but it is not within the 100-foot reach. The culvert is at the top of the park, with easy access for dumping from vehicular traffic. Some of the dumped items get carried downstream, for instance mattresses were observed in the stream at the lower end of the park. Littering is prevalent here also, though trash cans and a dumpster are present. On the west side of the creek is the recreation center and a large parking lot. The parking lot is clean. A street sweeper was observed cleaning the lot. The recreation center has a dumpster at the curb.

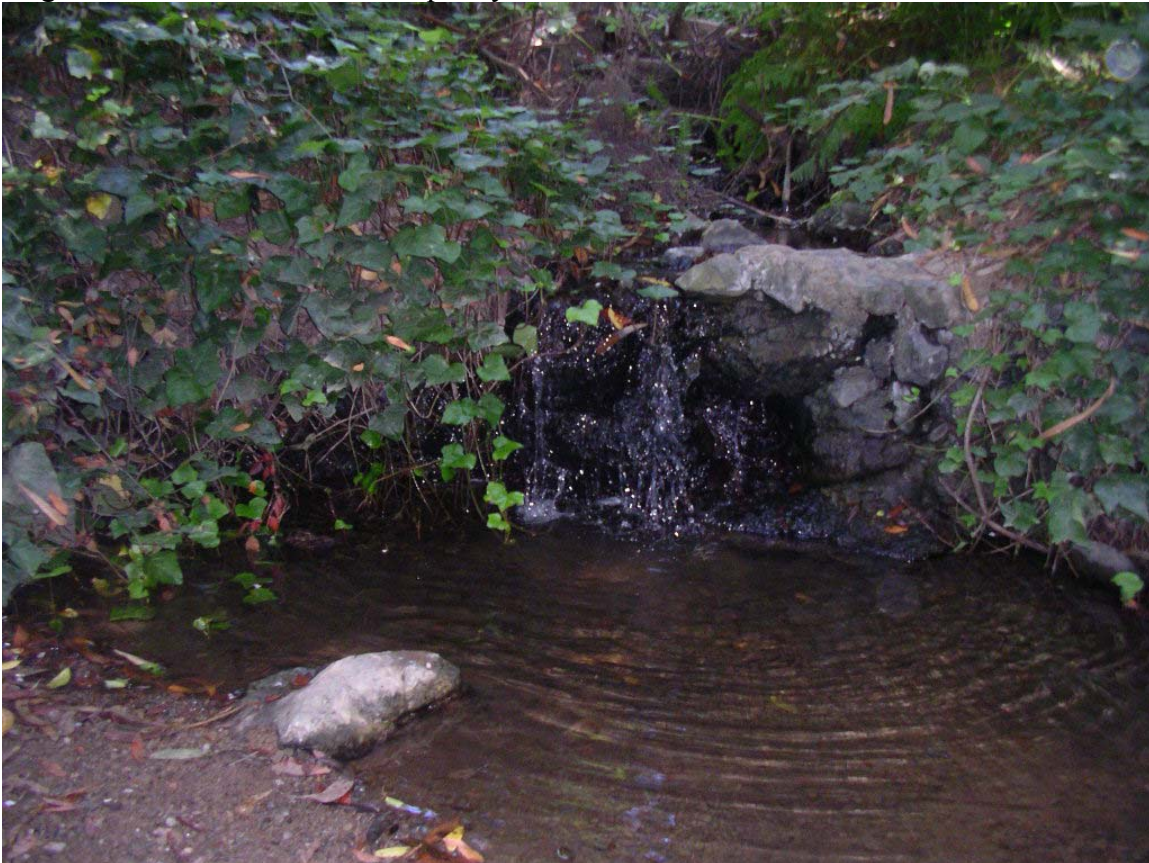
**Figure 11: View of trash survey site on Palo Seco Creek in Joaquin Miller Park, Oakland, CA, showing no trash during dry season survey. Some dog waste was in the creekbed, lowering the RTA score from optimal due to the threat to human health. Photo by Steve Moore, August 23, 2005.**

This site may have less public use than many parks, which explains the remarkably low levels of trash in the stream. Still, evidence of littering is present, probably commensurate with the density of use of the site by dog walkers and urban hikers. The lowering of the score through successive site visits (Figure 13) is based on human health indicators like pet waste, which can lower scores significantly due to the adverse effects on water quality. The management of trash at this location is related to the users of the park, the availability of pet waste containers, and its relatively remote location. Park staff have not been contacted as to the frequency of trash pickup, but the Friends of Sausal Creek, with their active stewardship, probably influence the level of trash at this site as well. It is not a coincidence that the active citizen group is correlated with the higher RTA scores consistently recorded at the two upper Sausal Creek sites. Local citizens concerned about quality of life in their neighborhood largely carry out trash management in 2005. Most people in these types of organizations believe that high trash levels in neighborhood creeks lowers the quality of life.

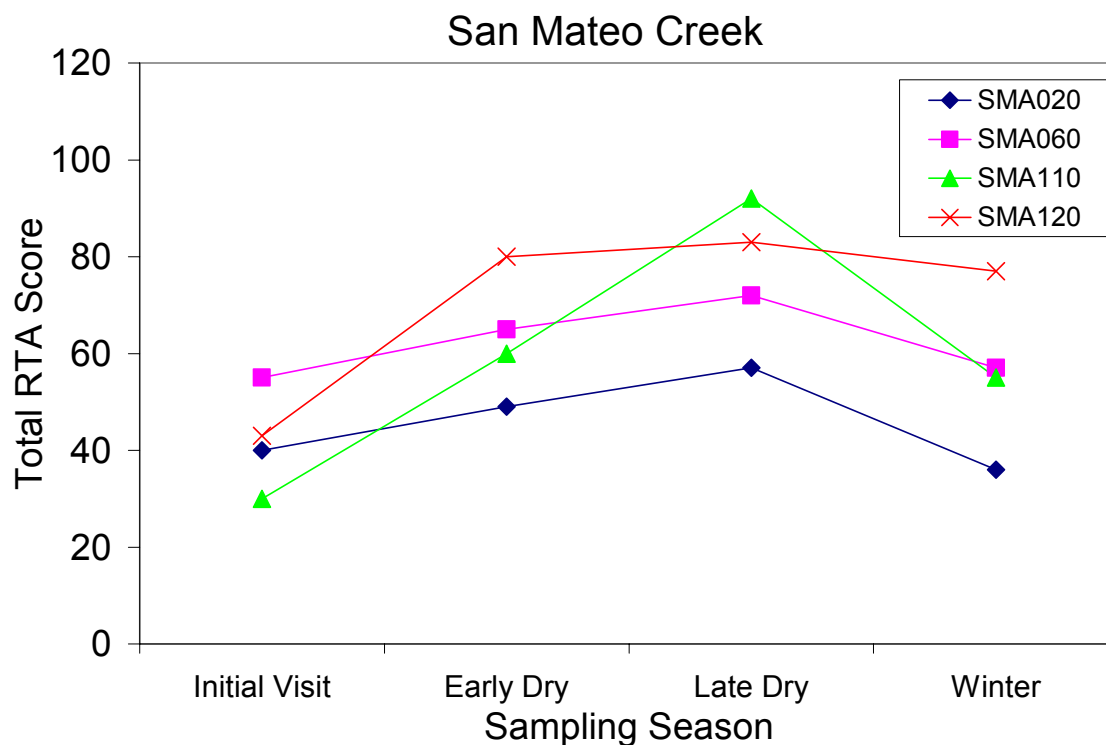
**Figure 12: RTA Scores at four sampling sites in the San Mateo Creek watershed along a longitudinal gradient. SMA020 is the lowest site, and SMA110 and SMA120 are the highest sites, both upstream of a confluence of Polhemus and San Mateo creeks.**

In Figure 12, the longitudinal trash characteristics of San Mateo Creek are apparent. The lower Gateway Park, though not initially having highest trash levels, had higher sustained trash levels and hence lower RTA scores. Arroyo Court Park, located 2 miles upstream but within urbanized portions of the city, tracked closely with Gateway Park, with higher scores in each season. Polhemus Creek, with the lowest initial score, had higher levels after trash was removed, but wet weather brought a significant return of trash from this residential area. The upper San Mateo creek site saw less return of trash with wet weather, due to less upstream urbanization. This site, known as SMA120 in Figure 12, exhibited the desirable pattern of higher initial levels and less return of trash after “management,” or cleanup associated with the RTA protocol, during both dry and wet seasons. Dry season RTA scores were lower at the Gateway and Arroyo Court Park sites, due to direct littering documented at these more publicly accessible sites.

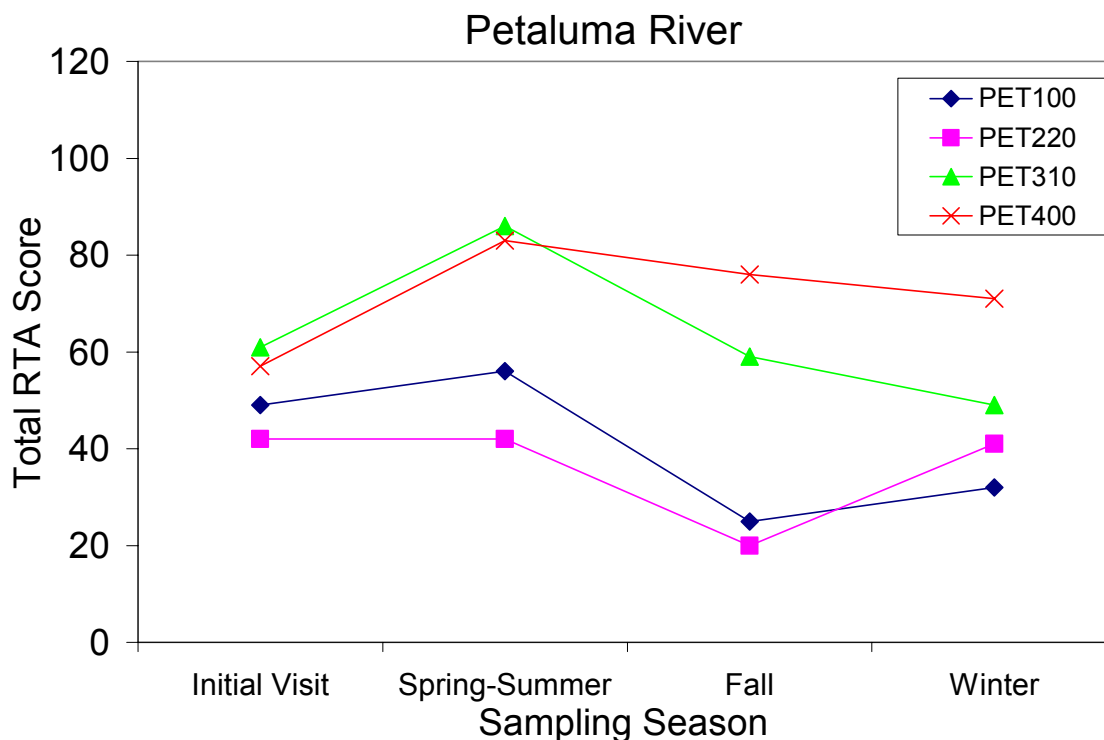
**Figure 13: RTA Scores at four sampling sites in the Petaluma River watershed along a longitudinal gradient.** PET100 is the lowest site, PET310 is upstream on the main branch, and PET220 and PET400 are the tributary sites. PET220 tributary (Washington Cr.) enters the main branch downstream of PET310. Except for PET400, the final scores are below the initial scores, indicating that trash levels may be getting worse in this watershed.

Figure 13 shows that the Petaluma River watershed had lower overall scores after the surveys and cleanups than initial scores. While it may be premature to conclude that trash levels are getting worse, it can be reasonably concluded that trash levels in streams are not improving in this watershed.

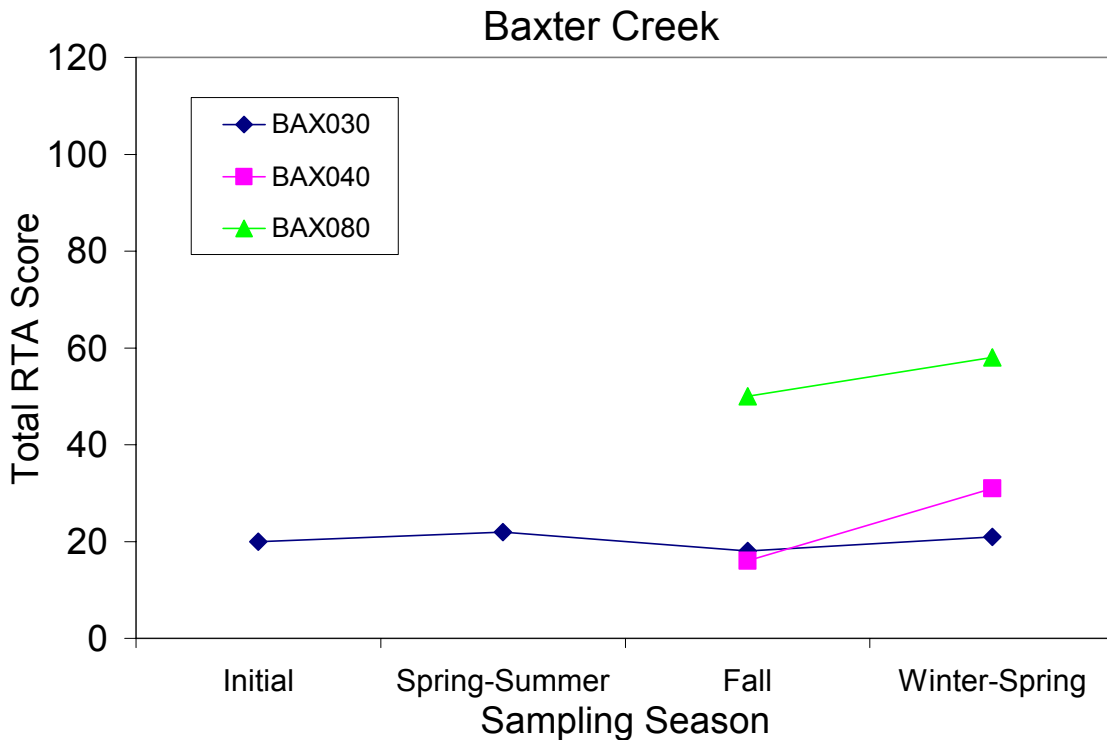
**Figure 14: RTA Scores at three sampling sites in the Baxter Creek watershed along a longitudinal gradient. BAX030 is the lowest site, BAX040 is upstream on the main branch at San Pablo Avenue, and BAX080 is at Canyon Trail Park, also on the main branch, in El Cerrito.**

The lowest site at Booker T. Anderson Park has been discussed above, and exhibits both dry and wet season inputs of trash. The flatline pattern of scores in Figure 14, at or around the low score of 20, shows a steady level of trash regardless of the trash removal conducted in the surveys, and regardless of season. Similar problems were documented at the next site upstream, but there was less wet season deposition effects than at Booker T. Anderson Park. The site at Canyon Trail Park in the El Cerrito hills had significantly higher RTA scores in dry and wet seasons, demonstrating the longitudinal pattern of trash levels seen region-wide.

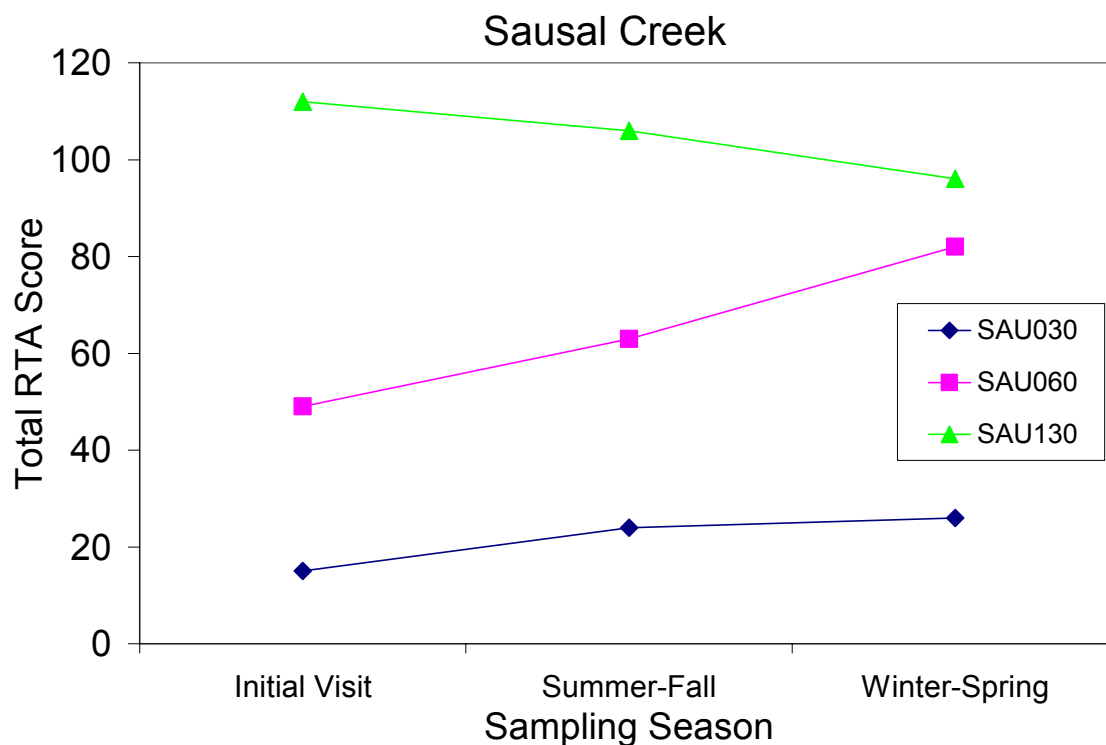
**Figure 15: RTA scores at three sampling sites in the Sausal Creek watershed along a longitudinal gradient. SAU030 is the lowest site at E. 22<sup>nd</sup> Street, SAU060 is at Dimond Park, and SAU130 is on Palo Seco Creek in Joaquin Miller Park, all in Oakland, CA.**

The lower Sausal Creek site at E 22<sup>nd</sup> St. shows a significantly different picture of a site heavily impacted by trash. The open channel upstream of the site appears to attract

illegal dumpers and litterers, and adjacent landowners were observed dumping their household trash into the stream area. This area could be a focus for progressive education, warning and enforcement of existing littering laws.

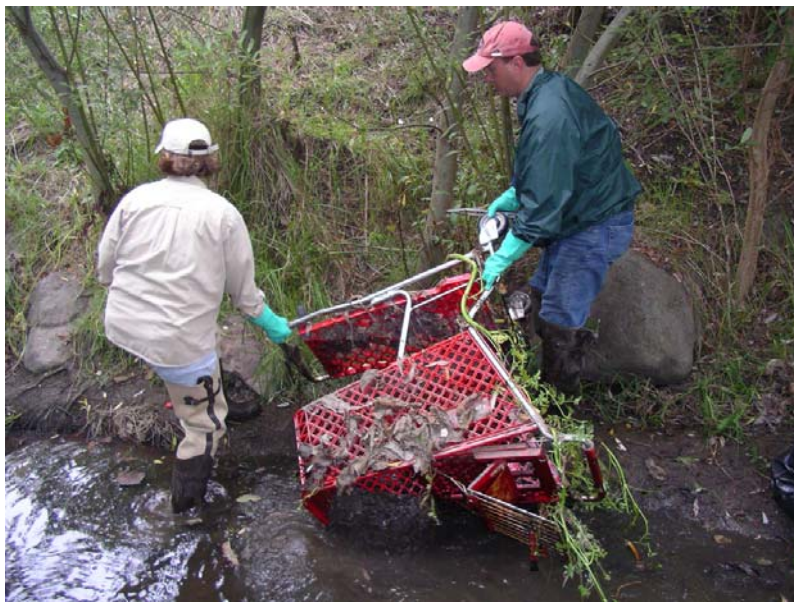
**Figure 16: Water Board staff remove a shopping cart from the Booker T. Anderson Park trash site. Photo by Kim Harrison, August 23, 2005.**
