Appendix B
Pre-Design CPT/MIP Boring Logs

MIP REPORT

228 Hookston Road, Pleasant Hill, CA

Hookston Station

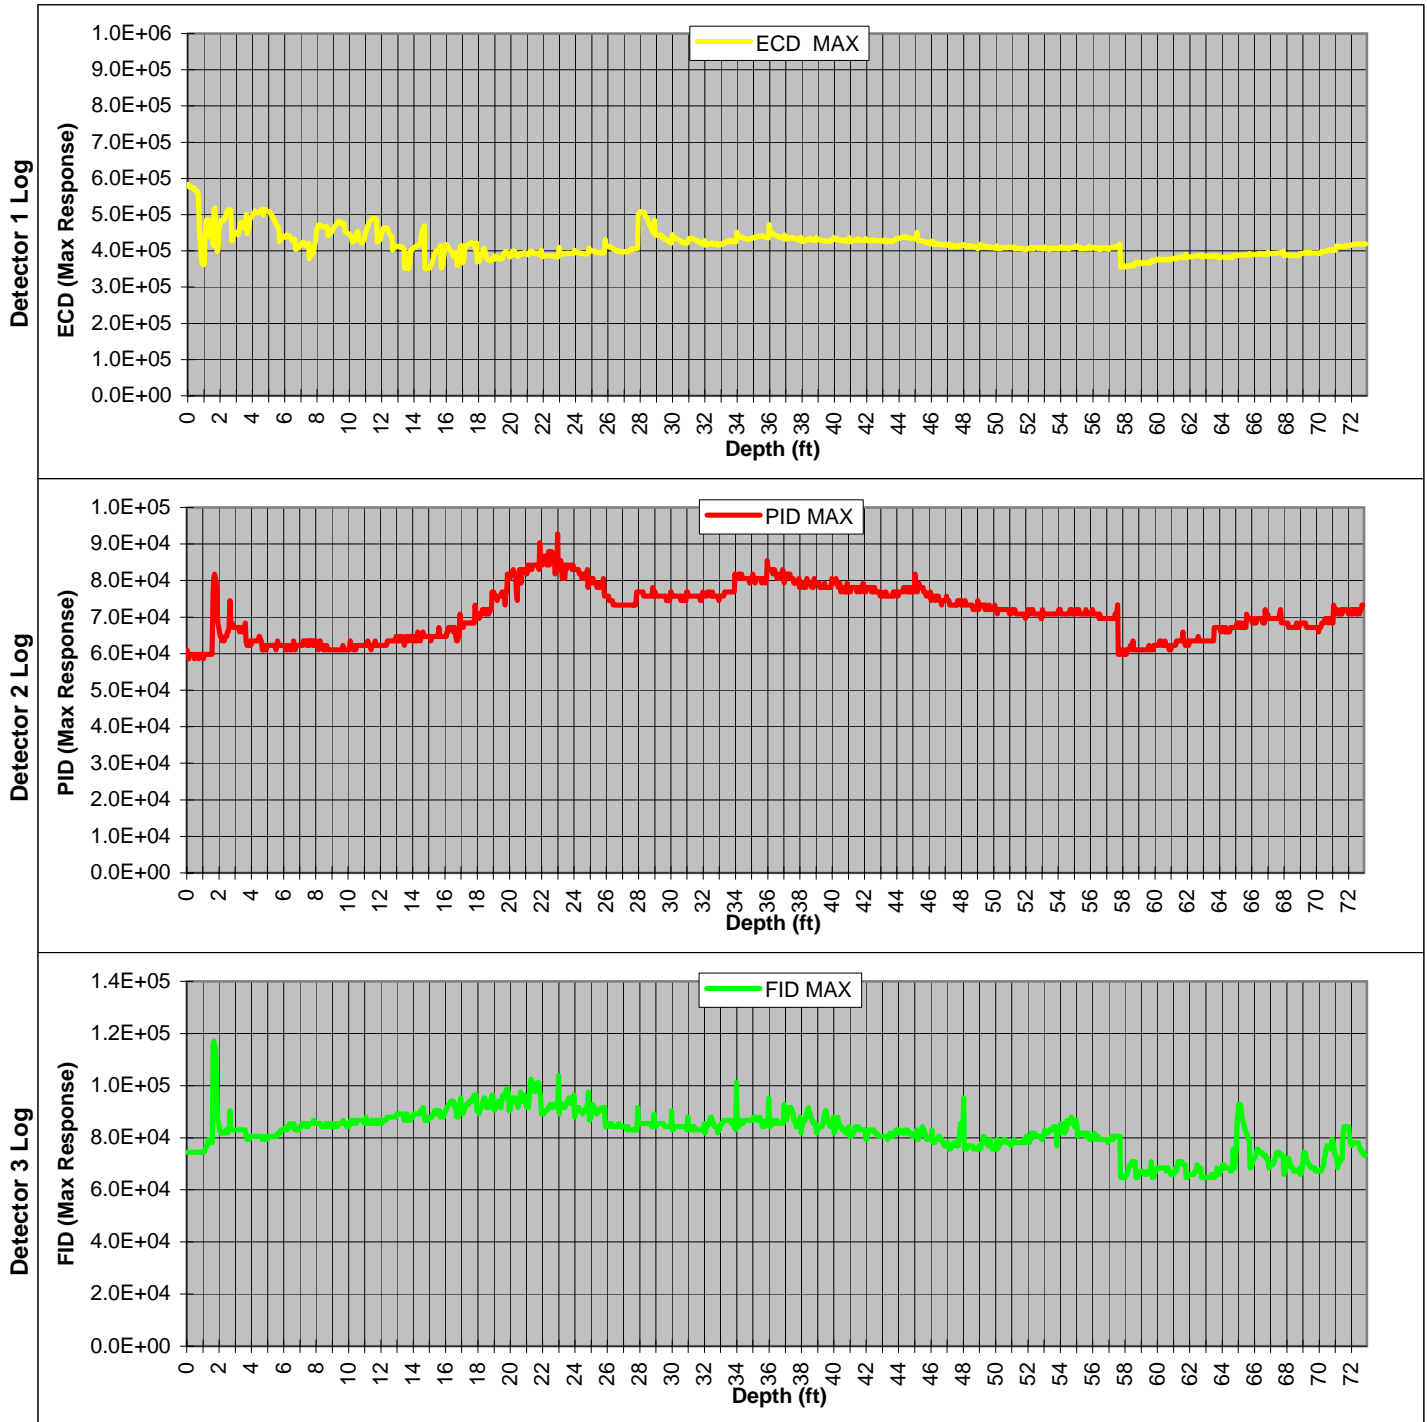
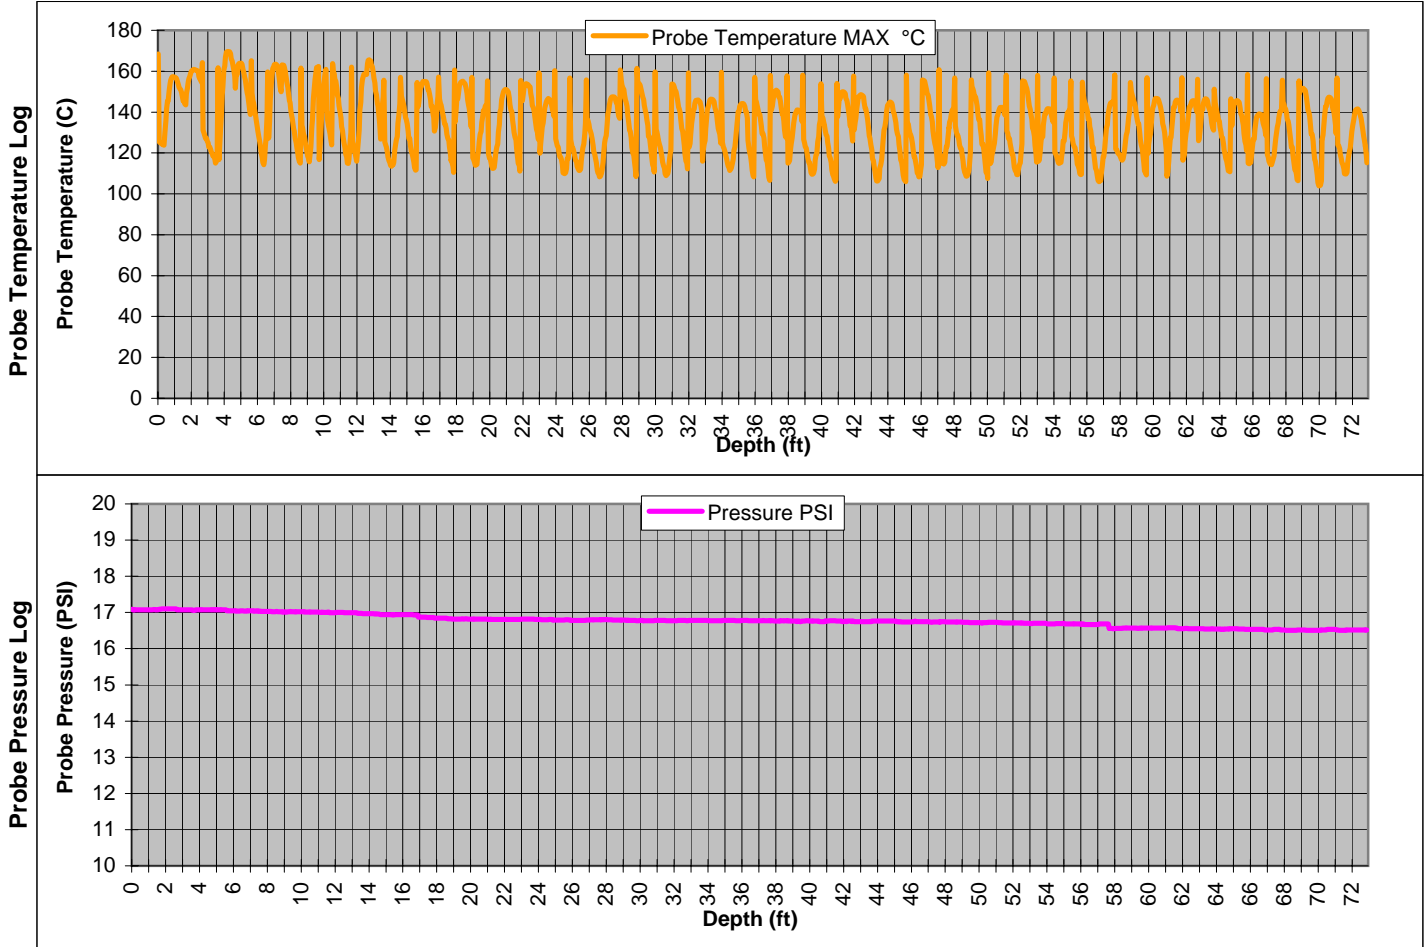
Boring I.D.: CPT-33

MIP Log Results by Boring - Detector Reading vs. Depth

Detector 1 : Electron Capture (ECD)

Detector 2 : Photo Ionization (PID)

Detector 3 : Flame Ionization (FID)

Graph 1 : Probe Temperature (C)

Graph 2 : Probe Pressure (PSI)

Explanation: Hand augered to 5' bgs.

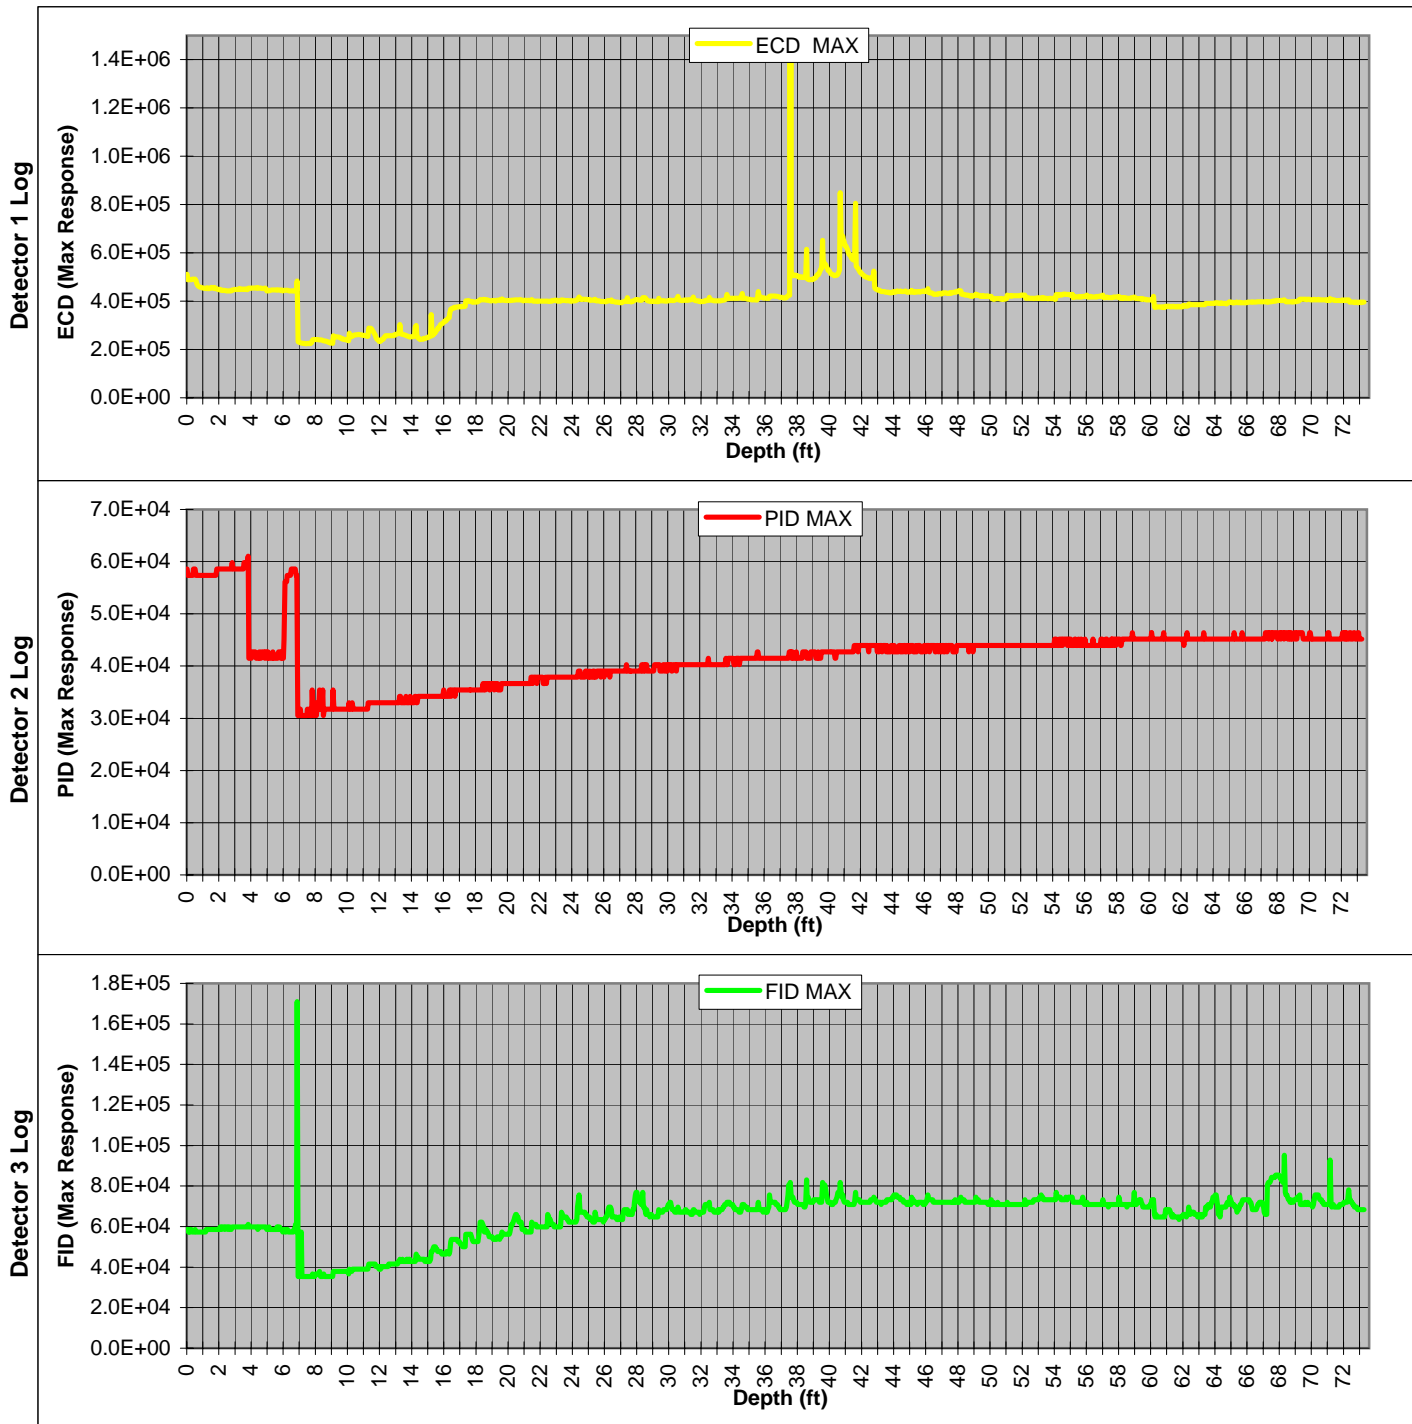
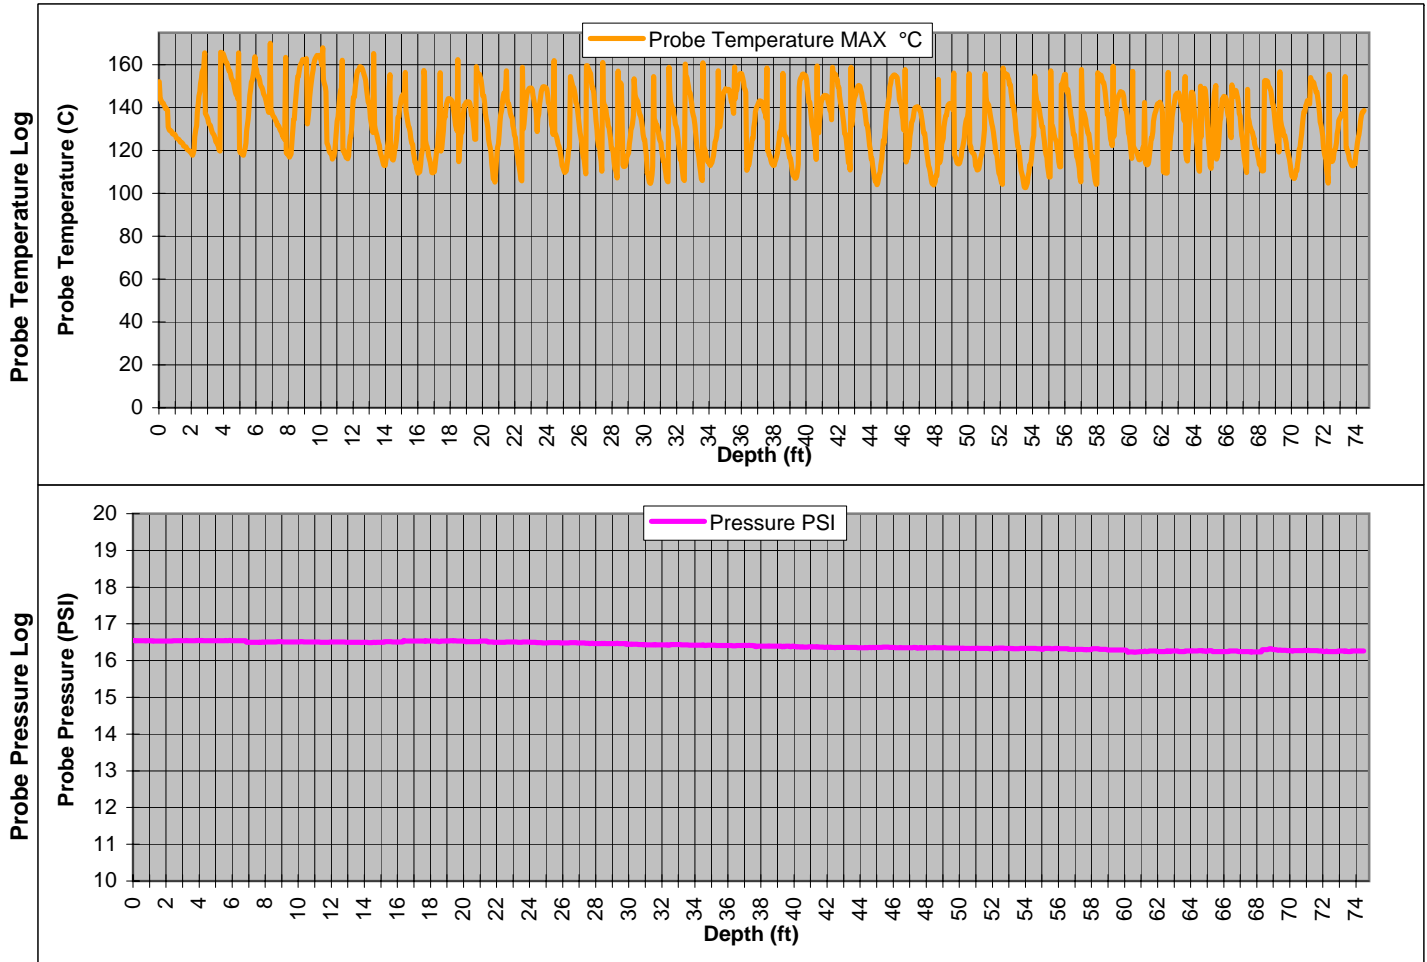
Boring I.D.: CPT-34

MIP Log Results by Boring - Detector Reading vs. Depth

Detector 1 : Electron Capture (ECD)

Detector 2 : Photo Ionization (PID)

Detector 3 : Flame Ionization (FID)

Graph 1 : Probe Temperature (C)

Graph 2 : Probe Pressure (PSI)

Explanation: Hand augered to 5' bgs. Attenuation error at 40.55'. Disregard data. PID lamp went out at approximately 9' bgs. FID signal at 9' caused by opening the system to check PID lamp.

CPT-33	Hand augered to 5' bgs.
CPT-34	Hand augered to 5' bgs. Attenuation error at 40.55'. Disregard data. PID lamp went out at approximately 9' bgs. FID signal at 9' caused by opening the system to check PID lamp.
CPT-35	Hand augered to 5' bgs.
CPT-44	Hand augered to 5' bgs. First 28.35' is not valid, due to stringpot error and/or potential open hole smearing/volatilization of contaminants.
CPT-46	Hand augered to 5' bgs.
CPT-45	Hand augered to 5' bgs.
CPT-43	Hand augered to 5' bgs.
CPT-42	Hand augered to 5.0' bgs. Range change at 4.0' bgs. Disregard ECD reading at that level. Stringpot had loose connection and data did not transfer for approx. 3-4'. From 60-64' bgs. The FC5000 needed to be reset at 66' due to a computer communication error.
CPT-47	Hand augered to 5' bgs.
CPT-40	Attenuation error/change at 5.6'-2.6', for actual.
CPT-39	Hand augered to 5' bgs.
CPT-48	Hand augered to 5'. Trigger off at 22.65' per Gregg Drilling request. Restarted in one minute and equilibrated for 80 seconds.

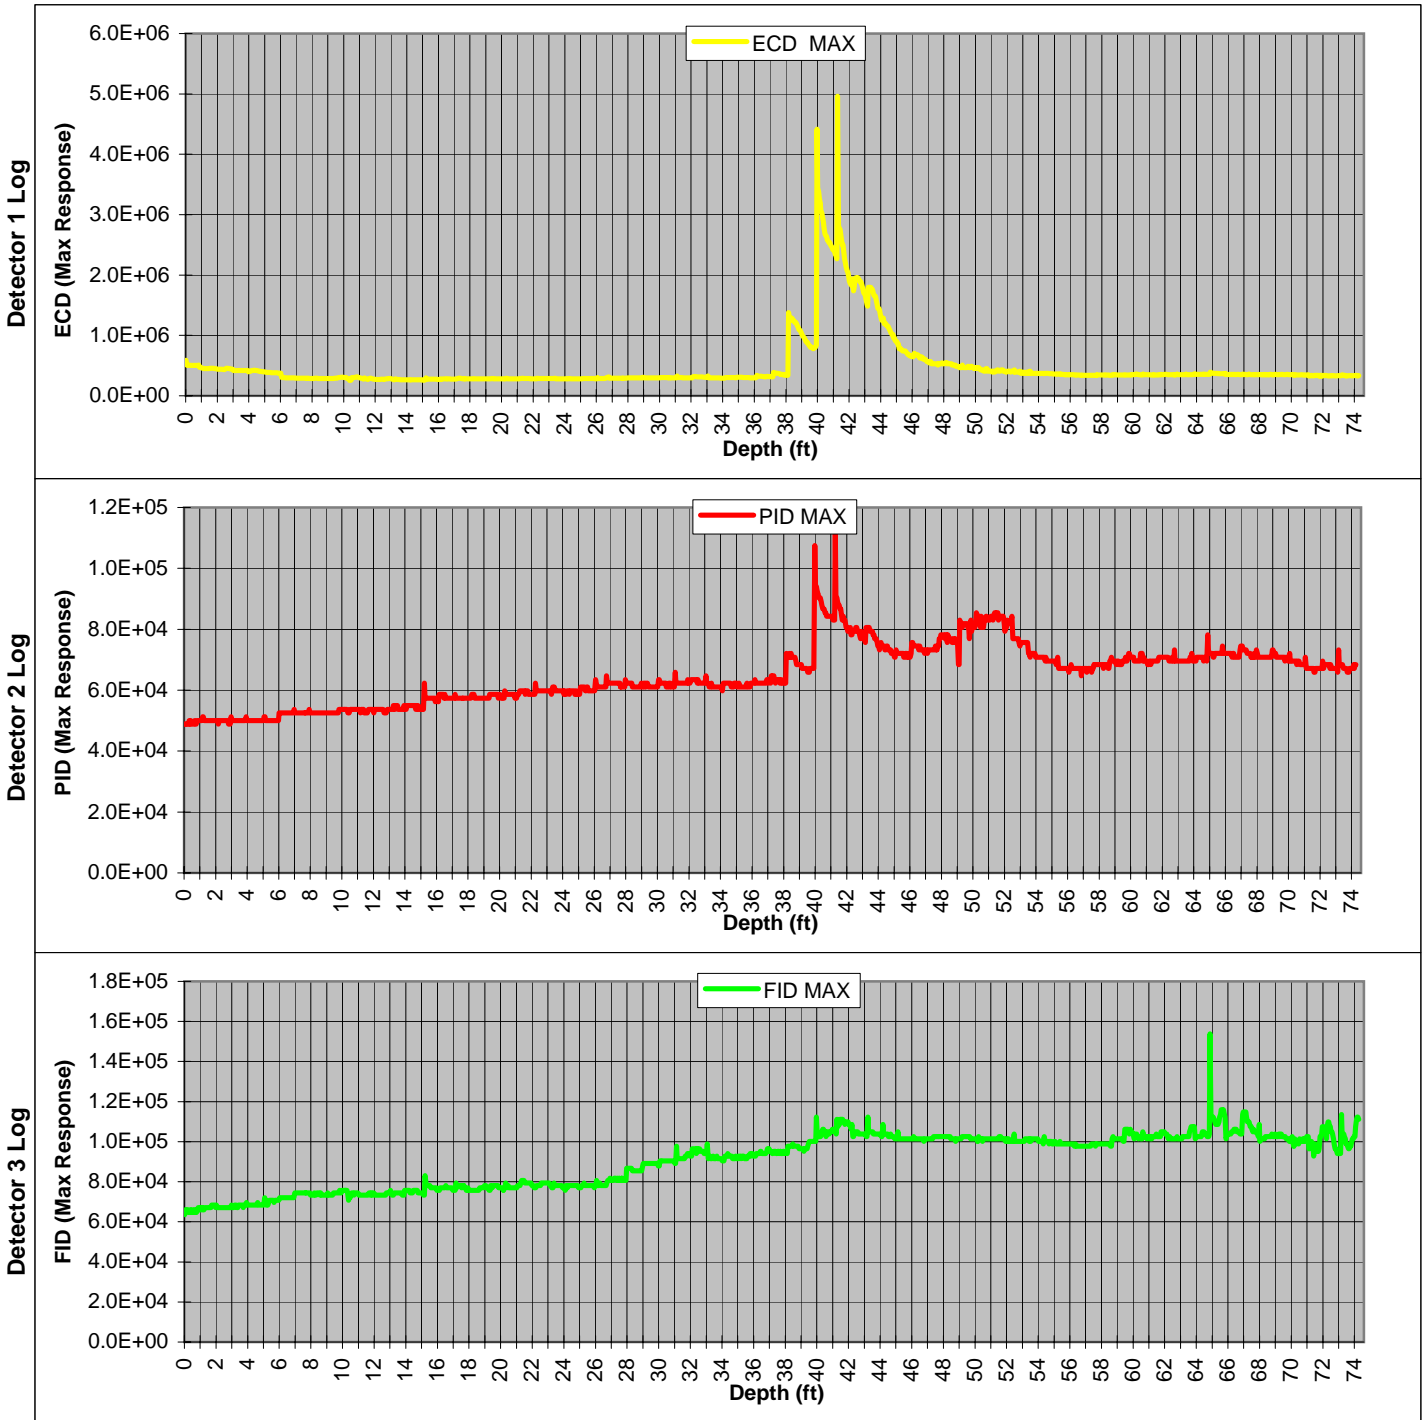
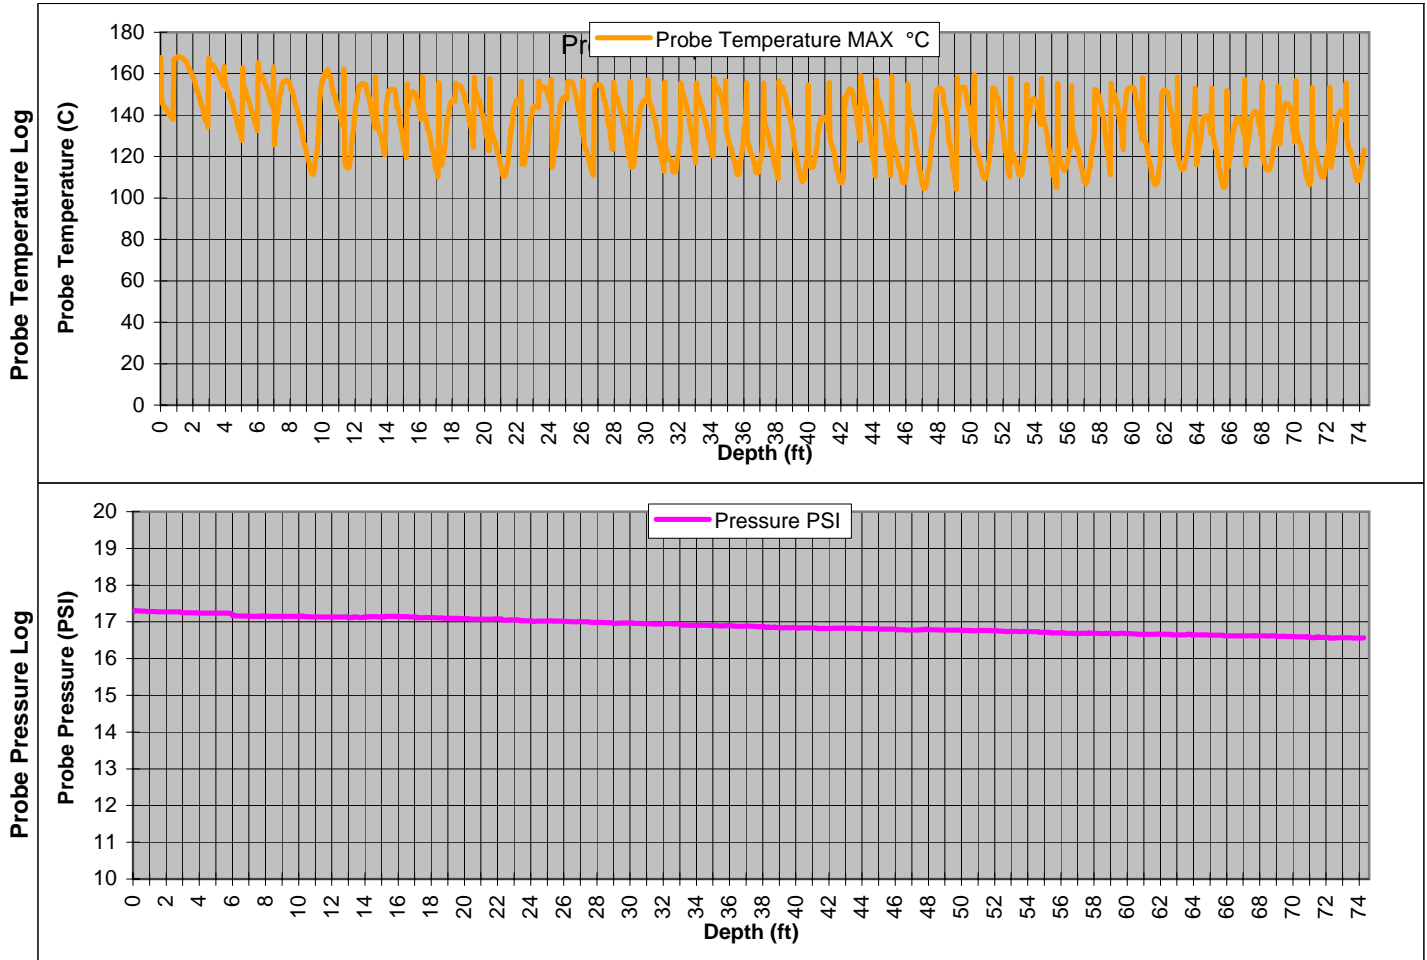
Boring I.D.: CPT-35

MIP Log Results by Boring - Detector Reading vs. Depth

Detector 1 : Electron Capture (ECD)

Detector 2 : Photo Ionization (PID)

Detector 3 : Flame Ionization (FID)

Graph 1 : Probe Temperature (C)

Graph 2 : Probe Pressure (PSI)

Explanation: Hand augered to 5' bgs.

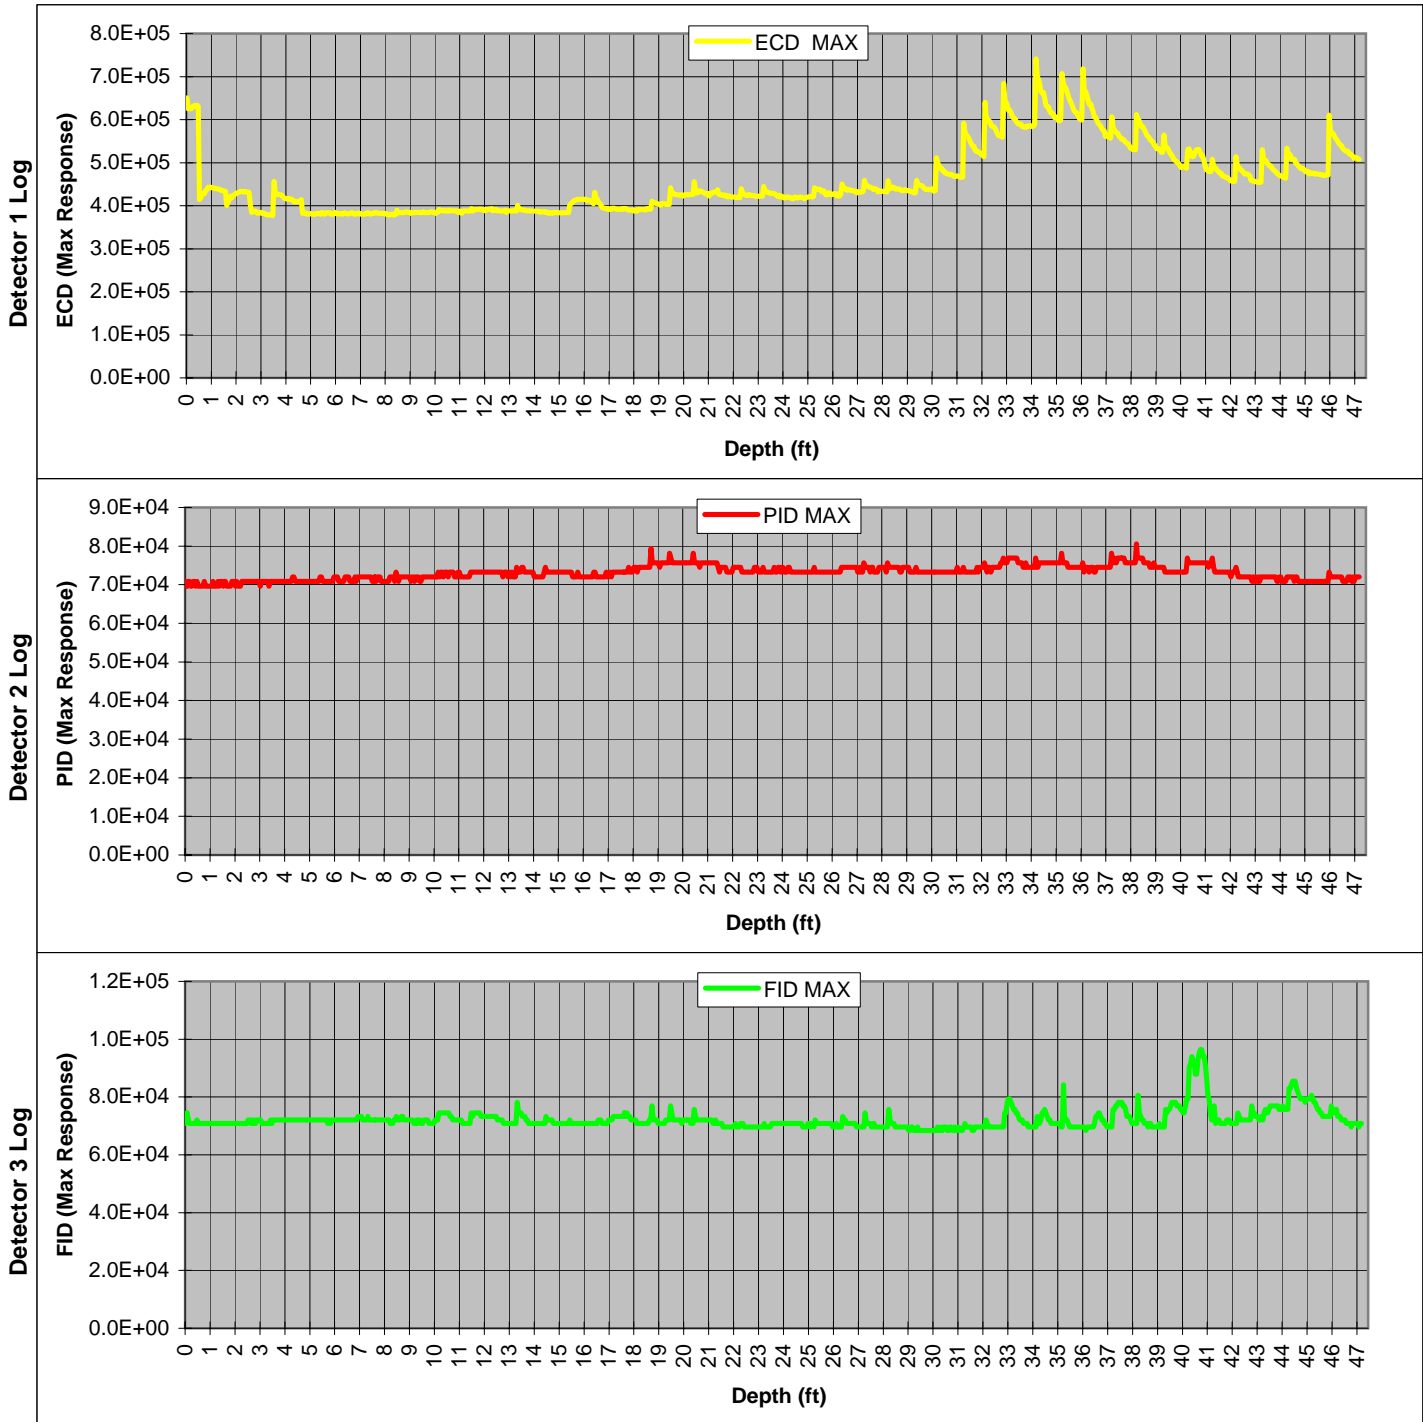
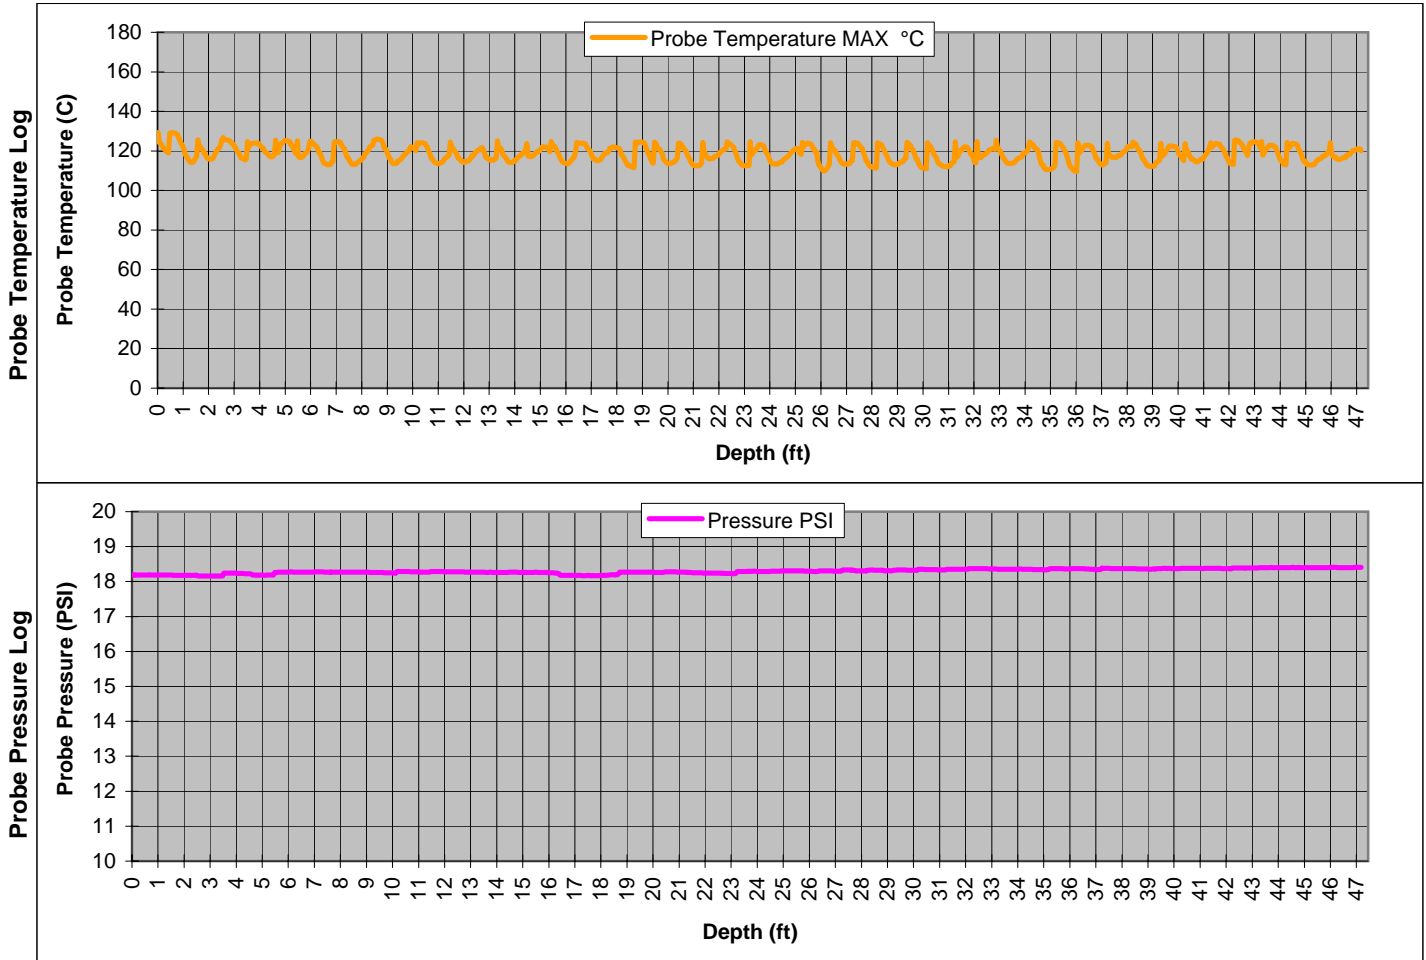
Boring I.D.: CPT-44

MIP Log Results by Boring - Detector Reading vs. Depth

Detector 1 : Electron Capture (ECD)

Detector 2 : Photo Ionization (PID)

Detector 3 : Flame Ionization (FID)

Graph 1 : Probe Temperature (C)

Graph 2 : Probe Pressure (PSI)

Explanation: Hand augered to 5' bgs. First 28.35' is not valid, due to stringpot error and/or potential open hole smearing/volatilization of contaminants.

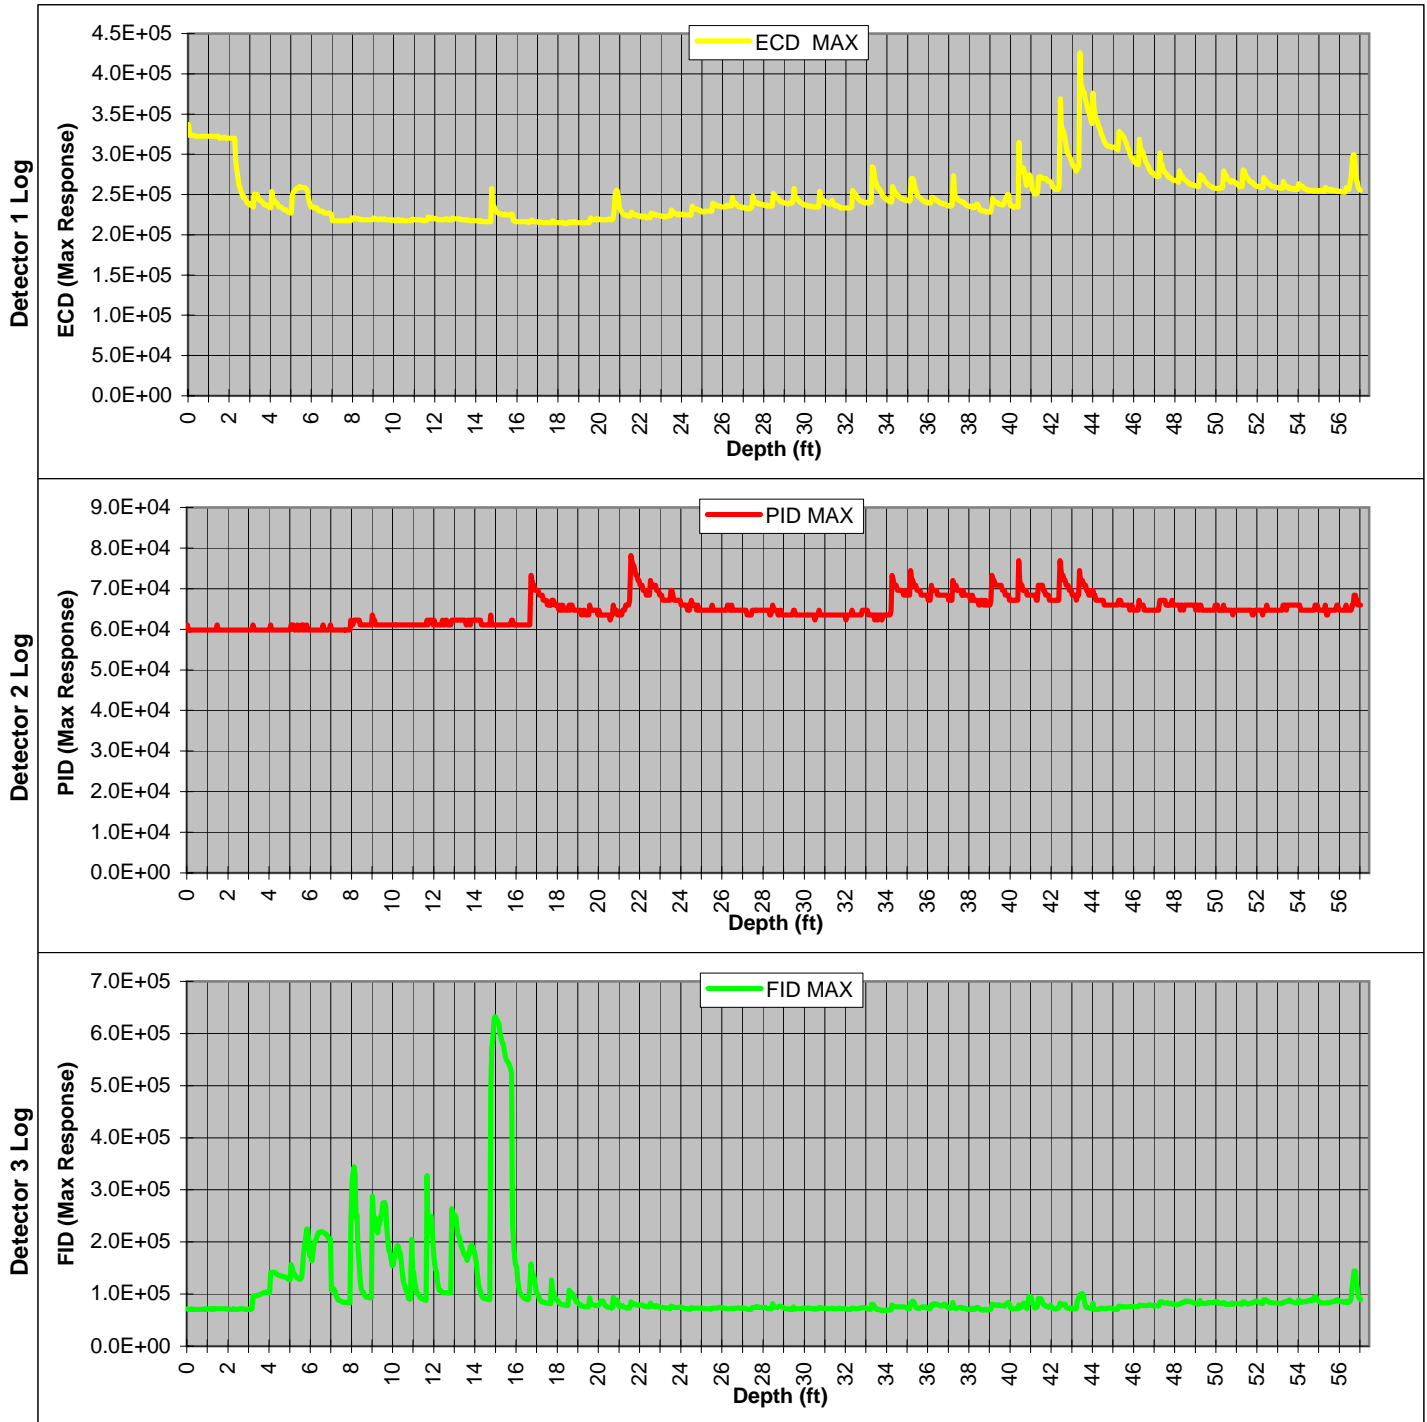
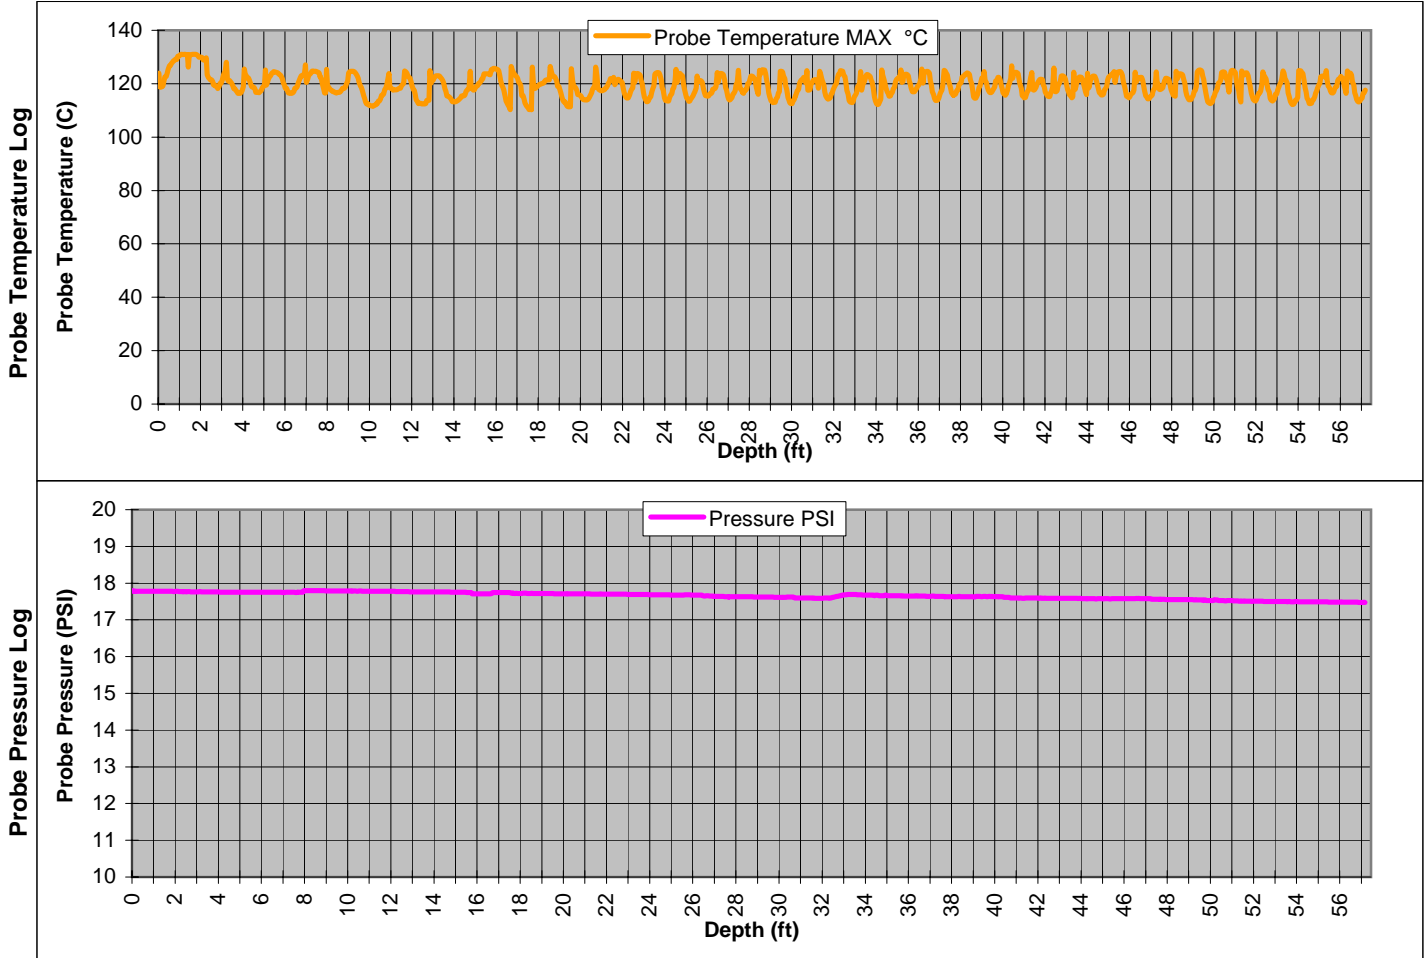
Boring I.D.: CPT-46

MIP Log Results by Boring - Detector Reading vs. Depth

Detector 1 : Electron Capture (ECD)

Detector 2 : Photo Ionization (PID)

Detector 3 : Flame Ionization (FID)

Graph 1 : Probe Temperature (C)

Graph 2 : Probe Pressure (PSI)

Explanation: Hand augered to 5' bgs.

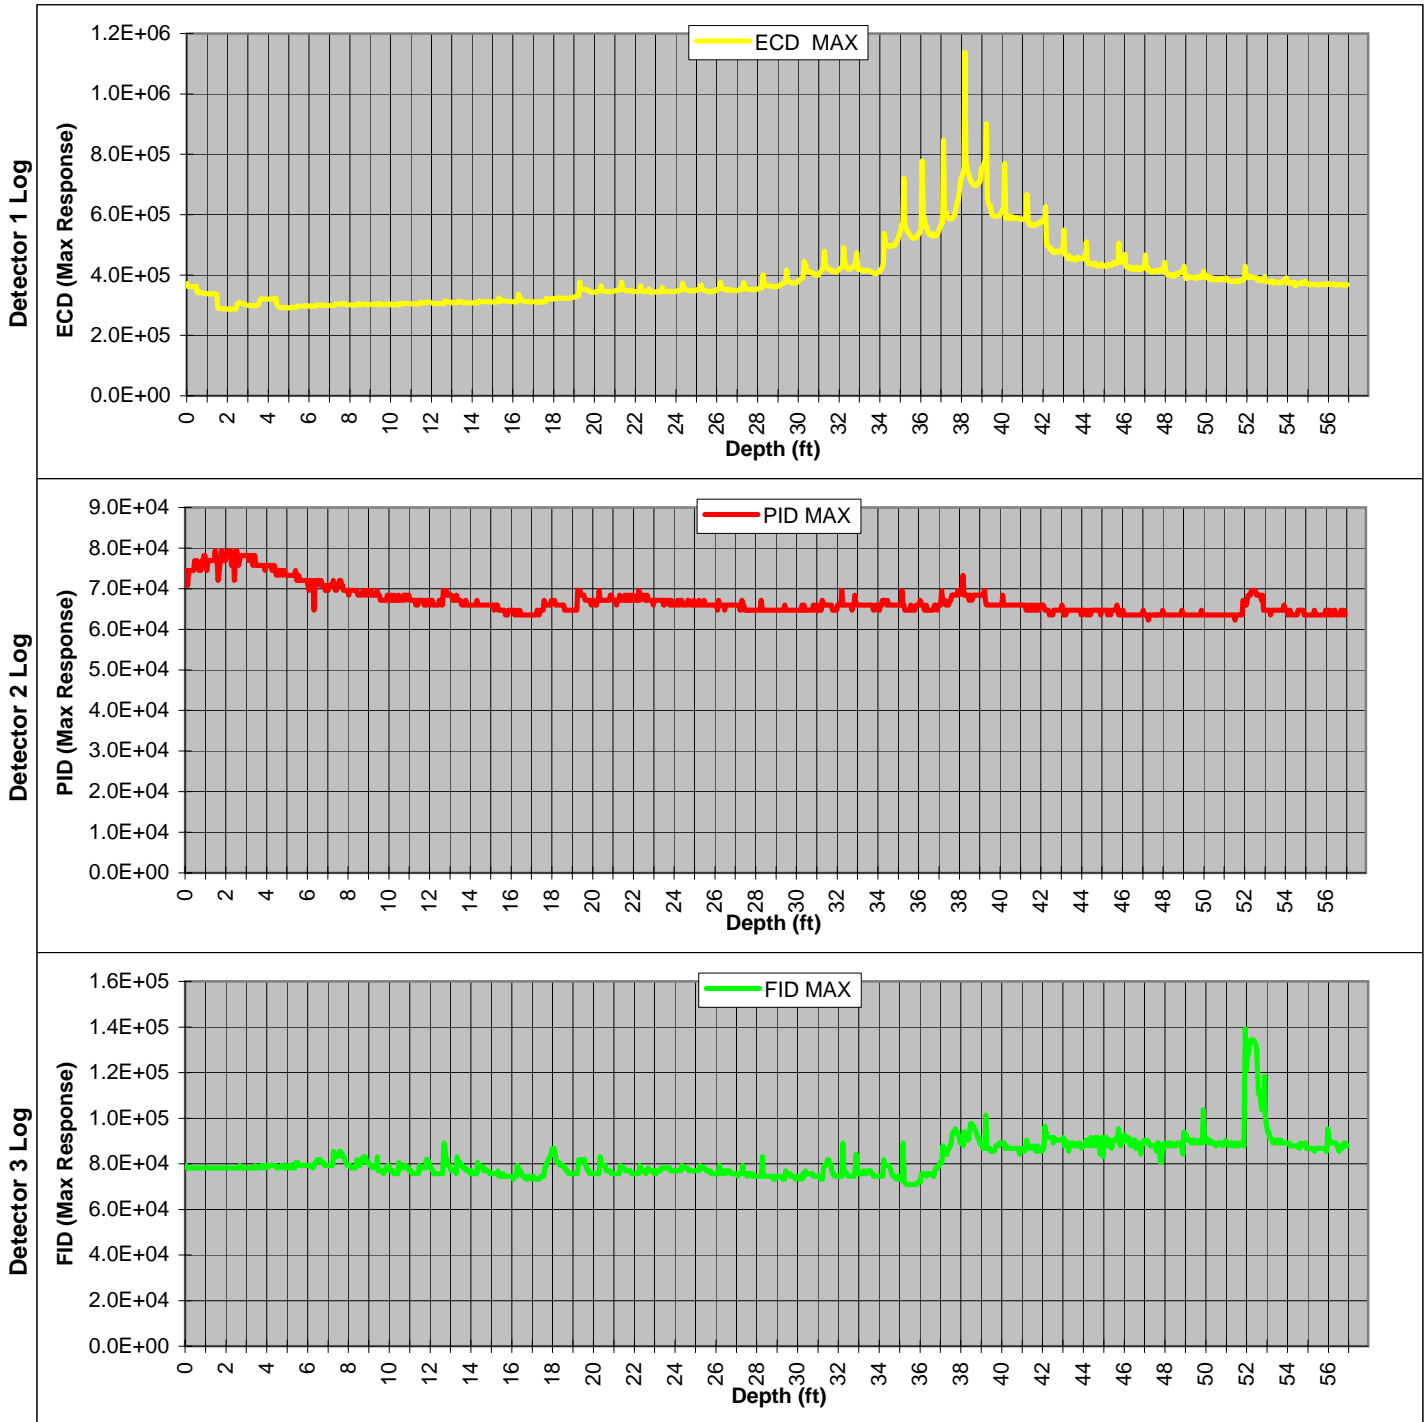
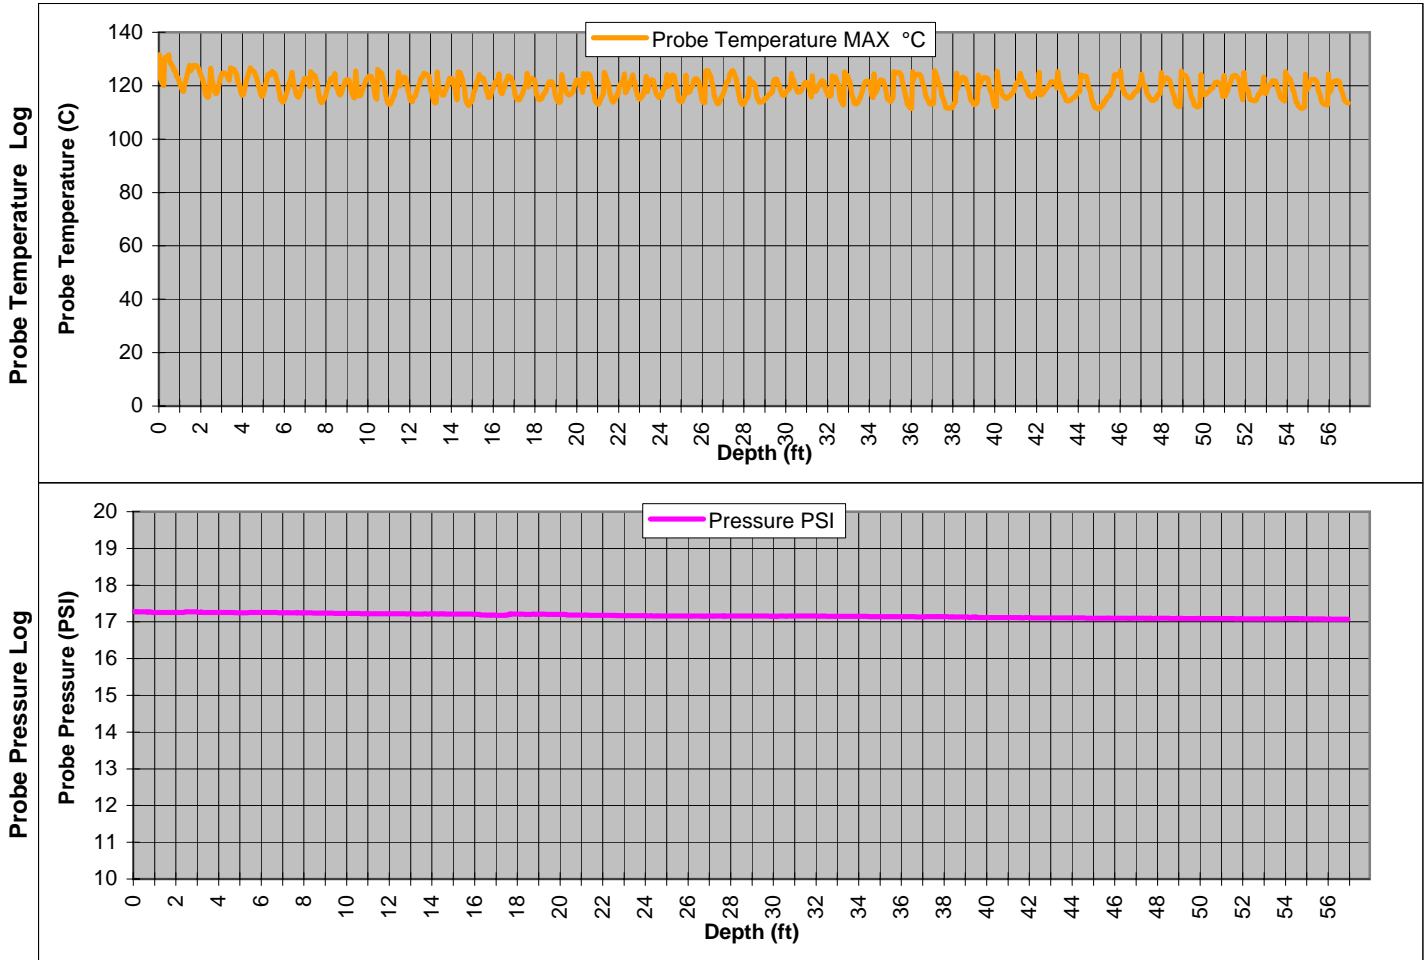
Boring I.D.: CPT-45

MIP Log Results by Boring - Detector Reading vs. Depth

Detector 1 : Electron Capture (ECD)

Detector 2 : Photo Ionization (PID)

Detector 3 : Flame Ionization (FID)

Graph 1 : Probe Temperature (C)

Graph 2 : Probe Pressure (PSI)

Explanation: Hand augered to 5' bgs.
