Appendix B
Pre-Design CPT/MIP Boring Logs

MIP REPORT

228 Hookston Road, Pleasant Hill, CA

Hookston Station

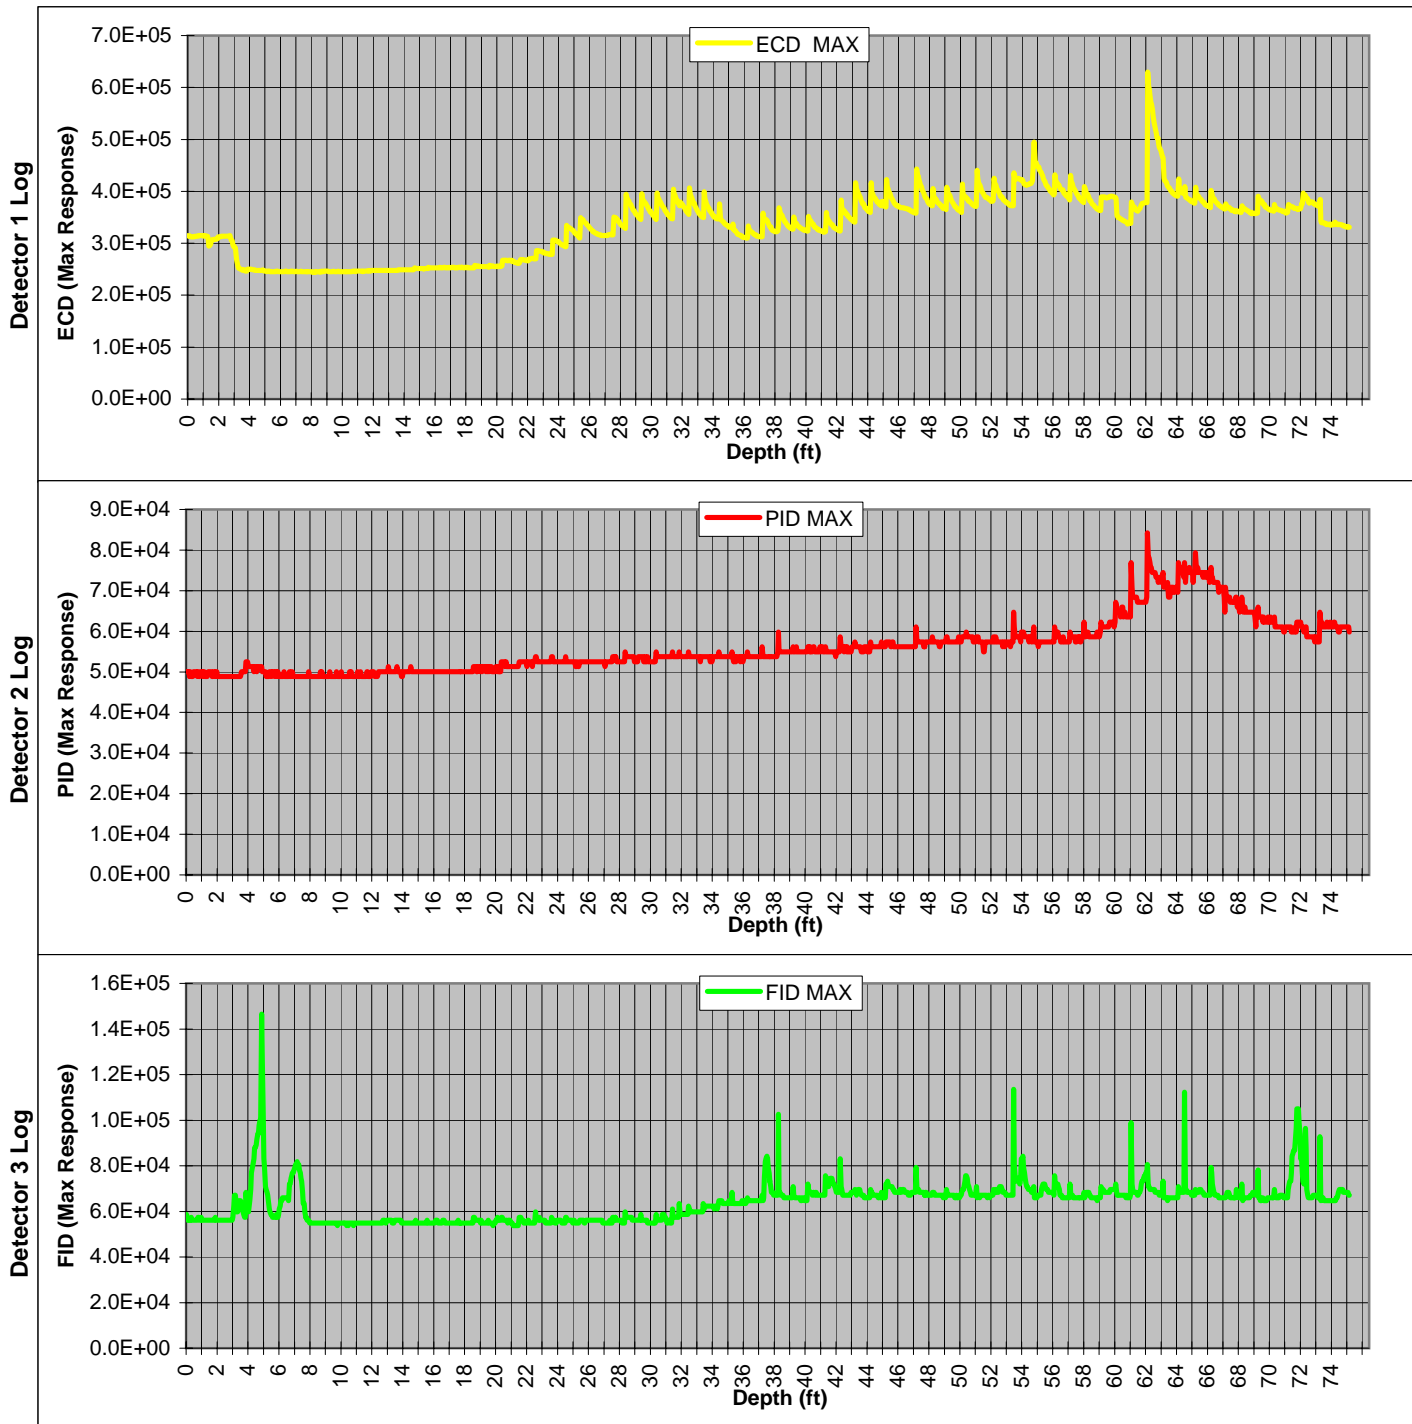
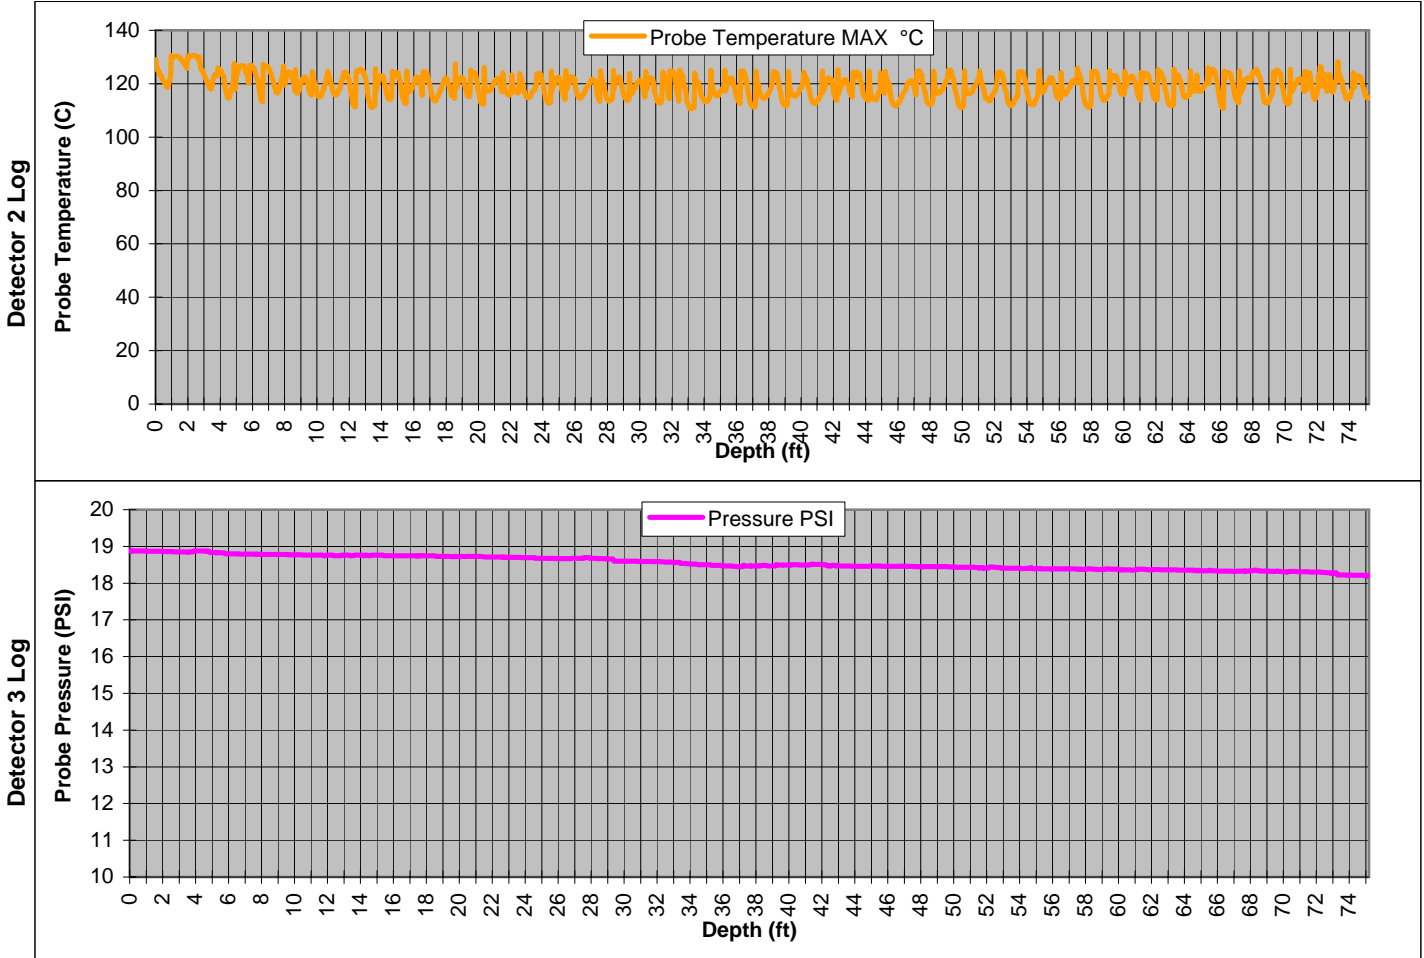
Boring I.D.: CPT-43

MIP Log Results by Boring - Detector Reading vs. Depth

Detector 1 : Electron Capture (ECD)

Detector 2 : Photo Ionization (PID)

Detector 3 : Flame Ionization (FID)

Graph 1 : Probe Temperature (C)

Graph 2 : Probe Pressure (PSI)

Explanation: Hand augered to 5' bgs.

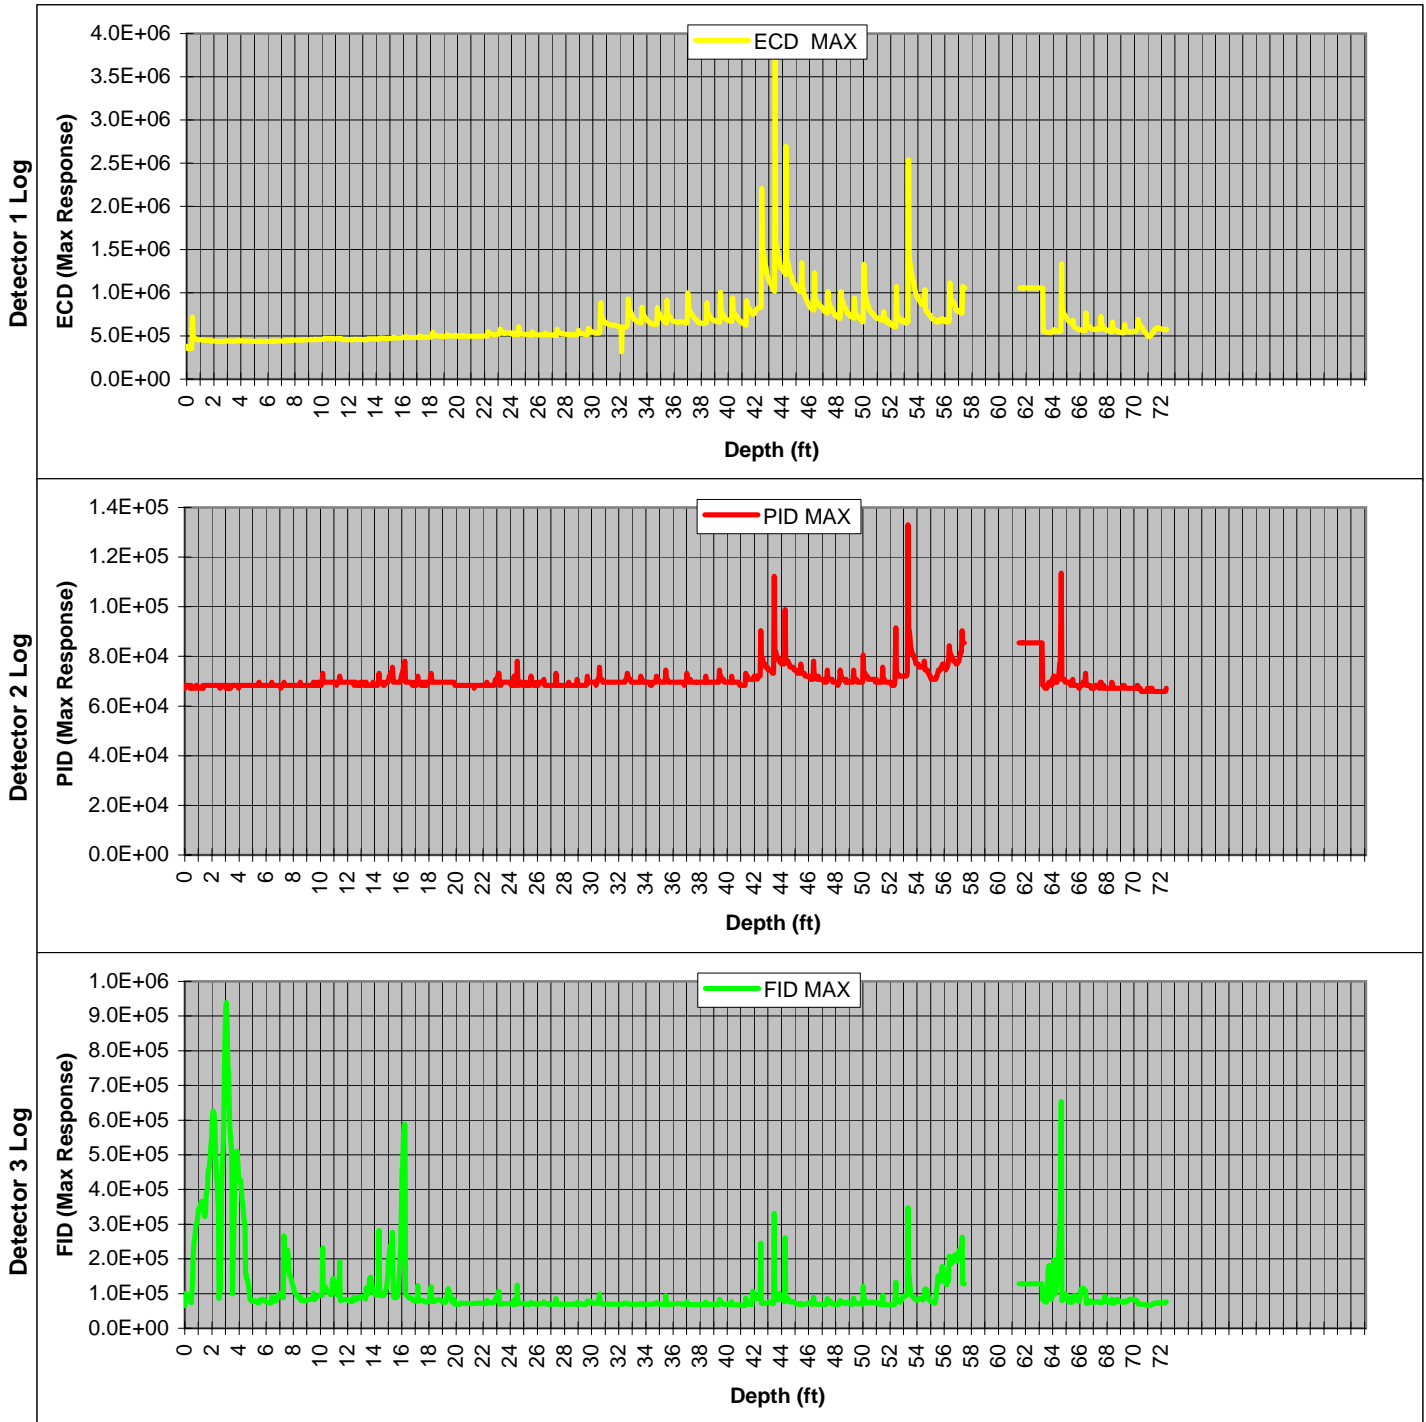
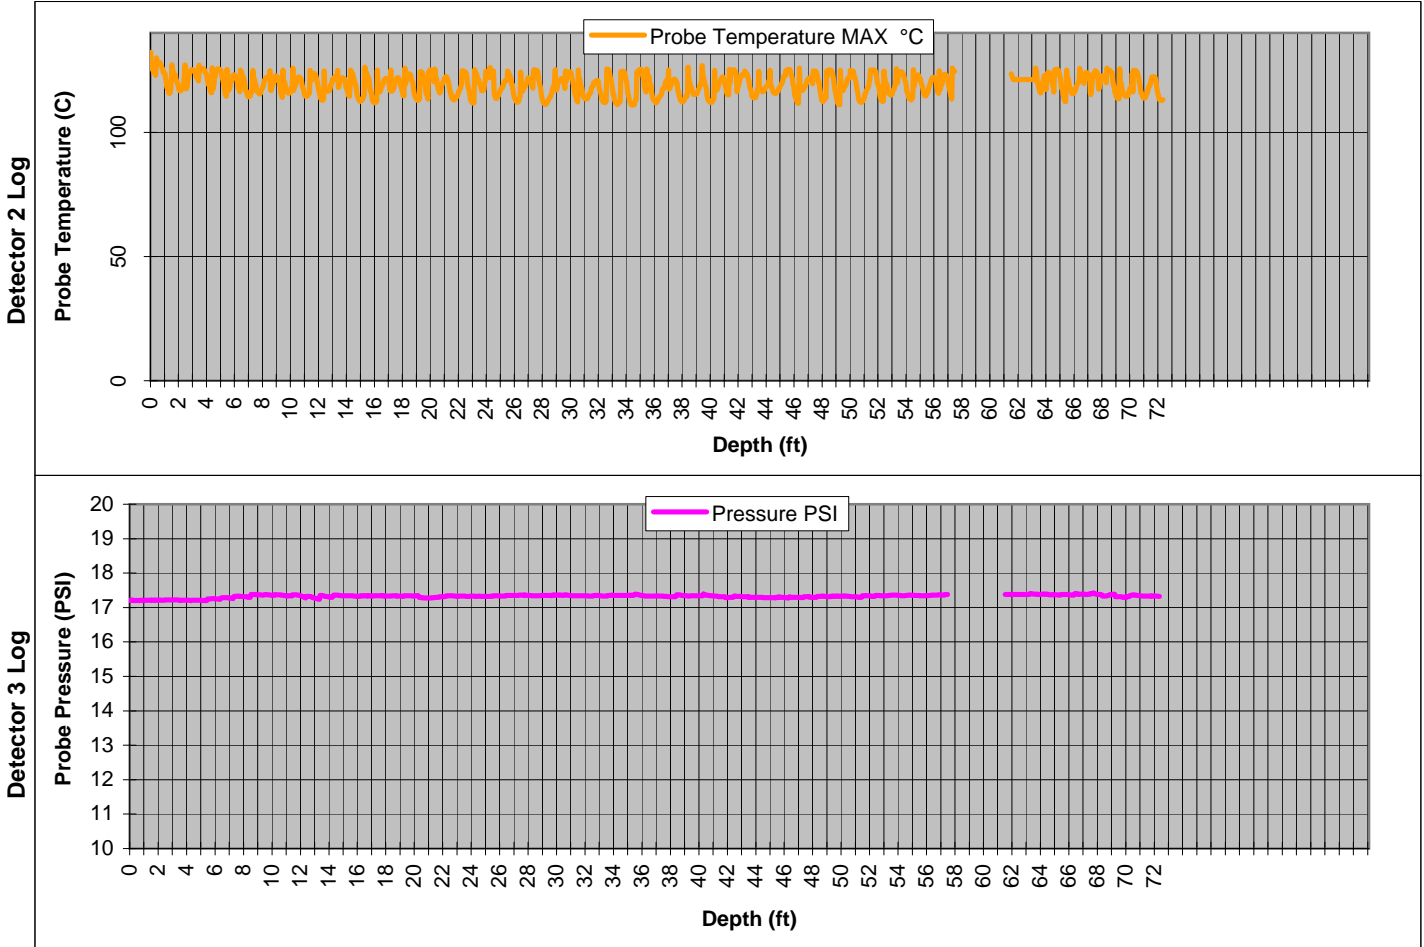
Boring I.D.: CPT-42

MIP Log Results by Boring - Detector Reading vs. Depth

Detector 1 : Electron Capture (ECD)

Detector 2 : Photo Ionization (PID)

Detector 3 : Flame Ionization (FID)

Graph 1 : Probe Temperature (C)

Graph 2 : Probe Pressure (PSI)

Explanation: Hand augered to 5.0' bgs. Range change at 4.0' bgs. Disregard ECD reading at that level. Stringpot had loose connection and data did not transfer for approx. 3-4'. From 60-64' bgs. The FC5000 needed to be reset at 66' due to a computer communication error.

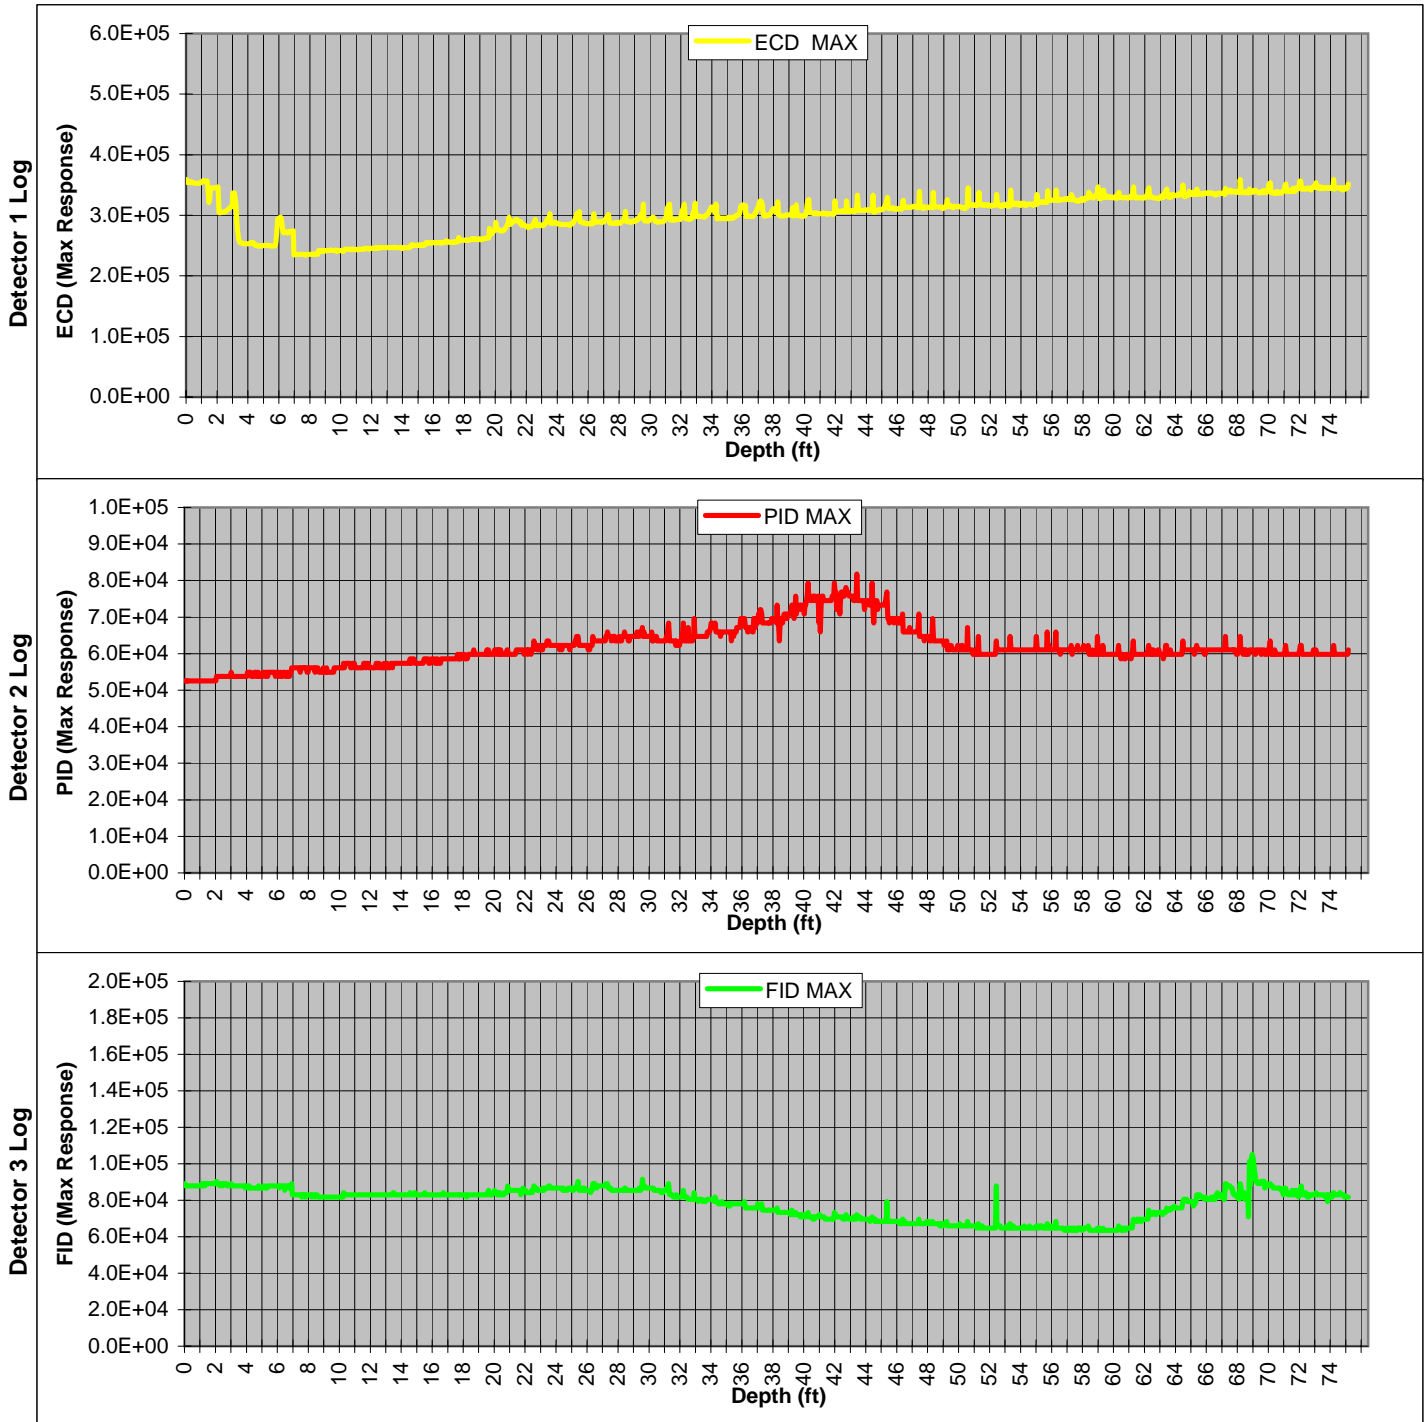
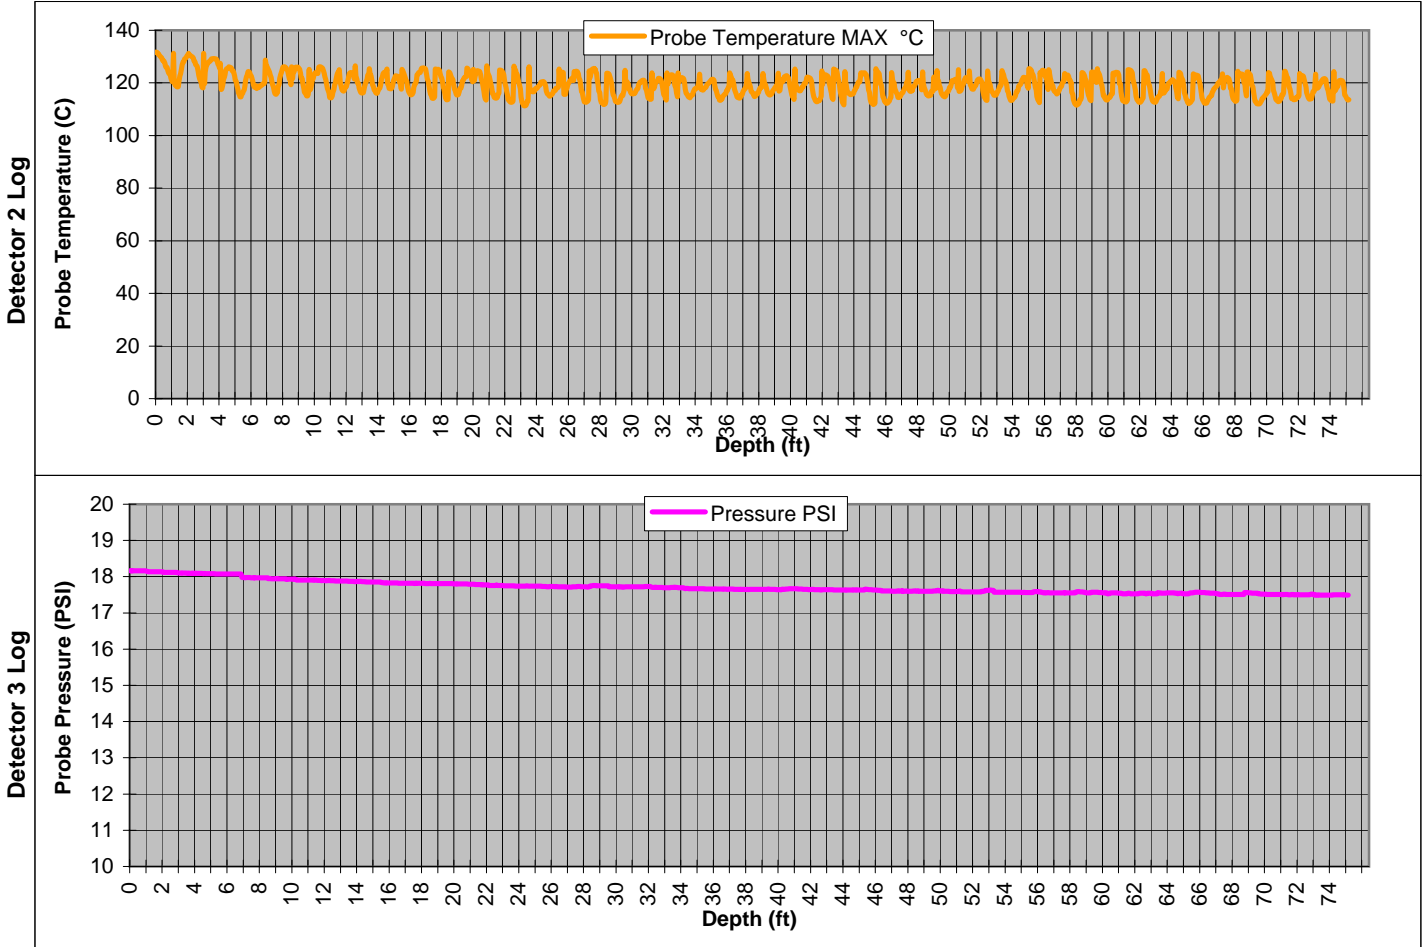
Boring I.D.: CPT-47

MIP Log Results by Boring - Detector Reading vs. Depth

Detector 1 : Electron Capture (ECD)

Detector 2 : Photo Ionization (PID)

Detector 3 : Flame Ionization (FID)

Graph 1 : Probe Temperature (C)

Graph 2 : Probe Pressure (PSI)

Explanation: Hand augered to 5' bgs.
