## **USE ATTAINABILITY ANALYSIS**

### **SANTA ANA-DELHI CHANNEL – REACHES 1 AND 2**

**OCTOBER 4, 2013**

**SANTA ANA REGIONAL WATER QUALITY CONTROL BOARD**

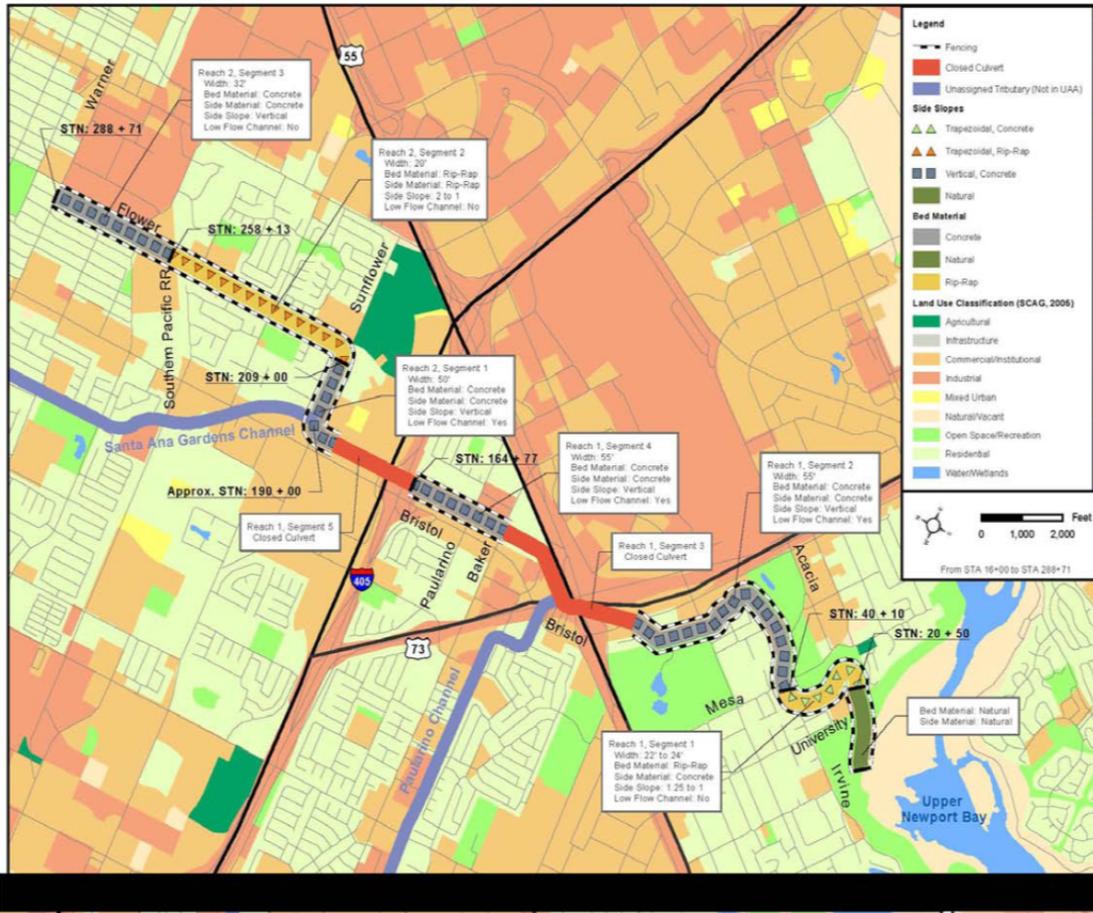
**Figure SAD-2: Santa Ana-Delhi Channel Characteristics and Adjacent Land Uses**  
 (Source: Use Attainability Analysis Technical Report for the Santa Ana-Delhi Channel, CDM, August 2010 Figure 2-9) **Note to reader: Increase the zoom level of this page to enhance the readability of this figure.**

Reaches 1 and 2 are located in a heavily developed watershed, with a mix of residential, commercial and industrial land uses. See Figure SAD-2 and Table SAD-2. Two golf courses border the lower portion of Reach 1. Most of Reach 1 is out of the view of residences and the public because of fencing (the entire length of the channel), dense vegetation, commercial and industrial land uses adjacent to the channel that discourage or preclude access to the fenced channel, earthen berms and dense vegetation on the golf course west of the channel, and the enclosed nature of segments of the Reach (in closed culverts underneath Interstate Highway 405 (San Diego Freeway), the Orange County Performing Arts Center and associated entertainment/business complex, and the State Highway Route 55 and 73 interchange). A little-used bicycle trail lies adjacent to the concrete-lined section of Reach 1 for about 1/3 mile between Bristol Street and Irvine Avenue near Mesa Drive. The trail is separated from the channel by the channel fencing.

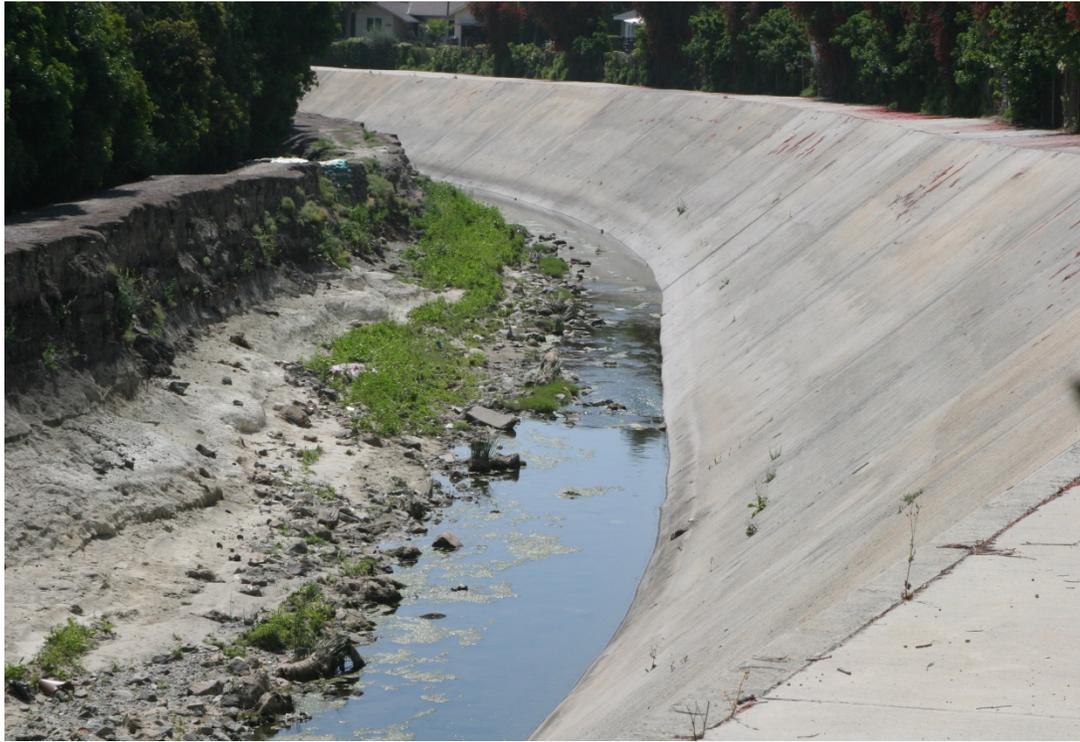
**Figure SAD-3. Reach 1 of the Santa Ana-Delhi Channel in the City of Newport Beach.** The most downstream segment of Reach 1 is earthen on the northeast slope and bottom and concrete on the southwest slope as shown in this Figure taken at Mesa Drive looking downstream. This earthen segment is approximately ¼ mile in length. Regional Board Staff photograph, June 2011.

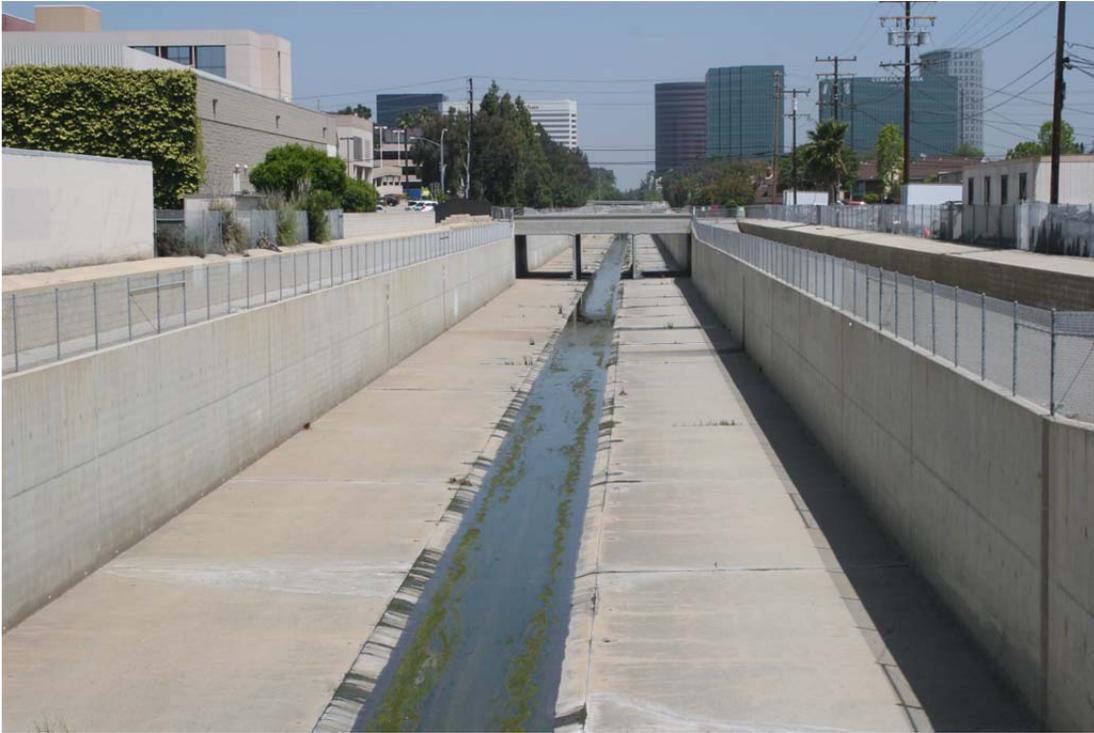
**Figure SAD-4. Reach 1 of the Santa Ana-Delhi Channel in the City of Costa Mesa.**  
Regional Board staff photograph, June 2010.

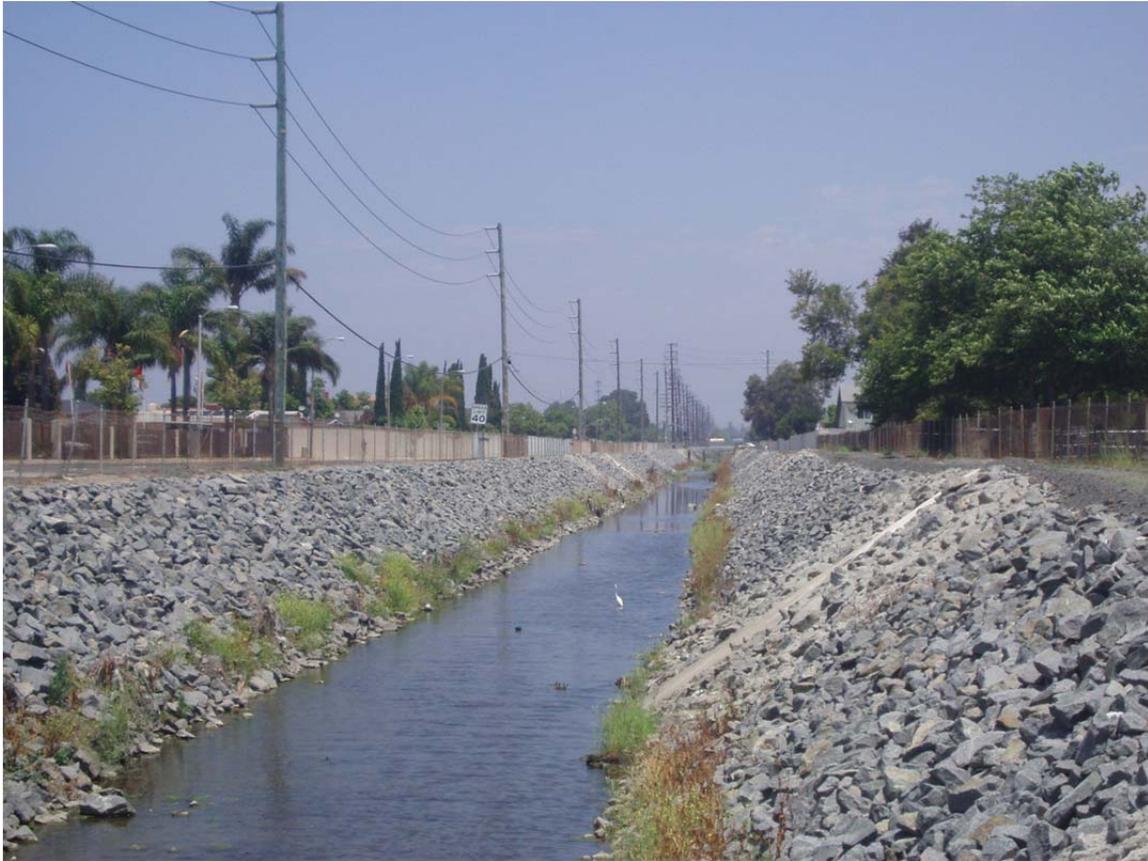
**Figure SAD-5. Reach 2 of the Santa Ana Delhi Channel at Sunflower Avenue and Flower Street, looking upstream.** This earthen riprap-sided segment transitions to a concrete rectangular segment approximately 0.9 mile upstream from this point. Low flows are approximately six inches deep at this point. Regional Board staff photograph, June 2010

From the intersection of Sunflower Avenue and Flower Street, Reach 2 consists of an earthen trapezoidal channel with fully rip-rapped 2:1 side slopes for about 0.9 miles. See Figure SAD-5. The bottom is approximately 20 ft. wide and the height of the channel is approximately 14 ft. Upstream of the earthen section, Reach 2 consists of a reinforced concrete, rectangular (vertical walls 15 ft. in height) channel for approximately 0.55 mile. The width is approximately 32 feet. See Figure SAD-6. In this section, the low flow channel is a shallow swale in the middle of the channel. Reach 2 terminates at Warner Avenue in the City of Santa Ana.

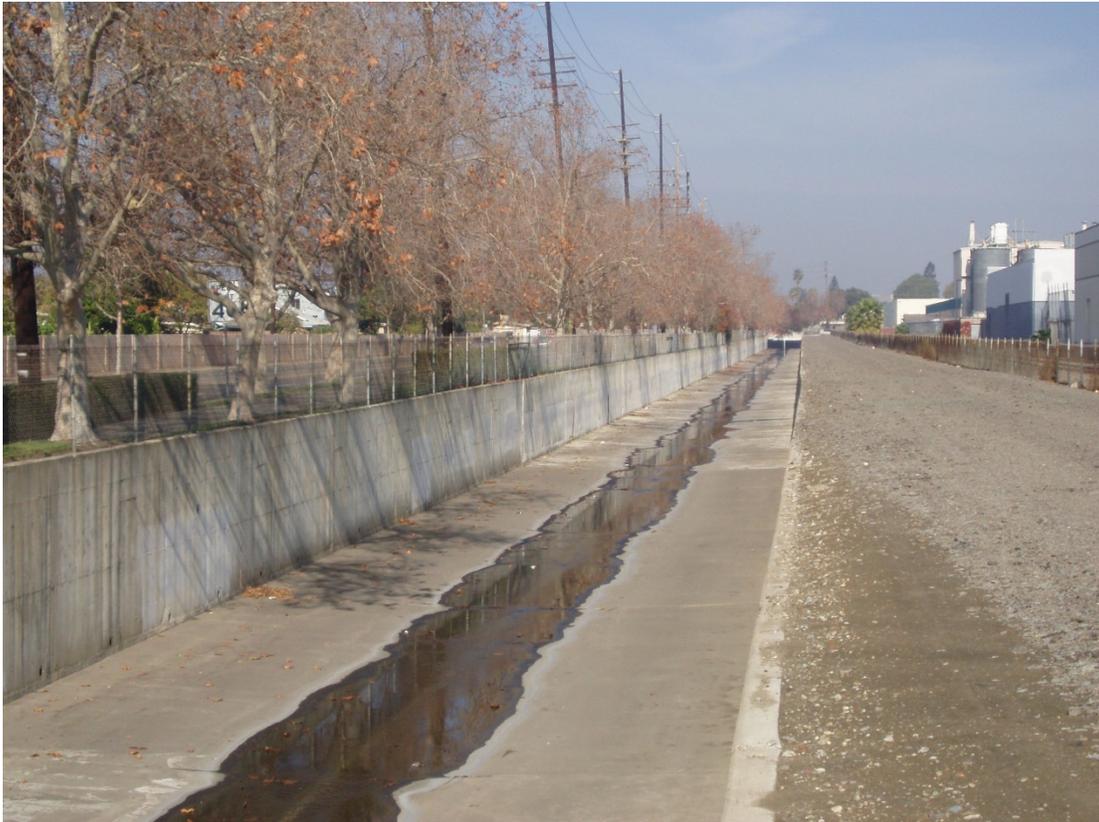
**Figure SAD-6. Reach 2 of the Santa Ana-Delhi Channel.** The most upstream section of Reach 2 features a vertical wall concrete channel for approximately 0.55 mile in length. There is a low flow swale mid-channel. In the distance is the upstream boundary of Reach 2, Warner Avenue.

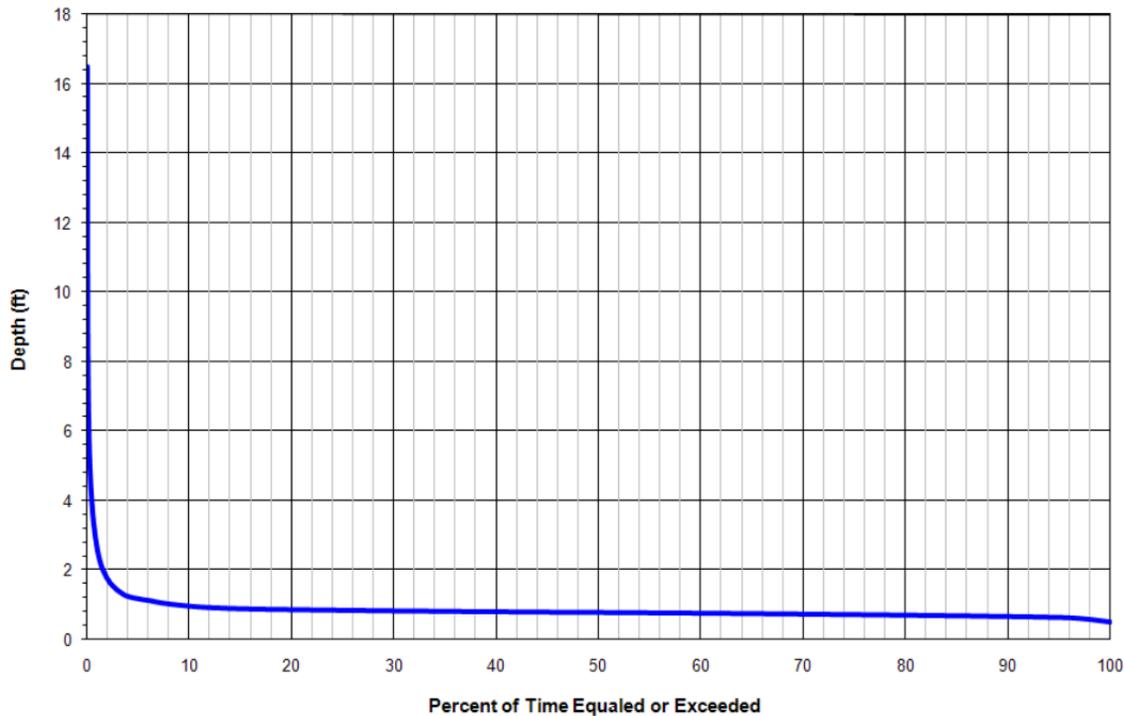
**Figure SAD-7 Channel Depth Curve for the Santa Ana-Delhi Channel at Irvine Avenue (1991-2008)**  
 (Source: Use Attainability Analysis Technical Report for the Santa Ana-Delhi Channel, CDM, August 2010, Figure 4-4)

CDM's analysis of the cumulative frequency curves of flow rate and depth in Reach 1 showed that more than 90 percent of the time, flow rates and depths are characteristic of dry weather flow conditions. As shown in Figure SAD-7, flow depths during 1991-2008 were less than 2 feet approximately 95 percent of the time and less than 1 foot approximately 90 percent of the time.

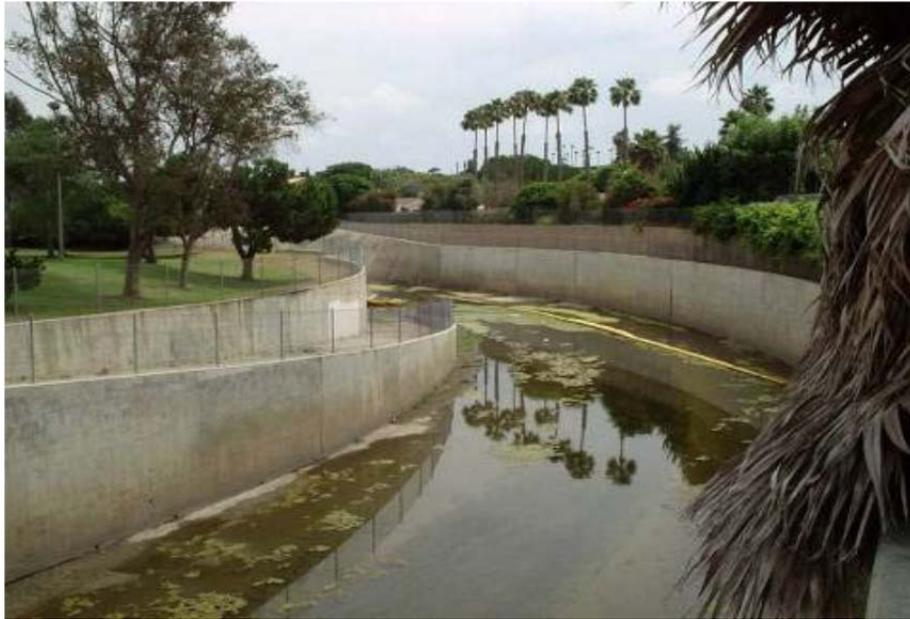
**Figure SAD-8**

**Photo of the Camera View at the Recreational Use Survey Location for Santa Ana-Delhi Channel at Mesa Drive looking downstream. (Reach 1)**

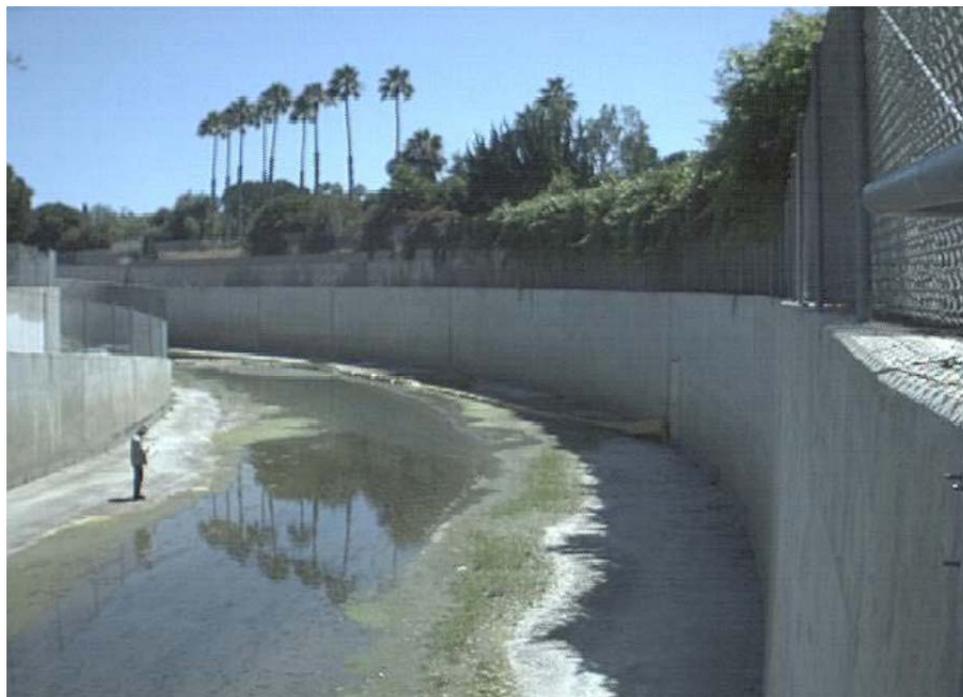
**Figure SAD-9**

**Photo of Activity at Santa Ana-Delhi Channel at Mesa Drive (Reach 1), 7/8/2006 14:30**

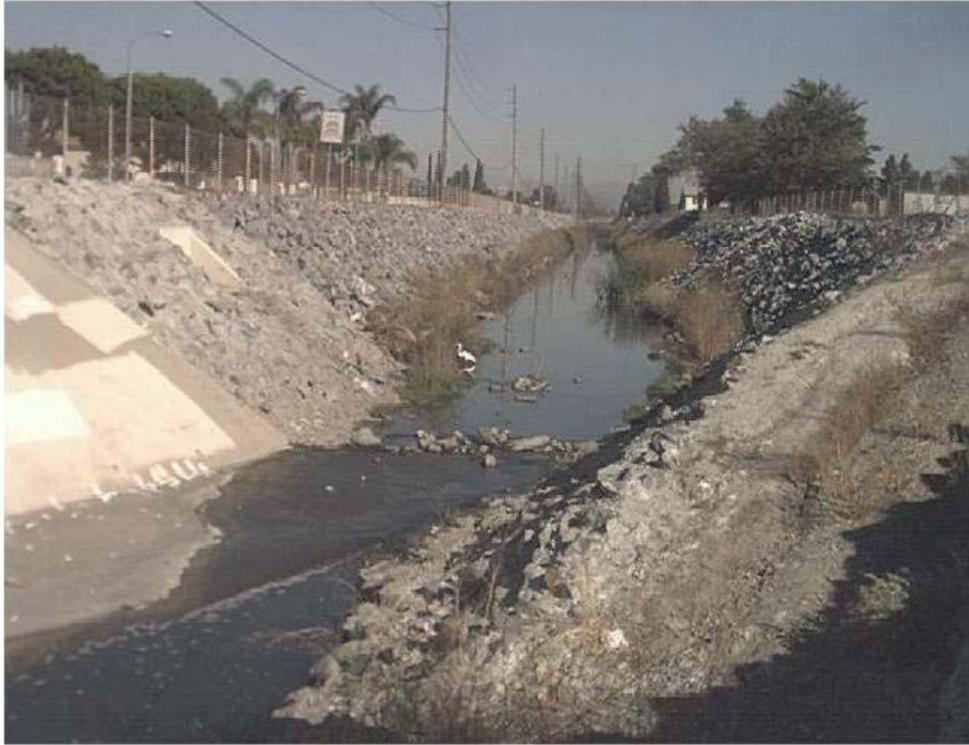
**Figure SAD-10**

**Photo of the Camera View of the Recreational Use Survey Location for Santa Ana-Delhi Channel at Sunflower Avenue (Reach 2)**

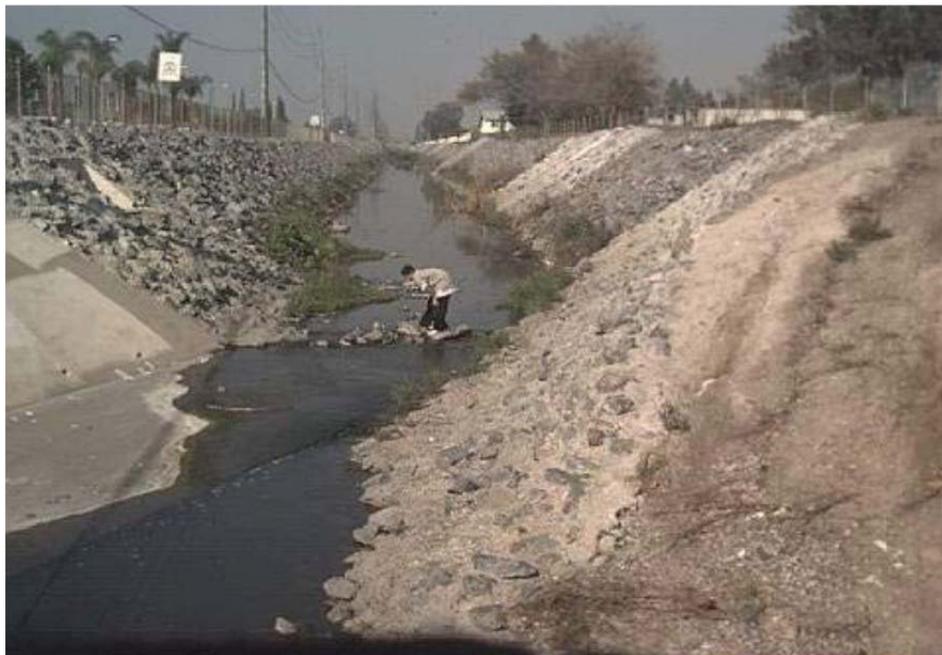
**Figure SAD-11**

**Photo of Activity at Santa Ana-Delhi Channel at Sunflower Avenue (Reach 2), 7/8/2006 14:30.** (Source: UAA Technical Report for Santa Ana-Delhi CDM, August 2010 Figure 3-7)

Table SAD-6 presents a summary of the activity recorded at the two camera locations. The seasonal periods defined in southern California NPDES stormwater permits were used to categorize the observations by season: dry season (April 1 to September 30) and wet season (October 1 to March 31). During the year-long REC photo surveys, six individuals were observed at Mesa Drive walking in the channel and seven individuals at Sunflower Avenue were captured walking in the channel. In no case at either location was there evidence of contact with water. At the Mesa Drive location (Reach 1), the individuals recorded were likely OCPW staff and Task Force Members conducting maintenance activities, monitoring or completing recreational use surveys. See Figure SAD- 9. At the Sunflower Avenue site (Reach 2) seven images were captured of young adults inside the channel fencing. Most of these individuals were walking in the channel; there was no evidence of contact with the water. One of these observations was of a young adult standing on rocks/rip-rap in the channel and bending down to observe the water, an activity considered to be REC2. See Figure SAD-11.

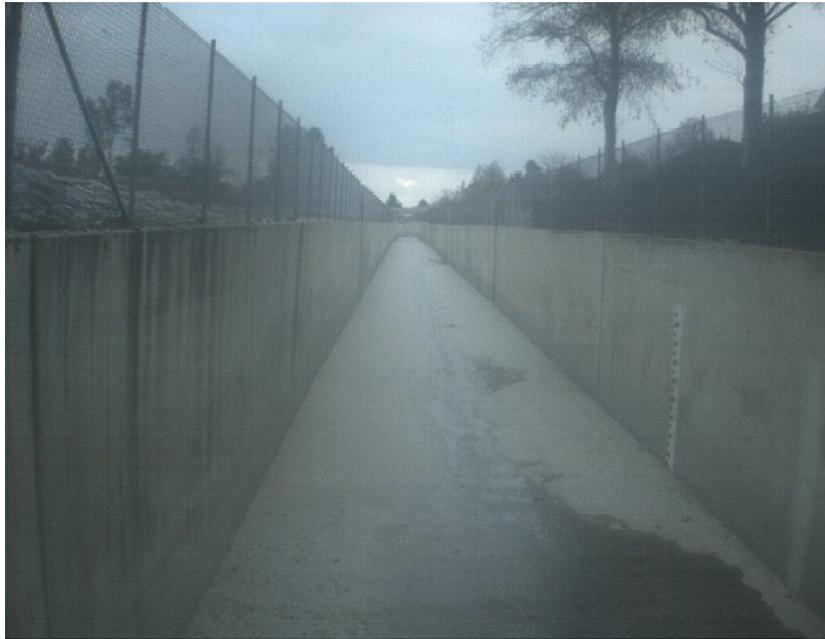
**Figure SAD-12: Demens Flood Control Channel**  
(Source: Recreational Use Survey – Demens Channel CDM, 7/2009)

Results from the cameras installed in the SAD Channel are consistent with the photographic evidence collected at similar concrete-lined boxed flood control channels in the Santa Ana Region. More than 21,000 pictures were taken in the Demens Channel located in a residential neighborhood in the city of Upland (see Figure SAD-12). No water contact recreation was observed in these photographs, nor in the nearly 24,000 photos taken in the Anza Channel adjacent to a public park (see Fig. SAD-13).

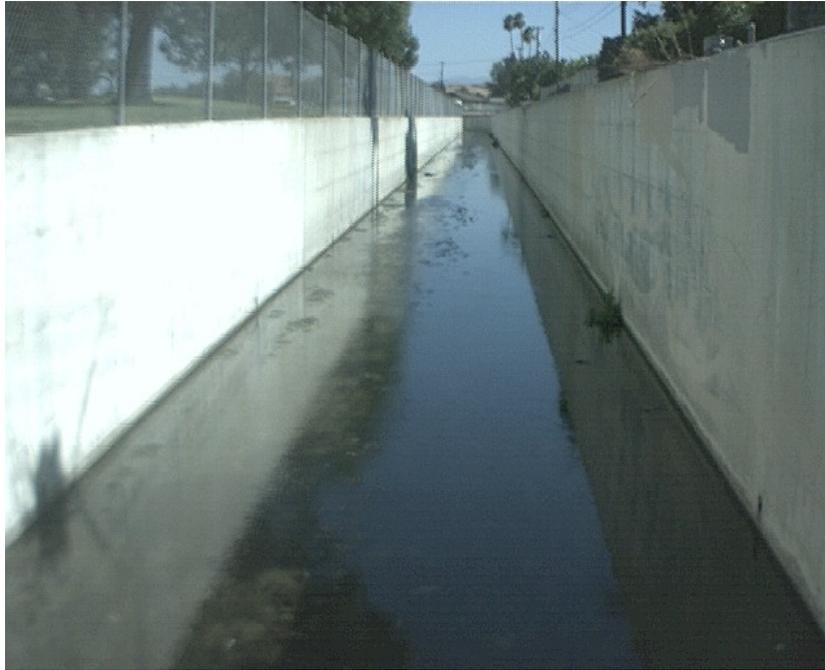
**Figure SAD-13: Anza Park Flood Control Channel**  
(Source: Recreational Use Survey – Anza Channel CDM, 4/2010)

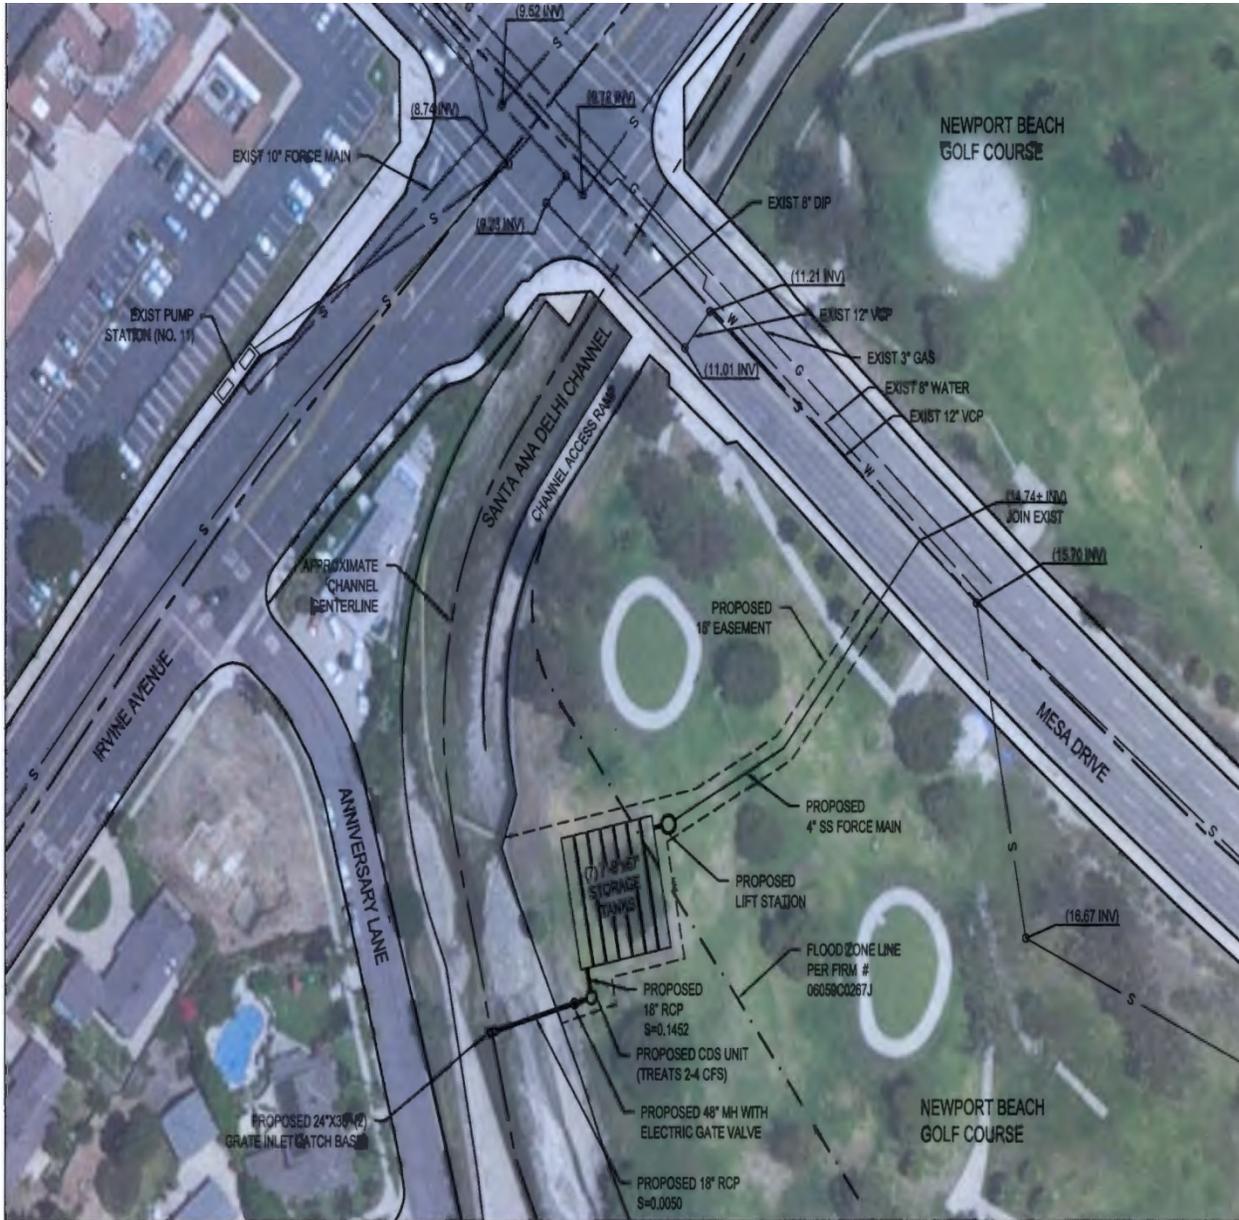
**Figure SAD-14. Santa Ana Delhi Channel Mesa Drive/Irvine Avenue Proposed Diversion Site Plan.** The diversion would divert low flows into the sanitary sewer or to be used as irrigation for the adjacent golf course. URS August 2012

BMPs, including inspections for illegal discharges/illicit connections and public education, are being implemented pursuant to the Orange County Urban Storm Water Runoff permit (MS4 Permit). The area tributary to the Santa Ana-Delhi Channel is sewered and septic tanks are not considered a source of bacteria inputs. Sewer system leaks have not been demonstrated to be a contributor to bacteria densities in the Channel. OCPW has conducted an extensive review of Best Management Practices (BMPs) for bacteria control (see Table SAD-10). Very few BMPs provide the level of effectiveness required to achieve consistent compliance with bacteria water quality standards. Those BMPs that are most effective (e.g. percolation ponds and artificial wetlands) require large amounts of land that is not available in the fully-developed watershed draining to the Santa Ana-Delhi Channel. Given the constraints of land availability, significant water quality improvement that results in consistent compliance with bacteria quality objectives as the result of BMP implementation is likely to be highly problematic. As part of the recreation standards amendments for inland waters, antidegradation targets for *E. coli* were calculated for Reach 2 by Regional Board staff (see discussion in Section 5.2 of the January 12, 2012 staff report for the recreation standards amendments). The intent of these targets and accompanying monitoring requirements is to assure that water quality conditions do not degrade in Reach 2 should REC1 not be designated and, accordingly, REC1 objectives not apply. A diversion is being planned near the downstream end of Reach 1 to address
