USE ATTAINABILITY ANALYSIS (UAA)

TEMESCAL CREEK – REACH 1 (PROPOSED REACHES 1A AND 1B)

SANTA ANA REGIONAL WATER QUALITY CONTROL BOARD

October 4, 2013

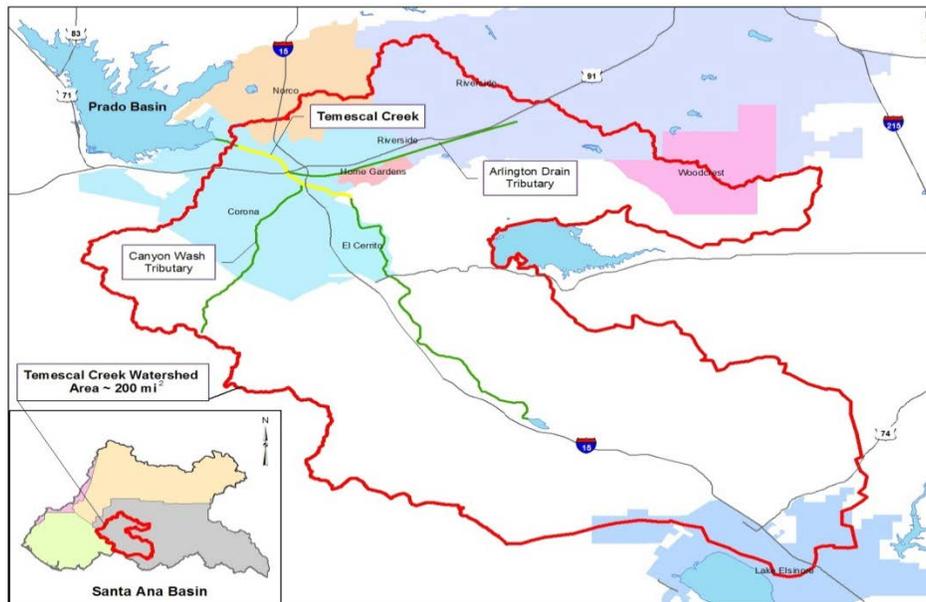
Figure TC-1. Map of Temescal Creek Watershed. Source: Use Attainability Analysis Technical Report for Temescal Creek, CDM, August 2010, Figure 2-1

The UAA reaches are shown in yellow in Figure TC-1. Tributaries to Temescal Creek, which include Arlington Channel, Canyon Wash, Oak Street Channel, and Main Street Channel, are not included in this UAA.

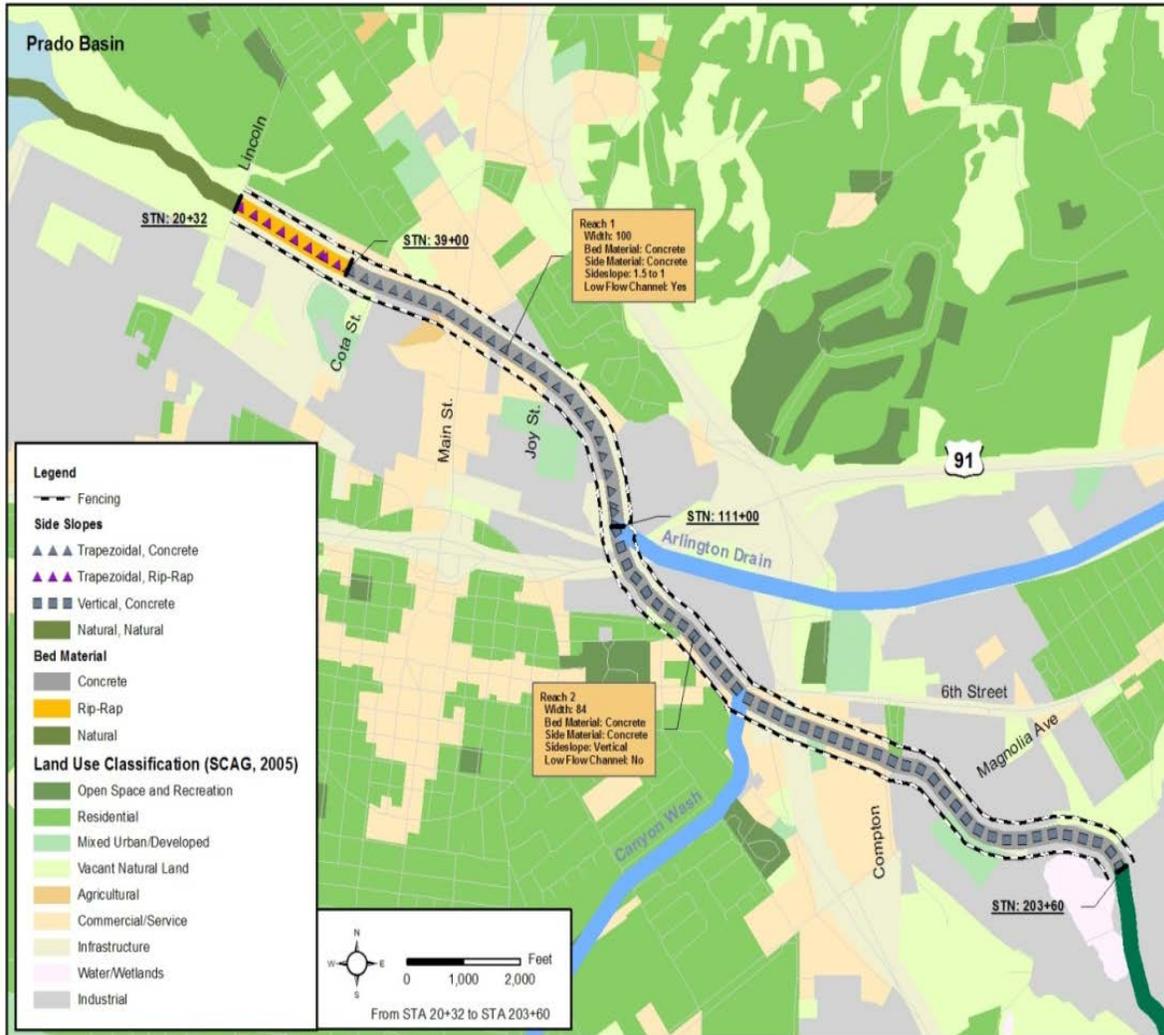
Figure TC-3. Temescal Creek: Channel Characteristics and Land Use. (Source: Use Attainability Analysis Technical Report for Temescal Creek, CDM, August 2010, Figure 2-5) **Note to reader: Increase the zoom level of this page to improve the readability of this Figure.**

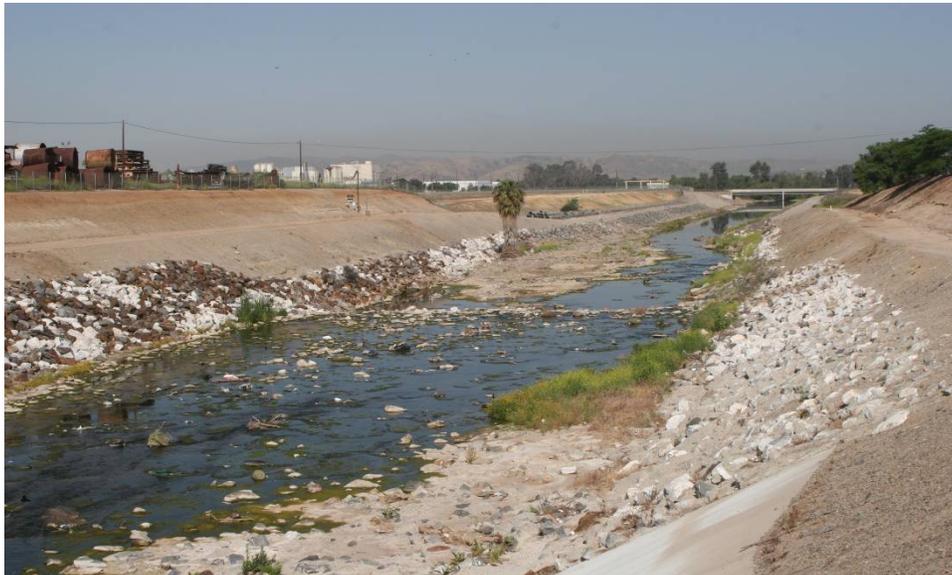
Figure TC-4. Temescal Creek, Reach 1a – facing downstream (downstream of Cota Street, Lincoln Avenue Bridge in distance) Regional Board staff photograph, May 2011

The remainder of Reach 1a (near Cota Street to Arlington Channel) has a concrete lined, trapezoidal configuration. This segment is 100 feet wide and 14 feet deep, with 1.5:1 sloped sidewalls (see Figure TC-5). This segment was constructed with a low flow depression along the centerline of the channel bottom to convey low flows at sufficient velocity to prevent excessive debris buildup. The low flow channel is two feet deep at its deepest point and is 40 feet wide.

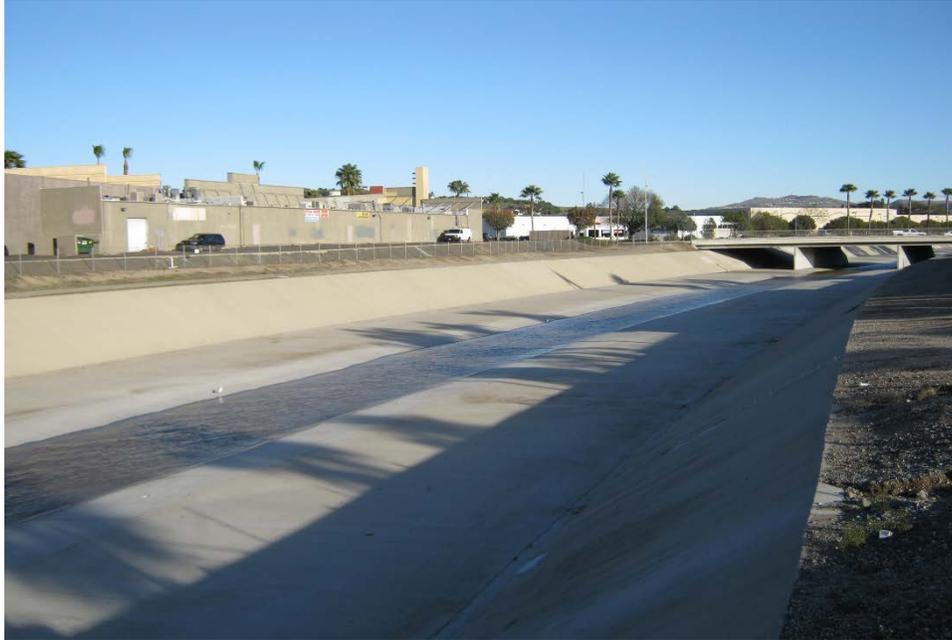
Figure TC-5. Temescal Creek, Reach 1a, at Cota Street looking upstream in the City of Corona. Regional Board staff photograph, December 2010

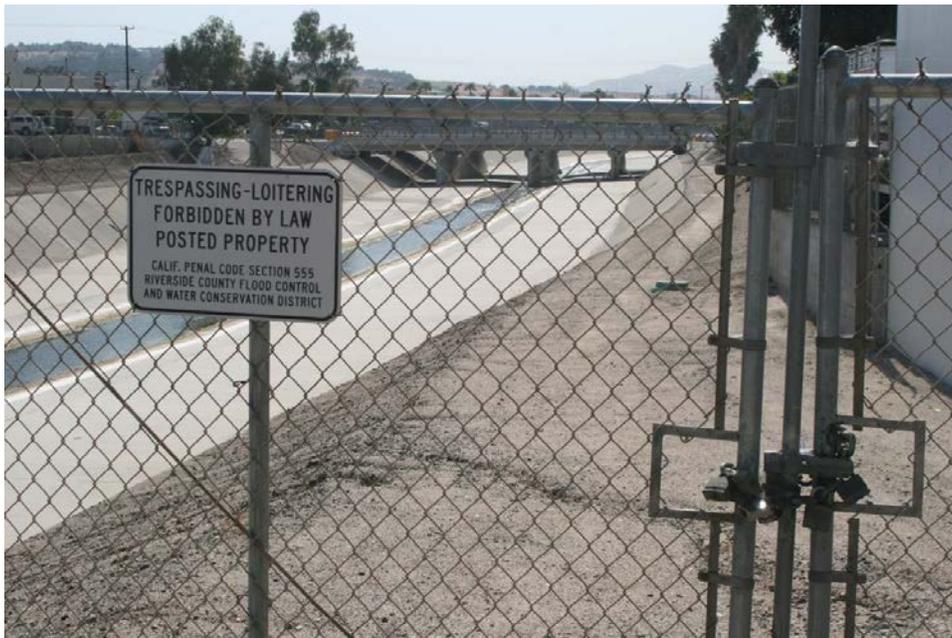
Figure TC-6. Temescal Creek, Reach 1a at Cota Street. Access is prohibited and the channel is fenced with locked gates. Regional Board staff photograph, May 2011

The total length of Reach 1a is approximately 3 miles. The entire length is fenced with a six foot high chain link fence and is gated to prevent individuals from accessing the channel. All gates are locked and the reach is posted with signs stating that trespassing and loitering are forbidden by law. See Figure TC-6.

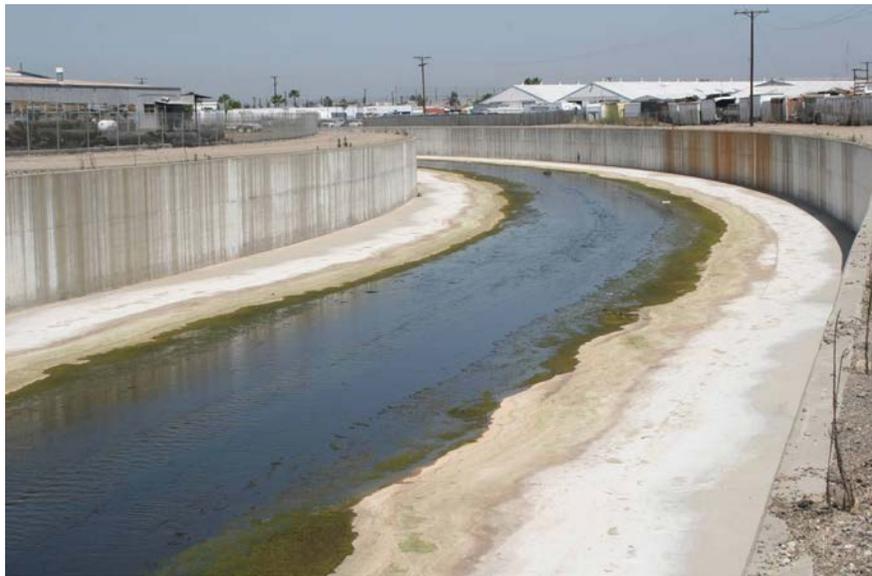
Figure TC-7. Temescal Creek, Reach 1b facing downstream at Magnolia Avenue in the City of Corona. Regional Board staff photograph, May 2011.

The entire length of Reach 1b is fenced with a six foot high chain link fence and is gated to keep individuals out of the channel. All gates are locked and the reach is posted stating that trespassing and loitering are forbidden by law.

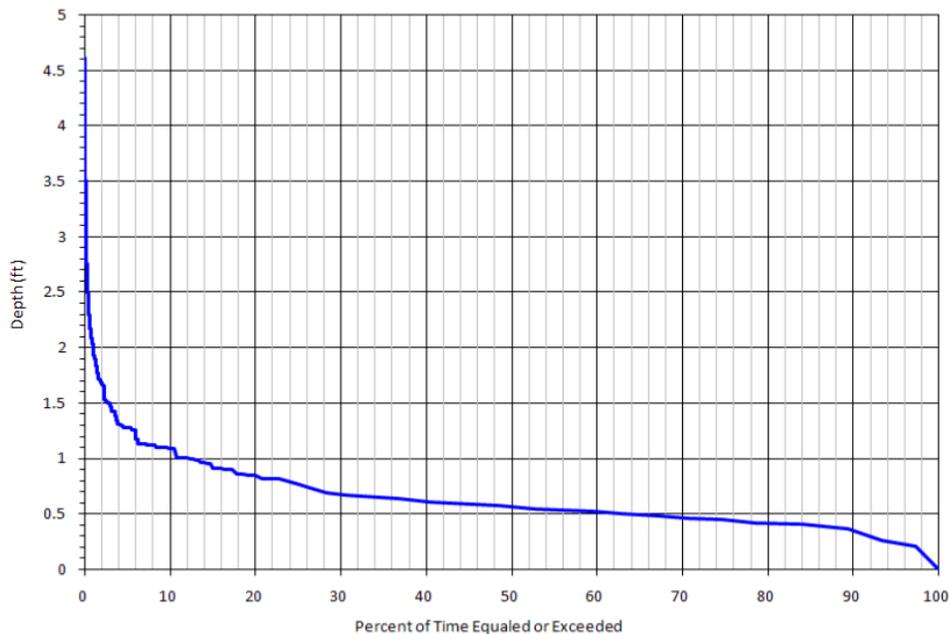
Figure TC-8. Channel Depth Curve for Temescal Creek at Main Street (Reach 1a) (1980-2008) (Source: Use Attainability Analysis Technical Report for Temescal Creek, CDM, August 2010, Figures 4-3 and 4-4)

CDM's analysis of the cumulative frequency curves of flow rate and depth from 1980 to 2008 at Main Street (Reach 1a) showed that more than 90 percent of the time, flow rates and depths are characteristic of dry weather flow conditions. As shown in FigureTC-8, flow depths during 1980 to 2008 were less than 2 feet approximately 99 percent of the time and less than 1 foot approximately 90 percent of the time.

CDM's engineering estimates are consistent with the actual depth measurements collected by Regional Board staff. Regional Board staff have observed that dry weather flows are contained within the designed low flow centerline depression in Reach 1a, with depths less than one foot. On August 15, 2013 Regional Board staff measured the deepest depth of flow to be four inches just upstream of Cota Street. Board staff observations confirm shallow (less than one foot) dry weather flows in Reach 1a near Lincoln Avenue, although water sometimes pools in a small area at the downstream end

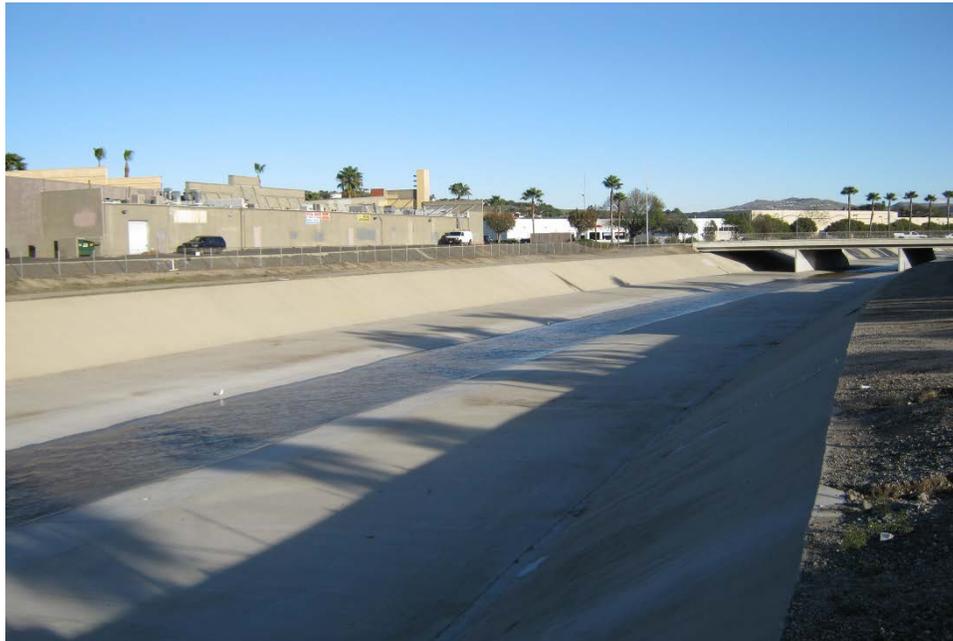
Figure TC-9. Temescal Creek, Reach 1a at Cota Street. Regional Board staff photograph, December 2010

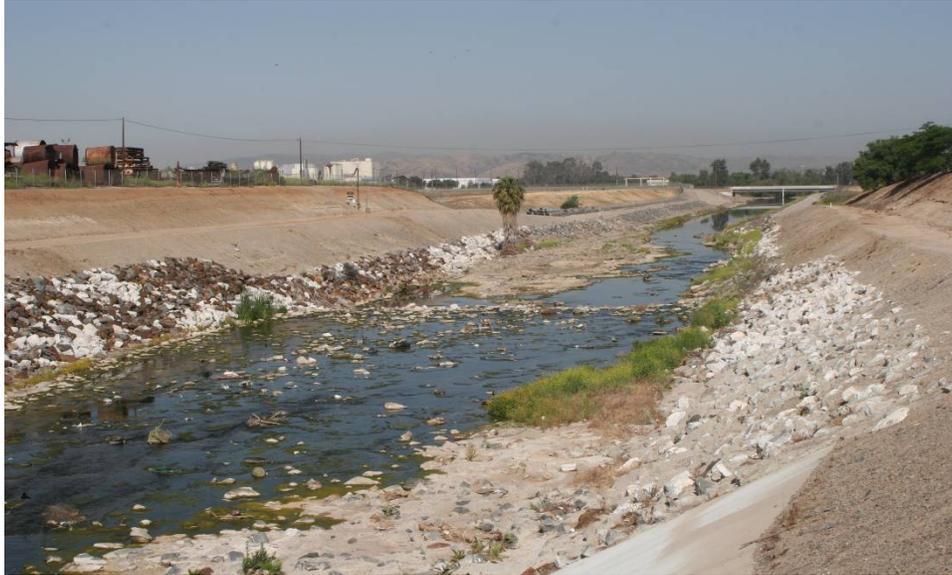
Figure TC-10. Temescal Creek, Reach 1a downstream downstream of Cota Street. Regional Board staff photograph, May 2011

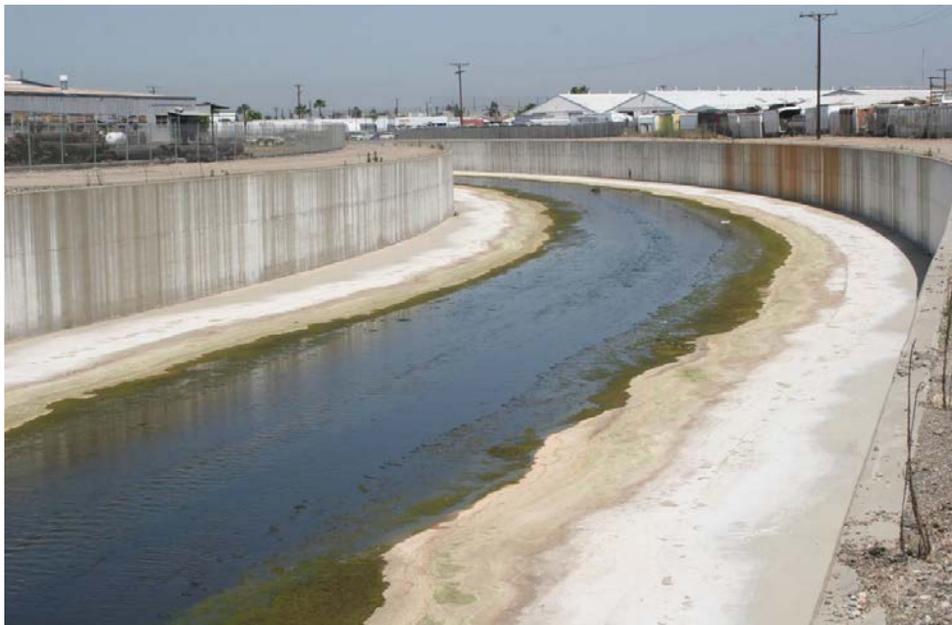
Figure TC-11. Temescal Creek, Reach 1b facing downstream at Magnolia Avenue in the City of Corona. Regional Board staff photograph, May 2011

Both Reaches 1a and 1b have been engineered and significantly modified to provide flood control protection. Reach 1a consists of 2.5 miles of trapezoidal, concrete lined channel with a bottom width of 100 ft. and channel height of 14 ft. (see Figure TC-11). The most downstream 0.5 mile segment of Reach 1a is lined with rip rap (see Figure TC-12). Reach 1b consist of 3 miles of vertical walled, concrete-lined channel with a bottom width of 84 ft. and channel height of 14 ft. (see Figure TC-13).

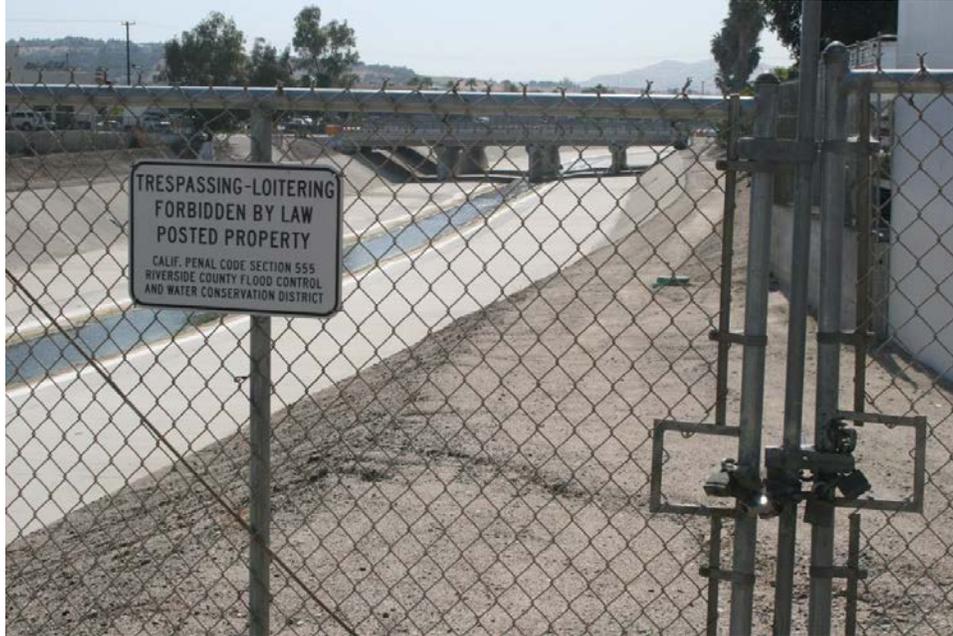
Figure TC-12. Fence and Gate on Temescal Creek at Cota Street. Regional Board staff photograph, May 2011.

The entire length of Reaches 1a and 1b is fenced with locked gates to prevent access, with signs forbidding trespassing.

Gaining access into Reaches 1a and 1b is difficult. In Reach 1a, the trapezoidal slopes are very steep making it difficult for an individual to climb down or back up the slope. In Reach 1b, the 14 ft. high vertical walls make getting into the channel extremely difficult and dangerous (see Figures TC-11 and TC-13). Those intent on water recreation are far more likely to choose other stream locations. Other areas of Temescal Creek upstream of Reaches 1a and 1b provide individuals with the opportunity to hike along a natural stream section (these other areas are designated both REC1 and REC2 and would remain so designated). More suitable and accessible water contact recreation opportunities may also be found in the nearby Santa Ana River upstream of the City of Corona.

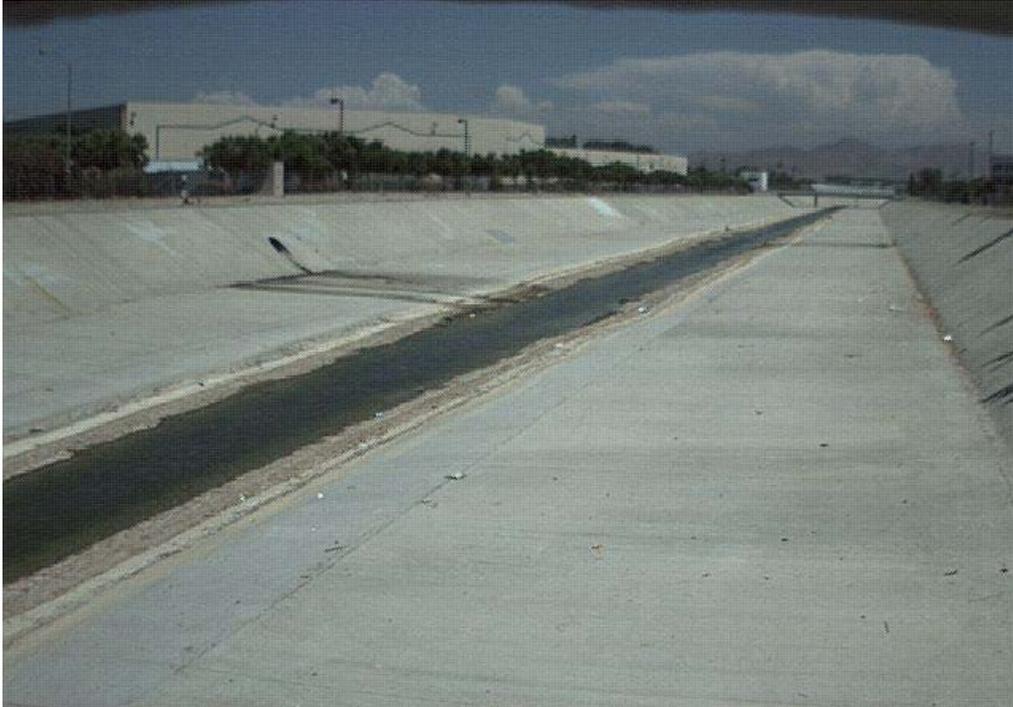
Figure TC-13. Photo of the Camera View at the Recreational Use Survey Location for Temescal Creek at Main Street (Reach 1a) Facing Upstream (Source: Use Attainability Analysis Technical Report for Temescal Creek, CDM, August 2010, Figure 3-2)

The duration of the survey and number of images collected for each location are shown in Table TC-4. At each survey location, an image was collected every fifteen minutes during daylight hours throughout the study duration unless signal strength fluctuations or equipment failures precluded collection and transmission.

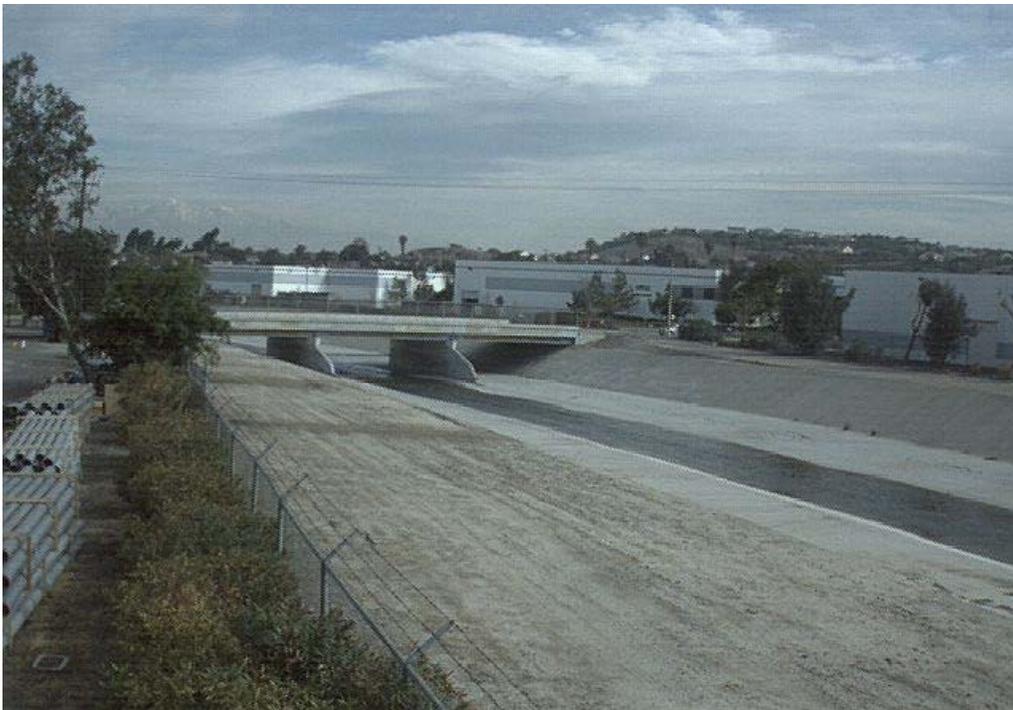
Figure TC-14. Photo of the Camera View at the Recreational Use Survey Location for Temescal Creek at City of Corona WWTP No. 2 (Reach 1a) - Facing

Downstream (Source: Use Attainability Analysis Technical Report for Temescal Creek, CDM, August 2010, Figure 3-3)

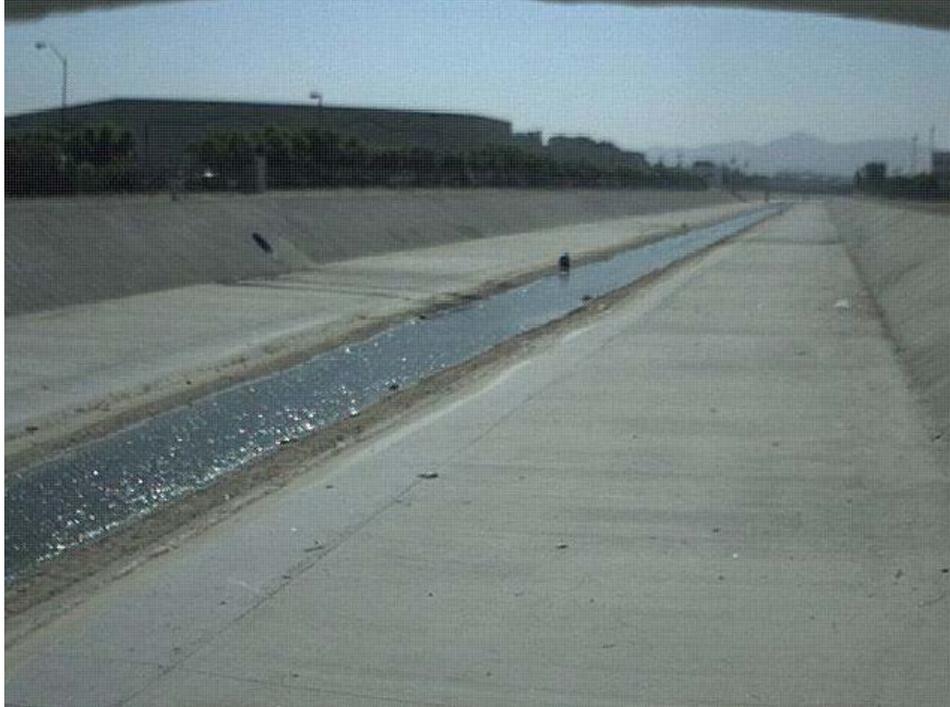
Figure TC-15. Photo of Activity at Temescal Creek at Main Street (Reach 1a), 7/27/2005, 10:00 (Source: Use Attainability Analysis Technical Report for Temescal Creek, CDM, August 2010, Figure 3-4)

As shown in Table TC-5, the camera survey results indicate a very low frequency of human activity of any kind in Reach 1a of the Creek. While no camera survey was conducted in Reach 1b, it is reasonable to expect similar results, and even less activity in Reach 1b given the channel morphology (vertical concrete walls and bottom; see Figure TC-5) and adjacent land use, which is largely industrial and commercial (see Figure TC-11). Of the 11,166 images collected at the camera survey locations in Reach 1a, only two suggested any type of water contact. In both cases, an individual was observed walking in or adjacent to shallow water in the center low flow depression, with any contact limited to below the ankle in depth and of short duration (less than 30 minutes). These images are included here as Figures TC-17 and TC-18. Thirty-one images showed a few individuals either walking or, on rare occasions, riding a bicycle in the channel without water contact. This type of activity is depicted in Figure TC-19.

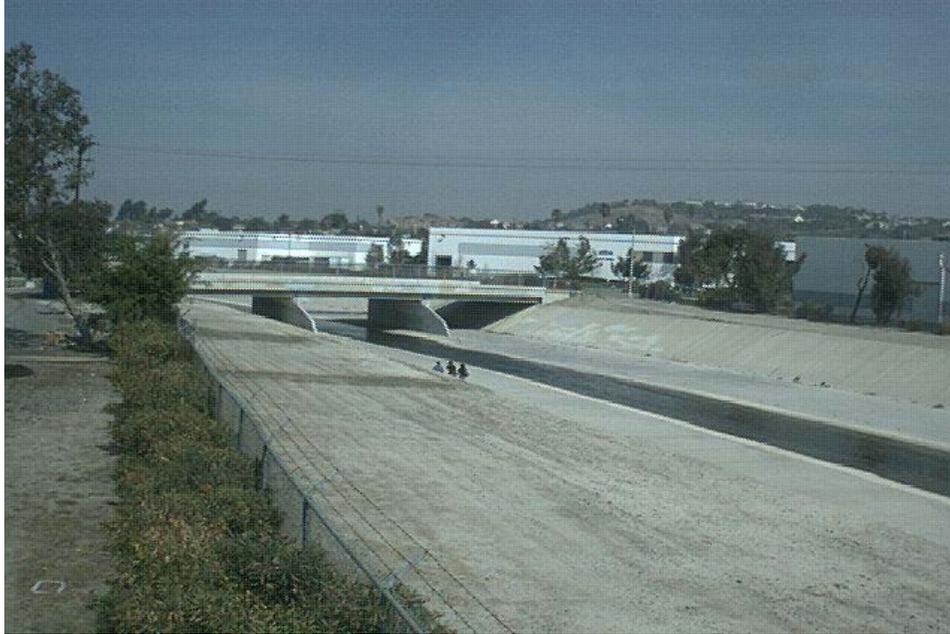
Figure TC-17. Photo of activity at Temescal Creek at Corona WWTP (Reach 1a), 2/25/2006, 12:15. (Source: Use Attainability Analysis Technical Report for Temescal Creek, CDM, August 2010, Figure 3-7)

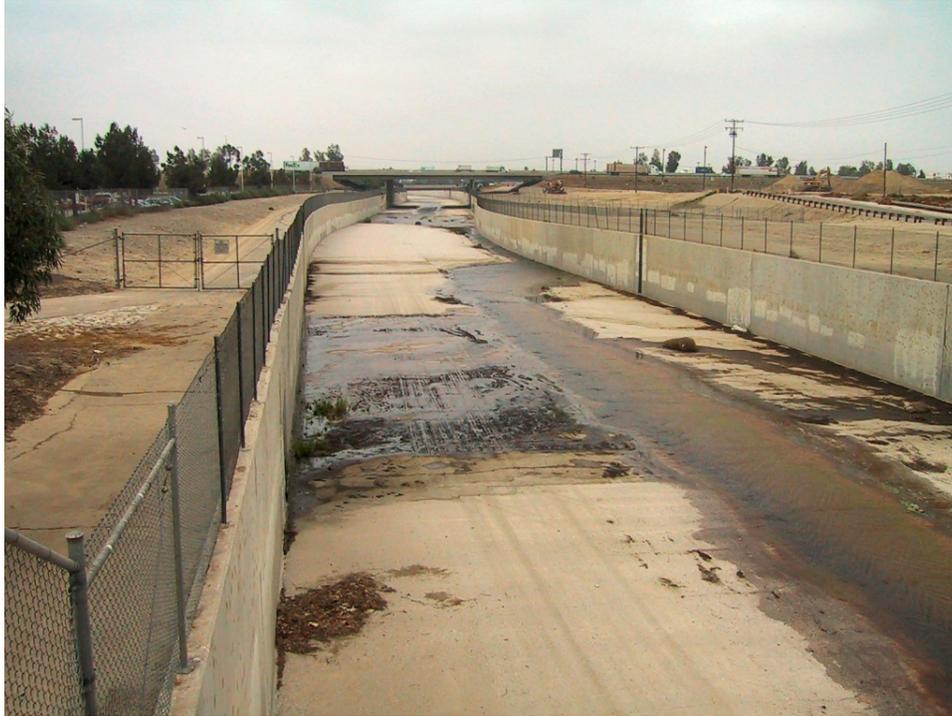
Figure TC-18. Cucamonga Creek Channel (Source: Recreational Use Survey, CDM 11/2006)

Concrete-lined flood control channels are quite common throughout the Santa Ana Region. Photographic evidence from the Greenville-Banning Channel and several similar locations, including Demens Channel, Anza Park Channel, and Cucamonga Creek (shown below), provide strong evidence that there is no meaningful water recreation occurring in these types of facilities.

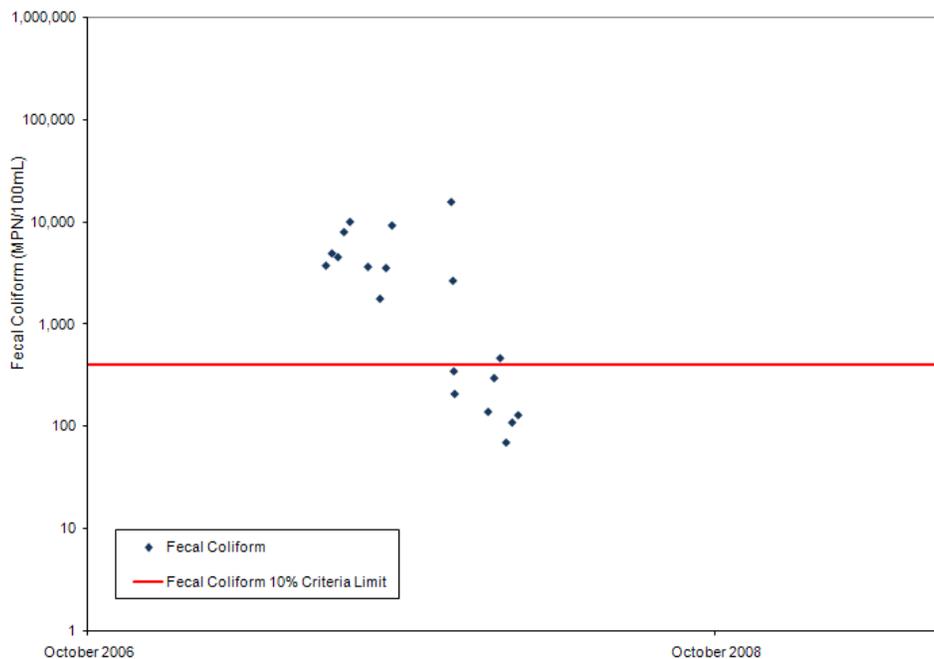
Figure TC-19. Time Series of Fecal Coliform Concentrations in Temescal Creek at Lincoln Avenue (Reach 1a) from 2007 through 2008 (Source: Use Attainability Analysis Technical Report for Temescal Creek, CDM, August 2010, Figure 3-9)

Water quality data and analysis show that the existing REC1 fecal coliform objectives are not consistently attained in Temescal Creek. As shown in Table TC-6, two geomean values were calculated for fecal coliform (5,912 and 13,232 MPN per 100 mL). Both values significantly exceeded the current Basin Plan fecal coliform geomean objective (200/100 mL). That part of the established REC1 objective that specifies that no more than 10% of the samples exceed 400 organisms/100mL for any 30-day period was consistently exceeded. Figure TC-21 presents fecal coliform concentrations from 2007 through 2008. As shown, more than half of the samples exceeded 400/100 mL fecal coliform.
