CHANNEL EROSION STUDY, SAN DIEGO CREEK, 2015

Stanley W. Trimble
Geomorphologist/Hydrologist
Professor of Geography Emeritus
UCLA

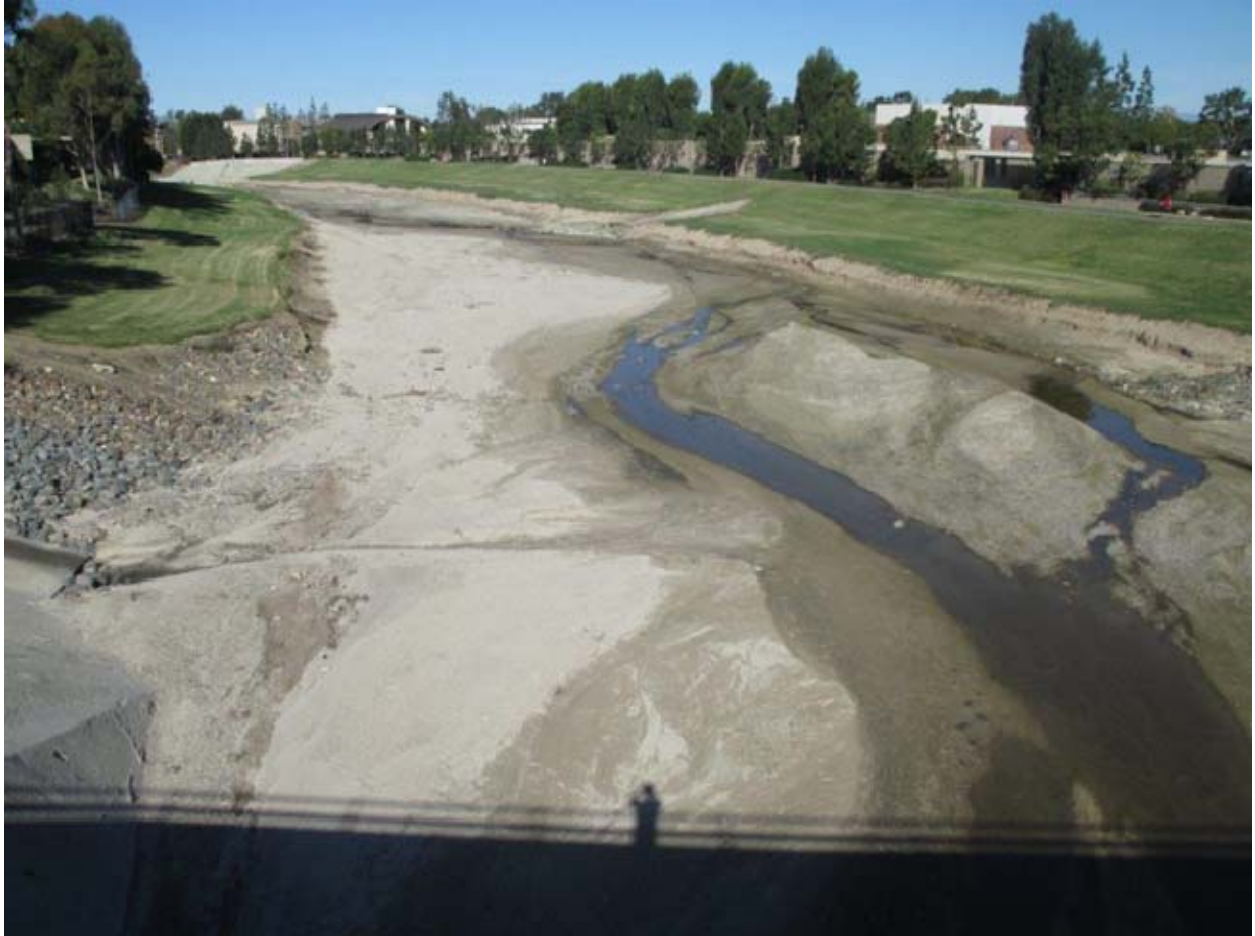
Two stream reaches, formerly stable, were noted to have undergone moderate channel erosion. Between West Yale Loop and Jeffrey Road (Fig 1, lower middle), San Diego Creek appears to be degrading slightly with erosion apparent at the base of the grassed banks sloping down to the sandy channel (Figure 2). If this continues, some conservation treatment might be appropriate. The other slightly destabilized channel is Central Irvine Channel (F25) between Sand Canyon Blvd and Peters Canyon Wash (Fig 1, middle, Figure 3). Here, some vertical erosion is evident and some sort of treatment should be considered.

Figure 2. San Diego Creek between West Yale Loop and Jeffrey Road looking downstream and showing mild channel erosion. Note that the base of the grassed slopes is eroded away in some areas.

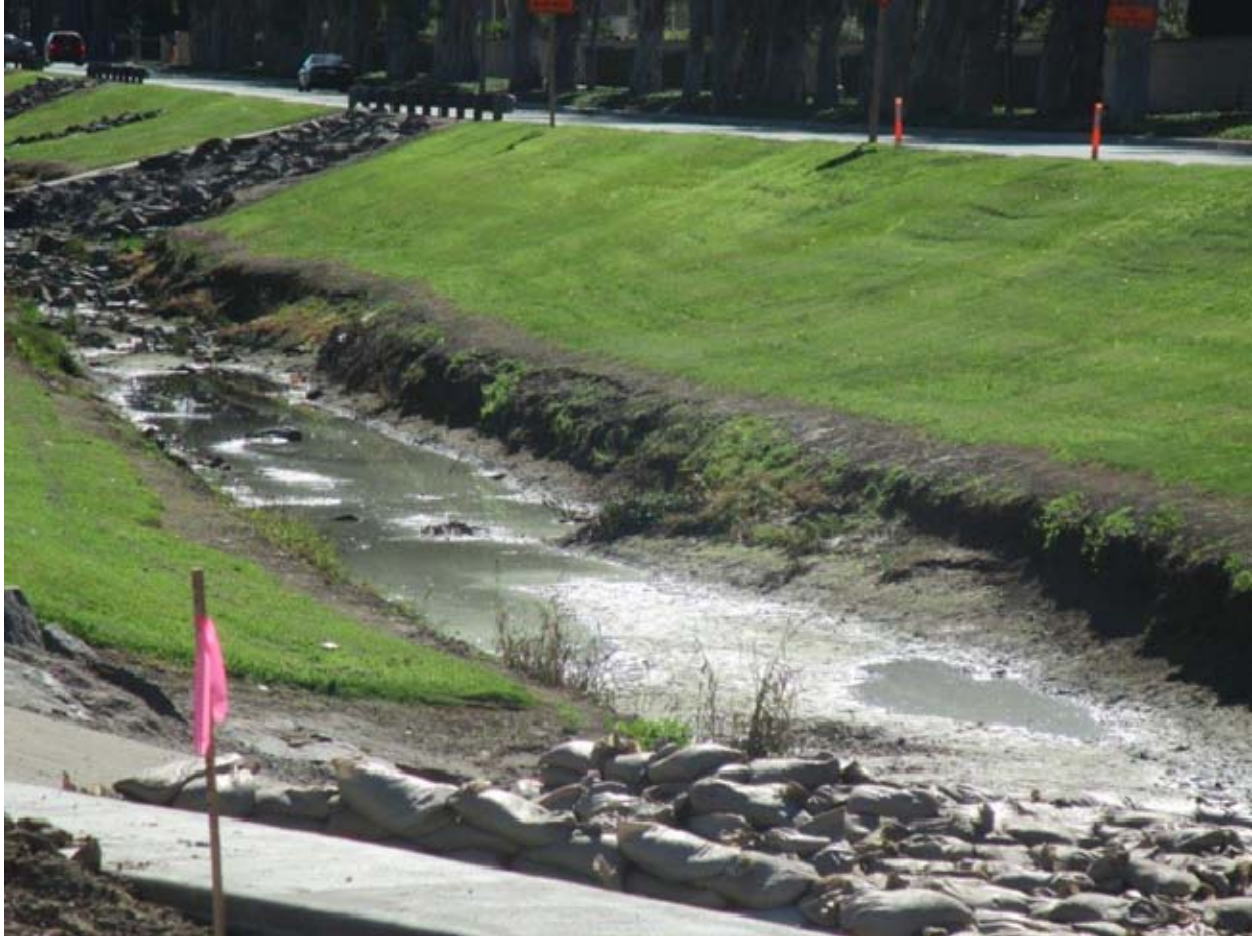
Figure 3. Central Irvine Channel near Culver Ave. looking upstream and showing mild channel erosion.

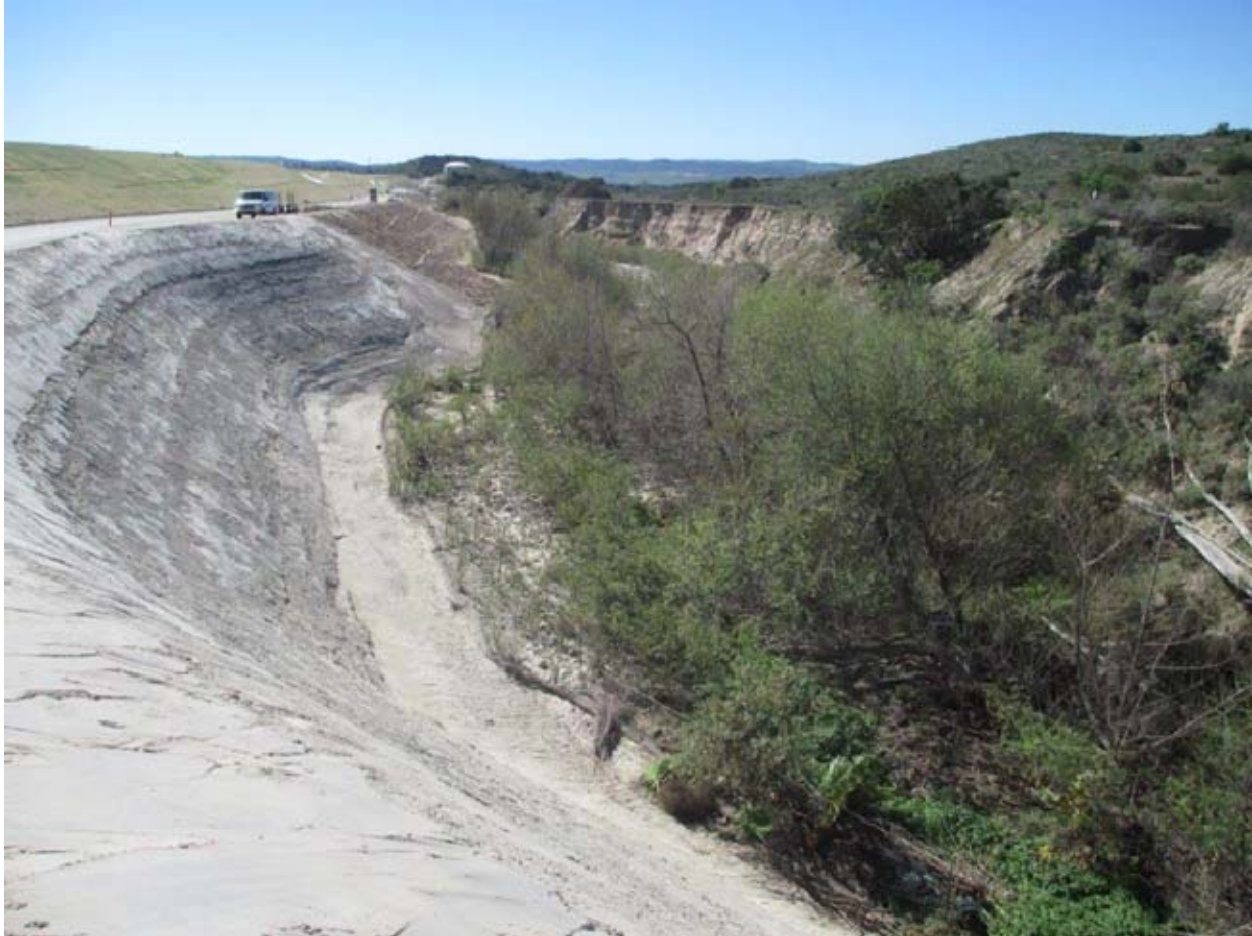
Two quite unstable stream reaches remain in the basin. The first of these is Borrego Creek (F20) starting several hundred feet below 241 Freeway and extending down to the subsurface inlet several hundred feet upstream of Irvine Blvd (Fig. 1, mid-lower right). This reach has been extensively studied and reported on in Trimble, 2004, 2005, 2006. The good news is that the huge and extremely unstable “Baker Ranch Gully” (Trimble, 2005) has been recently ameliorated to some degree. First, most of the flow is now diverted through a box and discharges of only 50-200 cubic feet/second (cfs) will be permitted to flow down the old gully. The gully itself has been modified with the left bank being smoothed and armored with “soilcrete”, a soft, concrete-like material (Figure 4). The right bank, on U.S. Government land, remains unmodified and is still extremely unstable being undercut and almost vertical in some places. The gully remains vulnerable, not only the right bank, but the left bank remains vulnerable because the stream could undercut it at the base below the soilcrete. I recommend that flows through the gully not exceed 50 cfs until results can be determined.

Figure 4. The Baker Ranch Gully looking downstream. The left bank on the Baker Ranch side has been smoothed and armored but the right bank on the U.S. government side has not been treated.

Given the changes I have seen, I changed the channel erosion category ("5") of Borrego Creek to a "4" on the new channel map but the whole reach bears watching, especially during any wet years.

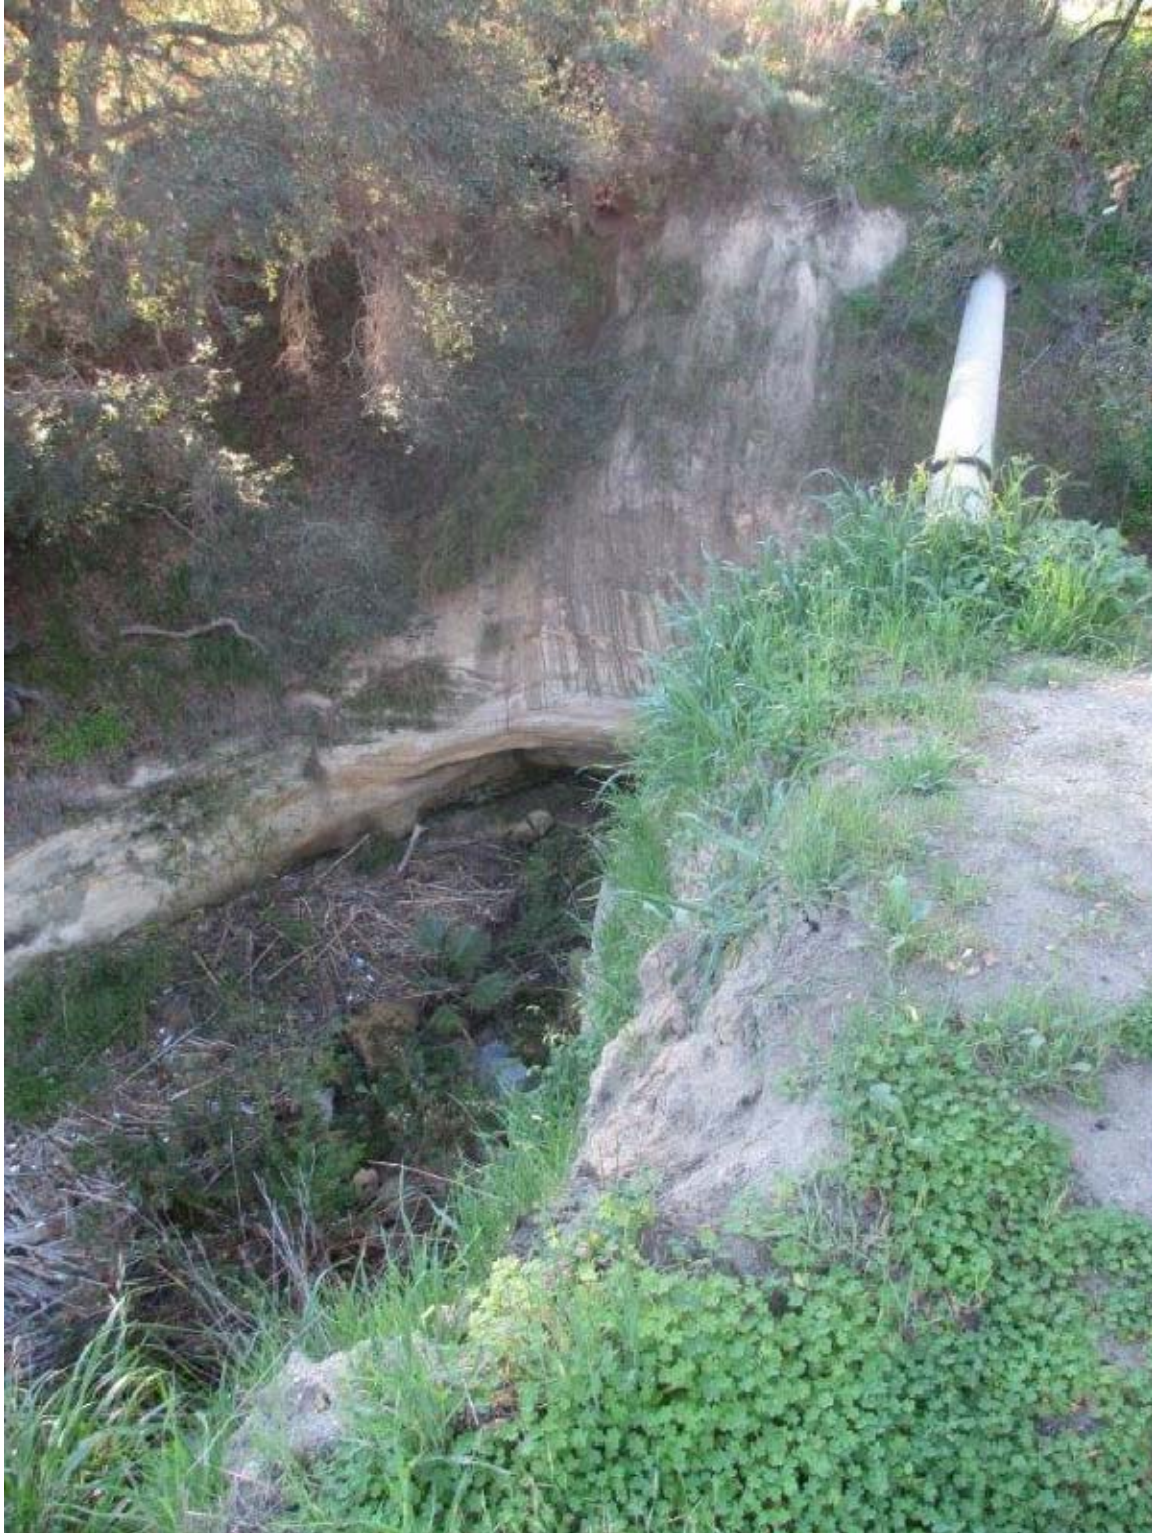
The other unstable channel reach in the basin is Serrano Creek (F19) between Dimension Ave. and Trabuco Road (Fig.1, lower right), particularly the upper half of this reach. The stream has cut down through soil and soft rock leaving many highly unstable cliffs, some over 30 feet high (Figure 5). Attempts to stabilize this reach in the past with grade control structures (dams) have not worked and the debris of the dams is still in the channel, some parts hanging from channel walls. Indeed, the stream in many places has cut to more than ten feet below the level when the dams were built. Also, many trees have been undercut and have fallen or are about to fall into the stream. On the east side, massive slope failures have threatened homes along Sharmila, within the Autumnwood Homeowners Association. While this channel instability is problematic from the standpoint of destabilizing adjacent property and furnishing downstream sediment, it is perhaps even more problematic in terms of public safety. There is an access road paralleling the valley on the west side which is used for recreation by the public, including children, for walking, jogging and biking. However, there are no fences to keep people away from the high and unstable cliffs often less than a hundred feet from the path. Moreover, the often dense vegetation permits people to approach these cliffs without seeing them.

Figure 5. Serrano Creek a few hundred feet below Dimension Road looking over the top of a cliff into the canyon. The cliffs are 25-30 feet high and are undercut and unstable and are often just a few feet from the pedestrian trail which parallels the creek on the west side.

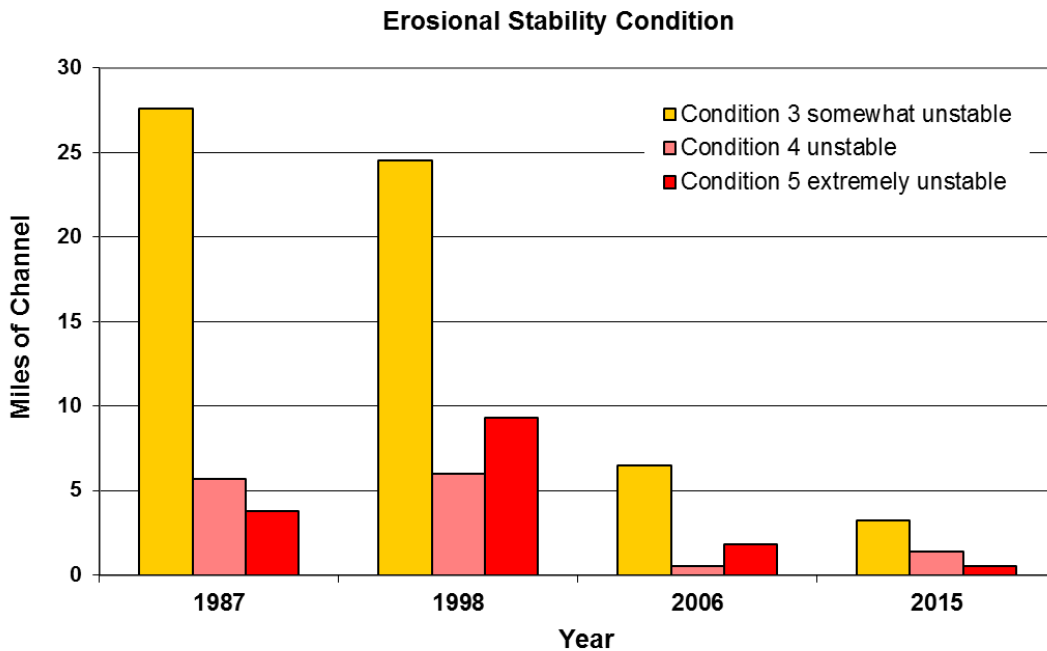
FIGURE 6. Total Miles of Channel by Erosional Stability Conditions.

One task of this ongoing channel study has been to periodically categorize stream channels on the basis of erosional stability (Trimble, 1988). Channels are evaluated on a continuum from Completely Stable (0) to Extremely Unstable (5). Measurements from the Channel Maps of 1987, 1998, 2006, and 2015 show an overall significant decrease in the lengths of unstable channels (Table 1).

The large increase of Condition 5 in 1998 is the result of an extremely wet year 1997-1998 which destabilized formerly stable stream reaches. Most of that destabilization was in the Borrego Wash and Serrano creek but much of that was later stabilized. (Federico, 2003; Trimble, 2005). The increase of Condition 4 for 2015 is largely the result of Condition 5 channels, especially Borrego and Serrano, being upgraded to Condition 4. The reduction of condition 3 2006-2015 is due both to channel improvements and also due to the removal from consideration of the natural channels tributary to the Bee canyon and Round Canyon retarding basins. This is because most of the sediment produced and transported by these channels will

be removed in the retarding basins. However it should be recalled that some channel reaches of San Diego Creek and Central Irvine Channel have been downgraded from Condition 0 to Condition 1 or 2 and this does not show up in the table.

The overall decrease of unstable channel from 1987 to 2006 is remarkable. Note that channels range from large to small so there cannot be an exact relationship between the condition given here and volume of eroded material. But there can be no doubt that volumes of channel erosion have drastically declined since 1987.
