**Inner Cabrillo Beach
Water Quality Improvement Project
Source Identifications and Mitigation Alternatives
Volume I Summary Report**

**Port of Los Angeles
Engineering Division**

**INNER CABRILLO BEACH
WATER QUALITY IMPROVEMENT PROJECT
SOURCE IDENTIFICATIONS AND MITIGATION ALTERNATIVES**

VOLUME I - SUMMARY REPORT

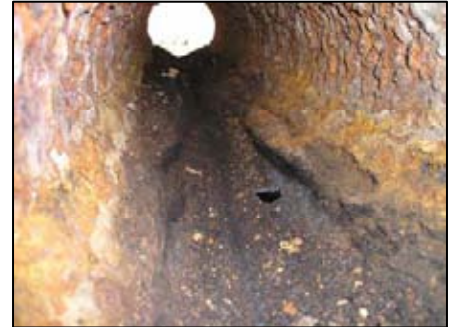
Figure 5. Leaking Sewer.

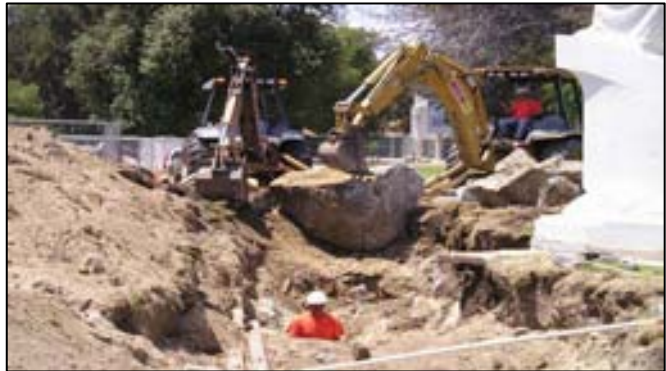
Figure 7. Construction on Sewer Repairs.

Previously in 2000 a partial bird exclusion structure was installed on Inner Cabrillo Beach. This action resulted in an apparent reduction of bacterial exceedances at CB02 but not sufficient to meet health and TMDL requirements. The Port of Los Angeles implemented a project completed in June 2004 to fix the leaky sanitary sewers and defective storm drain local to the south end of Inner Cabrillo Beach. Subsequent beach monitoring data response was confounded by a water main break up on Stephen White Drive that apparently raised contamination at CB02 by an order of magnitude, followed by a winter of record rains. The following 2005 dry season exceedances were low comparable to previous best years but did not approach zero days as required. Wet season violations also continue at an excessive frequency indicating remaining bacterial sources are still effective in causing water quality violations.

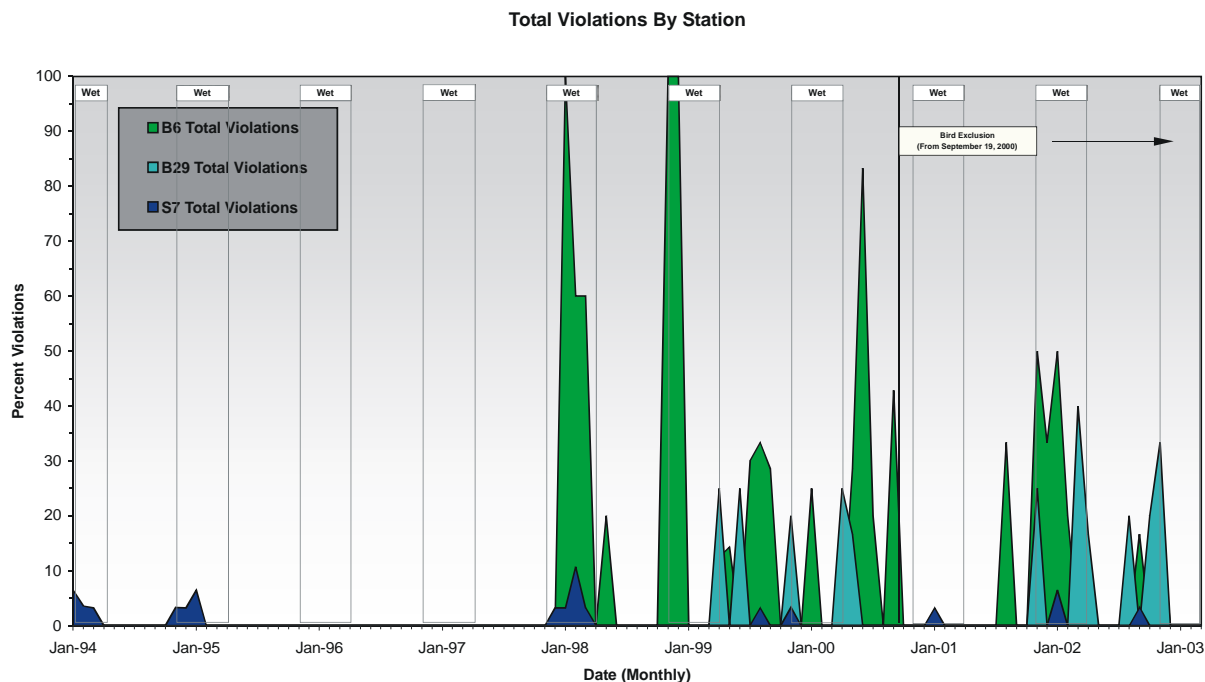
Figure 14. Percent of the Time Exceedances Occur at Other Protected Beaches, B6 - Long Beach and B29 - Alamitos Bay.

Site B-29 within Alamitos Bay has been studied as part of the City of Long Beach's Storm Water Monitoring Program (Kinnetic Laboratories, 2002). Violations at this protected beach were almost all directly related to rain events, with practically no violations in the dry season, both before and after installations of a dry weather diversion project. Another similar protected beach is Marina Beach located in the upper end of Marina del Rey Harbor that has also been studied recently (Kinnetic Laboratories, 2004). This protected beach normally has only a few violations during the dry season, though stormwater drainages cause frequent wet season violations.

Data from inland comparison beaches is in contrast to that of the data for CB02 at Inner Cabrillo Beach. Again, these results would tend to indicate a local source at Cabrillo Beach to explain the differences in violations, particularly in the dry weather period.

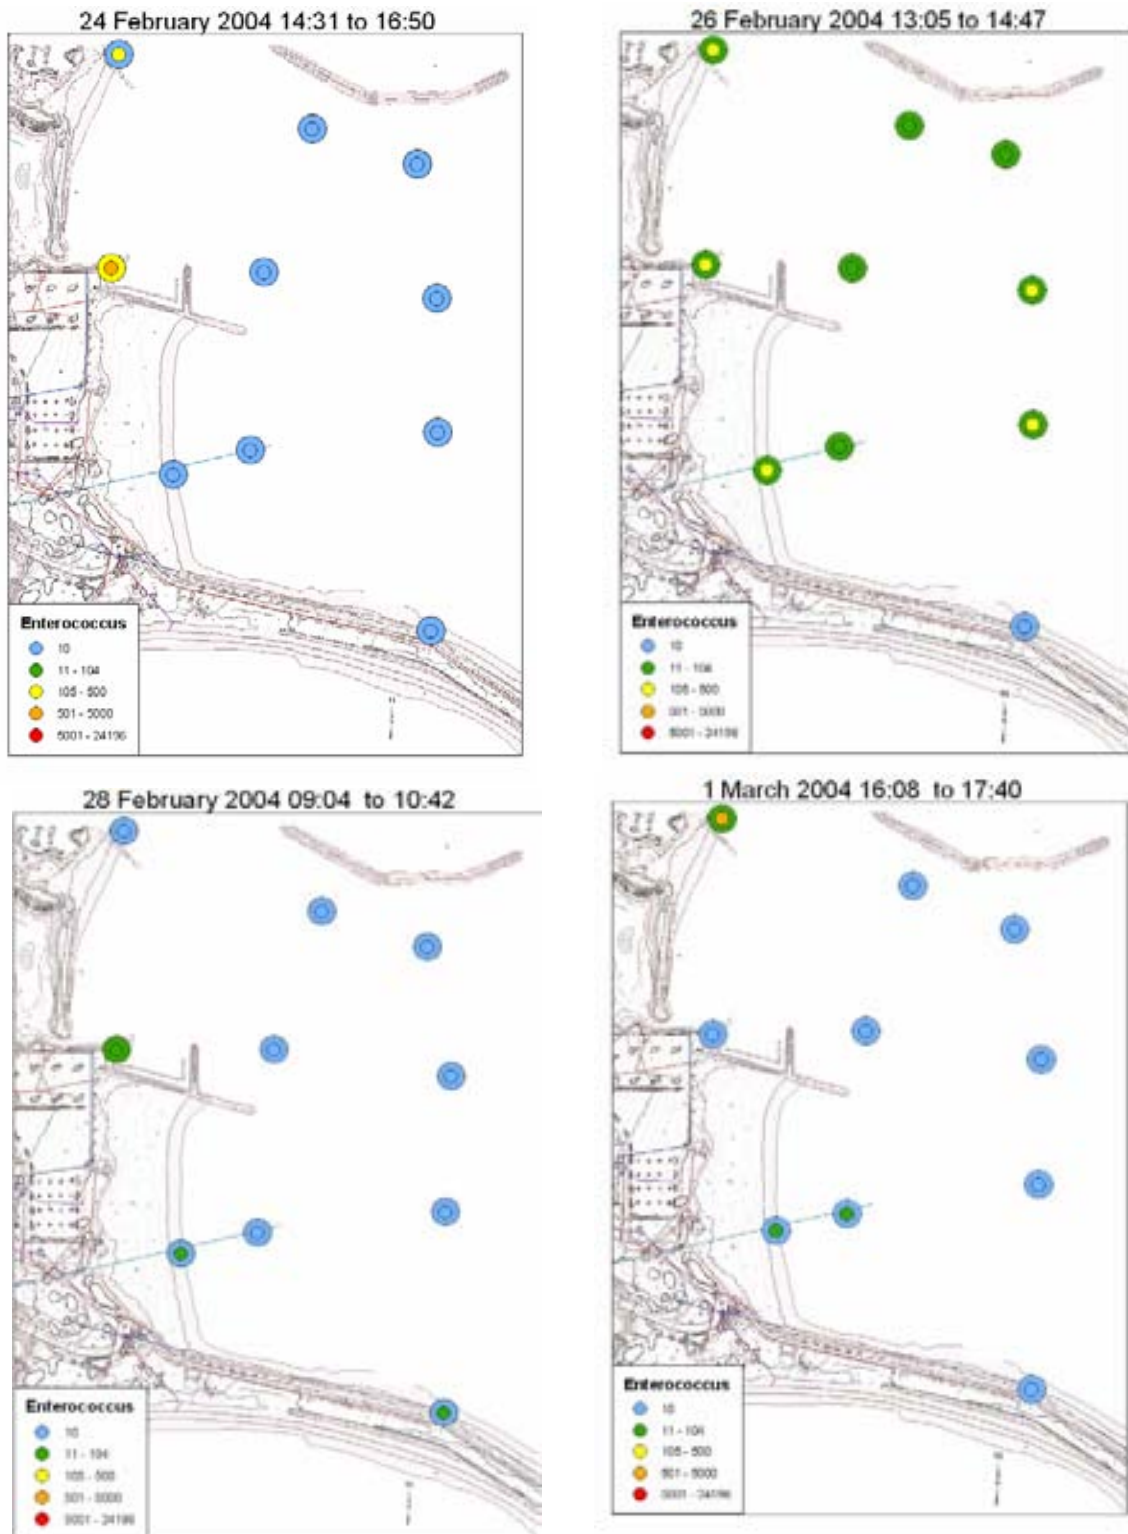
Figure 17. Typical Response of Offshore Stations to a Storm Event

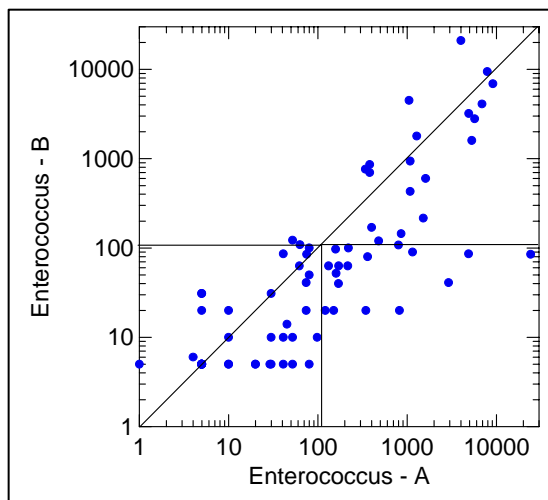
Figure 18. Enterococcus Measured in the Swash Zone (A) versus in Two Feet of Water (B).

The City Bureau of Sanitation monitors Inner Cabrillo Beach in a manner consistent with procedures used on all beaches, which is to sample in ankle deep water. Guidance on methods to be used is in AB411, codified in California Code of Regulations (CCR) Title 17 Public Health, Division 1 State Department of Health Services, Chapter 5 Sanitation (Environmental), SubChapter 1 Engineering (Sanitary), Group 10. Sanitation, Healthfulness and Safety of Public Beaches and Ocean Water-Contact Sports Areas. Section 7961(b) includes appropriate sampling depths for waters adjacent to public beaches. It states that samples should be taken from just below the water surface, in ankle- to knee-depth water, approximately 4- to 24- inches deep. The California Department of Health Services Saltwater Beaches Guidance (Draft) (<http://www.dhs.ca.gov/ps/ddwem/beaches/saltwater.htm>) for sampling under this regulation differs slightly. This guidance indicates that samples should be taken from just below the water surface, in ankle- to knee-depth water, approximately 12 to 24 inches deep.

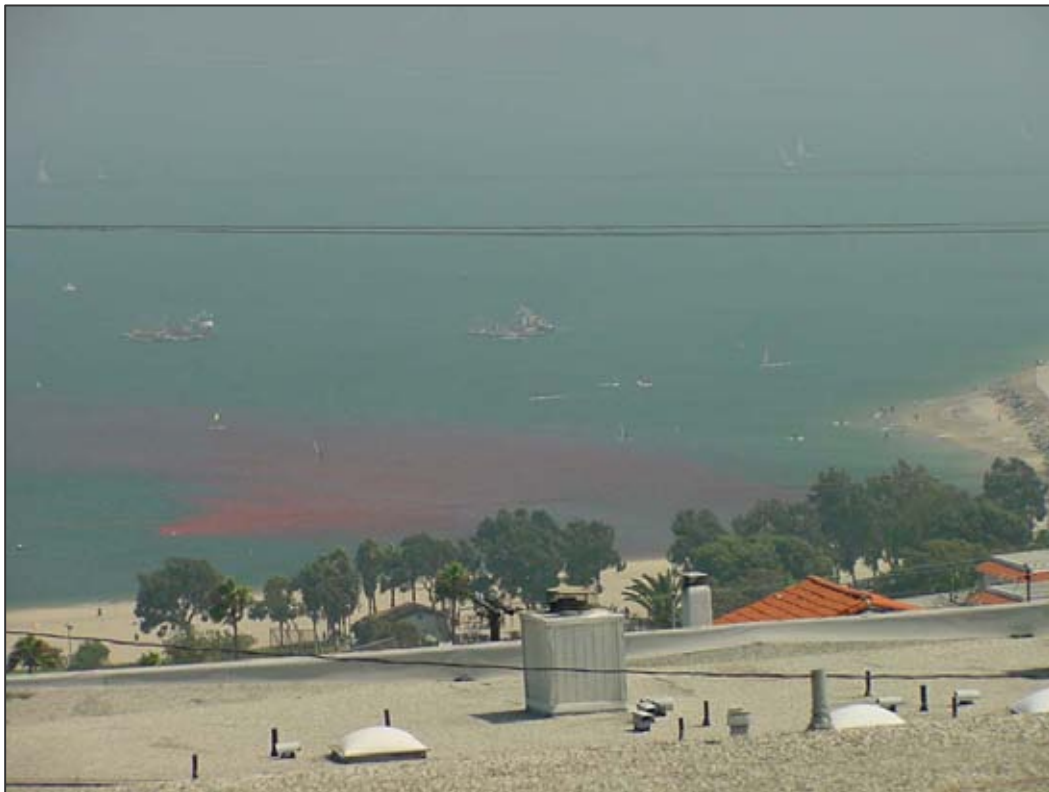
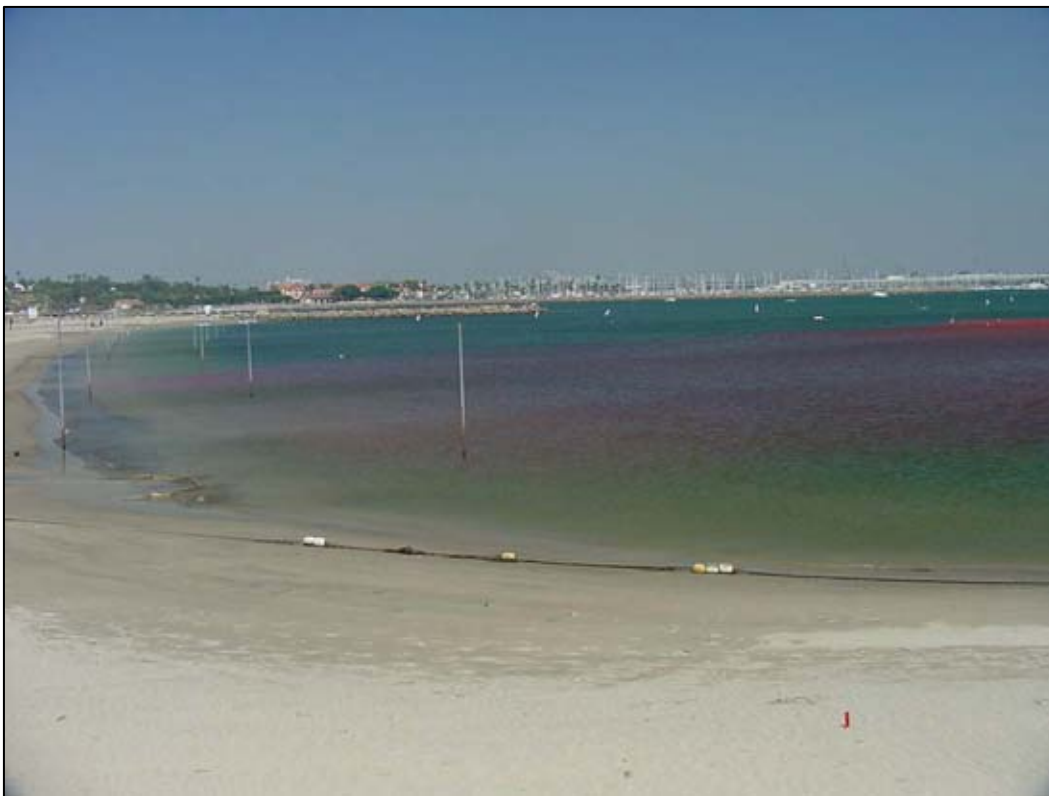
Figure 21. U.S. Corps of Engineers Dye Plume Under Predominate West Winds Inner Cabrillo Beach, 15 September 2002. Surface Layer Dye Plume Moves Offshore (top) and Transported to Beach by Bottom Countercurrent (bottom).

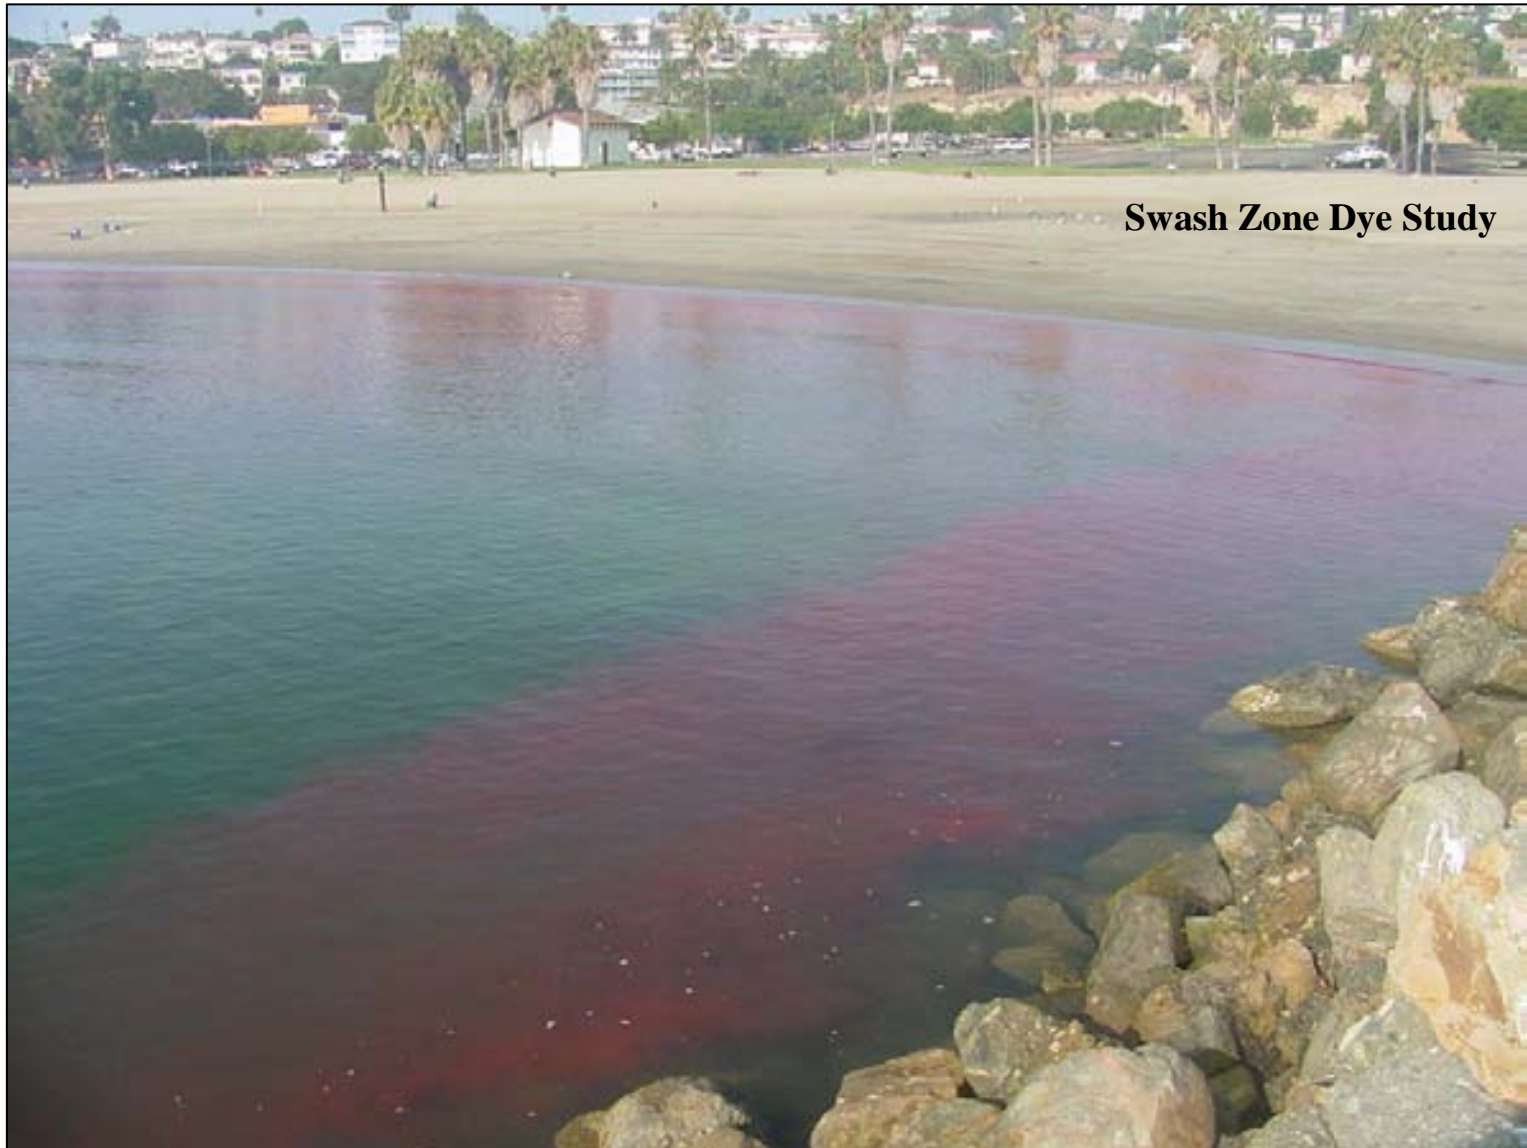
Figure 26. Dye Movement from Swash Zone in Nearshore Area Under Very Light Southwest Wind Conditions in Early Morning, 09:00 August 27, 2003, Wind 4 mph. 250-270 Degrees.

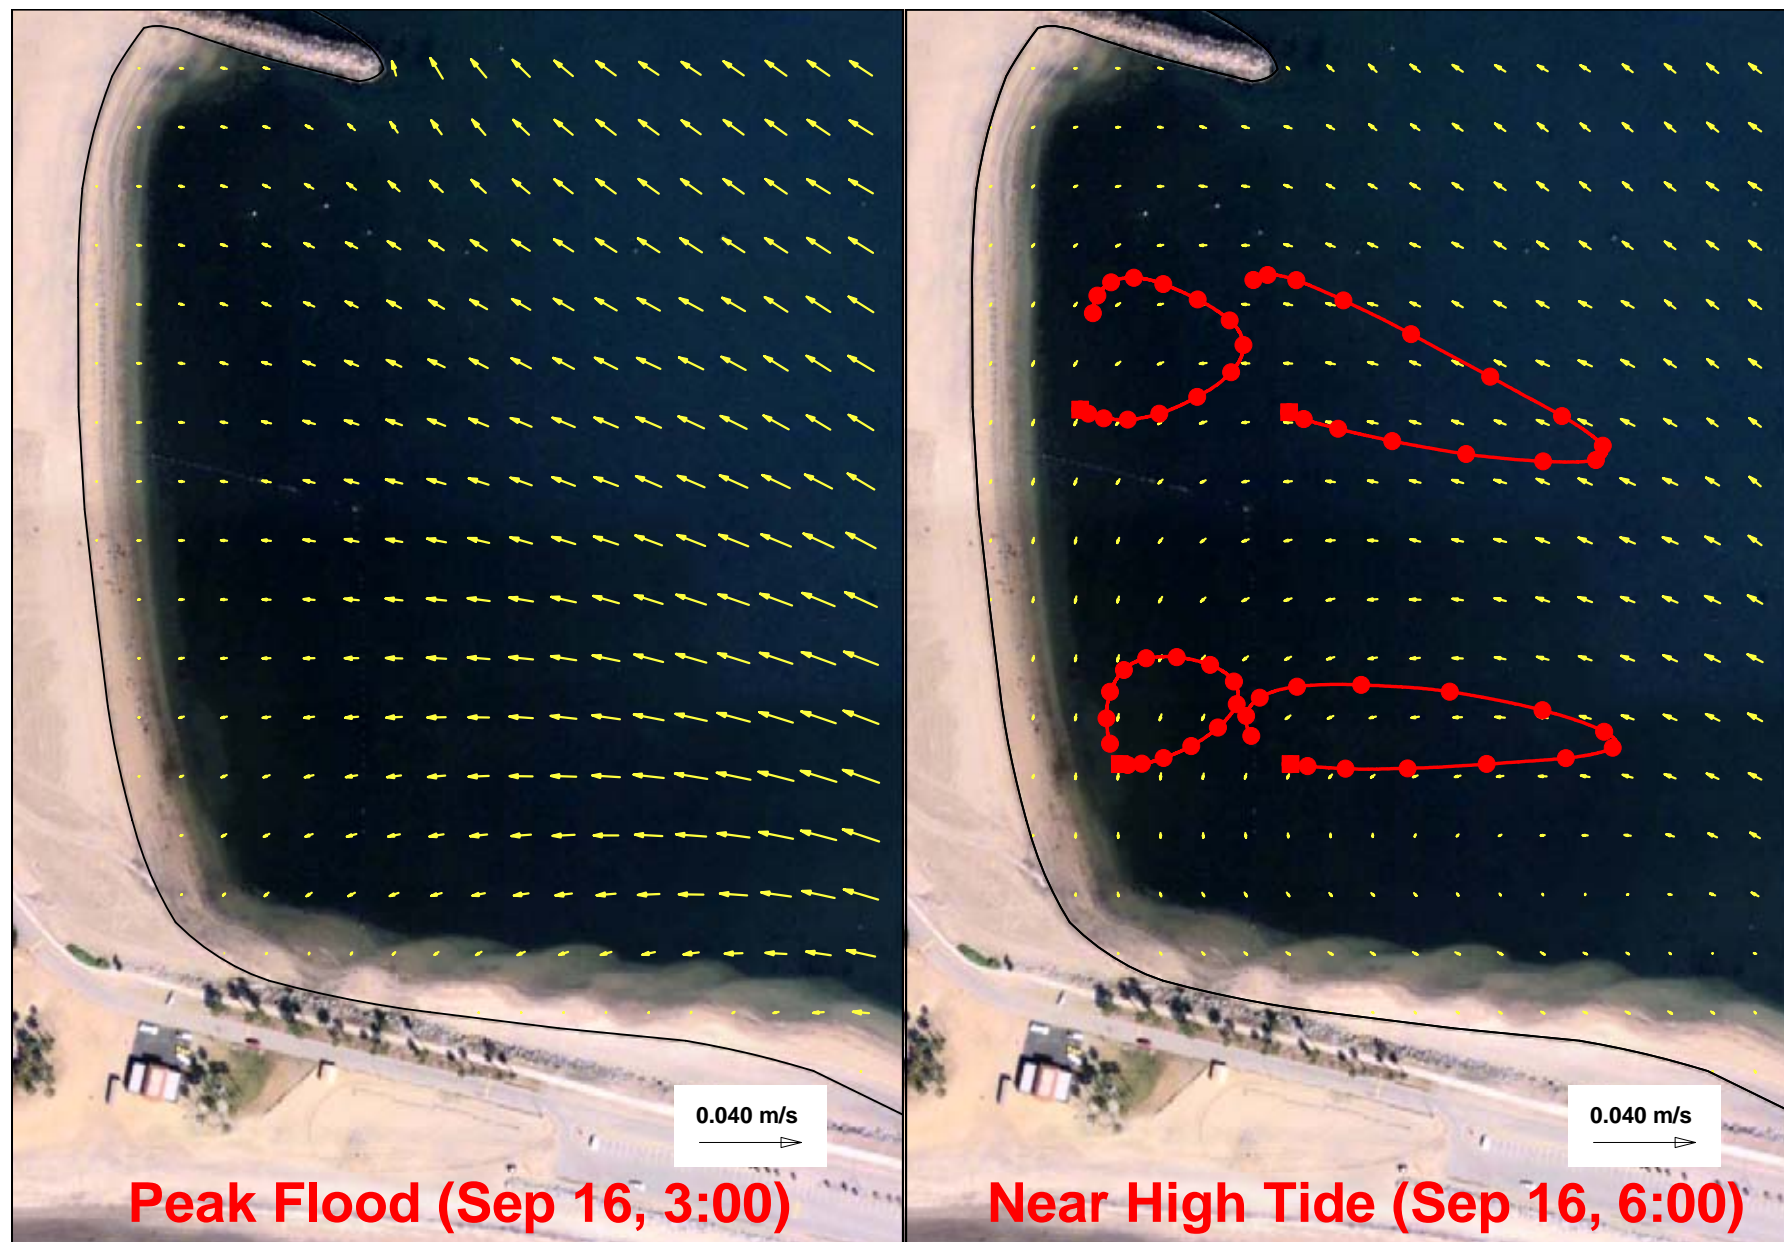
Figure 28. Inner Cabrillo Beach Base Condition, 2 Knot Wind @ 240 deg. from North (Left). Inner Cabrillo Beach Currents, No Wind. Red Traces Bottom Circulation Over 15 Hour Time Period (Right).

Figure 28 illustrates that nearshore currents at Inner Cabrillo Beach under no wind conditions are very low, tidal currents in the range of several hundredths of a knot (less than 0.02 m/sec) and less at the beach face. Bottom velocities were also low, with the particle tracer shown in Figure 28 illustrating little movement over a 15 hour time interval. With wind, the two layer flow regime is set up as illustrated in Figure 29 for the cases of a 5 knot southwest wind condition. The surface currents are increased substantially to about 0.04-0.05 m/s or almost 0.1 knot. Bottom water is brought into the beach. Figure 30 illustrates the movement of bottom water tracer particles that are brought into the beach, upwelled, and

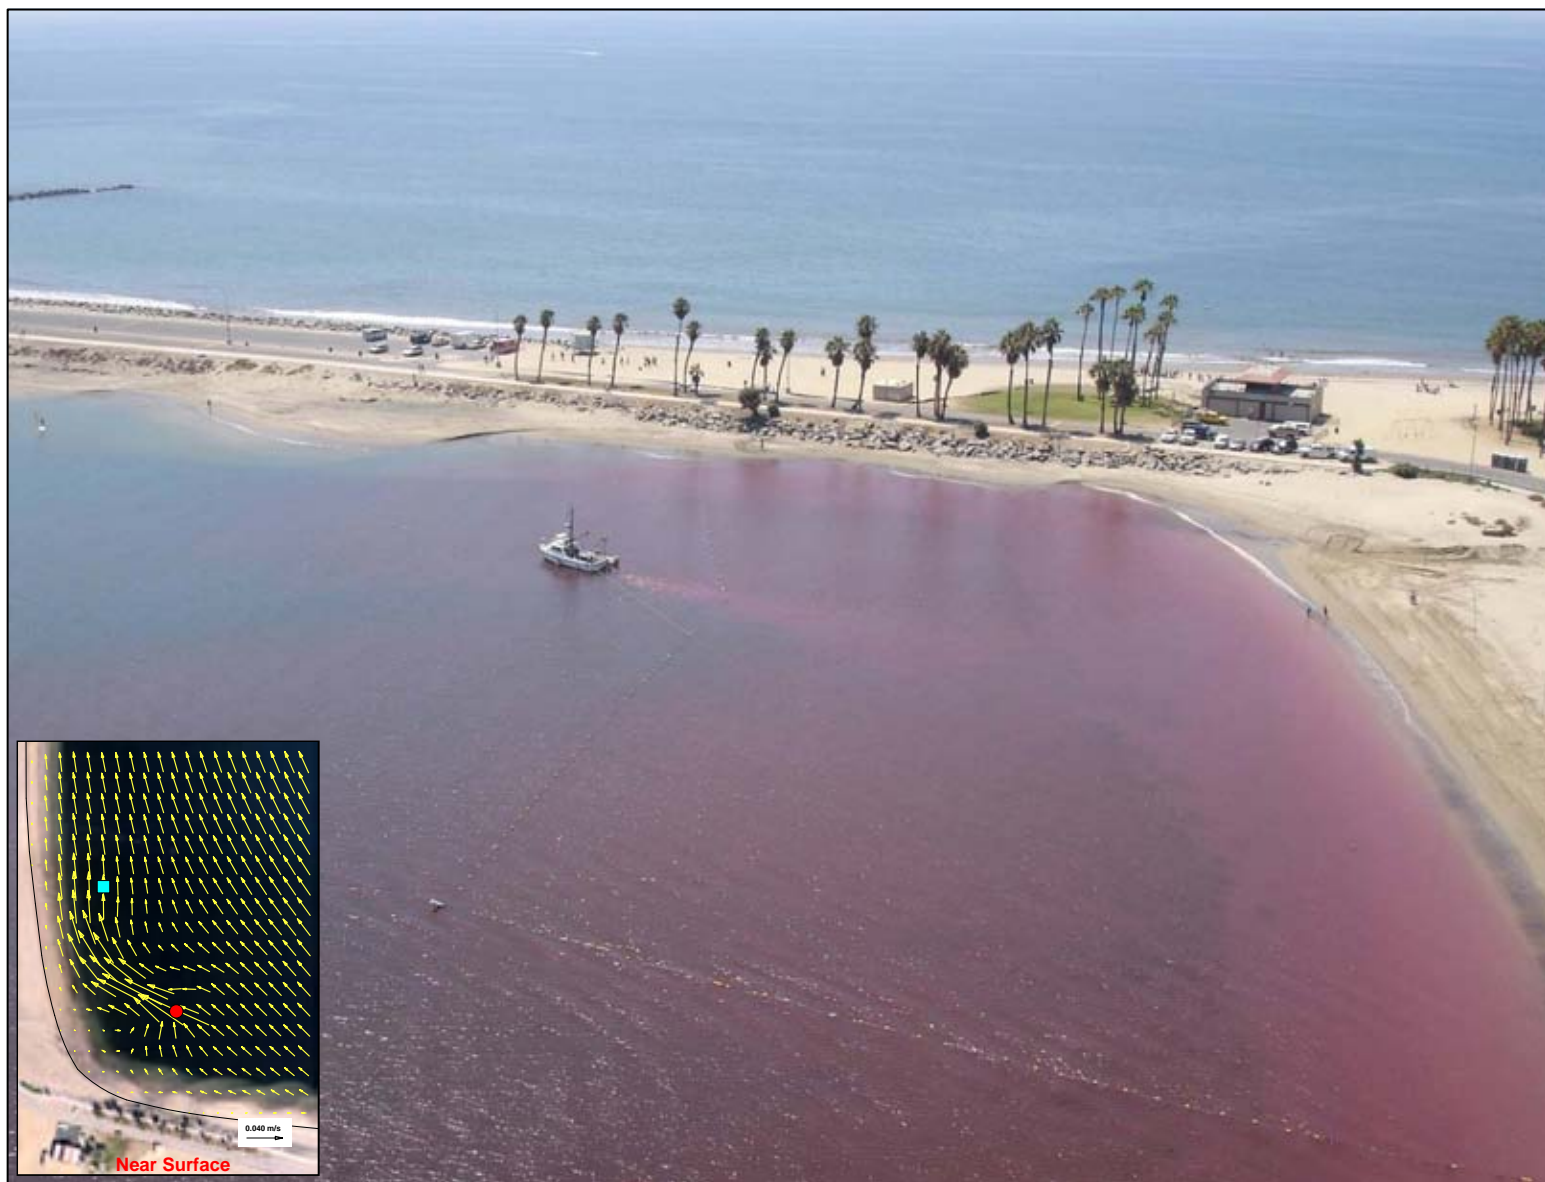
Figure 34. Aerial Photograph of Dye Distribution Southern Part of Inner Cabrillo Beach, 11:30, August 3, 2005. Insert RMA Model Predictions. (Note Pumping Started at 08:22). Red Indicates Clean Water Flushed to Beach

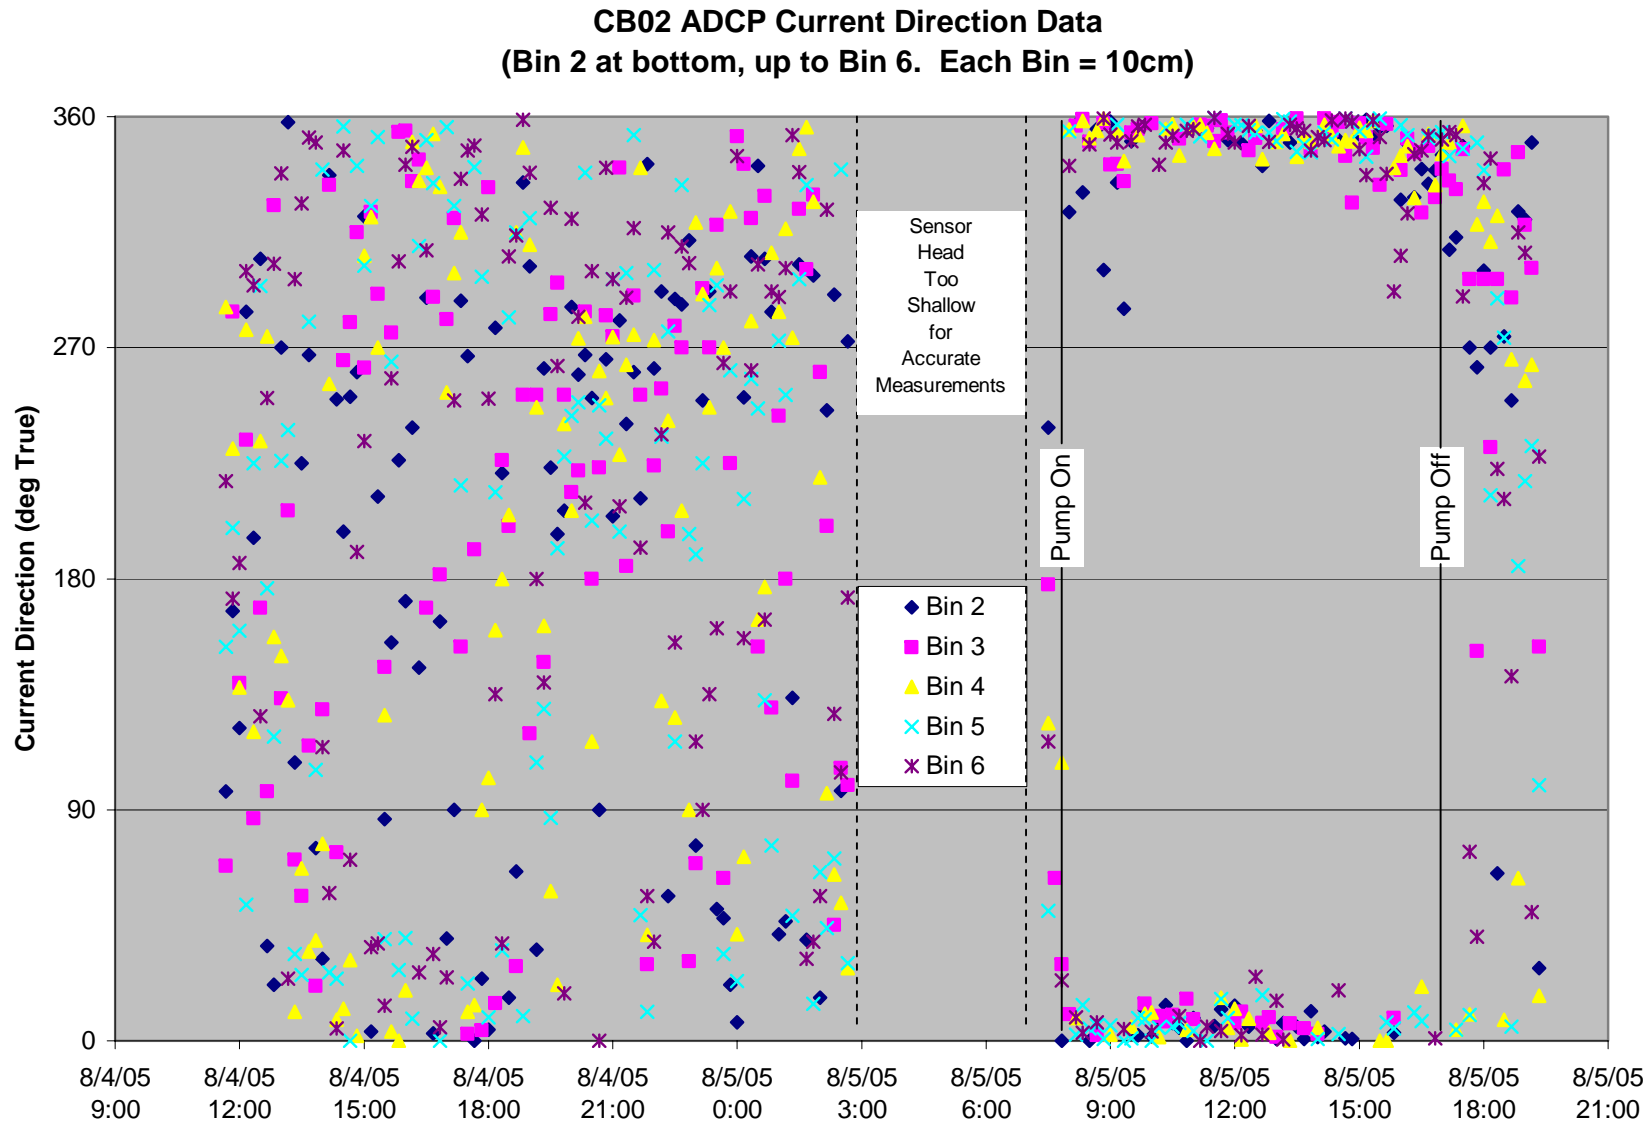
Figure 36. Current Directions in Water Column Above ADPC Current Meter, August 4 and 5, 2005.

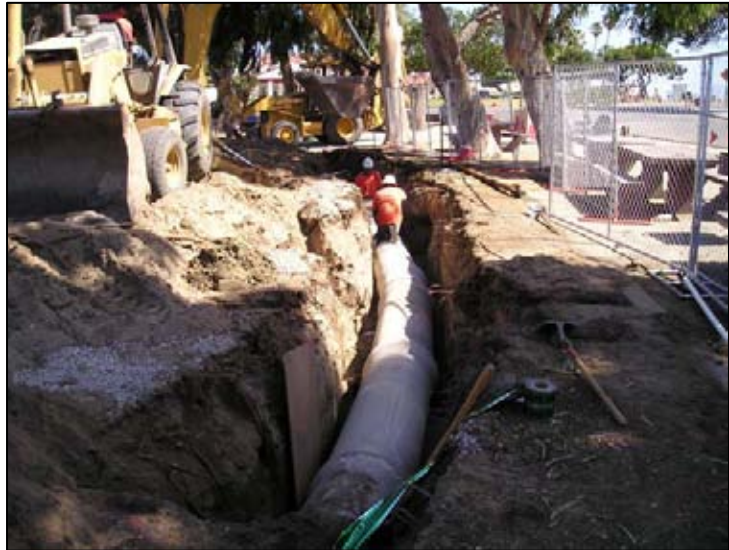
Figure 37. Repair/Diversion Interim Project

- Physical inspections and dye tracing of sanitary sewer systems.
- Physical inspections and dye tracing of stormwater sewer systems.
- Interstitial water, seeps, and groundwater sampling and testing to detect upland contamination sources that may be moving to the beach.
- Interim repair and diversions of local leaking sanitary and storm drains discovered at the south end of the beach (Figure 37).

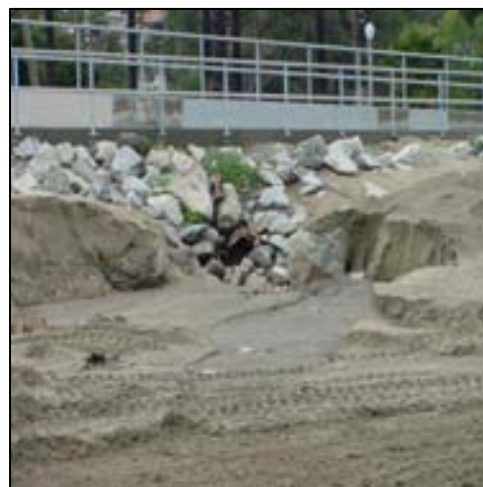
Figure 40. Overflow Stormwater Outfall at South Corner ICB

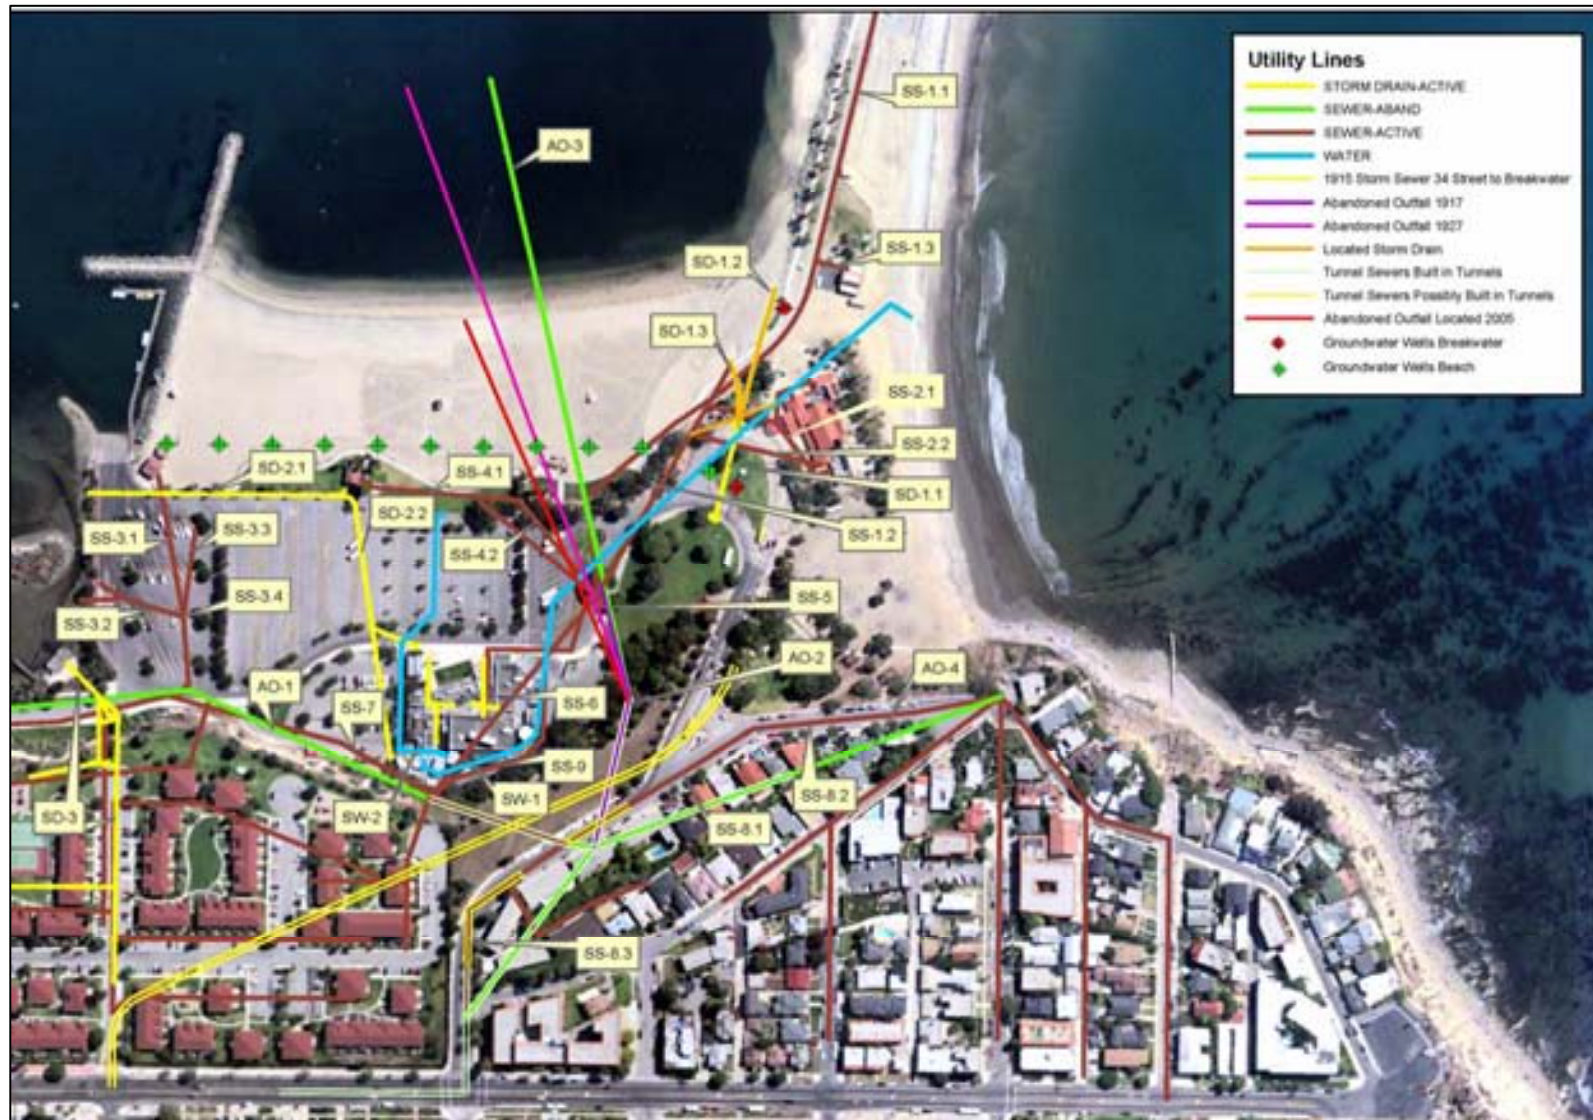
Figure 38. Storm Drains and Sanitary Sewage Lines at Inner Cabrillo Beach.

Storm drains from Inner Cabrillo Beach consist of discharges at the southern corner of the beach and a discharge near the launch ramp into the outlet of the Constructed Wetland (Figure 38). The drains at the southern end consist of an outfall which was found to be buried under the breakwater and sand, and an overflow structure that discharged across the beach sand from the southern corner (Figure 40). This 24-inch stormwater outfall collected a small amount of local drainage along with water from a portion of San Pedro on the hill above. The outfall at the Wetland outlet drains most of the Inner Cabrillo Beach park complex along with the large main parking lot. In addition, a 60-inch and a second 24-inch line discharges stormwater into the Wetland from a large area of San Pedro (Figure 39). An additional 24-inch line discharges into the Harbor from a portion of Cabrillo Marina to the north (Figure 39).

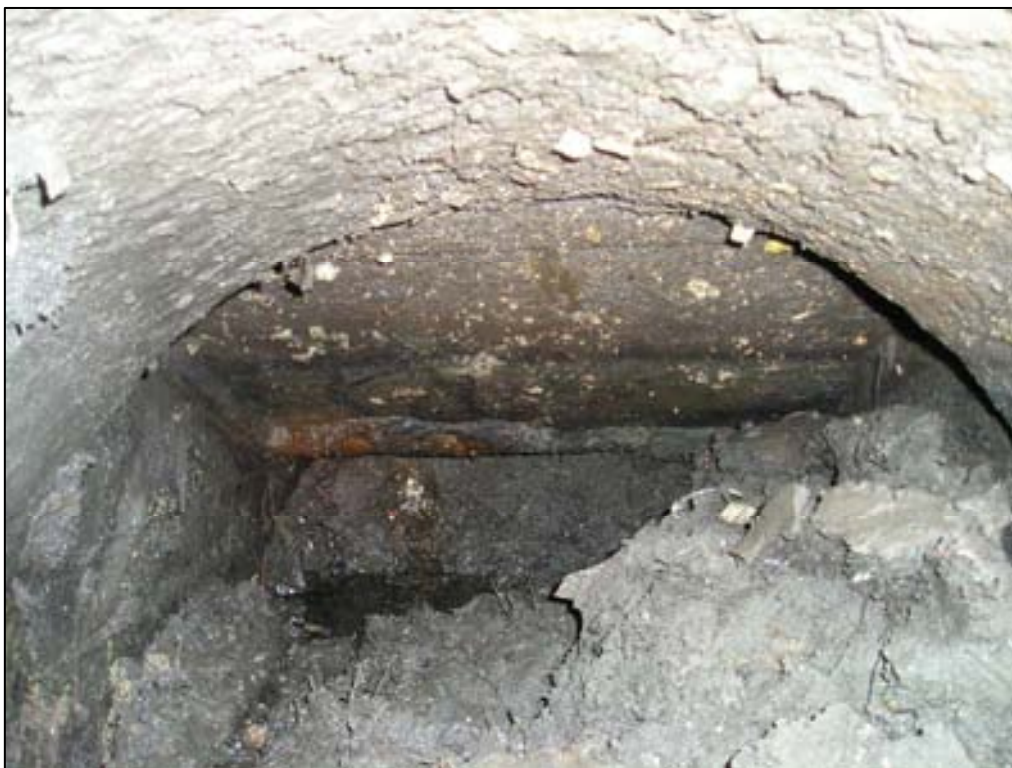
Figure 42. Sanitary Sewer from Bath House Built into Top of Clay Storm Drain, 1932.

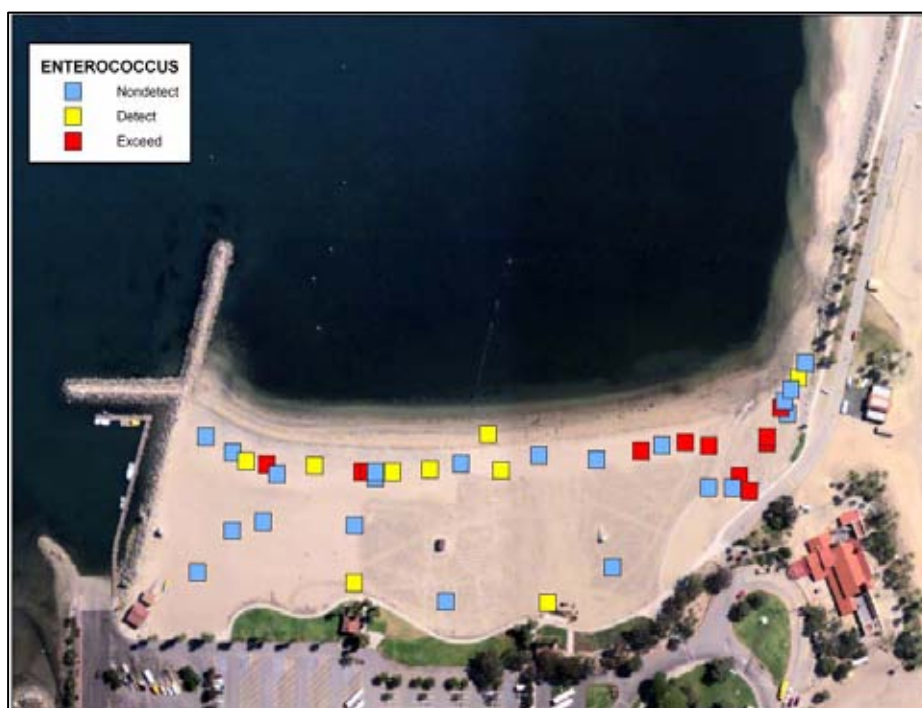
Figure 48. Enterococcus Results in May/June 2003 Interstitial Water Samples, Inner Cabrillo Beach.

Initial spring/early summer 2003 interstitial sampling was carried out in mid-May and early June, mostly by digging pits to the groundwater and then directly sampling. A somewhat simplified summary figure of these early summer results is shown in Figure 48 (shown for enterococcus) that indicates consistent groundwater contamination in the sand at the southern corner of the beach where the defective storm drain and suspected sanitary leaks were present. Rhodamine dye which was injected into the storm drain discharge was also measured in the groundwater in the south corner of the beach. Later in the summer/fall of 2003 dry season, contamination was not present in the beach interstitial water.

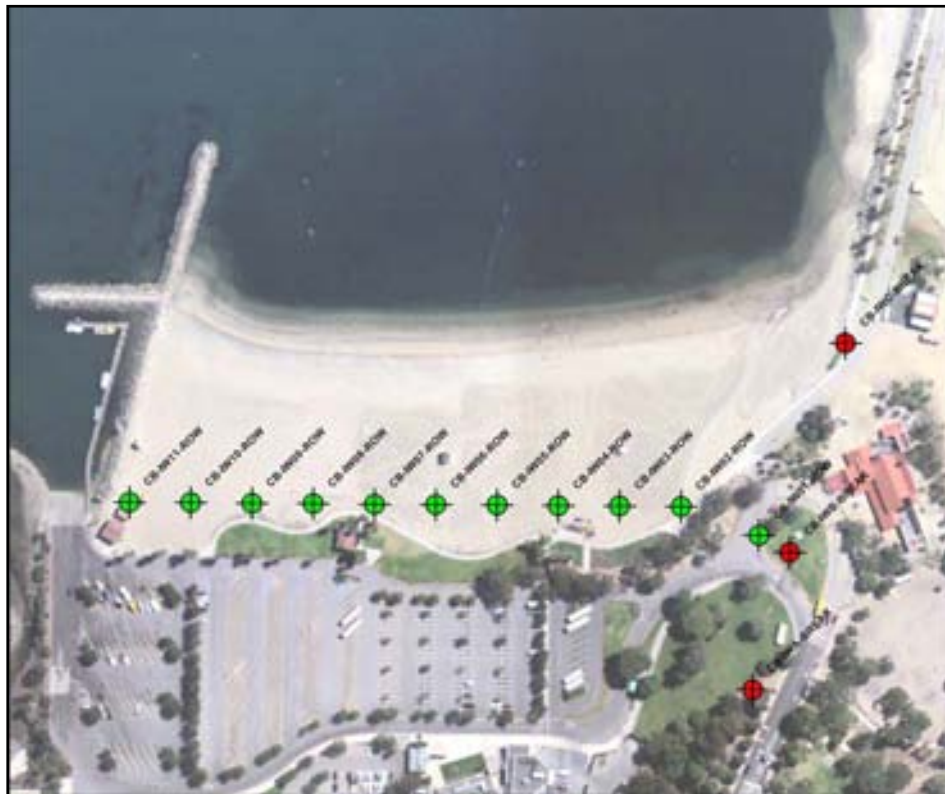
Figure 49. Location of Semi-Permanent Groundwater Wells at Inner Cabrillo Beach.

screen point interval over the approximate 5-foot depth range of MSW to MLLW. The main purpose of these wells was to further determine whether or not bacteria contamination is migrating through the groundwater from upland sources to the beach and offshore waters. Subsequent to their installation, the groundwater wells were sampled several times through June of 2005.

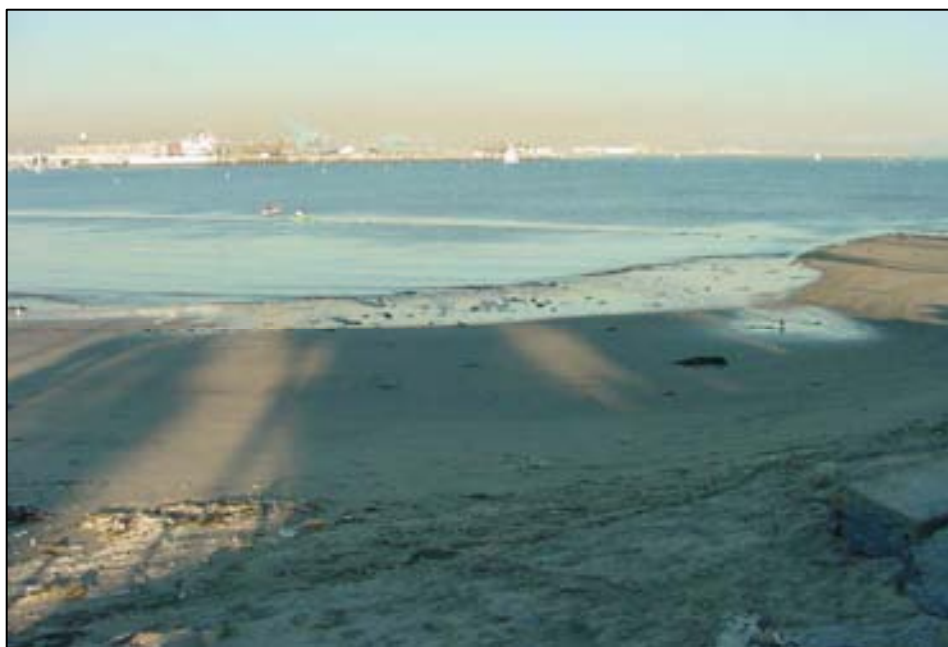
Figure 50. Persistent Brackish Water Seep at Southern Corner of Inner Cabrillo Beach.

All of the water sampled seeping in the lower intertidal across the beach face was found by salinity measurements to be seawater draining from the sand from the previous high tide, except in the southern corner of the beach. Here a persistent seep of brackish water existed as shown in Figure 50. This seep in the corner was usually in the range of 11 to 21 ppt salinity and was often contaminated with bacteria.

The results of the dry season seep sampling at the southern corner of the beach show elevated bacteria concentrations throughout extended dry weather periods. Samples collected in the swash zone were more often contaminated and to greater extent than the seep samples they were paired with.

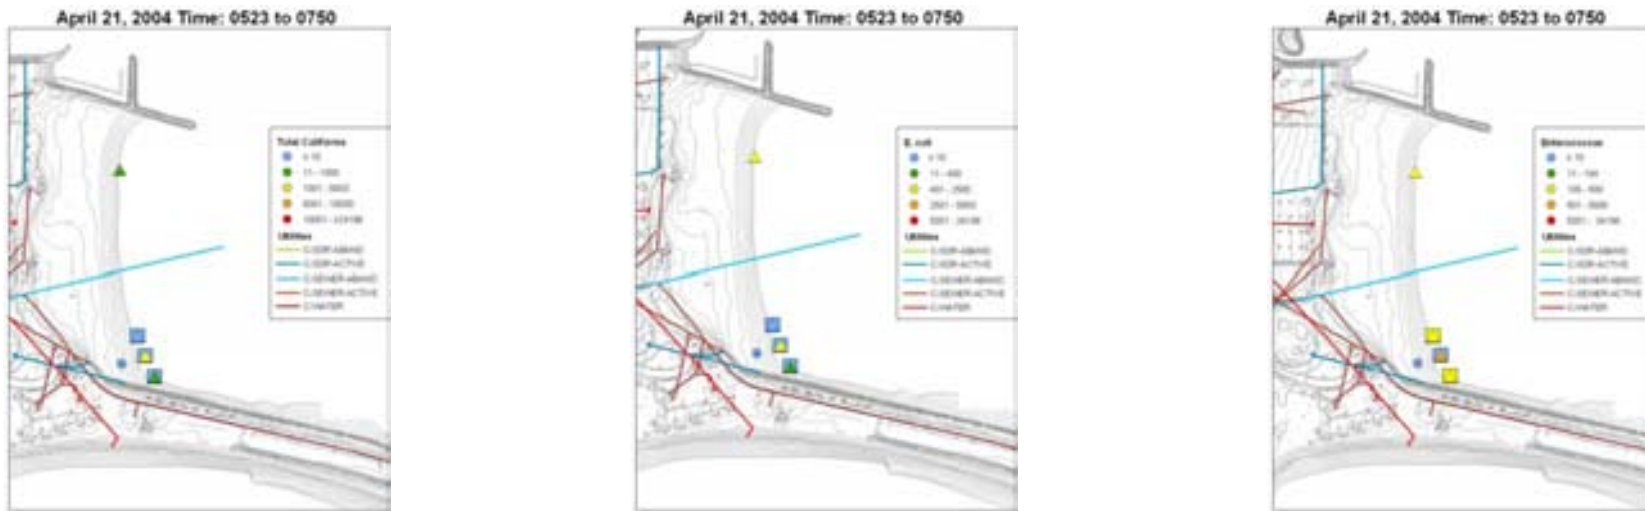
Figure 51. Dry Weather Seep Sampling, April 21, 2004. Rained 0.09", 4 Days Prior. Square—Seep Samples. Triangle—Ocean Samples. Dotted Circle—Interstitial Groundwater Sample.

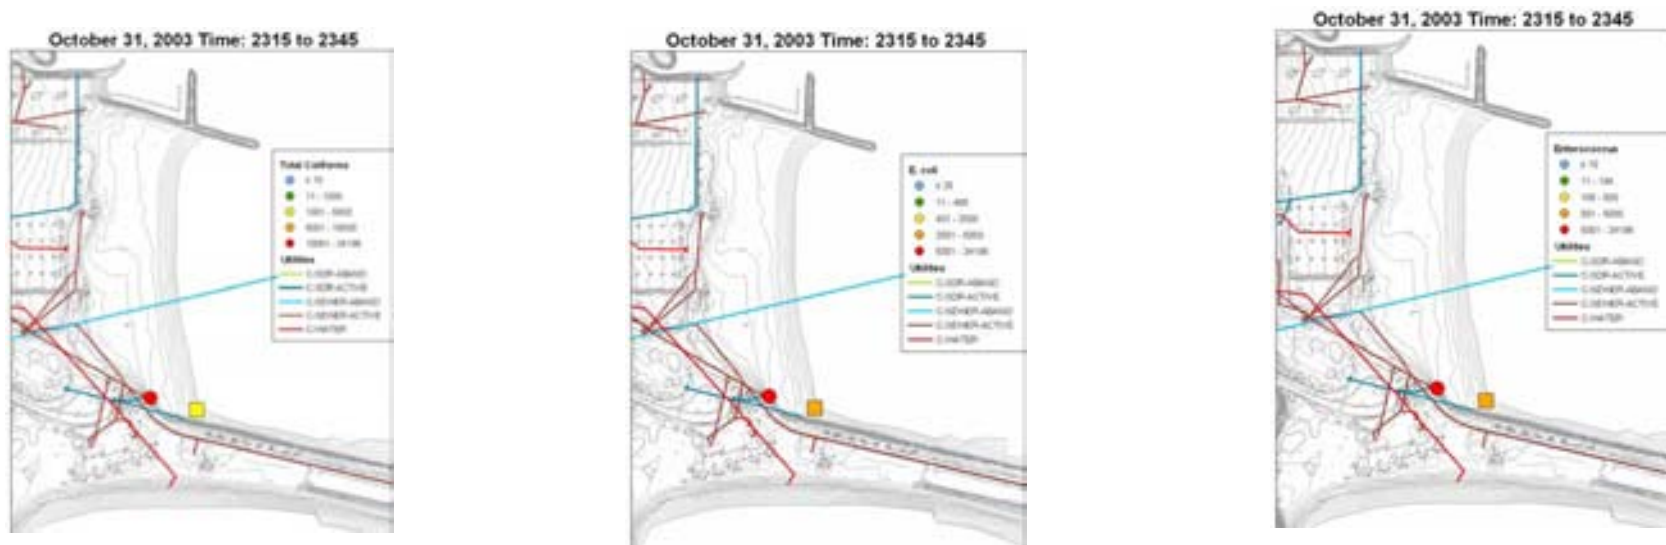
Figure 52. Wet Weather Seep Sampling, October 31, 2003. Rained 0.11", Same Day. Square—Seep Samples. Circle—Stormwater Samples.

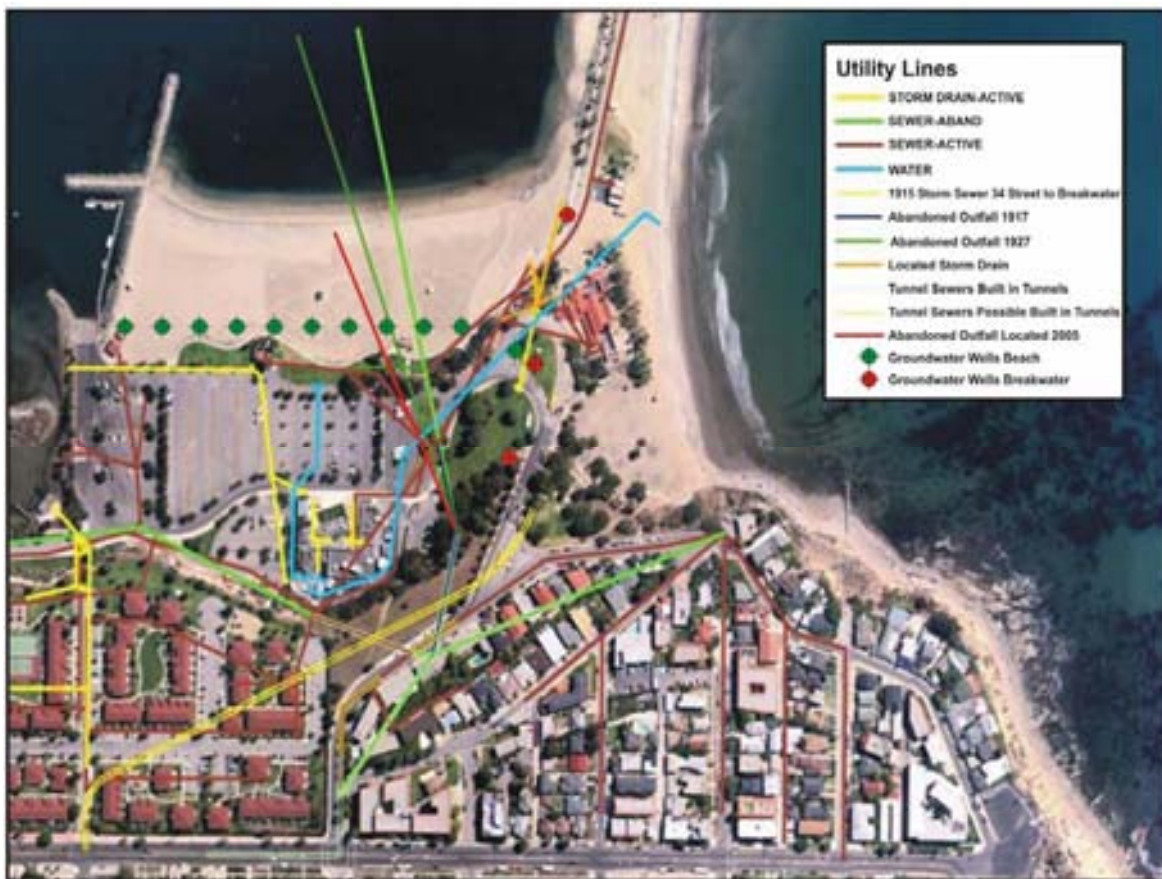
Figure 53. Location of Old Abandoned Sewer Outfall (Red Alignment as Found).
