**Inner Cabrillo Beach
Water Quality Improvement Project
Source Identifications and Mitigation Alternatives
Volume I Summary Report**

**Port of Los Angeles
Engineering Division**

**INNER CABRILLO BEACH
WATER QUALITY IMPROVEMENT PROJECT
SOURCE IDENTIFICATIONS AND MITIGATION ALTERNATIVES**

VOLUME I - SUMMARY REPORT

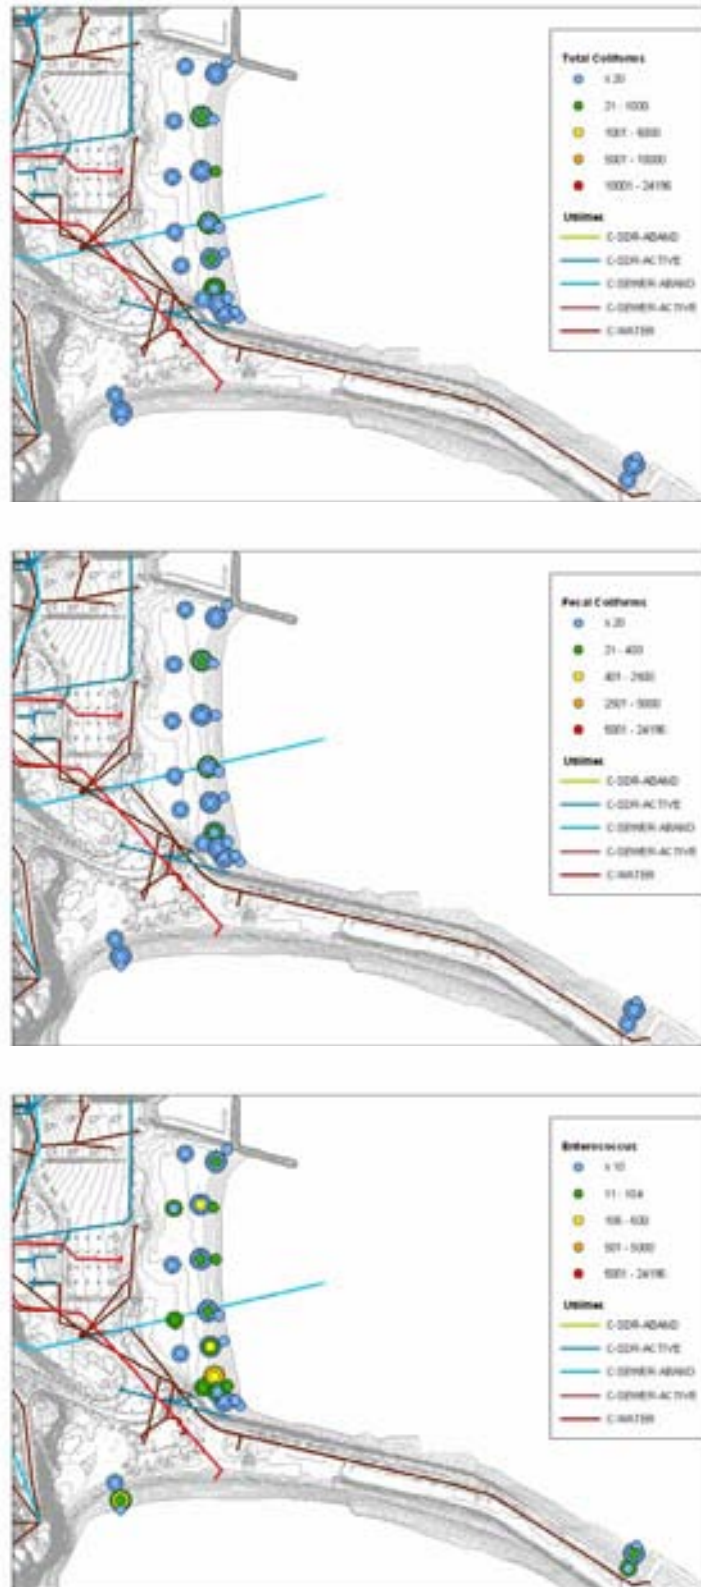
Figure 55. Pre-Wet Weather Sand Surveys, August 15 to September 30, 2003. Smallest Circle–Surface Samples. Medium Circle–6-inches Deep. Largest Circle–12-inches Deep. Rain 0.3”, 16-62 Days Prior. Wind 3-8 KT, 150-220°.

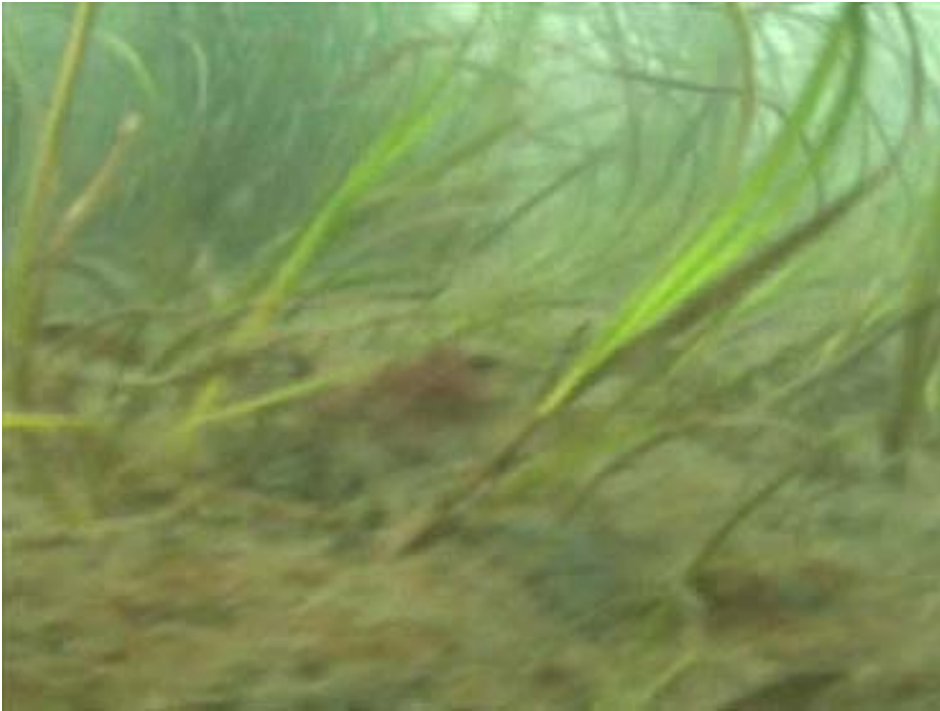
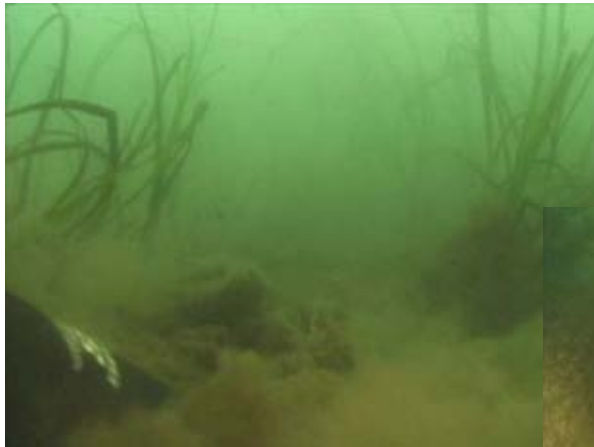
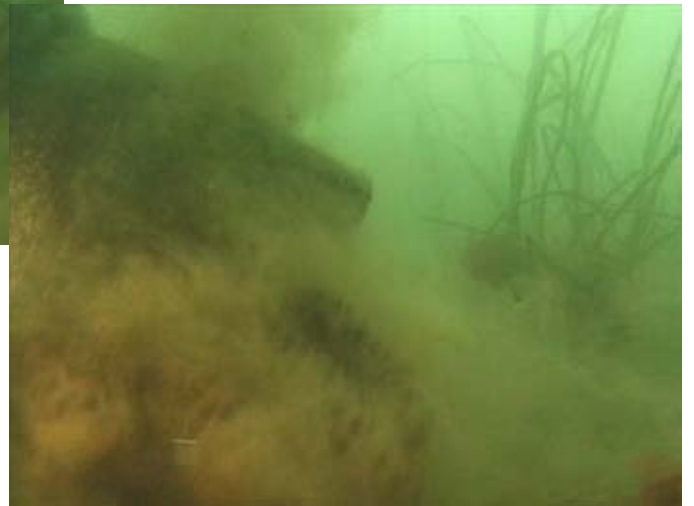
Figure 61. Eelgrass Beds and Fine Sediment/Detrital Material Offshore Inner Cabrillo Beach.

Viewing of the underwater video showed that fine sediments exist in the eelgrass bed and they could be disturbed into a cloud of sediment with a diver's hand, Figure 61. Unless disturbed however, neither turbid nor detrital layers (nepheloid layer) existed on the bottom moving with the small surge present during the survey in this part of the Harbor. In other words, the eelgrass bed seemed, in general, to be stabilizing the bottom and the fine sediments were cohesive enough so that constant turbidity was not

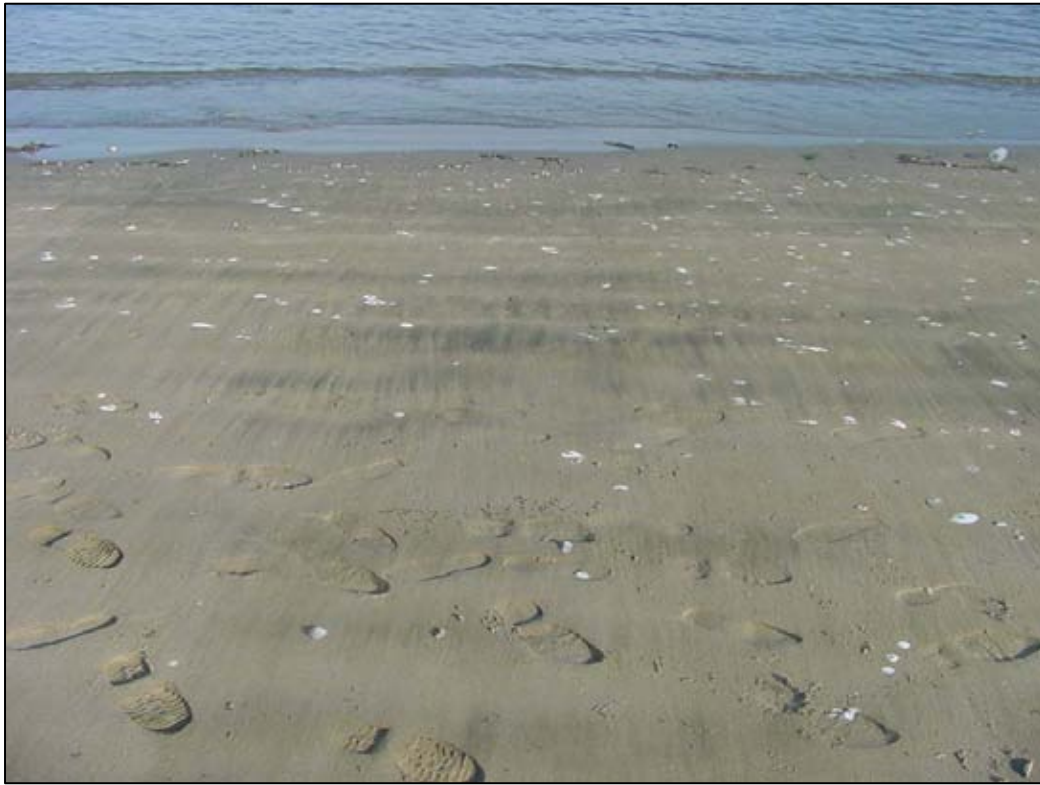
Figure 64. Bird Excrement on Northern Part of Inner Cabrillo Beach.

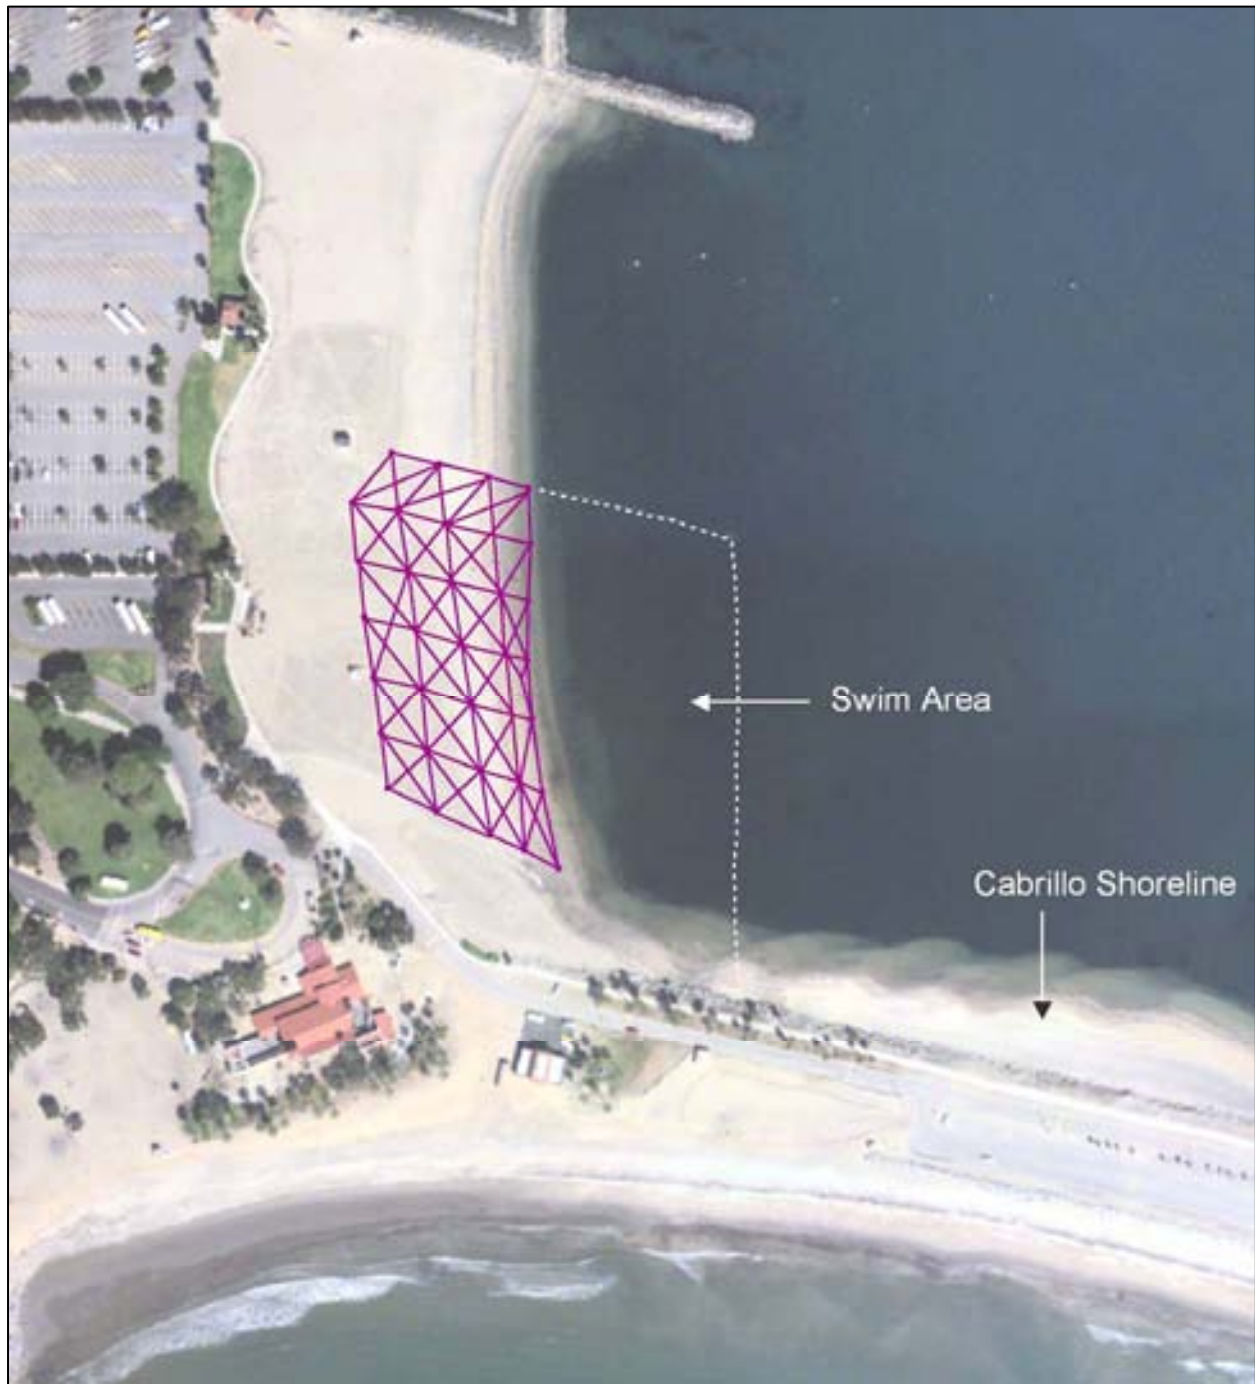
Figure 65. Bird Exclusion Structure Erected on Inner Cabrillo Beach, September 2000.

In order to reduce the number of birds particularly the large number of gulls using the beach, a bird exclusion structure was constructed in September 2000 along with implementation of a covered trash can program at the beach. The structure covered only the southern part of the lower beach and intertidal area. The bird exclusion structure consisted of long galvanized fence poles placed in a grid fashion, approximately 80 feet apart in the north south direction parallel to the beach and 60 feet apart in the east/west direction across the lower beach and intertidal area. A schematic of the beach coverage is shown in Figure 65 and views of the structure are shown in Figure 66. Dacron braid was strung in a crisscross pattern from the top of the poles.

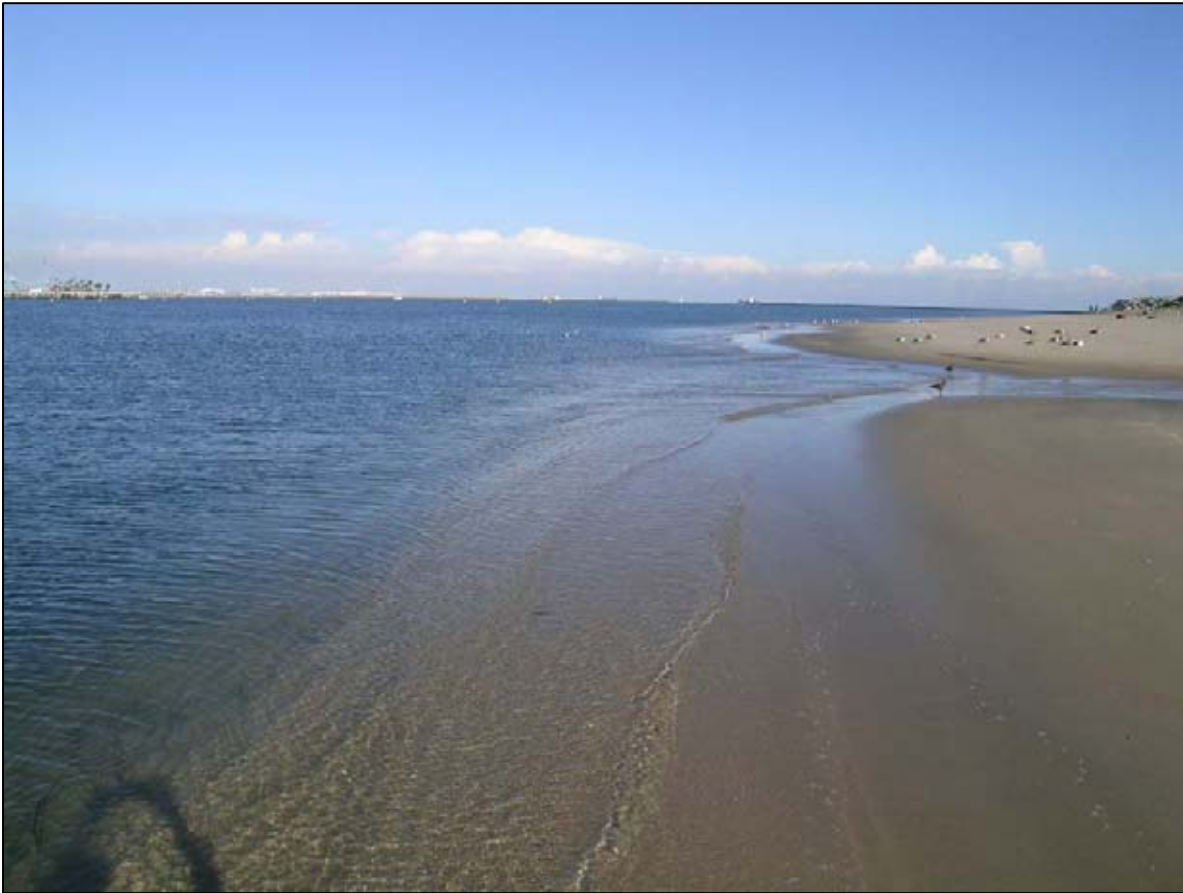
Figure 68. New Beach Accreting on Inside of Breakwater Now Being Used by Birds.

Sand transported from offshore over the breakwater by high waves, and fine sand transported across the breakwater due to wind erosion have been acting to accrete a beach along the inside of the breakwater extending from the area of the fishing pier to the main Inner Cabrillo Beach. Reputedly, this accretion has occurred during the past 10 years. This long beach (approximately 2000 feet in length) is now starting to be used by the public with access from the adjacent parking lots. It is also being used more and more by birds similar to their use of the recreational beach itself. A view of this beach from near Inner Cabrillo beach is shown in Figure 68. This beach area inside the breakwater is used by birds, particularly near the main recreational beach and near the Fishing Pier. Beach profiles along this inside beach get steeper as one goes eastward out toward the Fishing Pier.

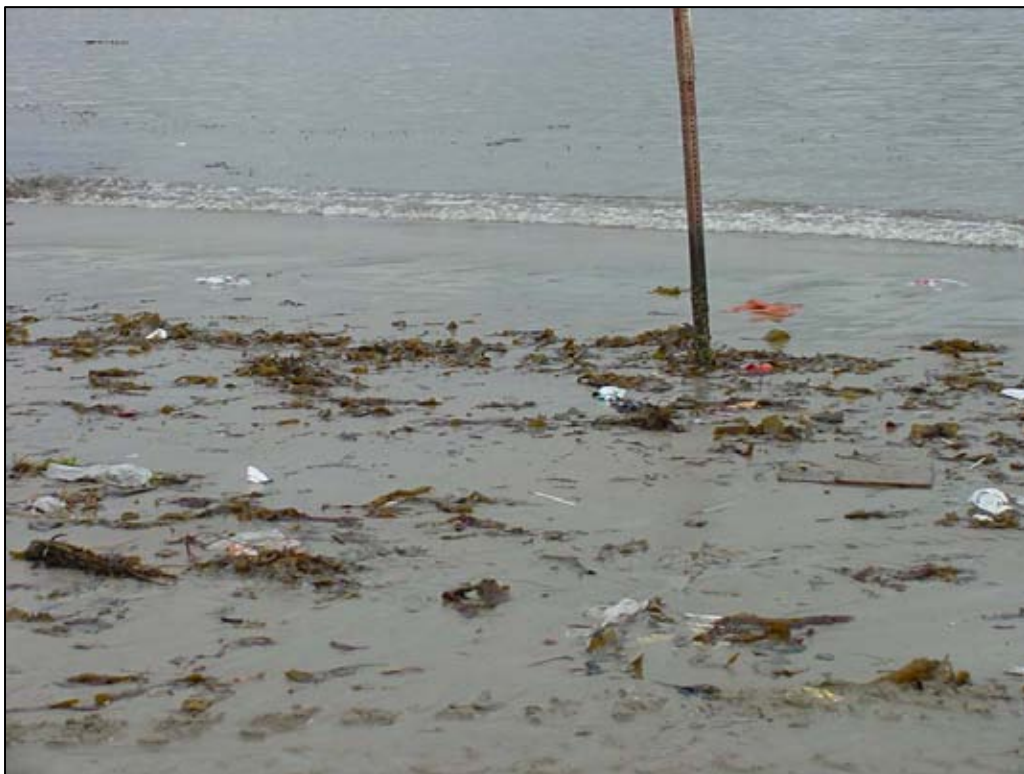
Figure 70. Trash Deposited on Inner Cabrillo Beach by Onshore Winds and Tide.

A problem specific to Cabrillo Beach is the necessity for raking of trash, debris, dead algae, eelgrass, or kelp that washes up on Inner Cabrillo Beach daily (Figures 69 and 70). Depending upon wind and tide conditions, debris from elsewhere in the Port also deposits on the beach.

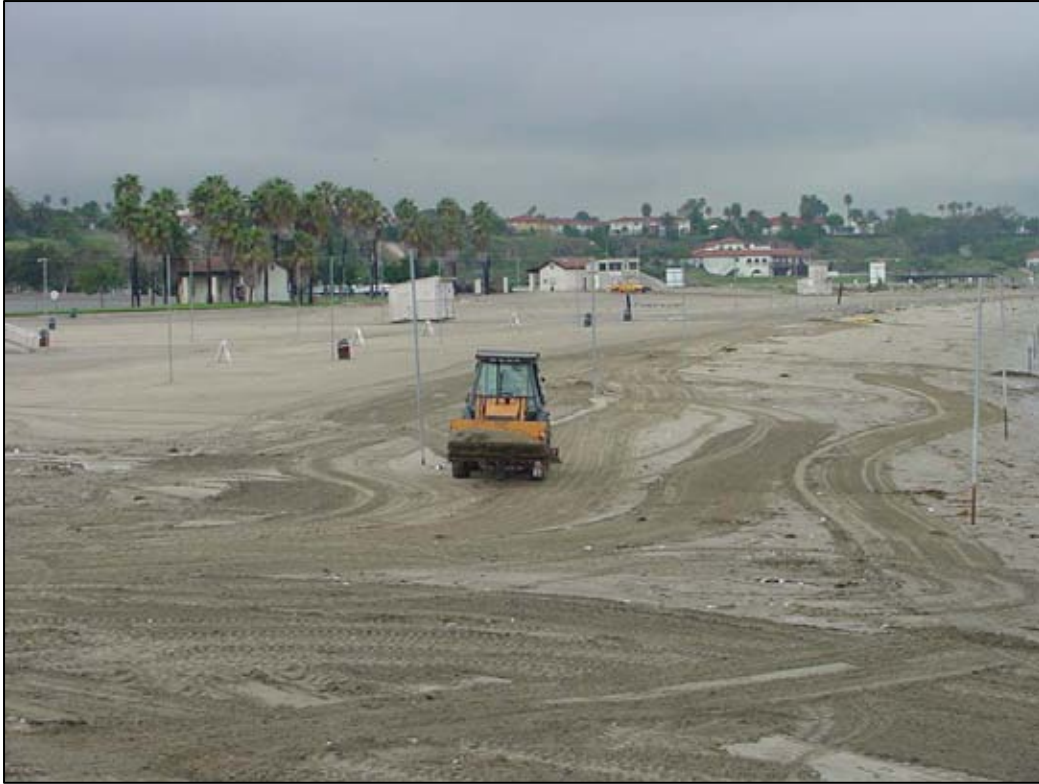
Figure 71. Front End Loader Used to Maintain the Inner Cabrillo Beach.

Sand grooming is carried out 5 days per week at Inner Cabrillo Beach by the Recreation and Parks Department. A tractor equipped with a bucket, rake and/or drag is used to clean debris from the sand and to regrade the sand (Figures 71 and 72). This is done each weekday starting about 6:30 am prior to public arrival at Cabrillo Beach. In addition, a specially designed (Herrington) sand sifter machine is available to clean debris from the beach sand (Figure 73).

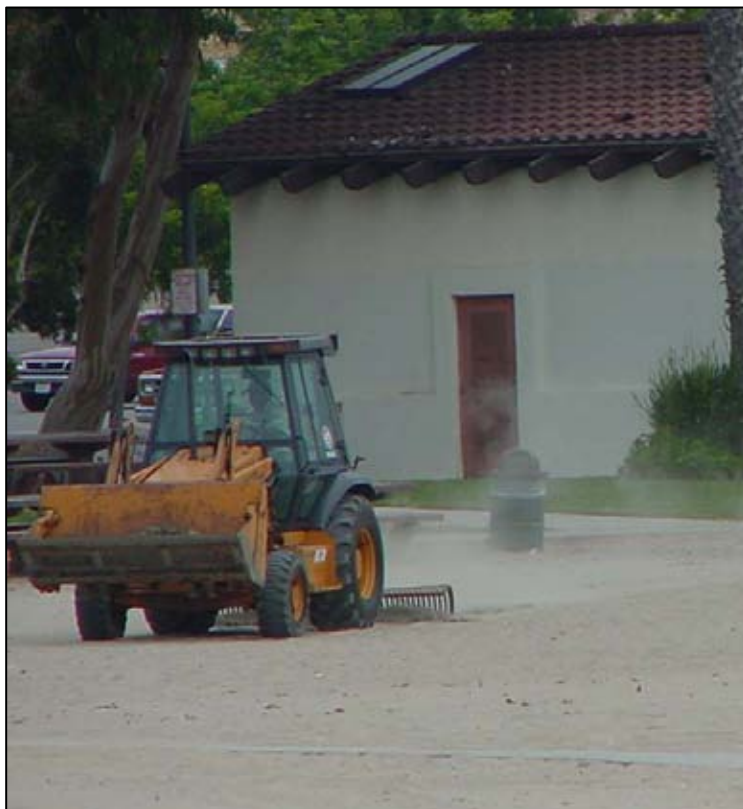
Figure 72. Rake is Used Extensively to Gather Trash and to Groom the Beach Sands.

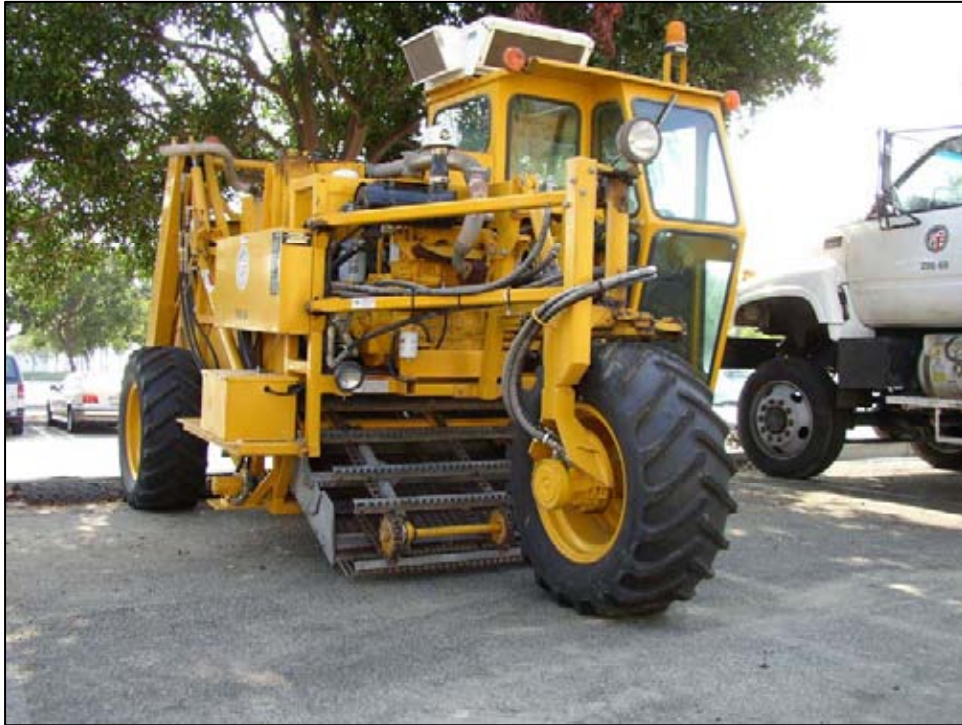
Figure 73. Herrington Beach Sand Grooming Equipment.

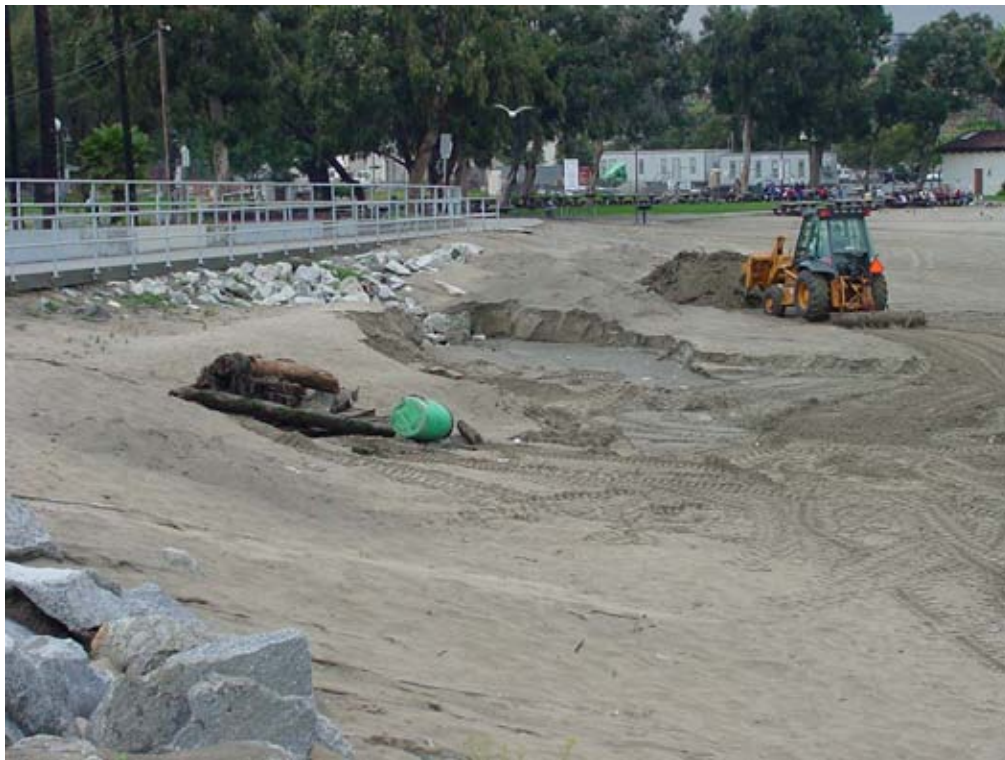
Figure 74. Clearing Sand at Inner Cabrillo Beach.

Presently, excess sand raked to the south end of the beach is removed (Figure 74) and trucked back to the northern end for redistribution, usually deposited near the Lifeguard Building at the northern end and re-spread on the upper beach. Trash and debris raked from the beach and sand are loaded into a dump truck

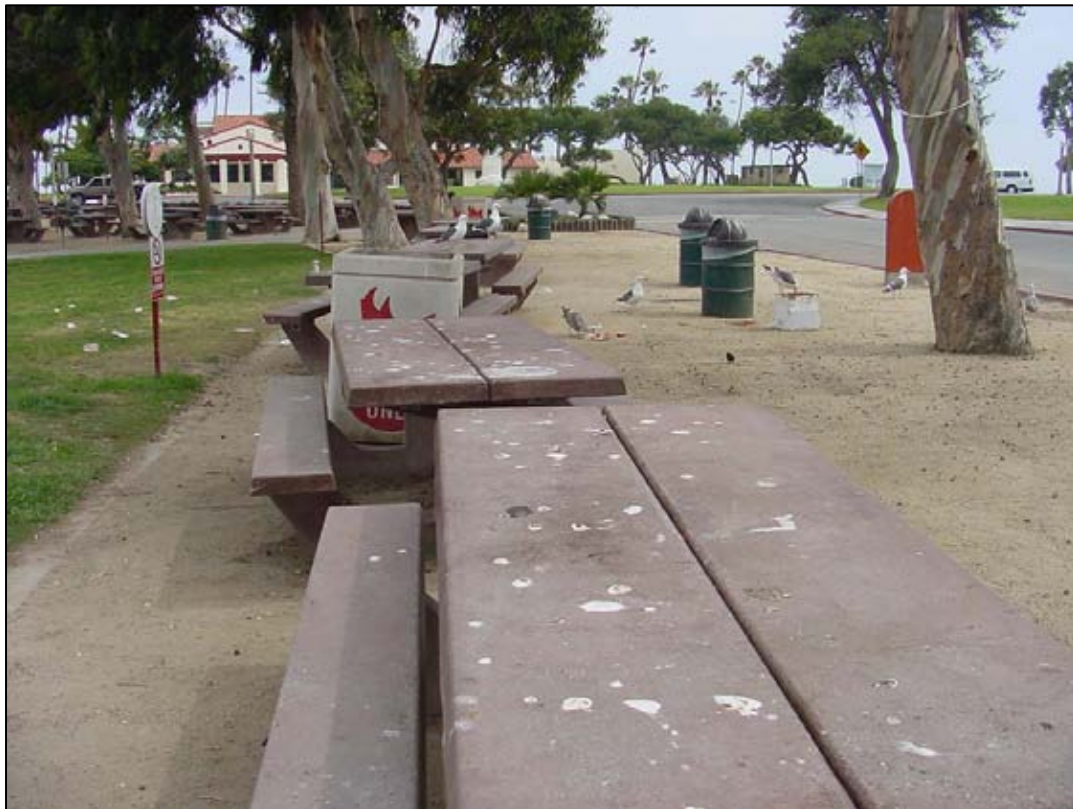
Figure 76. Fecal Contamination on Picnic Tables from Birds.
