2004 Jurisdictional Delineation Map 3

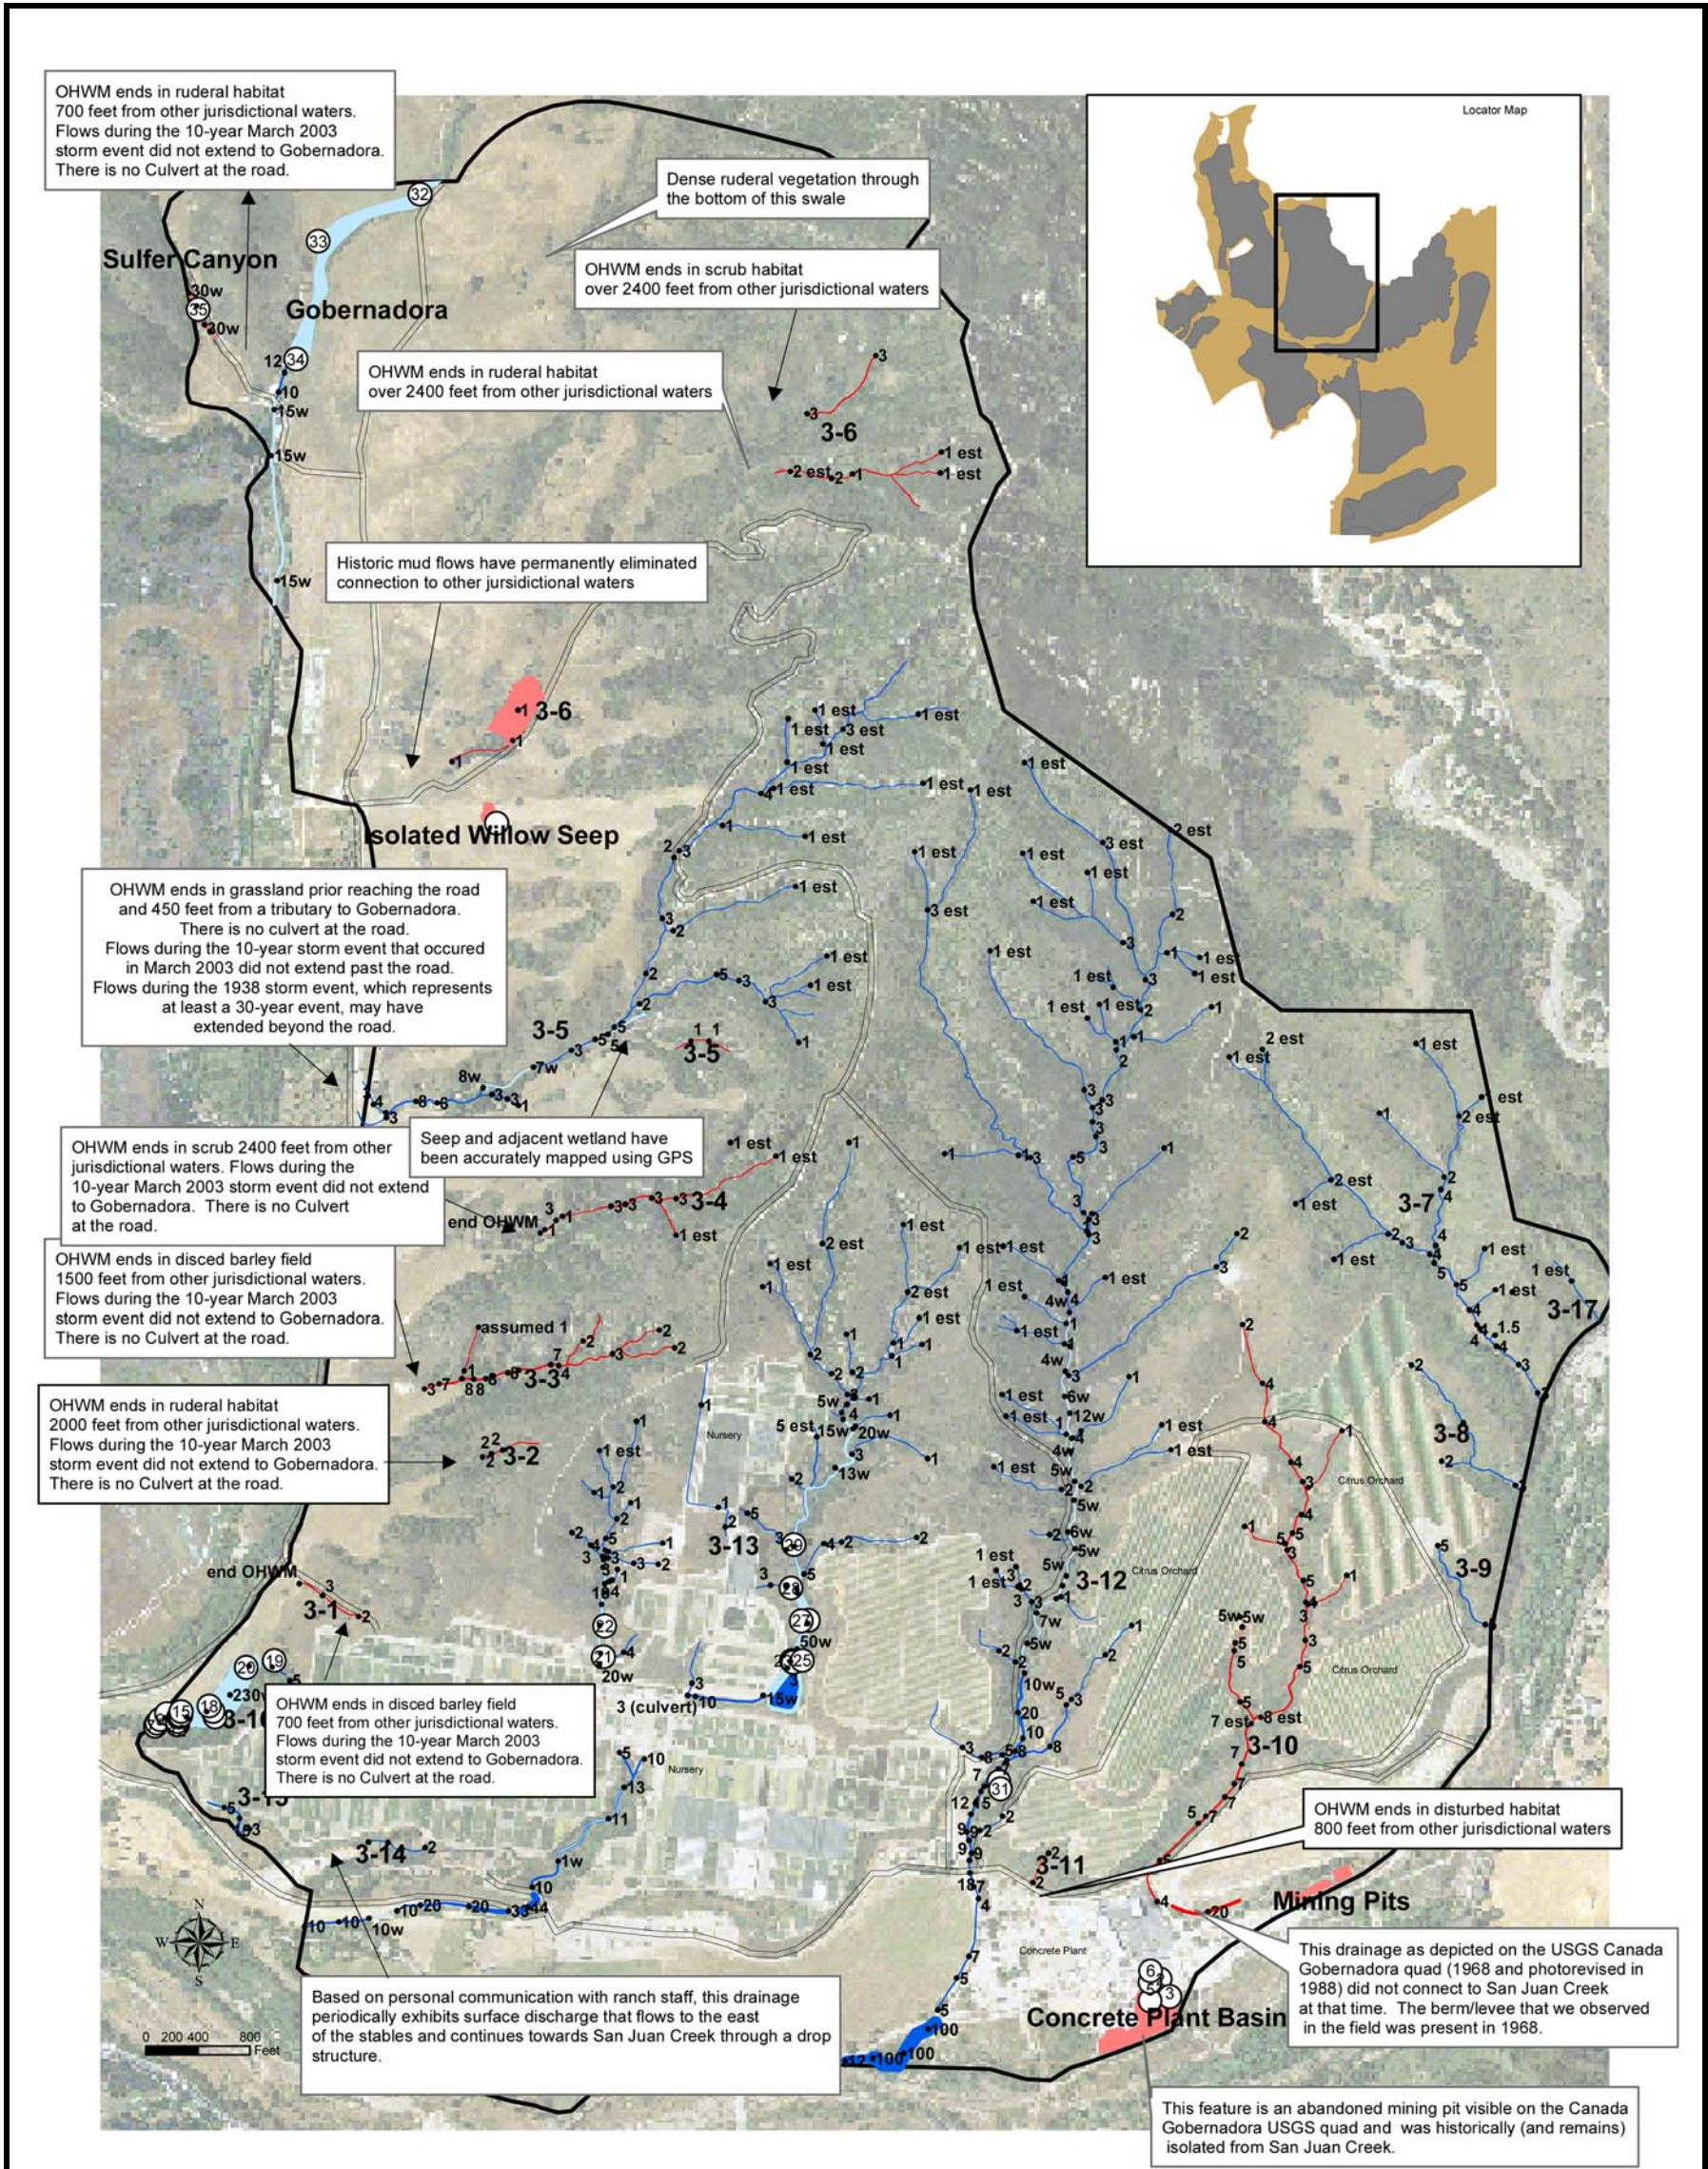
OHWM ends in ruderal habitat 700 feet from other jurisdictional waters. Flows during the 10-year March 2003 storm event did not extend to Gobernadora. There is no Culvert at the road.

Dense ruderal vegetation through the bottom of this swale

OHWM ends in scrub habitat over 2400 feet from other jurisdictional waters

OHWM ends in ruderal habitat over 2400 feet from other jurisdictional waters

Historic mud flows have permanently eliminated connection to other jurisdictional waters

OHWM ends in grassland prior reaching the road and 450 feet from a tributary to Gobernadora. There is no culvert at the road. Flows during the 10-year storm event that occurred in March 2003 did not extend past the road. Flows during the 1938 storm event, which represents at least a 30-year event, may have extended beyond the road.

OHWM ends in scrub 2400 feet from other jurisdictional waters. Flows during the 10-year March 2003 storm event did not extend to Gobernadora. There is no Culvert at the road.

Seep and adjacent wetland have been accurately mapped using GPS

OHWM ends in disced barley field 1500 feet from other jurisdictional waters. Flows during the 10-year March 2003 storm event did not extend to Gobernadora. There is no Culvert at the road.

OHWM ends in ruderal habitat 2000 feet from other jurisdictional waters. Flows during the 10-year March 2003 storm event did not extend to Gobernadora. There is no Culvert at the road.

OHWM ends in disced barley field 700 feet from other jurisdictional waters. Flows during the 10-year March 2003 storm event did not extend to Gobernadora. There is no Culvert at the road.

OHWM ends in disturbed habitat 800 feet from other jurisdictional waters

This drainage as depicted on the USGS Canada Gobernadora quad (1968 and photorevised in 1988) did not connect to San Juan Creek at that time. The berm/levee that we observed in the field was present in 1968.

Based on personal communication with ranch staff, this drainage periodically exhibits surface discharge that flows to the east of the stables and continues towards San Juan Creek through a drop structure.

This feature is an abandoned mining pit visible on the Canada Gobernadora USGS quad and was historically (and remains) isolated from San Juan Creek.
