### Public Employees for Environmental Responsibility

# Also, below is a Notice of Violation filed by the Lahontan Regional Water Board to the Tahoe Basin for the Angora Hazard Tree Removal project:

IN THE MATTER OF VIOLATION OF LAHONTAN )
WATER RESOURCES CONTROL BOARD )
RESOLUTION R6T-2007-008, WAIVER OF WASTE )
DISCHARGE REQUIREMENTS FOR DISCHARGES )
RELATED TO TIMBER HARVEST AND ) NOTICE OF VEGETATION MANAGEMENT ACTIVITIES ISSUED )
TO THE US FOREST SERVICE – LTBMU AND )
THE WATER QUALITY CONTROL )
PLAN FOR THE LAHONTAN REGION )
EL DORADO COUNTY, WDID NO. 6AT50908027 )

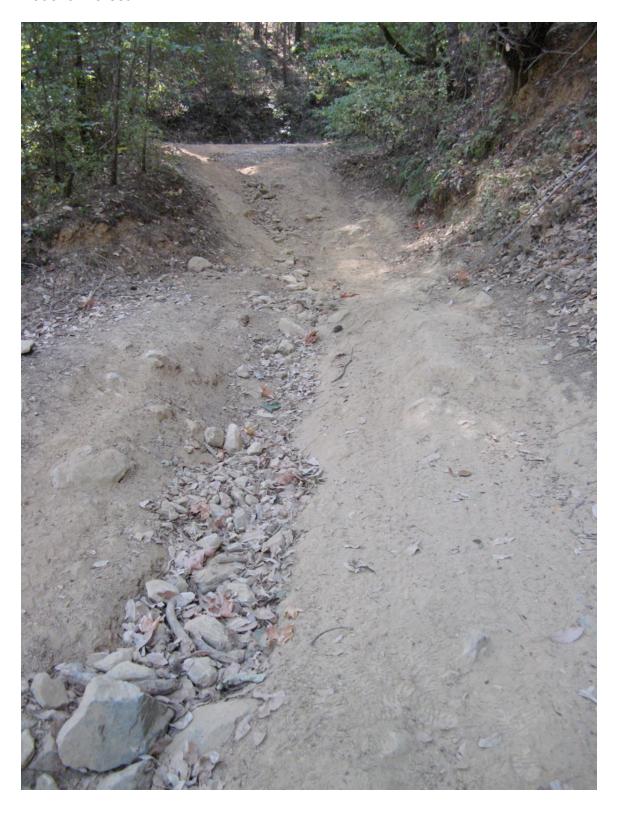
The photos below show a designated OHV crossing, designated by the Eldorado National Forest.

## Approach to Rock Creek Crossing, Eldorado NF

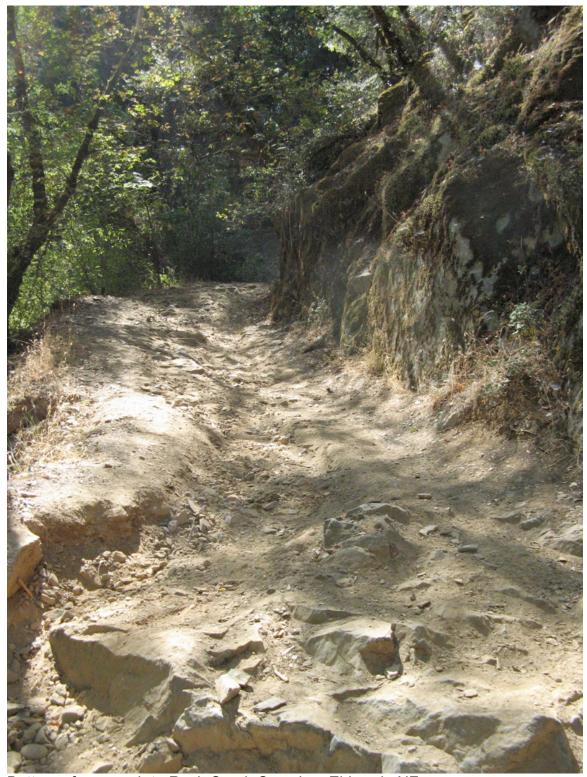
Bottom of approach to Rock Creek Crossing, Eldorado NF

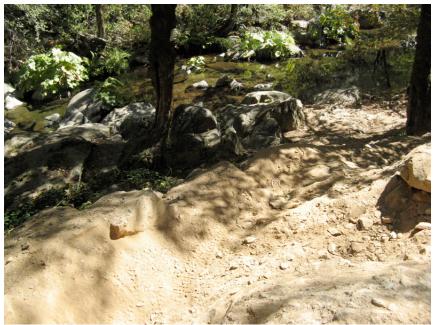
Bottom of approach to Rock Creek Crossing, Eldorado NF

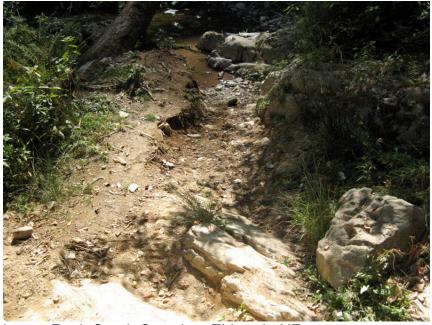
Lower Rock Creek Crossing, Eldorado NF

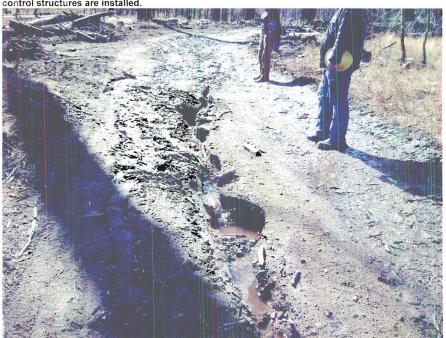
Refer to enclosed photos 1-4, showing lack of erosion control measures on Project sites on October 13, 2009. An inspection by staff members of the Water Board and the Tahoe Regional Planning Agency on October 15, 2009, revealed that the site was not winterized at that time, in violation of the Basin Plan.

Photo 2: Forest Road 17E49, north of Seneca Pond in Unit 5 on October 15, 2009. No erosion control structures are installed.

- 1. <u>Immediately</u> cease any and all new soil disturbance activities. You are only authorized to **stabilize** areas already disturbed by Project activities.
- To completely stabilize all disturbed soils on Project sites by <u>October 23</u>, <u>2009</u>, including decommissioning roads, trails, and removing temporary crossings as described in the Decision Memo and project documents which may amend the Decision Memo.
- Decommission the former primary access road at the Seneca Drive entrance to Unit 5 by October 23, 2009.
- Submit a report to the Lahontan Water Board by <u>October 30, 2009</u>, which
  describes and documents the completion of site stabilization activities per
  identified project area. Documentation must include photo documentation.

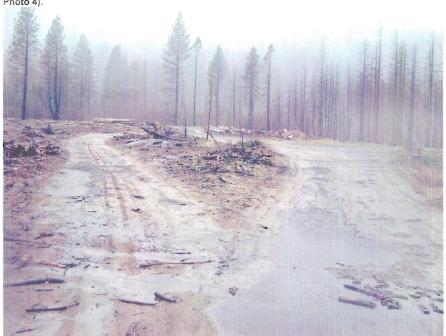
Additional detail regarding BMPs for erosion control is contained in the Decision Memo Appendix B. BMP 1-16 states that "all landings will be ditched and outsloped for proper drainage . . . ." BMP 1-17 states that "drainage dips will be installed on haul routes and main skid trails at an average spacing of 150 linear ft." Refer to photos 1-7 in Appendix A, showing lack of erosion control structures in the Project area.

Photo 3: Landing near Seneca Pond in Unit 5 on October 13,2009. Note lack of erosion control structures. Stormwater was running from landing, down road to discharge into Angora Creek (see Photo 4).

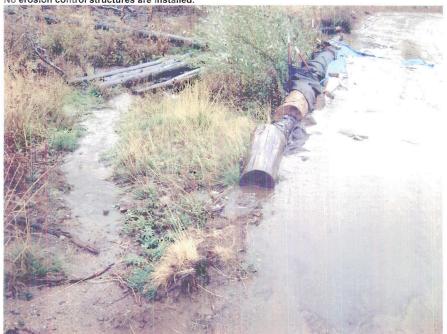
Inspections conducted on October 13 and 14 revealed sediment discharges into Angora Creek and its tributaries from roads and landings in the Project area due to lack of erosion control structures. Refer to photos 4-6 showing sediment-laden stormwater discharging into Angora Creek from a road in the Project area. No waterbars or other stormwater control measures were installed to prevent the discharge.

Photo 5: Sediment-laden stormwater discharging from road and crossing 11 into Angora Creek. No erosion control structures are installed.

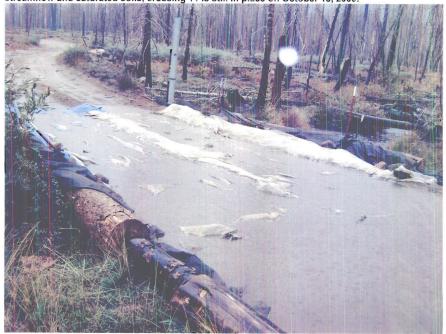
Refer to Photo 7, taken on October 15, 2009, showing the crossing 11 on Angora Creek in place. An email received on October 13, 2009 from LTBMU staff states that "Crossing 11 is still in as there are still logs in the Seneca Pond landing that still need to be chipped."

Photo 7: Crossing 11 on Angora Creek still in place on October 13, 2009. Due to increased streamflow and saturated soils, crossing 11 is still in place on October 15, 2009.
