Lake Elsinore and Canyon Lake Watersheds Nutrient TMDL Monitoring 2016-2017 Annual Report

Prepared for:

Lake Elsinore & San Jacinto Watersheds Project Authority
11615 Sterling Avenue
Riverside, California 92503

October 11, 2017

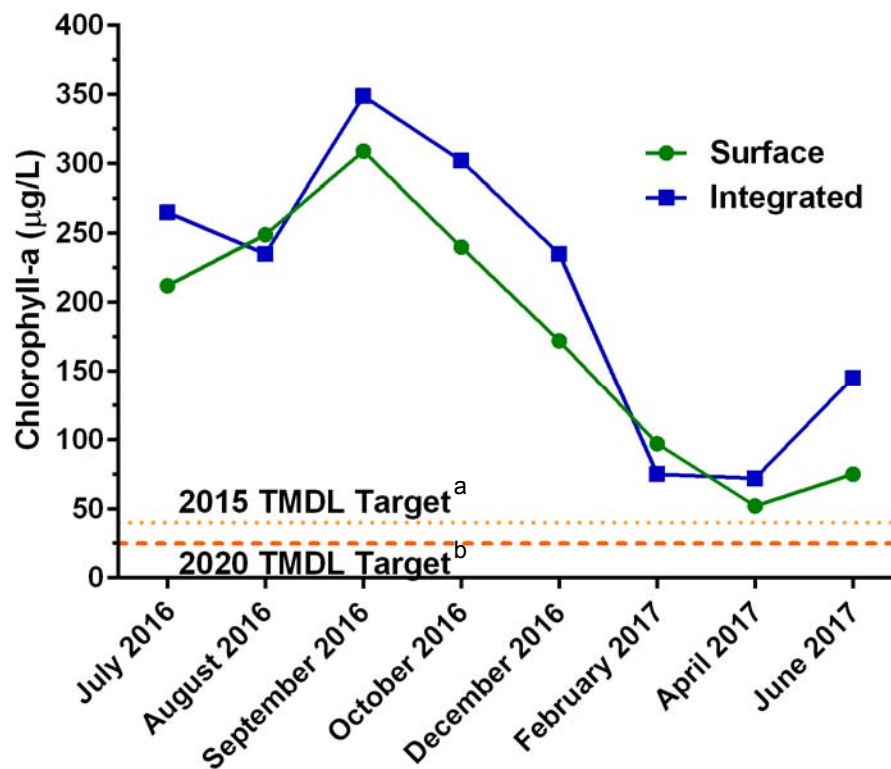
^aSummer average no greater than 40 µg/L no later than 2015

^bSummer average no greater than 25 µg/L no later than 2020

All chlorophyll-a values observed exceeded the 2015 TMDL target concentration of 40 µg/L. The highest depth-integrated chlorophyll-a concentration was observed in September 2016 at 349 µg/L, and subsequently exhibited a decrease with each monitoring event through April 2017 to 72 µg/L. The June 2017 monitoring event saw an increase back up to 145 µg/L.

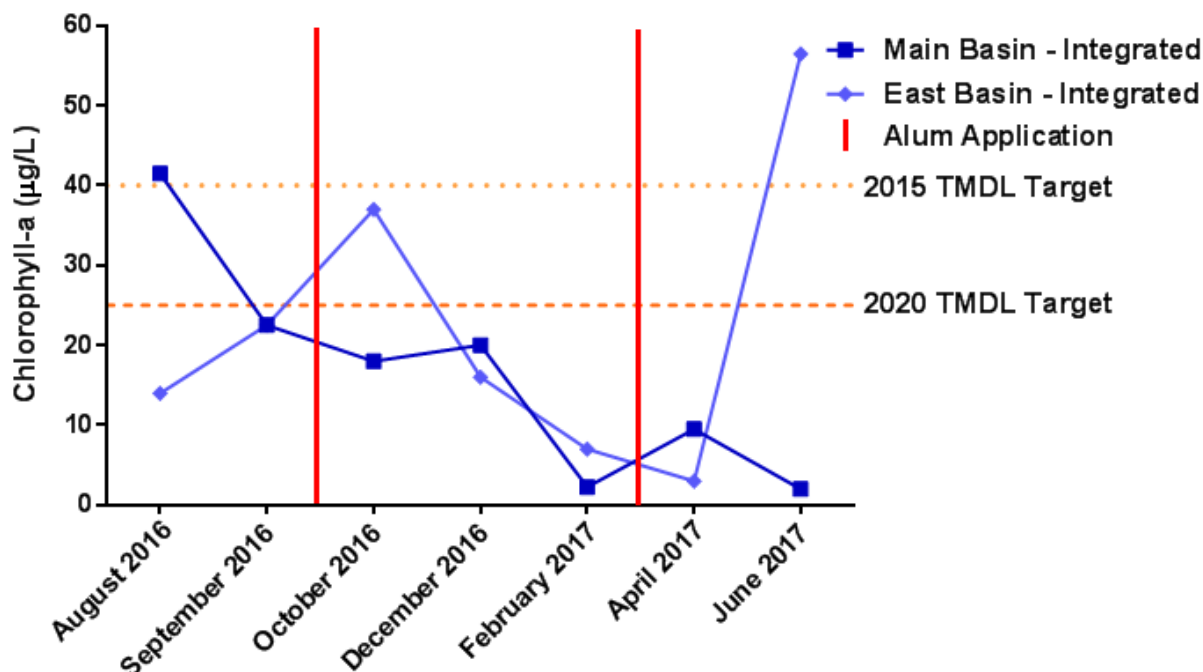
^aAnnual average no greater than 40 µg/L no later than 2015

^bAnnual average no greater than 25 µg/L no later than 2020

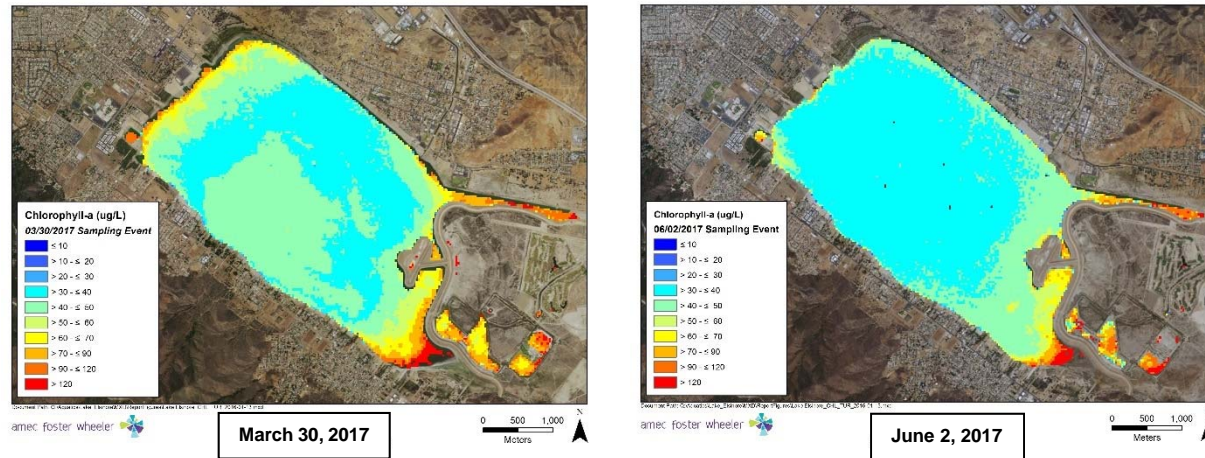
Figure 3-12. Satellite Imagery of Chlorophyll-a Concentrations in Lake Elsinore

(data gaps in August, September, and December are due to large surface cyanobacterial slicks)

the report are presented in Figures 3-12 through 3-15. Significant spatial variability in chlorophyll-a is evident across each lake providing a more complete assessment of algal density conditions across each lake.
