Draft Trash Assessment Methodology

California Department of Transportation

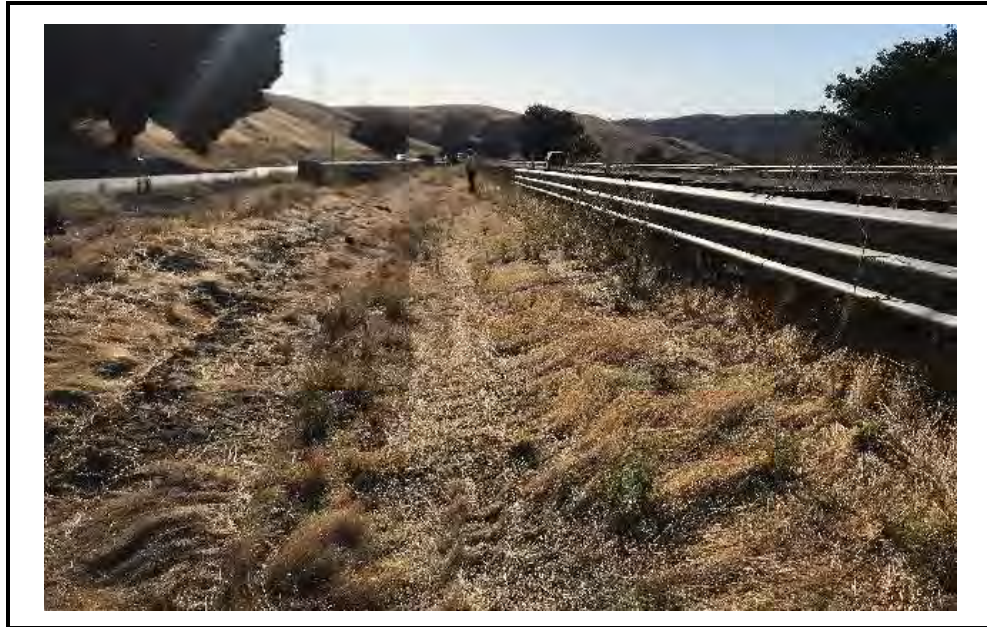
PHOTO A: VEGATED STRIP AND SWALE – DOWNSTREAM (SOUTHEAST)

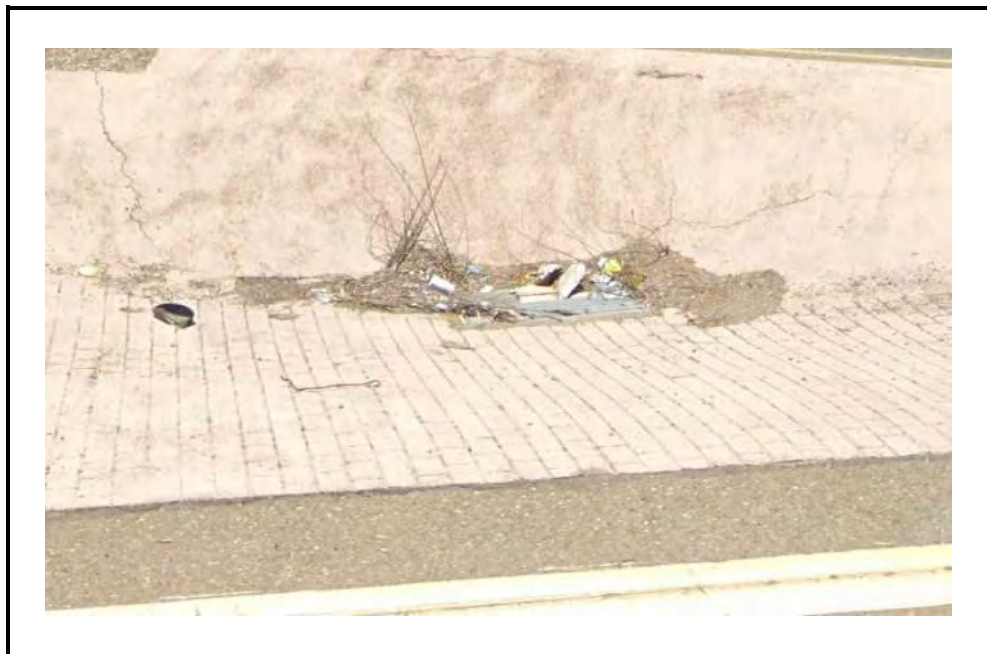
PHOTO A: CAPTURE DEVICE LOCATION (DROP INLET)

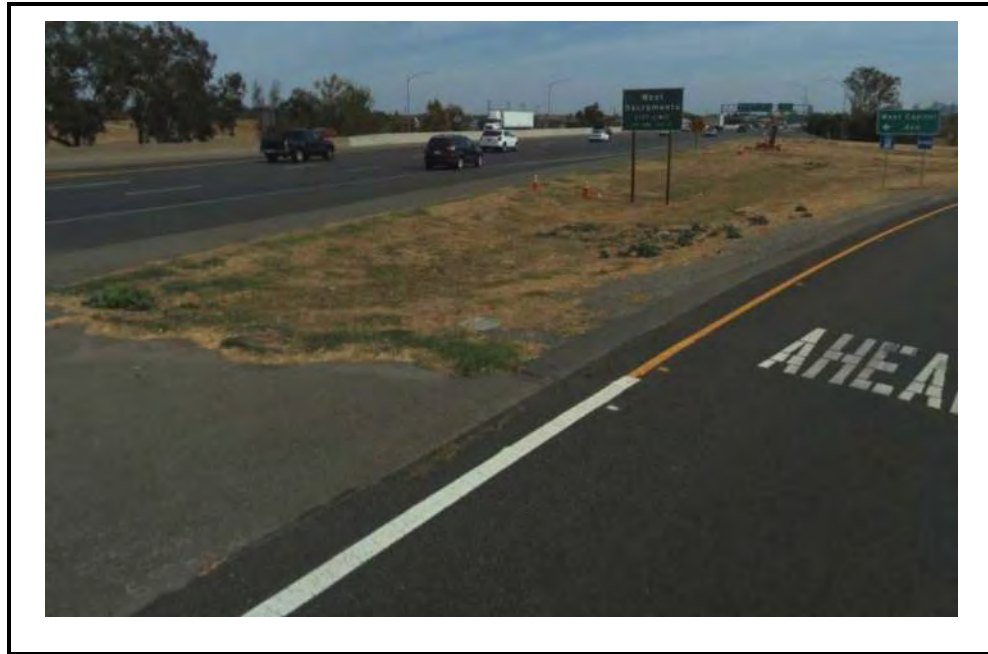
**PHOTO B: CAPTURE DEVICE LOCATION
TRASH AND DEBRIS OBSERVED AT GRATE**

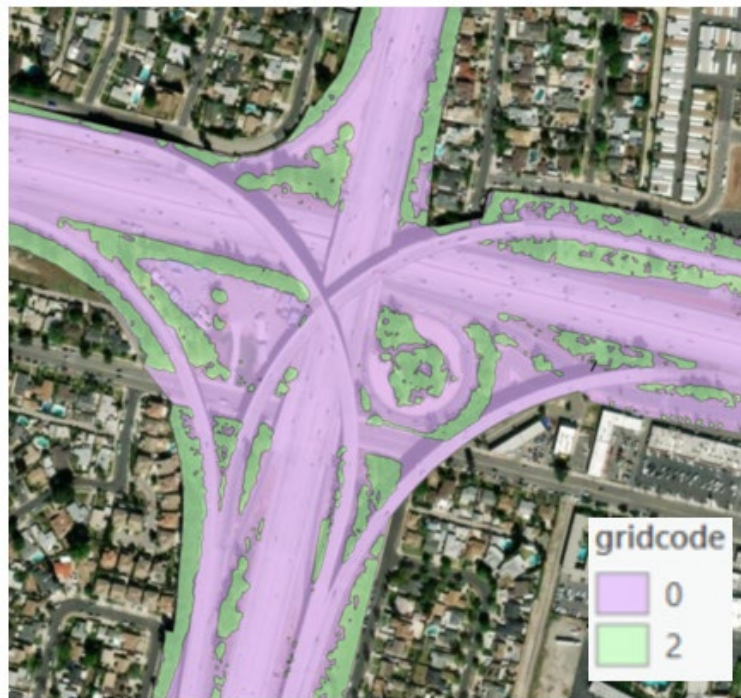
Figure 1: Final Landcover Classification Polygons (gridcode 0 = non-vegetated, gridcode 2 = vegetated)

Using the trained model, each pixel of the NAIP images received one of the three classifications. Then, post processing methods were used to denoise the classifications and to impute the shadow areas with a vegetated or non-vegetated label. Additionally, iterative focal majority filters were used to remove large, shadowed areas. Any remaining shadow pixels were removed using ESRI's "nibble" tool, which replaced shadow pixels with values of their nearest neighbors (vegetated or non-vegetated). Results were then converted from raster to polygon format. Due to the pixelated nature of the raster products, ESRI's "Simplify Polygon" tool was used to remove relatively extraneous vertices while preserving the essential shape. A sample of the final polygons are presented below. A summary of the entire classification workflow is also provided.
