DEPARTMENT OF FORESTRY AND FIRE PROTECTION

February 11, 2004

Subject: DRAFT Water Quality Control Policy for Developing California's Clean Water Act Section 303(d) List

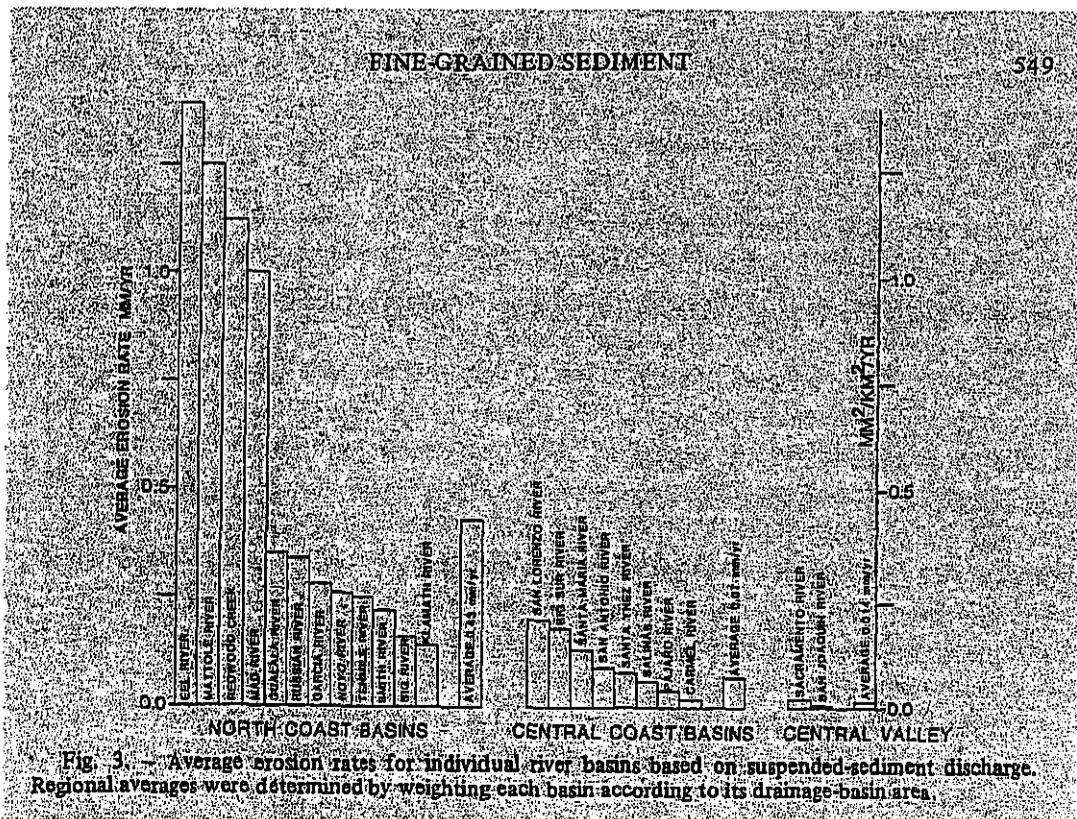
Figure 1. Average erosion rates for selected northern coastal California Rivers (from Griggs and Hein, 1980)

Note: 1 mm/v = about 5000 tons/sq mi/vr, depending on density

Other regional-scale studies of suspended sediment done for many of the major rivers on the California North Coast suggest natural sediment yields range from approximately 300 to greater than 7000 tons/sq mi/yr (de la Fuente and Haessig, 1993; Hawley and Jones, 1969; Janda and Nolan, 1979; Griggs and Hein, 1980). As mentioned previously, this wide range is largely due to the regional variations in percentage of geologic materials making up each watershed, the strength of these geologic materials, the hydrology (rainfall, infiltration, depth of soil), the topographic relief and slope aspect, the vegetation density and type, and the rates of regional tectonic uplift. Table 3 shows suspended sediment yields taken from the above literature for six of the seven watersheds included in the July 2002 EPA analysis. Note that these suspended sediment yields include both natural and anthropogenic sources. However, even applying the average natural sediment yield ratio of 43% used in the EPA analysis, natural rates based on the suspended yield rates listed in Table 3 are approximately double those used in the July 2002 EPA analysis. These values do not include bedload which studies of north coast California rivers have found to range from 4 to 30 percent of suspended sediment loads (Hawley and Jones, 1969; Janda and Nolan, 1979). In addition, Figure 1 shows a comparison of estimates of average erosion rates for a number of other California North Coast watersheds based on off-shore sedimentation studies (Griggs and Hein, 1980). Note an average erosion rate of 1 mm/yr is approximately equal to 5000 tons/sq mi/yr of sediment, depending

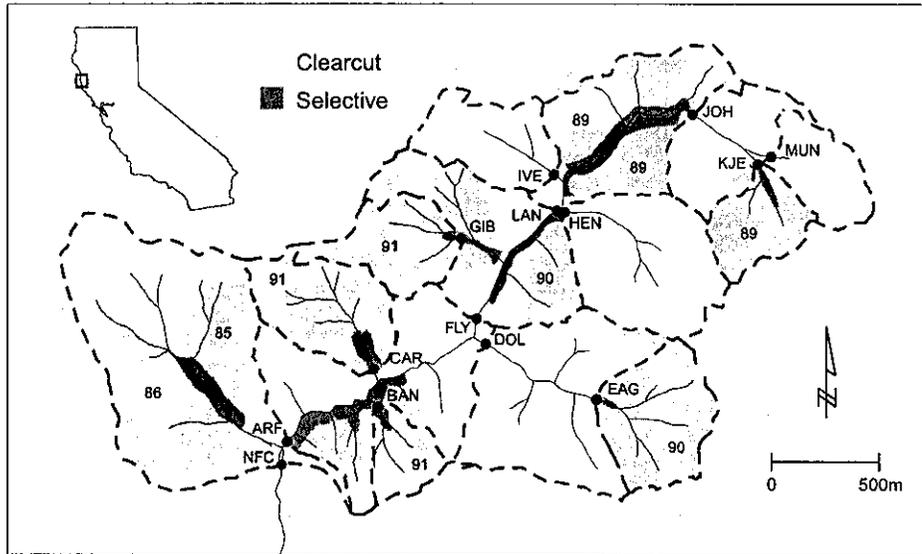
Figure 1. North Fork Caspar Creek. Gaging stations are identified by 3-letter abbreviations and dots, subwatershed boundaries by dashed lines, and logged areas by shading. Inset locates Caspar Creek within California.

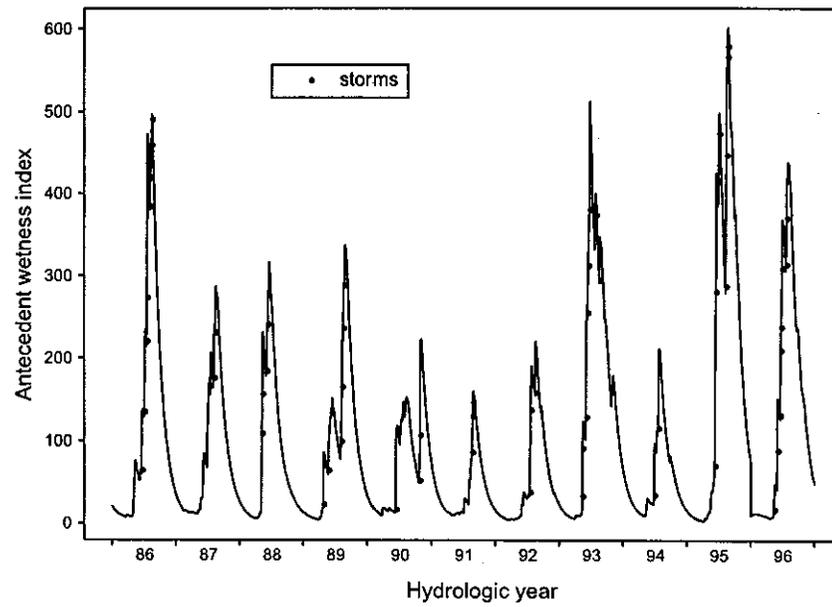
Figure 2. Antecedent wetness index (equation (2)) and temporal distribution of storms for the period of study (1986-1996). Solid circles indicate the wetness level at the start of each storm.

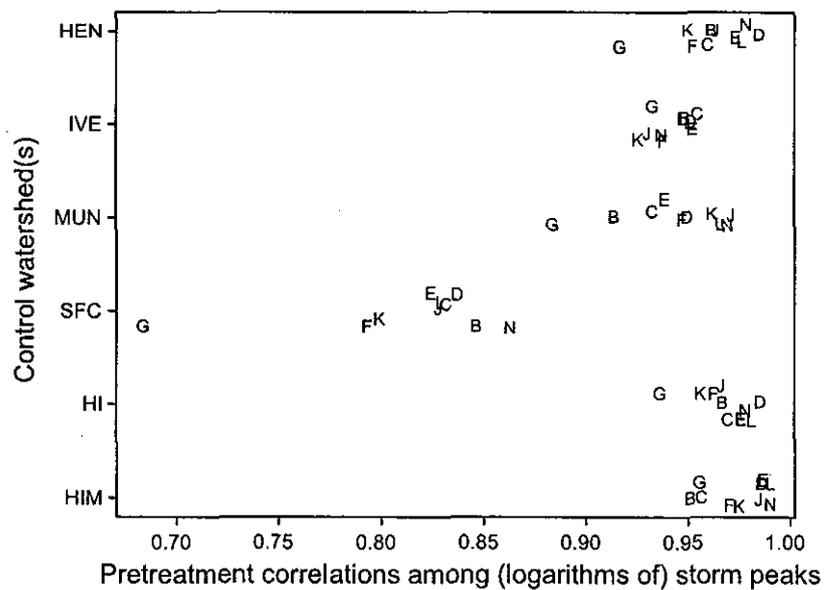
Figure 3. Pretreatment correlations between logarithms of storm peak at treated watersheds and alternative control watersheds. Letters designate watersheds (e.g. G is watershed GIB). Random noise has been added to the vertical plotting positions to improve readability.

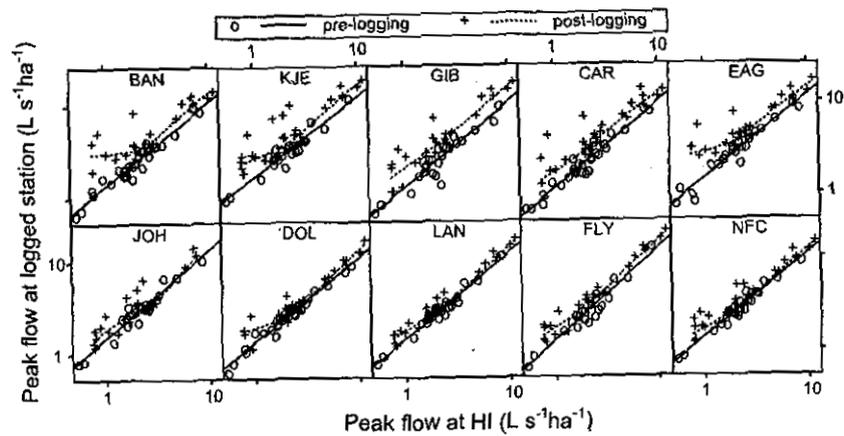
Figure 4. Relation between peak streamflow in the 10 treated tributaries in the North Fork of Caspar Creek, and that of the HI control. Post-logging relations were fitted by locally weighted regression [Cleveland, 1979]. The top row represents 95-100% clear-cut watersheds.

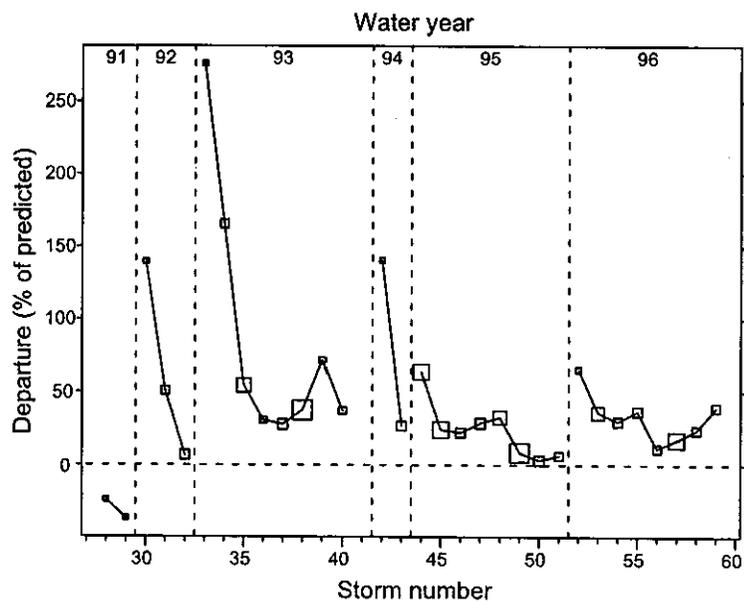
Figure 5. Post-logging departures of storm peaks (as percentage of predicted) at watershed EAG from those predicted from pretreatment regression on HI control. Axes are logarithmic. Symbol sizes indicate relative size of storm peak at HI control. Vertical dotted lines separate water years. About half the watershed was winter-logged before storm 28 and logging was completed by storm 30.

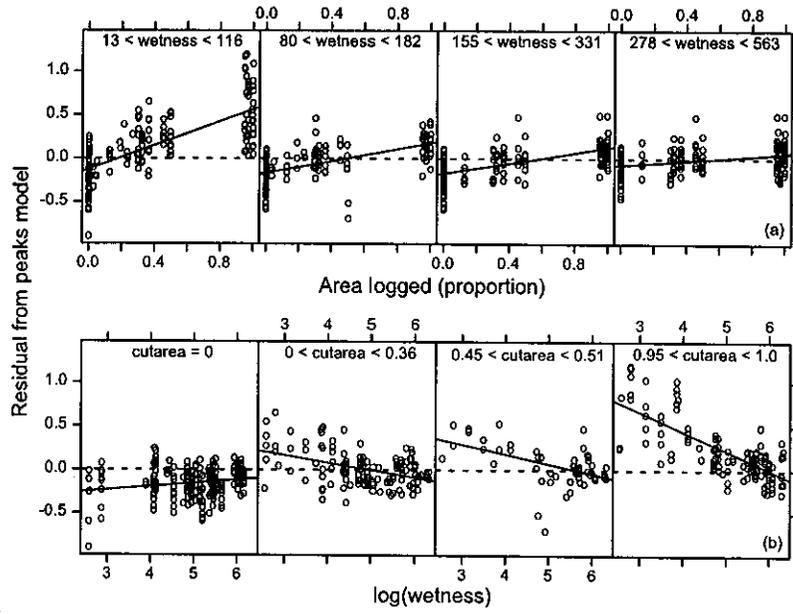
Figure 6. Conditioning plots of residual from storm peaks model (3) and interaction between area logged and antecedent wetness index with (a) wetness index fixed in each frame, and (b) proportion of area logged fixed in each frame.

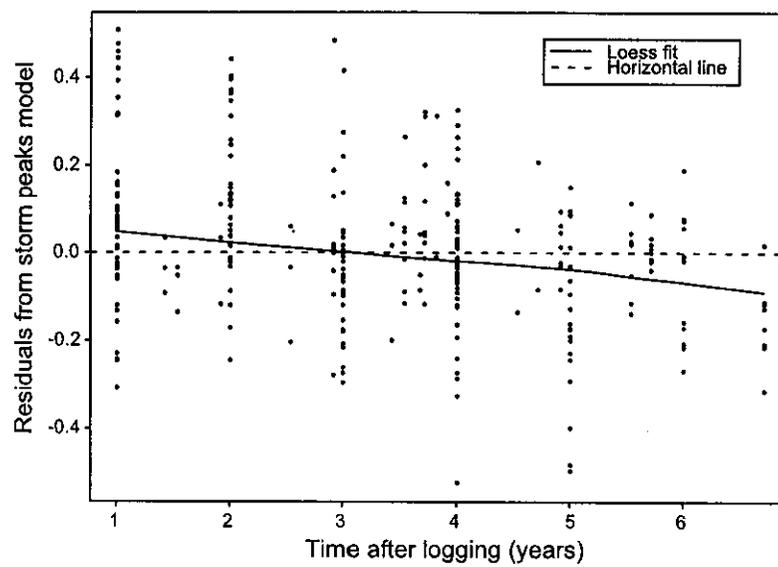
Figure 7. Relation between storm peak residuals and time after logging. Curve is fit by loess method [Cleveland, 1979]. Residuals are from least squares fit to the model

$$\log(y_{ij}) = \beta_0 + \beta_1 \log(x_{ij}) + \beta_4 D_{ij} + \beta_6 D_{ij} \log(w_j) + \epsilon_{ij}.$$

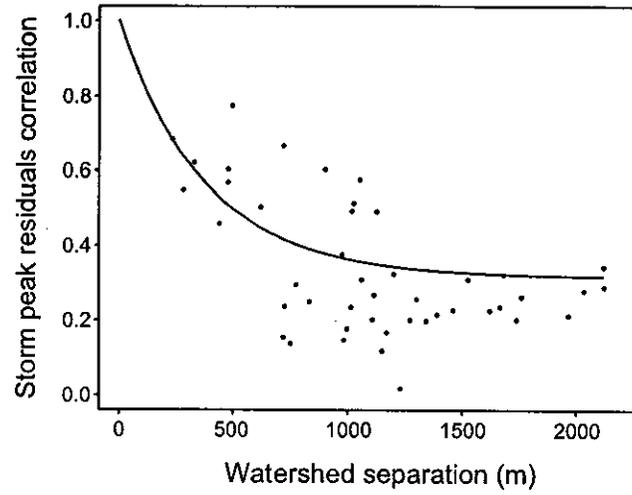
Figure 8. Relation between storm peak residuals correlation and distance between watershed centroids. Residuals are from maximum likelihood fit to storm peak model $\{(10),(16),(18)\}$. Curve depicts equation (16), with estimated parameters $\hat{\theta}_1$ and $\hat{\theta}_2$.

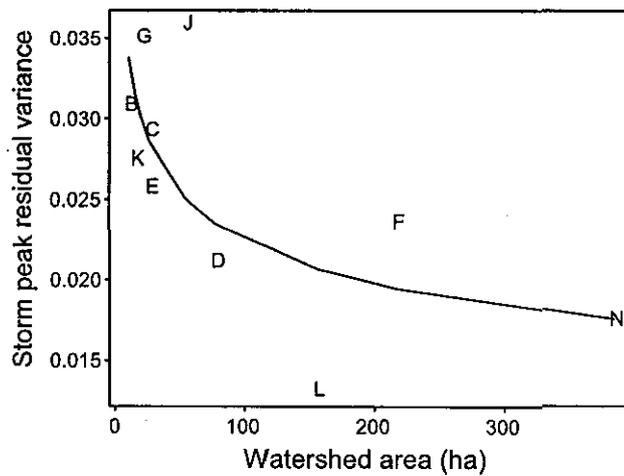
Figure 9. Relation between variance of storm peak residuals and watershed area. Residuals are from maximum likelihood fit to storm peak model $\{(10),(16),(18)\}$. Curve depicts equation (18) with estimated parameters $\hat{\theta}_3$ and $\hat{\theta}_4$. Letters designate watersheds (e.g. G is watershed GIB).

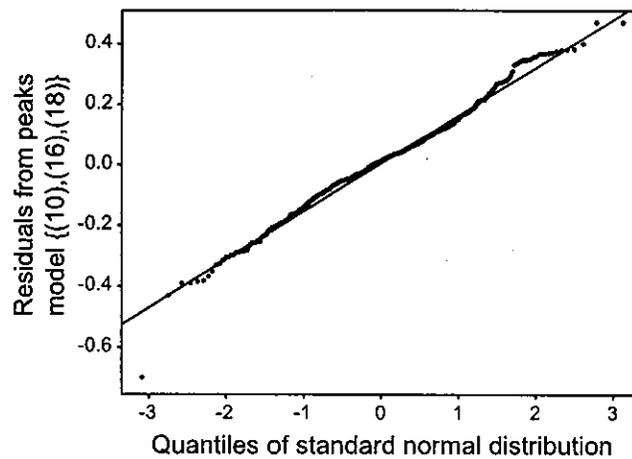
Figure 10. Normal quantile plot of residuals from storm peak model $\{(10),(16),(18)\}$. Line is least squares fit.

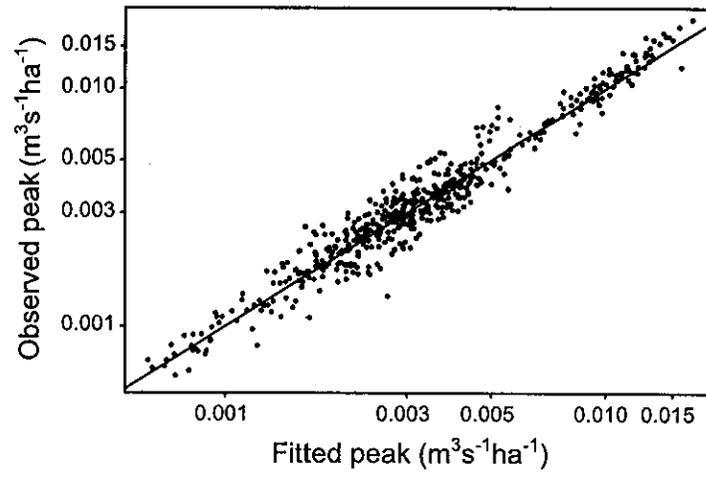
Figure 11. Observed storm peaks versus fitted values from model {(10),(16),(18)}.
Line is $y = x$.

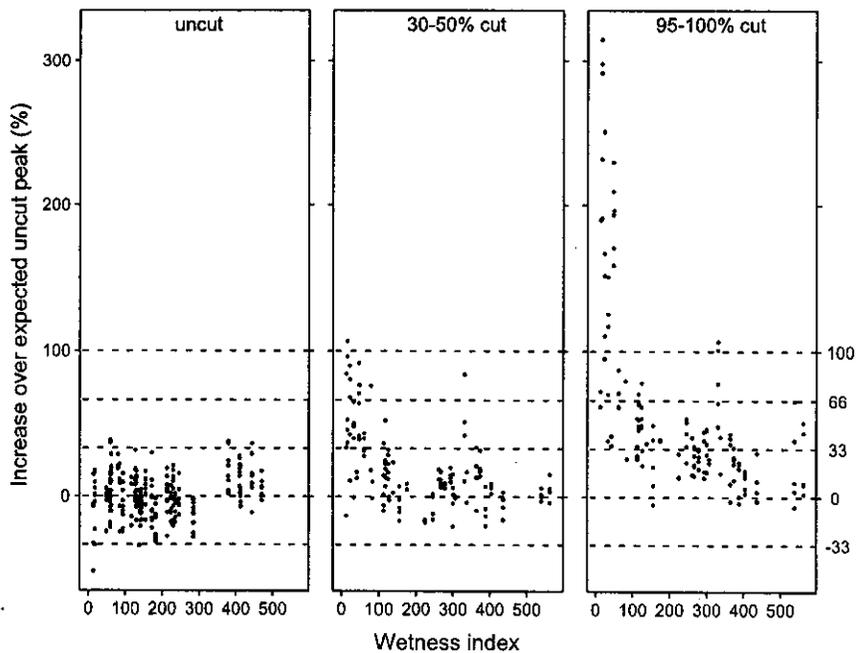
Figure 12. Percentage increase over expected uncut storm peak as related to antecedent wetness index for uncut (before treatment), partly (30-50%) clear-cut, and (95-100%) clear-cut watersheds. Bias-corrected predictions are from model $\{(10),(16),(18)\}$ with disturbance set to zero.

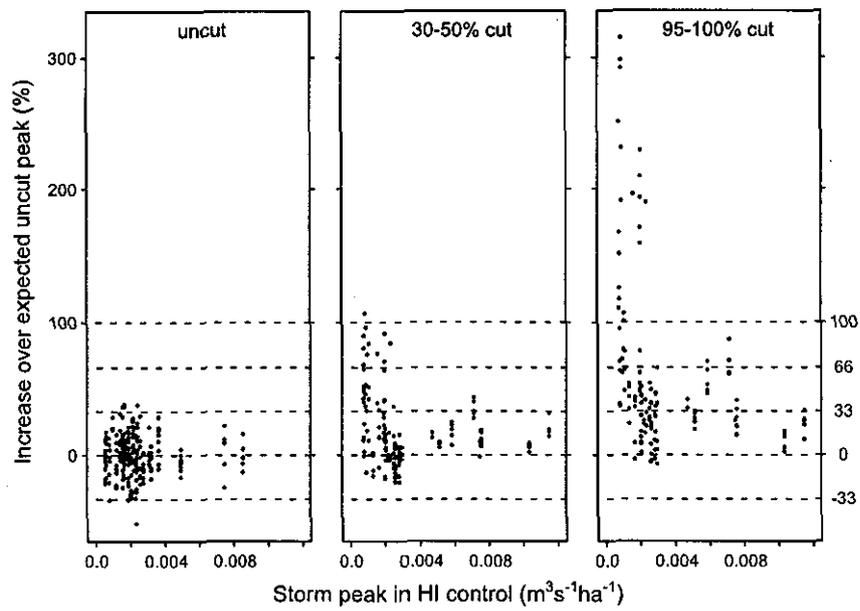
Figure 13. Percentage increase over expected uncut storm peak as related to peak size in the HI control for uncut (before treatment), partly (30-50%) clear-cut, and (95-100%) clear-cut watersheds. Bias-corrected predictions are from model $\{(10),(16),(18)\}$ with disturbance set to zero.

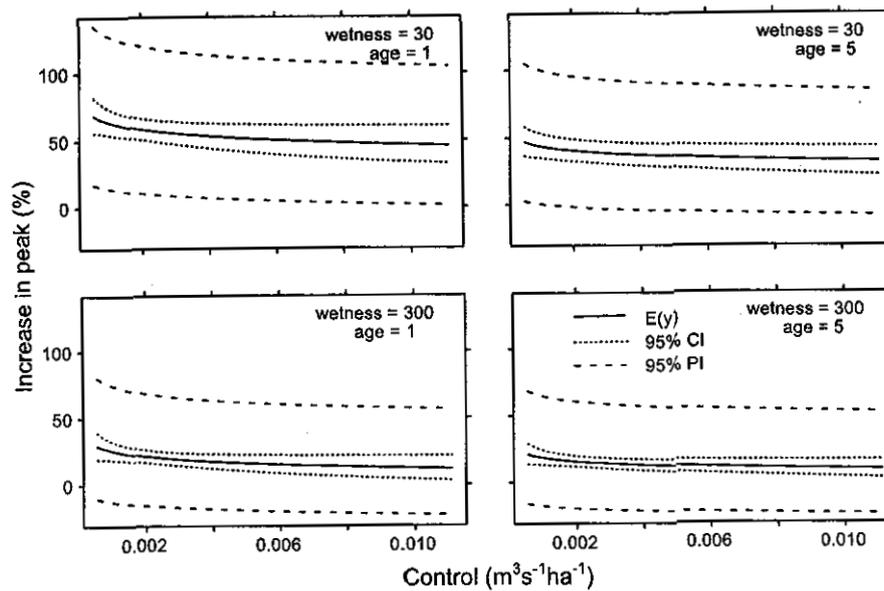
Figure 14. The effect of wetness and age after cutting on predictions from storm peak model $\{(10), (16), (18)\}$ after clear-cutting 50% of a 20 ha watershed. Expected increases and 95% confidence (CI) and prediction (PI) intervals are shown for two levels of antecedent wetness 1 and 5 years after cutting.

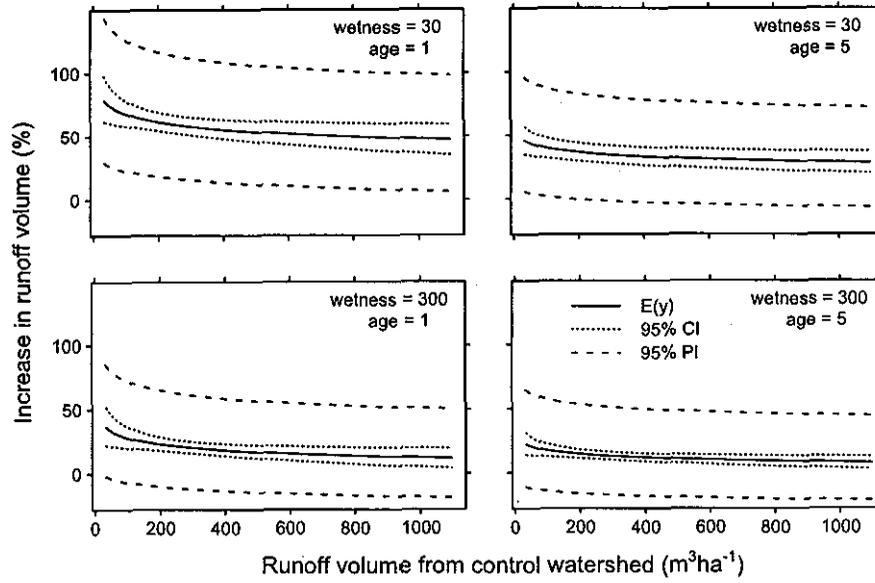
Figure 15. The effect of wetness and age after cutting on predictions from storm runoff volume model $\{(10),(17),(18)\}$, after clear-cutting 50% of a 20 ha watershed. Expected increases and 95% confidence (CI) and prediction (PI) intervals are shown for two levels of antecedent wetness 1 and 5 years after cutting.

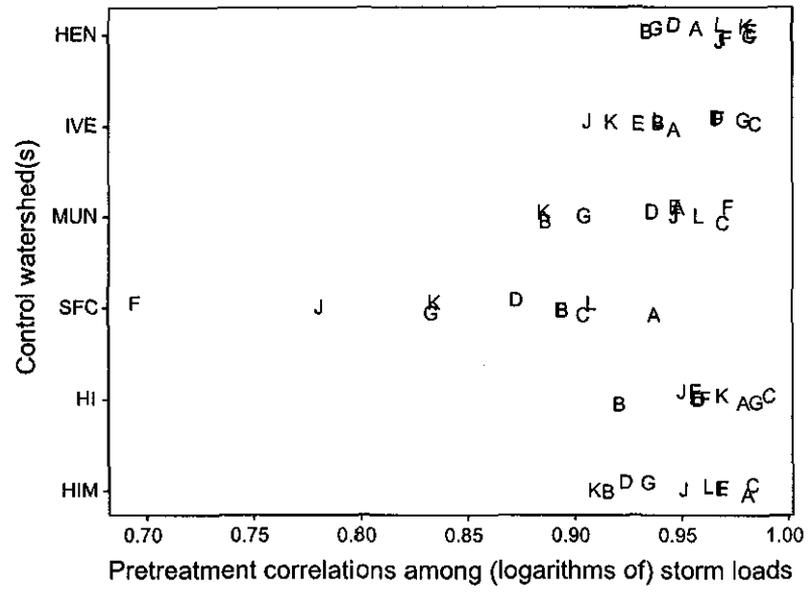
Figure 16. Pretreatment correlations between logarithms of storm sediment load at treated watersheds and alternative control watersheds. Letters designate watersheds (e.g. G is watershed GIB). Random noise has been added to the vertical plotting positions to improve readability.

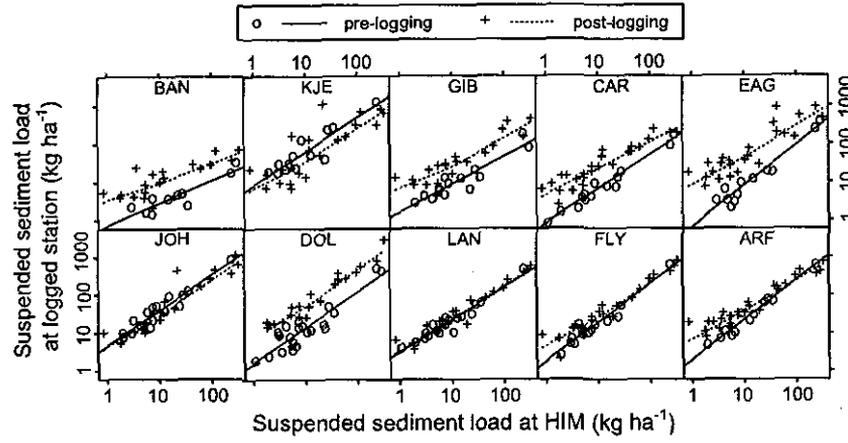
Figure 17. Relations between storm suspended sediment loads at logged subwatersheds in the North Fork and the the HIM control from 1986 to 1995. Post-logging relations were fitted by loess method [Cleveland, 1979]. The top row represents 95-100% clear-cut watersheds.

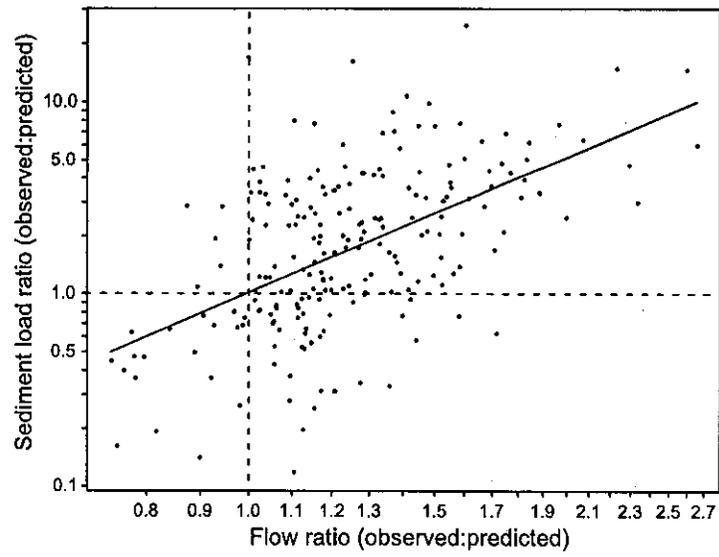
Figure 18. Relation between post-treatment sediment load departures from pretreatment relationship (3) and flow departures $\Delta q_{ij}^{(1)}$. Departures are expressed as the ratio of observed to predicted response.

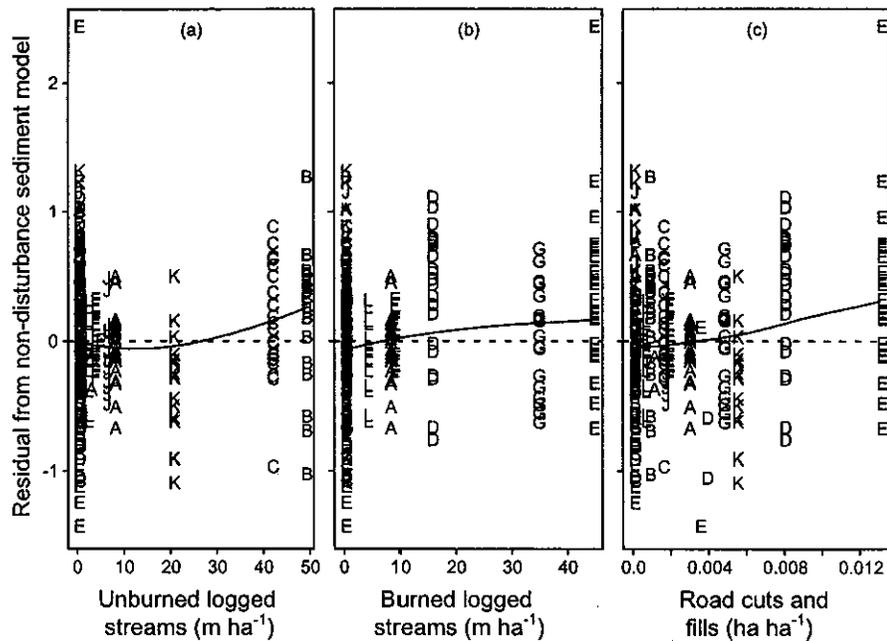
Figure 19. Relation between sediment load residuals and disturbance per unit watershed area.

Disturbance variables shown are (a) length of stream in unburned clear-cut areas, (b) length of stream in burned clear-cut areas, and (c) road cut and fill area. Letters designate watersheds (e.g. G is watershed GIB).

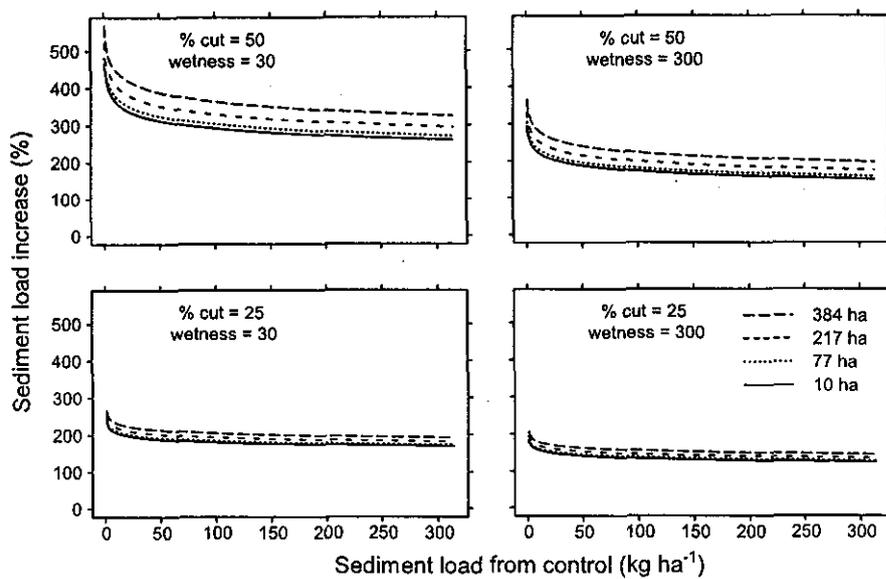
Figure 20. Effect of watershed area on predictions from sediment model $\{(24),(17),(18)\}$ for two levels of cutting and two levels of antecedent wetness. Watershed areas are those of ARF, FLY, DOL, and BAN (Table 1). Predictions are for first year after cutting with $x_{ij}^{(1)} = x_{ij}^{(2)} = 12 \text{ m ha}^{-1}$.

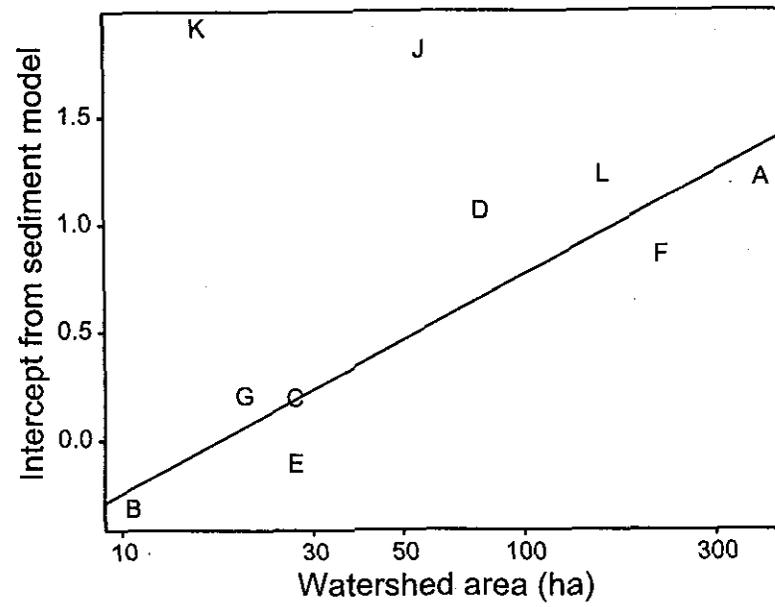
Figure 21. Relation between watershed area and fitted intercepts b_0 from model $\{(24),(17),(18)\}$, with β_6 fixed at zero. Watersheds JOH (J) and KJE (K) are omitted from regression. Letters designate watersheds (e.g. G is watershed GIB).

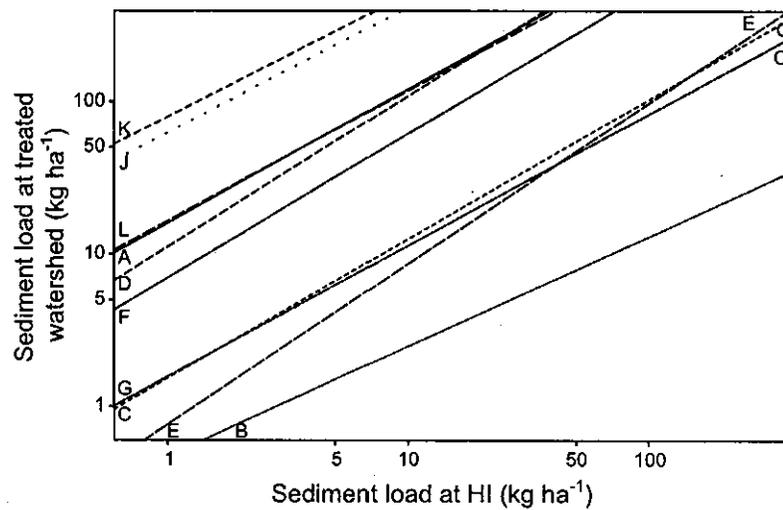
Figure 22. Regression lines for each watershed based on intercepts b_{0i} and slopes b_{1i} of sediment model $\{(24),(17),(18)\}$, with β_6 fixed at zero. Letters designate watersheds (e.g. G is watershed GIB).

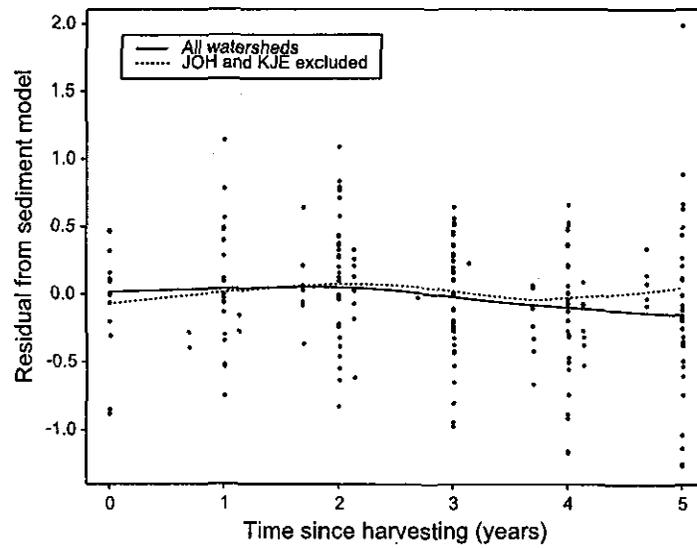
Figure 23. Relation between residuals from sediment model $\{(24),(17),(18)\}$ and time after logging. Curves are fit by loess method [Cleveland, 1979], with and without the anomalous watersheds JOH and KJE.

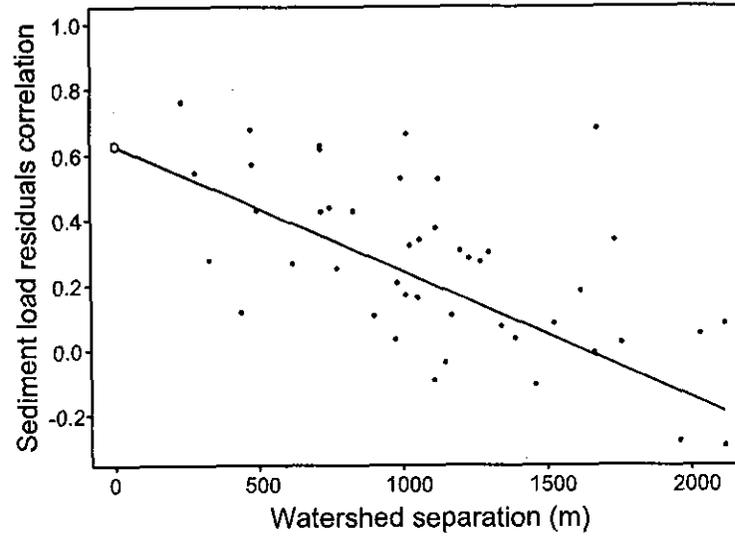
Figure 24. Relation between sediment residuals correlation and distance between watershed centroids. Residuals are from maximum likelihood fit to sediment model $\{(24),(17),(18)\}$. Curve depicts equation (17), with estimated parameters $\hat{\theta}_1$ and $\hat{\theta}_2$.

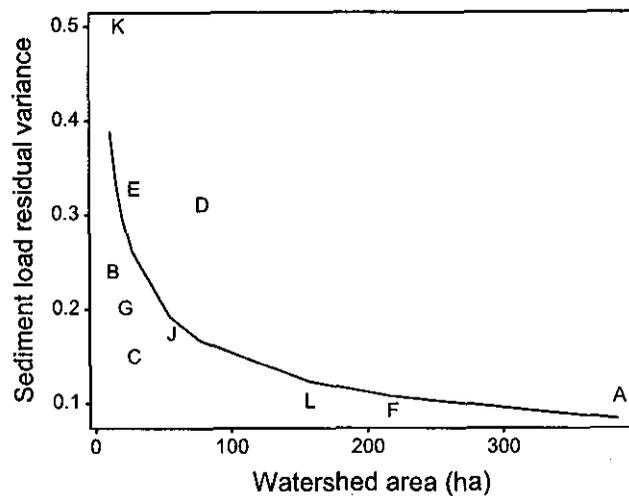
Figure 25. Relation between variance of sediment residuals and watershed area. Residuals are from maximum likelihood fit to model $\{(24),(17),(18)\}$. Curve depicts equation (18) with estimated parameters $\hat{\theta}_3$ and $\hat{\theta}_4$. Letters designate watersheds (e.g. G is watershed GIB).

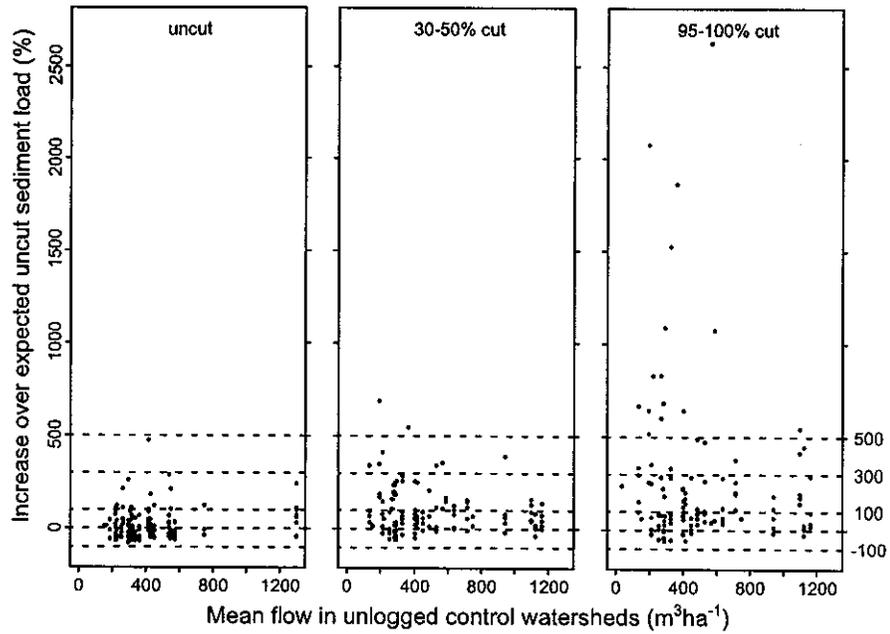
Figure 26. Percentage increase over expected uncut storm sediment load as related to mean of storm runoff volume in HIM control watersheds for uncut (before treatment), partly (30-50%) clear-cut, and (95-100%) clear-cut watersheds. Bias-corrected predictions are from model $\{(25),(17),(18)\}$ with disturbance set to zero.

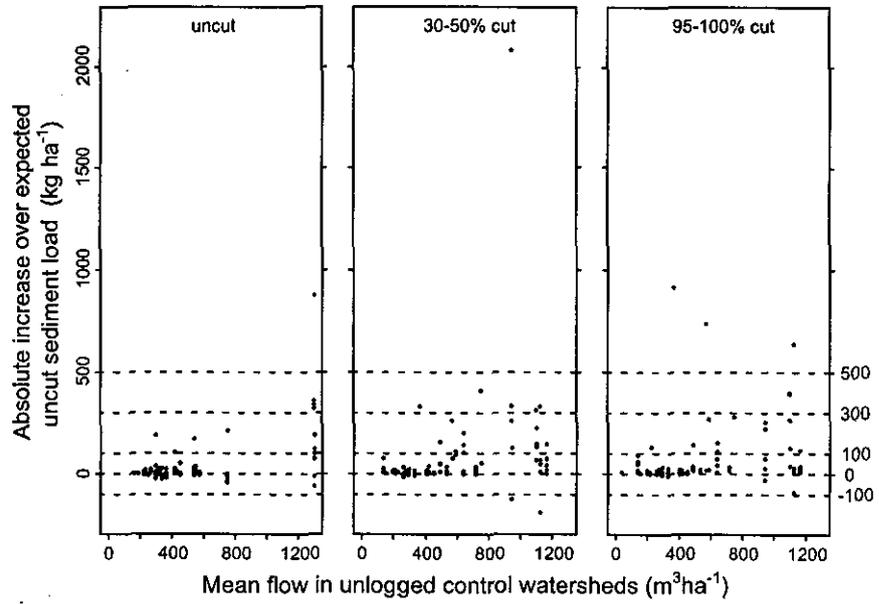
Figure 27. Absolute increase over expected uncut storm sediment load as related to mean of storm runoff volume in HIM control watersheds for uncut (before treatment), partly (30-50%) clear-cut, and (95-100%) clear-cut watersheds. Bias-corrected predictions are from model $\{(25),(17),(18)\}$ with disturbance set to zero.

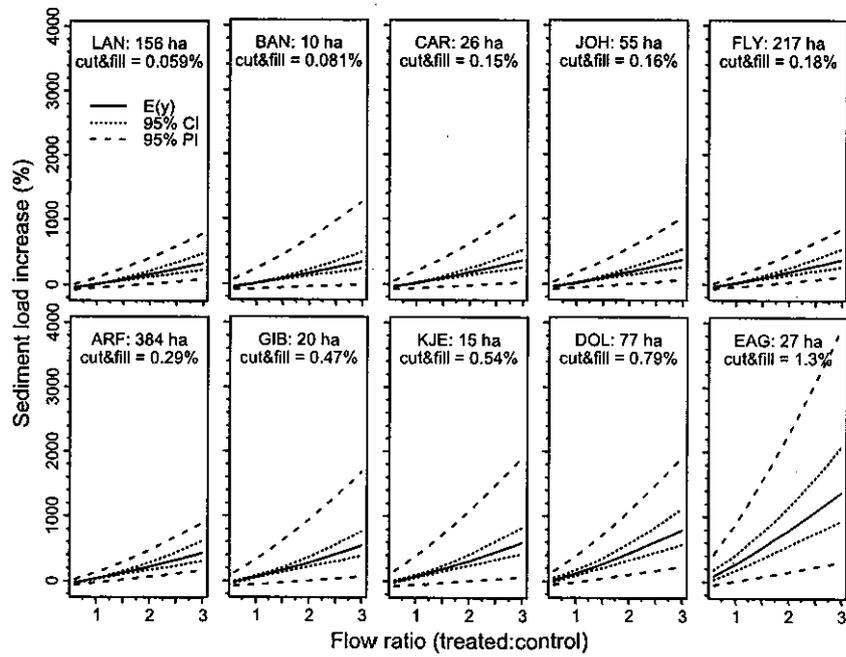
Figure 28. Predictions of sediment load as a function of flow ratio ($\Delta q_{ij}^{(2)}$) based on sediment load model $\{(25),(17),(18)\}$, with area interaction term for cumulative impacts (β_4) fixed at zero. Expected increases and 95% confidence (CI) and prediction (PI) intervals are shown for each treated watershed, ordered by proportion of the watershed occupied by road cuts and fills.

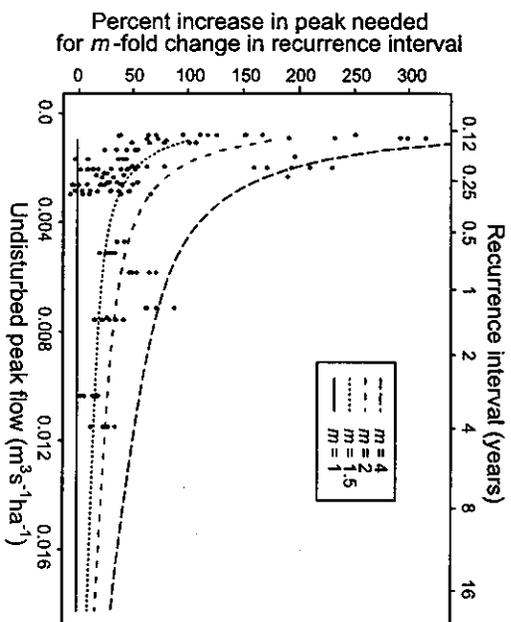
Figure 29. The curve shows the percentage increase in peak flow necessary to reach a size that formerly had 1 to 4 times the recurrence interval. The data points are from Figure 13 (third frame), representing the observed percentage increases in storm peak flow (based on the HI control, plotted on the abscissa) in 95-100% clear-cut watersheds.

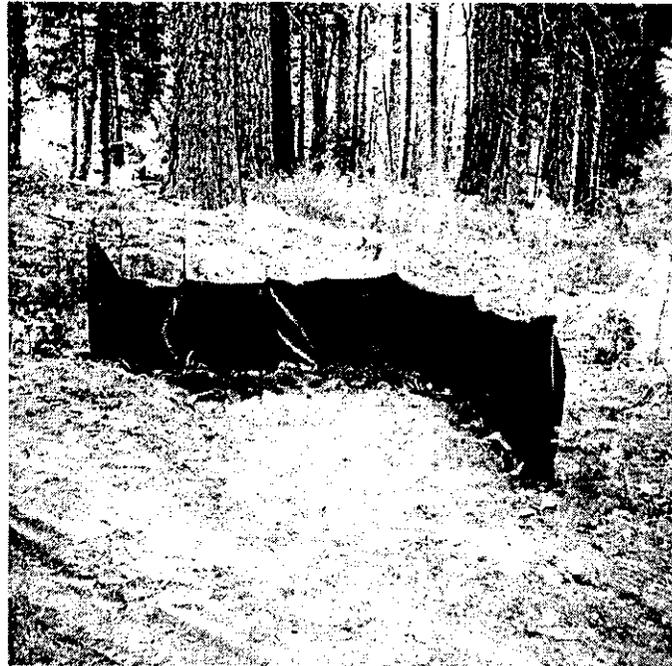
Figure 1. Example of one of 147 sediment fences installed to measure sediment production rates in the central Sierra Nevada Mountains (photo by Drew Coe used with permission).

Overall, the highest sediment production rates were often associated with insloped road segments located downslope of areas with shallow, impermeable bedrock. Because the product of area and slope was a dominant control on road segment sediment production, the older roads with inadequate drainage produced much more sediment per unit area than roads that followed current drainage specifications. Hence the best means to reduce erosion rates from native surface roads is to alter the road surface by rocking, decreasing the product of area and slope by improving and maintaining road drainage, and avoiding areas with shallow bedrock that increase sideslope drainage and increase ditch runoff. Areas with shallow bedrock also appear to facilitate the generation of extended gullies that can link roads to the stream network. These segments, together with road crossings, account for nearly all of the road-derived sediment that is being delivered to the stream network.

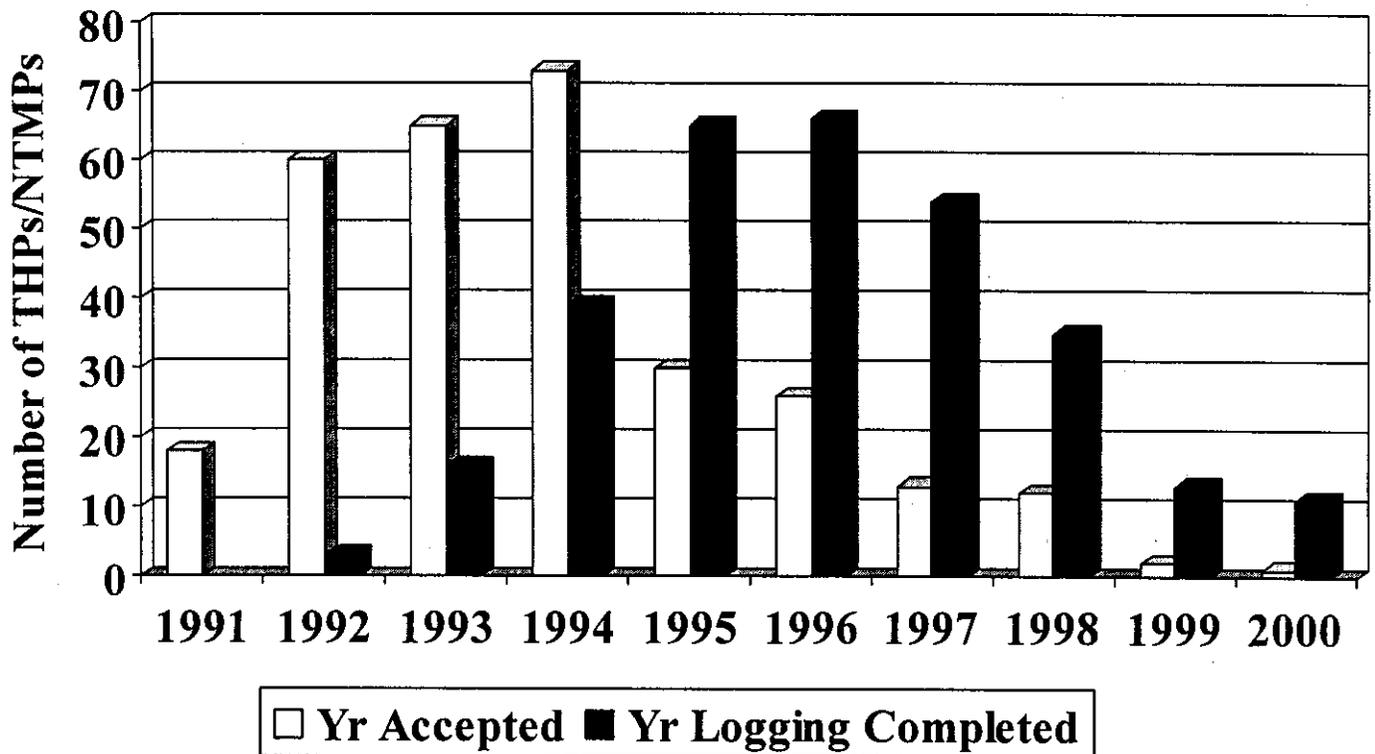
Figure 3. Distribution of when THPs and NTMP NTOs were accepted by CDF and when the logging was completed.

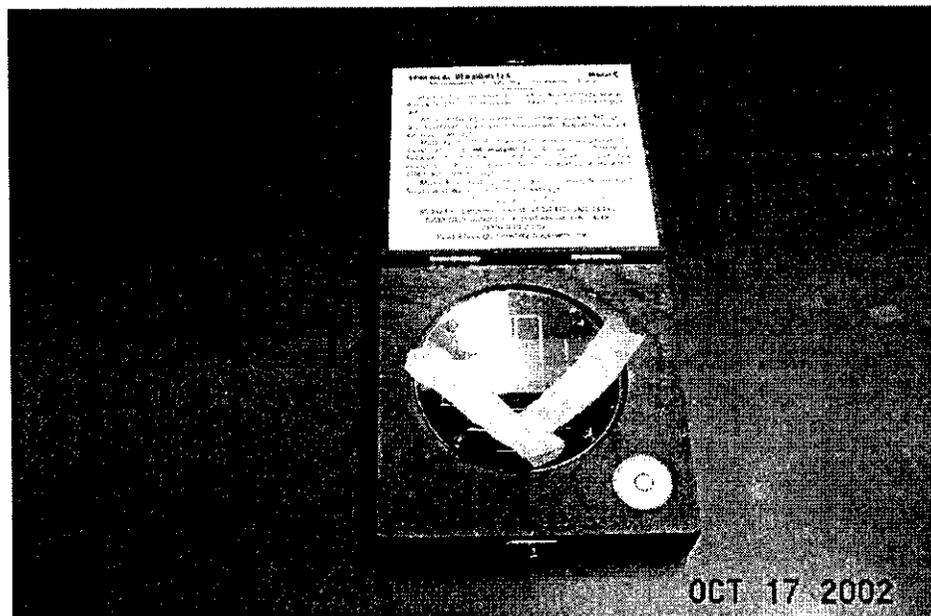
Figure 5. Concave spherical densiometer used for canopy measurements from 1996 to 1998 (the Strickler (1959) modification was utilized in 1997 and 1998 to reduce bias).

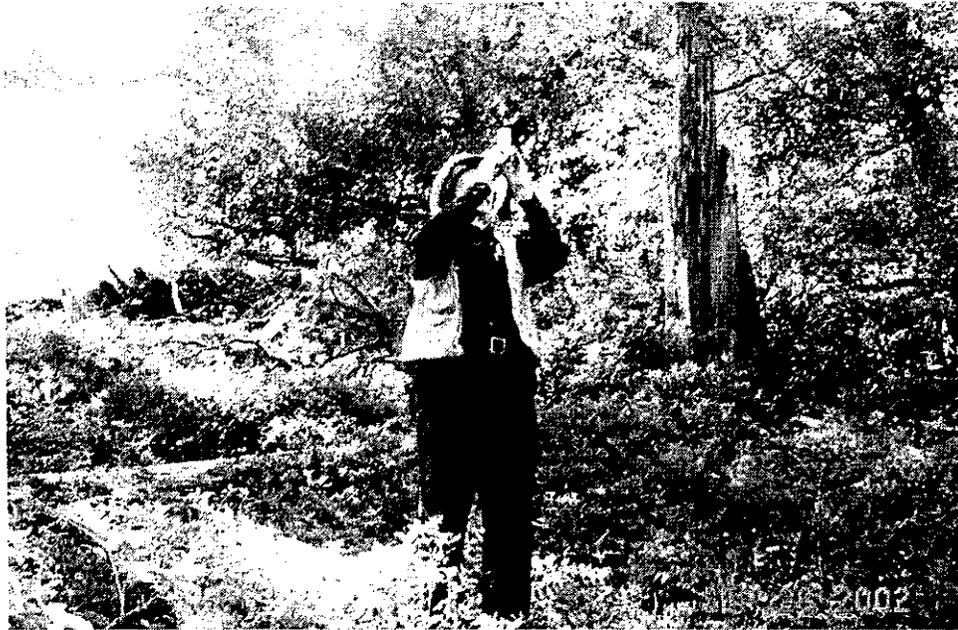
Figure 7. The sighting tube in use in the field. This instrument was utilized for obtaining an unbiased estimate of canopy cover from 1999 through 2001.

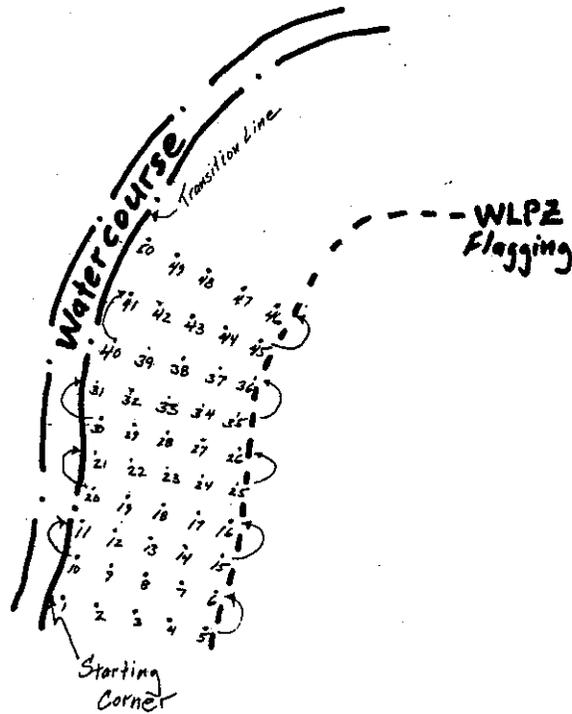
Figure 8. Example of the systematic grid used for a 125-foot WLPZ to determine canopy cover with a sighting tube for a randomly selected 200 foot reach of Class I or II watercourse (total number of sighting tube points varied from 44 to 56 depending on WLPZ width). Diagram drawn by Mr. Clay Brandow, CDF, Sacramento.

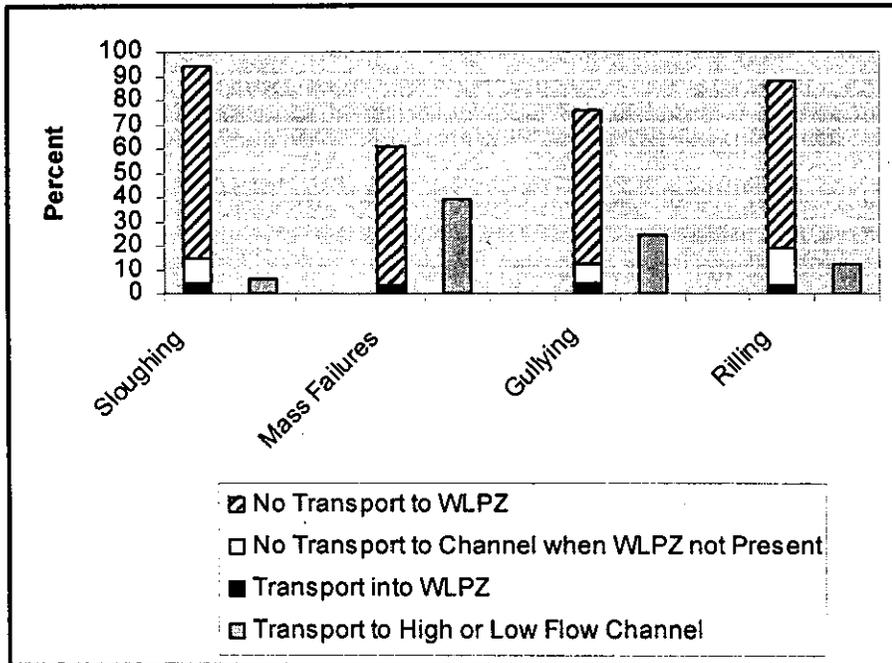
Figure 9. Percent of erosion features with dry season evidence of delivered sediment to the high or low flow channel of a watercourse from road transect erosion features related to the current THP or NTMP NTO.

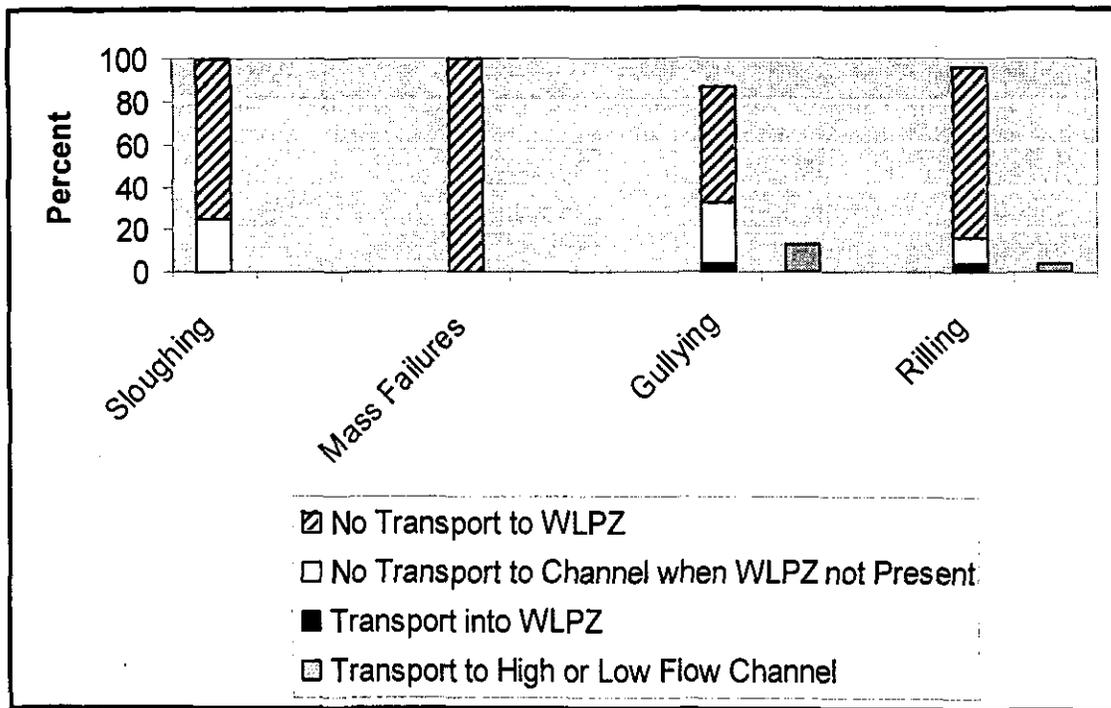
Figure 10. Percent of erosion features with dry season evidence of delivered sediment to the high or low flow channel of a watercourse from skid trail transect erosion features related to the current THP or NTMP NTO.

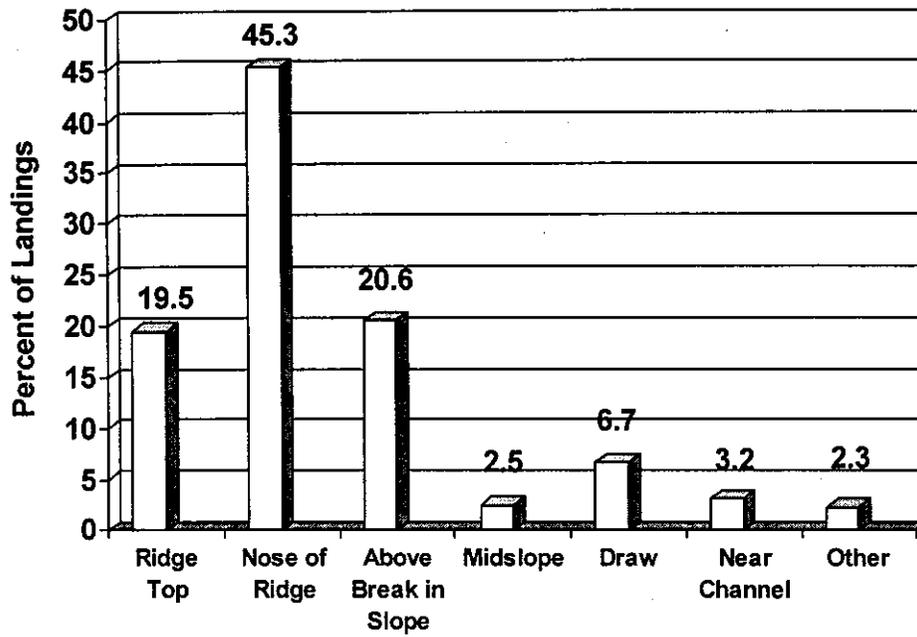
Figure 11. Distribution of landing geomorphic locations.

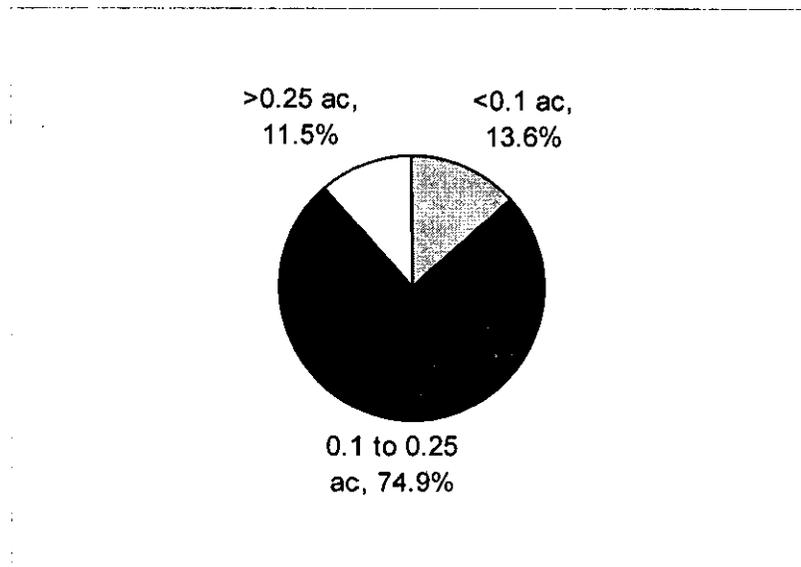
Figure 12. Landing size.
