DEPARTMENT OF FORESTRY AND FIRE PROTECTION

February 11, 2004

Subject: DRAFT Water Quality Control Policy for Developing California's Clean Water Act Section 303(d) List

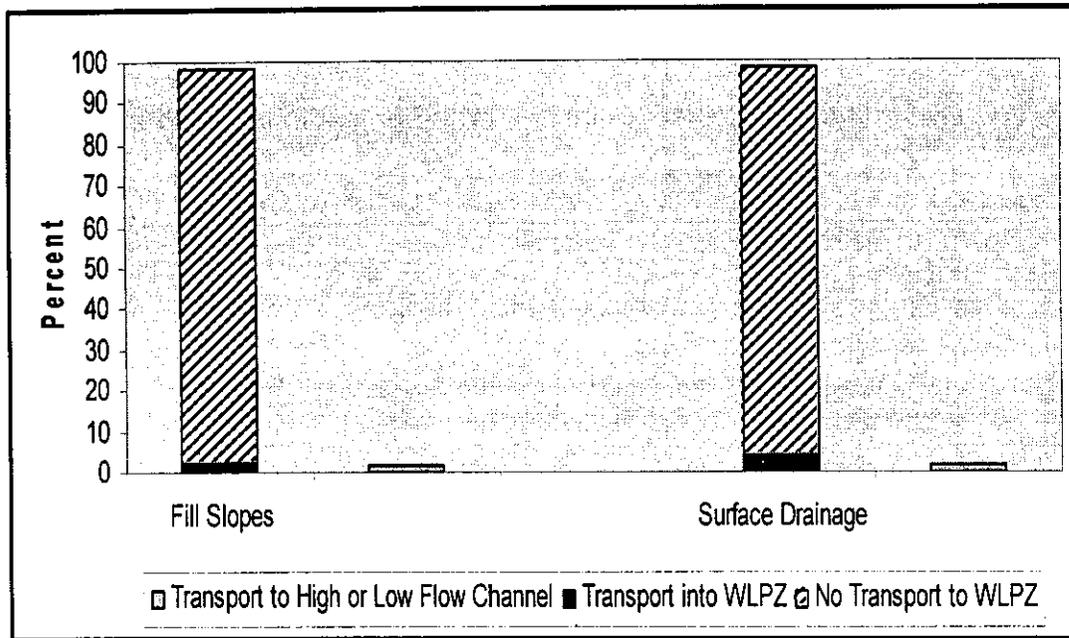
Figure 13. Percent of landing features related to the current THP or NTMP project that had dry season evidence of sediment delivered to either the WLPZ or the high/low flow channel of a watercourse.

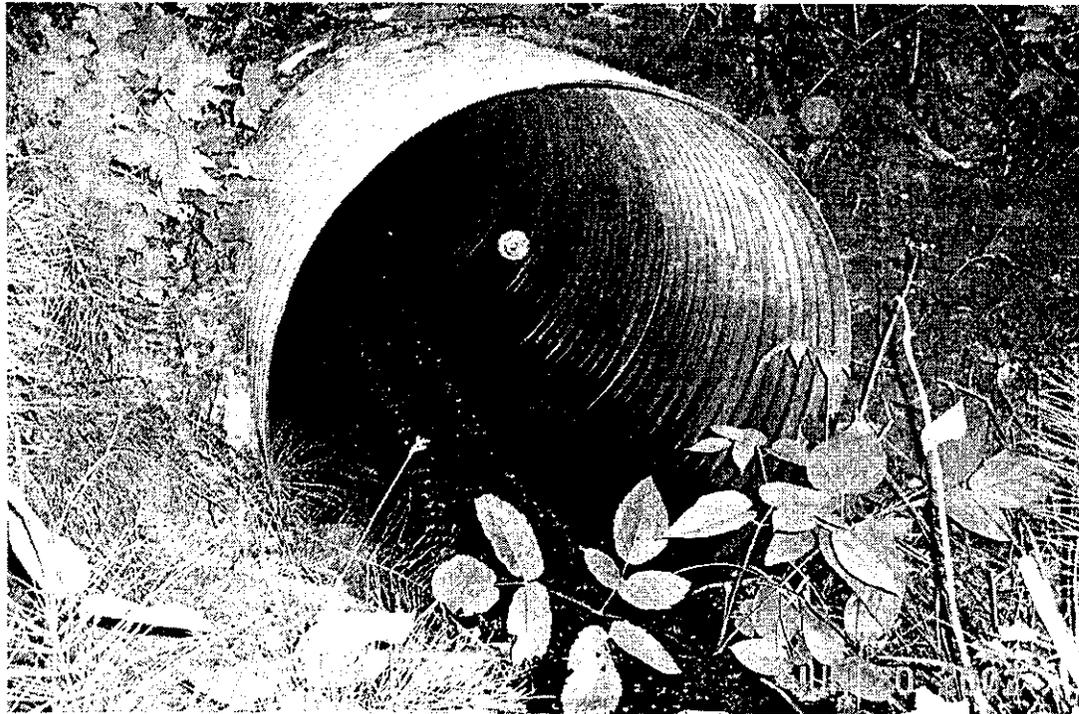
Figure 14. Typical watercourse crossing sampled in the Hillslope Monitoring Program. This culvert was a crossing included in the sample for the 2002 field season.

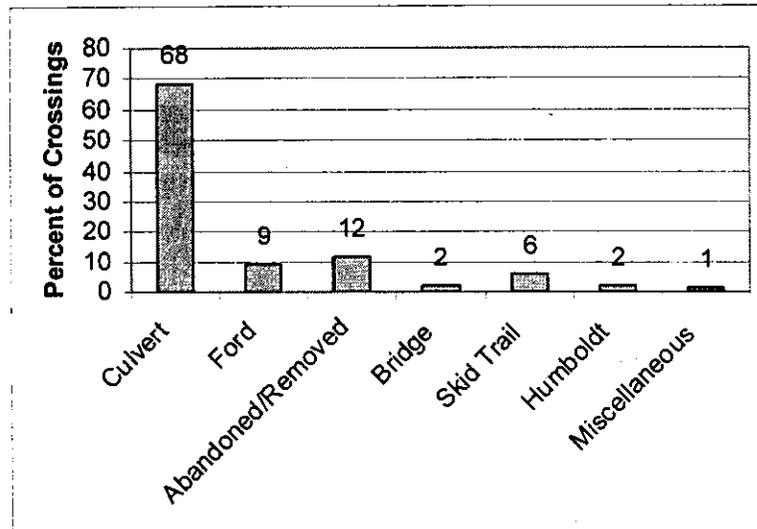
Figure 15. Distribution of watercourse crossing types evaluated from 1996 through 2001. The total number of crossings was 491.

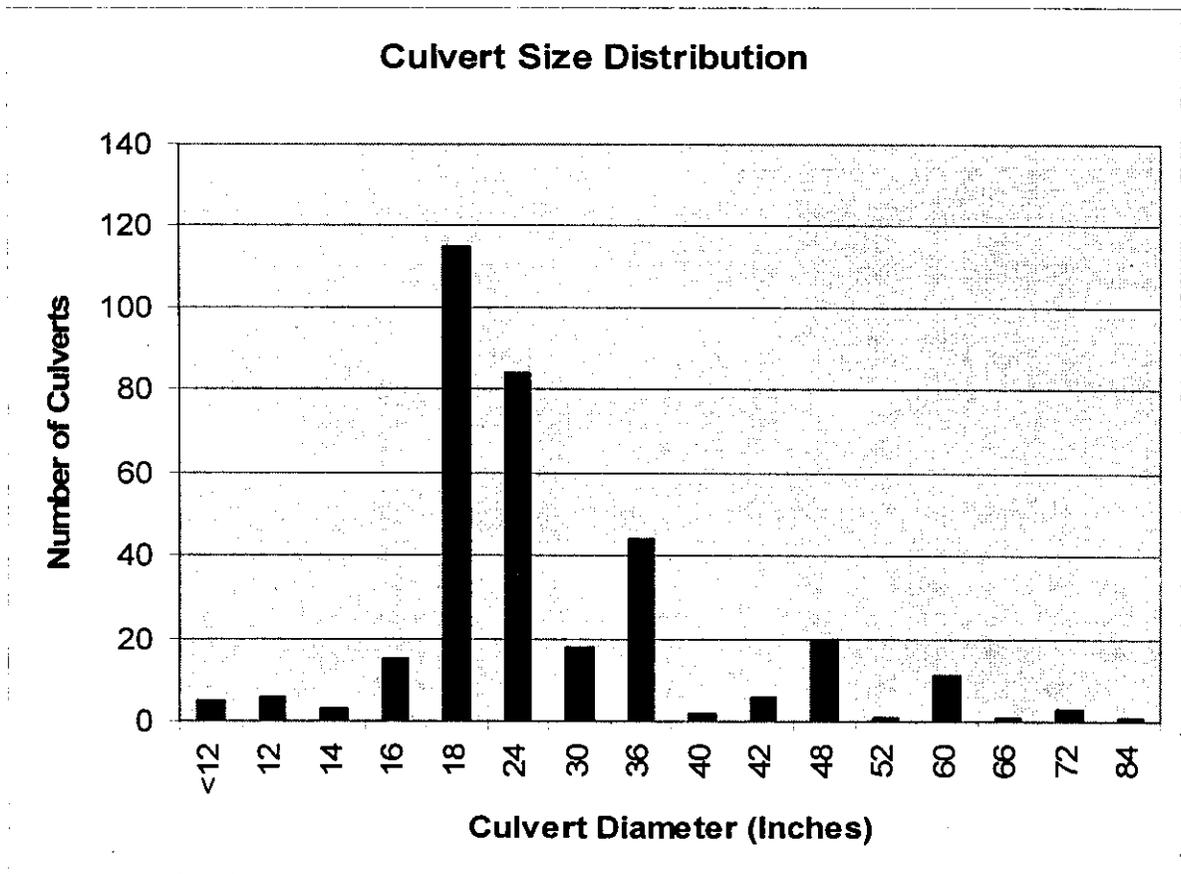
Figure 16. Culvert size distribution for watercourse crossings with pipes.

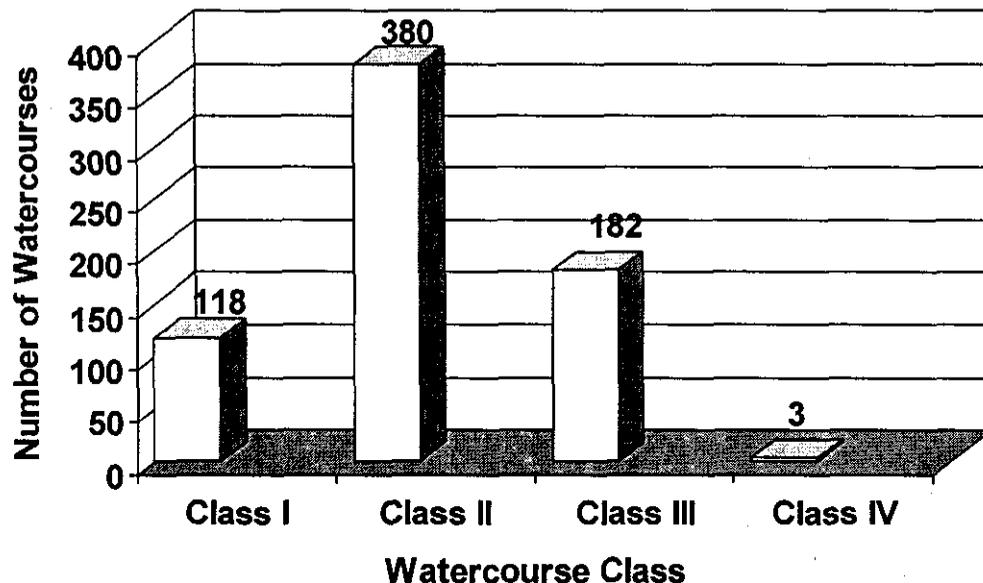
Figure 17. Distribution of watercourse classes evaluated from 1996 to 2001.

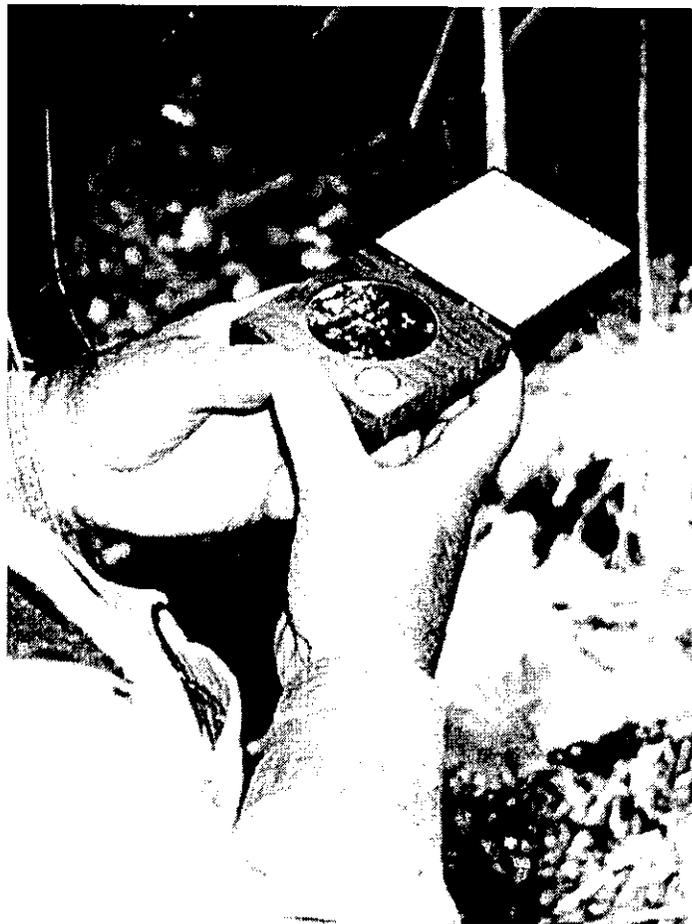
Figure 18. Measuring canopy cover with the spherical densiometer in western Mendocino County in 1996.

Year/Location	Class I Canopy Cover (%)	Class II Canopy Cover (%)
1996—North Coast Spherical Densiometer	79	77
1997 to 1998—Statewide Spherical Densiometer	74	75
1999 to 2001—Statewide Sighting Tube	73	75

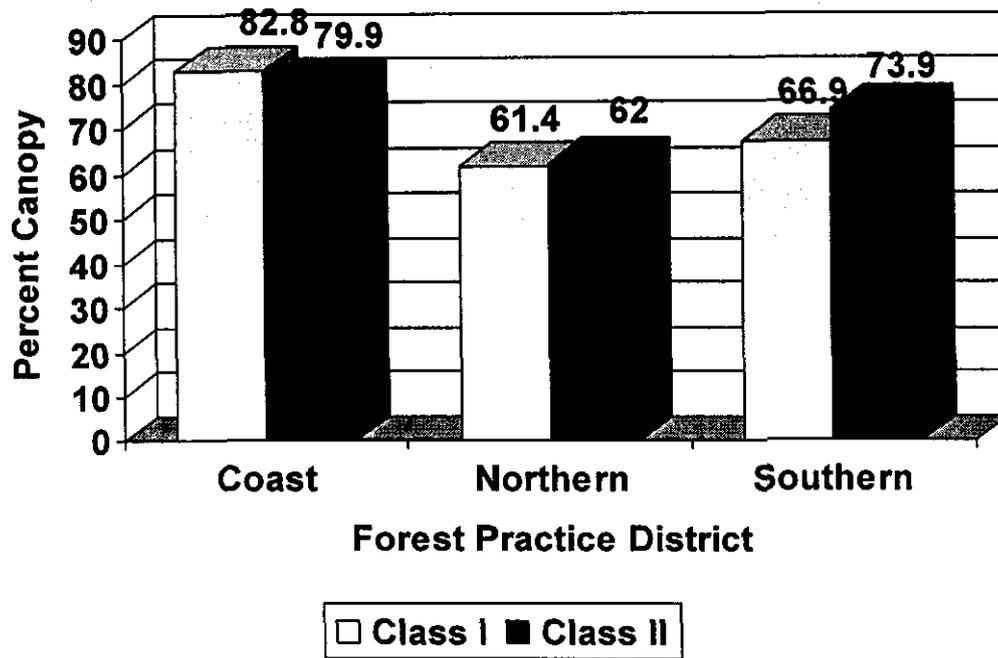
Figure 19. Total canopy cover percentages for Class I and II watercourses from 1999 through 2001 by Forest Practice District (data measured with a sighting tube).

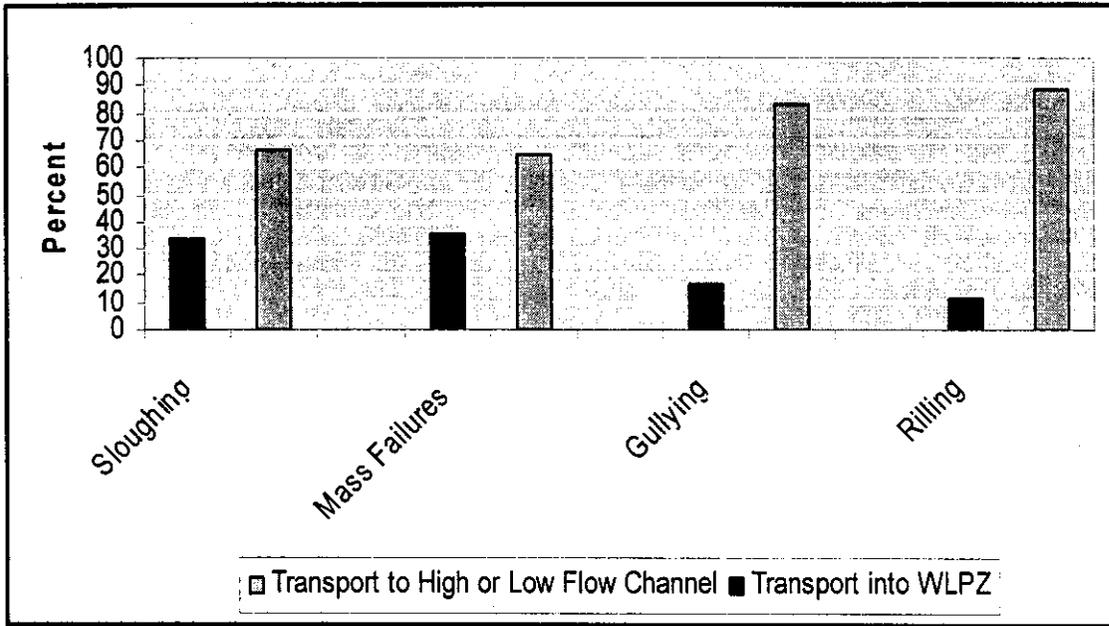
Figure 20. Percent of erosion features with dry season evidence of delivered sediment to the high or low flow channel of a watercourse from watercourse protection zone transect features associated with the current THP or NTMP project.

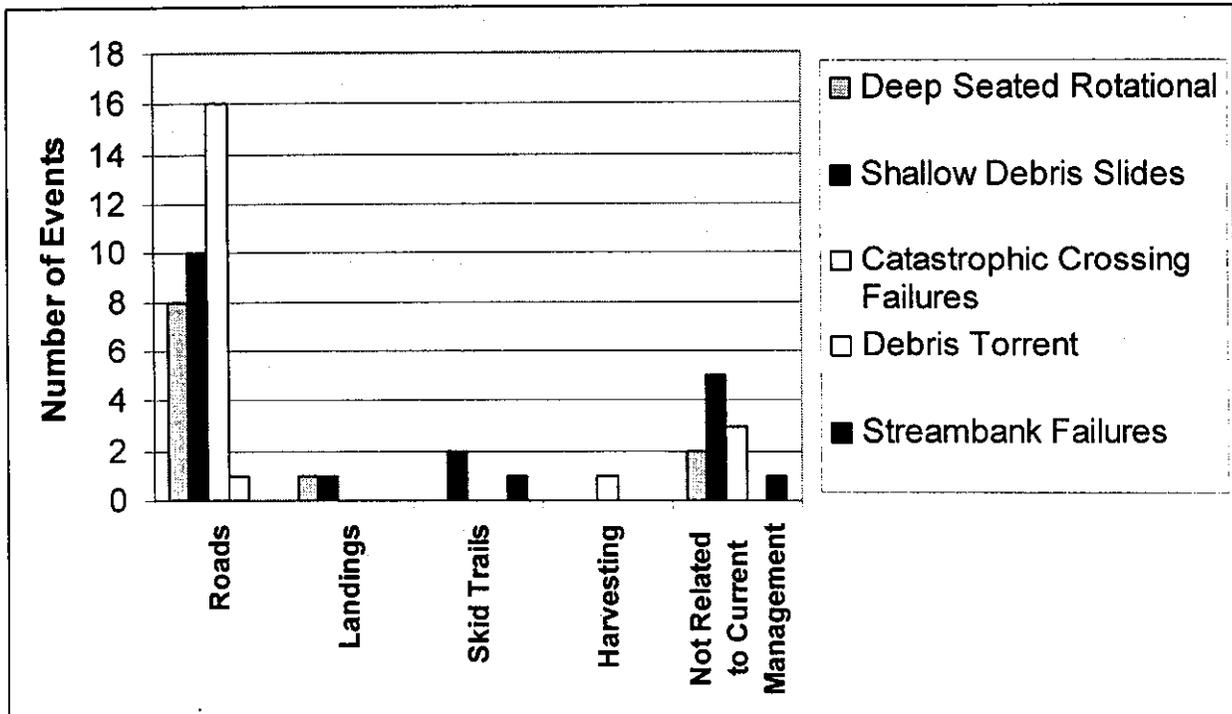
Figure 21. Primary causes of large erosion events and type of feature (note that multiple causes were assigned in some instances).

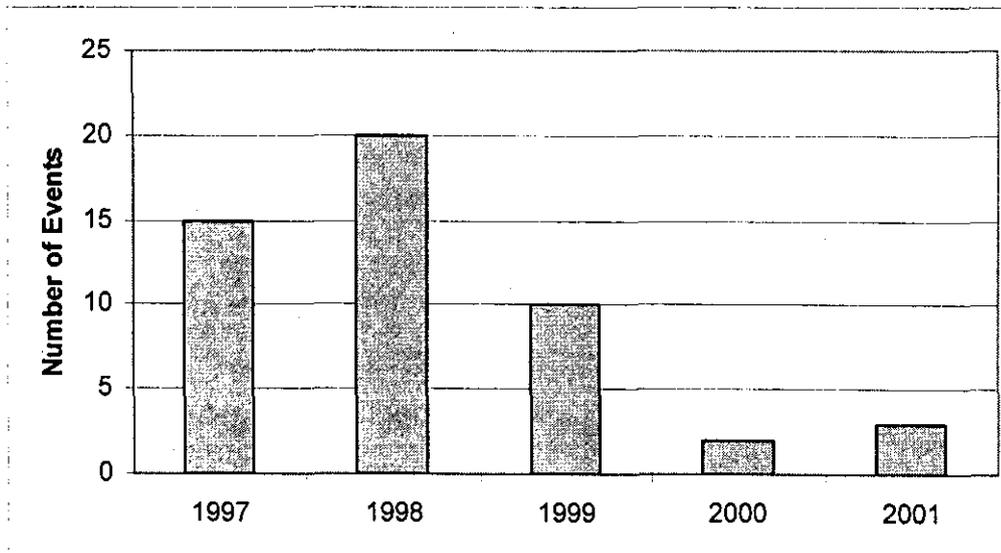
Figure 22. Year data was recorded on the large erosion events inventoried.

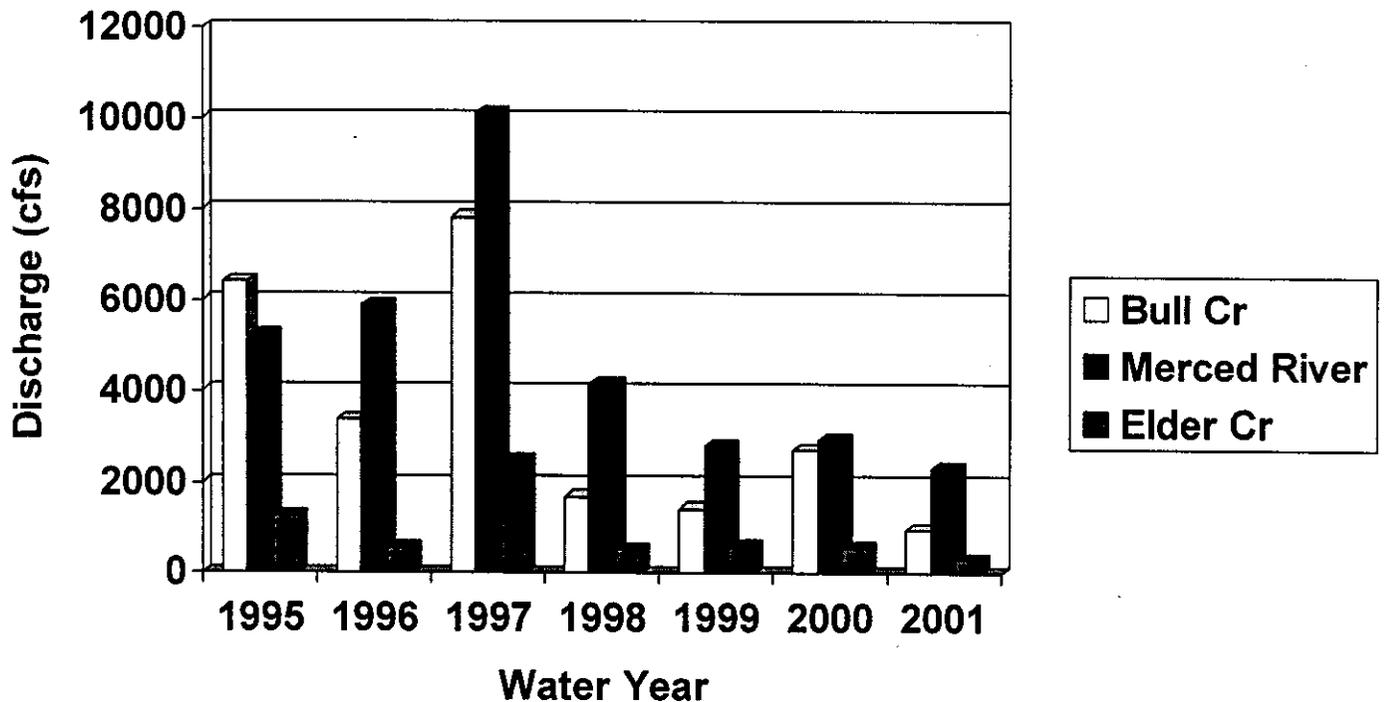
Figure 23. Stream gauging station maximum annual instantaneous peak discharge data for three free flowing river systems. The Merced River at Happy Isles is located in Yosemite National Park in the central Sierra Nevada Mountains, Bull Creek is located in southern Humboldt County, and Elder Creek is located in western Mendocino County.
