THE JACOBY CREEK WATERSHED

PAST, PRESENT, AND FUTURE

REDWOOD COMMUNITY ACTION AGENCY

OCTOBER, 1988

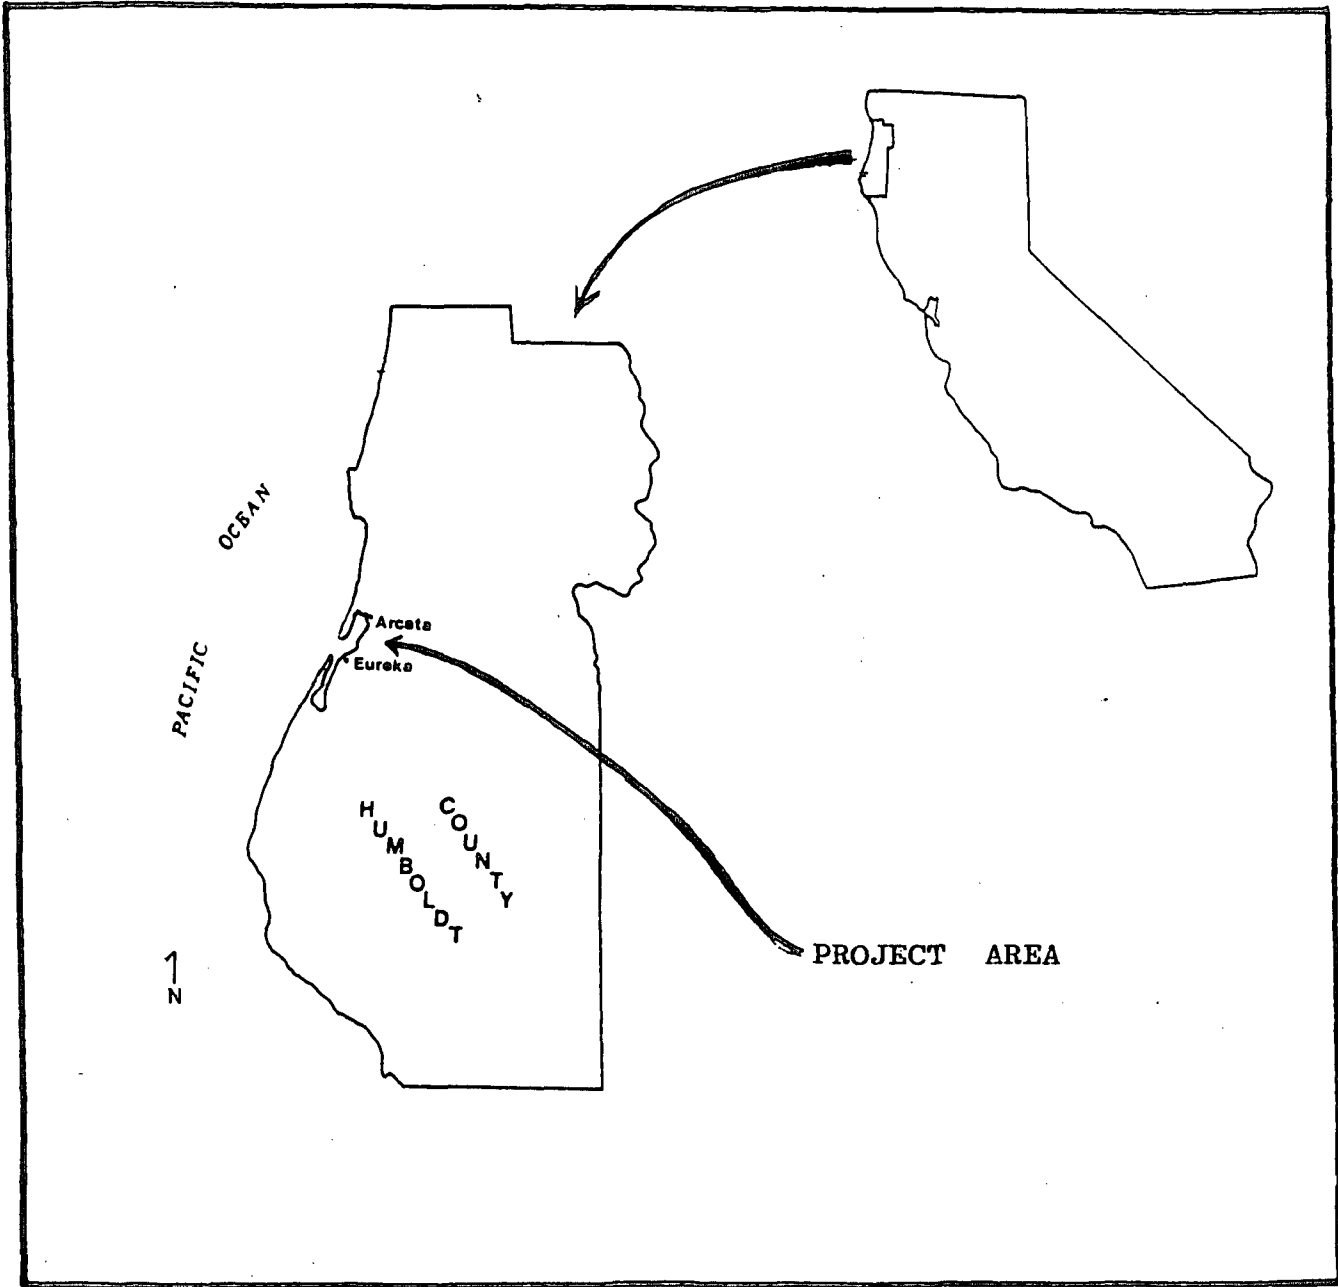
Figure 1

Location of Jacoby Creek Improvement Project

The Jacoby Creek watershed is located (see Fig.1) in the coast ranges of northern California between the cities of Eureka and Arcata. The watershed is 16.6 sq. miles in area (Tuttle and Dickert, 1987) and empties into the northeastern portion of Humboldt Bay. The main stream channel is 11.1 miles long.

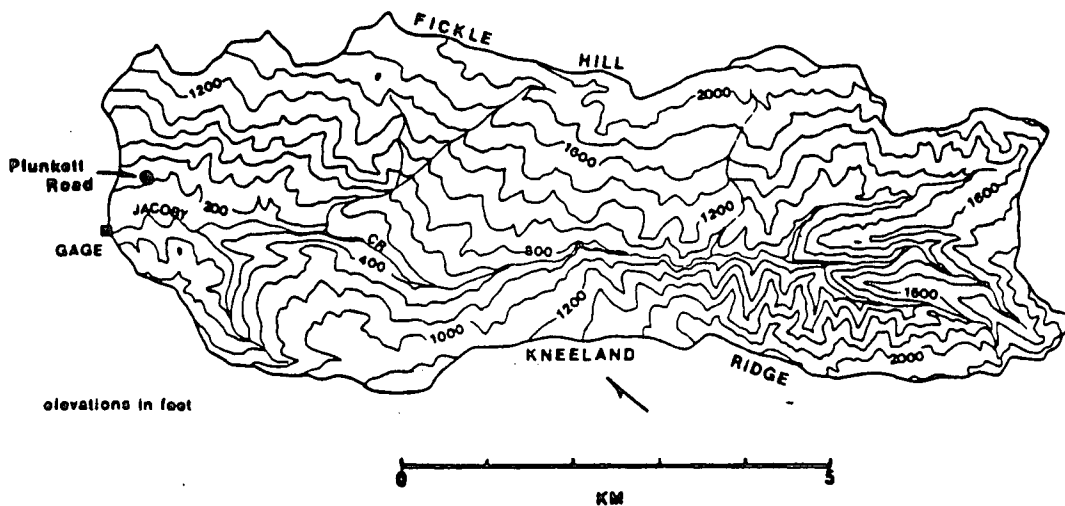
Figure 3

Topographic and Geologic Maps of Jacoby Creek Basin
 (From Lehre & Carver, 1985)

Topographic map of Jacoby Creek drainage basin above Tom Lisle's gage at Brookwood bridge, compiled from Arcata South, Korbel, and Inaja Buttes 7.5' quadrangles. Gage is located 4.7 km SE of Arcata, CA. Note that elevations are in feet.

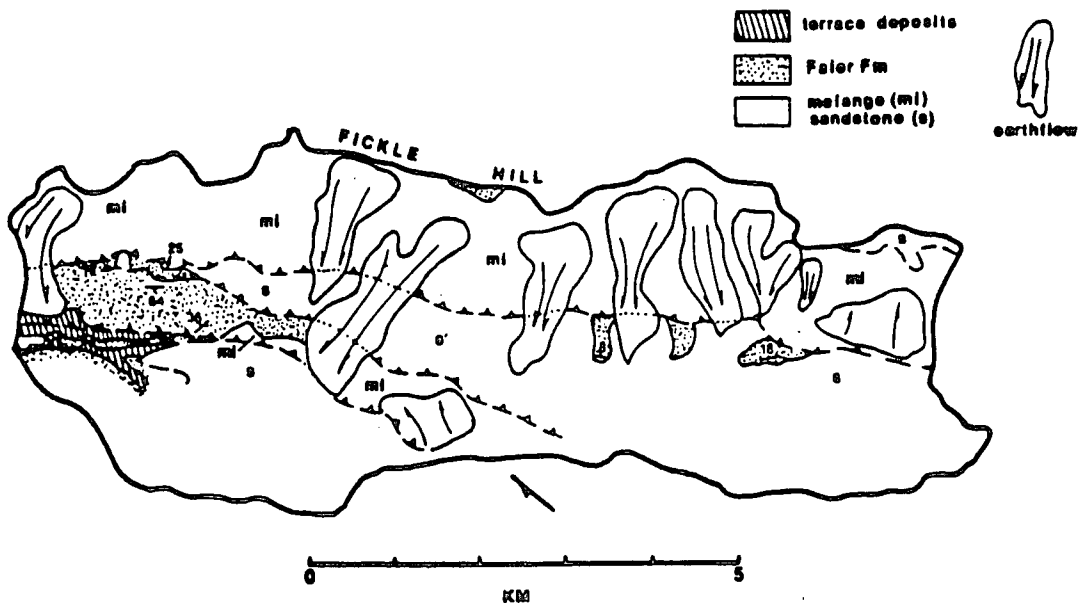
Geologic map of Jacoby Cr basin, simplified from mapping of Carver and Stephens (1985). Melange (mi) and greywacke sandstone (s) belong to the Franciscan group. Only active earthflows are indicated.

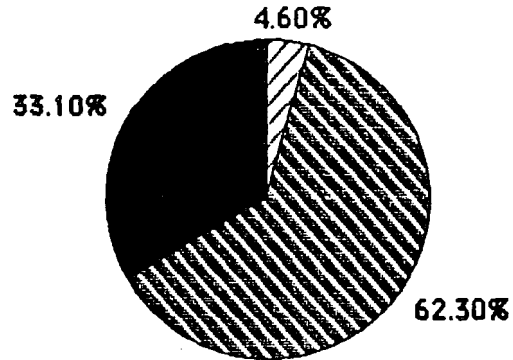
MIDDLE JACOBY CREEK (7600 m.-10061 m.)
PERCENTAGE OF TOTAL VOLUME
BY HABITAT TYPE

Middle Reach

This reach has a steeper gradient than the previous one with run types predominating 70% of the wetted surface area. Step Runs, long runs separated by short riffle sections, make up almost 75% of the run types in terms of area. The average run length was 37.6 m.

The predominant pool type here is the Lateral Scour Pool Associated with Boulder. These tend to be short (average length = 8 m) and shallow, with boulders providing instream shelter. Lateral Scour Pool Associated with Large Debris is the next most prevalent pool type here. Combined surface area of all pools in this reach accounts for only 17% of the wetted surface area.

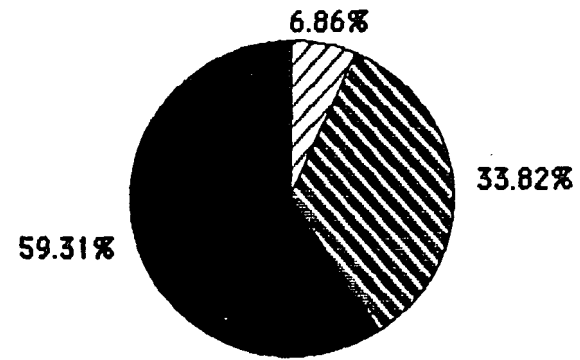
UPPER JACOBY CREEK (10061 m.-11390 m.)
PERCENTAGE OF TOTAL VOLUME
BY HABITAT TYPE

Upper Reach

The beginning of the upper reach is at a steep, boulder-filled cascade below the Blue Slide which appears to be a migration barrier for coho salmon. Some steelhead managed to negotiate the cascade in the 1986-87 winter, as young- of-the- year steelhead were found during electrofishing upstream of the cascade. Runs make up over 40% of the surface area. Step Runs are the predominant type. Plunge Pools and Lateral Scour Pools with Boulders each comprise about 11 % of the area, despite the fact that the latter occurs twice as often.

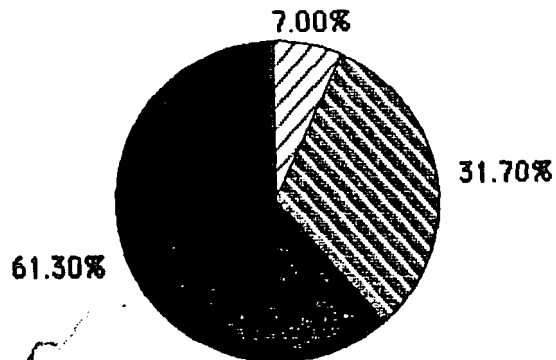
LOWER JACOBY CREEK (HIWAY 101-7600 m.)
PERCENTAGE OF TOTAL VOLUME
BY HABITAT TYPE

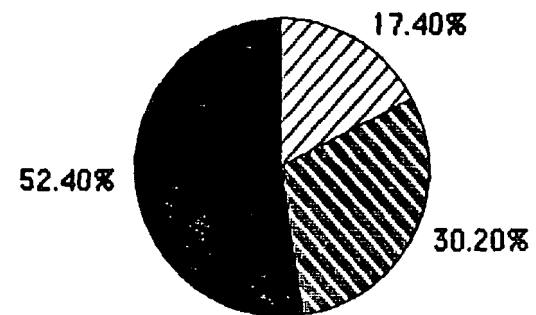
JACOBY CREEK: NON-ANADROMOUS SECTION
(11,390 m.-14,400 m.)
PERCENTAGE OF TOTAL VOLUME
BY HABITAT TYPE
