# Mass Movement in the Redwood Creek Basin, Northwestern California

By DEBORAH R. HARDEN, STEVEN M. COLMAN, and K. MICHAEL NOLAN

U.S. GEOLOGICAL SURVEY PROFESSIONAL PAPER 1454-G

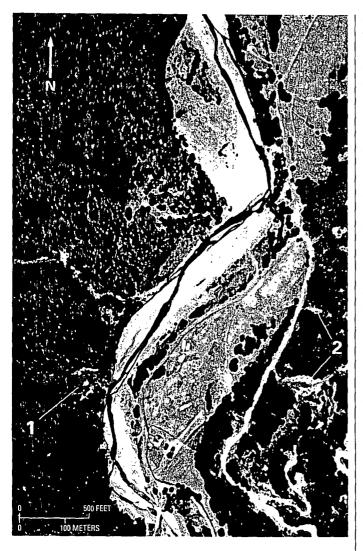
FIGURE 6.—Protective influence of flood plains on streamside hillslopes. Streamside landslides are numerous where Redwood Creek abuts hillslopes directly (1). On opposite bank, landslides (2) are separated from the active channel by a low flood plain. The photograph depicts the main channel of Redwood Creek immediately below the mouth of Minor Creek.
